Summary of Alloy 617 and Alloy 709 Elevated Temperature Crack Growth Test Results from the Planned FY24 Crack Growth Test Activities

INL/RPT-24-81003

Advanced Reactor Technologies

This report covers the creep crack growth rate and creep-fatigue crack growth rate testing performed on Alloys 617 and 709 during fiscal year 2024. Crack growth rates over time are reported for several conditions. Challenges in performing the tests were identified, as well as recommendations to improve the testing/analysis for future testing.

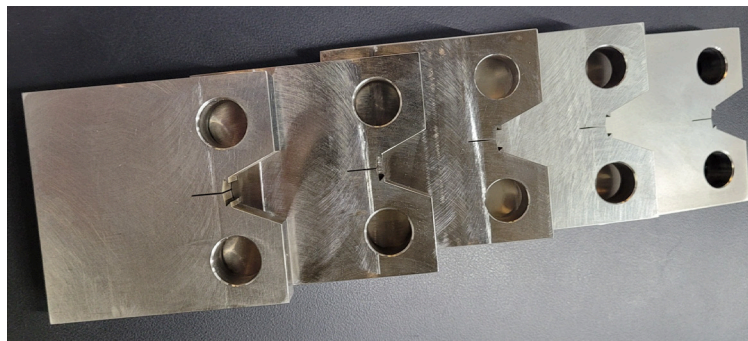
Figure 1. (a) Schematic of CT specimens to permit load line displacement measurements, with actual specimens shown in (b).

The design of the CT specimen used in this work is shown in Figure 1. The geometry near the mouth of the notch, between the pin loading holes, allows for the use of an extensometer to measure load-line displacement. DCPD wires are welded on to the front face, spanning across the machined mouth/notch from which the crack will initiate and propagate. DCPD is a method of continuously monitoring the crack length based on the potential drop measured as the crack propagates and forces the current to travel further around the crack.

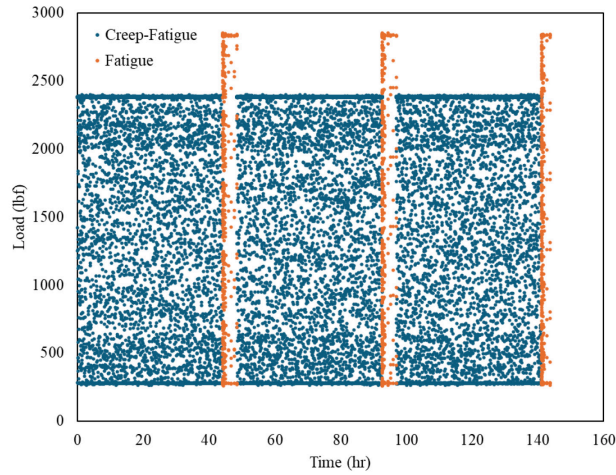
Figure 3. Load vs time for Alloy 709 C-FCGR, Test 1.

Similar pre-crack procedures were performed on all specimens although later tests went from higher to lower K values, and included a third and final step at a K of $20 \text{ MPa}\sqrt{\text{m}}$. The fatigue cycles were intended to act as markers on the fracture surface to validate crack length. However, an issue identified after the test was performed was that the peak load during the creep-fatigue section of the test was 2381 lbf, instead of 2831 lbf, as seen in Figure 3. This results in slow C-FCGR, as compared to CGR during the fatigue cycles that were performed with the correct maximum load. The crack length vs time, relative to the load-line displacement vs time, are shown in Figure 4. While crack growth does occur during the creep-fatigue portion of the test, particularly as the total crack length increases (because this is a load-controlled test, and not stress-intensity controlled), there is concern that the plastic zone ahead of the crack tip during the fatigue cycles may influence the CGR during the creep-fatigue cycles, due to the higher maximum load during the fatigue cycles.

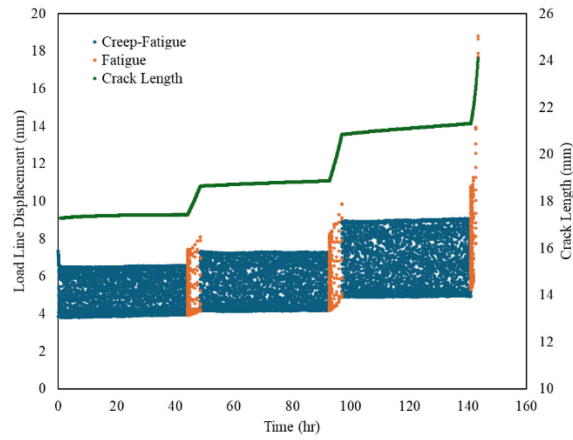
Figure 4. Crack length and load-line displacement versus time of Alloy 709, C-FCGR Test 1.

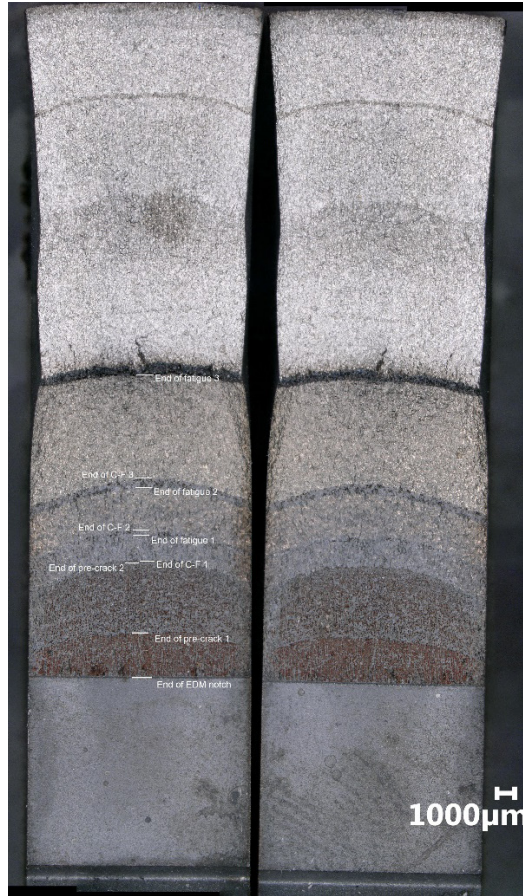
Figure 5. Fracture surface of Alloy-709 specimen from the C-FCGR, Test 1.

The DCPD values were checked against measurements taken on the fracture surface (Figure 5), and the results are shown in Table 2. Nine measurements were taken on the fracture surface for each segment, spaced roughly evenly across the width of the specimen; at times the measurement location was moved a little to the side where the fracture surface lines were clearer. In general, the DCPD results match well with the fracture surface measurements. The DCPD data were collected beyond the end of the test, and it was noted that the crack length continued to increase, though these data were cut from the analysis. This is why the final, measured crack length is much greater than the DCPD final measurement.

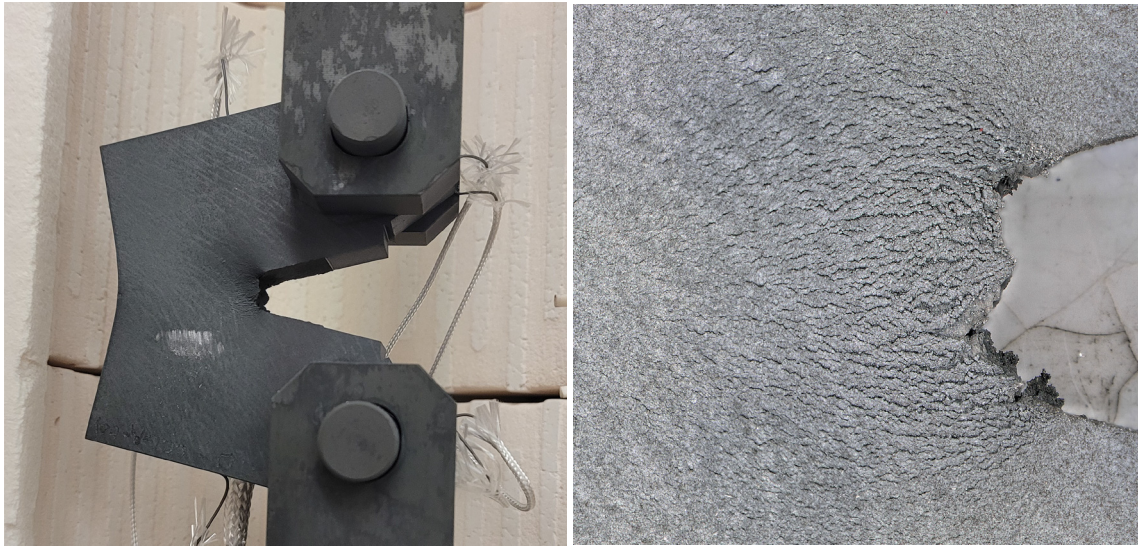
Figure 6. Alloy 709 CCGR, Test 1, CT specimen after termination of the test. Higher-magnification image of the notch tip is shown on the right.

The second test on A709 was a CCGR test performed at 800°C and held with a constant load of 2119 lbf. This test underwent rapid creep deformation, resulting in the load-line displacement extensometer reaching its maximum extension prior to the test specimen's failing. The deformation greatly outpaced the crack growth, resulting in a very blunt crack tip, as shown in Figure 6. While the test was shorter than expected, it did show that the test frame maintained good load control throughout the test (Figure 7), and the load-line displacement and crack-growth rate were collected during the entire load hold (Figure 8) although the extensometer reached its limit around 25 hours, due to the large amount of creep deformation resulting in a large load-line displacement. As in a standard creep test, the load-line displacement saw a rapid increase in creep strain at first (primary creep), followed by a steady-state region (secondary creep). A gradual increase in creep rate (tertiary creep) is just visible prior to the extensometer reaching its limit.

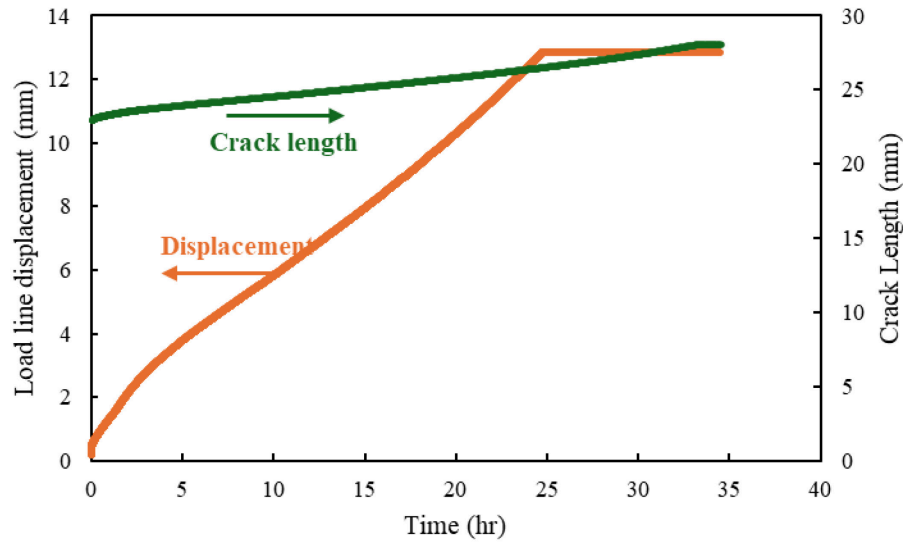
Figure 8. Load-line displacement and crack length over time for Alloy 709, CCGR Test 1.

The creep crack resulted in a more-extreme, non-uniform crack front than has been observed from the fatigue and creep-fatigue cracking. More-severe deformation was also observed at the edges of the specimen around the creep crack. As a result, rather than taking measurements along the width of the specimen that would result in large variations, crack lengths were measured on the fracture surface, as shown in Figure 9, along the center of the thickness. These results are shown in Table 3. While the DCPD underestimates the crack length during the fatigue pre-cracking, it severely overestimates the cracking during the creep step. This is a result of severe deformation occurring during the CCGR step of the test. The creep deformation also resulted in a rapid increase in load-line displacement during the relatively slow crack growth of the test that is seen in Figure 8.

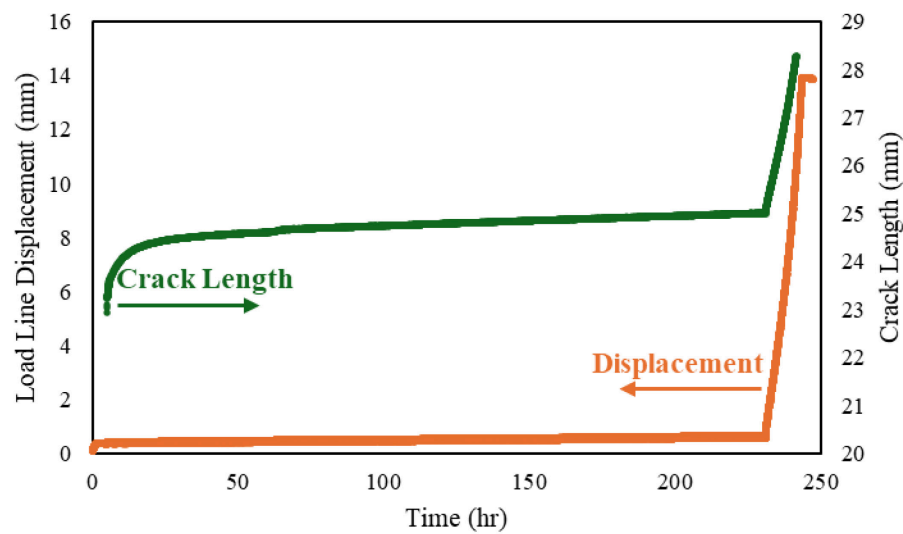
Figure 11. Load-line displacement and crack length vs. time for Alloy 709, C-FCGR Test 2.

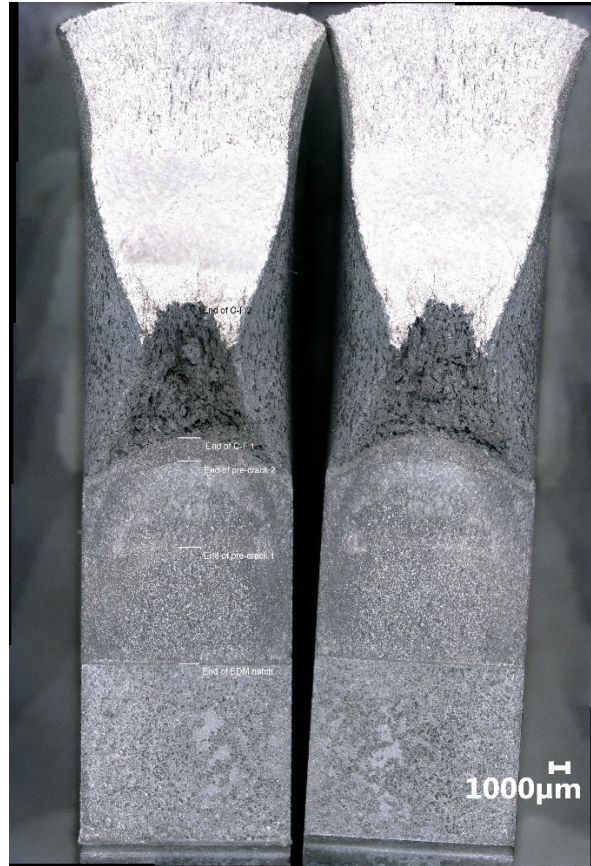
Figure 12. Fracture surface of Alloy 709 from C-FCGR Test 2.

final results of the DCPD and measurements taken from the fracture surface are shown in Table 4. The DCPD measurements appear similar to the post-test measurements, with the exception of the high-load creep-fatigue segment, where the DCPD heavily underestimates the crack length. This is possibly due to the uneven crack front.

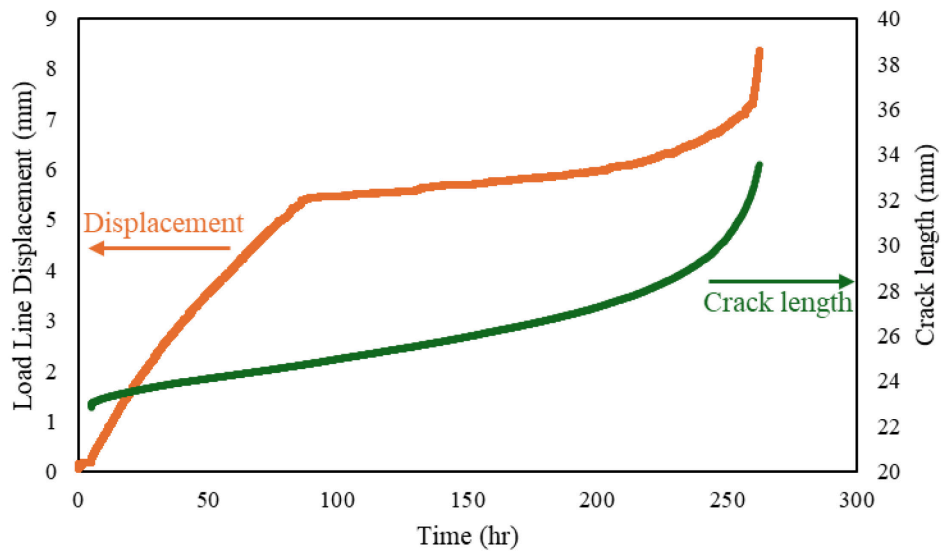
Figure 14. Load-line displacement and crack length vs time for Alloy 617, CCGR Test 1.

The Alloy 617 CCGR test was performed in FY 2024 at 850°C and a constant load of 981 lbf (shown in Figure 13, with the inclusion of a 5-hour hold to ramp and soak at temperature). Load-line displacement and crack length are shown in Figure 14. The crack length increases slowly at first, but begins to increase rapidly towards the end of the test as the total crack length increases (resulting in higher stresses at the crack tip). The load-line displacement follows a similar trend at the end of the test, but it is unclear why, at the beginning, it has a sharp knee in the displacement graph at around 90 hours. It appears to be an exaggerated change between primary and secondary creep, but typically would not appear as such a sharp change in deformation rates in typical creep curves.
