# **Evaluation, Refurbishment, and Characterization of Fast Neutron Scintillators for the TREAT Fuel Motion Monitoring System**

Jay D. Hix, David L. Chichester, Scott M. Watson, James T. Johnson, Scott J. Thompson

October 2017

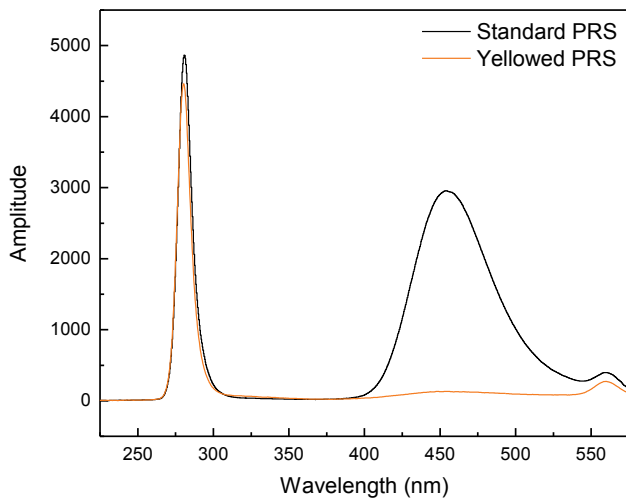
Figure 1 This plot shows a spectrogram with 280-nm stimulation light and the  $\sim 452$ -nm output emission light from two PRS buttons under test, one with a white scintillator and the other with a yellowed scintillator. The small peak at 560 nm is a result of half-harmonic generation from the 280-nm LED.

These physical variations between individual PRS buttons were quite evident upon visual inspection. Some physical variations were correlated to the PRS light output emission. These include scintillator discoloration (yellowing) along with sanded PRS surfaces, both of which were observed to correlate with lower PRS light emission as measured in a light-integrating sphere. Overall, scintillators that were white in color have higher emission intensities than those scintillators that are yellow. An example of the lower count rate is shown in Figure 1. The spectrogram of a white PRS button is shown in black, and a yellowed PRS button is shown in yellow; a 280-nm light-emitting diode (LED) was used for illumination. The peak count values are the maximum amplitude of the spectrograms at a wavelength of  $\sim 452$  nm.

The yellowing of the ZnS(Ag) wafers may be due to age, prolonged exposure to light, humidity, contact with ionizing radiation, or variations in manufacturing. When comparing two PRS buttons, one with a yellowed wafer and the other a white wafer, it is evident that the PRS button with the yellowed wafer has a greatly reduced light output emission when compared to the PRS with a bright-white wafer.

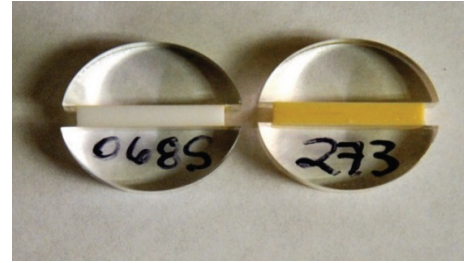
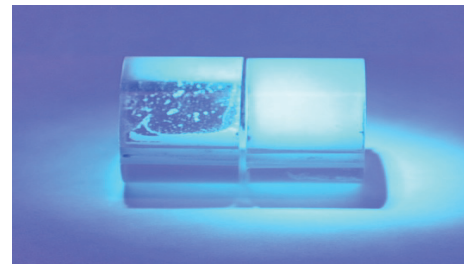
Figure 2 The top picture illustrates the difference between a white and a yellowed PRS wafer. The picture on the bottom gives an example of a PRS button that is starting to delaminate (left) between the scintillator wafer and waveguide.

and misaligned waveguide geometries, sanded and non-sanded PRS surfaces, delamination between scintillator and waveguide, and epoxy left on PRS surfaces. The majority of the PRS buttons have some degree of misalignment and delamination. The misalignment of the PRS could be due to the hand making of the buttons. The degree of delamination could be caused by the epoxy drying faster in some spots before the scintillator and the light guides were placed together presenting a delaminated aspect from the outside in. Also, over time the epoxy could have lost its strength, displaying a delaminated appearance. It was observed that only limited quantities were in proper alignment and displayed no delamination.

The majority of the PRS buttons have some degree of misalignment or delamination, perhaps because they were

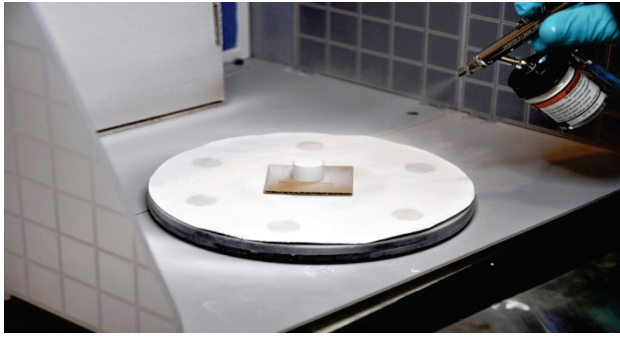
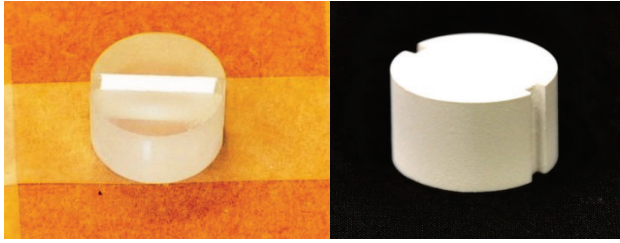
Figure 4. The top picture shows re-painting of a reclaimed PRS button. The bottom picture illustrates a before-and-after painting comparison.

Once all of the PRS buttons were cleaned, measured, and sorted, the identified candidates were prepared for the next step in the process. The PRS buttons were sanded using 500-grit sandpaper. The buttons were sanded on the top and the sides while the bottom of the button was left un-sanded but polished, for coupling to a PMT. After each button was sanded, and washed again using ethanol, they were ready for re-painting using Eljen Technologies EJ-510 reflecting coating. Each button was placed on a turntable and spun as paint was applied by using an air brush, to achieve even distribution of the paint. Thus process is shown in Figure 4.

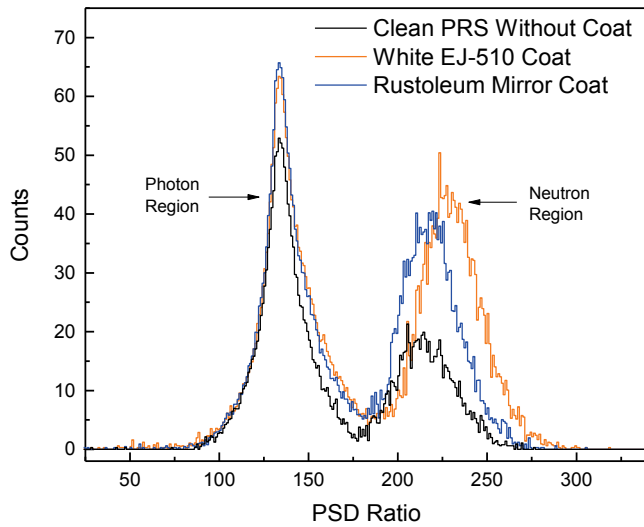
Figure 5. Example of PSD 2-D spectra for three tested PRS coatings. The PSD ratio is tail area/peak area. The FOM applied to these spectra score higher for both coated PRSs for neutron region efficiency and separation of the neutron and photon regions.

The PRS scintillators exhibit excellent neutron-photon pulse shape discrimination. A small study was performed to assess if specular (reflective) paint would perform better than diffuse (white) paint for this application. A standard pulse-shape discrimination (PSD) figure-of-merit (FOM) was used to characterize the performance of a Rust-Oleum mirror finish, EJ-510 paint, and a clear PRS. Measurements were performed for 900 seconds in each case, using a  $^{252}\text{Cf}$  neutron source for irradiation. The data collected in each case are shown in Figure 5 and are tabulated in Table I. The button with EJ-510 paint showed the best PSD FOM.

Coating	Sensitivity	Figure of Merit
Clear (no coating)	$3.5 \pm 0.1$	1.42
Rust-Oleum mirror finish	$10.0 \pm 0.1$	1.47
EJ-510 white paint finish	$14.3 \pm 0.1$	1.66

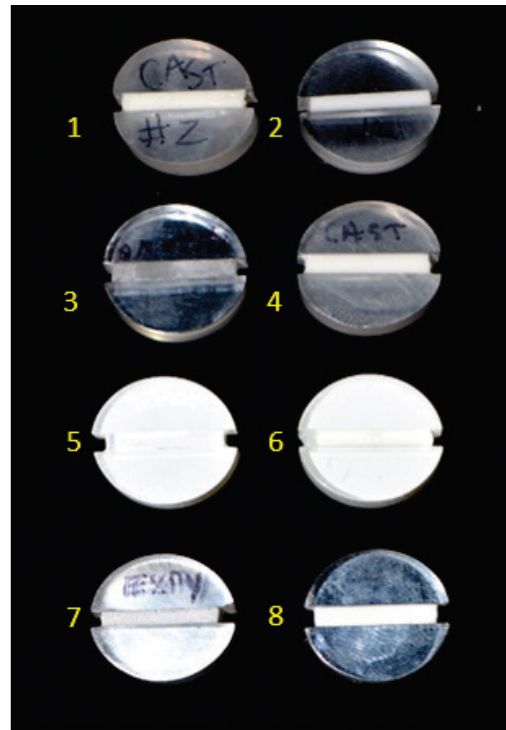
Figure 5. The picture above illustrates candidate PRS wafers.

1. Acrylic cast resin with 5% ZnS(Ag)
2. PRS reference ZnS(Ag) (for comparison)
3. Stilbene
4. Acrylic cast resin
5. EJ-34 PSD plastic (painted white in photo)
6. EJ-34A PSD plastic (painted white in photo)
7. EJ-500 optical cement with 5% ZnS(Ag)
8. EJ-500 optical cement with 20% ZnS (Ag)

Example buttons made with these materials are shown in Figure 5 (the button labeled as 2 is one of the 118 reclaimed buttons, for comparison). Example scintillation spectra from these wafers are shown in Figure 6.

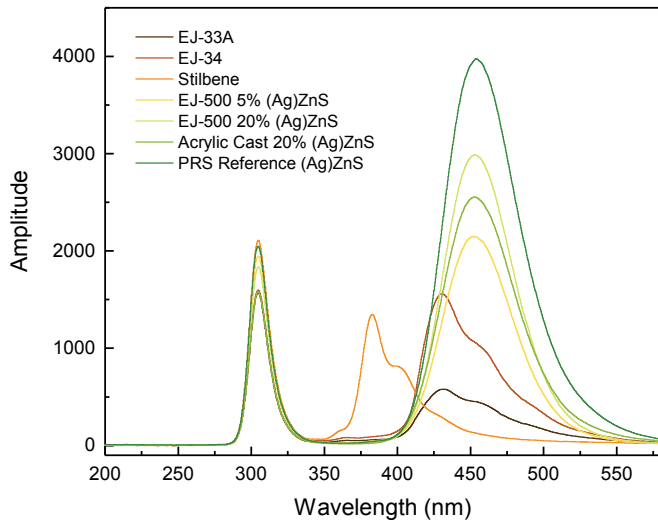
Figure 6. This plot shows a spectrogram with 280-nm stimulation light, and the output emission light from the candidate PRS wafers.
