Microwave Fire Lessons Learned

CEM Mars 6 Incident

November 6, 2019

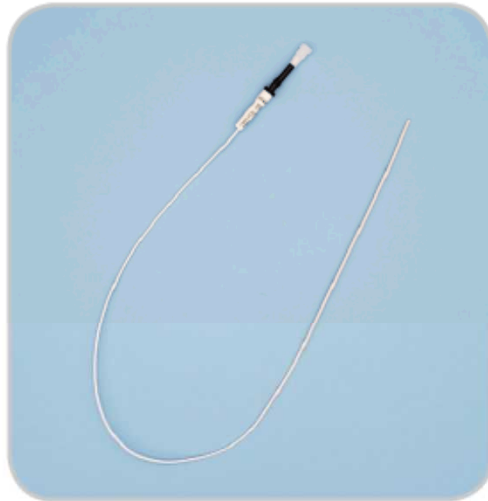
MTS-300

P/N 314355

White probe with white end

Temperatures < 250 °C

MARS 6 only

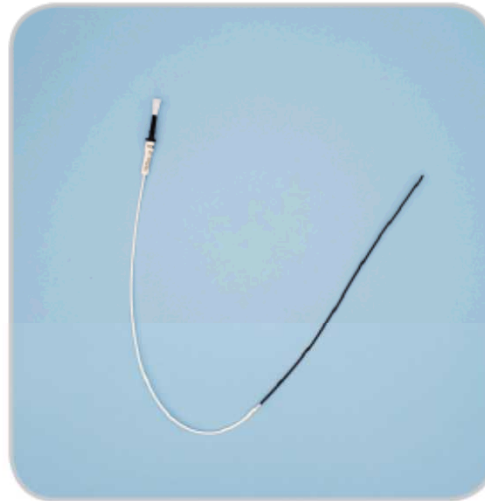
MTS-300 High Temp

P/N 281461

White probe with black end

Temperatures > 250 °C

MARS 6 only

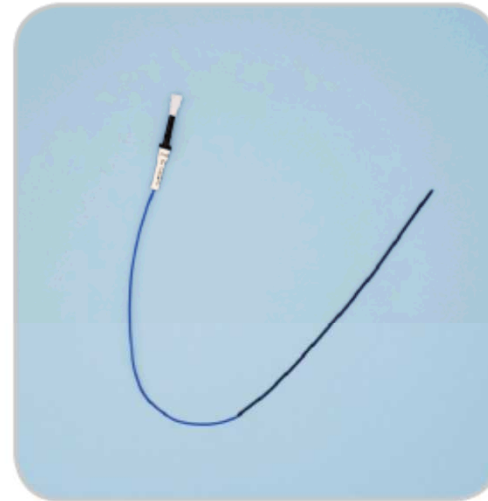
RTP-300+

P/N 314305

Blue probe with blue end

Temperatures < 250 °C

MARS 5 only

**RTP-300+ probes are not compatible with the MARS 6 unit as they are shorter than the MTS-300 probe and will not reach the bottom of the thermowell in the control vessel if used in the MARS 6.*

- Blue Mars 5 thermocouple probe (16") used in a Mars 6 device. Incorrect S/N and GF.
- Unattended run. Acid fume sensor (optional, but not purchased) on exhaust line not used.
