# Non-destructive Examinations of ATF-2 Baseline Rodlets

# **Non-destructive Examinations of ATF-2 Baseline Rodlets**

**Idaho National Laboratory  
Characterization and Advanced PIE Division  
Idaho Falls, Idaho 83415**

## **SUMMARY**

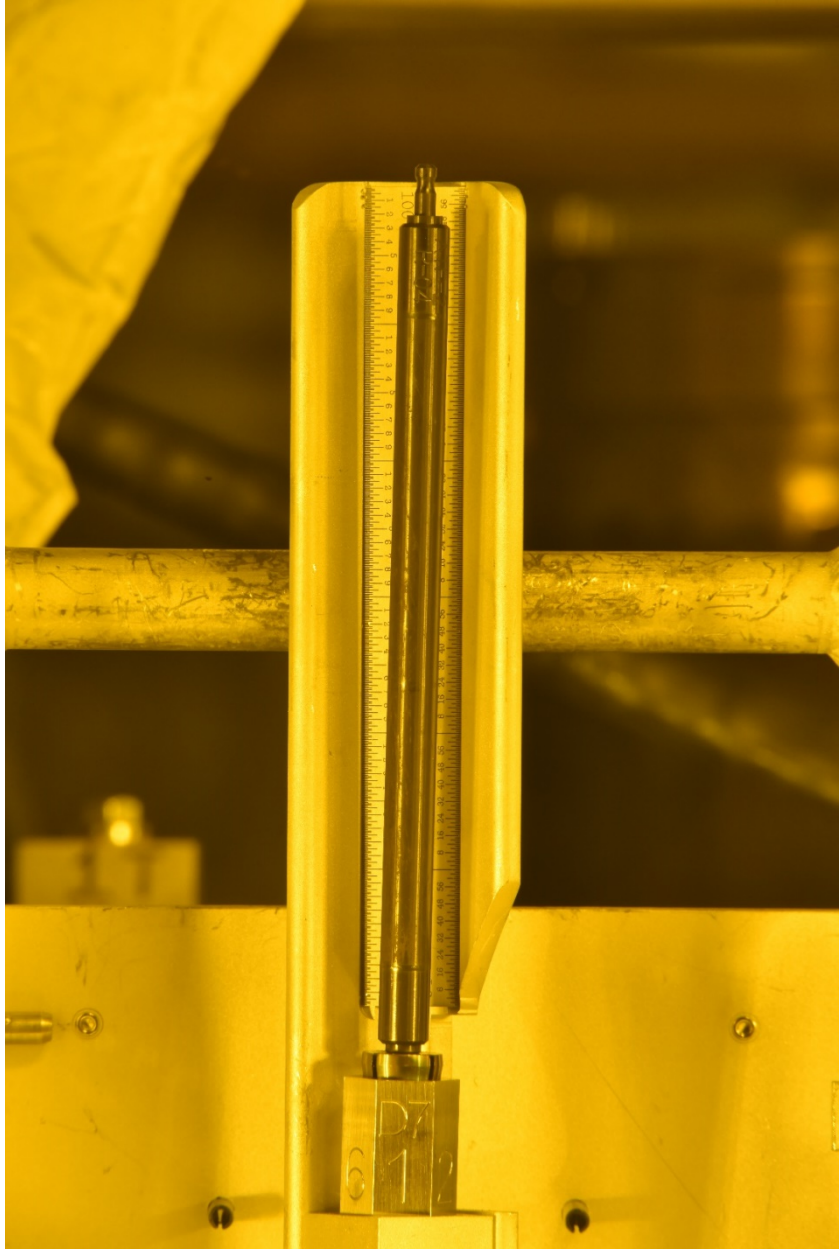
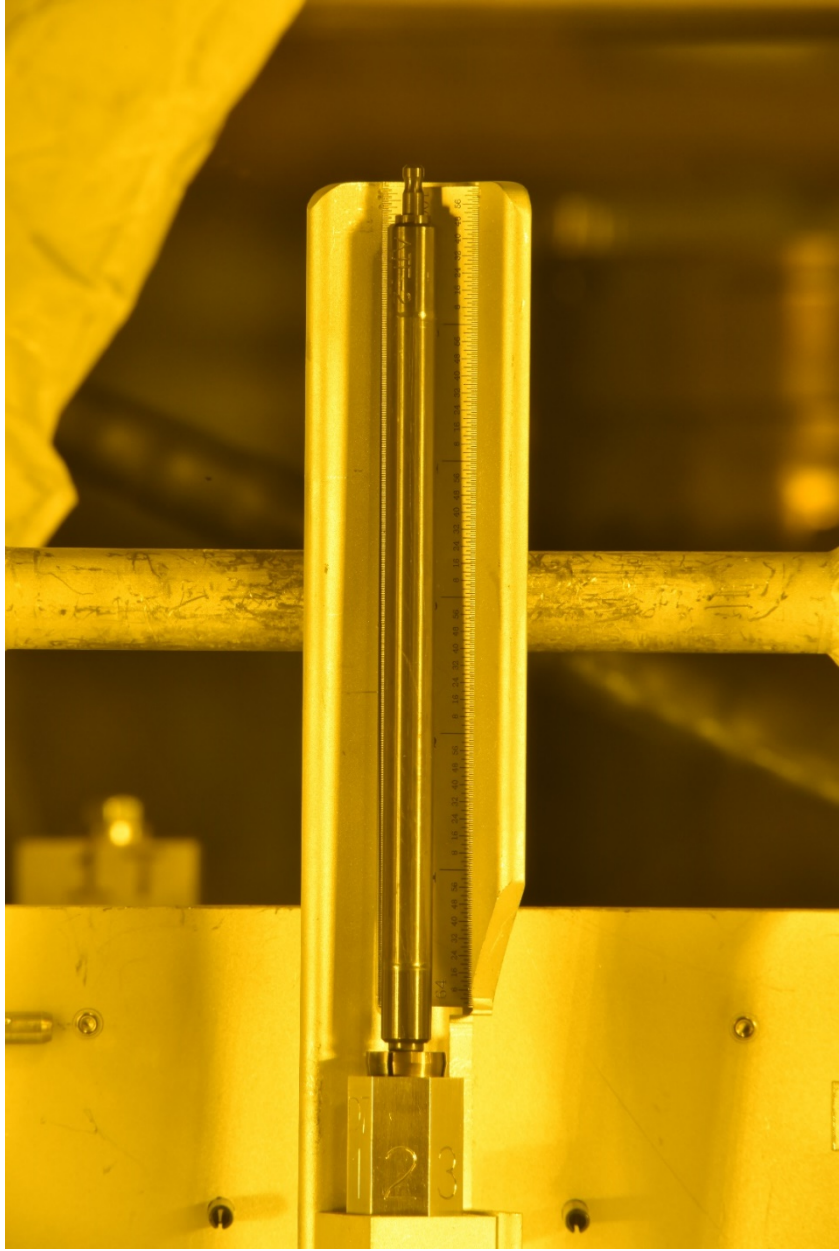
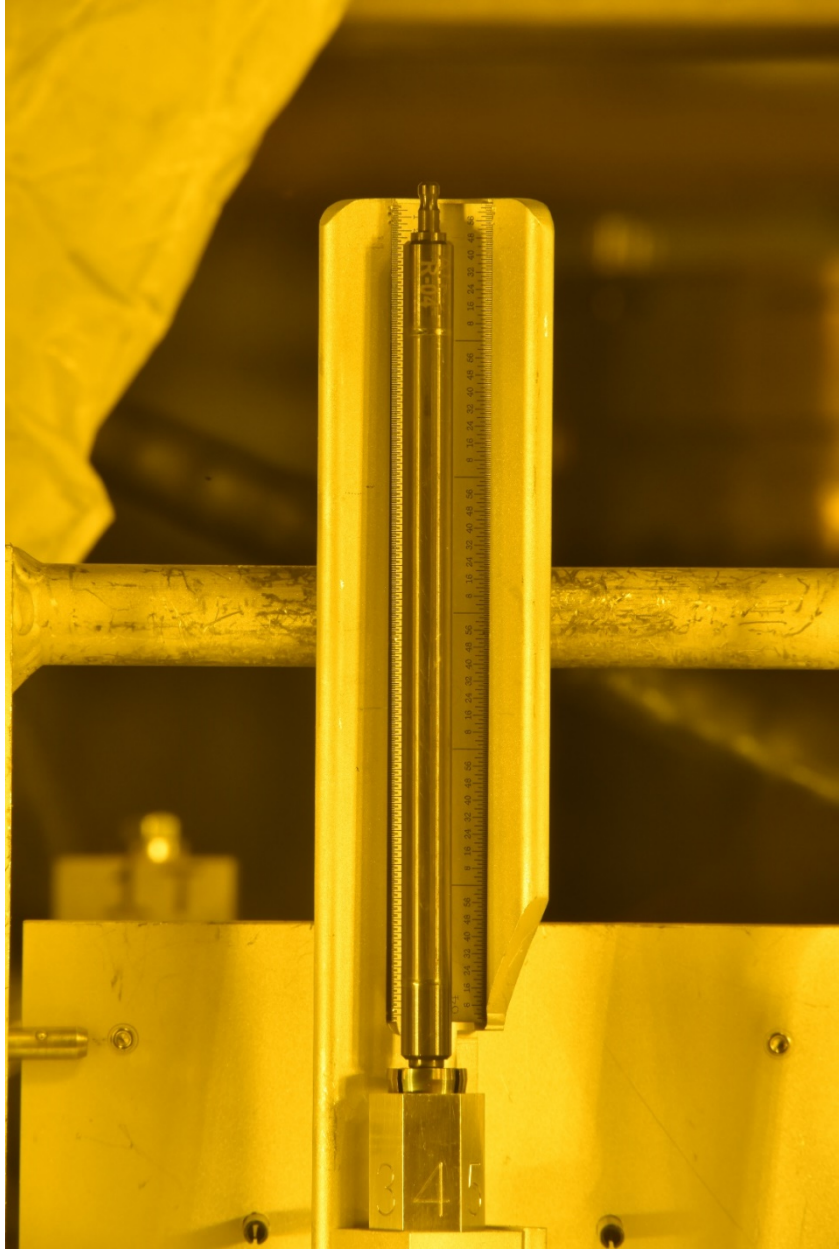
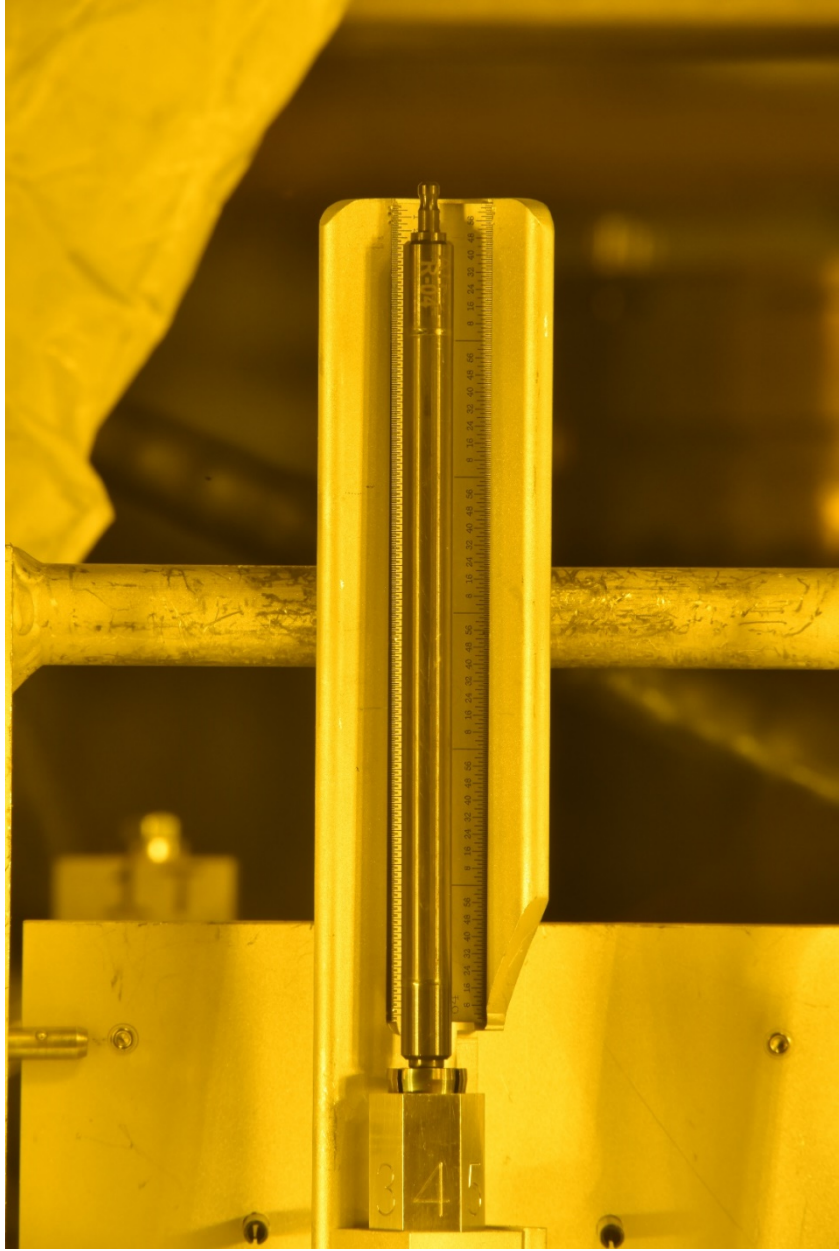
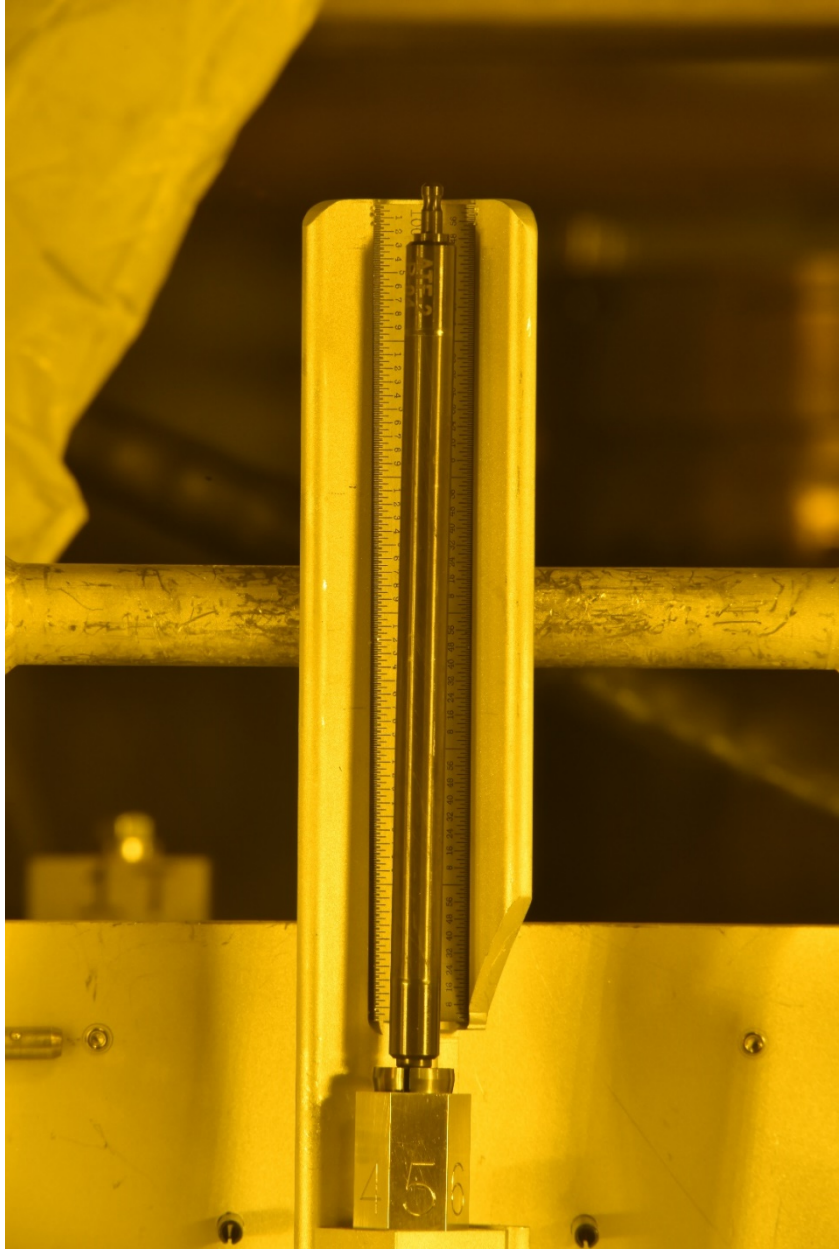
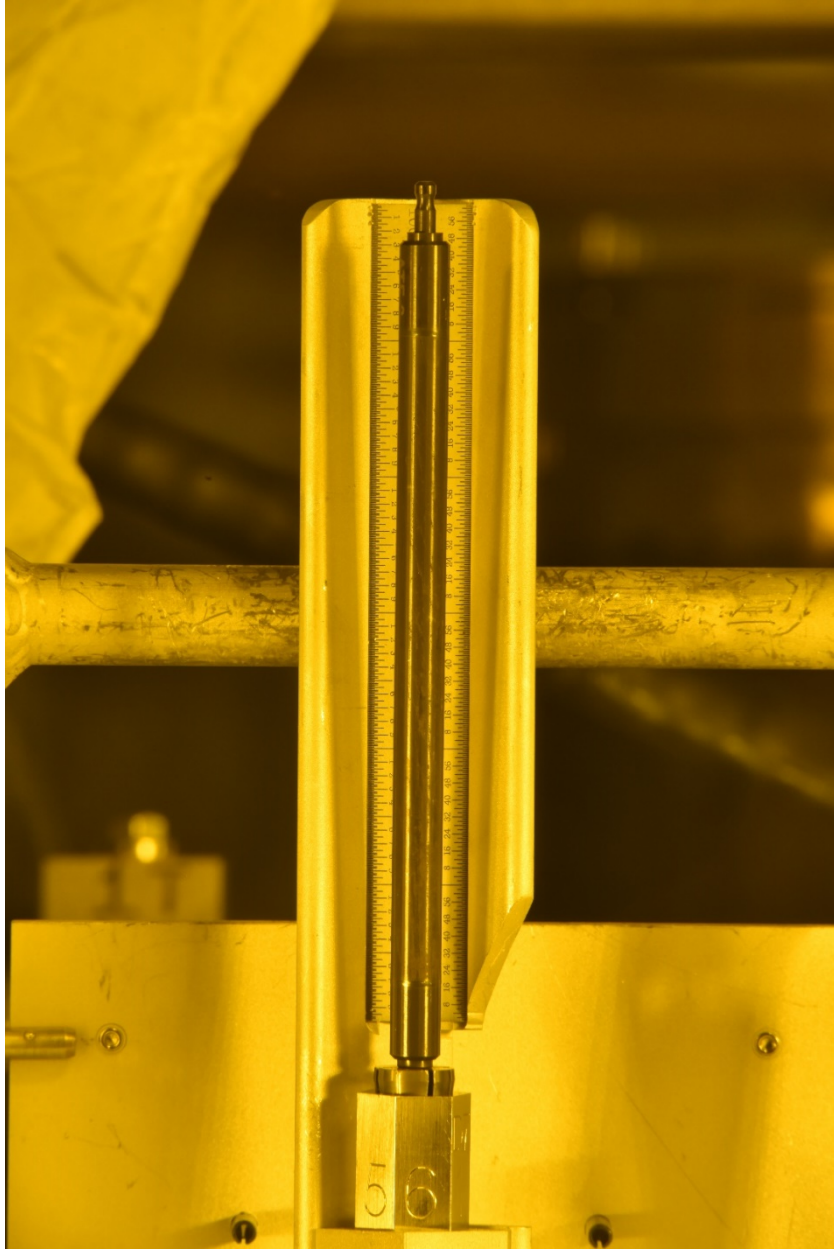
Figure 1. (a)-(f) Visual examinations of R04.

From the analysis of all the various viewing angles, it can be seen that the cladding surface of all rodlets presents several superficial scratches, either parallel to the rodlet axis or along a slightly diagonal direction. The rodlets were handled several times in the canal during tier re-organization. The rodlet holder has abrasive pin support separators in the shape of four strips that hold the rodlets in place in the tier. As they were pulled out for tier re-organization and shipping in the cask basket, abrasion is likely to have occurred, causing the observed shallow scratches. Occasionally, deeper scratches are present, such as the one visible in Figure 2c starting ~5 cm from rodlet bottom and spanning along the rest of the rodlet height. Other examples can be seen in Figure 3a starting at the bottom of R06, on the right side of the viewing angle, and in Figure 7a. Patchy discoloration was observed at the top of R06 in Figure 3b, underneath the rodlet ID. The surface of R06 both in Figure 3d and e appears heterogeneous in color, with discontinuous opaque areas, likely an effect of oxidation. The surface of R08 in Figure 5c, of R09 in Figure 6c and d, and of R10 in Figure 7c-f shows analogous characteristics. A circular spot was observed at approximately 2.5 cm from bottom in R06 (Figure 3e). A similar, but smaller circular spot was observed in Figure 2f at similar height in R05, and in R08 at 11.4 cm from rodlet bottom (Figure 5a). A round bright spot can be also seen at the very bottom of R09 (Figure 6a).

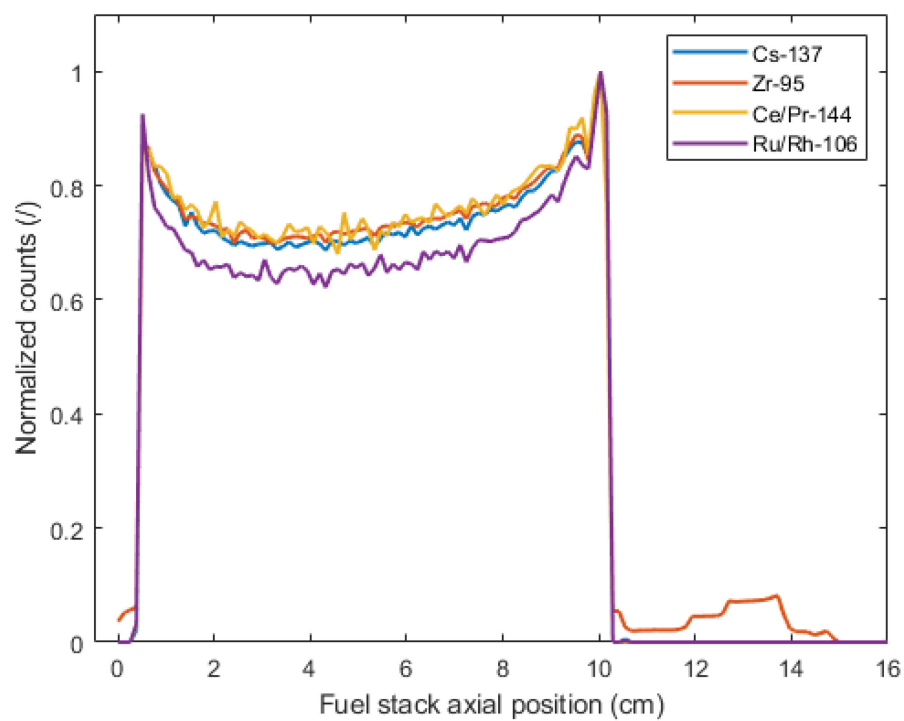
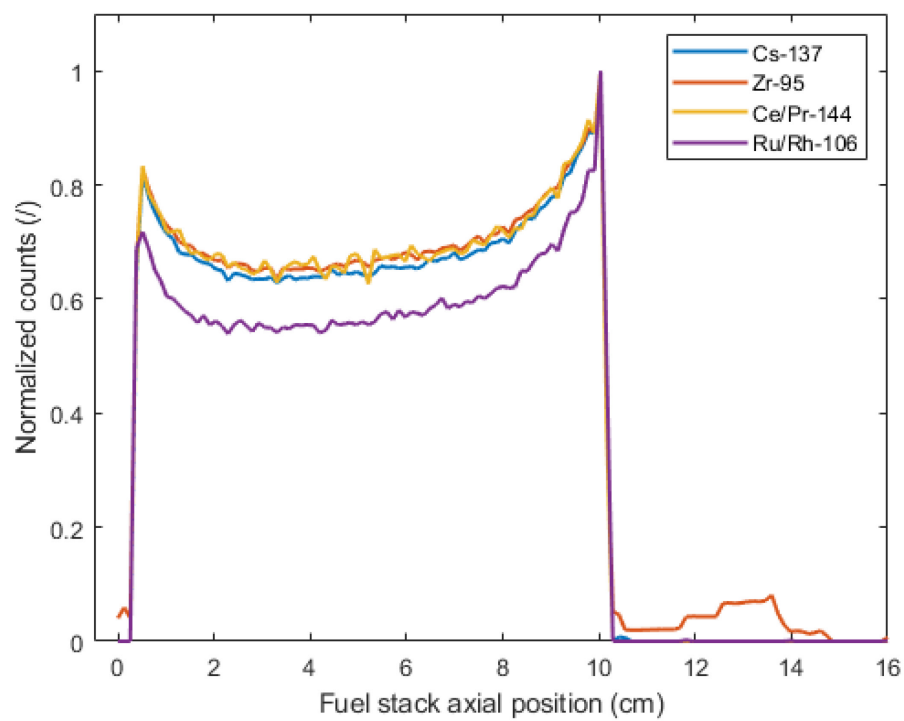
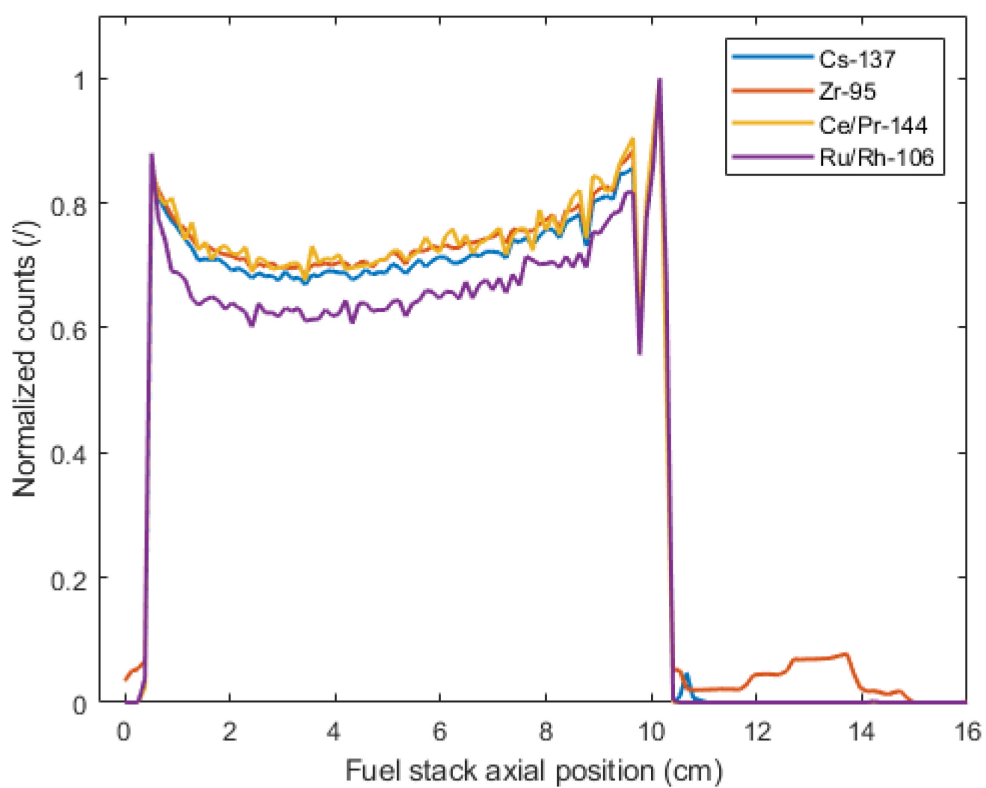
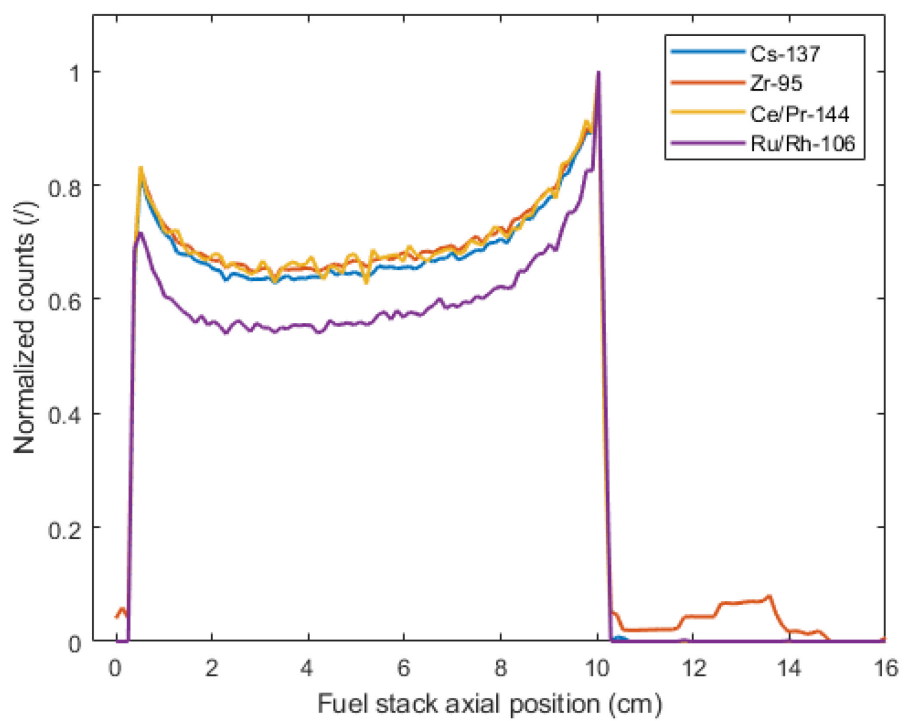
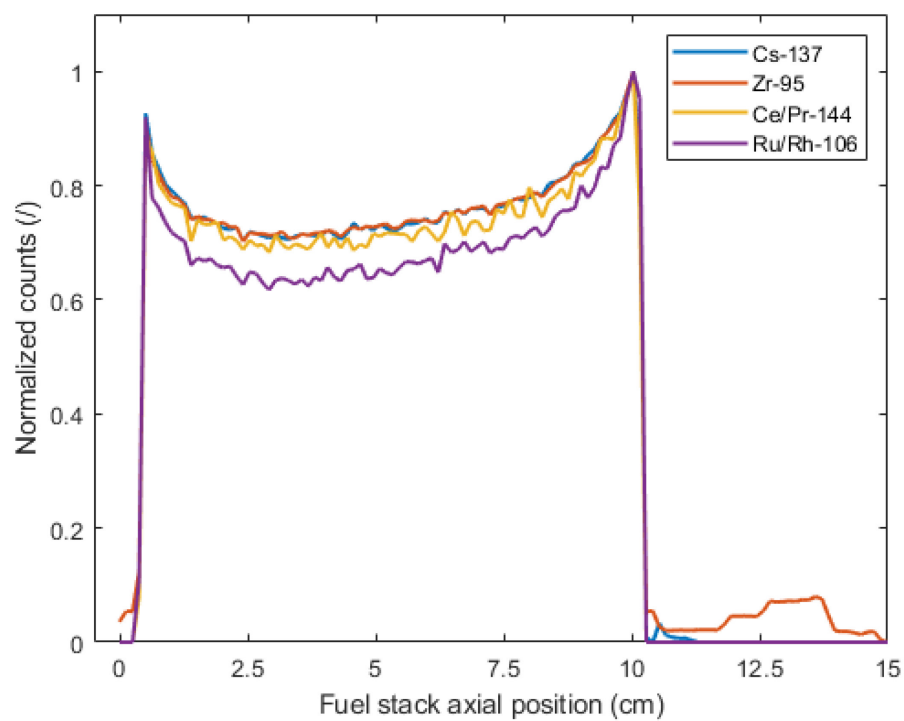
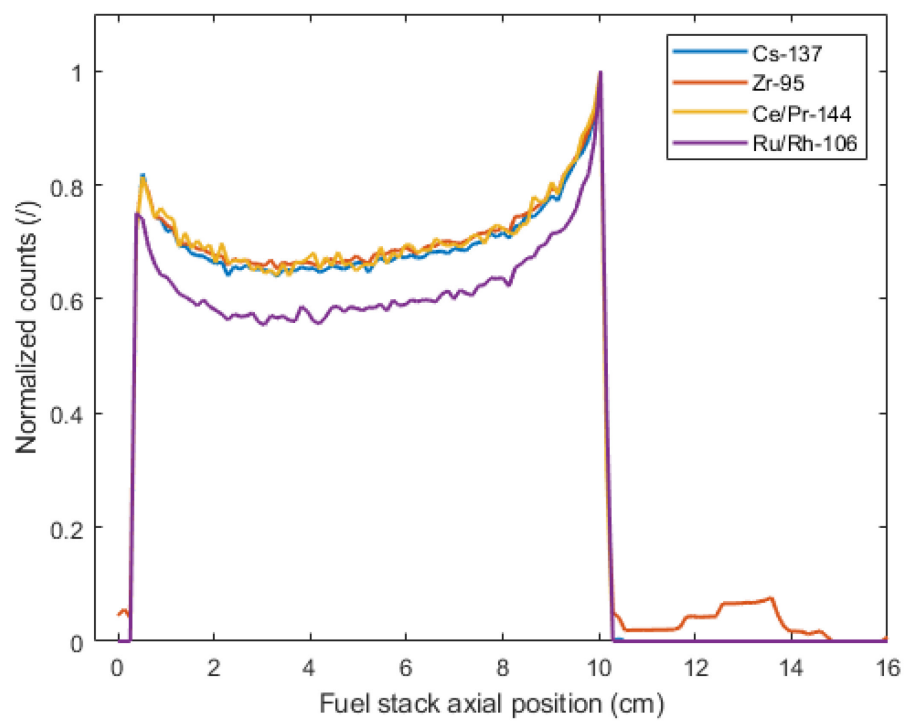
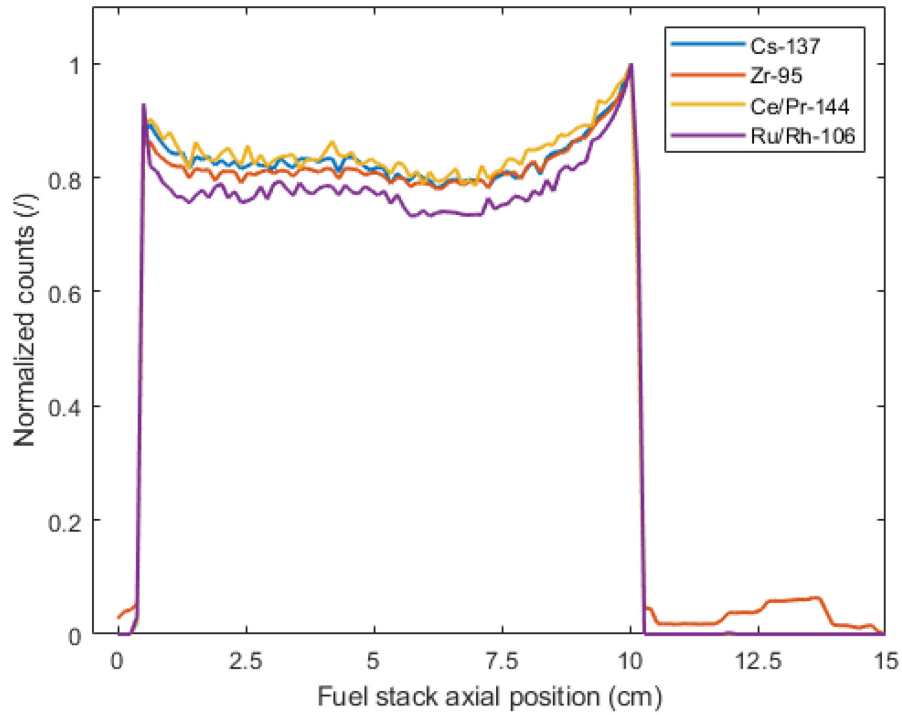
Gamma spectrometry of the rodlets was performed using the HFEF Precision Gamma Scanner (PGS). Details about the system have been reported in other PIE reports [3,4]. The results of some of the principal gamma emitters generally used as burnup monitors are shown in Figure 8a through Figure 8g for each of the rodlets. Axial gamma spectrometry of all the rodlets showed that most detectable fission products did not redistribute axially, including the volatile Cs. An increase in the relative power towards the end of each fuel stack was expected from neutronic calculations. The pellets in the middle portion of the fuel rodlets experienced less flux due to a “shielding” effect from the top and bottom pellets, not occurring for the outermost ones. The axial depression of Ru/Rh is larger than for the other nuclides [5]. The fission yield of metallic fission products is much larger for Pu-239 than U-235. The enrichment of Pu-239 towards the end of the fuel stack has been predicted by the neutronic calculations [2], leading to a larger contribution to fission from Pu-239 at the outermost parts of the active fuel stack. This, in turn, would result in a higher production of metal fission products at the stack periphery, explaining the more pronounced depression of Ru/Rh profile compared to the other fission products. Overall, the results among pins R04 to R09 are similar and consistent. All rodlets show a decreasing burnup profile while moving from the top to the bottom of the rodlet, in agreement with the axial variation of the flux in Tier 2, where those pins were irradiated. Tier 2 is the second of the entire test train, positioned below the core center. In Figure 8c (corresponding to the results for R06), a sharp depression in the fission product signals is visible at the top of the active fuel stack. The depression corresponds to the missing fuel piece detected in the neutron radiography (see Figure 10 in the next section). This was the only anomalous result detected.

In Figure 8g, corresponding to R-10, a fluctuation in the axial power profile is visible. This rodlet was irradiated in Tier 1, which is the first holder at the bottom of the test train [6]. Being the furthest from the core centerline, an axial gradient in the neutron flux would be expected. In order to limit the variation, a hafnium shroud adjacent to only the top half of the fuel rodlets was added to the tier. The half-length hafnium shroud significantly reduced the axial power variation, as evident in the measurements.

Figure 8: Axial gamma scan profile of selected fission products. The counts proceeded from the bottom of the fuel stack ( $x=0$ ) till the top of each rodlet. (a) R04, (b) R05, (c) R06, (d) R07, (e) R08, (f) R09, (g) R10.

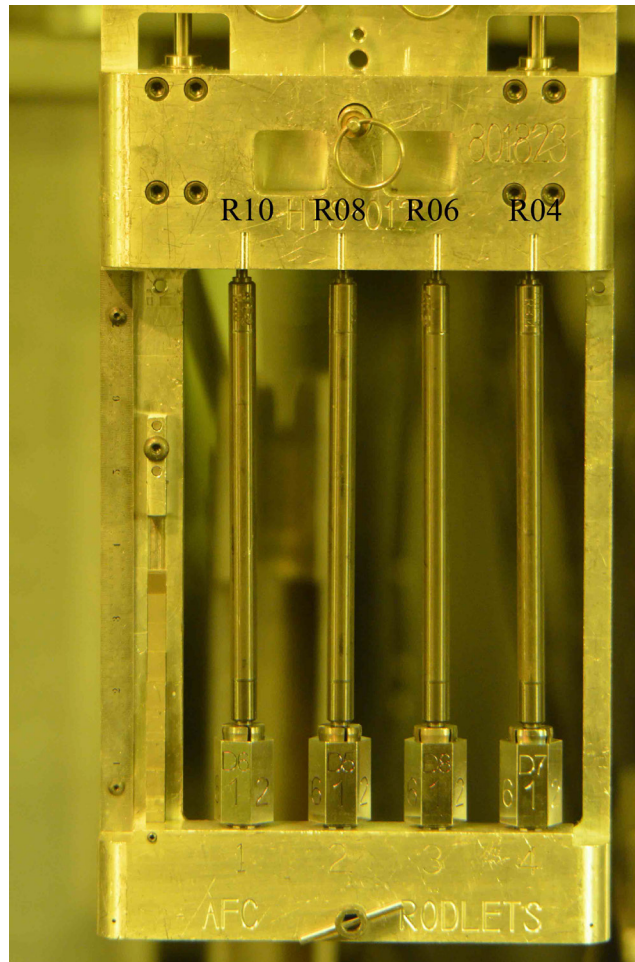
Neutron radiography of the rodlets was performed with indirect radiography using the Neutron Radiography (NRAD) Reactor located in HFEF [**Error! Reference source not found.**]. An existing carrier could be used by adapting the height of the collets, which were designed and fabricated specifically for this PIE campaign. The collet is placed in the socket which allows for precise rodlet rotation to acquire images at different orientations. Radiographs of the rodlets were taken at 3 different viewing angles,  $120^\circ$  apart. A picture of the carrier loaded with the four rodlets before image acquisition is shown in Figure 9. The neutron radiographs, obtained with both thermal and epithermal neutrons, are shown in Figure 10 through Figure 12 for the three orientations. As already mentioned from the analysis of the gamma scanning result, rodlet R06 presented a missing fuel piece at the top of the fuel stack, visible from the neutron radiography. Other than considerable cracking of the first pellet in R04 and of the upper insulator discs in R08, no additional unusual features could be observed in any of the orientations.

Figure 9. Carrier loaded with the four rodlets.

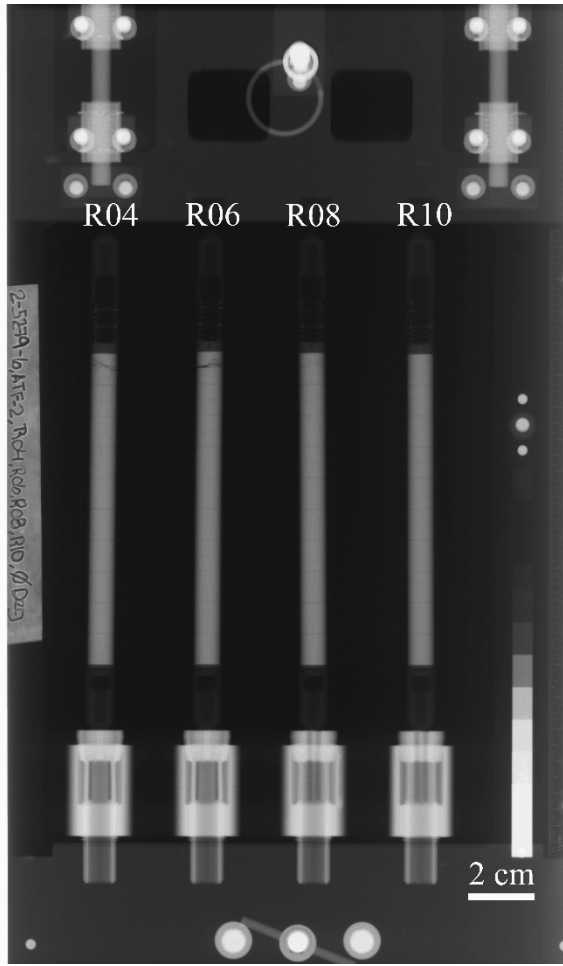
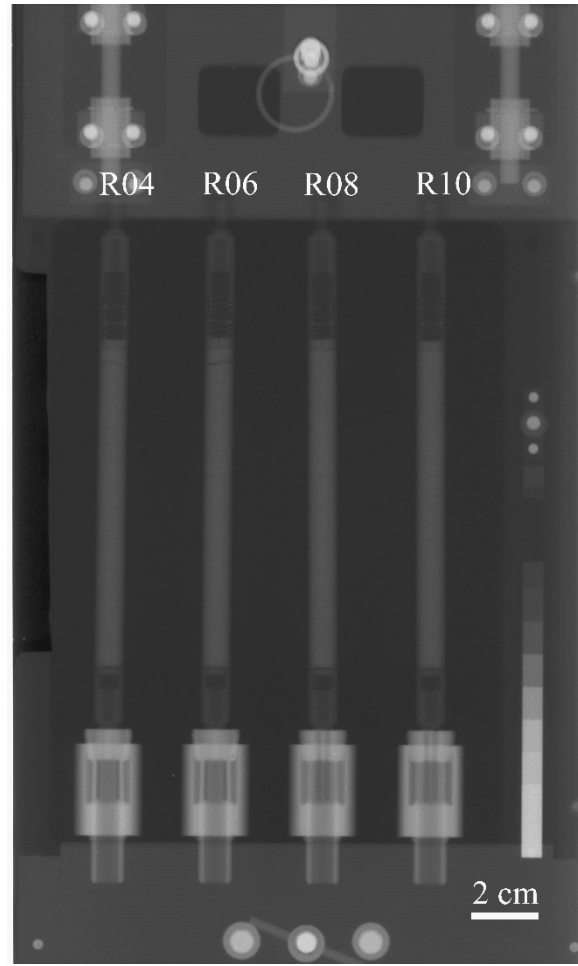
Figure 10. (a) Thermal and (b) epithermal neutron radiography of the rodlets at viewing angle  $0^\circ$ .

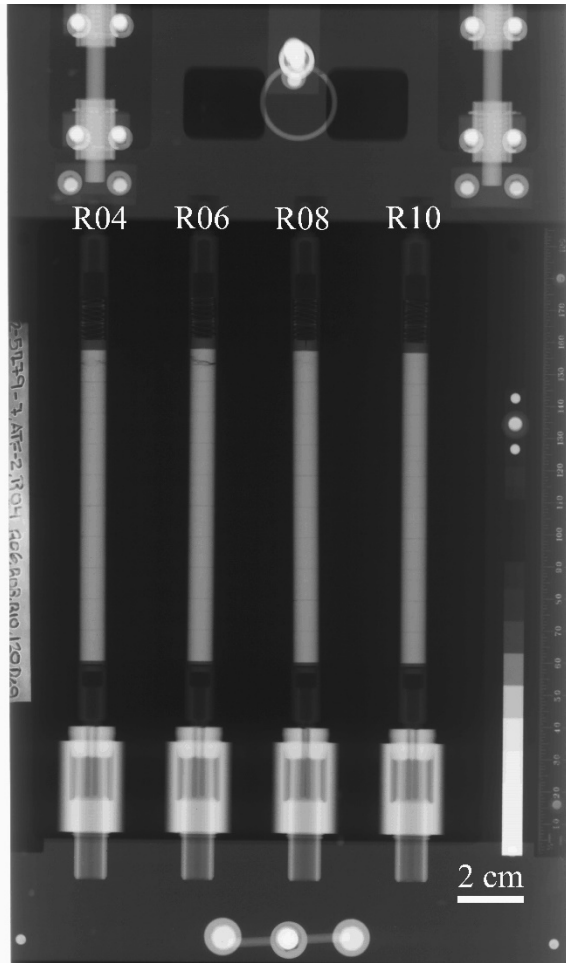
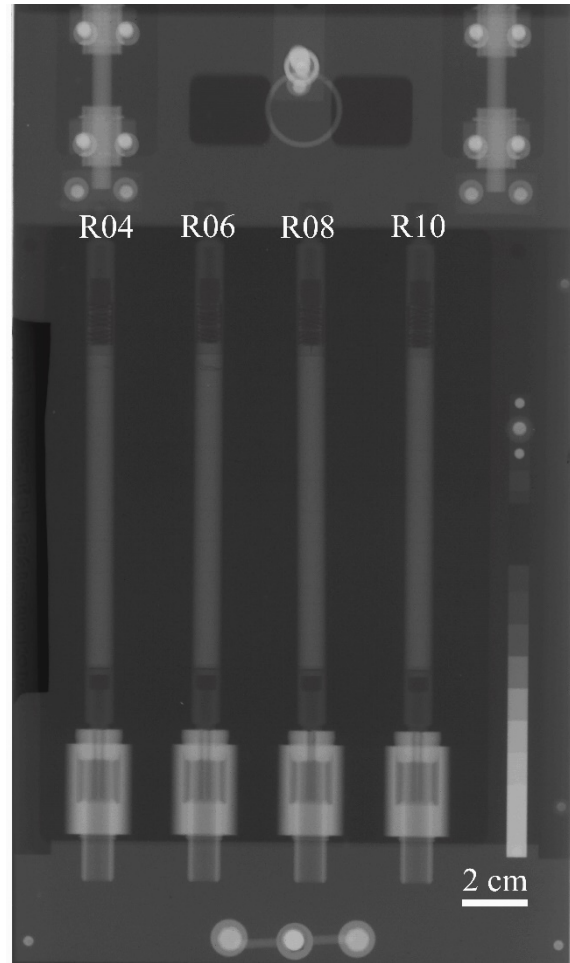
Figure 11. (a) Thermal and (b) epithermal neutron radiography of the rodlets at viewing angle 120°.

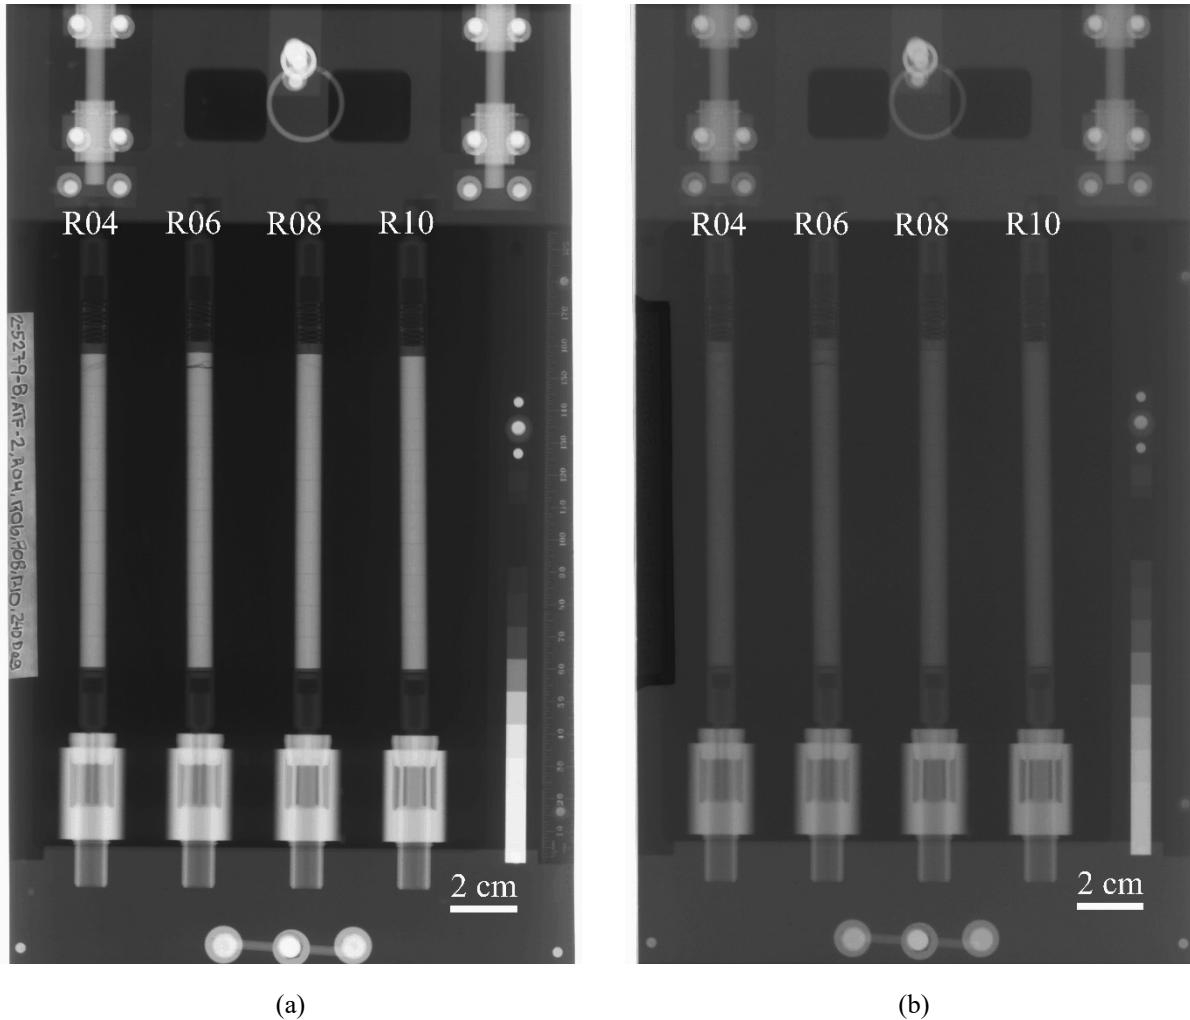
Figure 12. (a) Thermal and (b) epithermal neutron radiography of the rodlets at viewing angle 240°.

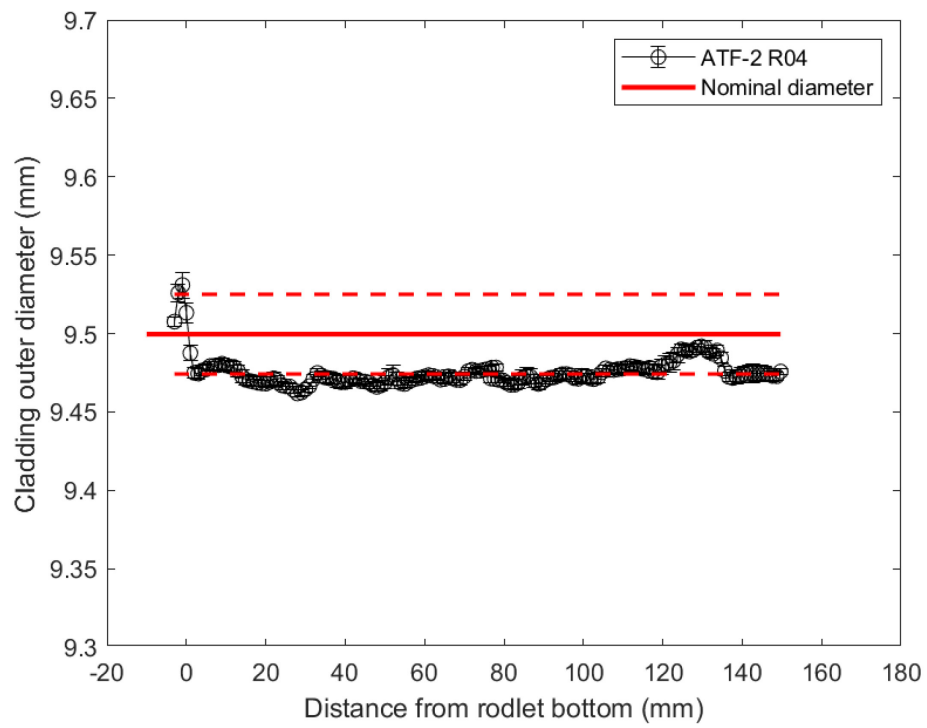
Dimensional inspection of the rodlets was carried out using a dimensional inspection device in HFEF. Outside diameter measurements were collected all along the rodlets in roughly 0.5 mm increments and at 36 angles every 5° from the initial scan angle to 180°. Diameter measurements were collected with  $\pm 5 \mu\text{m}$  accuracy. The measurements at each axial location were averaged across the different angles. The results are shown in Figure 13 for R04, Figure 14 for R06, Figure 15 for R08, and Figure 16 for R10. The measured cladding dimension is within fabrication tolerance for each of the rodlets; hence, it is difficult to assess whether creep down could have occurred. At the axial location corresponding to the missing fuel piece in rodlet R06 spotted by gamma scanning and neutron radiography, no enhanced variation of the cladding outer dimension was measured.

Figure 13. R04 cladding measured outer diameter (black circles). The solid red line represents the nominal diameter, while the dashed lines indicate the fabrication tolerance.

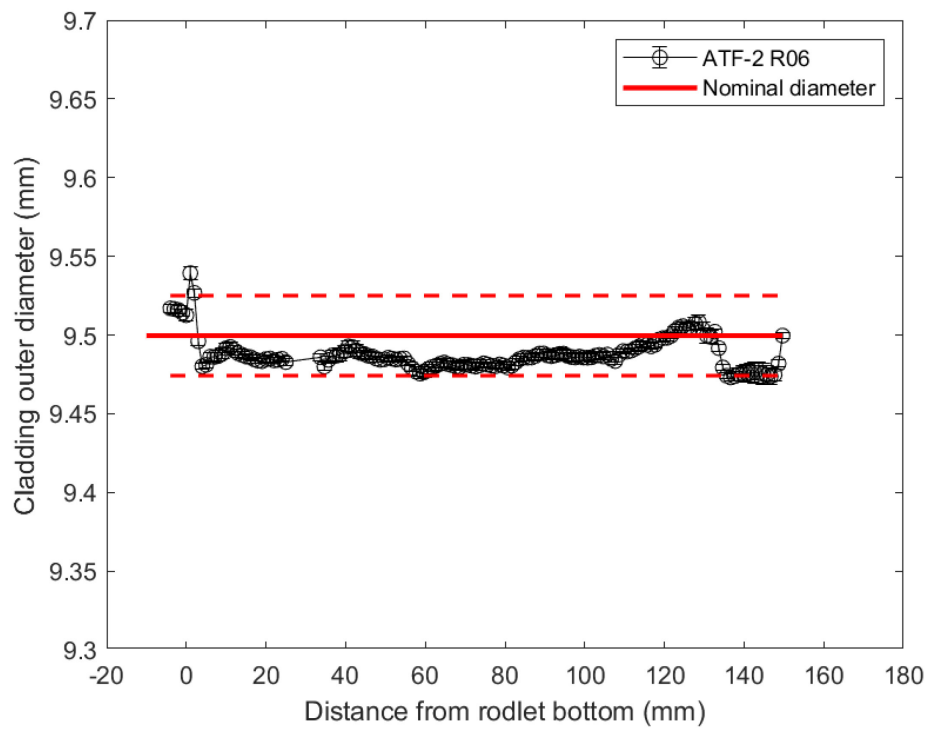
Figure 14. R06 cladding measured outer diameter (black circles). The solid red line represents the nominal diameter, while the dashed lines indicate the fabrication tolerance.

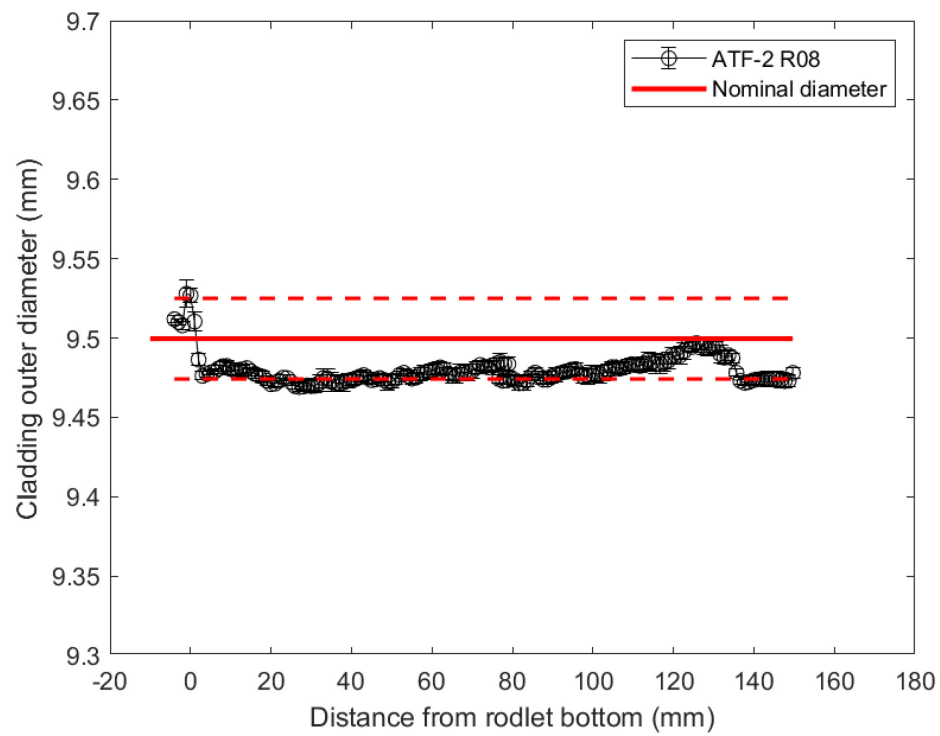
Figure 15. R08 cladding measured outer diameter (black circles). The solid red line represents the nominal diameter, while the dashed lines indicate the fabrication tolerance.

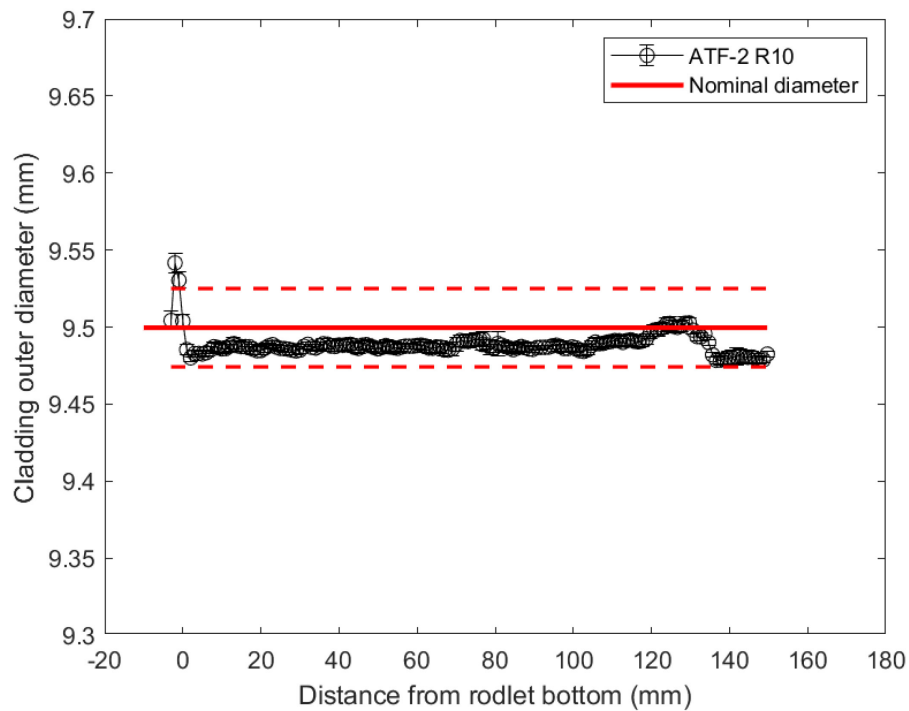
Figure 16. R10 cladding measured outer diameter (black circles). The solid red line represents the nominal diameter, while the dashed lines indicate the fabrication tolerance.
