CEM MARS 6 Microwave Incident

September 2020

Robert Fox, Ph.D., Roy Nelson, David Young, Nick Mueller, and Michael Cates

Idaho National Laboratory

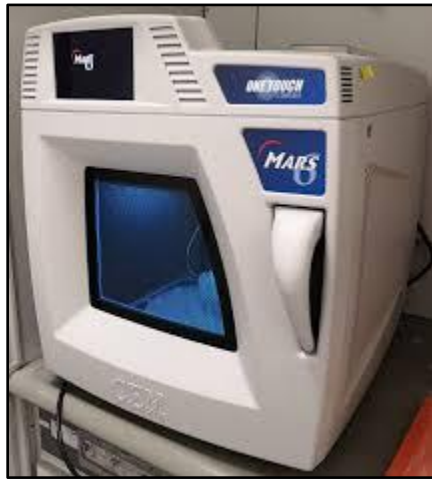
Figure 1. CEM MARS 6 stock photo.

CEM Corporation, based in Matthews, North Carolina, is an international laboratory instrument and scientific methods development company that has designed and developed laboratory instrumentation and scientific methods (both microwave-based and non-microwave technologies) for more than 40 years. CEM microwaves are used by major companies, research institutes, and universities around the world for sample digestion as well as materials synthesis. With more than 40-years of experience developing microwave products the engineering design, features, and capabilities of the CEM MARS 6 microwave (Figure 1) reflects CEMs industry-leading position.

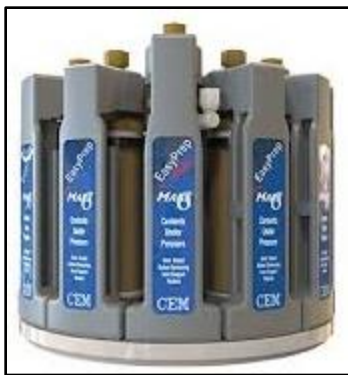
Figure 2. EasyPrep stock photo.

The CEM EasyPrep (Figure 2) carousel assembly can hold up to 12 Teflon® sample digestion cells having an internal volume of 100 ml each. The EasyPrep cells are rated to 300°C at 800 psi and are compatible for use with concentrated mineral acids and bases as well as solvents. Under those conditions the most recalcitrant of materials are rapidly attacked by strong mineral acids/caustics and rendered into soluble forms. The EasyPrep vessel assembly (Figure 3) consists of a Teflon® vessel which is the main reaction vessel. A composite, thermally-resistant, structurally-rigid liner slips over the reaction vessel to lend it structural rigidity and to contain the thermal energy within the reaction vessel. Each vessel is capped with a Teflon® lid. Each lid has a steel support ring to prevent the seal from extruding under pressure. The vessel, support sleeve, and lid sit within a cassette module made of grey glass-filled polypropylene. Compressive sealing is applied to the lid of the vessel through use of a glass-filled Ultem compression lid and gland nut. Lids are sealed using 84 in-lb torque from a factory-supplied, calibrated torque wrench. The EasyPrep ensemble also uses a Reference cell which is equipped with a more substantial lid and a thermal well. The thermocouple probe, used for measuring process temperature during the run, inserts into the thermal well. The CEM MARS 5 and early MARS 6 units utilize both thermocouple and infra-red sensors to monitor reaction vessel temperature. Later versions of the MARS 6 utilize in-situ wireless technology for temperature sensing in each vessel during operation.

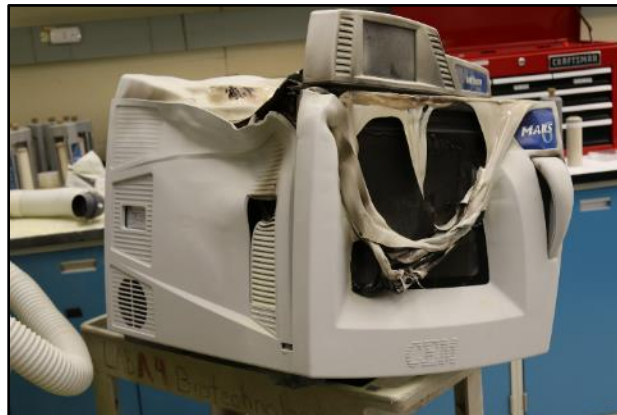
Figure 5. Front left view of microwave.

Figure 6. Front right view of microwave.

Figure 5 and Figure 6 indicate the intensity of the heat generated by the fire and the consequent damage to the unit. In Figure 6 the microwave’s white exhaust hose (background, right) was detached from the back of the unit and left on the laboratory bench by the fire suppression team. Yellow fire extinguishing media coated the local bench tops and the microwave unit. The inside of the microwave was amply covered in extinguisher media. The microwave exhaust hose attaches to the rear of the microwave via the grey 90° PVC fitting seen in Figure 6. The exhaust hose was routed to the adjacent fume hood seen in the background of the Figure 6 photograph (background, left). From Figure 7 and Figure 8 it is seen that smoke was being actively vented to the fume hood during the microwave run as evidenced from the soot marks where the exhaust hose vented to the hood, and the presence of soot in the exhaust line. Additional evidence obtained by examining soot patterns and melting on exterior panels and vents of the microwave point to the fire occurring in the microwave cavity. The strongest evidence showing the most intensive heating and damage due to fire was found within the microwave cavity itself.

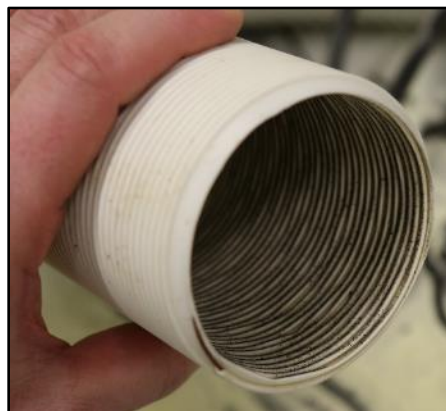
Figure 8. Soot in the exhaust line.

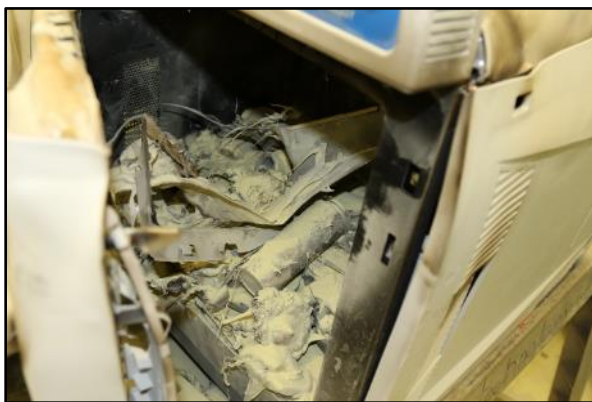
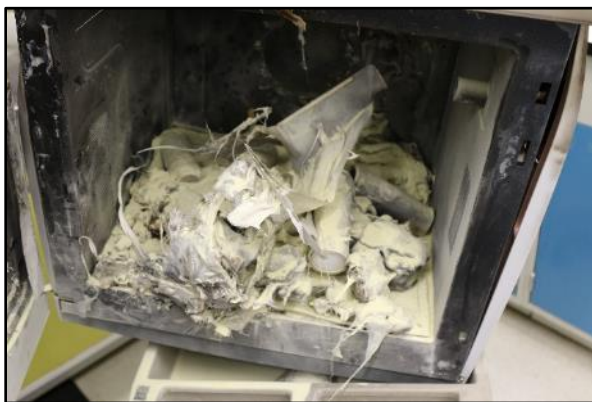
Figure 9 and Figure 10 show what greeted the investigation team when the damaged microwave door was opened. The microwave contents were covered in finely-divided, yellow extinguishing media. It was noted the bulk of the material consisted of unrecognizable, melted polymeric materials interspersed with intact fiber-reinforced composite sleeves which serve as a thermal barrier between the Teflon® sample vessels and the grey, glass-filled polypropylene sample cassettes. The polymeric door molding was melted and had fallen into the microwave cavity. The steel microwave cavity walls were soot blackened and covered with extinguishing media. Teflon® sample vessels were mostly intact where they were protected by the composite sleeves, but no liquids remained, and as will be seen later only one sample had an intact lid; all other sample vessel lids were off including the lid to the Reference cell. In only two instances could lids be confirmed as belonging to their original sample cells (i.e., the Reference cell, and cell #10). No glass-filled polypropylene sample cassette remained intact. Only cassette bases remained and were melted to the top of the carousel.

Figure 9. First look at microwave contents.

Figure 10. Second look at microwave contents.

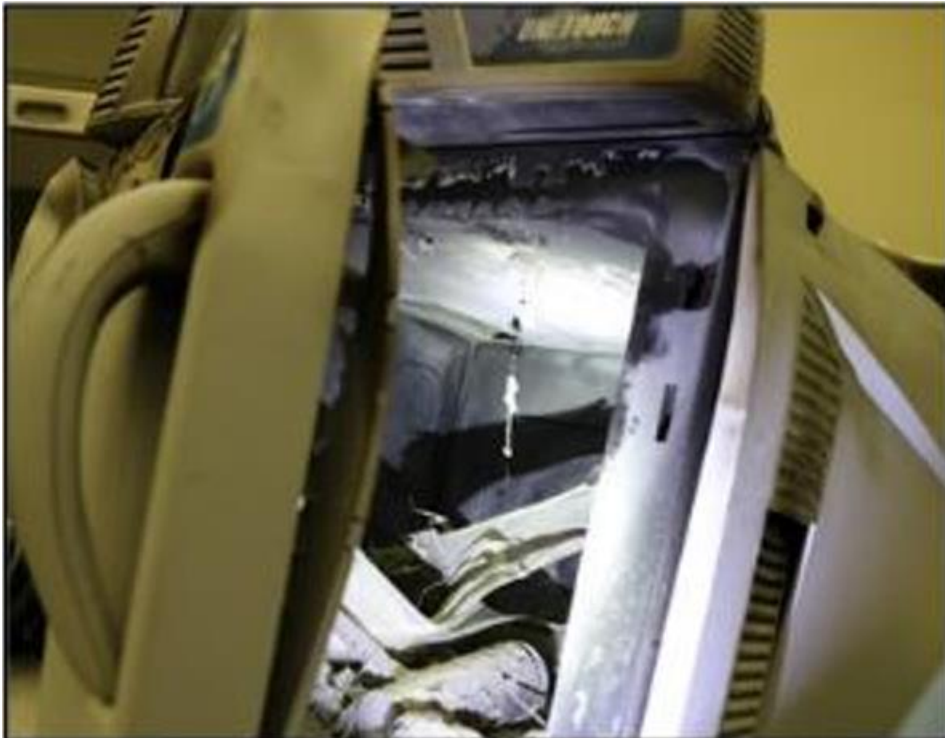
The third section of the thermocouple was still attached to the fixture in the ceiling of the microwave cavity (Figure 19), and that section of thermocouple was extremely damaged from heat, showing severe melting of the coating and central fiber. The serial number and other identifying marks on the thermocouple were damaged beyond recovery. The only definitive evidence showing what type of thermocouple was used is the blue coating on the section of thermocouple coming out of the Reference cell lid.

Figure 19. Thermocouple section dangling from the ceiling fixture.

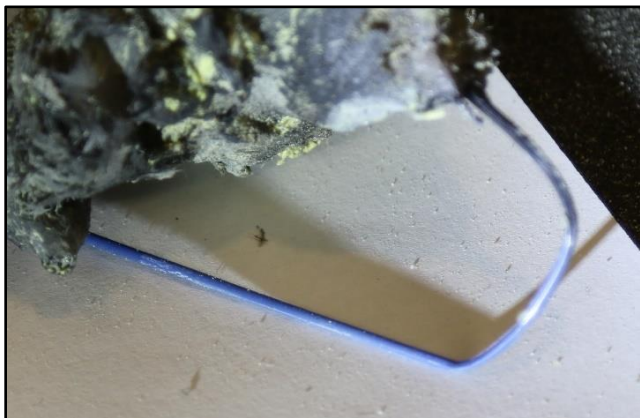
Figure 20 clearly illustrates the blue color of the coating on the thermocouple jacket exiting the Reference cell lid. Additional supporting evidence showing the type of thermocouple used during the run can be obtained from manufacturer literature and product containers thermocouples arrive in.

Figure 20. Blue jacketing material on thermocouple exiting the Reference cell lid.

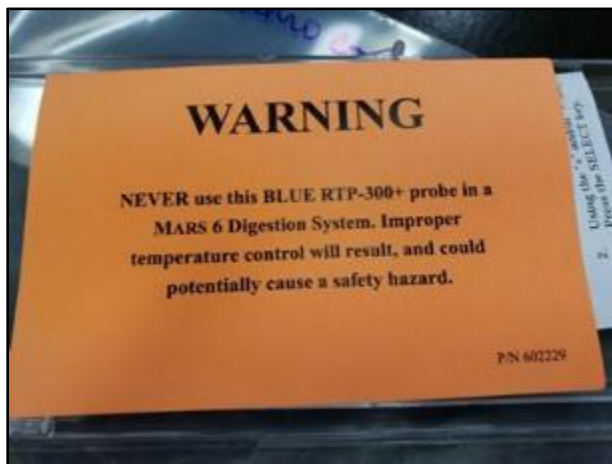
Figure 24 shows the orange manufacturer-supplied warning label found in the MARS 5 thermocouple box. The Reference cell, lid, and blue thermocouple pieces were carefully collected, photographed, and bagged. There is strong evidence that a blue MARS 5 thermocouple was deployed during the run.

Figure 24. Manufacturer-supplied warning label found in the MARS 5 thermocouple box.

- Over-reliance on equipment, the manufacturer, on past successful runs, and on personal knowledge/skills.
- Sign blindness. Bright orange WARNING label in the probe box.
- Conditioning/culture that enables us to ignore instructions and warning labels.

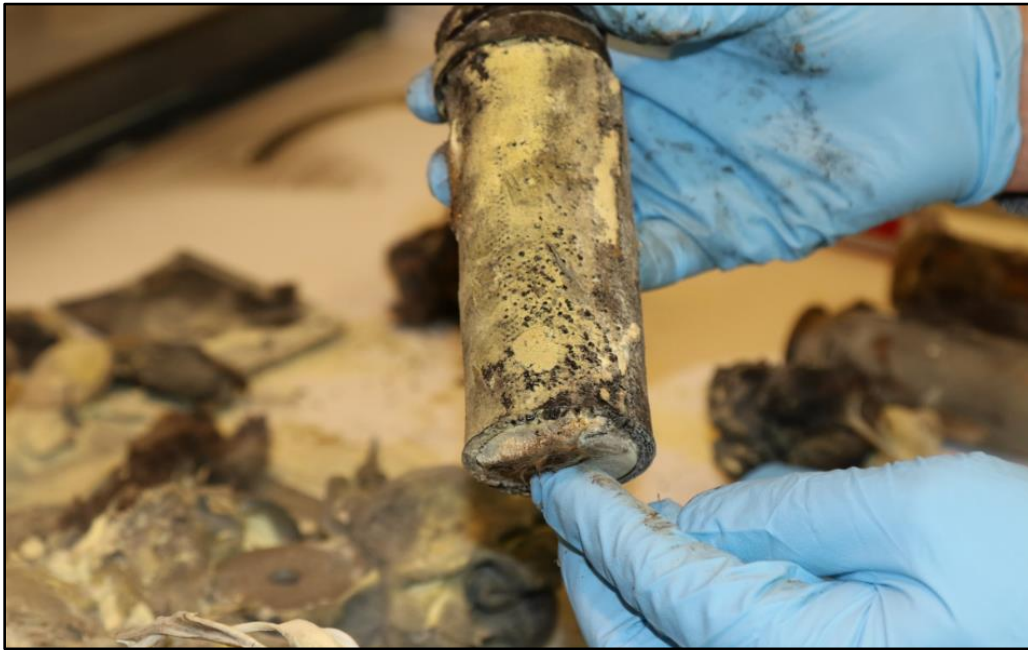
The torque wrench used to compress sample lids was tested. Even though the wrench was set at 83 in.-lb, and the manufacturer specifies 84 in.-lb, the wrench at its current setting was supplying 81.56 in.-lb torque which is 2.9% low, but still well within the manufacturer's tolerances for the torque wrench and force applied to the MARS 5/6 sample lids. Even though the lids were tight, the blue MARS 5 probe reported an incorrect temperature and over-powered the run causing loss of acid contents into the microwave cavity. The temperature probe did not break during the run. Microwaves kept pouring into the overheated and venting sample containers. The run eventually stopped in the 180° position and intensive heat damage could be seen to sample cells #10, the Reference cell, and cell #3. It is unknown which sample cell or cells vented first, and it really does not matter because the results are the same, but #10, #3, and the Reference cell are most strongly suspected. Sample cell #10's lid had undergone such intense heat that the sample cell lid was fused to the cell body and the composite thermal barrier sleeve was scorched (Figure 29).

Figure 29. Scorched composite thermal sleeve surrounding Sample cell #10.

When cell #10's lid was pried off it was noted that a solid mass of material remained in the vessel which appeared to be undigested or partially digested, consolidated, soil sample; an indication of loss of acid early in the run cycle. Loss of contents caused for very hot concentrated acid (HNO_3/HF) to exit the sample vessel(s) at >800 psi. If the blast were directed at the cassette body, the glass-filled polyethylene would have melted. Fire was caused when microwave transparent materials became microwave absorbing and the temperature sensor failed to shut the microwave off, and microwaves continued to rapidly over-heat cassette polymers. The primary material combusted was the grey, glass-filled polyethylene cassettes. The ReactiGuard failed to sense a vessel rupture and did not shut the microwave off until active smoke and flame were present. Microwaves rapidly over-heated cassette polymers causing loss of structural integrity and venting of vessels. Even though polypropylene is somewhat chemical/acid resistant, very little can handle >200°C concentrated acid blasting out at >800 psi. Fire was caused by the temperature probe failing to accurately sense temperature and causing significant heating of the acid-splashed cassette polymers which caught fire. Fire and heat were most intense at the back of the microwave, melting polymers, scorching thermal shielding, and melting the main fan shroud in the back of the microwave.

3. Keep MARS 5 and MARS 6 probes separate.
4. 84 in-lb is the torque recommended by the manufacturer to seal the EasyPrep assemblies. Proper torque is necessary to prevent venting scenarios and is a function of a properly operating torque wrench.
