# An Investigation of Liquefaction in Irradiated TRIGA Fuel Exposed to Relatively High Temperatures

November 2020

**Idaho National Laboratory  
Idaho Falls, Idaho 83415**

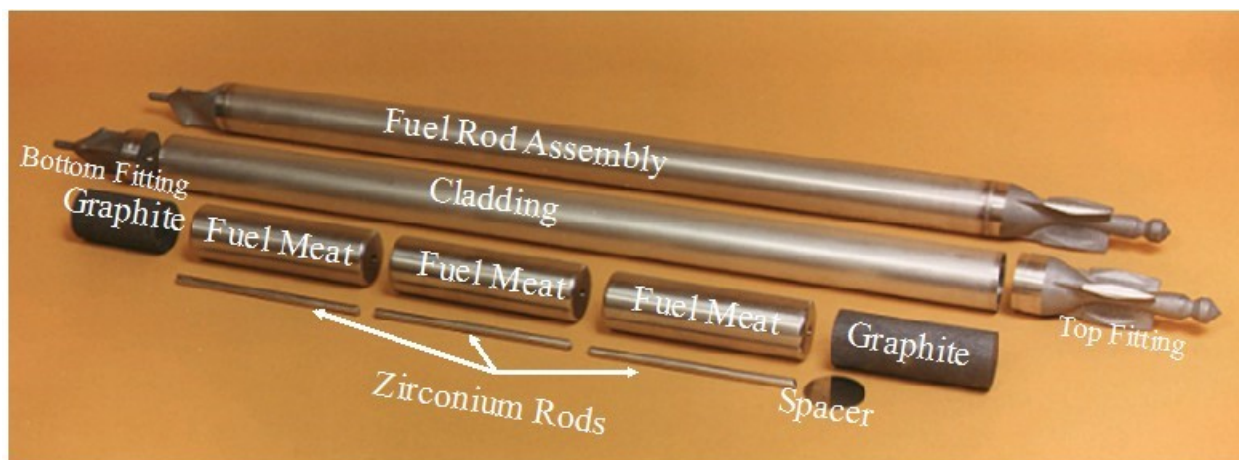
Figure 1. TRIGA fuel rod and components. The zirconium rods run through holes present in the fuel-meat sections.

A TRIGA fuel-rod assembly with its components is shown in Figure 1. The fuel rod is axially centered in the Type 304 stainless-steel (SS) cladding tube with a graphite reflector slug at each end. Molybdenum discs are placed between the fuel meat and the graphite slug as shown in Figure 1. There is no bonding material between the cladding and fuel meat. The fuel meats have a hole in the center where a solid zirconium rod is inserted in each fuel meat during assembly. The zirconium rod provides for increased hydrogen content in the fuel element. End fittings are heliarc welded to the top and bottom ends of the cladding tube, encapsulating all internal pieces.

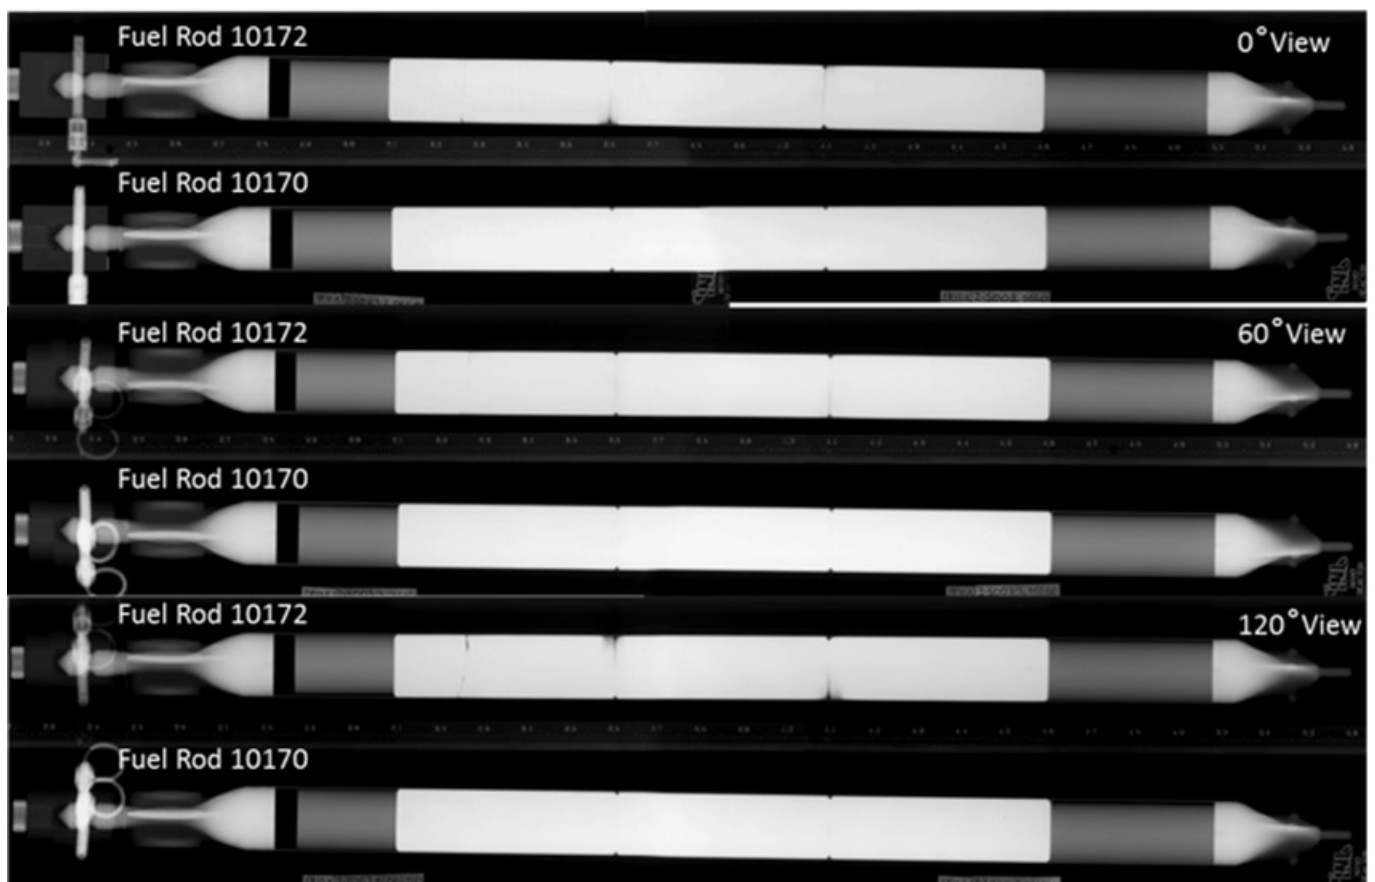
Figure 2. Dysprosium exposure for Fuel Rods 10172 and 10172 for the 0, 60- and 120-degree rotations.

The NRAD imaging of TRIGA Rods 10170 and 10172 was successful in providing data with which to assess the general condition of the fuel region of both rods. Both are shown in Figure 2 for the dysprosium exposure. Regions of dehydriding are observed in both rods (most pronounced in the 120-degree view) and are primarily located in the regions between the fuel meats. These areas were characterized by the circled darker regions on the fuel meats in the radiographs shown in Figure 3 for Fuel Rod 10170 and 10172. It is hypothesized that these were areas of higher temperatures during the operation of the reactor and the hydrogen diffused from these areas to cooler areas.

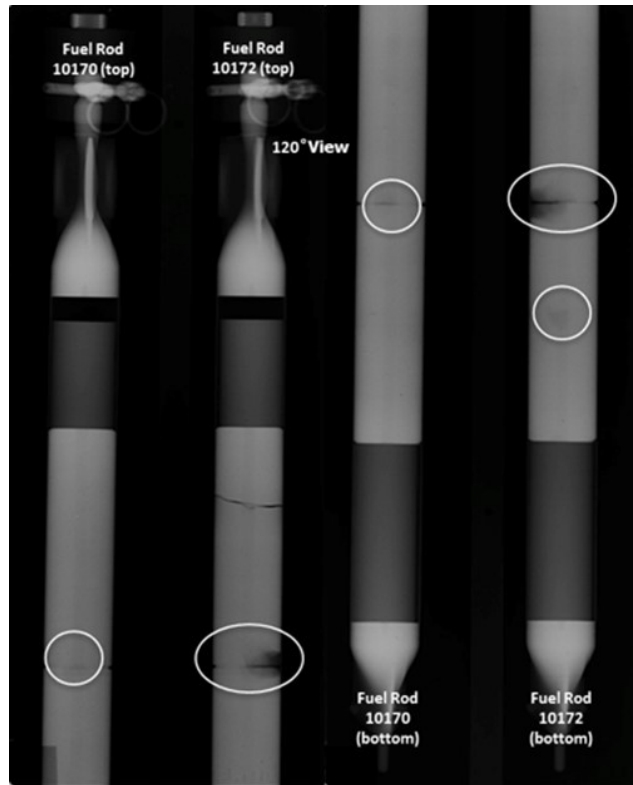
Figure 3. Fuel Rods 10170 and 10172 shown for the 120-degree view. The circled regions are dehydride locations in the fuel meat.

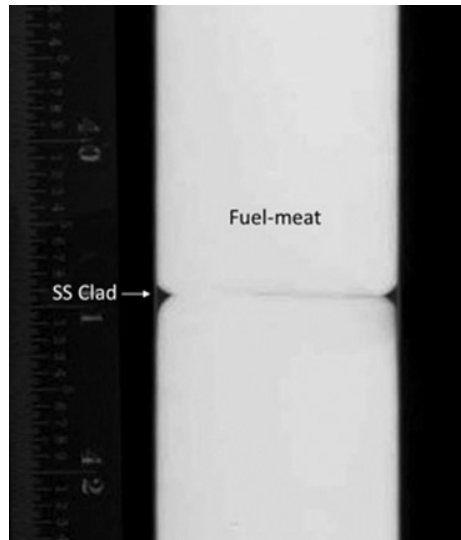
Figure 4. Example of fuel meat to cladding interface for Fuel Rod 10172.

Due to irradiation-induced fuel swelling, the fuel meat expanded. Of interest was if this resulted in good contact between the fuel and the cladding. Figure 4 shows that there may be good fuel meat contact with the cladding for the higher burnup rod, Fuel Rod 10172, excluding the regions between the fuel meats where the fuel-meat ends are chamfered and do not contact the cladding. Once several variables were considered, Fuel Rod 10172 was selected for sectioning because it potentially had good fuel and cladding contact, was the highest-burnup rod, and contained the highest inventory of lanthanide fission products.

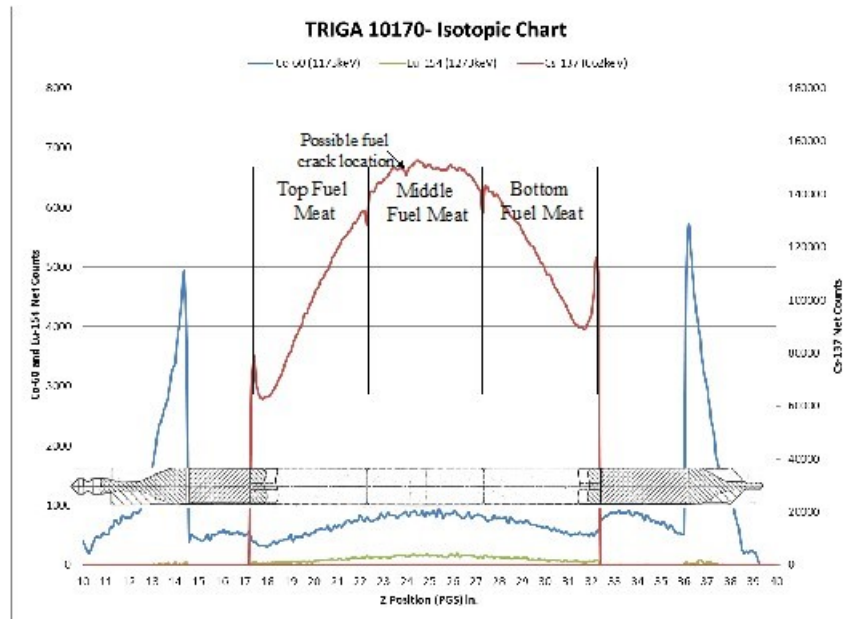
Figure 6. Isotopic gamma-scan profile for TRIGA Fuel Rod 10170.

Gamma-scanning results are shown in Figure 6 and Figure 7, and  $^{137}\text{Cs}$ , which is a longer-lived fission product (half-life of 30.07 years), was selected to indicate burnup levels for the rods relative to each other. Spectral profiles of  $^{137}\text{Cs}$  for both rods indicate the peak burnup location within each rod to be in the middle (center fuel meat) region of the rods. Also indicated in the  $^{137}\text{Cs}$  spectra is a dip between each of the fuel meats (see Figure 6 and Figure 7). While both Fuel Rods 10170 and 10172 have a slight dip in the  $^{137}\text{Cs}$  spectra located in the center fuel-meat region, neutron radiography of the fuel rods indicate that the fuel is intact. Also, the uncertainty in the data indicates that the dips are not statistically significant relative to other data points in this region.  $^{60}\text{Co}$  (half-life 5.27 years) is an activation product from the SS cladding of the fuel rod and end fittings.  $^{154}\text{Eu}$  (half-life 8.59 years) is another gamma-emitting fission product by which burnup can be benchmarked.

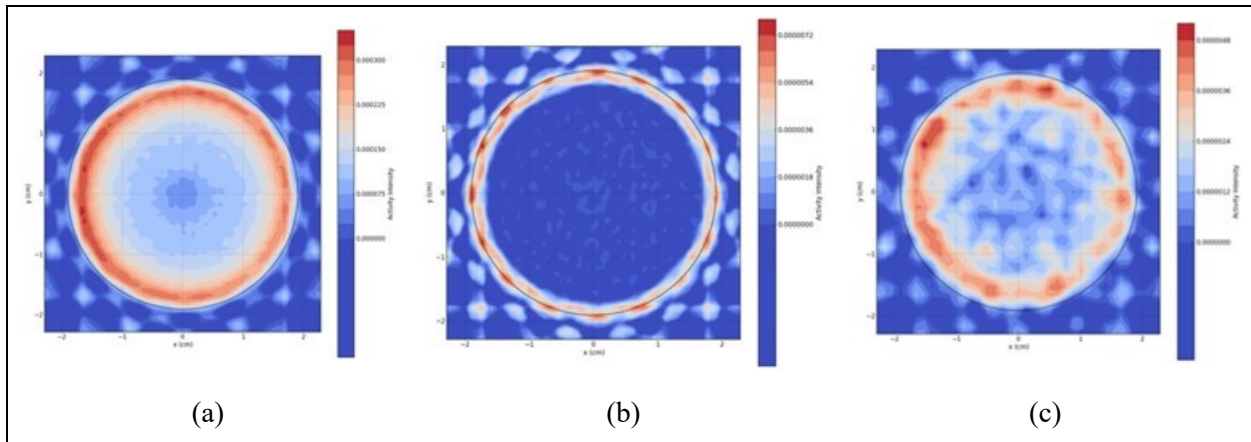
Figure 12. BOT217  $^{137}\text{Cs}$  (a),  $^{60}\text{Co}$  (b) and  $^{154}\text{Eu}$  (c) tomographic maps.

Scans were centered over the puck centerline and were taken in 0.01-in. steps at nine different angles for BOT217, 218, and 219. Decay counts were not high due to the long decay period of the fuel rod. Therefore, to improve the resolution of the plots and reduce statistical noise for  $^{137}\text{Cs}$  and  $^{60}\text{Co}$ , data from two step locations were summed. Even lower counts for  $^{154}\text{Eu}$  necessitated summing data from five step locations. The tomographic images of  $^{137}\text{Cs}$ ,  $^{60}\text{Co}$ , and  $^{154}\text{Eu}$  from these data are shown in Figure 12 for the BOT217 specimen. Results from the tomographic reconstruction of the circumferential count locations indicate a radial gradient in the burnup in the fuel meat. The higher  $^{137}\text{Cs}$  count data at the perimeter indicate greater burnup relative to the center of the fuel meat. Data for  $^{60}\text{Co}$  are where they would be expected, at the fuel-perimeter and cladding region. The shape of the cobalt data is an artifact of the scanning method.

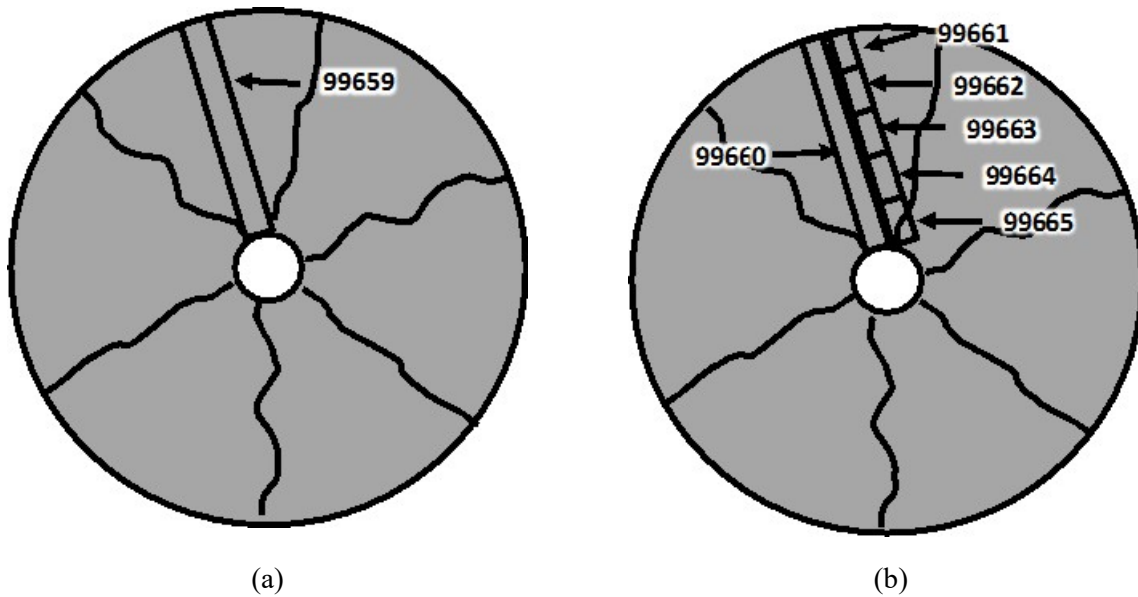
Figure 13. Chemistry sample-sectioning diagrams from Specimen BOT215 from Fuel Rod 10172, fuel pieces -2 (a) and -1 (b).

Samples from BOT215 (see Figure 13) were used to confirm the radial burnup profile of the tomographic data compiled from the PGS both chemically and using gamma spectroscopy. Sample IDs are ordered left to right relative to the outside edge of the cross section, moving into the center of the cross section (see Figure 13). Results from gamma spectroscopy are shown in Figure 14 for  $^{137}\text{Cs}$  (a) and  $^{154}\text{Eu}$  (b), measured in solid form and as measured in solution for Cs and Eu (c and d, respectively). Qualitatively, the four plots illustrate a radial burnup gradient and are consistent with the PGS tomographic scan data.

The burnup results for the 20% enriched fuel meat are found in Table 3 for the radial specimens that received chemical analysis. A specimen-sectioning diagram is shown in Figure 13 for fuel-rod Slugs 10172-2, specimen ID 99659 (a.) and Fuel Rod 10172-1, specimen IDs 99660-99665 (b.). Data obtained from chemical analysis and ICP-MS are shown in Table 3 and plotted in Figure 15 for the radial mini-sections for piece 1. These results indicate a radial gradient burnup profile in the  $^{235}\text{U}$ , which is consistent with the tomographic gamma-scan data. The burnup value for specimen 99659 of 18% is in reasonable agreement with the physics burnup calculation of 20%.

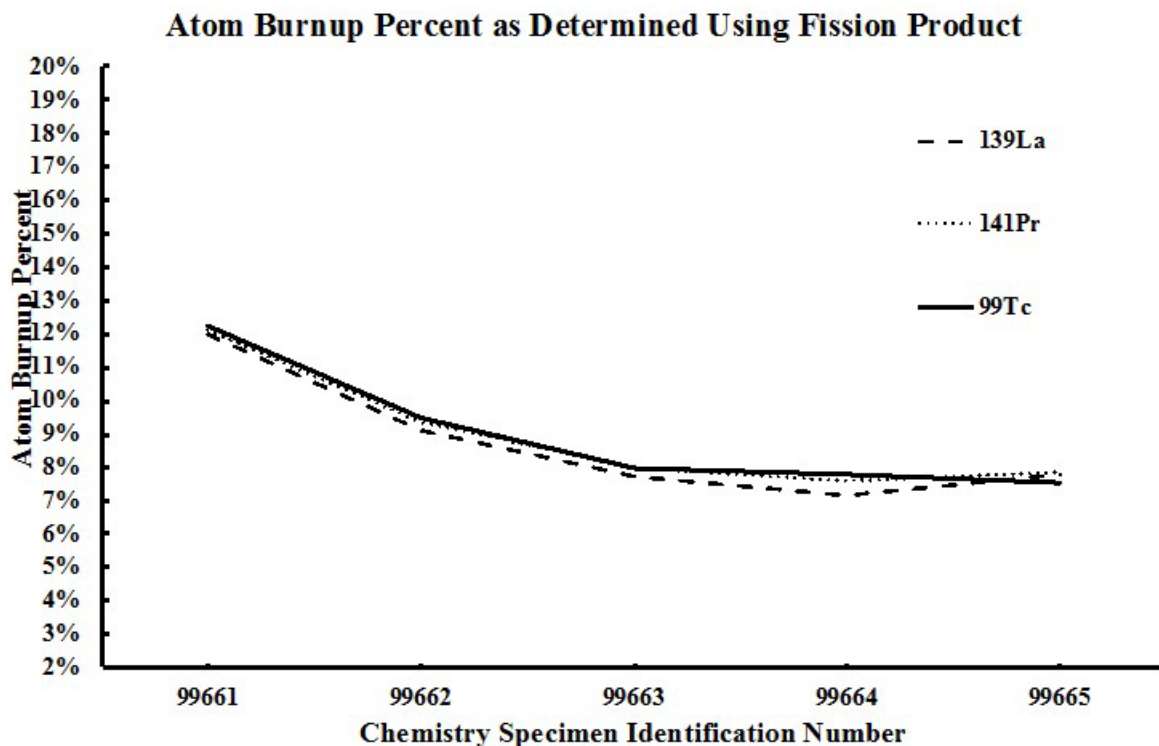
Figure 15. Plotted burnup values calculated via fission product measured using chemistry and ICP-MS.

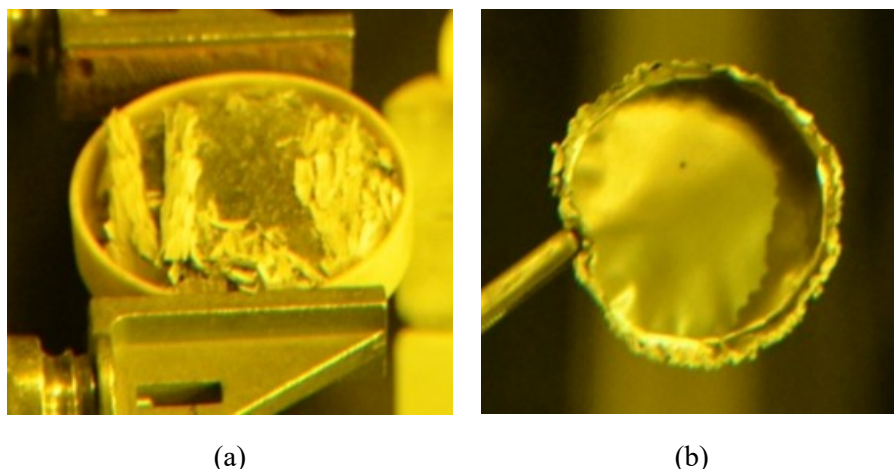
Figure 17. Tantalum wrap for Specimen BOT223 heat treated at 800°C for 6 hr with first layer of Ta reacted, as shown in (a), and the final layer of Ta in pristine condition, as shown in (b).

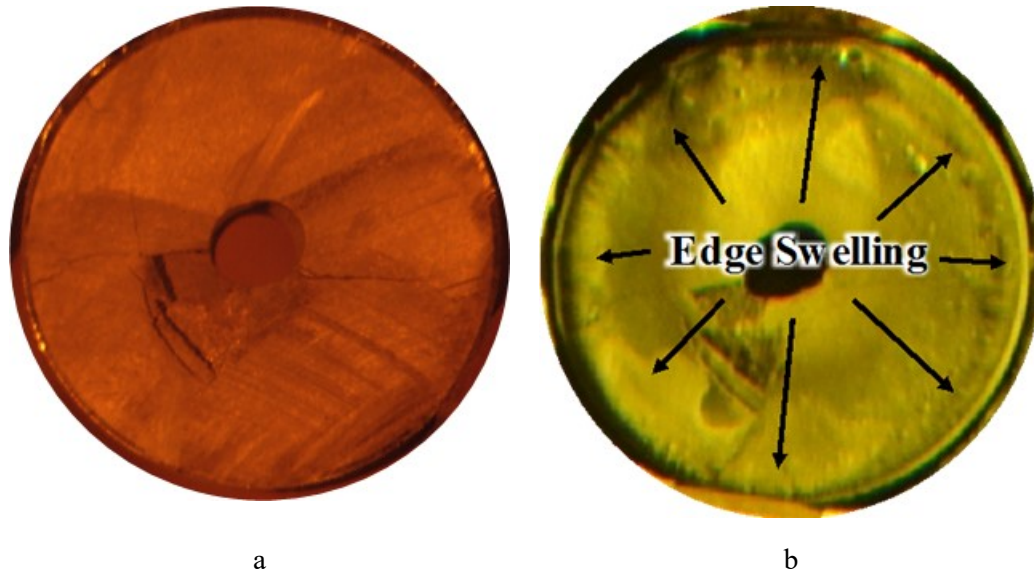
Figure 19. Pre-anneal image of BOT224 (a) and the post-anneal swelling shown for Specimen BOT224 (b).

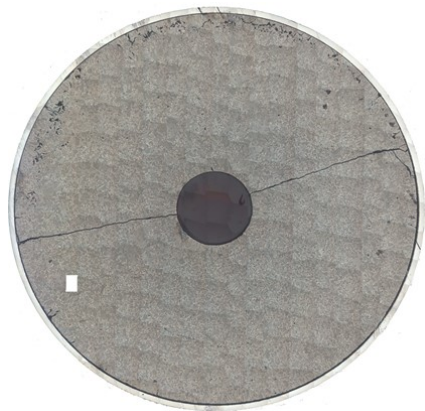
Figure 22. BOT228/MNT55Y 730°C-heat-treated specimen full montage at 31.5× magnification. The white rectangle is a missing image in the montage.

A montage of 31.5× magnification optical images of the as-irradiated TRIGA fuel after a heat treatment at 730°C for 6 hr is shown in Figure 22, and a 200× magnification image of the fuel and cladding interface in the specimen is presented in Figure 23. The image in Figure 22 suggests that intimate contact at the fuel and cladding interface was not commonly present after heat treatment.

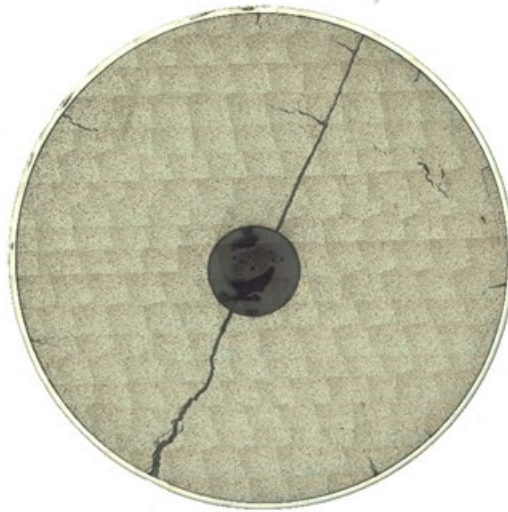
Figure 24. BOT223/MNT94Y 800°C heat-treated specimen full montage at 31.5× magnification. A crack is running down the center of the specimen.

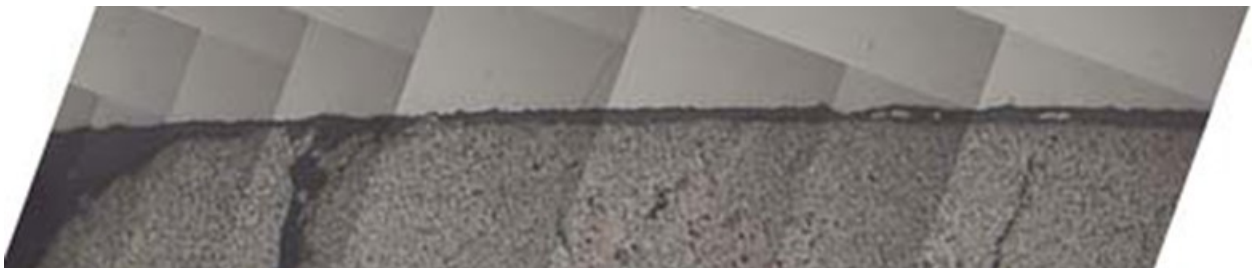
Figure 25. BOT223/MNT94Y 800°C heat-treated specimen partial montage at 200× magnification showing a fuel to cladding region with the best signs of good contact.

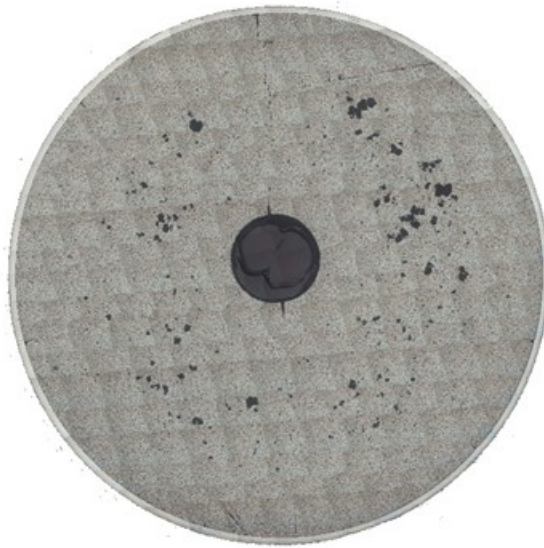
Figure 26. BOT222/MNT91Y 900°C heat-treated specimen full montage at 31.5× magnification. Dark regions toward center of specimen are Zr-H phase.

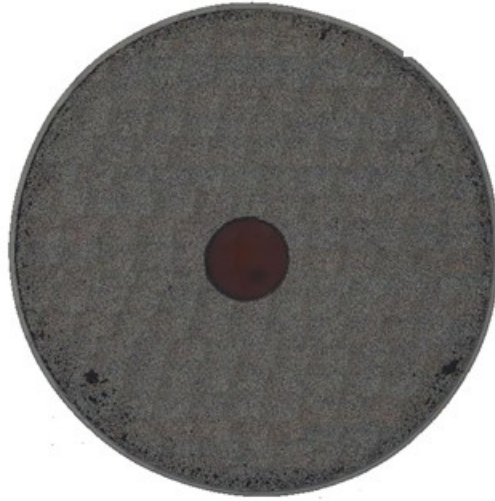
Figure 28. BOT221/MNT92Y 950°C heat-treated specimen full montage at 31.5× magnification.

A montage of 31.5× magnification optical images of the as-irradiated TRIGA fuel segment BOT221/MNT92Y, after a heat treatment at 950°C for 6 hr, is shown in Figure 28, and a 200× magnification image of the fuel and cladding interface in the specimen is presented in Figure 29. The image in Figure 29 suggests that intimate contact at the fuel and cladding interface was present, at least in some locations after heat treatment resulting in the development of an interaction layer. A montage of 31.5× magnification optical images of the as-irradiated TRIGA fuel segment BOT224/MNT99Y, after a heat treatment at 950°C of 6 hr, is shown in Figure 30. A 200× magnification image of the fuel and cladding interface in the specimen is presented in Figure 31 that shows FCCI had likely occurred and an interaction layer had developed.

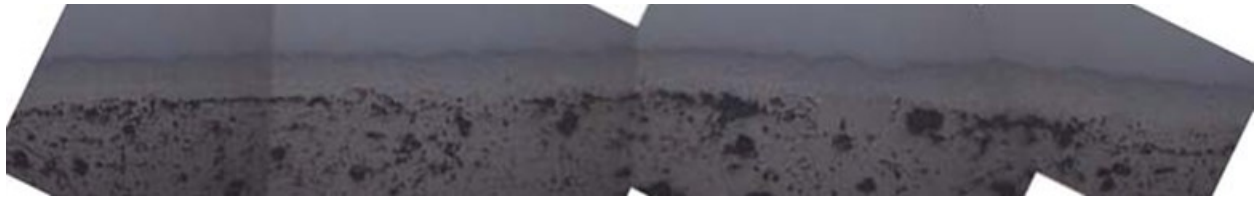
Figure 29. BOT221/MNT92Y 950°C heat-treated specimen partial montage at 200× magnification showing observed FCCI that resulted in the formation of a layer at the fuel and cladding interface.

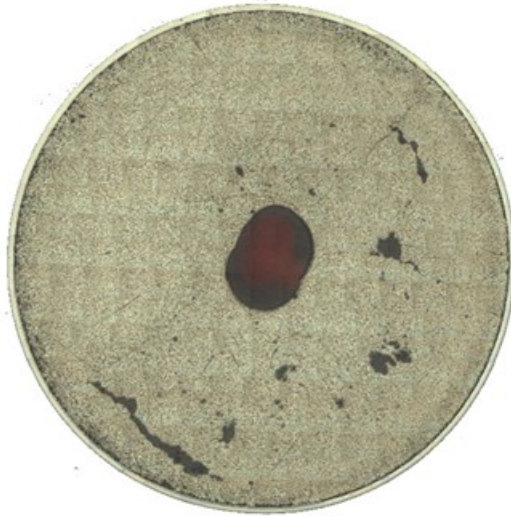
Figure 30. BOT224/MNT99Y 950°C heat-treated specimen full montage at 31.5× magnification. Dark regions toward center of specimen are Zr-H phase.

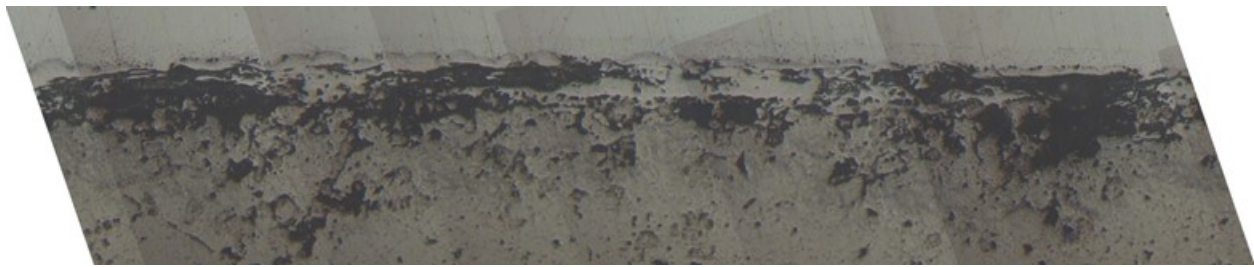
Figure 31. BOT224/MNT99Y 950°C heat-treated specimen partial montage at 200× magnification showing observed FCCI at the fuel and cladding interface.

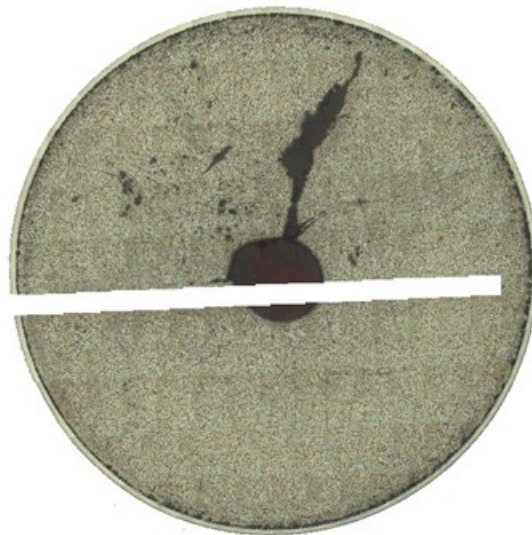
Figure 32. A full montage at 31.5× magnification of the BOT225/MNT01Z specimen heat treated at 950°C for 12 hr. The white strip is missing montage data discovered after micrographs were collected. Dark regions toward center of specimen are Zr-H phase or specimen damage that occurred during sample preparation.

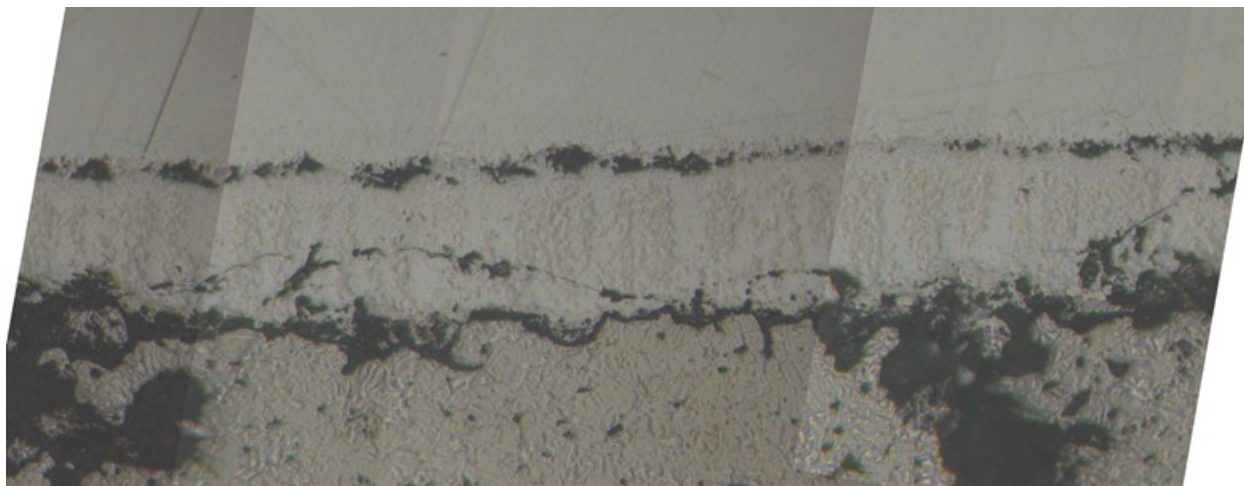
Figure 33. BOT225MNT01Z 950°C 12-hr heat-treated specimen partial montage at 200× magnification showing observed FCCI at the fuel and cladding interface and the resulting development of an interaction layer.

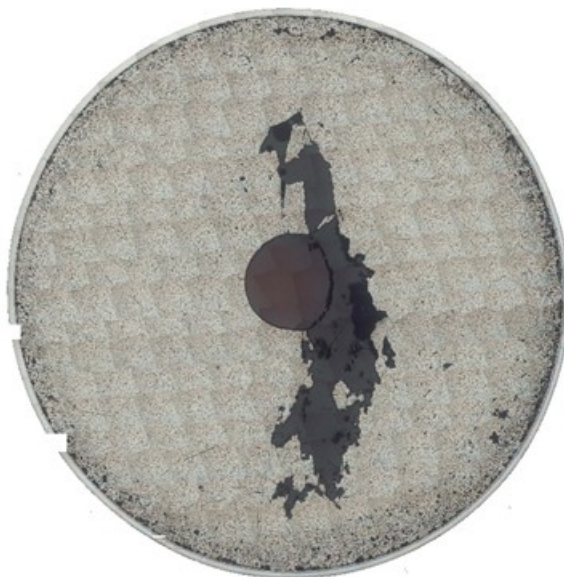
Figure 34. BOT220/MNT93Y 1000°C heat-treated specimen full montage at 31.5× magnification. Dark regions toward center of specimen are Zr-H phase or sample damage during polishing.

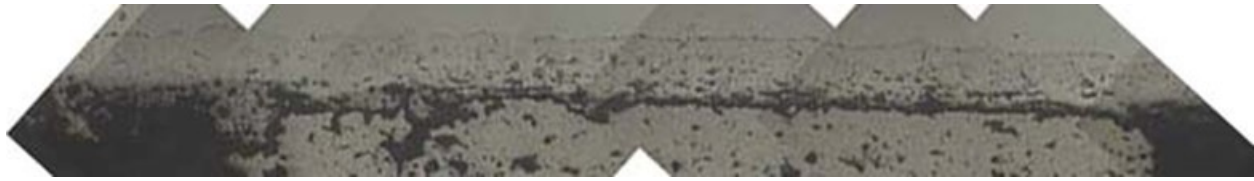
Figure 35. BOT220/MNT93Y 1000°C heat-treated specimen partial montage at 200× magnification showing the fuel to cladding contact region.

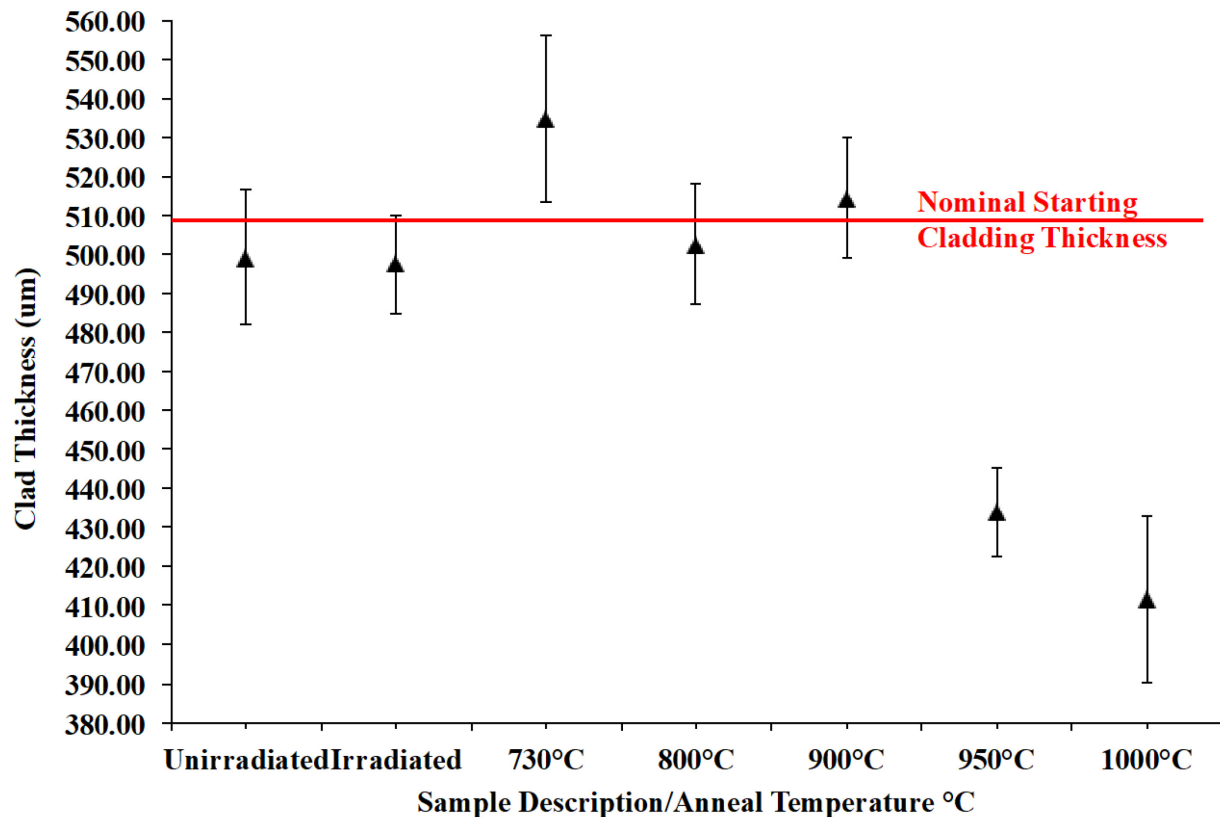
Figure 36. A plot of the thickness of the cladding not impacted by FCCI at different locations for the different annealed specimens. Data is based on evaluation of OM images. Even at 1,000°C, over 75% of the cladding thickness is devoid of fuel and cladding interaction.

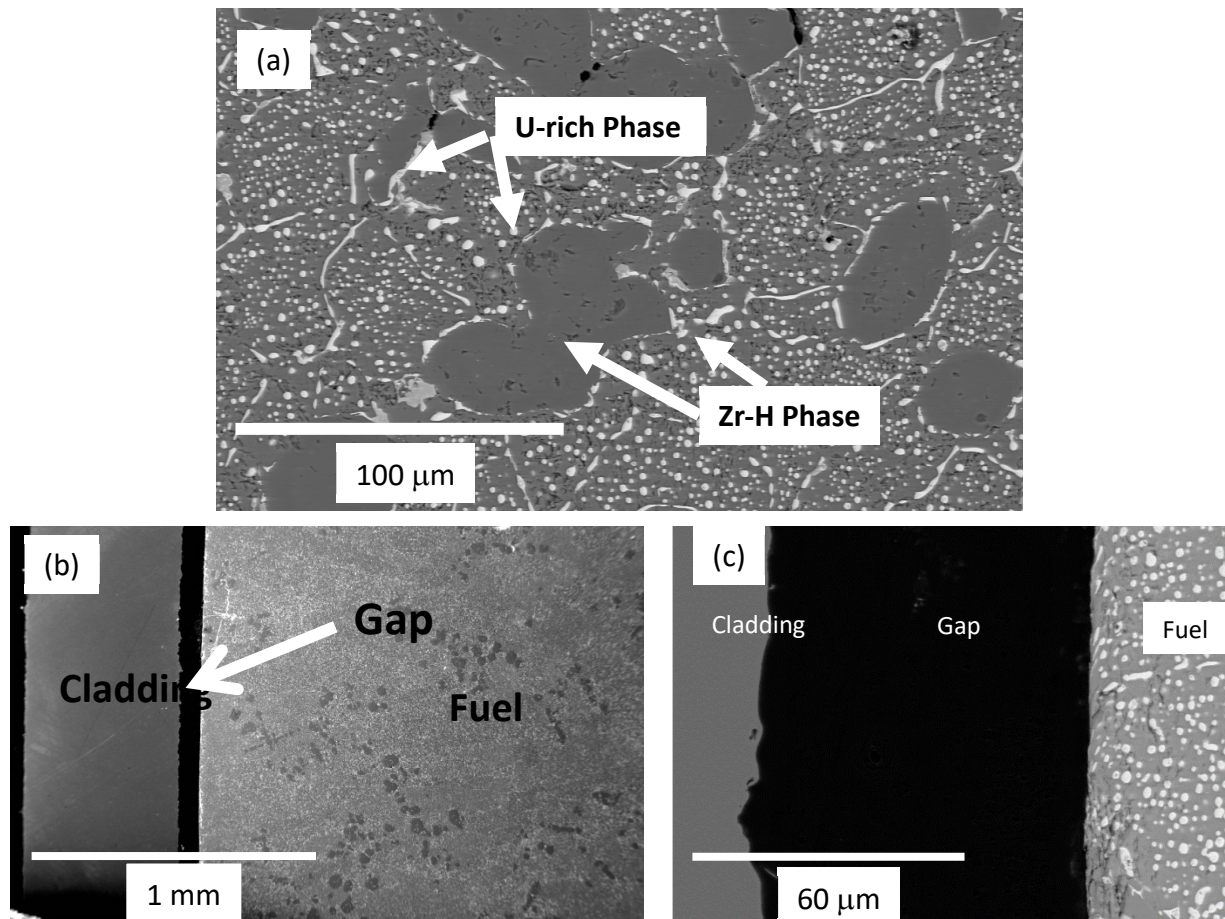
Figure 37. Backscattered electron images (a–c) showing the as-irradiated TRIGA fuel microstructure (a) and a gap (b,c) that was observed at the fuel and cladding interface.

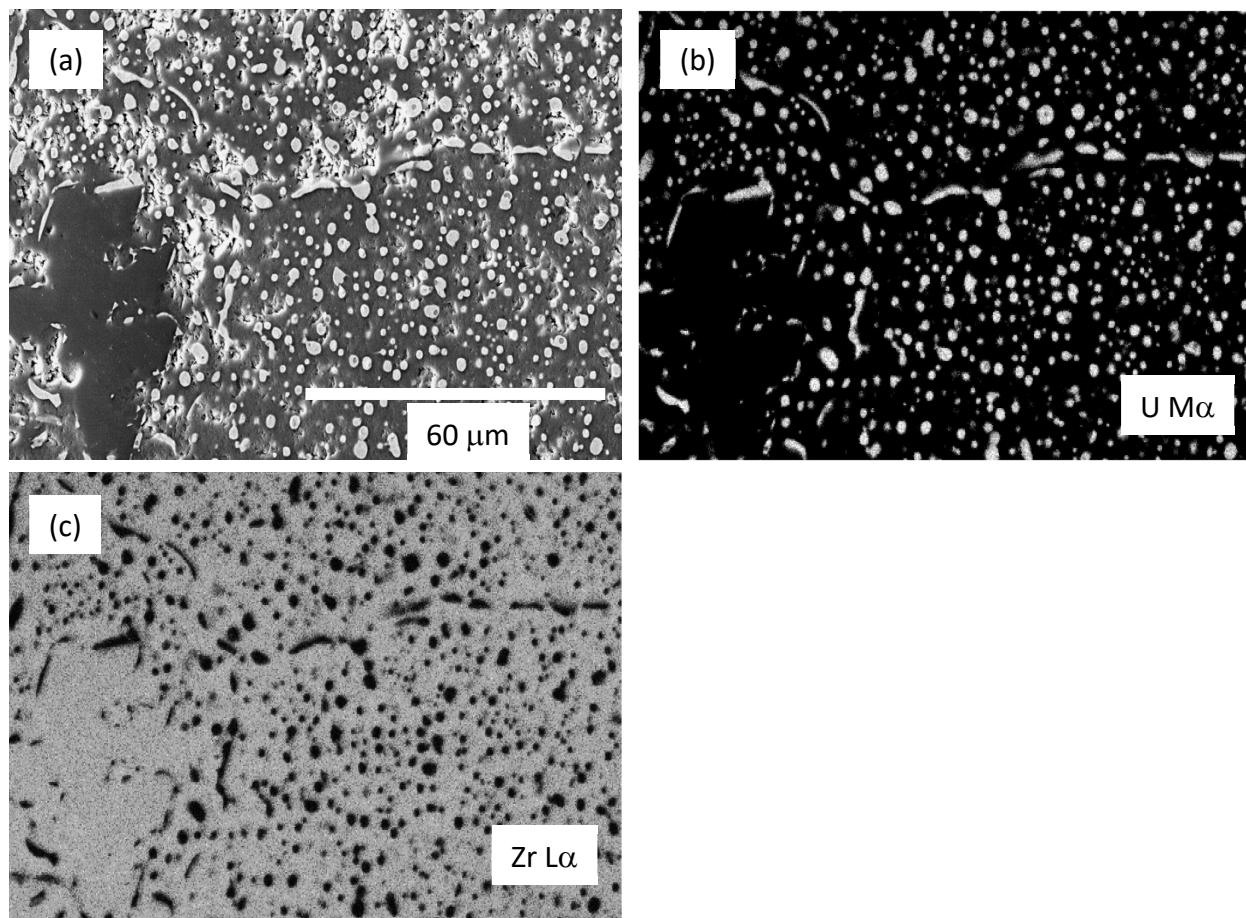
Figure 38. A BSE image of the irradiated fuel specimen microstructure (a) and WDS x-ray maps for (b) U and (c) Zr. Hydrogen cannot be detected using WDS.

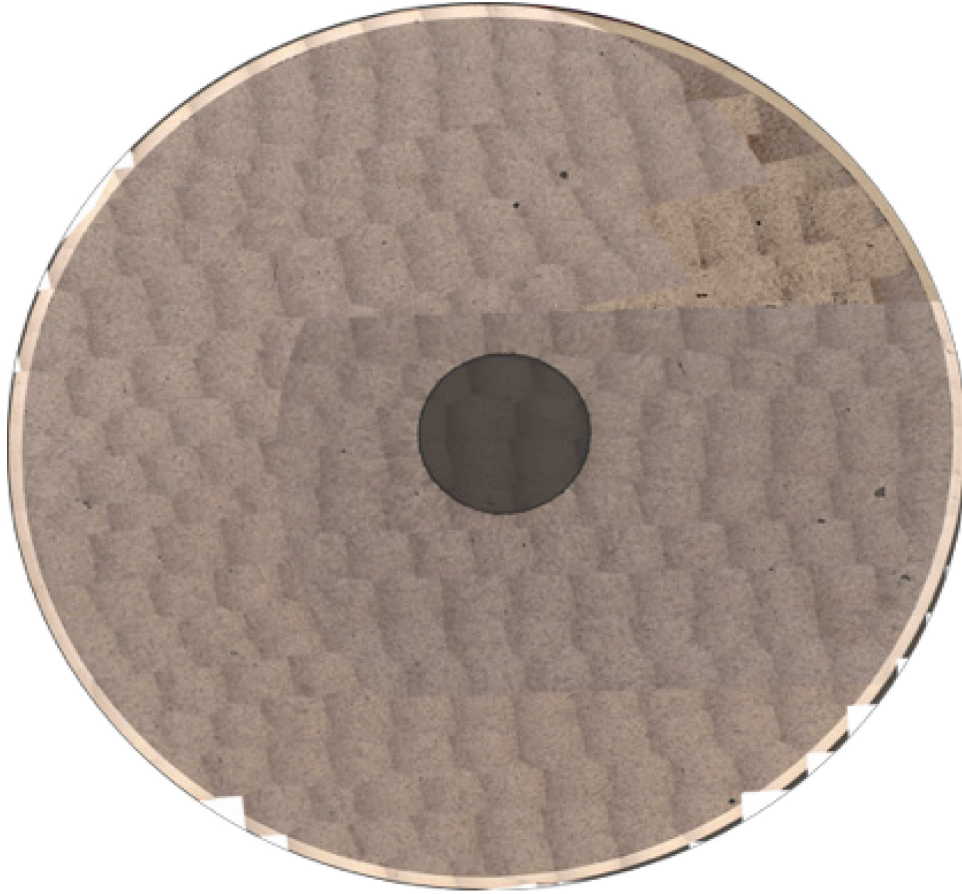
Figure 39. Montage of optical images showing as-fabricated TRIGA fuel.

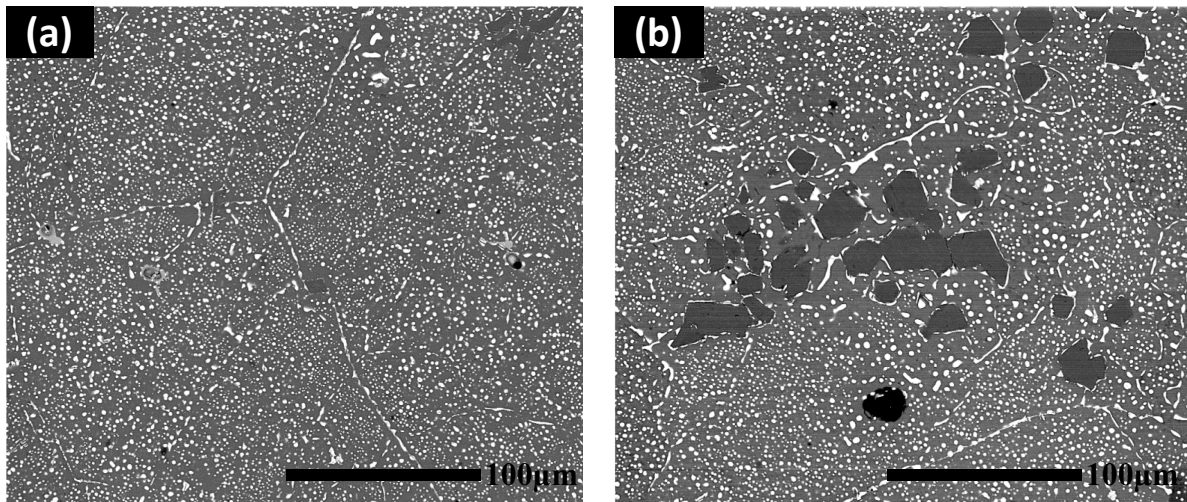
Figure 40. BSE images (a,b) of the microstructure for as-fabricated TRIGA fuel [2].

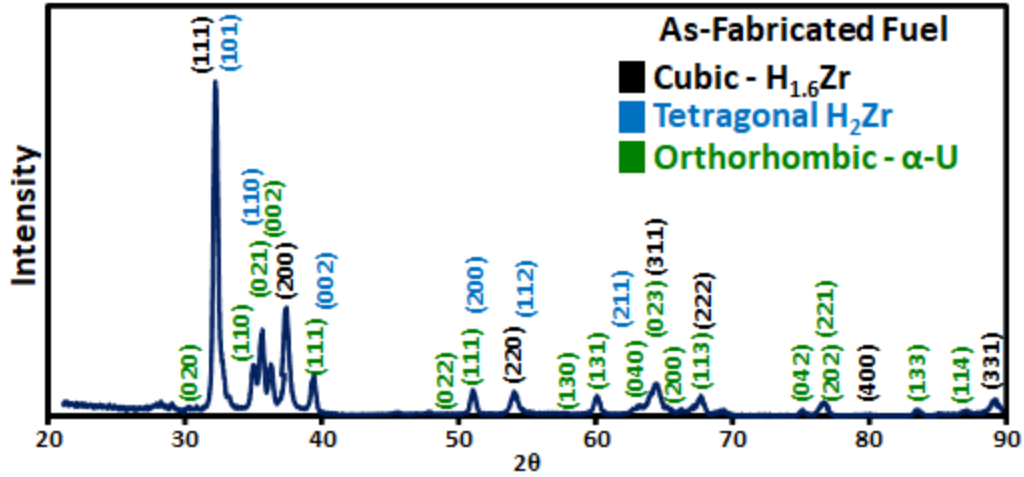
Figure 41. XRD pattern obtained from as-fabricated TRIGA fuel.

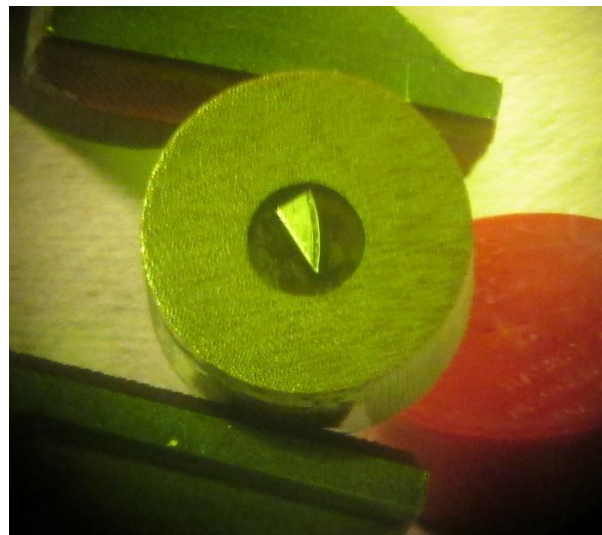
Sample 05A (730°C, 6 Hrs)

Figure 43. Photographs of the as-mounted samples from the TRIGA fuel that was heat treated at 730°C for 6 hr that were generated for SEM analysis.

The specimen tested at 730°C for 6 hr was selected for SEM characterization, since this temperature is just above the eutectic U-Fe composition that can exhibit melting at 725°C [3], and it has been hypothesized that due to fuel and cladding interaction this phase might be present in irradiated TRIGA fuel [1]. An optical image that shows where the SEM specimen was produced for characterization of the fuel and cladding interface is presented in Figure 42. Some dark-contrast, precipitate-like features were present at this location that might indicate some interaction had occurred between the fuel and cladding during the 730°C heat treatment for 6 hr. The specimen was sliced into two pieces using a slow-speed saw to fit into available mounts. Figure 43 shows photographs of the mounted pieces.

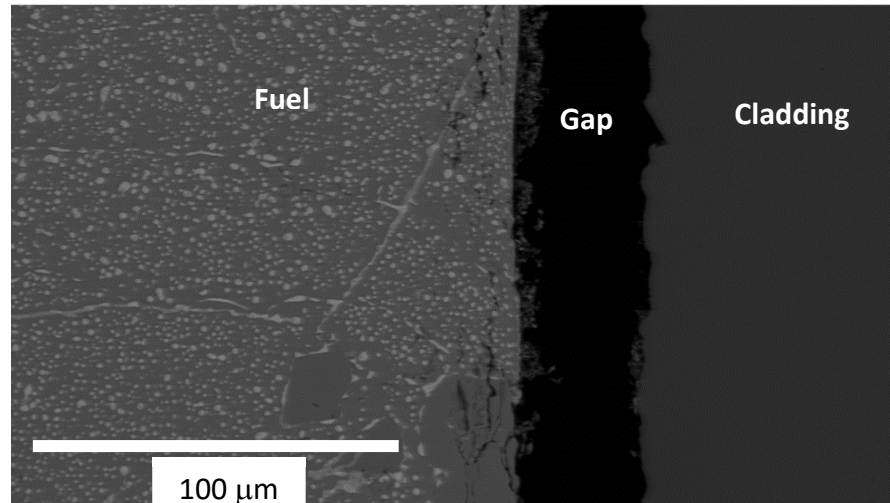
Figure 44. BSE image of the fuel and cladding interface for Sample 03A. A gap was observed.

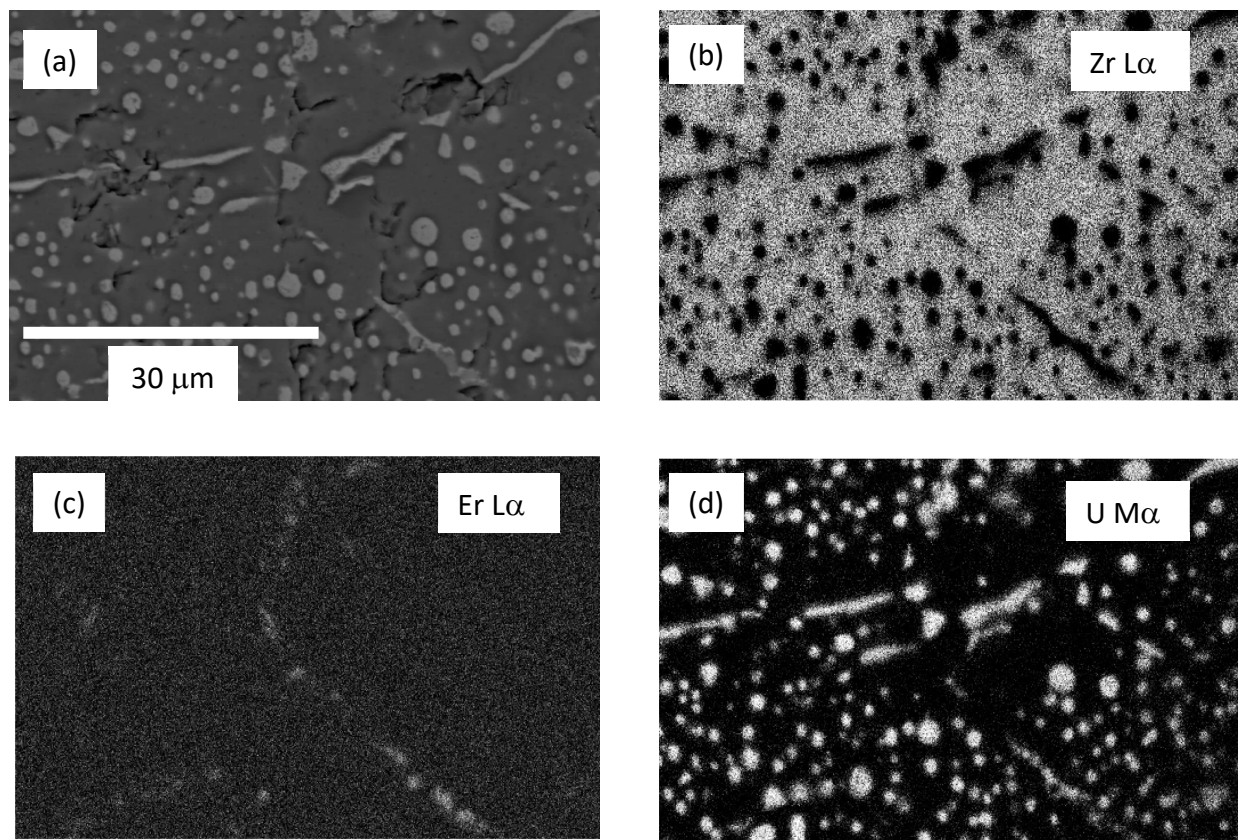
Figure 45. BSE image (a) and WDS x-ray maps for (b) Zr, (c) Er, and (d) U in the TRIGA fuel for Specimen 03A after the heat treatment at 730°C for 6 hr.

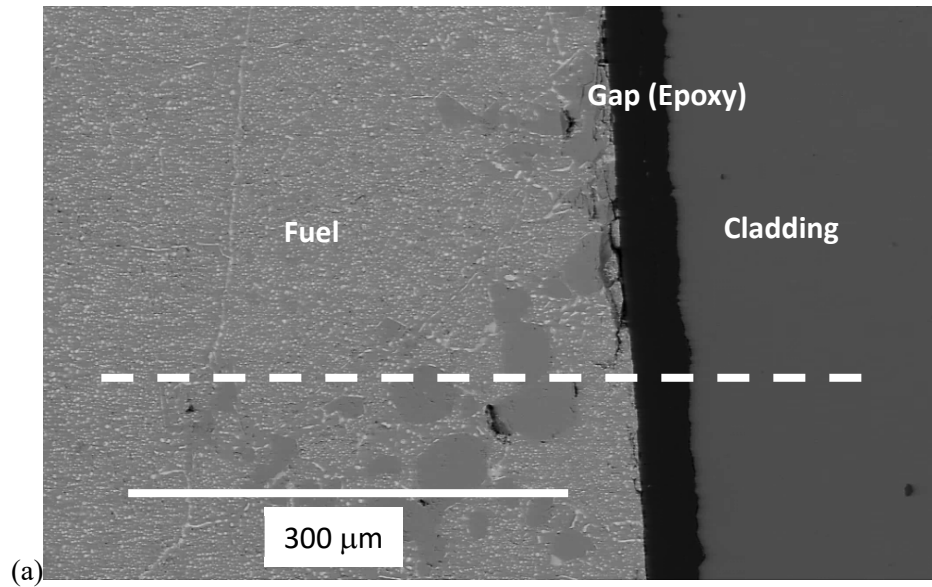
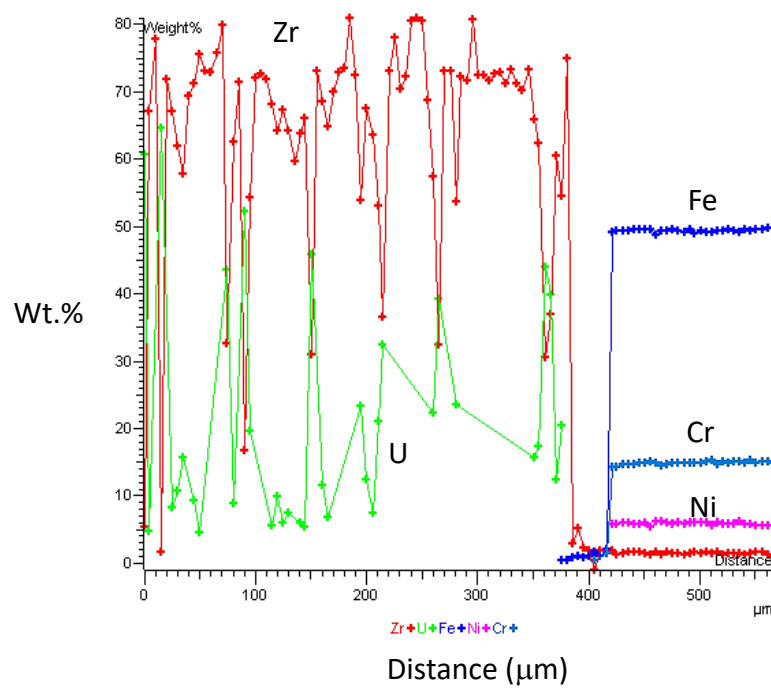
Figure 46. BSE image (a) showing location of EDS line scan (dashed line), and (b) variations of Fe, Cr, Ni, Zr, and U concentrations along line scan for Sample 03A.

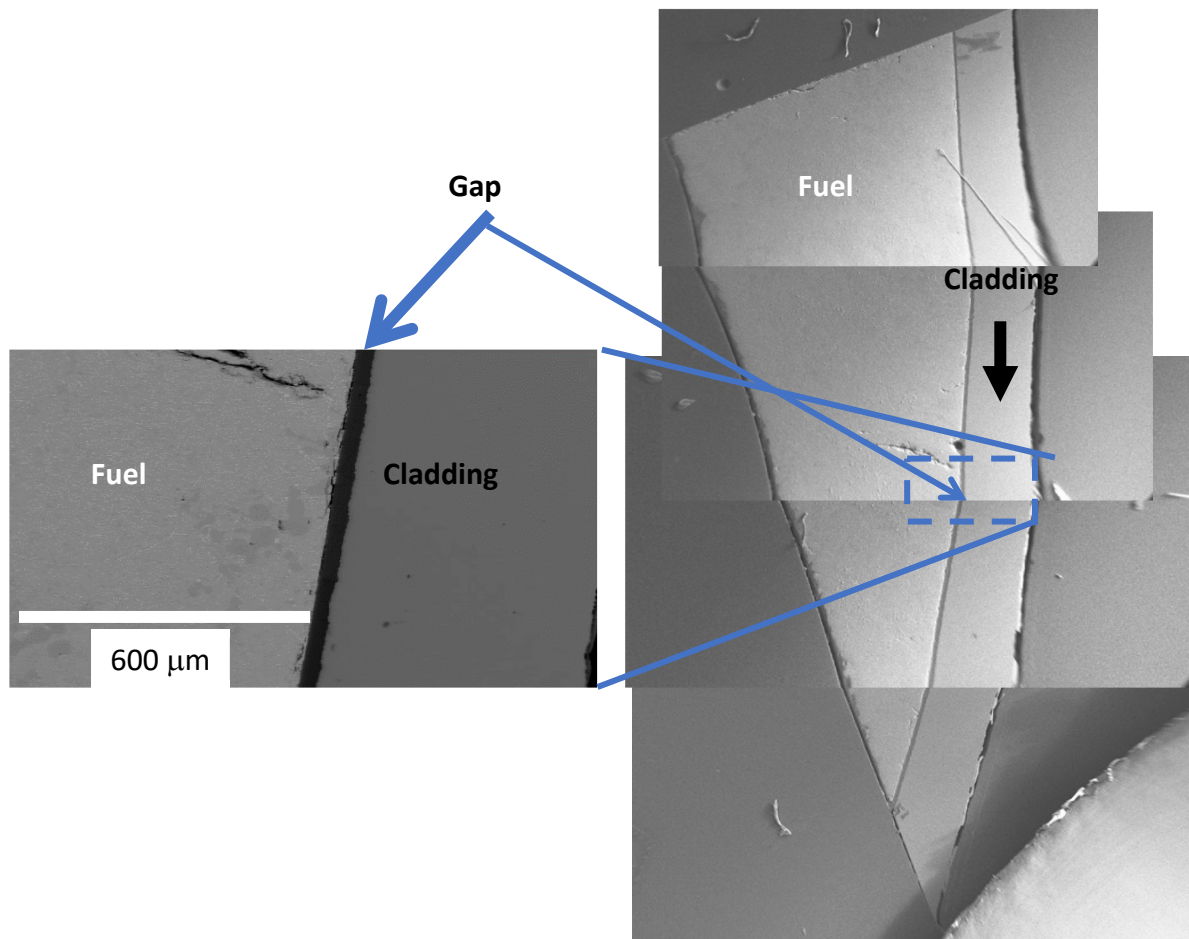
Figure 47. BSE micrographs of Sample 05A. A gap was observed at the fuel and cladding interface.

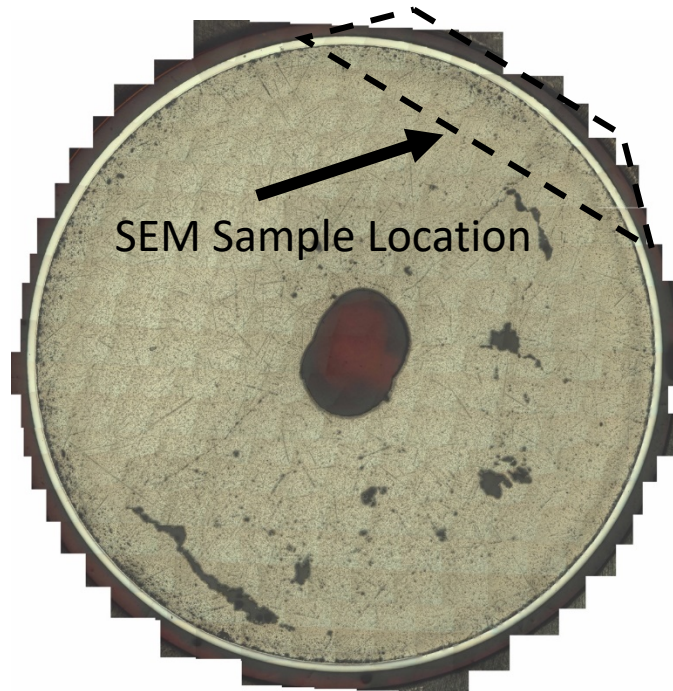
Figure 48. Montage of OM images showing location where SEM sample was taken (area in dashed line box). Isolated dark areas are Zr-H phase.
