# An Investigation of Liquefaction in Irradiated TRIGA Fuel Exposed to Relatively High Temperatures

November 2020

**Idaho National Laboratory  
Idaho Falls, Idaho 83415**

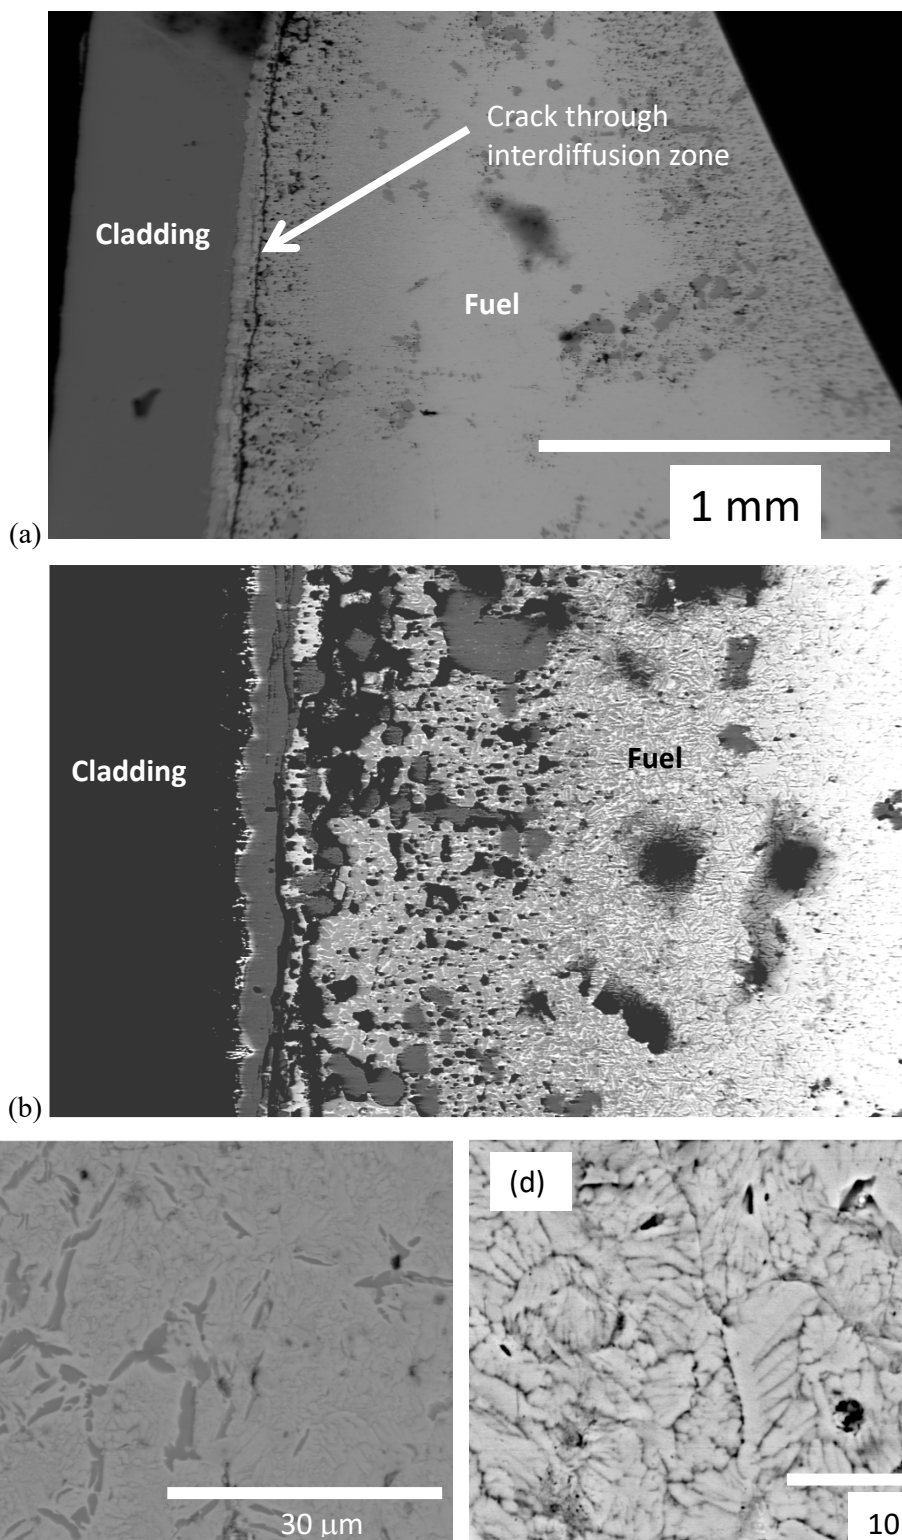
Figure 50. BSE images (a–b) The microstructure at the fuel and cladding interface for Sample 02A (annealed at 950°C for 6 hr). A crack parallel to the fuel and cladding interface was observed towards the fuel (c–d). The fuel microstructure is well away from the interdiffusion zone. Over 80 at.% Zr was measured in the bright-contrast phase depicted in (c–d).

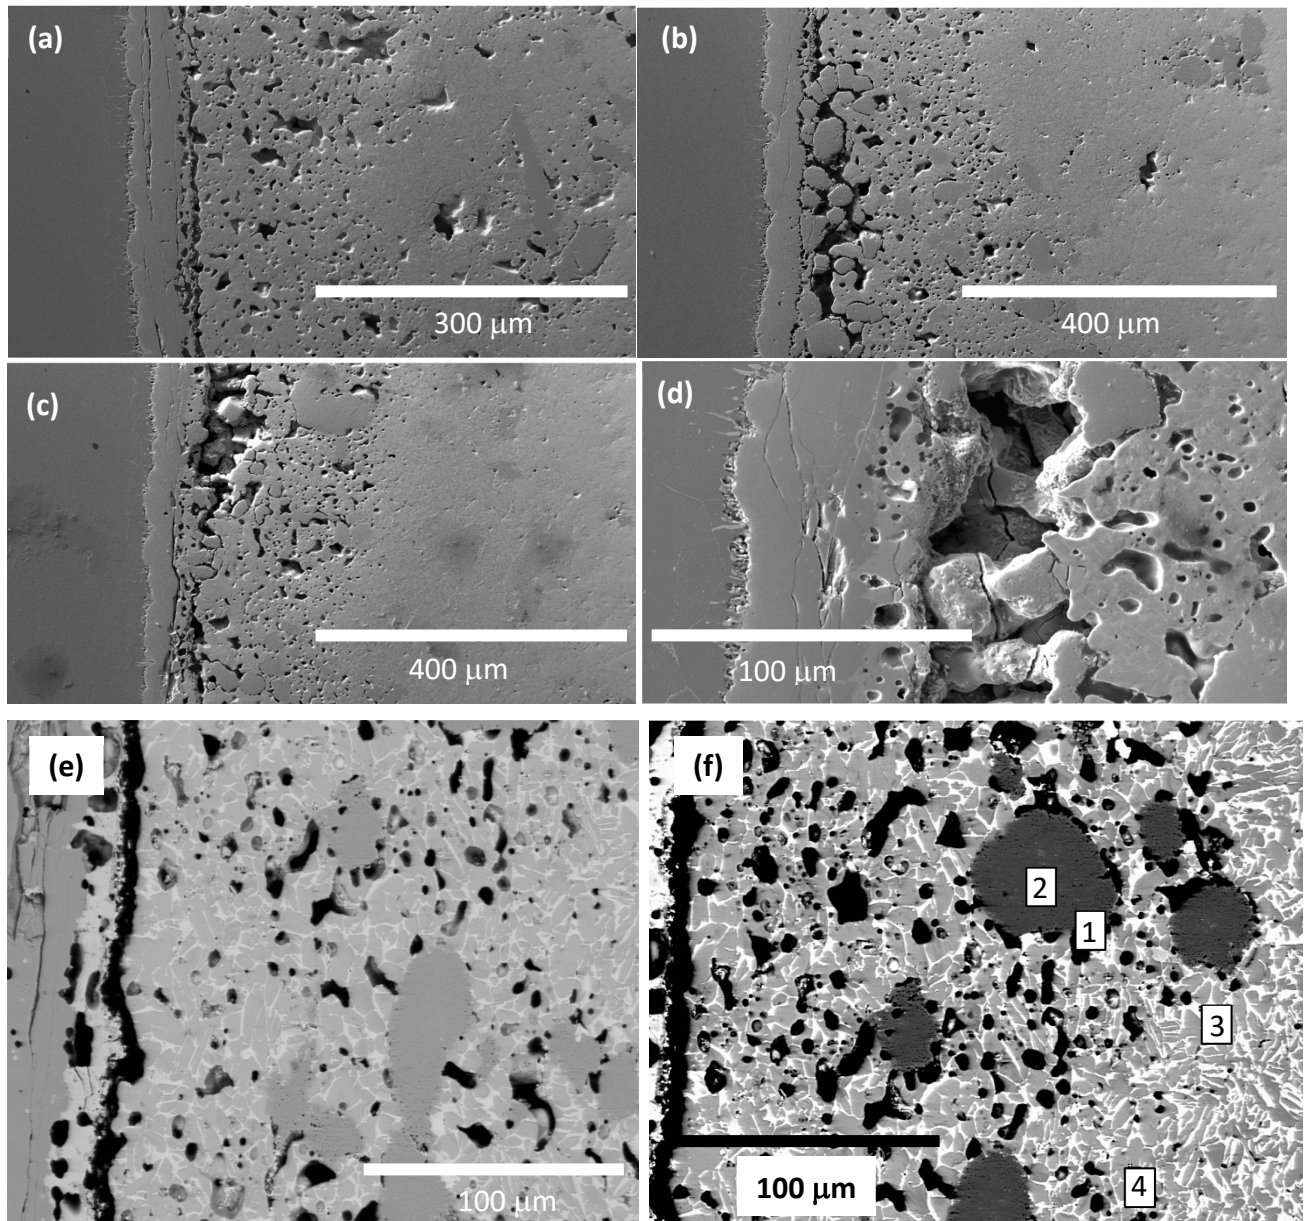
Figure 51. SE images (a–d) and BSE image (e–f) showing porosity that can be observed in the interaction zone. Points 1–4 in (e) are locations where compositions were measured using EDS. Points 1 and 2 are in the darkest contrast phase, Point 3 is in the brightest contrast phase, and Point 4 is in the medium-gray contrast phase.

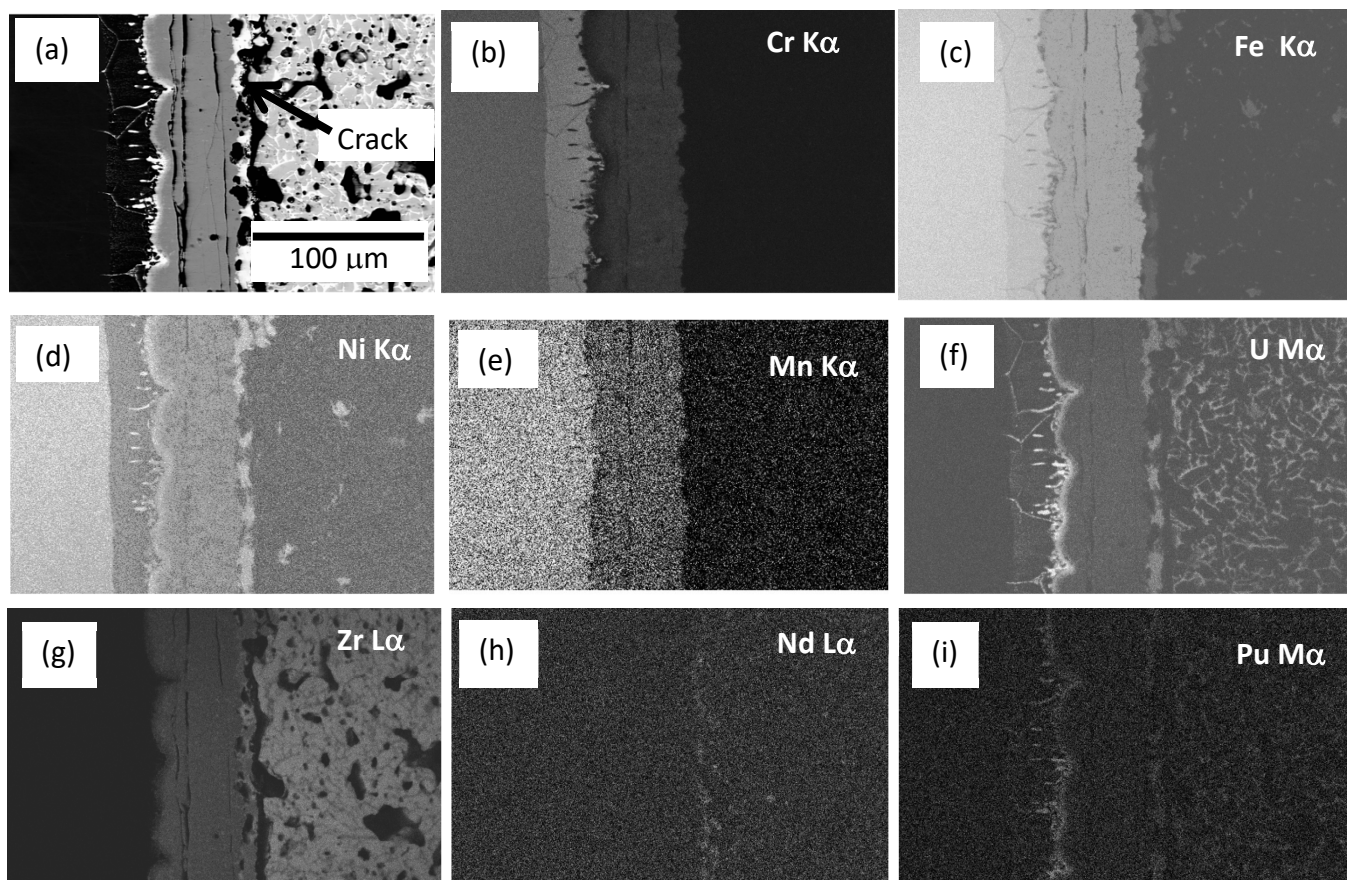
Figure 52. BSE image of interdiffusion zone (a) and WDS x-ray maps (b–i) for Cr, Fe, Ni, Mn, U, Zr, Nd, and Pu, respectively.

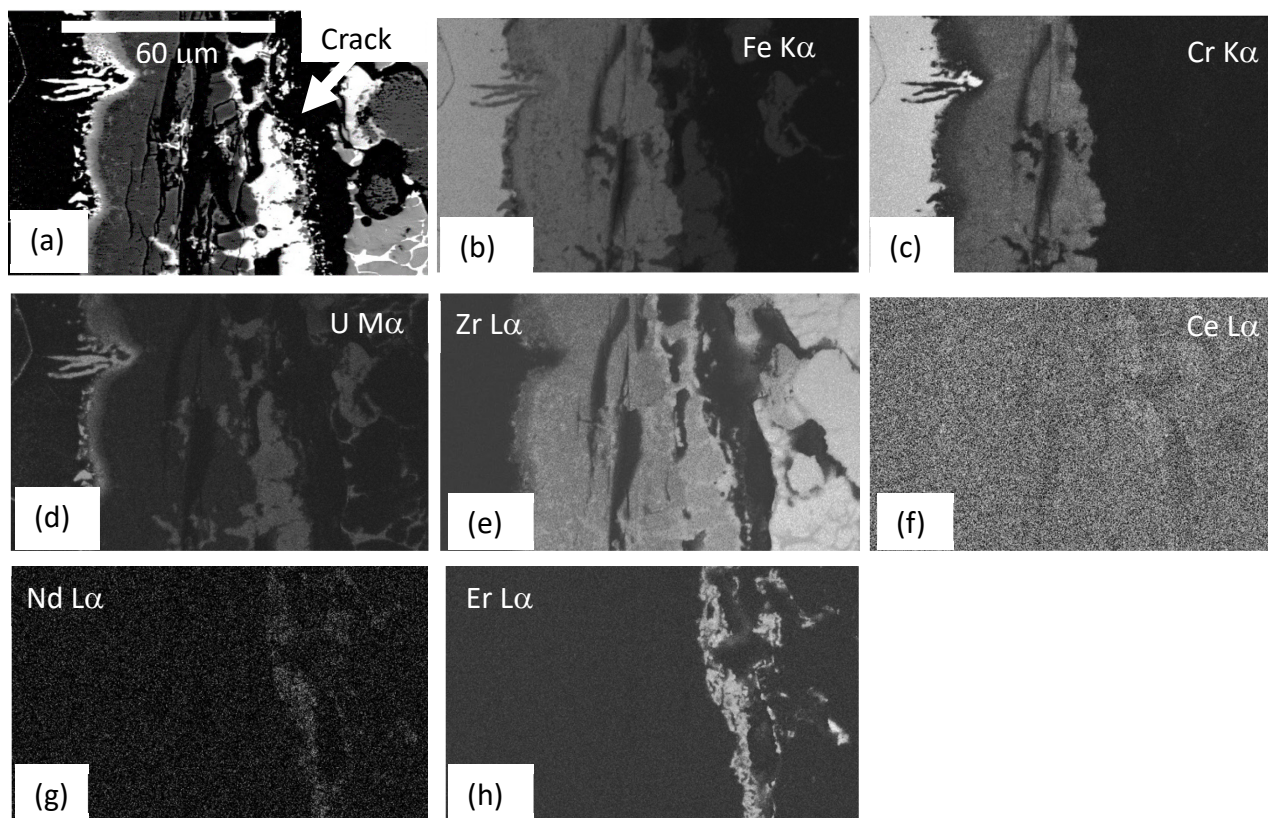
Figure 53. BSE image of interdiffusion zone (a) and WDS x-ray maps (b–h) for Fe, Cr, U, Zr, Ce, Nd, and Er, respectively.

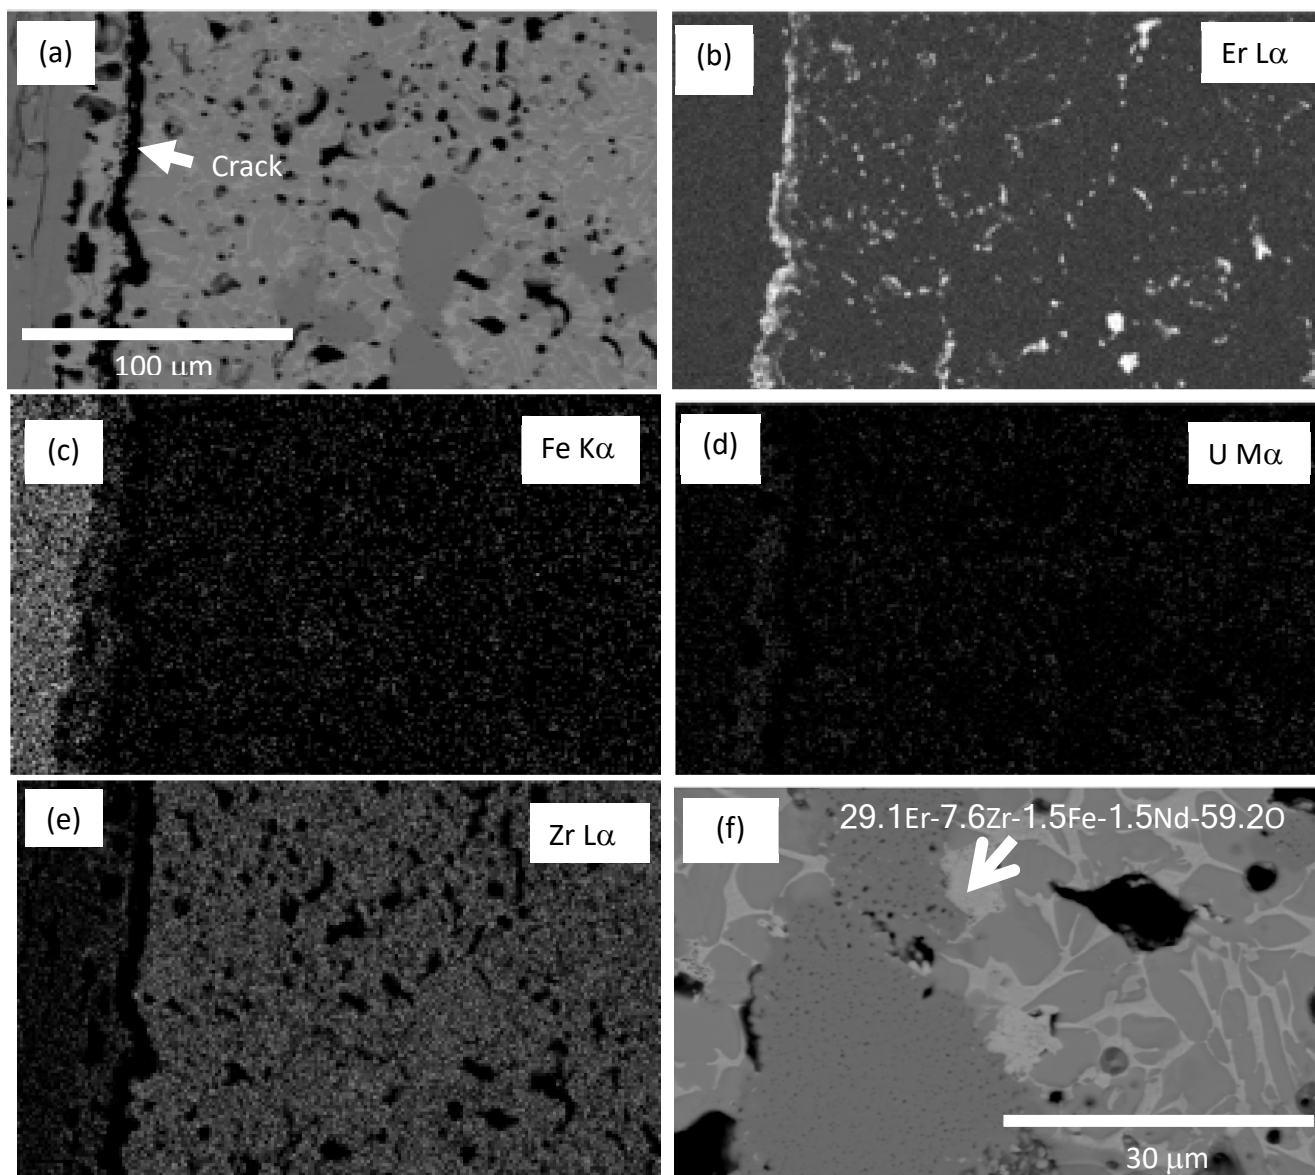
Figure 54. BSE image of interdiffusion zone (a) and WDS x-ray maps for (b) Er, (c) Fe, (d) U, and (e) Zr. The BSE micrograph in (f) shows the location where the composition of an erbium-containing phase was determined using EDS analysis, with the caveat that oxygen is difficult to measure with EDS at a high accuracy. Hydrogen cannot be measured using SEM and EDS and is not included as a possible constituent.

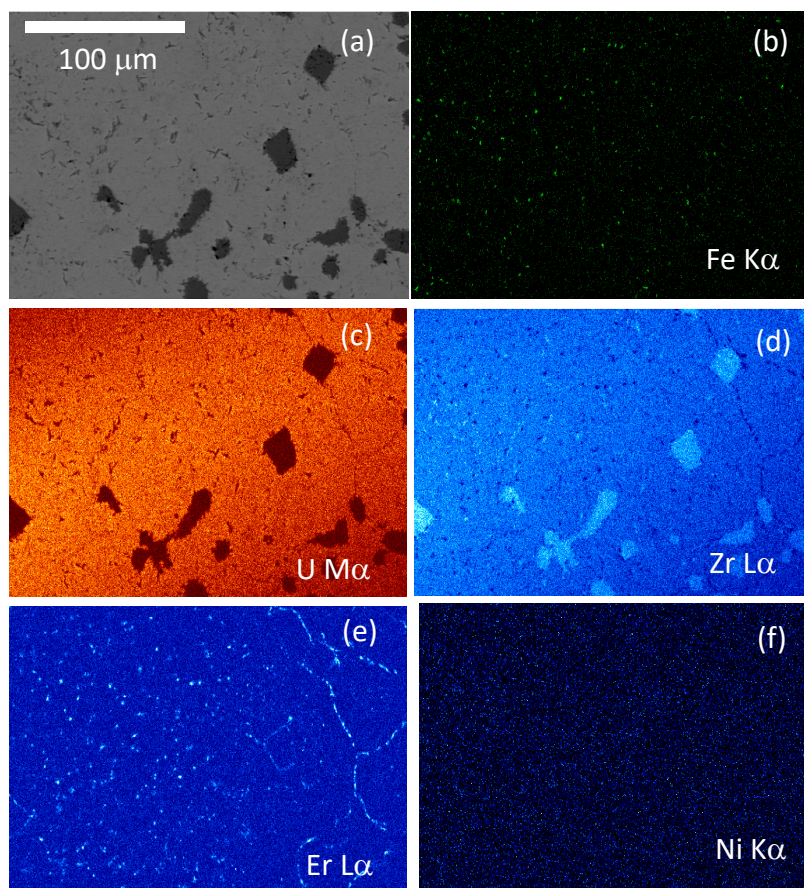
Figure 56. BSE image (a) and WDS x-ray maps for (b) Fe, (c) U, (d) Zr, (e) Er, and (f) Ni.

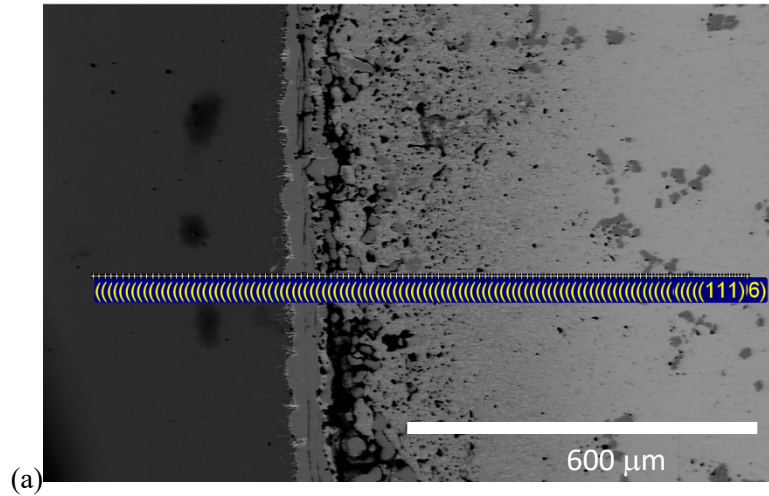
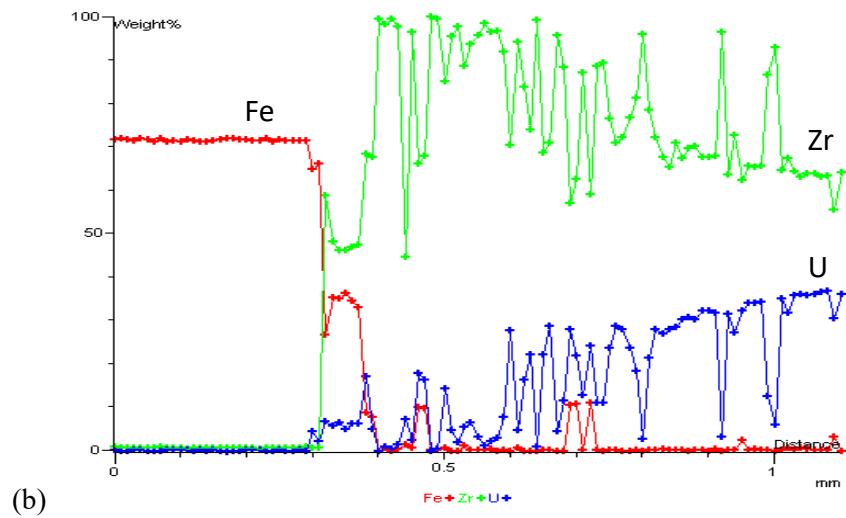
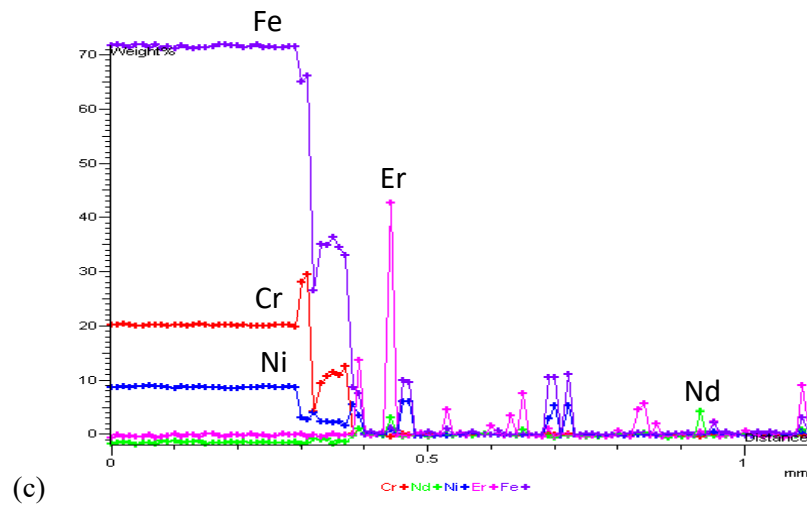
Figure 57. (a) BSE image showing a line of EDS composition measurements (in wt.%) taken through the interdiffusion zone; (b) a plot of the results for Fe, Zr, and U; and (c) a plot of the results for Cr, Nd, Ni, Er, and Fe.

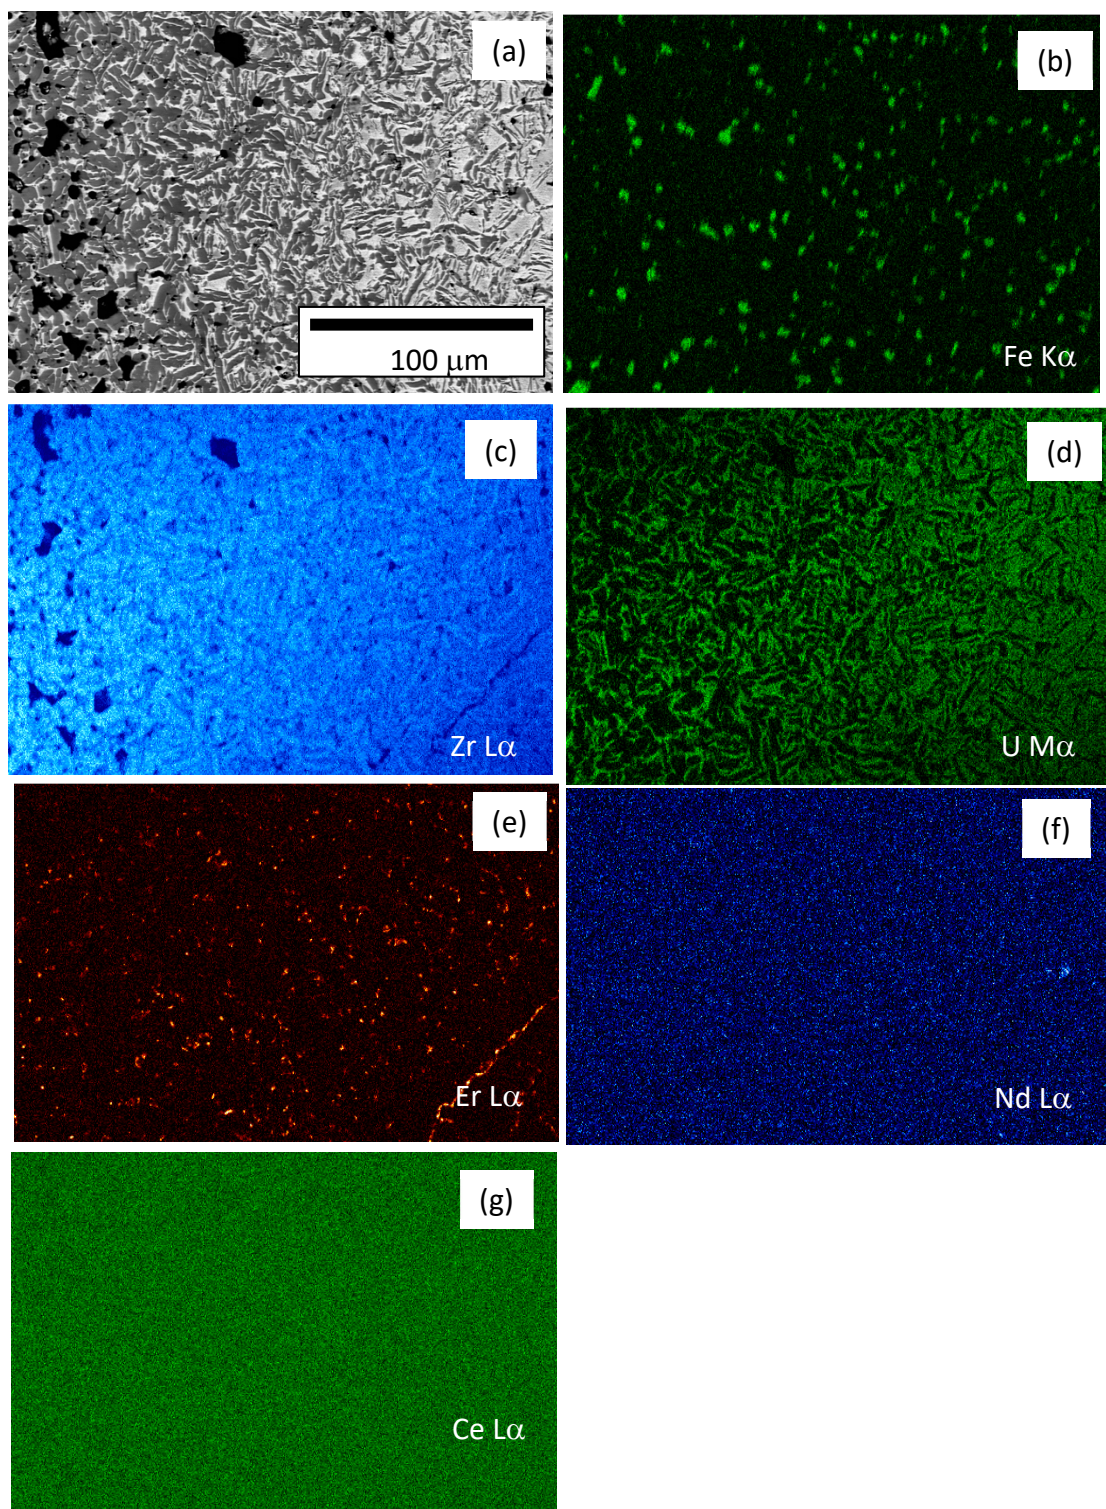
Figure 58. BSE image (a) and WDS x-ray maps for (b) Fe, (c) Zr, (d) U, (e) Er, (f) Nd, and (g) Ce.

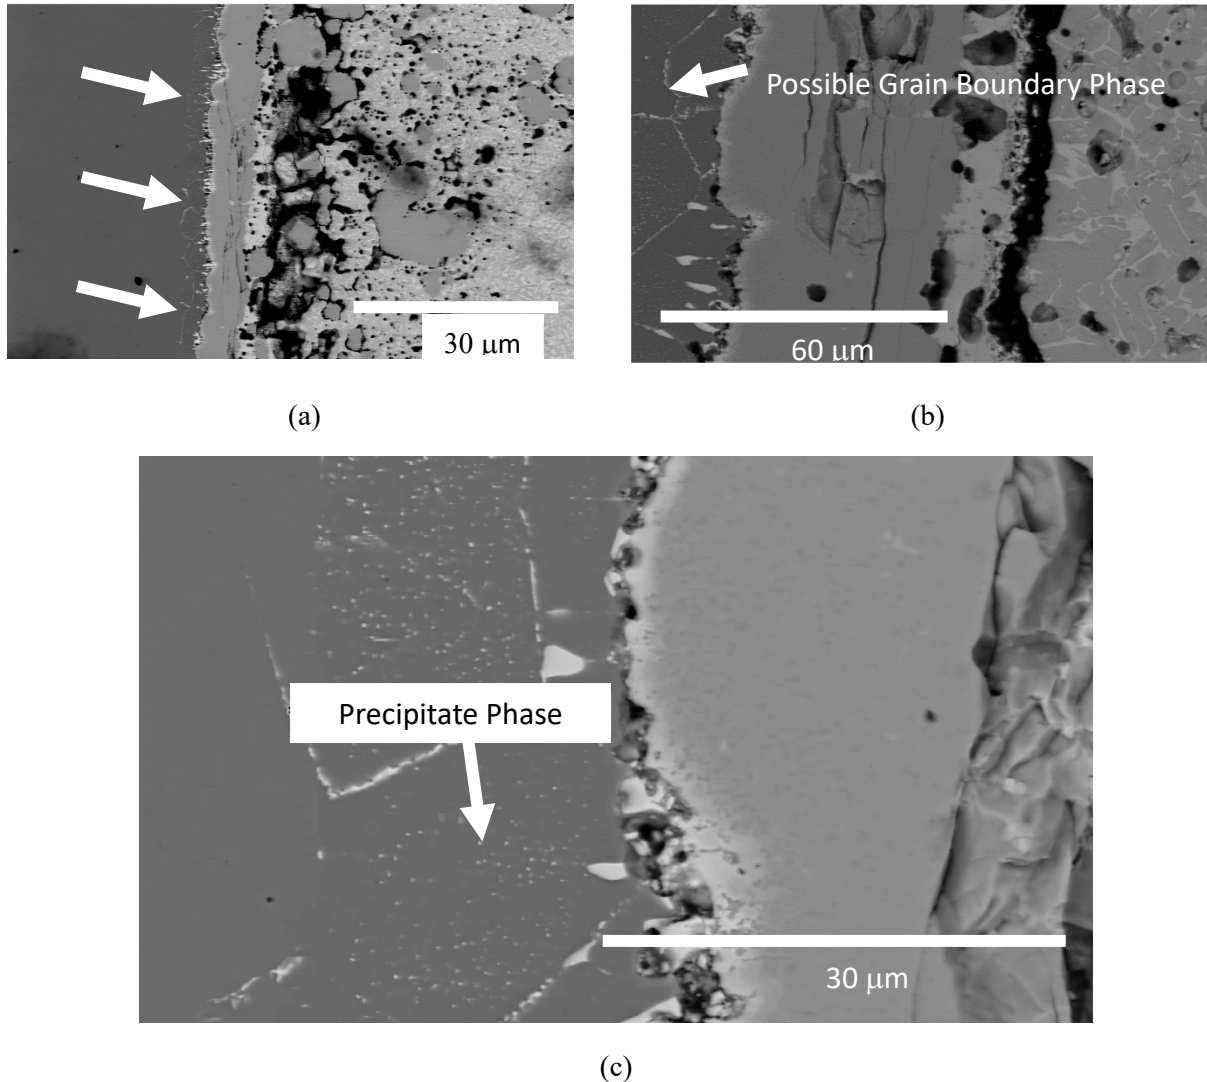
Figure 59. BSE images (a–c) showing fine phases present in the interdiffusion zone nearest the unreacted cladding.

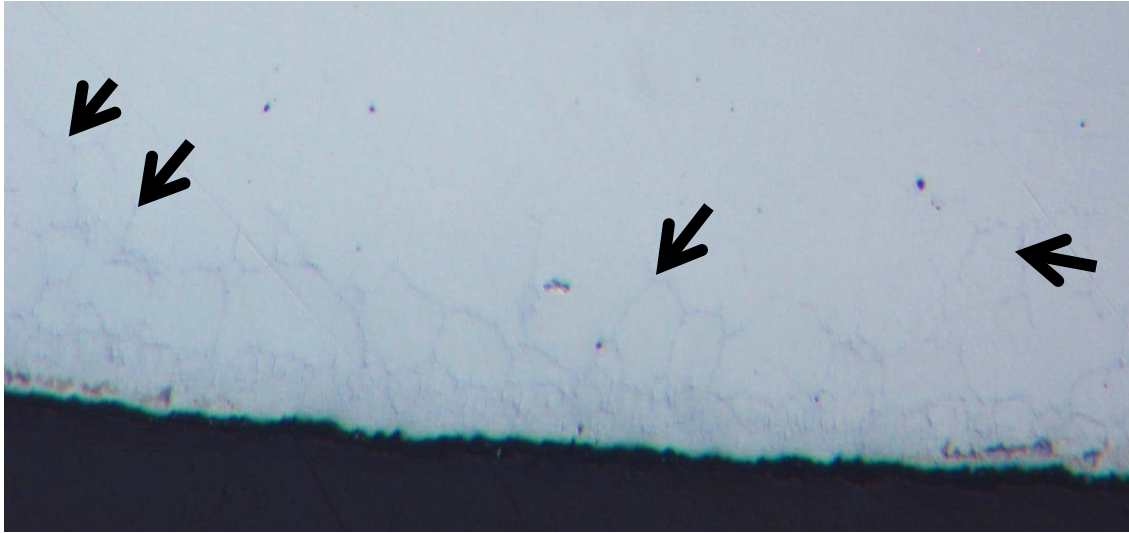
Figure 61. OM image (100x magnification) showing the location of possible grain boundary phase(s) present on the unreacted cladding side of the interdiffusion zone for the specimen annealed at 950°C for 6 hr.

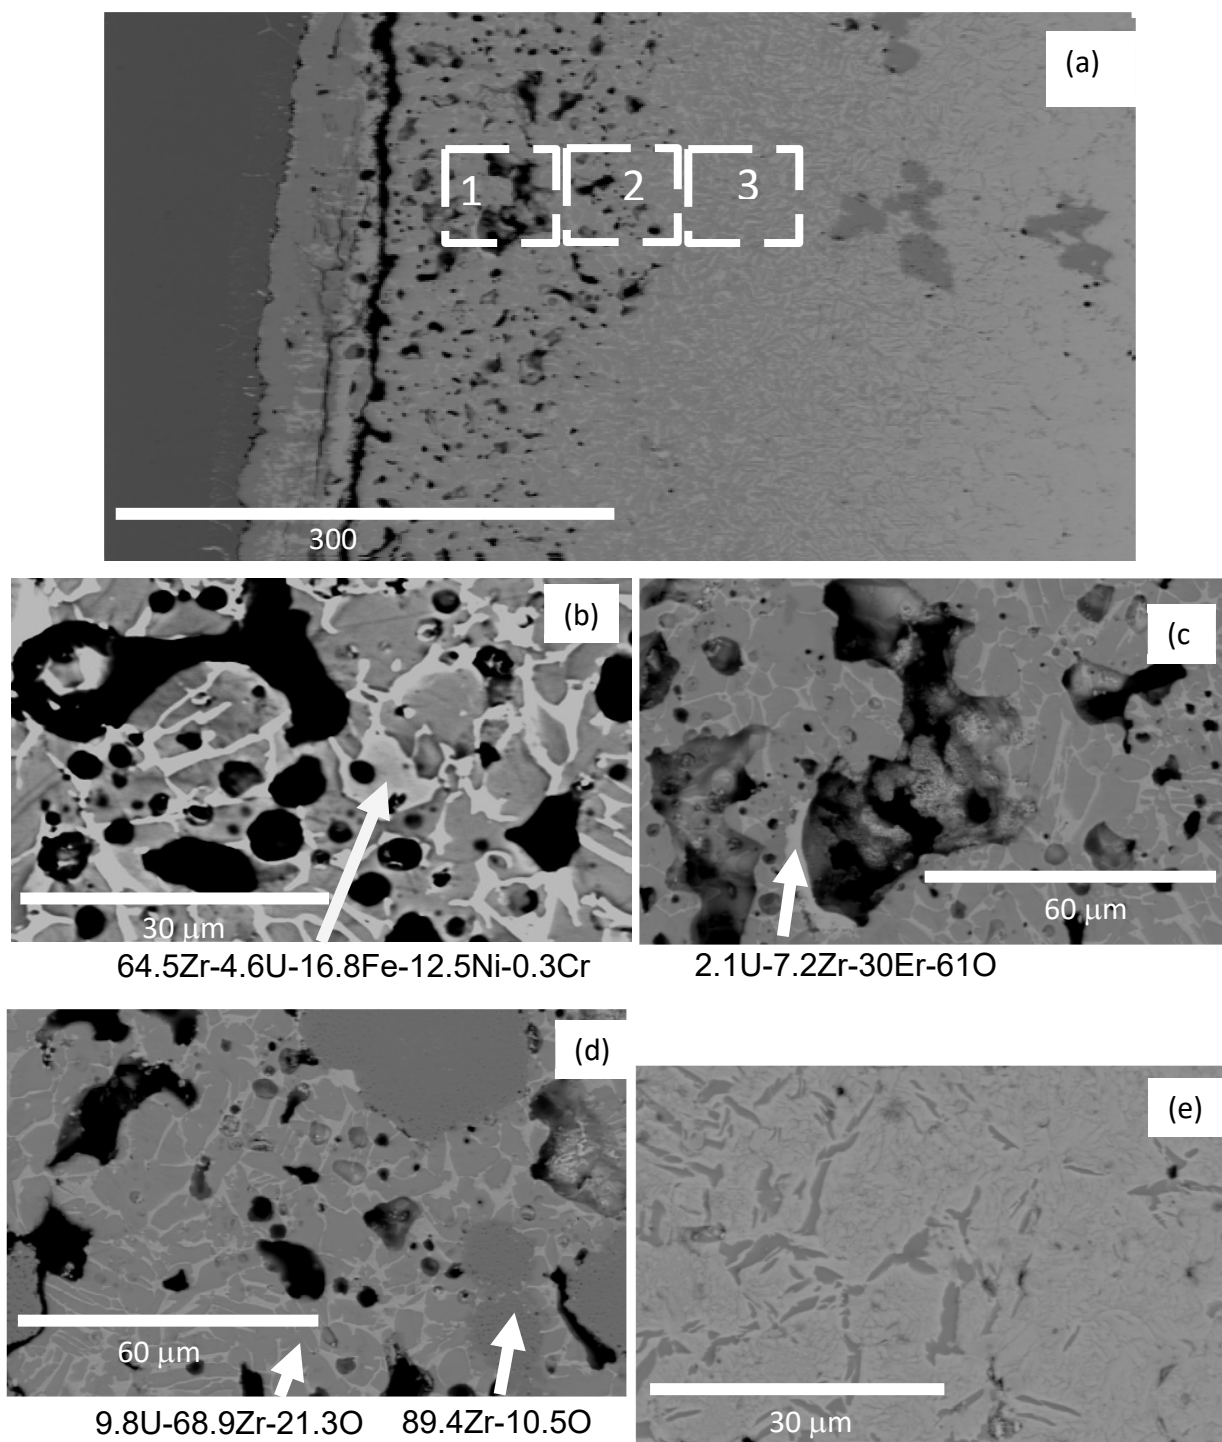
Figure 62. BSE image (a) showing microstructure of fuel and cladding interaction zone. BSE images in (b) and (c) show representative images of the microstructure observed in Box 1 of image (a), and (d) and (e) show representative images for Box 2 and Box 3, respectively. In (b–c) some phase compositions (in at.%) are shown, with the caveat that oxygen is difficult to measure with EDS at a high accuracy. Hydrogen cannot be measured using SEM/EDS and is not included as a possible constituent.

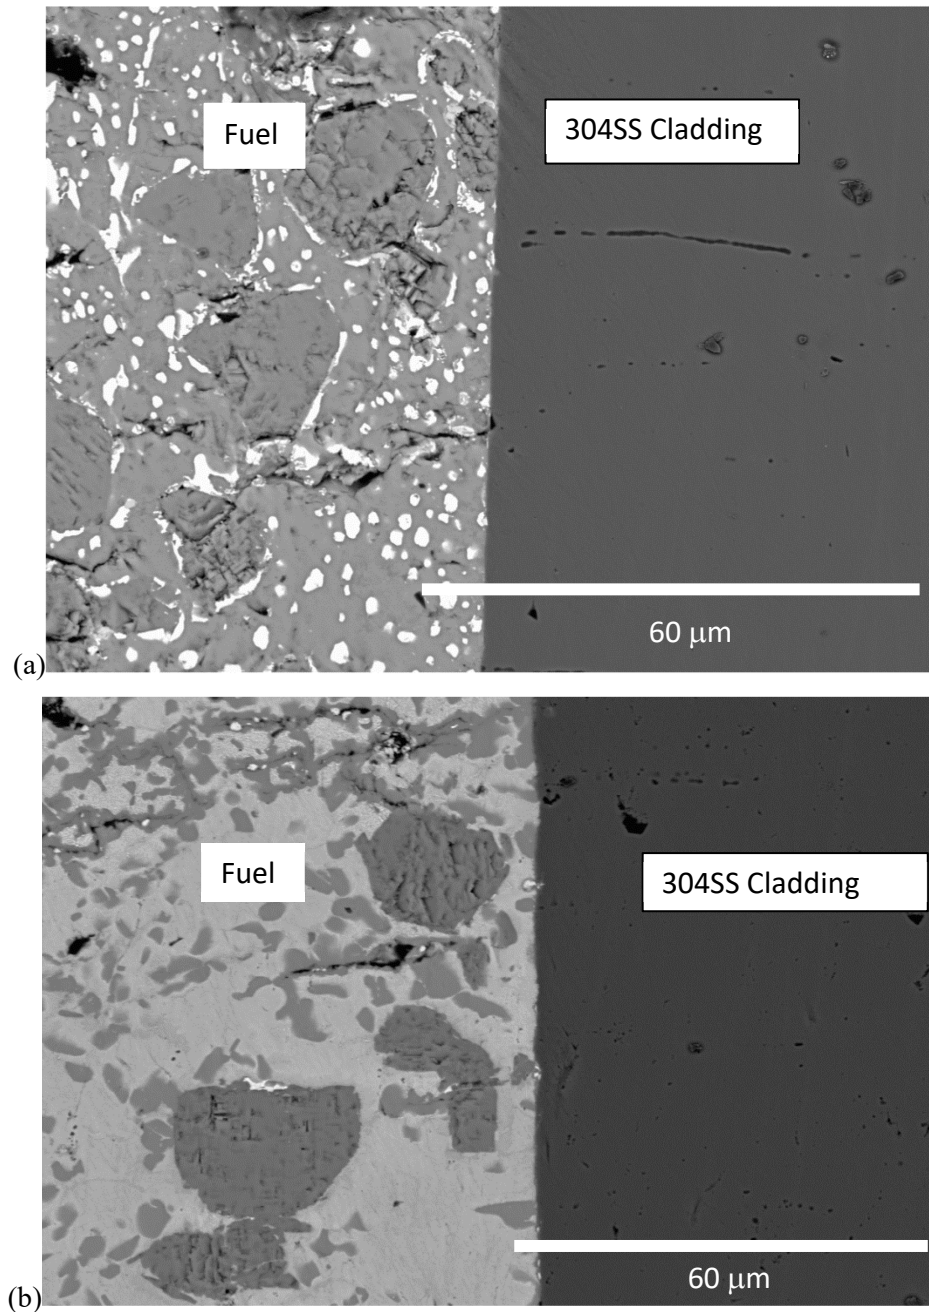
Figure 64. Fuel and cladding interface for a diffusion couple annealed at (a) 730°C for 1 hr and (b) 800°C for 1 hr [5].

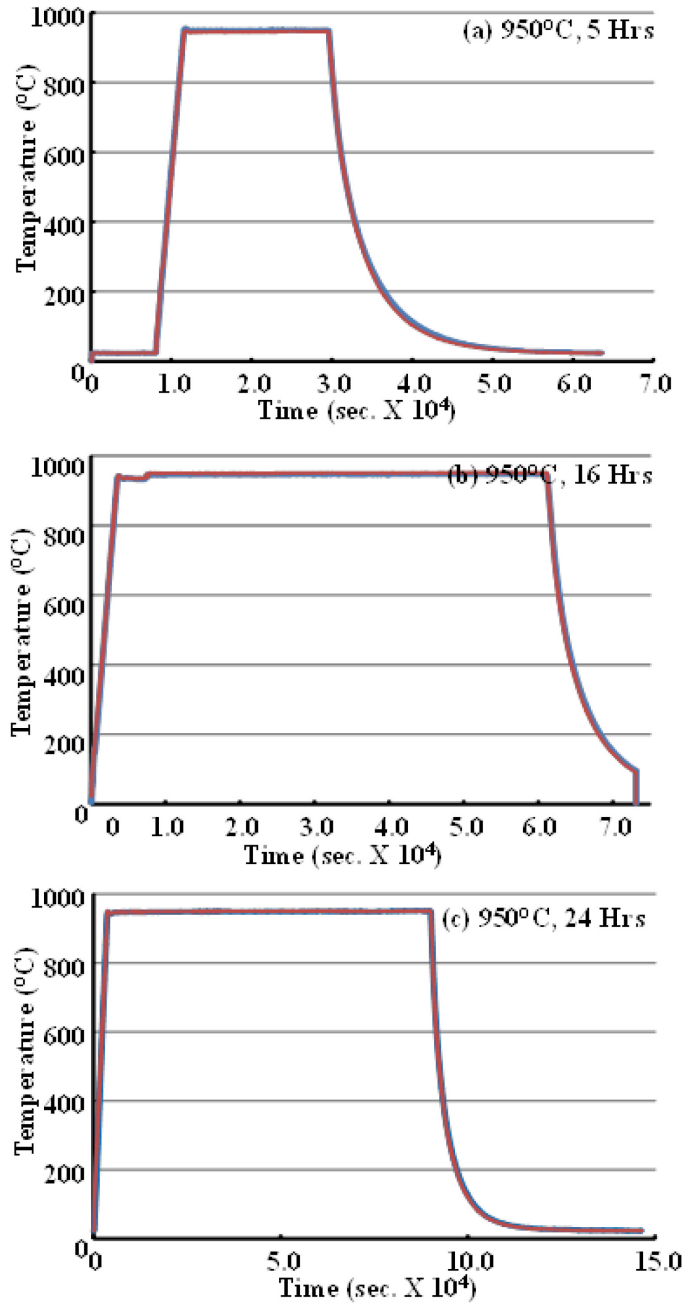
Figure 65. Temperature profiles generated from the TRIGA fuel heat-treating process at 950°C for (a) 5, (b) 16, and (c) 24 hr.

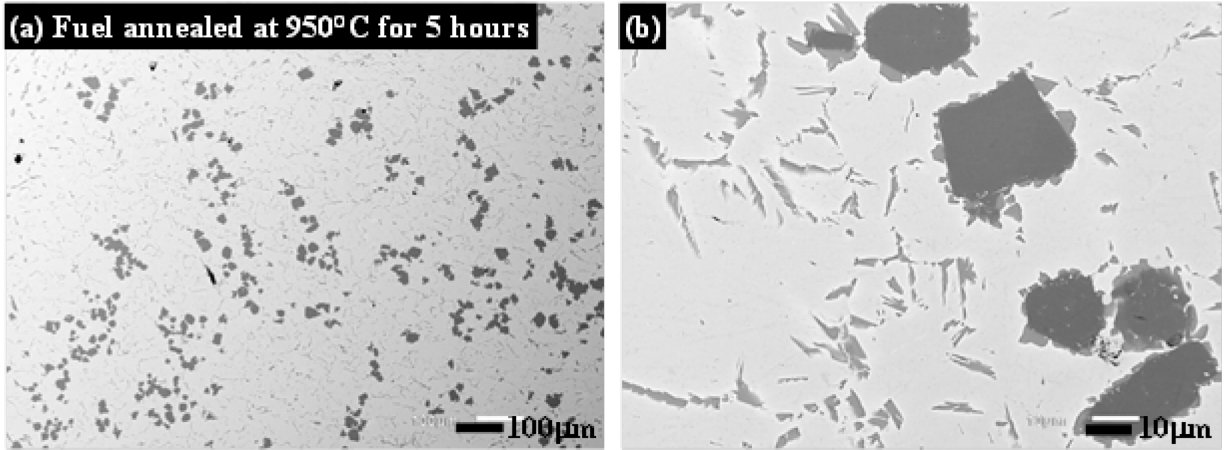
Figure 66. TRIGA fuel microstructure after heat treating at 950°C for 5 hr: (a) low and (b) higher magnification BSE micrographs.

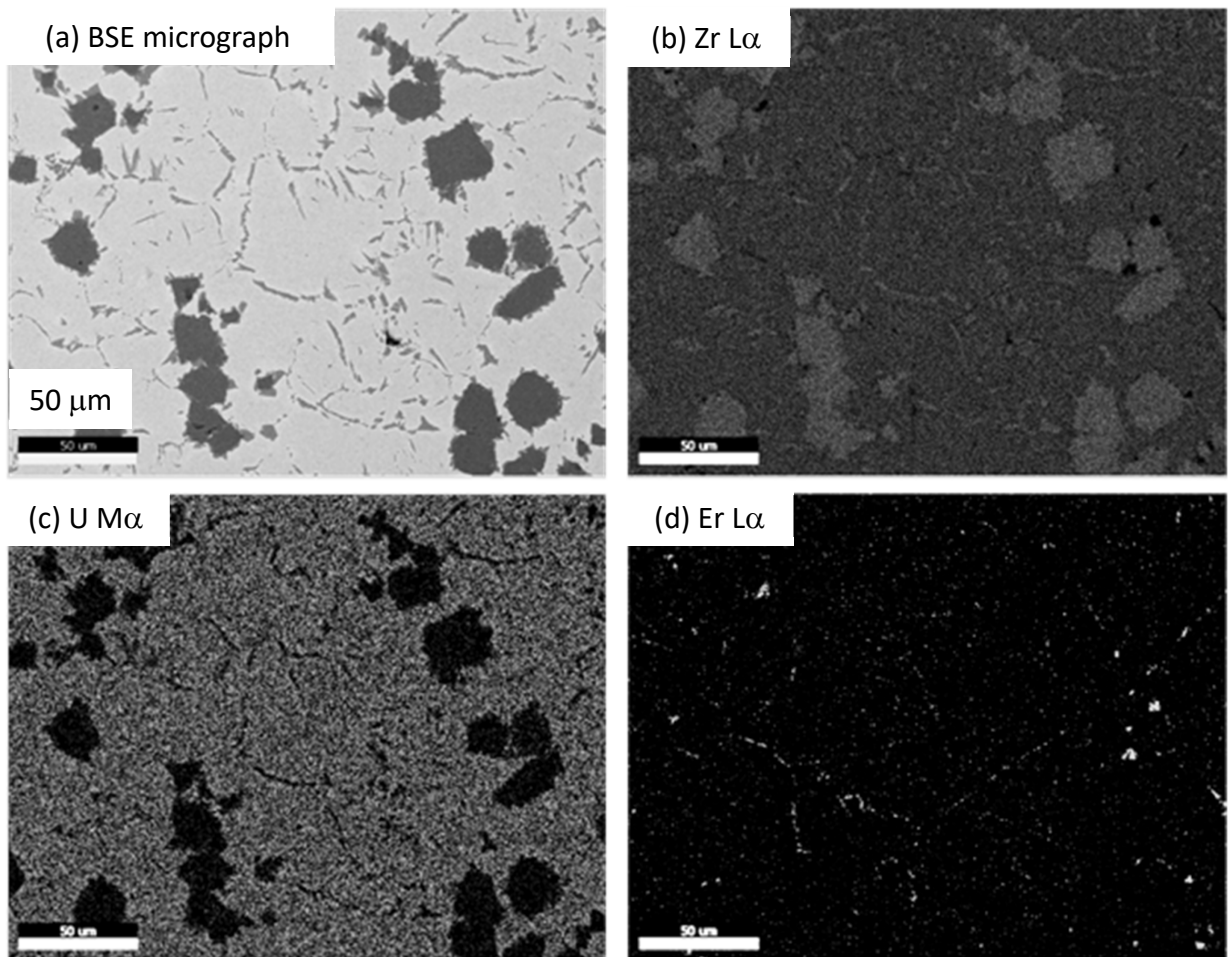
Figure 67. (a) BSE micrograph of a selected microstructural area of unirradiated TRIGA fuel annealed at 950°C for 5 hr. EDS x-ray maps are shown for (b) Zr, (c) U, and (d) Er.

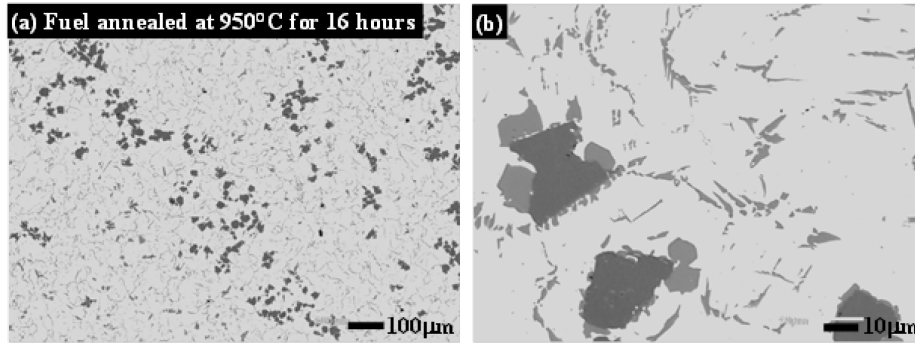
Figure 68. TRIGA fuel microstructure after heat treating at 950°C for 16 hr: (a) low and (b) higher magnification BSE micrographs.

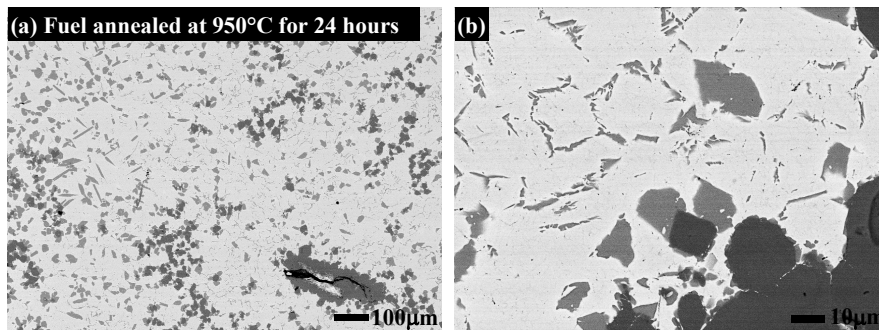
Figure 69. TRIGA fuel microstructure after heat treating at 950°C for 24 hr: (a) low and (b) higher magnification BSE micrographs.

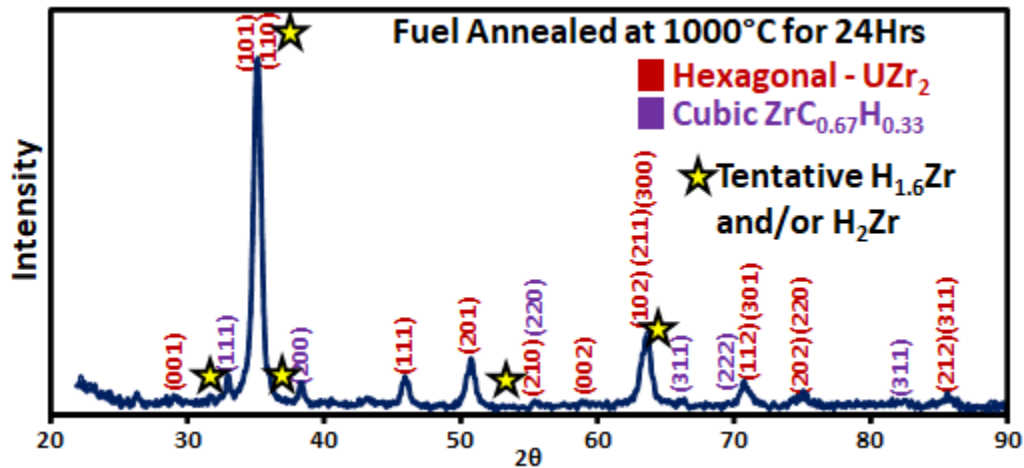
Figure 70. XRD pattern obtained from the TRIGA fuel annealed at 1000°C for 24 hr.

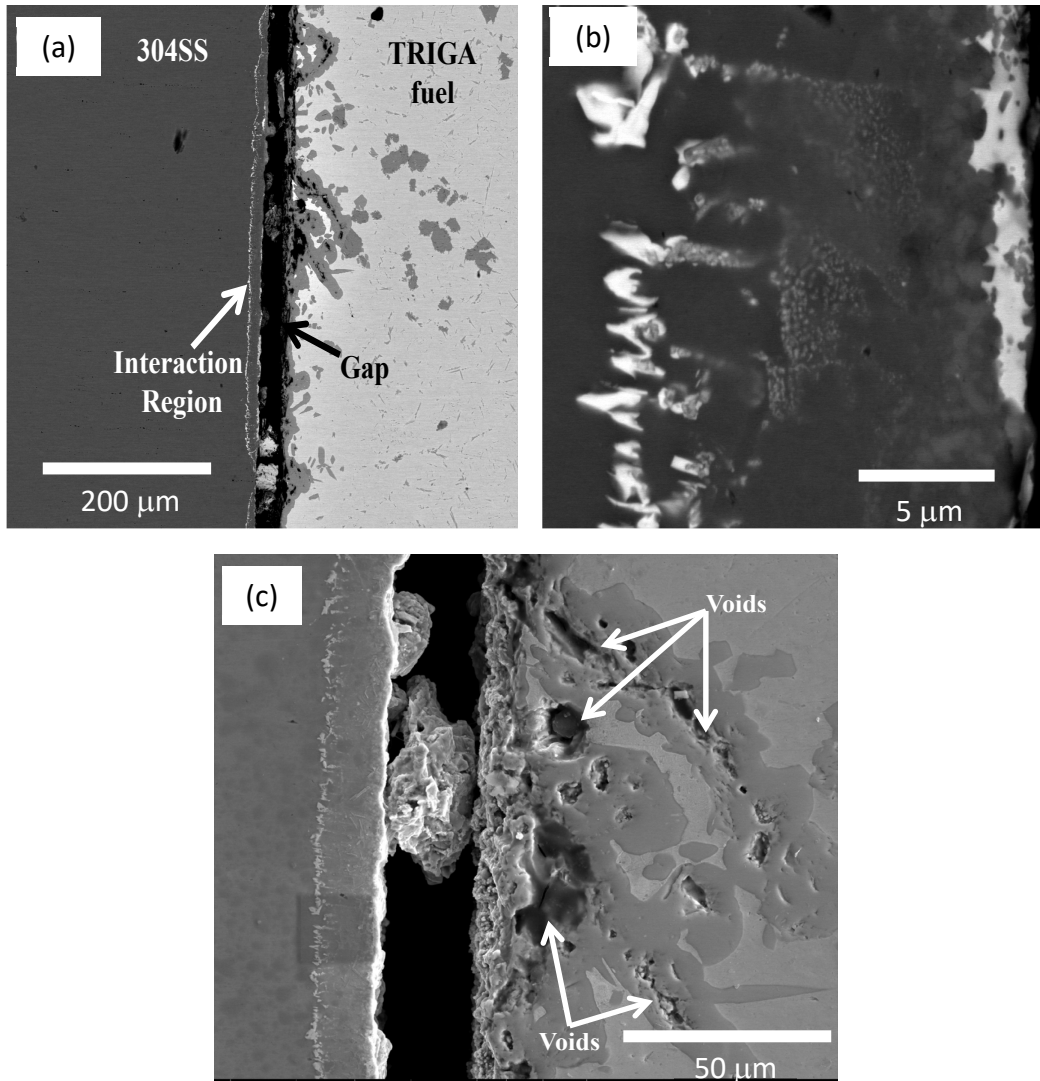
Figure 71. BSE image (a) of a diffusion couple annealed at 1000°C for 5 hr where a gap near the fuel and cladding interface is present, along with the presence of a microns-thick FCCI zone that extends into the cladding, and (b) is a higher magnification image of this interaction zone, (c) is an SE image showing voids moving towards the TRIGA fuel.

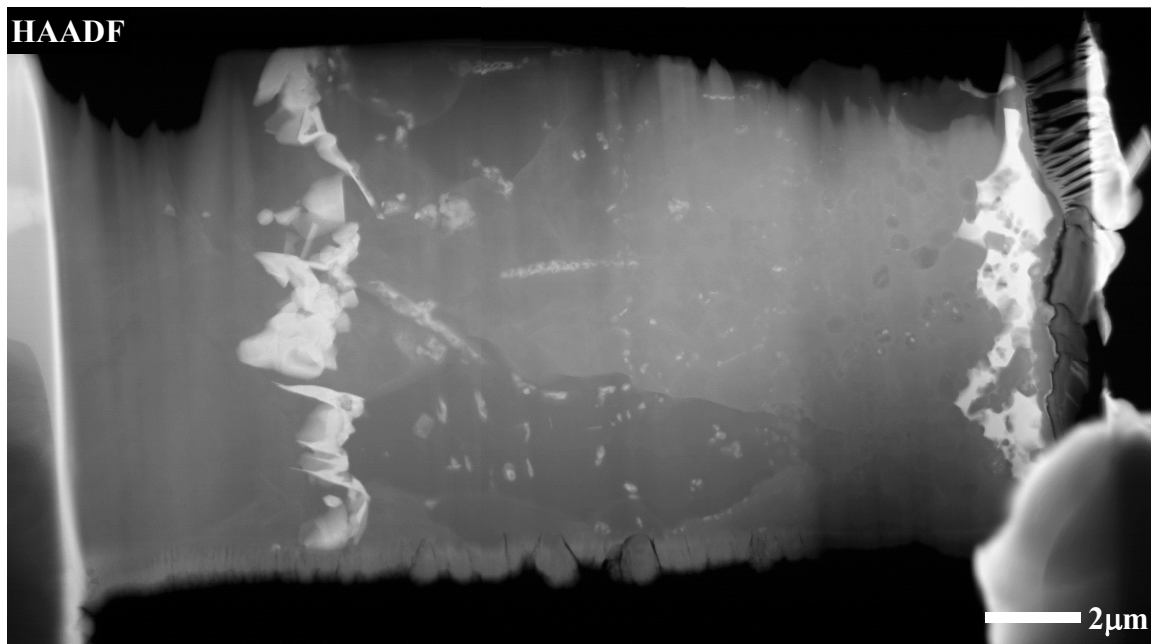
Figure 72. High-angle annular dark-field micrograph of the TEM sample obtained from the interaction region of the diffusion couple of TRIGA fuel versus Type 304SS annealed at 1000°C for 5 hr. The sample encompasses the entire thickness of the interaction region present on the cladding side of the gap depicted in Figure 71.

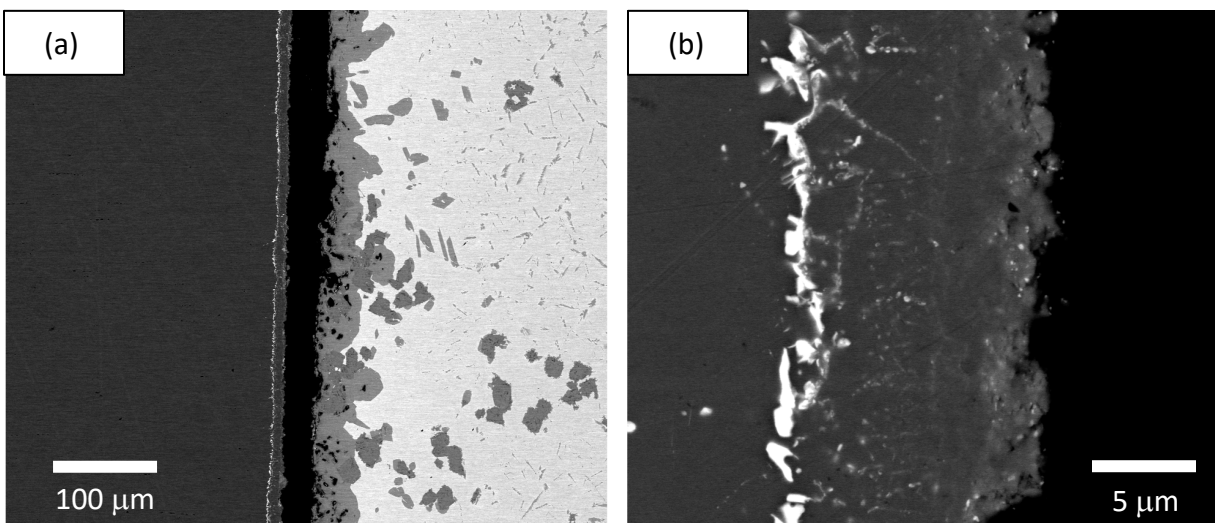
Figure 73. Backscatter electron micrographs of (a) a selected region from the TRIGA fuel versus 304SS diffusion couple annealed at 1000°C for 24 hr, and (b) a detailed micrograph of the interaction region.
