# An Investigation of Liquefaction in Irradiated TRIGA Fuel Exposed to Relatively High Temperatures

November 2020

**Idaho National Laboratory  
Idaho Falls, Idaho 83415**

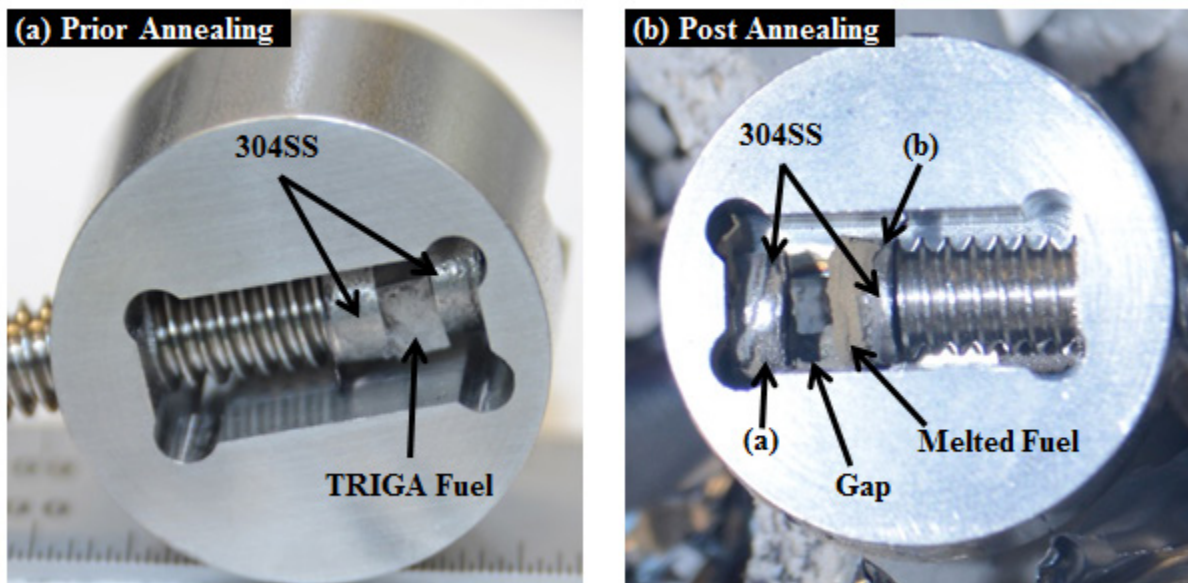
Figure 75. Diffusion couple run at 1000°C for 24 hr in the advanced diffusion jig (a) prior to heat treating and (b) post heat treating. A gap is seen in (b) likely due to melting that had occurred.

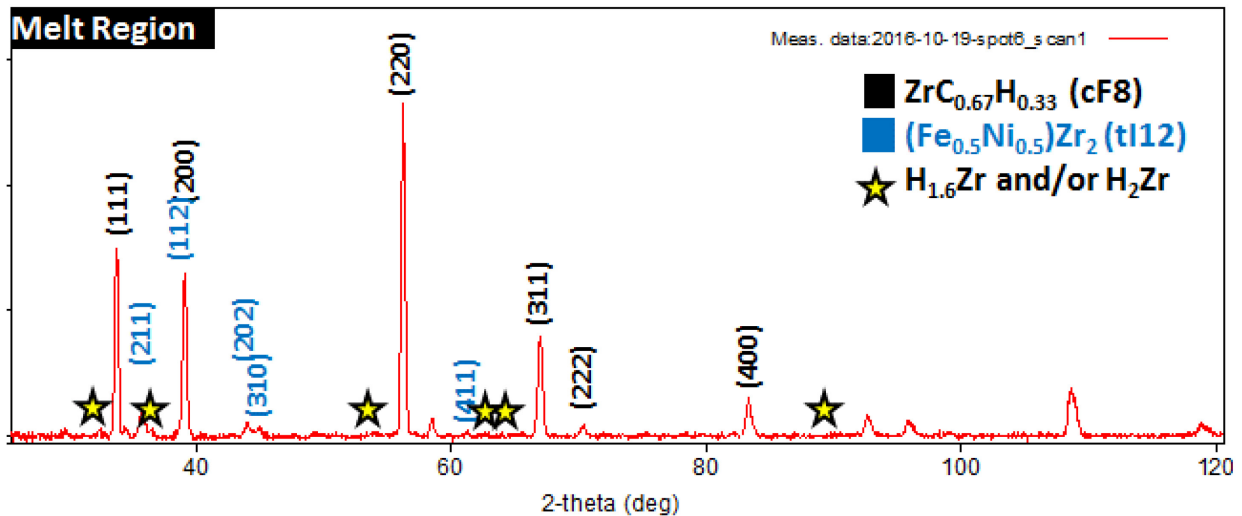
Figure 77. XRD pattern of a selected area in the re-solidified material in a diffusion couple run at 1000°C for 24 hr using the advanced diffusion couple jig.

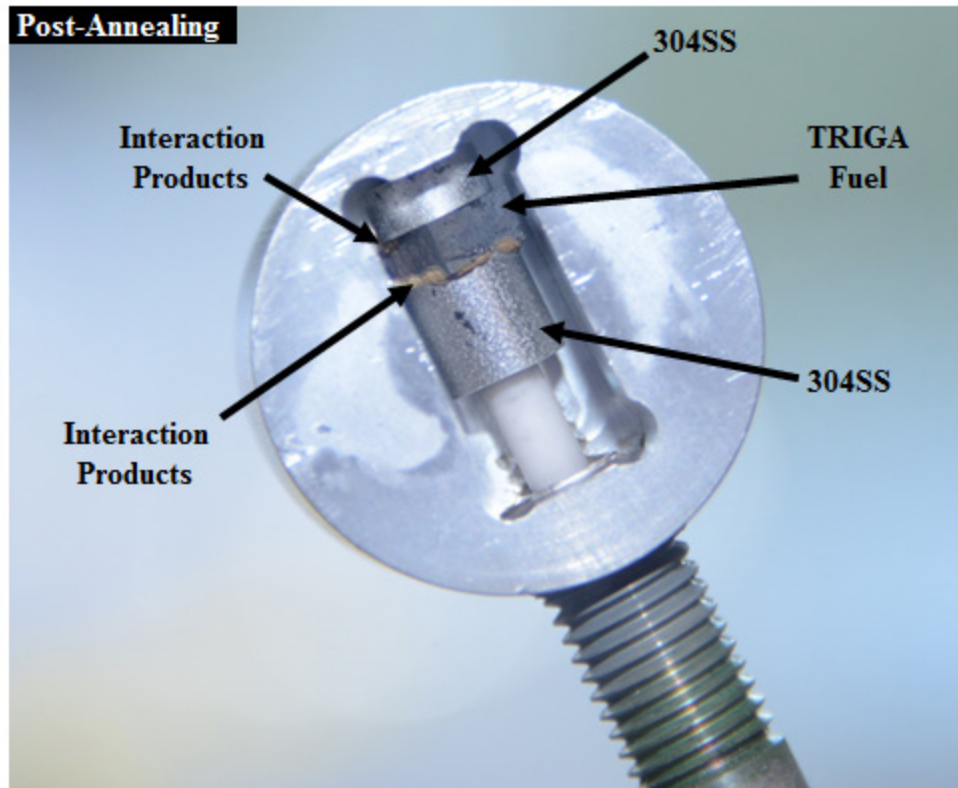
Figure 78. Diffusion couple run at 900°C for 24 hr in an advanced diffusion jig in the post heat-treating condition.

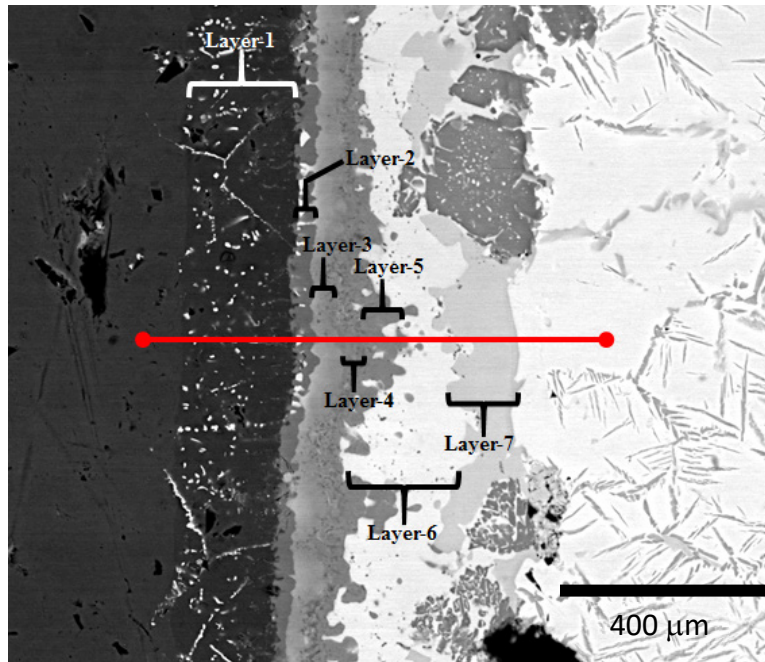
Figure 80. BSE micrograph of a selected region of the fuel and cladding interaction zone. The red line marks the location where the Zr, Cr, Fe, Ni, and U concentration profiles in Figure 81 were collected. The interaction zone is divided into seven layers of differing composition and phase morphology.

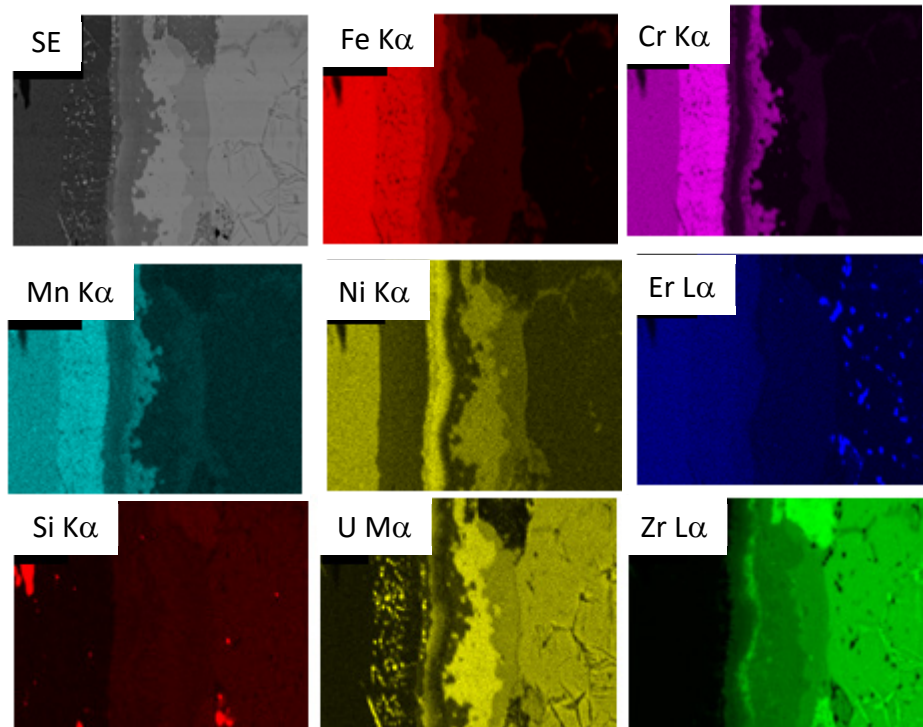
Figure 82. SE image and EDS x-ray maps for Fe, Cr, Mn, Ni, Er, Si, U, and Zr in the same region along the fuel and cladding interface that was selected for the concentration profile in Figure 81.

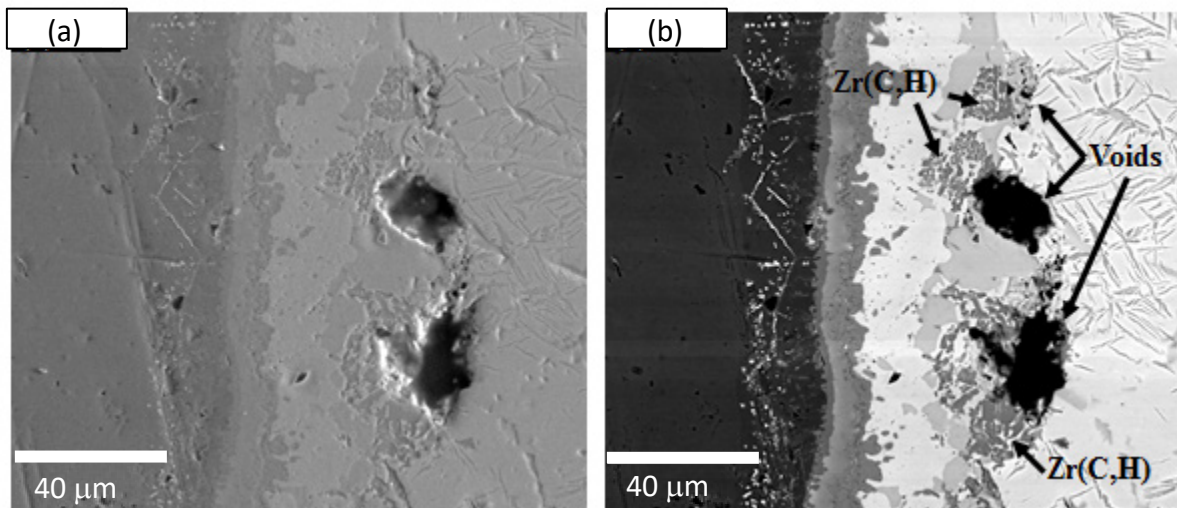
Figure 83. (a) SE and (b) BSE micrographs of a selected region of the interaction zone where voids can be observed.

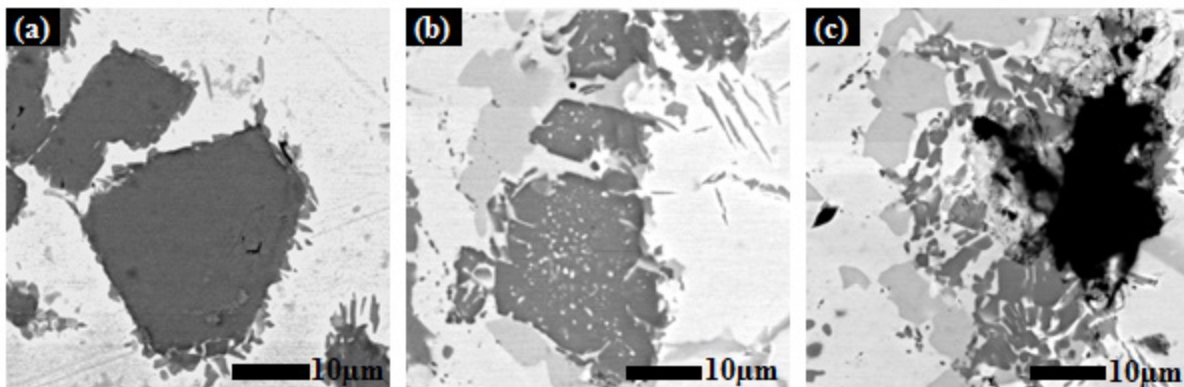
Figure 84. Higher magnification BSE micrographs of the interaction zone region that contains the Zr(C, H) phase (a) in the fuel far away from the interaction region, (b) within the interaction region, possibly at an early stage of melting and decomposition, and (c) within the interaction region at a later stage of the melting and decomposition process.

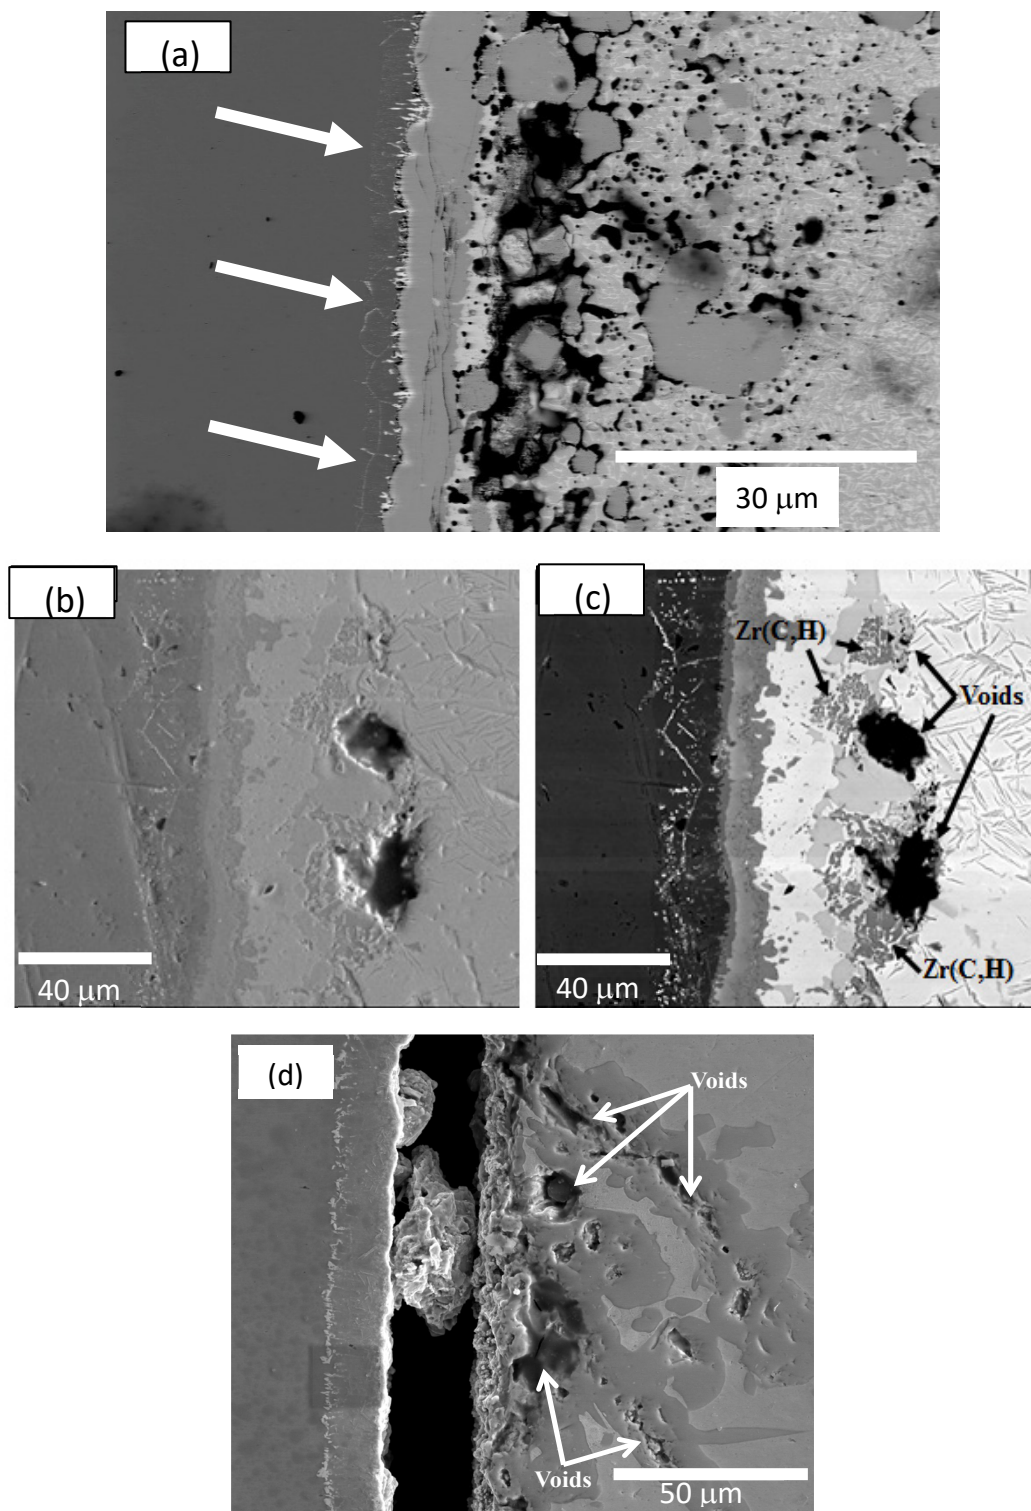
Figure 87. (a) a BSE image of the fuel and cladding interaction zone for the irradiated TRIGA fuel sample annealed at 950°C for 6 hr (arrows show presence of bright-contrast phases that form along grain boundaries in the cladding), and an SE image (b) and BSE image (c) for the diffusion couple annealed at 900°C for 24 hr using an advanced diffusion couple jig that keeps pressure at the fuel and cladding interface, and (d) BSE image for the diffusion couple annealed at 1000°C for 5 hr that used a standard diffusion couple jig where debonding ultimately transpired leaving a gap.

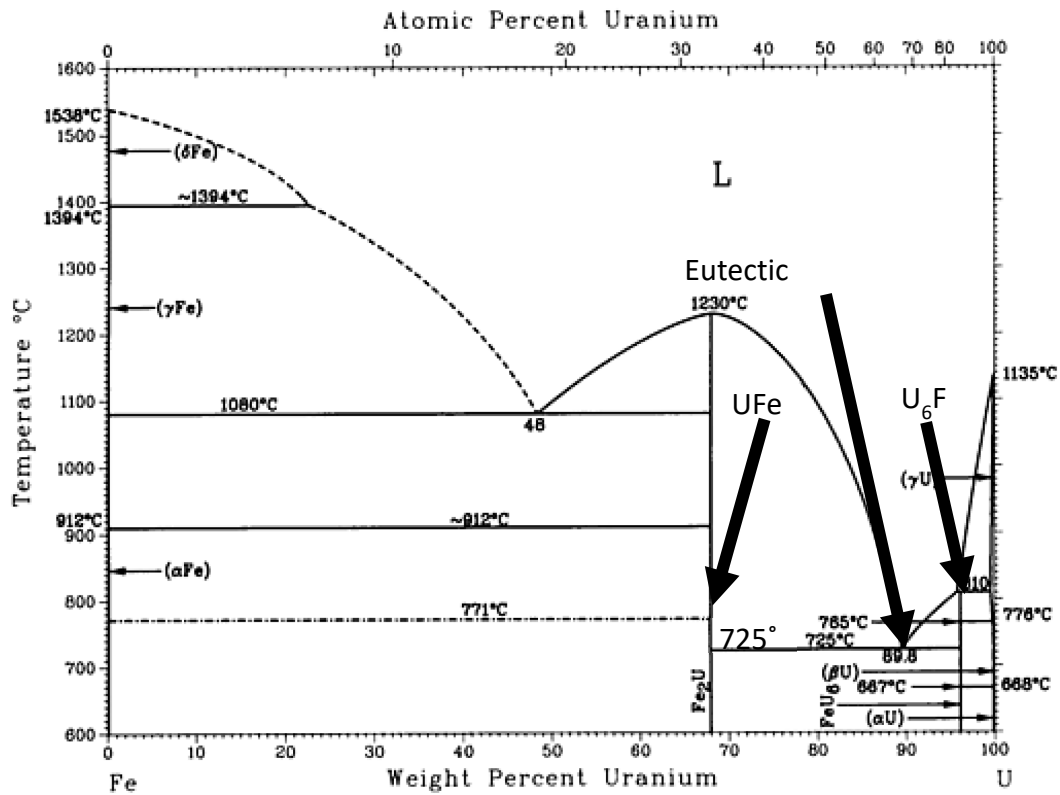
Figure 89. U-Fe equilibrium phase diagram [3].

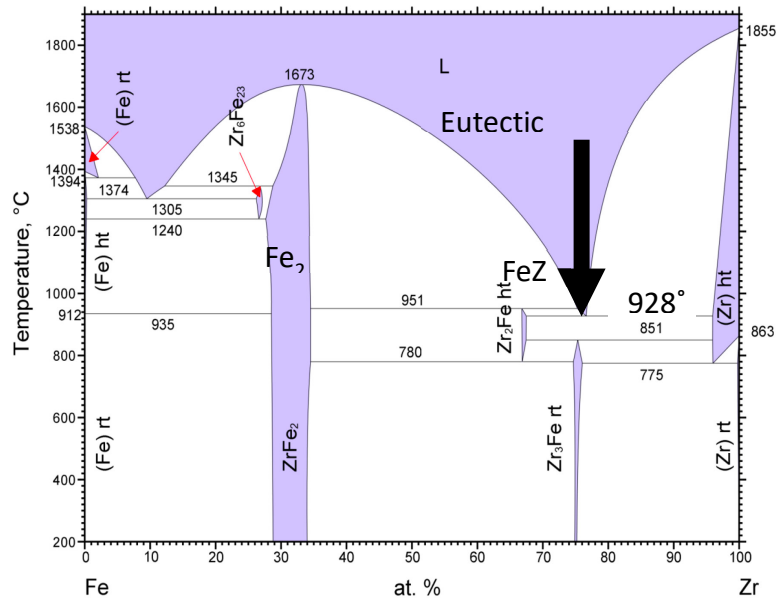
Figure 90. Fe-Zr equilibrium phase diagram [3].

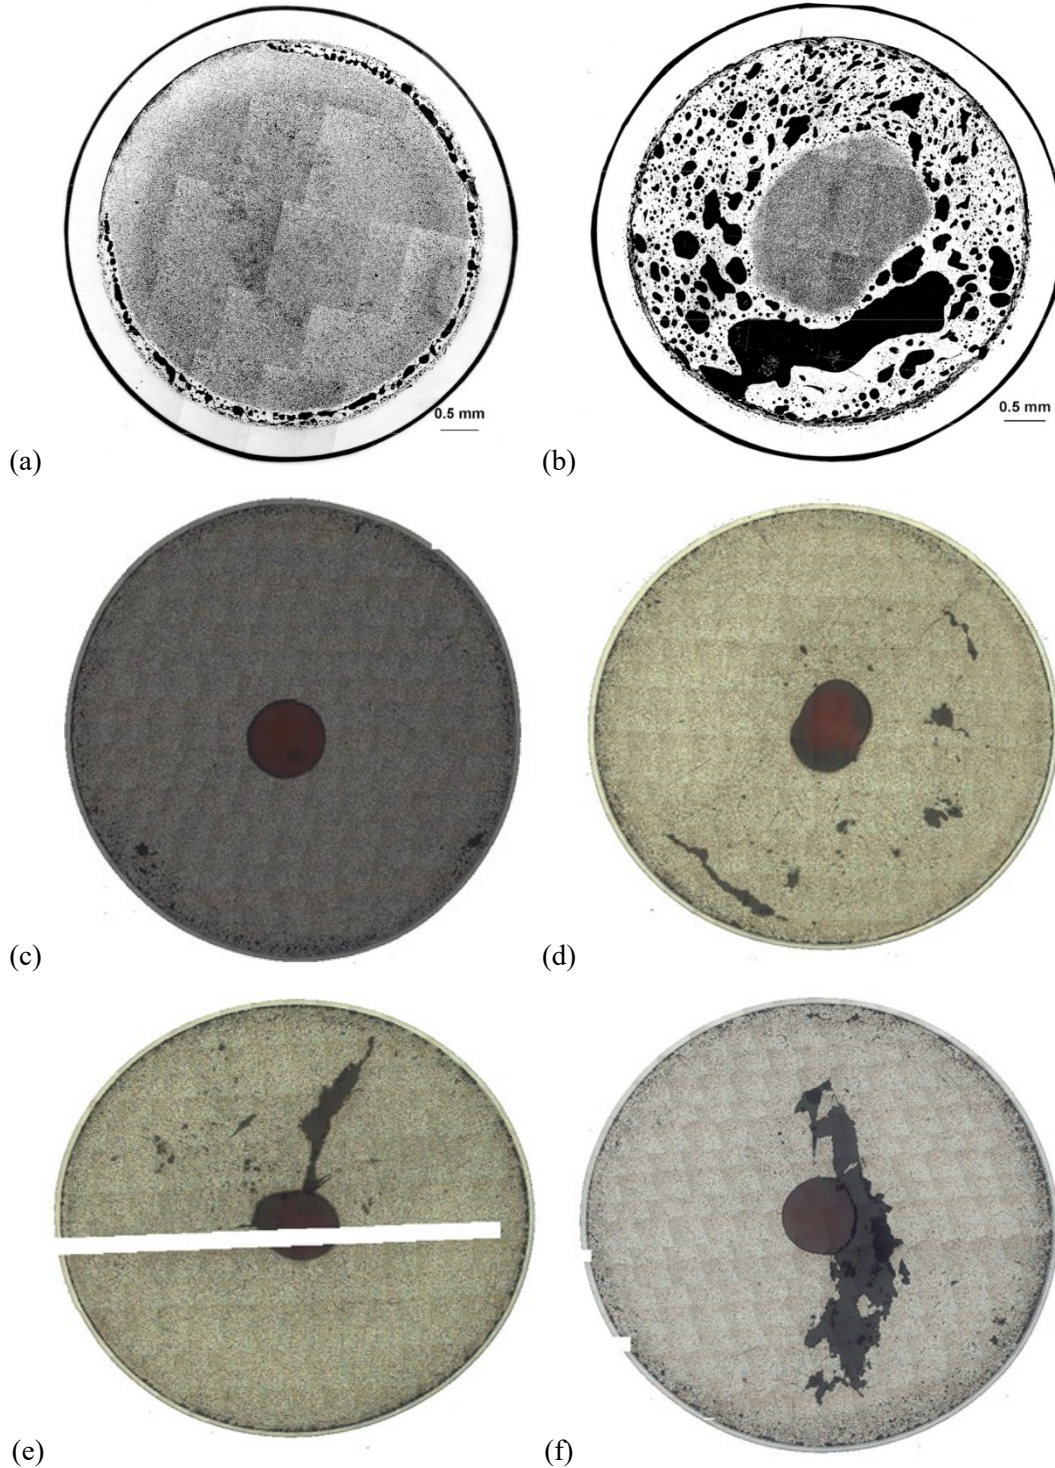
Figure 92. (a) OM image of a FBTA test result showing an HT9-Clad U-10Zr fuel pin segment (~3 at.% BU) after being heated at 750°C for 1 hr and (b) OM image of a FBTA test result showing an HT9-Clad U-10Zr fuel pin segment (~3 at.% BU) after being heated at 800°C for 1 hr. Note that all but the fuel center has been at least partially melted, and the cladding has not been fully penetrated. (c–f) shows OM images of the microstructures for irradiated TRIGA fuel segments after heating at (c–d) 950°C for 6 hr, (e) 950°C for 12 hr, and (f) 1000°C for 6 hr.
