Uranium Annealing Analysis

INL/EXT17-41916
Revision 1

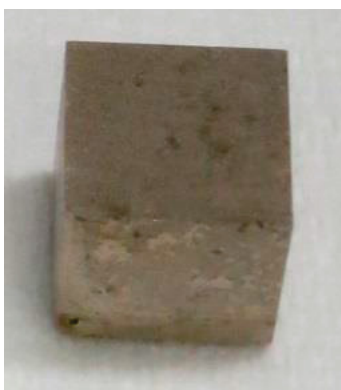
Figure 1. DU cube after cleaning, prior to the salt annealing step.

After the initial experiment, a second set of two ½ in. cubic samples were prepared for annealing in molten salt at 650°C for 30 minutes and 1 hour. After annealing, these samples were quenched in water. Figure 1 shows an example of the depleted uranium (DU) cube after cleaning prior to the salt annealing step. Figure 2 shows the same DU cube after a 1-hour salt anneal.

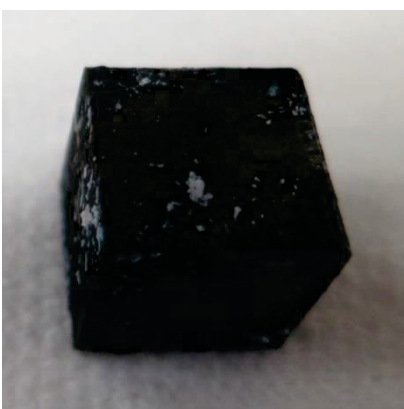
Figure 2. DU cube after a 1-hour salt anneal.

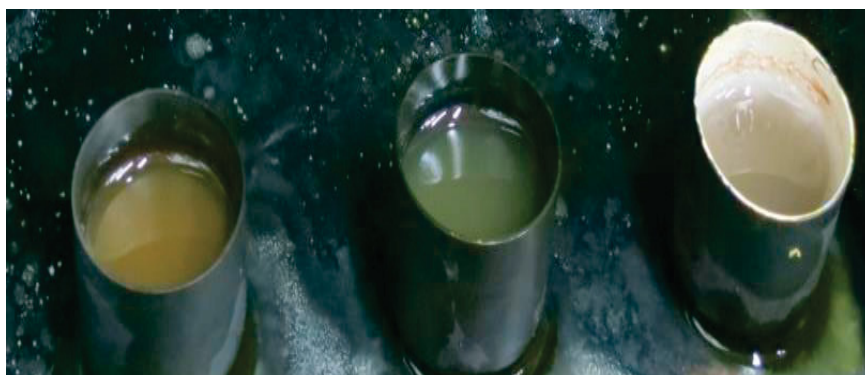
Figure 3. Crucibles used for annealing test. Crucible on the right coated in AREMCO Products Pyro Paint 634-ZO.

A third annealing experiment was performed by placing two ½ in. cubic samples in Cartecsal molten salt for 1 hour at 650°C. In this experiment, one cube was placed in a crucible coated with AREMCO Products Pyro Paint 634-ZO (designated as “1 hour [coated crucible]”), and one cube was suspended in

the salt using stainless steel wire (Figure 3) to limit contact with the crucible (designated as “1 hour [suspended]”). After annealing, these samples were quenched in water.

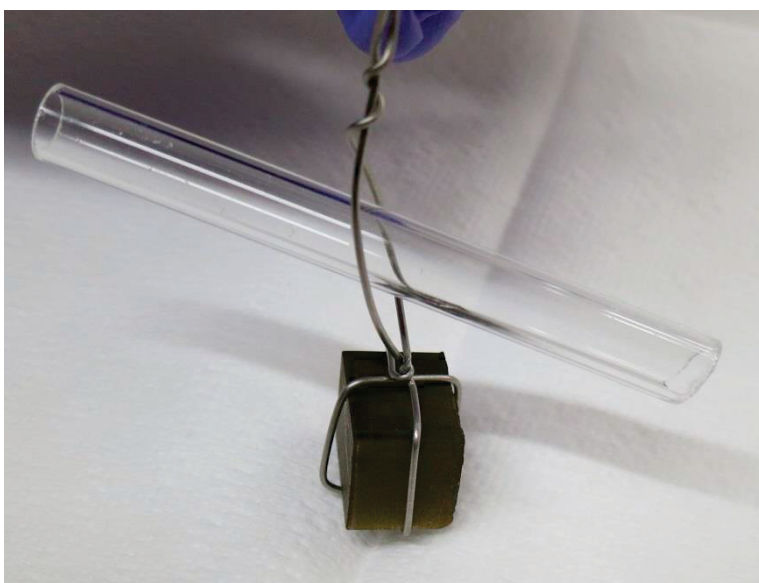
Figure 4. DU cube wrapped in stainless steel (SS) wire. The SS wire was held in the salt bath by a quartz tube to prevent a circuit from developing with the crucible.

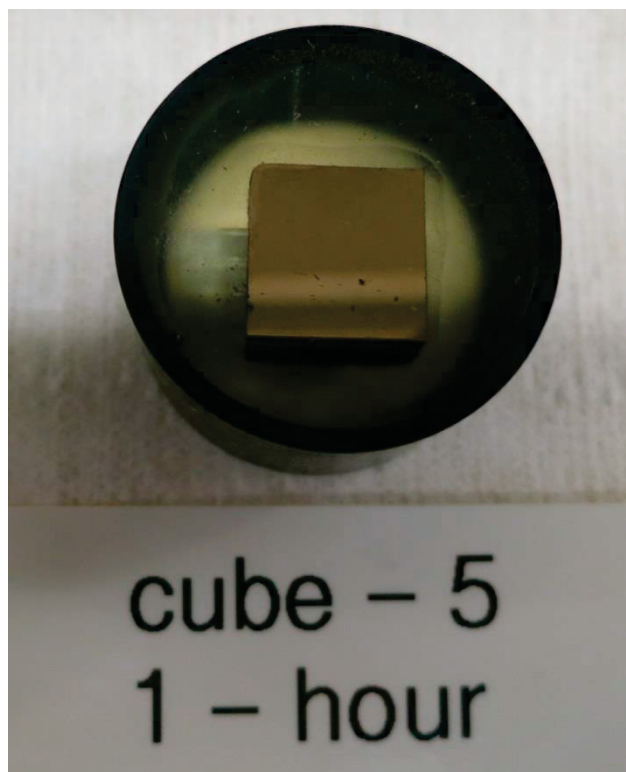
Figure 5. DU cube after a 1-hour salt anneal.

The measurements were difficult due to stretching around the indents. This is shown in Figure 5. Although the indent is well-defined, stretching lines are observed below the indent. These lines are not scratches from the polishing, and were not present prior to the indentation. In many cases, one of the vertices was not well-defined. Due to the stretching, the hardness values cannot be considered absolute. Regardless, they are in the correct range for uranium, so they are probably close to the absolute hardness value. The stretching, and therefore the difficulty in determining the vertices, was present in all four samples. Although the absolute value cannot be guaranteed, all of the data points were measured in the same manner, so the comparison between samples should be valid.

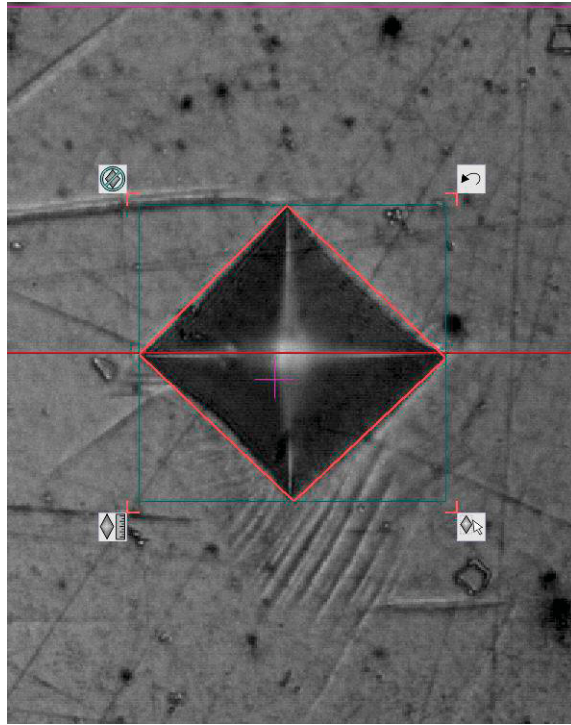
Figure 6. Indentation showing elastic stretching of surrounding area.

In order to avoid the sample stretching, the suggestion was made to use less force to do the measurements. This was not successful. Less force (50 gf) for the indents caused less stretching, but the smaller indent was still affected by the stretching.

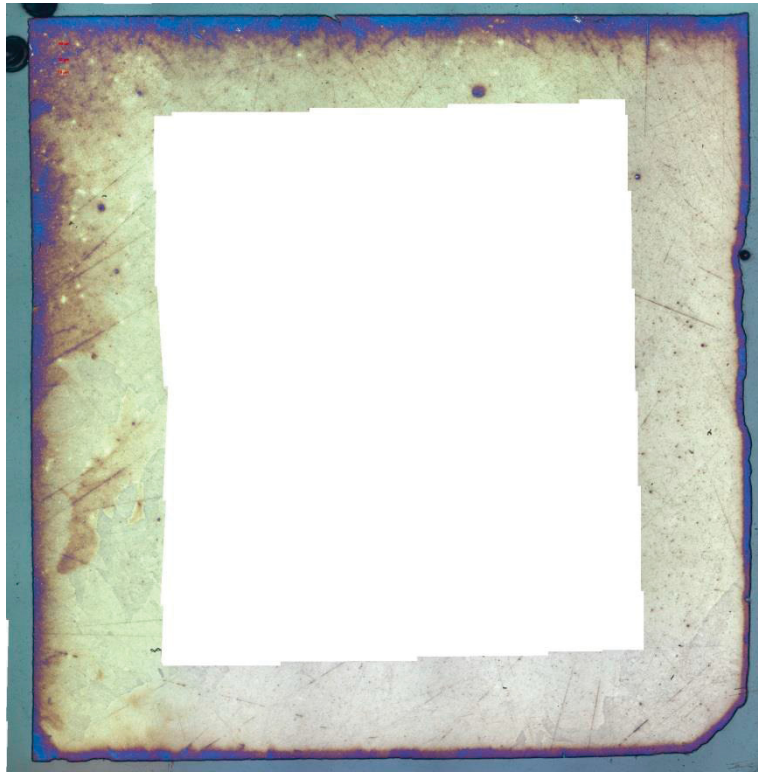
Figure 7. Composite image of DU Cube #1 (untreated).

After the oxide crust length measurements were completed, the images were merged using Photoshop. Merged images for each DU cube are shown in Figures 6–12. Spatial distortions in the images occurred in the merging process. Length measurements are shown in red along the periphery in Figures 7–13. As summarized in Table 3, increased time in the salt bath generally resulted in increased oxide crust layer thickness. The untreated billet showed no evidence of an oxide crust (Figure 6). Additionally, the increased time in the salt bath resulted in more abundant and deeper pitting of the billet cubes. Comparison of 1-hour treated samples suggests that suspending the sample may decrease pitting (Figures 8–11). However, the suspended sample may have interacted with the wire used to suspend it as indicated by the silvery precipitates along the top edge of Figure 11. Additional analysis would be necessary to evaluate whether or not the DU cube interacted with the SS wire. The images from the third experiment (Figures 10, 11, 18, and 19) are more colored in appearance. It is assumed that the coloration was due to increased surface oxidation, as these samples were delayed in analysis as compared with the samples from previous experiments. Indentations from micro-hardness testing, described in the previous section, are observable in Figure 8.

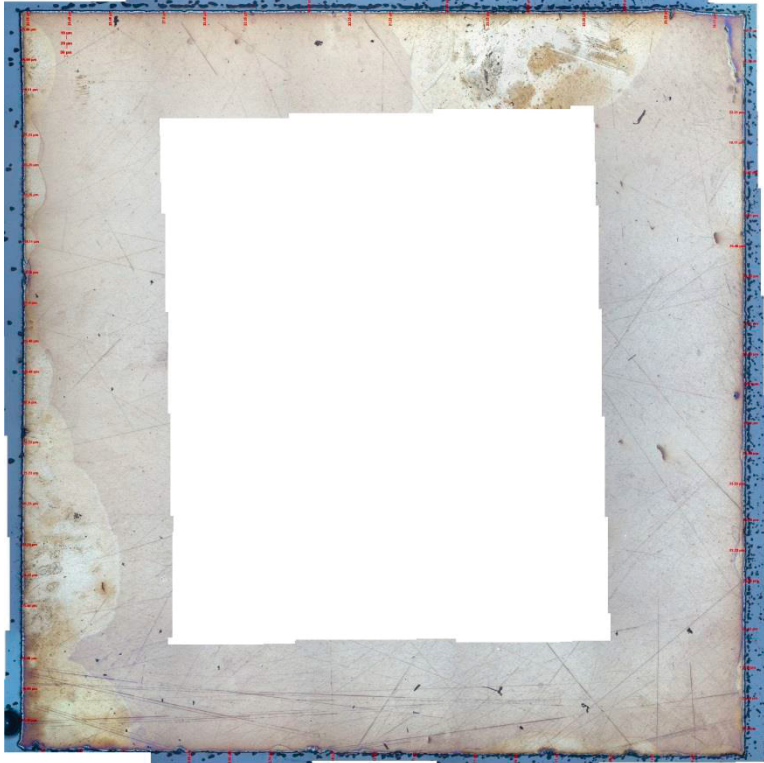
Figure 8. Composite image of DU Cube #6, treated in the salt bath for 30 minutes and quenched in water.

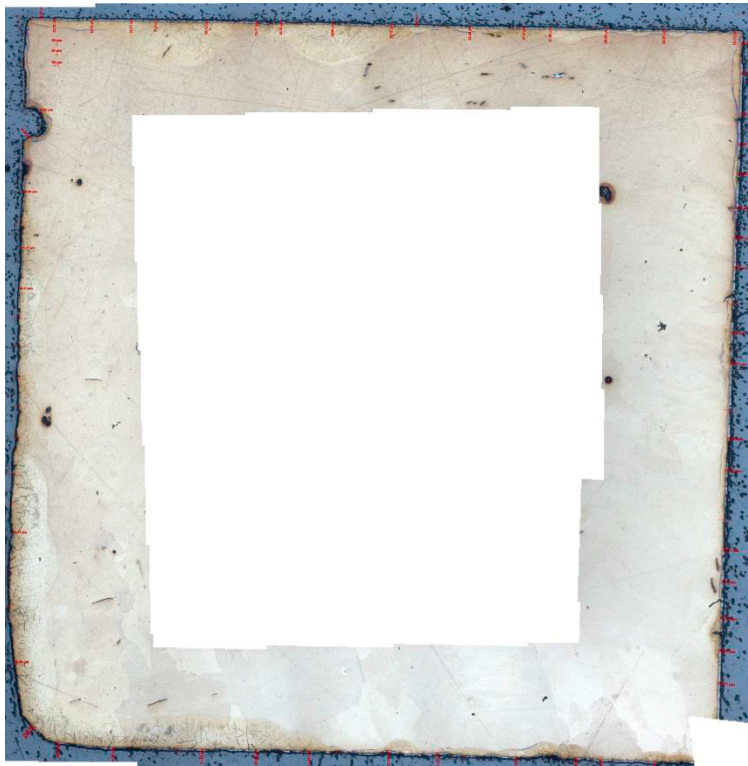
Figure 9. Composite image of DU Cube #5, treated in the salt bath for 1 hour and quenched in water.

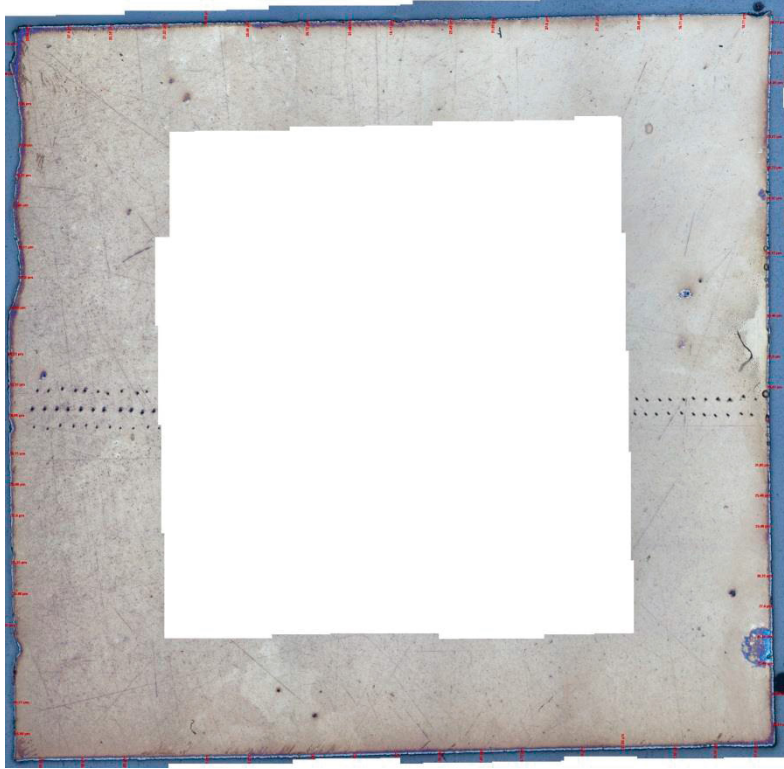
Figure 10. Composite image of DU Cube #3, treated in the salt bath for 1 hour followed by air cooling.

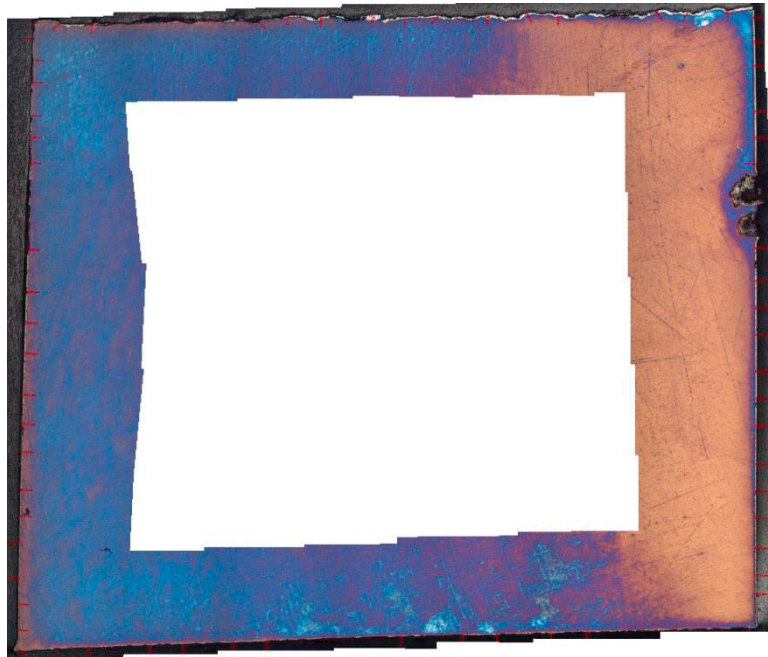
Figure 11. Composite image of DU Cube #7, treated in the salt bath within a crucible coated with AREMCO Products Pyro Paint 634-ZO for 1 hour and quenched in water.

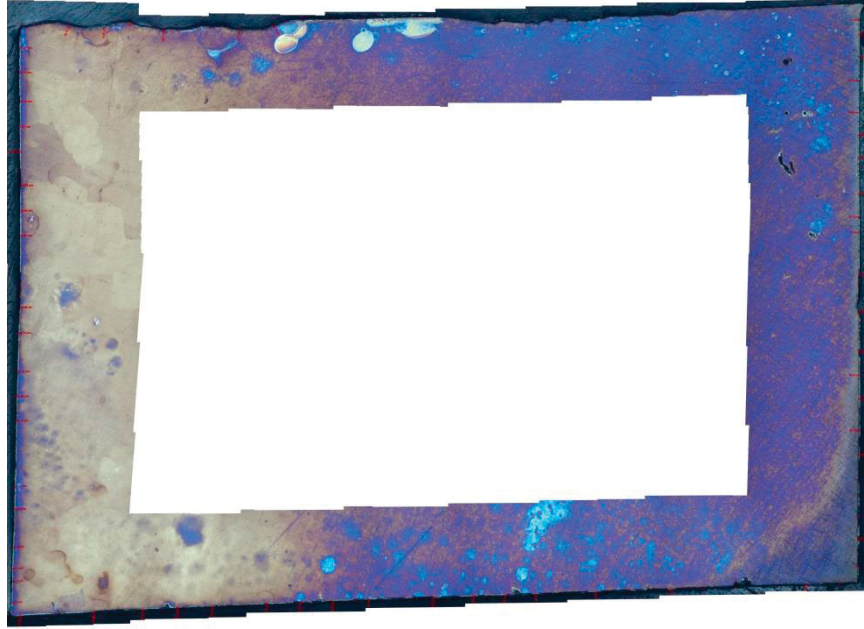
Figure 12. Composite image of DU Cube #9, suspended for 1 hour in the salt bath using SS wire and quartz tube to prevent developing a circuit with the crucible. After annealing the samples was quenched in water.

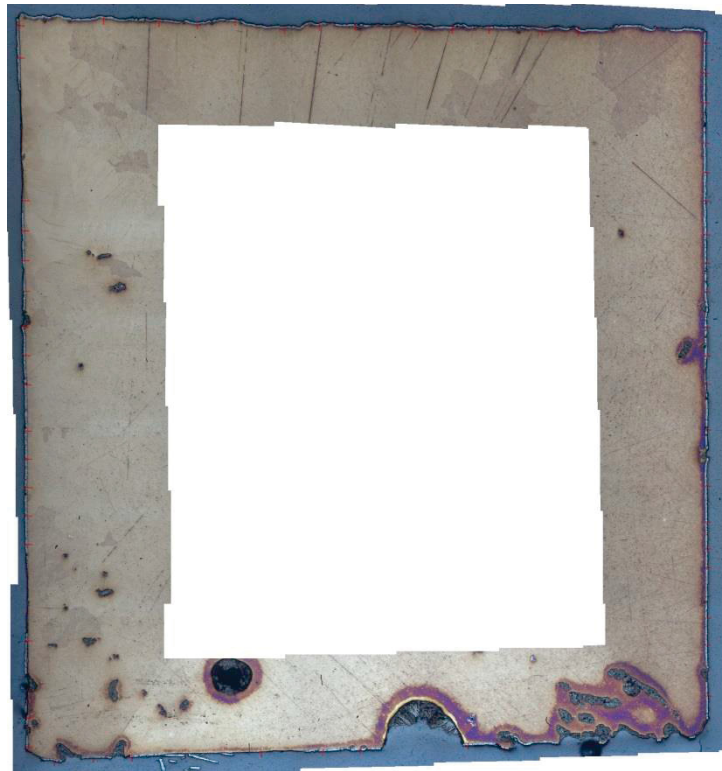
Figure 13. Composite image of DU Cube #2, treated in the salt bath for 2 hours followed by air cooling.

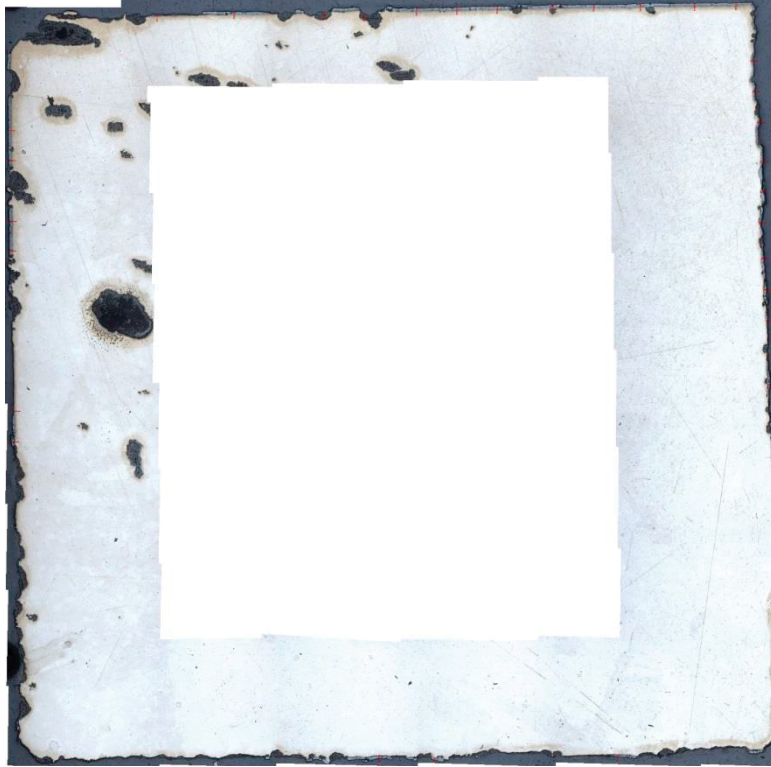
Figure 14. Composite image of DU Cube #4, treated in the salt bath for 4 hours followed by air cooling.

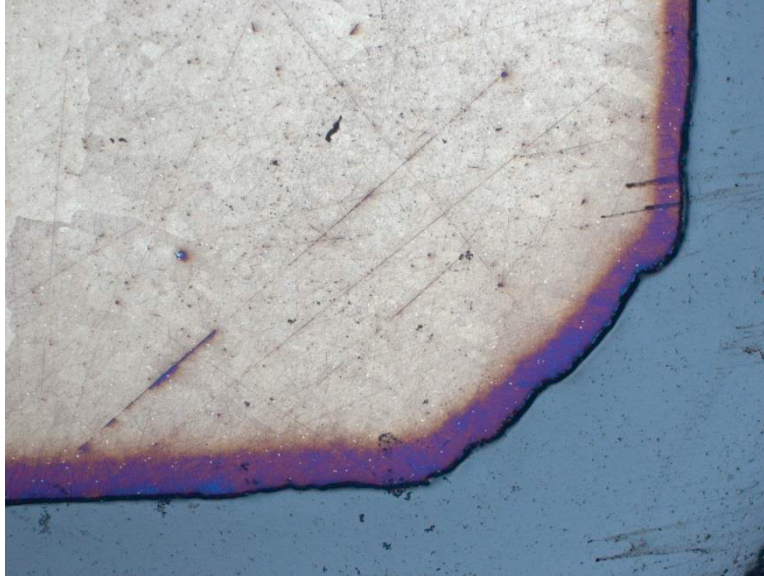
Figure 15. Image from the bottom right corner of untreated DU Cube #1.

Figures 15–21 show images of a corner of the DU cubes and are representative of the images acquired prior to merging. These images show the presence of oxidized uranium on a polished surface, in addition to the oxide crust around the edges, as exemplified by the purple shading along the edges of the cube in Figure 14. This observation could be due to a variety of factors, including differences in topography due to polishing procedure, different material properties in this region due to reaction, or increased nucleation of oxides at the edge of the material. It is likely that the white speckles observed in Figure 20 are due to incomplete cleaning of the sample surface prior to image acquisition.

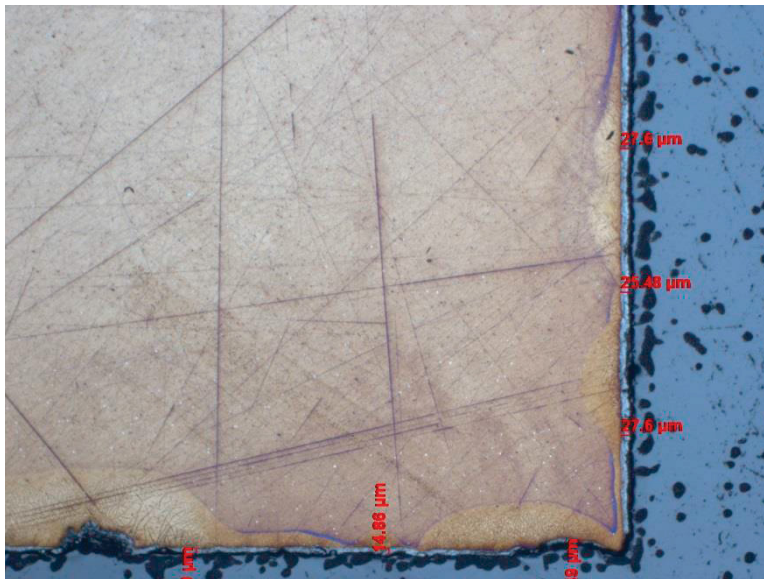
Figure 16. Image from the bottom right corner of DU Cube #6, treated in the salt bath for 30 minutes and quenched in water.

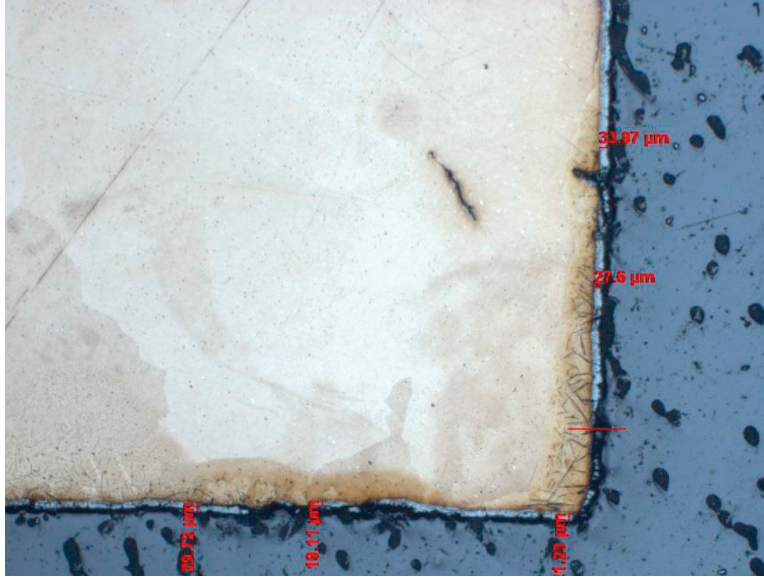
Figure 17. Image from the bottom right corner of DU Cube #5, treated in the salt bath for 1 hour and quenched in water.

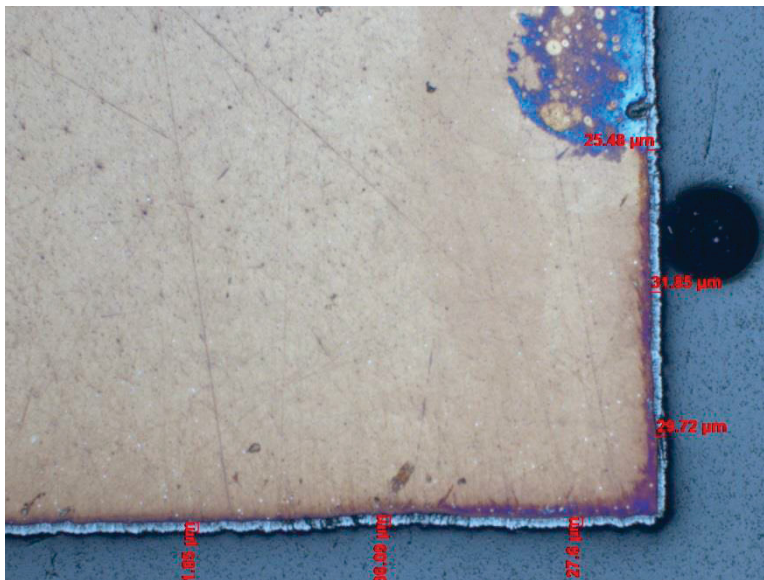
Figure 18. Image from the bottom right corner of DU Cube #3, treated in the salt bath for 1 hour followed by air cooling.

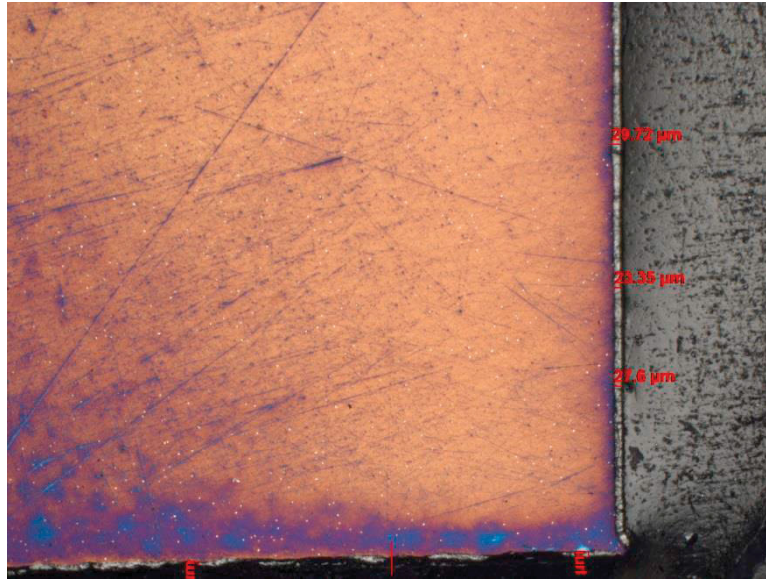
Figure 19. Image from the bottom right corner of DU Cube #7, treated in the salt bath within a crucible coated with AREMCO Products Pyro Paint 634-ZO for 1 hour and quenched in water.

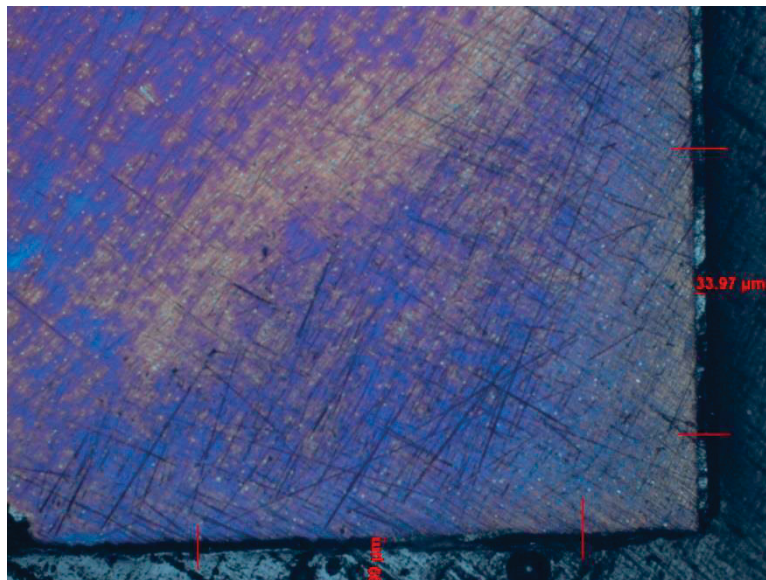
Figure 20. Image from the bottom right corner of DU Cube #9, suspended for 1 hour in the salt bath (using SS wire and a quartz tube to limit contact with the crucible) and quenched in water.

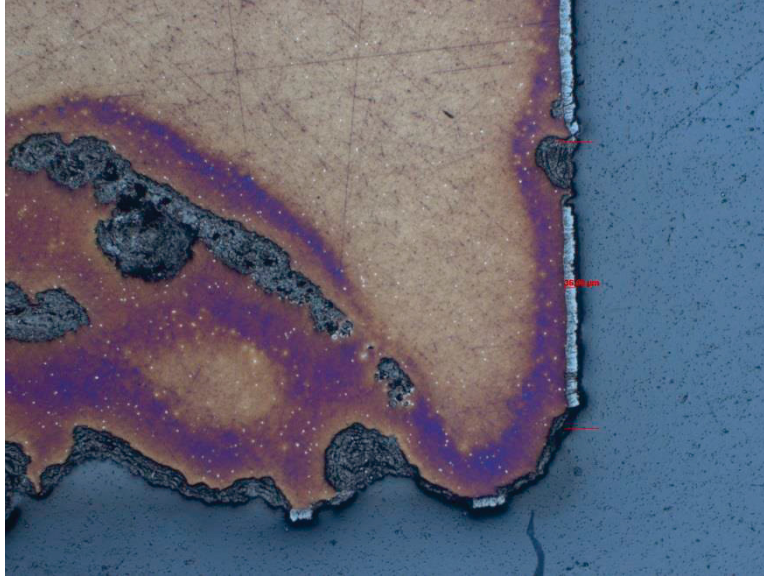
Figure 21. Image from the bottom right corner of DU Cube #2, treated in the salt bath for 2 hours followed by air cooling.

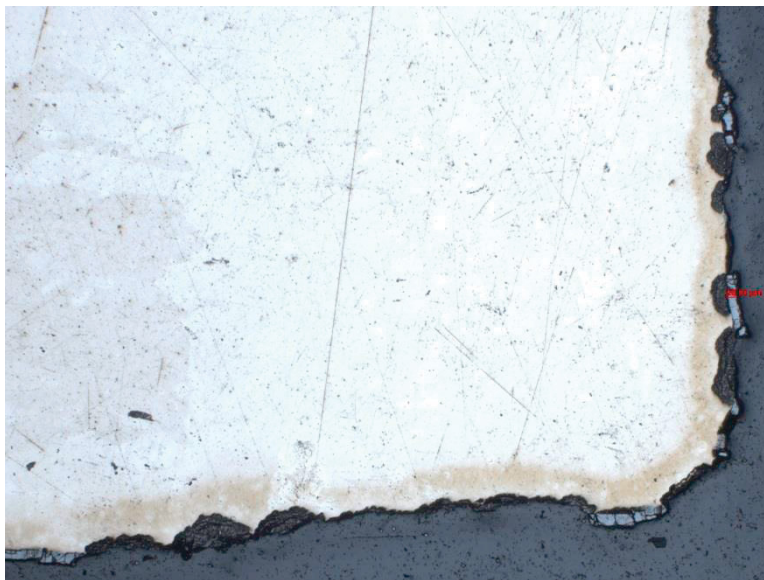
Figure 22. Image from the bottom right corner of DU Cube #4, treated in the salt bath for 4 hours followed by air cooling.

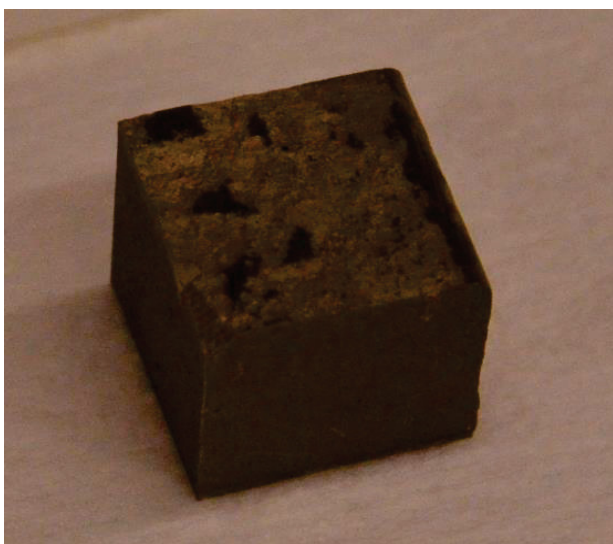
Figure 23. Old salt sample prior to annealing treatment.

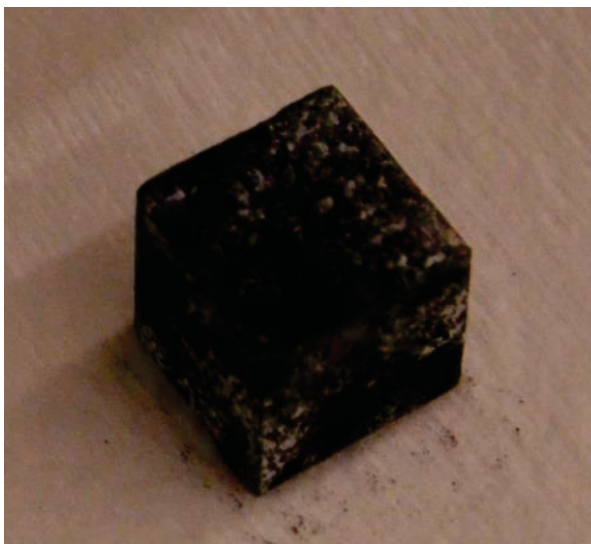
Figure 24. Old salt sample post annealing treatment.

After being removed from the quench, a visible oxide layer was present on all three samples. Also visible was a film layer of salt on all samples. Treatments and average rind thickness are shown in Table 5.

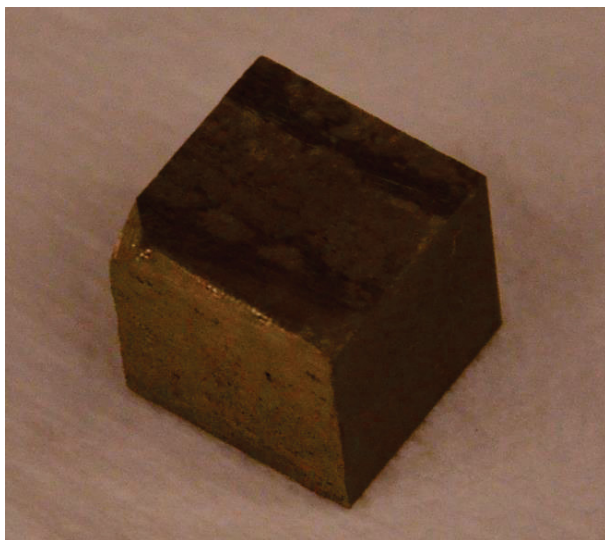
Figure 25. New salt sample prior to annealing treatment.

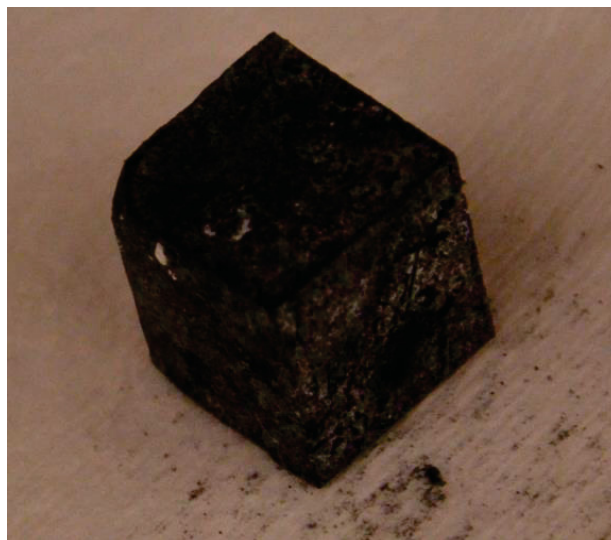
Figure 26. New salt sample post-annealing treatment.

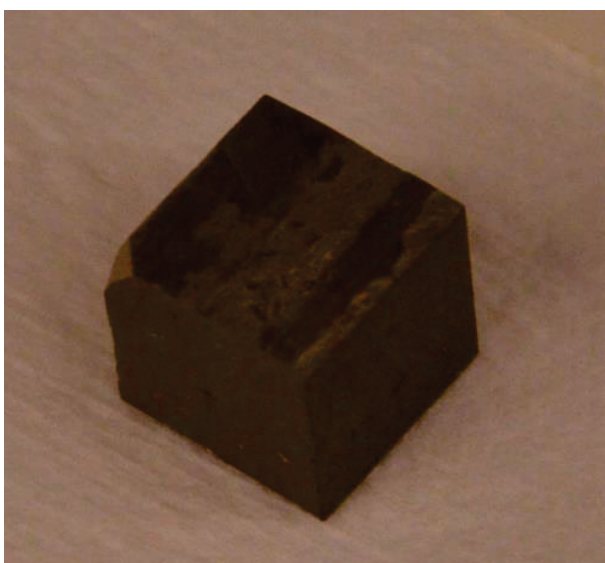
Figure 27. Thirty minute sample prior to annealing treatment.

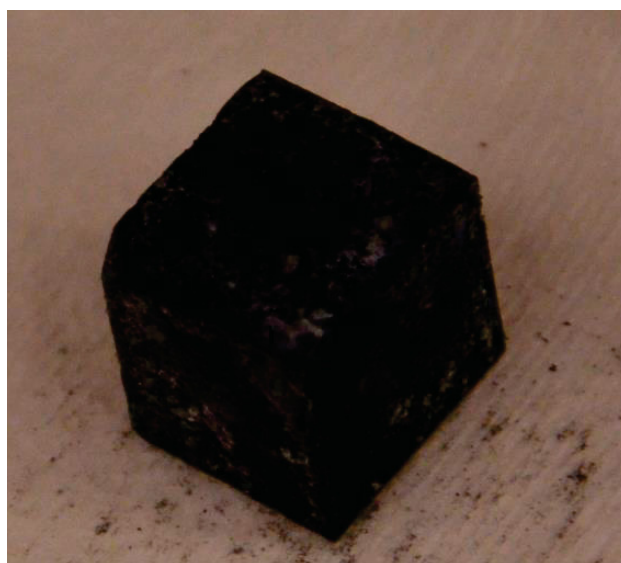
Figure 28. Thirty minute sample post-annealing treatment.
