Microstructural and chemical characterization of medium burnup fast reactor MOX using electron microscopy

February 2021

Fabiola Cappia, Jason Harp

**Idaho National Laboratory
Characterization and Advanced PIE Division
Idaho Falls, Idaho 83415**

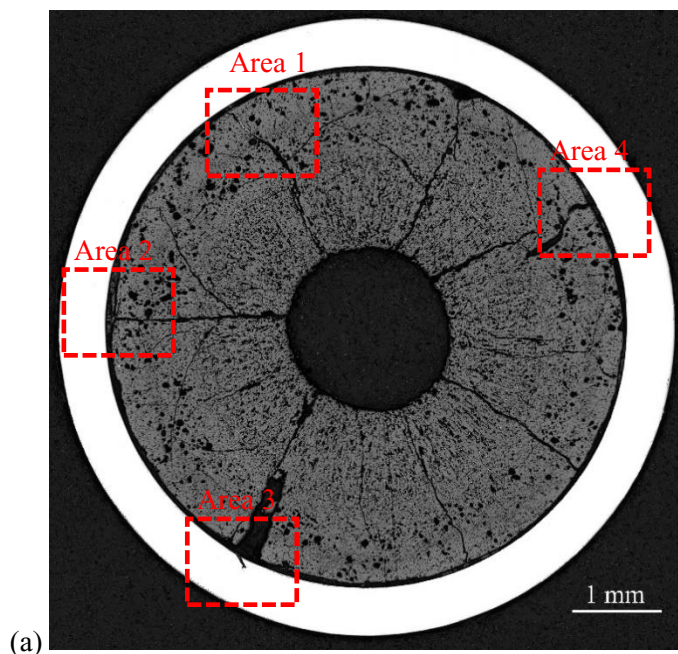
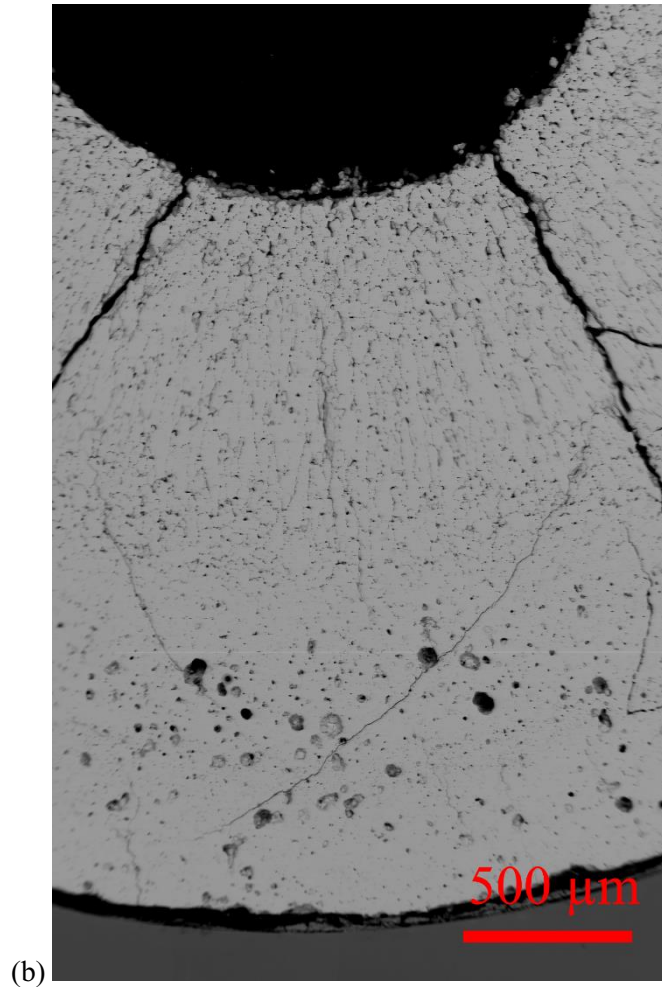
Figure 1. (a) Overview of sample 1. (b) Low magnification SEM image.

The overview of the first sample taken with the optical microscope is given in Figure 1a. Low-magnification images have been acquired using the SEM (Figure 1b) and confirm the presence of an equiaxed grain region and a columnar grain region. Manual measurements of the extension of the columnar grain area have been made. Based on the average measurement made on SEM images, the columnar grain region extends through 0.66 ± 0.01 (/) of the fuel radius, in relative units. The value is slightly below the one calculated from texture analysis with the optical microscopy, where a value of 0.71 for the columnar grain extension was obtained. As the resolution of the optical microscope was limited and the samples were not etched, some discrepancy between the two methods is reasonable.

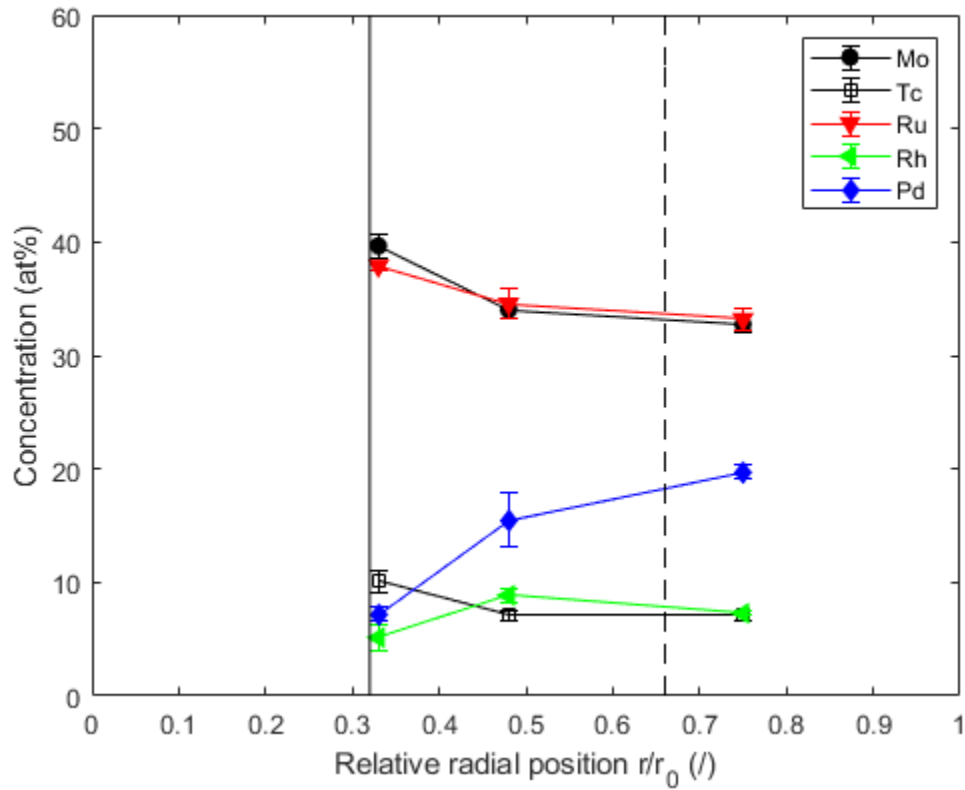
Figure 2. Five metal precipitates approximate composition as a function of the pellet radius. The black solid line represents the central hole, while the dashed line is the extension of the columnar grain as measured manually from SEM images.

The presence of fission product precipitates was already clear from the optical microscopy analyses previously performed on these samples. Semi-quantitative EDS analyses have been done at different radial locations to map the evolution of the metallic precipitates. The radial measurements are shown in Figure 2. The increase of Pd concentration towards the fuel periphery is a consequence of its higher volatility compared to the other products. Of particular interest is the ratio between Mo and Ru, as the decrease in Mo concentration in the metallic precipitates is used to monitor the oxygen potential of the fuel [5,6]. It can be seen that the ratio between Mo and Ru remains approximately constant and close to one, a sign that oxidation of Mo has not occurred to significant extent in the majority of the pellet radius. Precipitates in the outermost part of the pellet, i.e., for $r/r_0 > 0.8$ were too small to be seen and measured via SEM/EDS and were analyzed using TEM instead.

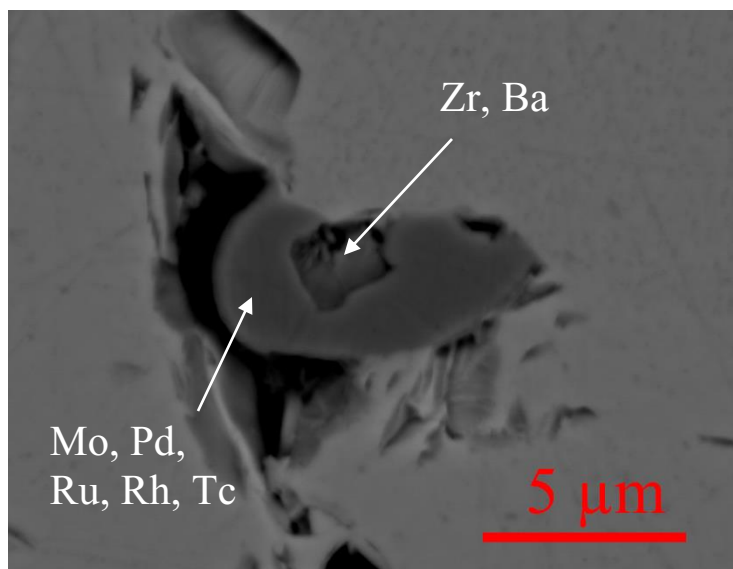
Figure 3. Large inclusion observed between the equiaxed and columnar grain region. The inclusion is formed by a core of oxide grey phase and a metallic shell.

Close to the border between the columnar grain region and the equiaxed one, a precipitate with both a metallic phase and an oxide phase was observed (Figure 3).

Co-existence of grey phases and metallic precipitates in large inclusions towards the periphery of the fuel has been already reported by Sato et al. [7]. A possible explanation is a multiple stage condensation of the insoluble fission products on the surface of a large pore. It is likely that the grey phases precipitated at an early stage, followed by later precipitation of the metallic fission products.

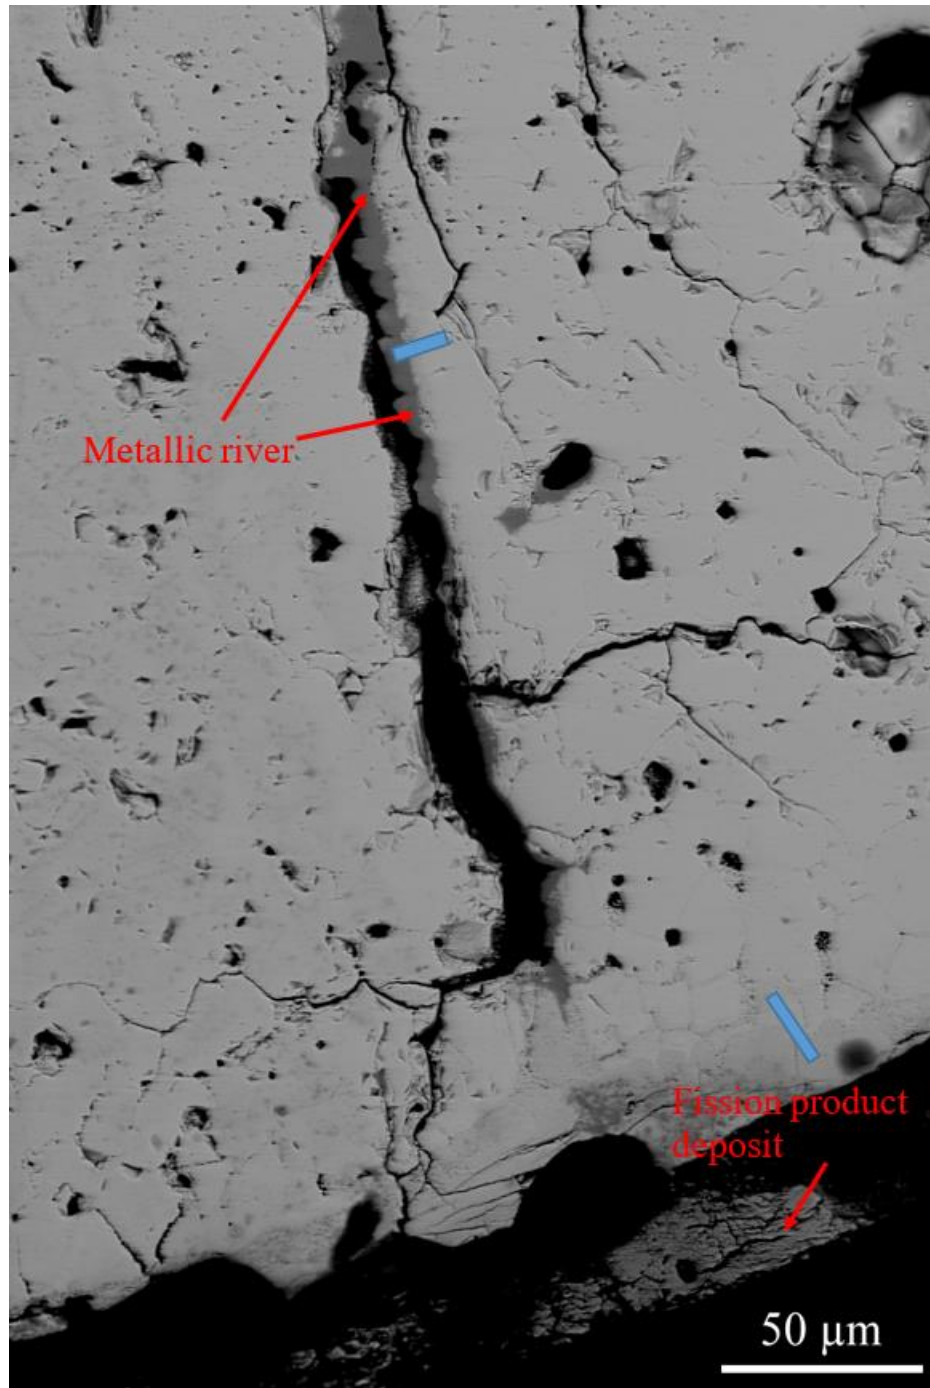
Figure 4. BSE image of the metallic river. The rectangles indicate the location of the TEM lamellae described in the next sections.

In the equiaxed grain region indicated by the square Area 1 in Figure 1a, a “metallic river” was observed, which is shown in Figure 4. Metallic rivers were associated with transport of cladding components, particularly Fe, into the fuel [8]. Qualitative EDS spectra of the river indicated that, in this case, the main component is Pd. More in-depth analyses of the river have been performed with TEM, which are shown in Figure 5 through Figure 7. In Figure 5a, an overview of the interface between the fuel and the metallic river is presented. On one side, the metallic phase exhibits large grains with presence of twinning. In the lower part of the lamella, the fuel shows a crystalline structure with sub-micrometric grains close to the interface. The diffraction patterns for the two phases are shown in Figure 5b and c. Chemical analysis of the metallic phase by TEM confirmed the SEM results, showing that the phase is almost entirely composed of Pd (see Figure 6), with minor content of Mo. Traces of U and Pu are also detected, but they could be due to the interference of signal from the bulk of the lamella. The diffraction pattern in Figure 5b is in excellent agreement with the fcc structure of pure Pd (space group $Fm\bar{3}m$, n 225). The derived lattice parameter is $3.86 \text{ \AA} \pm 0.01 \text{ \AA}$ from this diffraction pattern. A slightly larger value of $3.88 \text{ \AA} \pm 0.01 \text{ \AA}$ was obtained from a second data set. Both data sets are comparable with literature values [9,10]. Twin grains are present, as indicated in Figure 5b. The full description of the twinning of the Pd structure is beyond the scope of these analyses, but formation of twins, which are generally a consequence of deformation or annealing growth, is not totally surprising. The metallic river has likely formed over the in-reactor life, and the area experienced steep temperature gradients which, in turn, translate in stress gradients. Under such circumstances, twinning of an fcc structure could have been caused.

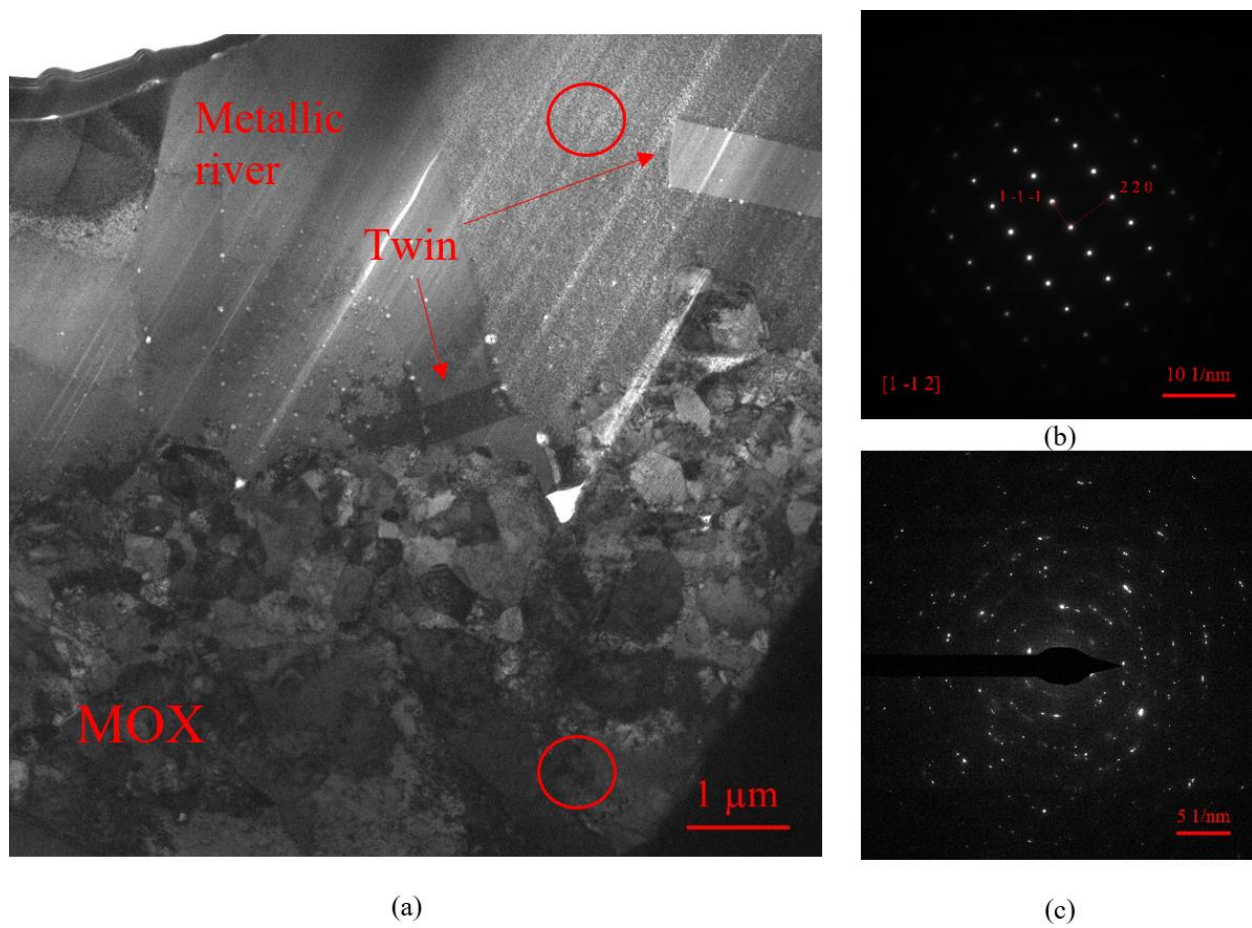
Figure 5. Bright-field TEM image of the structure at the interface between the metallic river and the MOX fuel. The red circles represent the location of the diffraction patterns shown in the insets on the right.

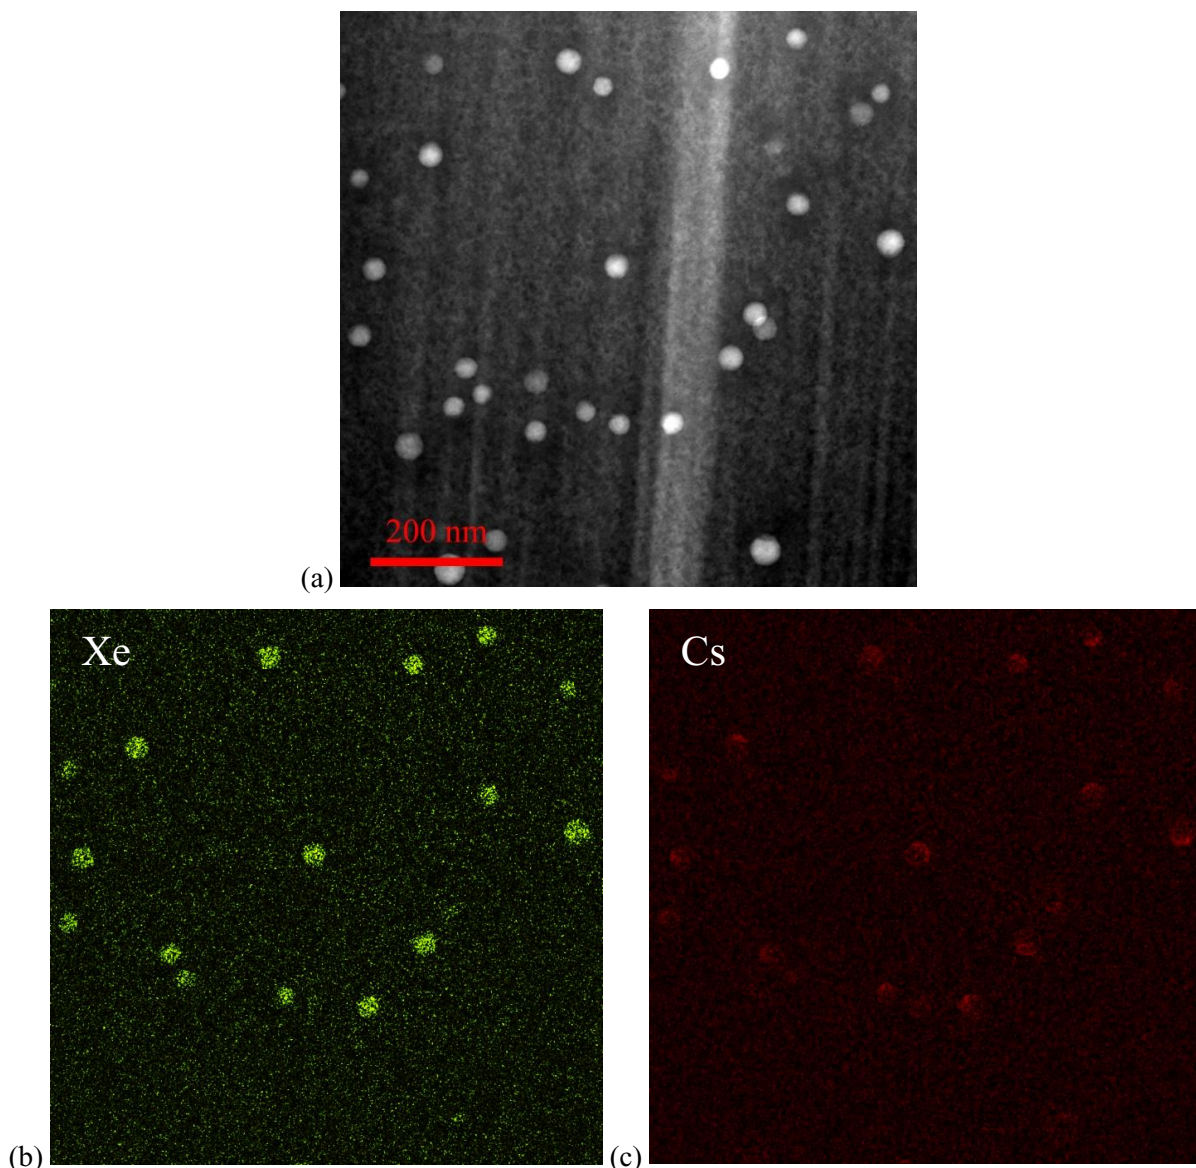
Figure 7. EDS maps (in at %) showing the presence of fission gas bubbles in the Pd matrix. Cs accumulates on the surface of the bubbles.

Even at low magnification, bubbles can be seen in the Pd phase in Figure 5. A high magnification image of the bubbles as well as the atomic concentrations of Xe and Cs are shown in Figure 7a, b and c, respectively. Xe has been injected into the metallic phase via fissioning processes and have formed bubbles within the metal. The precipitation of Xe indicates insolubility of the gas in the Pd, in line with atomistic calculations of solution and accommodation energies of this product in ϵ phases [11]. It is interesting to note the precipitation of Cs on the surface of the bubbles in Figure 7c. Cs is also predicted to be insoluble in epsilon phases [11], Cs could both be a decay product of Xe-133, but signature of Ba within the bubbles was also measured, indicating that part of the Cs could be Cs-137 or Cs-134. To the author’s knowledge, this is the first time the co-existence of gaseous and volatile fission products is directly reported in the metallic precipitates.

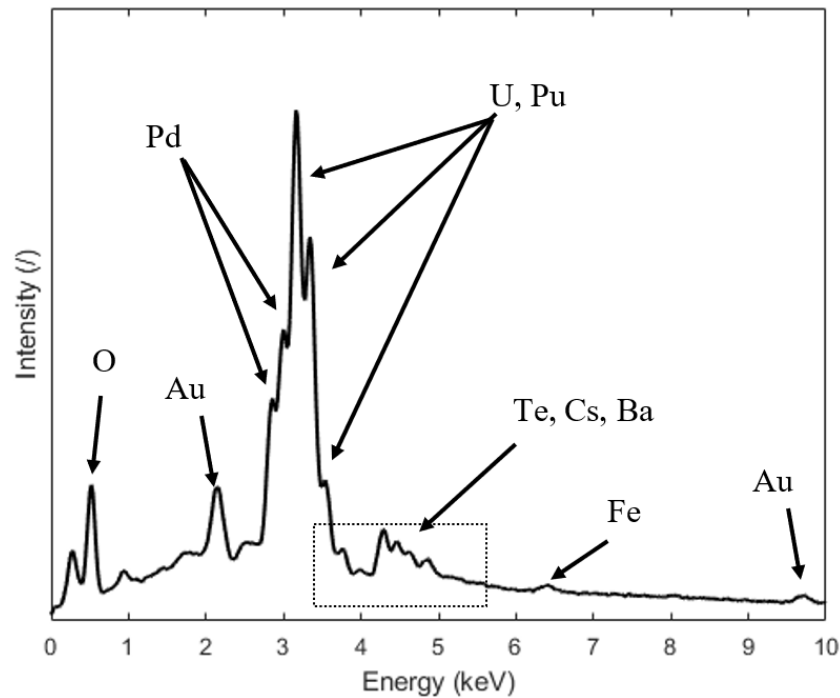
Figure 8. EDS spectrum of the fission product deposit shown in Figure 4.

At the pellet periphery initial stages of fission product precipitation in the gap had occurred. The corresponding EDS spectrum is shown in Figure 8. Qualitatively, the deposit is composed mainly by fuel (U, Pu)O₂, with presence of some Pd, whose X-ray L edges partially overlap the U, Pu M edges. In the energy range 3.78 keV to 4.9 keV, the L edges of Cs, Ba and Te could be confirmed, but low energy EDS cannot clearly distinguish each single contribution. The peaks at 2.14 and 9.7 keV are a result of the gold coating, while the minor Fe peak observed is probably from the SEM chamber, as Fe peaks intensity was the same in all the spectra. Concentration of alkali metals occurred at the outermost periphery of the fuel, as highlighted both in Figure 9b and 9c. Similar results were obtained in another peripheral location next to the river, shown in Figure 10a and 10b. In addition to the Cs-enrichment, large metallic precipitates were seen, mainly composed of Pd and Ag. WDS was used to detect Pd and distinguish it from Ag and it is shown in Figure 10c. Ag accumulated only at the outermost part of the pellet, consistent with its higher volatility compared to Pd.

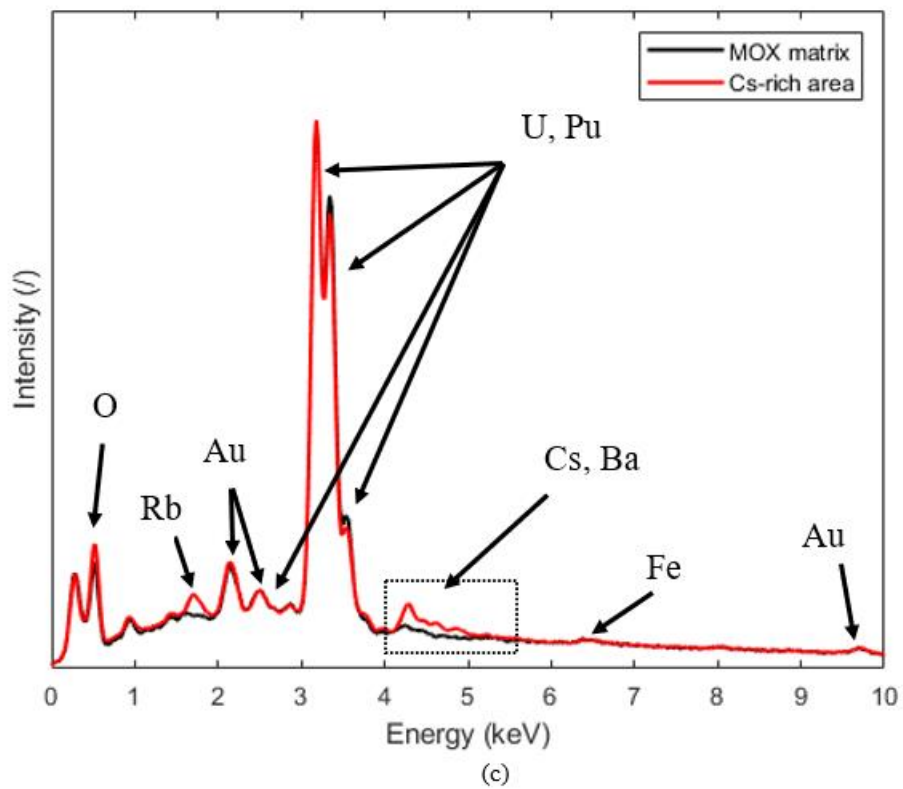
Figure 9. (a) High magnification (2500x) image of the outermost part of the fuel pellet at the end of the metallic river. (b) Qualitative map of Cs signal. (c) Comparison of the spectra from the boxes in (a) showing the enrichment of the alkali metals with respect to the matrix.

In both Figure 9, Figure 10a and Figure 10b, a different morphology of the grain structure can be qualitatively determined from the SEM images. The grain subdivision occurring where the fission products have accumulated becomes obvious from the EBSD map shown in Figure 11. The structure is slightly different from the typical High Burnup Structure (HBS), as the micrometric pores are not present, rather, the layer is quite compact. The region has been further analyzed by TEM, and the results are shown in the next section focused on the fuel periphery and cladding region.

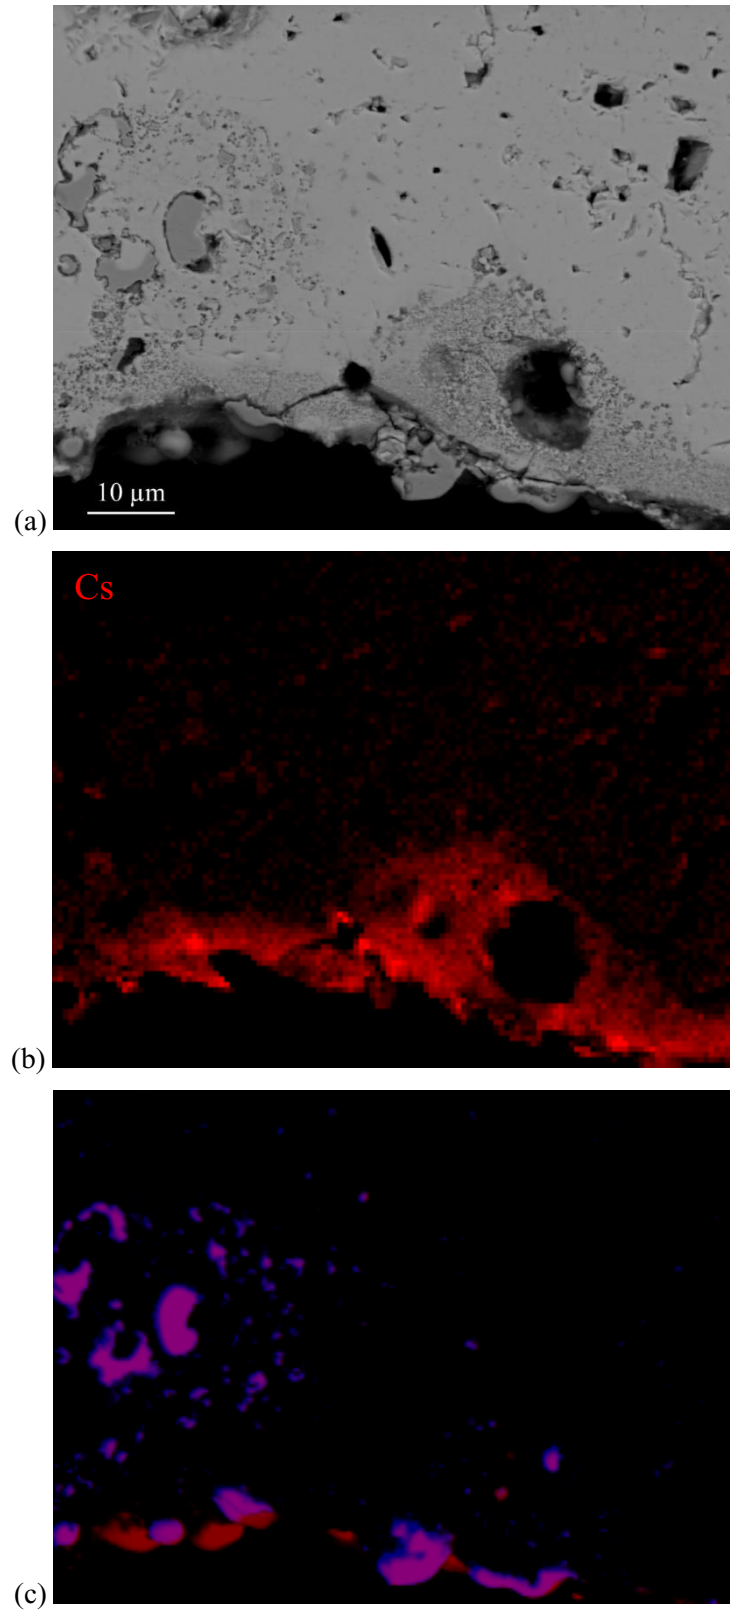
Figure 10. (a) BSE of another peripheral location adjacent to the metallic river. (b) Cs elemental qualitative map. (c) Overlay of the EDS signal from Ag (red) and the WDS signal of Pd (blue). The purple color is the result of the overlap.

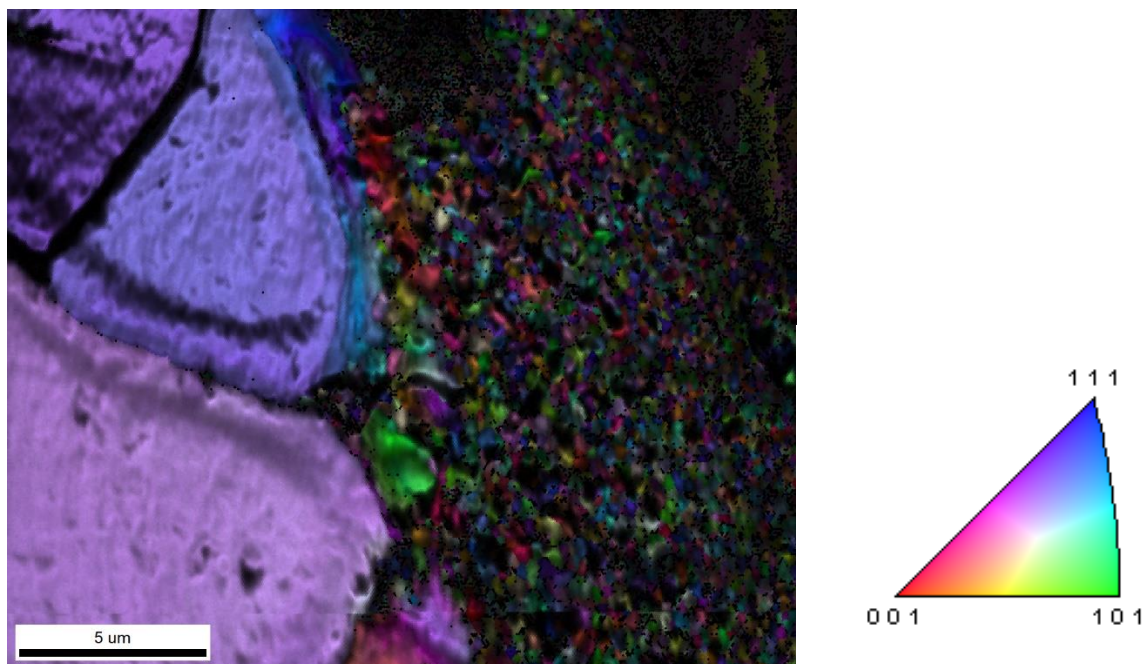
Figure 11. Inverse Pole Figure (IPF) overlaid to the image quality (IQ) map of the area at the interface between the fission product rich zone and the fuel matrix.

An additional location at the fuel periphery showed exposed grain surfaces exhibiting grooves that resemble the grain subdivision, similar to the subdivided grains of the HBS (Figure 12). EBSD mapping has been taken just outside this area (Figure 13), but no grain subdivision could be observed past the exposed fresh fracture in Figure 12. This proves that the phenomenon is restricted to that area. Some Cs enrichment was measured in the recessed zone, which suggests that a phenomenon similar to what is shown in Figure 11 has taken place.

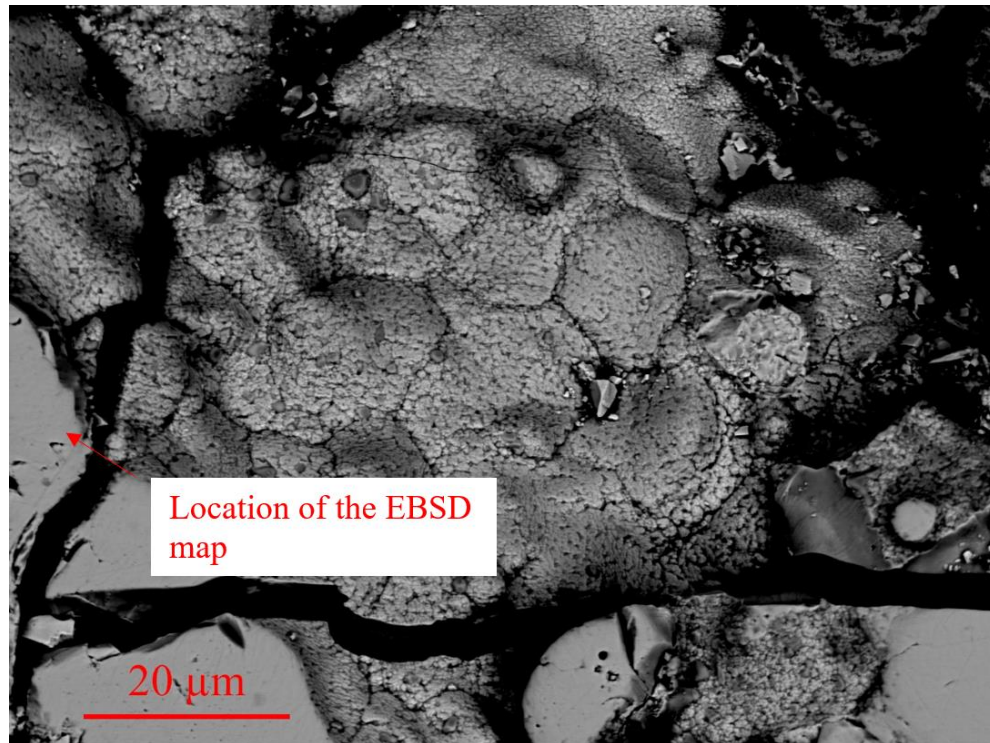
Figure 12. SEM image showing a "cauliflower-type" structure at the outermost fuel periphery.

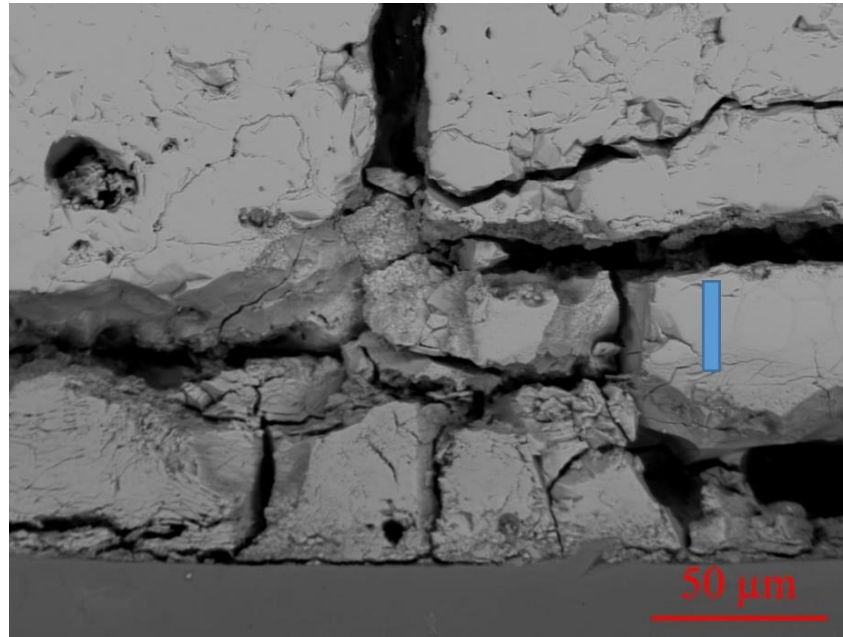
Figure 14. BSE image of the fuel to cladding region from area 2 (from Figure 1a). The rectangle indicates where the TEM lamella was extracted.

TEM analyses focused on the fuel side only. TEM lamellae were extracted at the locations of the boxes in Figure 14 and Figure 16a. The SEM/EDS maps showed previously (e.g., Figure 9b and Figure 16b-e) indicate that the majority of the corrosive fission products is still retained in the outermost portion of the fuel matrix, hence, it is necessary to provide details regarding the fuel chemical composition and structure in these regions. Low magnification overviews of the lamellae are reported in Figure 19. The three lamellae were extracted from locations with distance of $\approx 70\text{ }\mu\text{m}$, $\approx 55\text{ }\mu\text{m}$ and $\approx 18\text{ }\mu\text{m}$ from the cladding inner surface, respectively.

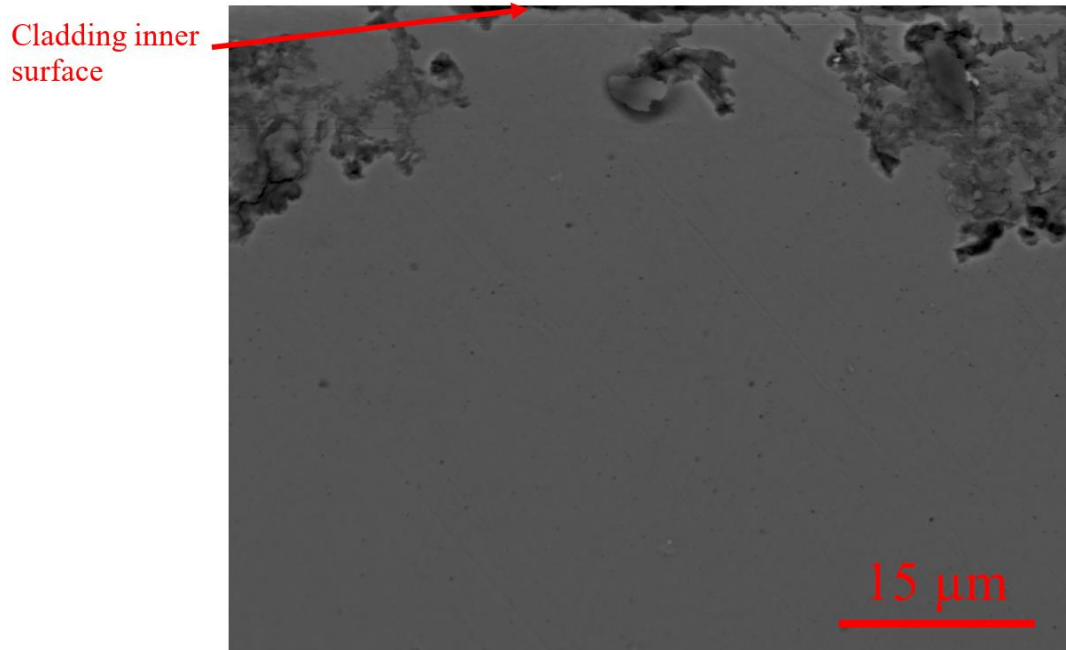
Figure 17. Overview of intergranular corrosion in the HT-9 cladding.

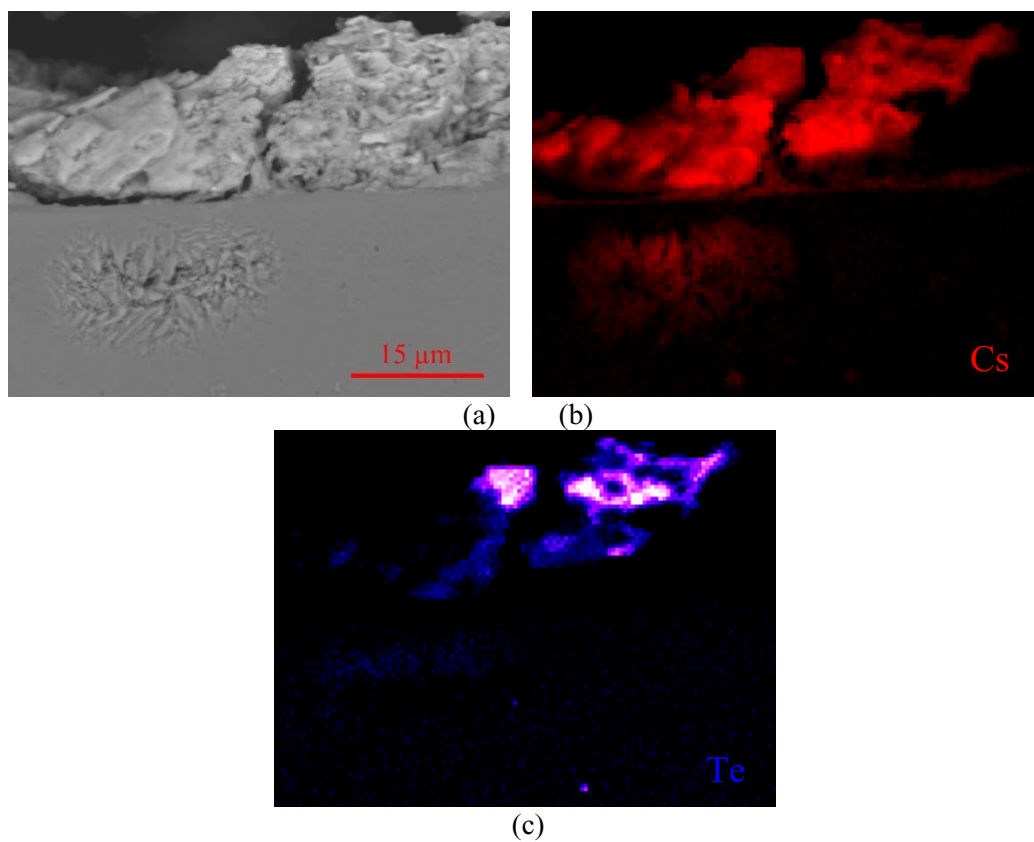
Figure 18. Other location in the HT-9 cladding with initial stages of corrosion. Cs and Te are associated with the corroded area.

surface. The irregularity of the surface and its depth did not allow the gathering of EDS data, but it is apparent, from the surface morphology, that grain subdivision has occurred. The most interesting deposit was formed in area 4, showing a considerable amount of Cs (Figure 16c) and spots rich in Te close to the cladding (Figure 16d). Pd appears mostly deposited on the internal crack surface, and only spots in the interaction layer show some Pd enrichment, visible as dots in Figure 16e. In two locations, intergranular corrosion of the HT-9 has initiated (Figure 17 and Figure 18a). Cs and Te are associated with the corroded area, confirming the historical results regarding the influence of Te and Cs on the cladding corrosion process [12–15].

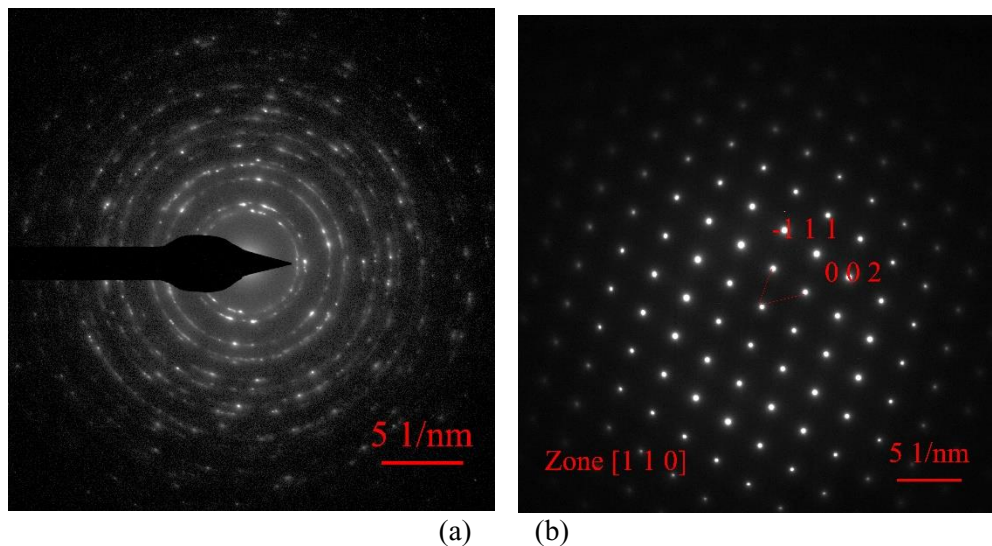
Figure 23. (a) Representative diffraction rings pattern from the nanocrystalline area of the lamella. (b) Isolated large grain present in the lamella.

Moving towards the cladding, the analysis of the second lamella in Figure 19b gave similar results to the previous lamella. The matrix is largely nanocrystalline, but isolated grains could also be mapped, whose diffraction pattern agrees with a cubic structure (Figure 23). However, some patterns could not be fitted with the MOX fluorite structure. The amount of fission products increases, in particular some grains are more rich in Cs, as can be seen from Figure 24b. Figure 25 shows Te deposition preferentially along the cracks. No cladding components were found associated with Te or other fission products at this distance.

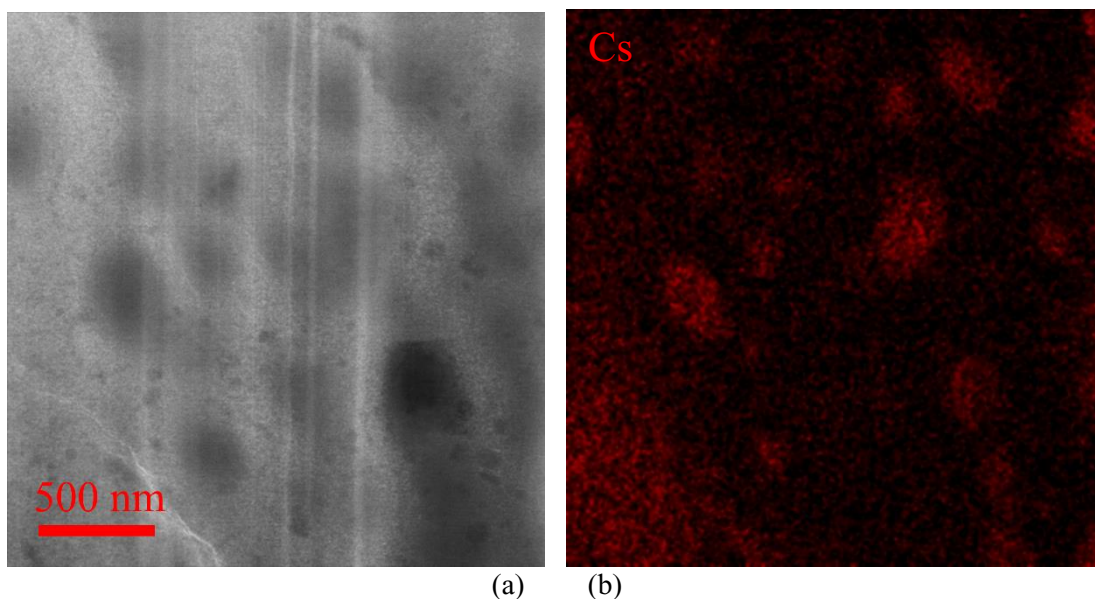
Figure 24. (a) Dark Field STEM image of the nanocrystalline domain. (b) EDS map showing Cs enrichment in some of the grains (map shows at%).

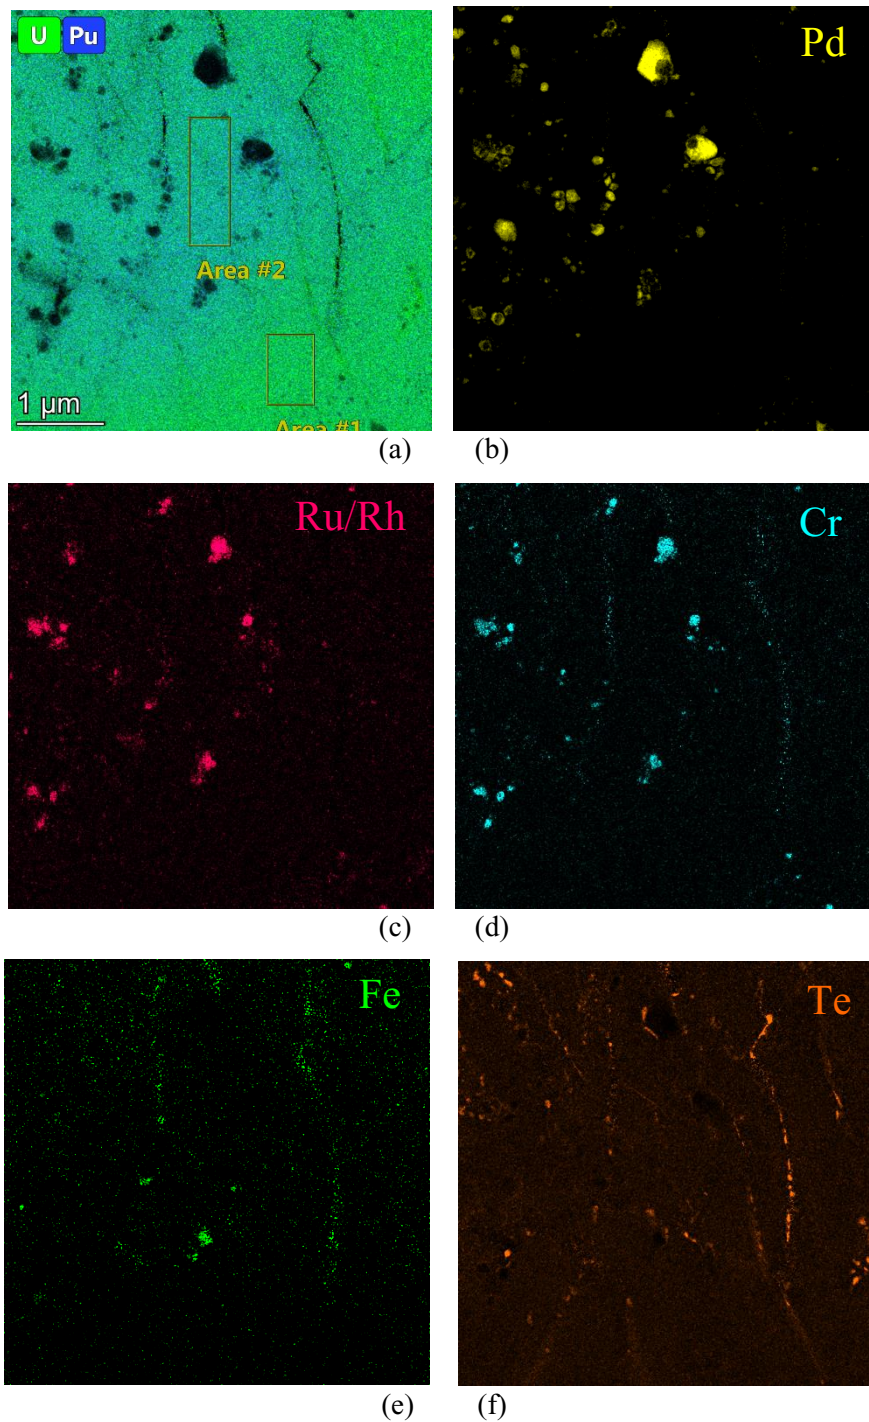
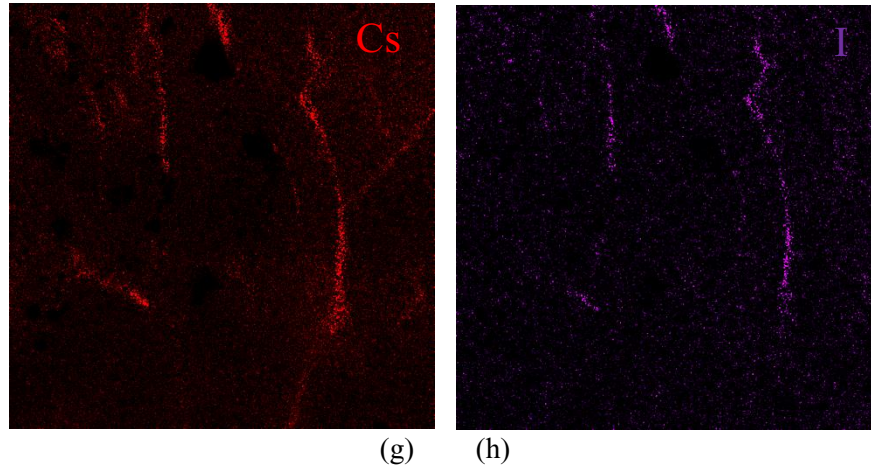
Figure 26. Atomic maps of the lamella from area 4.

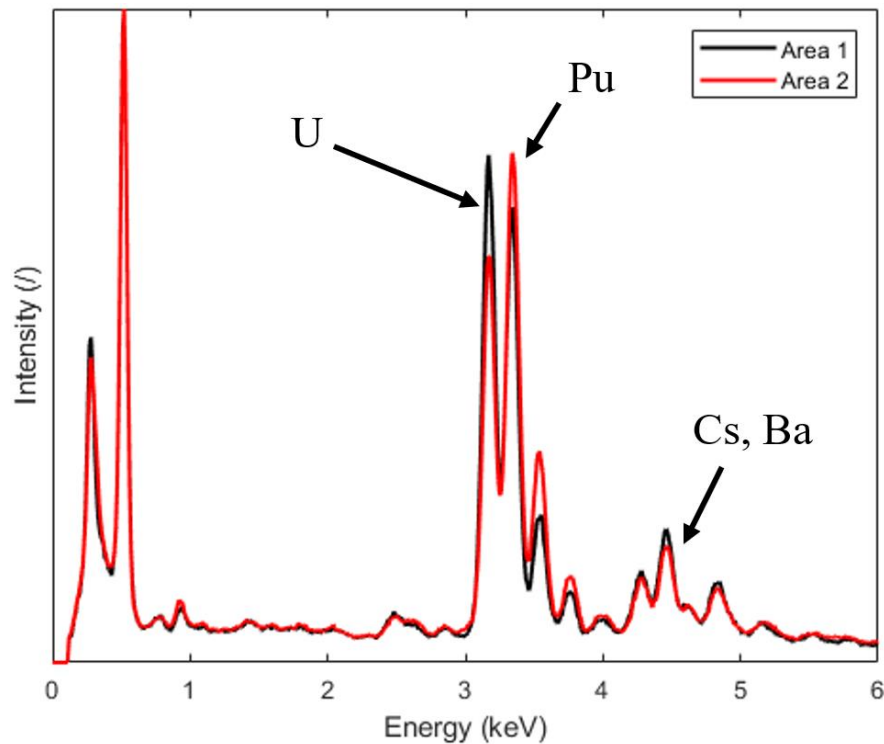
Figure 27. Spectra corresponding to area 1 and 2 in Figure 26a. The different enrichment in U and Pu can be appreciated by the relative height of the characteristic main peak.

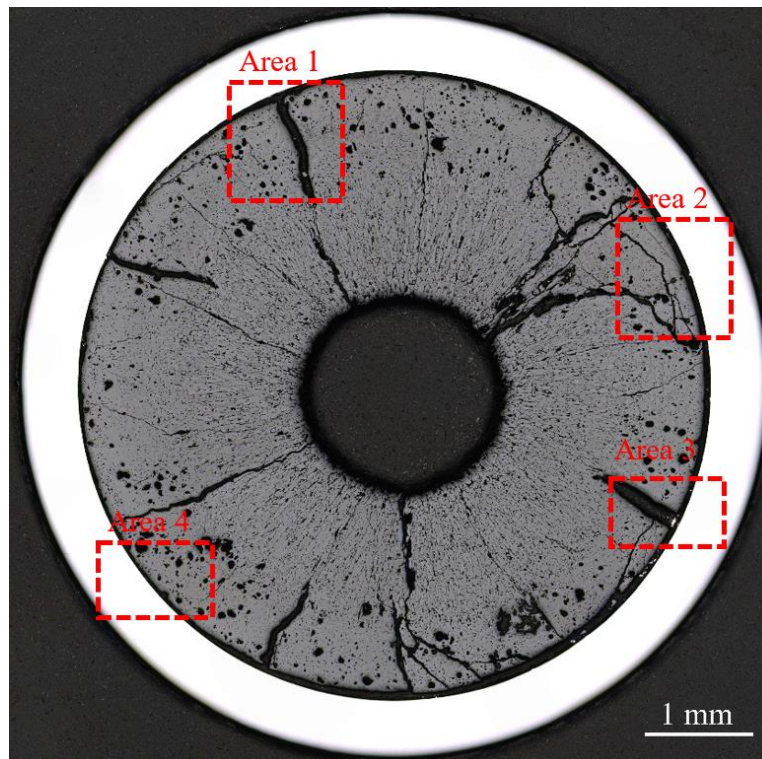
Figure 28. Overview of sample 2.

Similar investigations have been performed on the other sample from pin K06, which is shown in Figure 28. The microstructure shows similar features as in the previous sample, i.e., enlarged central hole, the columnar grain region and the equiaxed grain region. Images of the grains in the columnar grain region reveal a dense population of intergranular gas bubbles, some of which have connected forming tunnels (Figure 29b). Metallic precipitates decorate the surfaces of the bubbles. Various locations along the pellet periphery and inside the large cracks have been examined, as indicated in Figure 28 by the

rectangular areas. Toward the crack tip in Area 1, an area covered by the grey phases was detected, radially located at the interface between the columnar grain and the equiaxed grain region. The secondary phases are shown in Figure 30. The phase contained Ba and its daughter Ce. The presence of Zr could not be assessed, as the Zr edge corresponds to the Au M edge. Fuel microstructure in the equiaxed region and at the pellet's outermost areas has been analyzed and presented localized anomalies. In between area 1 and 2, a region with unconventional grain morphology was formed, as shown in Figure 31a. The region was characterized by a local enrichment in Pu content, as can be seen from the spectra in Figure 31b. Mixed oxide pellets were fabricated by mechanical blending of plutonia and urania powders [27]; hence, it is not surprising that occasional inhomogeneities could have occurred in the mixing. This could explain the Pu-enrichment in a localized island such as the one seen in Figure 31a. This being the case, a local increase in burnup could have occurred above the threshold of HBS formation, creating the subdivided grains seen in the island. EBSD maps have been acquired outside the island, and it can be seen that the subdivision remains local (Figure 32). The appearance of small grains has been observed in other regions, mainly inside large pores, such as those shown in Figure 33. The phenomenon remains confined in the cavities. Another area that showed onset of grain modification is visible in the fresh fracture surface in Figure 34, where the surface of some of the pre-existing grains is presenting signs of morphology change (top right of the figure). The surface corresponds to area 2 in Figure 28 where a piece of fuel broke off before the SEM analyses.

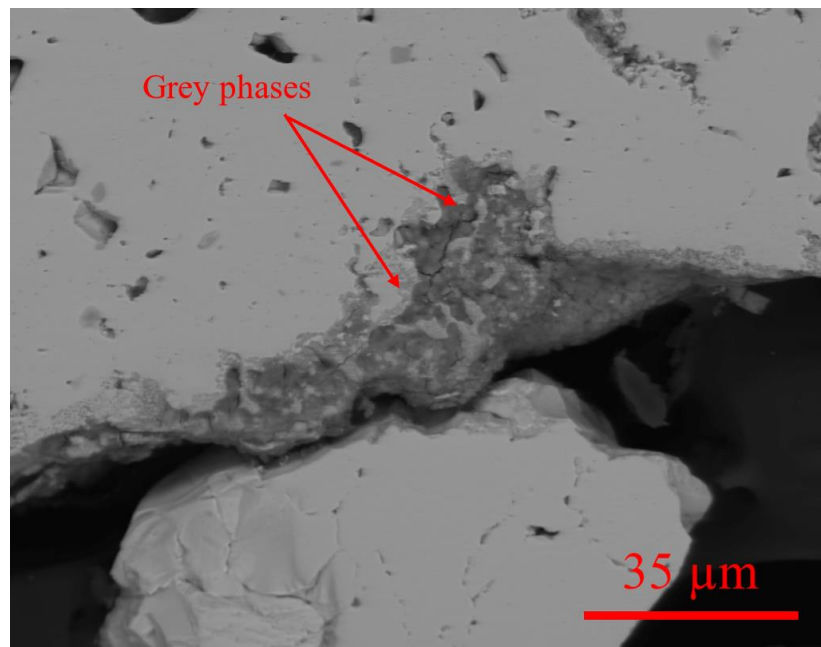
Figure 30. Accumulation of grey phases along a large crack surface.

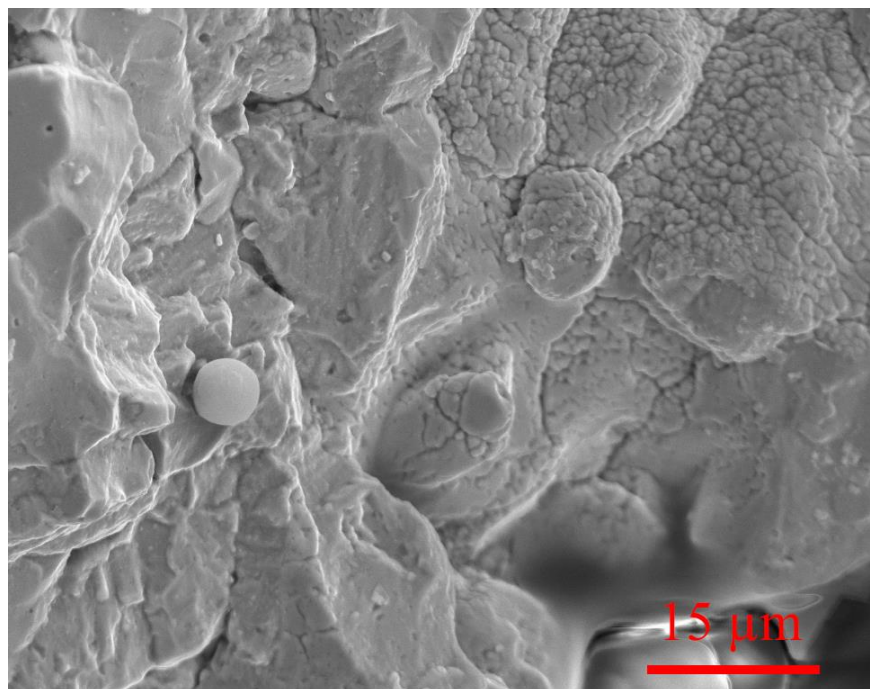
Figure 34. Missing fuel piece from area 2 showing onset of grain subdivision on the surface of pre-existing grains.

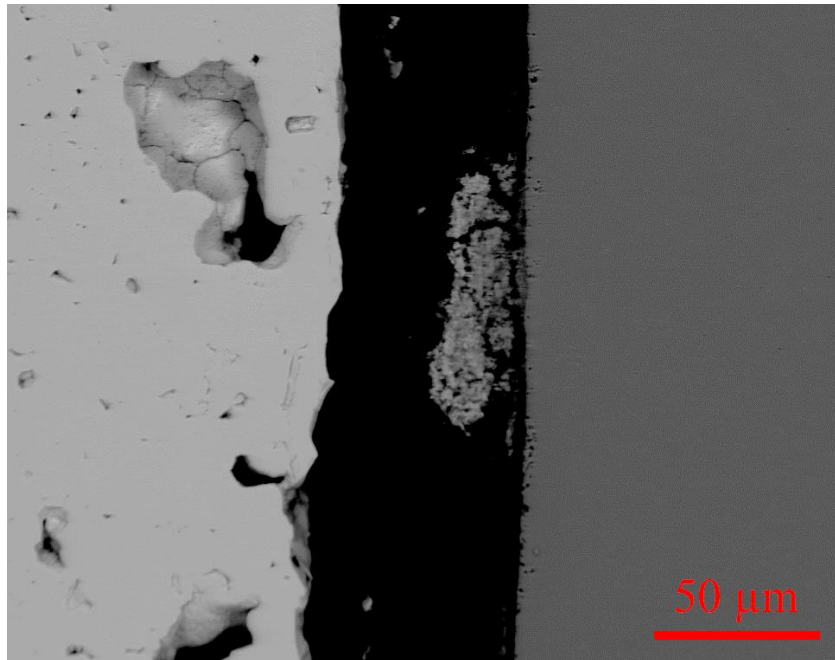
Figure 35. Onset of intergranular corrosion at the inner surface of the cladding surface.

The precipitation of fission products and the interaction with the cladding was more extensive than in the previous sample, consistent with the higher cladding temperatures that are known to play a significant role in the extension of the FCCI. Part of the cladding showed onset of intergranular corrosion, as can be seen in Figure 35. Other azimuthal direction showed that the cladding inner surface was covered by a deposit mainly composed of Pd, which can be seen in the light color attached to the cladding in Figure 36. The “liner” thickness remains below 5 μm , but localized thickness increase of the attacked zone was observed in various locations, e.g., in Figure 37, Figure 38, Figure 39 and Figure 40. The composition of the corroded zones varies, being either metallic (mainly where Pd is present, occasionally Ag too) or an oxide (for example, see Figure 37h). In some cases, it contains fuel elements, while in others, it does not. The most prominent fission products are Pd, Cs, which are always detected. Te is often also present in different amount, while I typically occurs as in traces. Cr seems to form oxides and compounds with local presence of Cs (see Figure 37b, d and h) or Te, likely alloyed with I. Further TEM analyses reported below showed that, in the majority of the cases, Cr remains in metallic phase. Where the thickness of the corroded layer was beyond 10 μm , as in Figure 40, regions with different compositions were present, as can be seen from the spectra in Figure 40b. In this area, additional analyses have been performed by TEM, extracting a lamella as indicated by the blue rectangle in Figure 40a.
