Microstructural and chemical characterization of medium burnup fast reactor MOX using electron microscopy

February 2021

Fabiola Cappia, Jason Harp

**Idaho National Laboratory
Characterization and Advanced PIE Division
Idaho Falls, Idaho 83415**

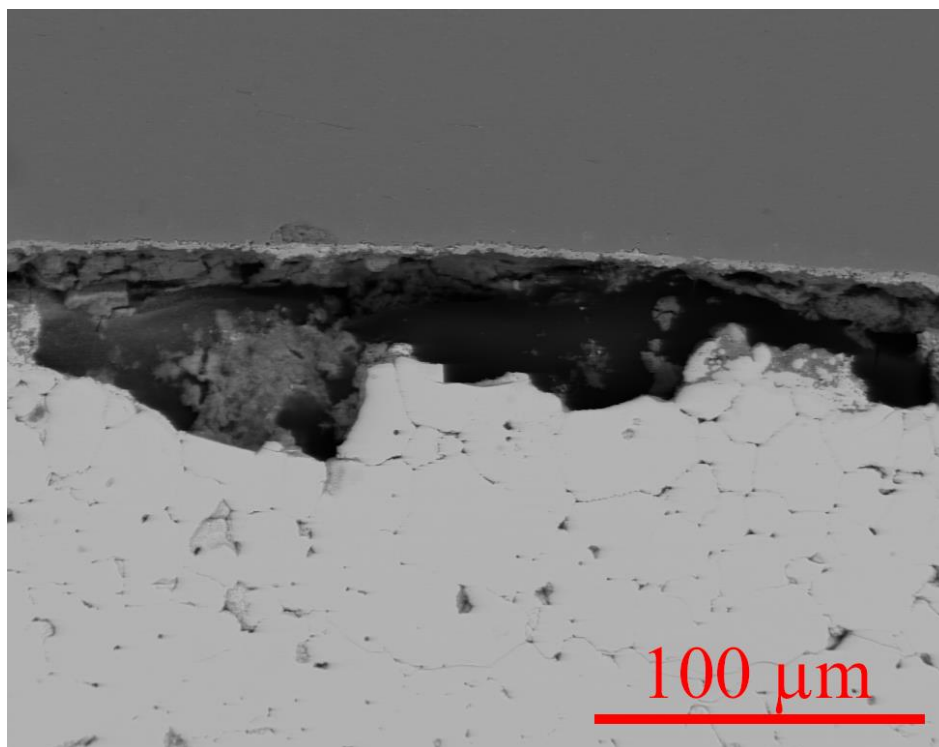
Figure 36. BSE image showing the Pd liner formation on the inner cladding surface.

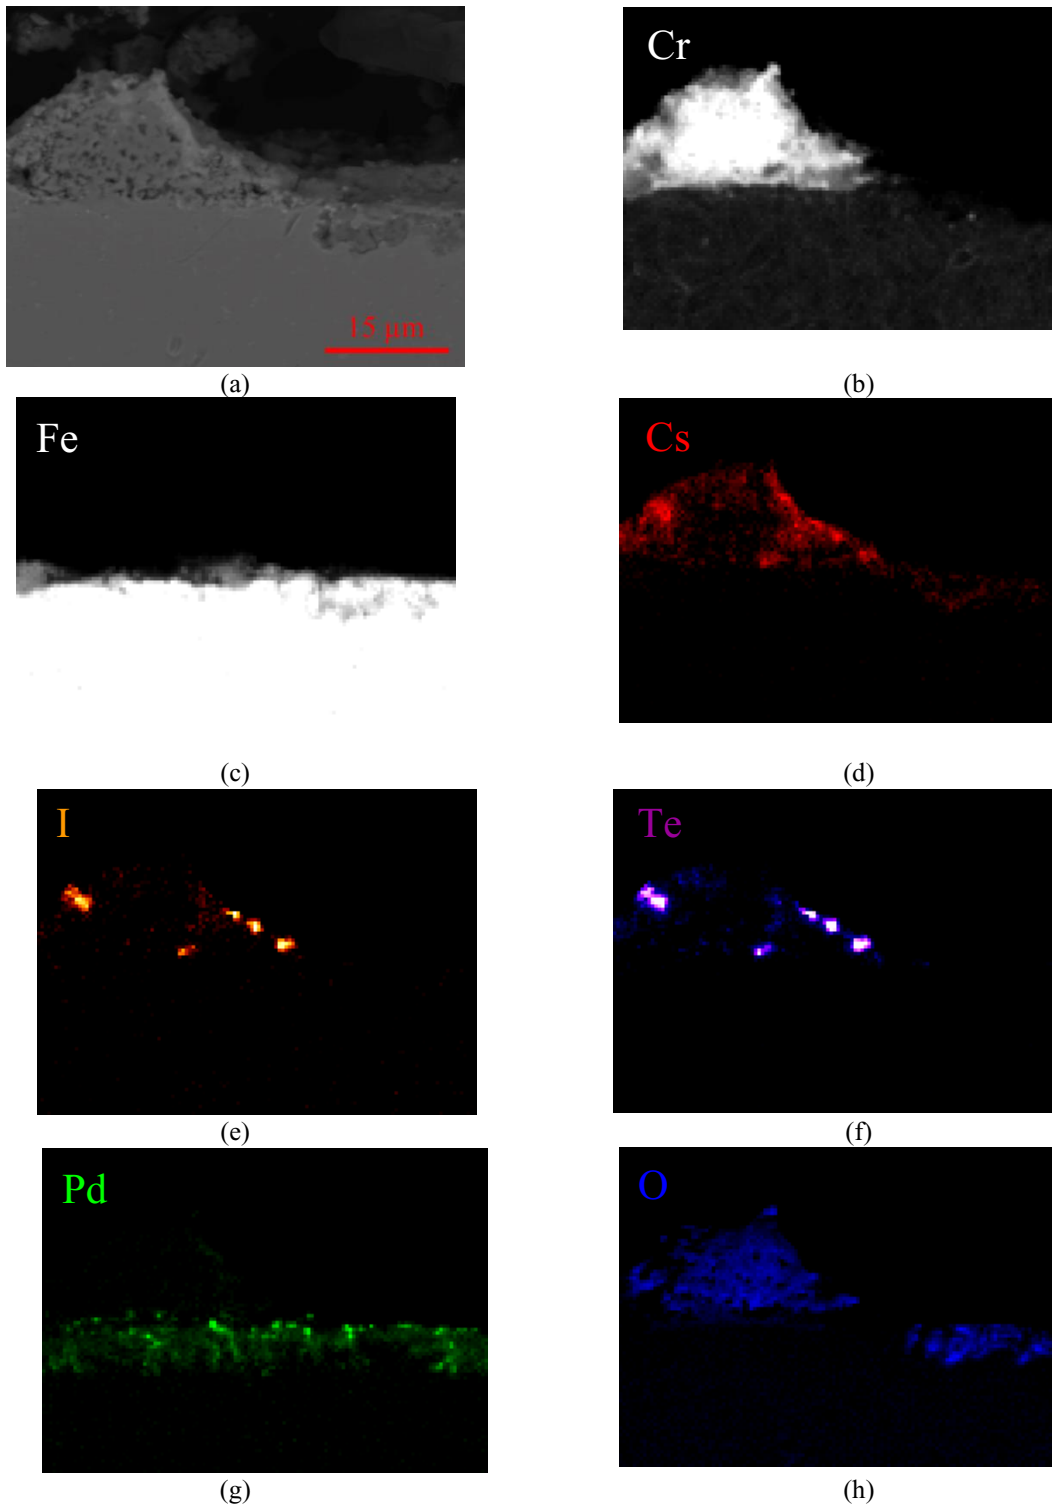
Figure 37. (a) BSE image of FCCI. (b)-(h) Chemical mapping of fission products and major cladding components. No U and Pu were present in the corrosion island.

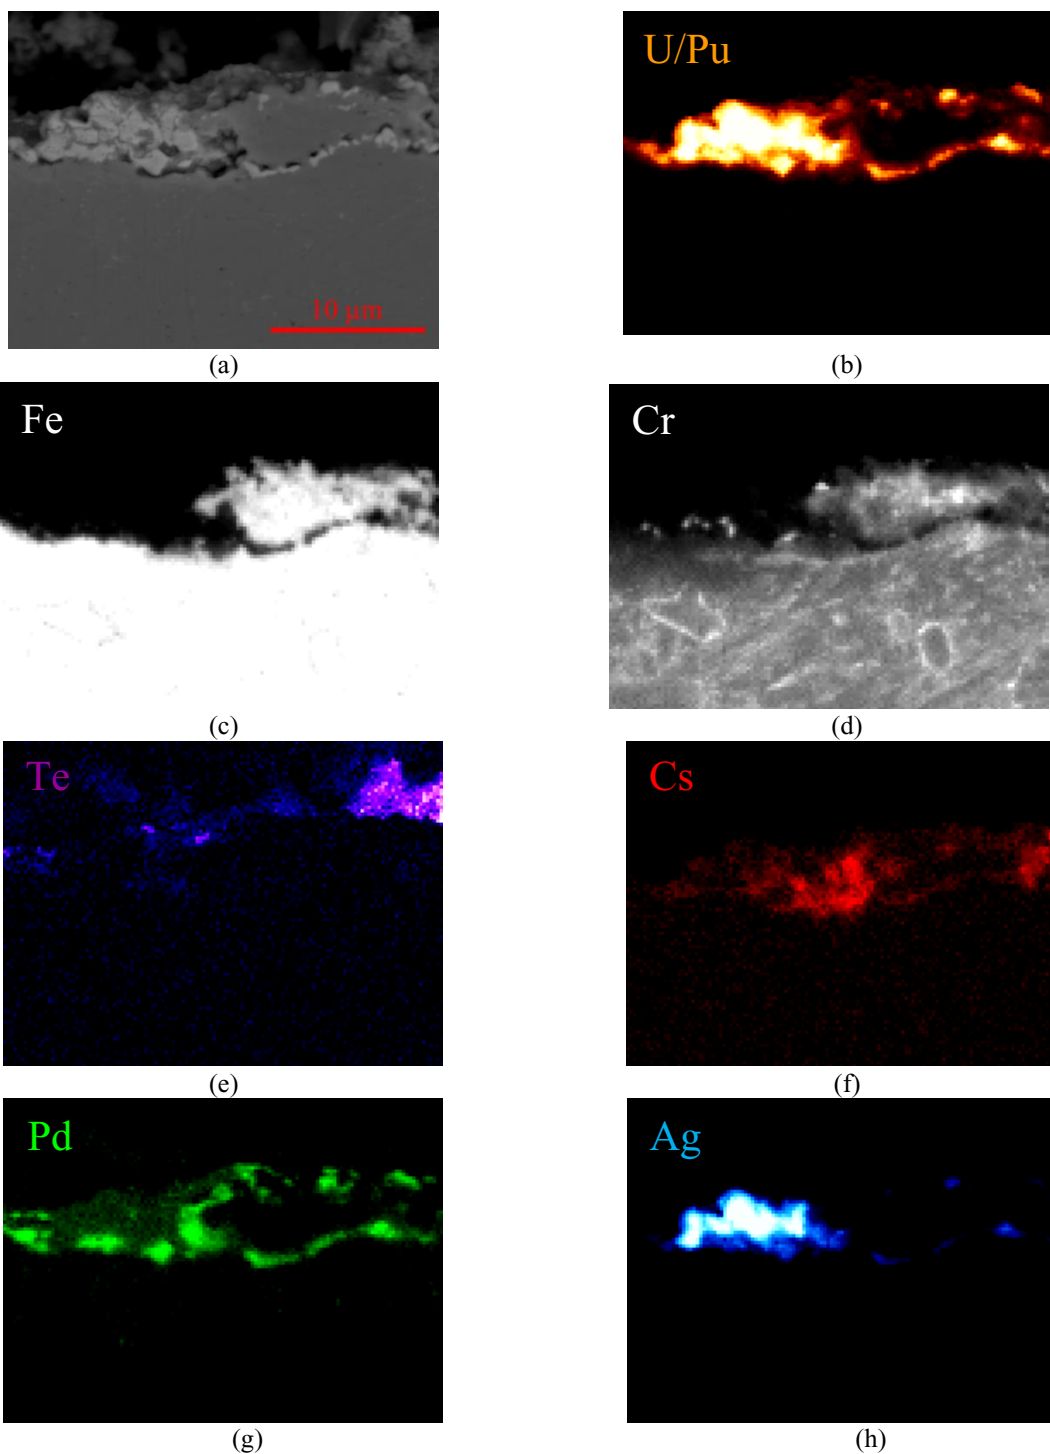
Figure 39. (a) BSE image of FCCI. (b)-(h) Chemical mapping of fuel, fission products and major cladding components. Maps in (e) and (g) correspond to WDS signal, whereas the others are EDS maps.

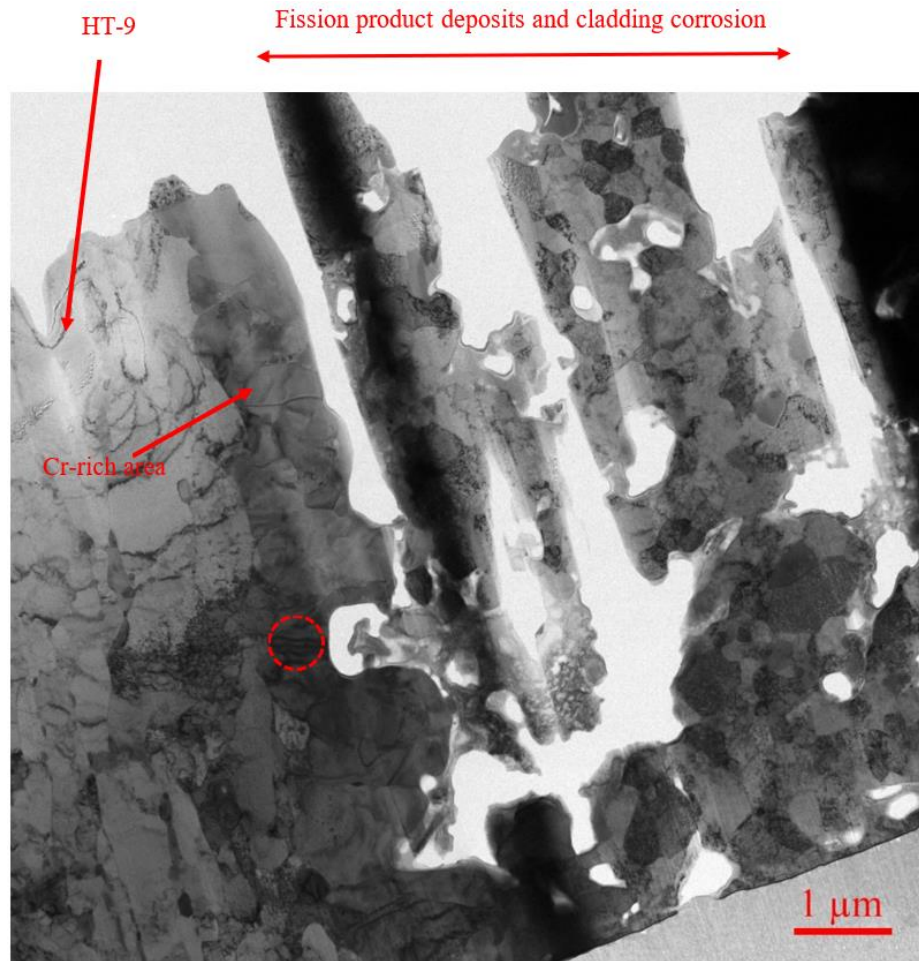
Figure 41. Overview of the lamella extracted between zone 2 and 3 in Figure 40a. The red circle indicates the location of the SAED patterns in Figure 43.

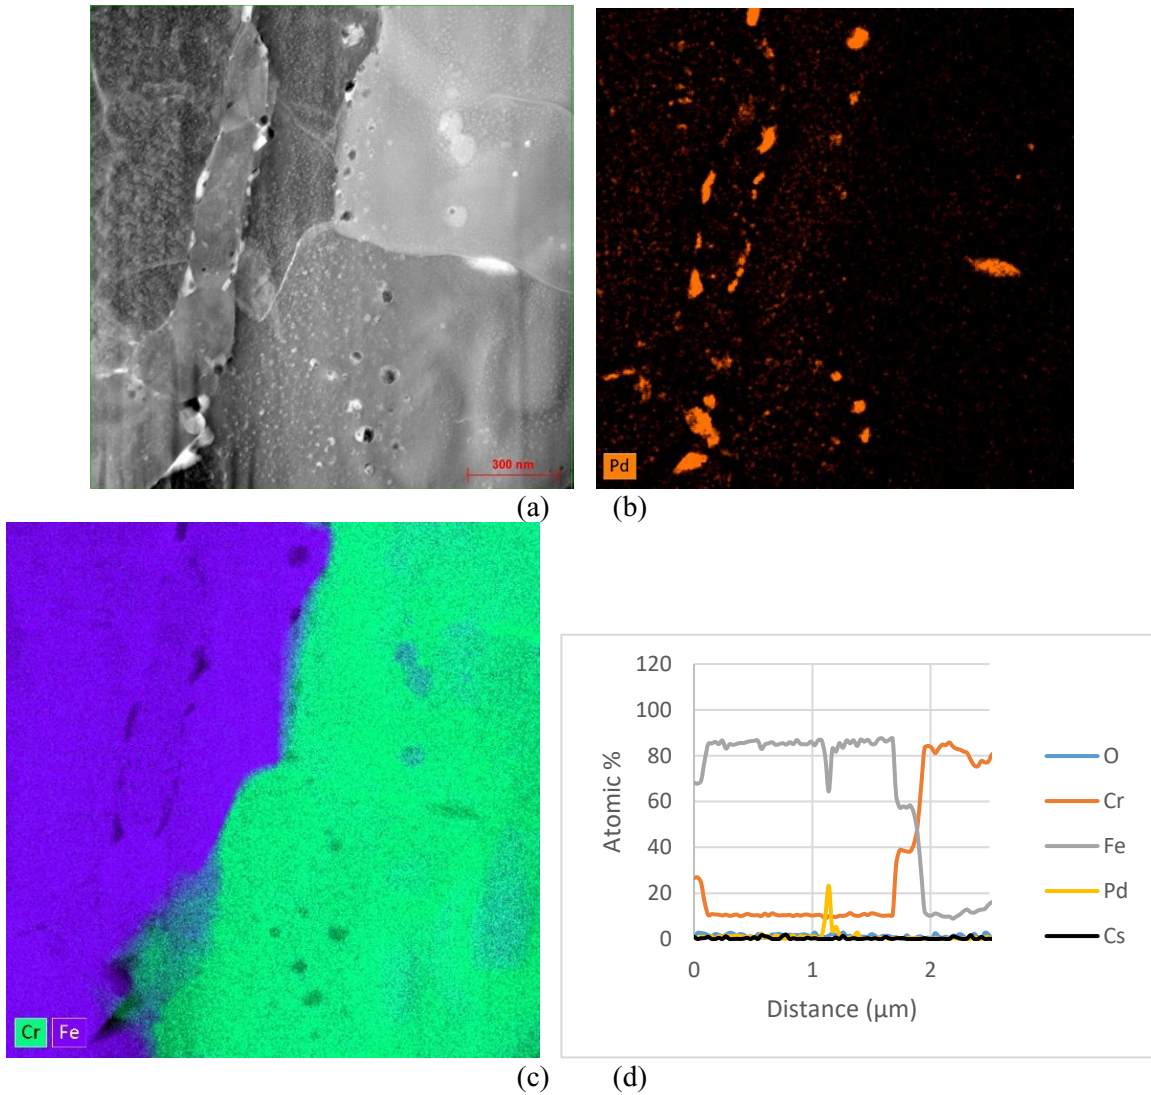
Figure 42. (a) HAADF of the interface between the HT-9 and the Cr-rich region. (b), (c) Qualitative EDS maps showing precipitation of Pd along grain boundaries and the Cr-rich interface. (d) Normalized element concentration across the two phases.

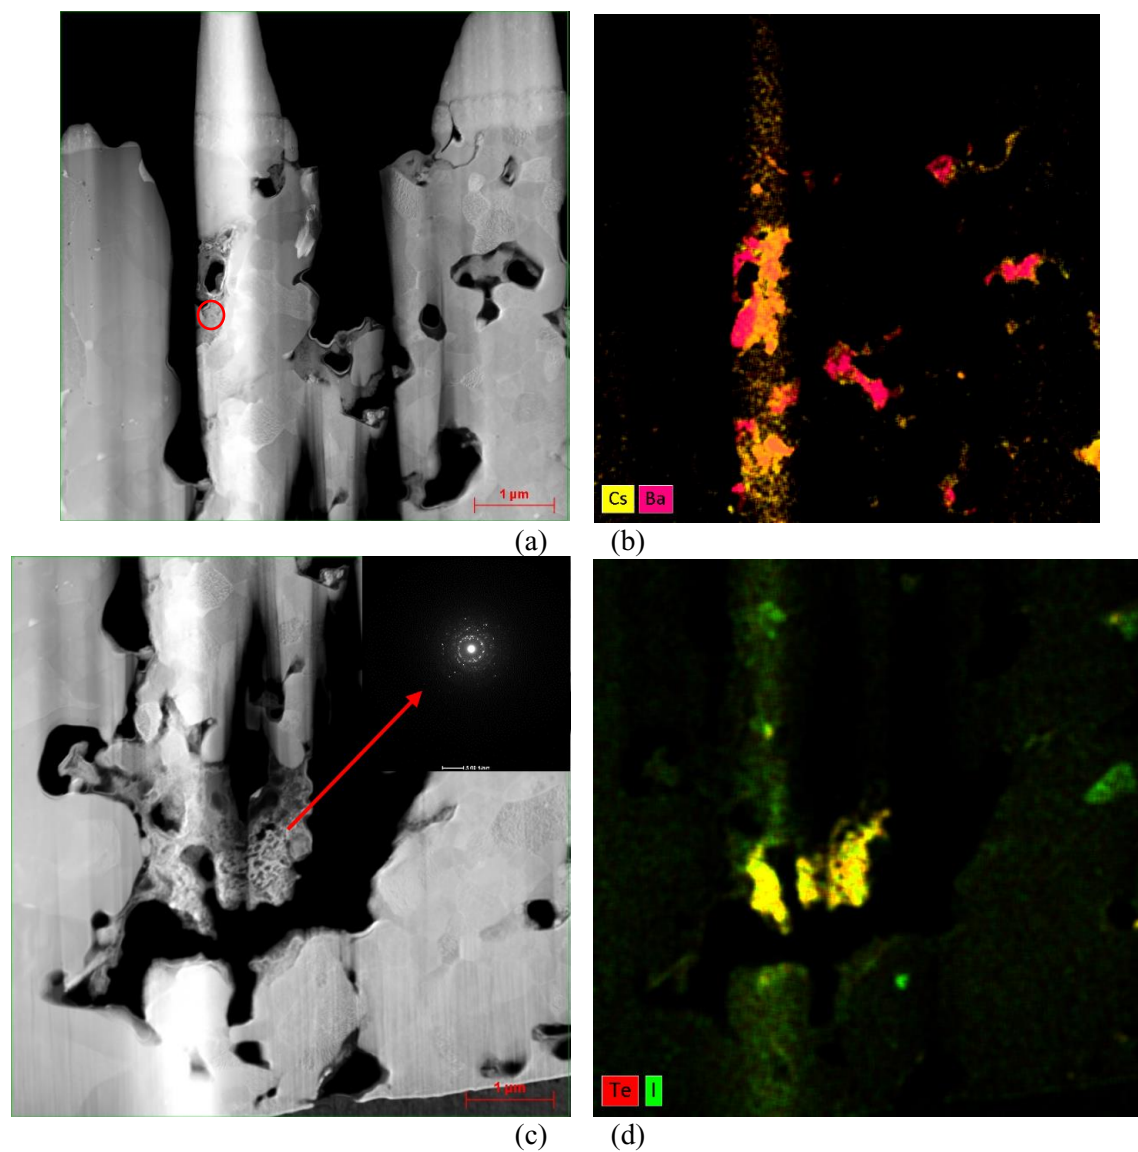
Figure 44. HAADF image of the (a) upper part of the lamella, (c) lower part of the lamella. (b), (d) EDS qualitative maps of the most prominent fission products in the two parts, respectively. The inset shows the nanocrystalline structure of the Te and I-rich region.

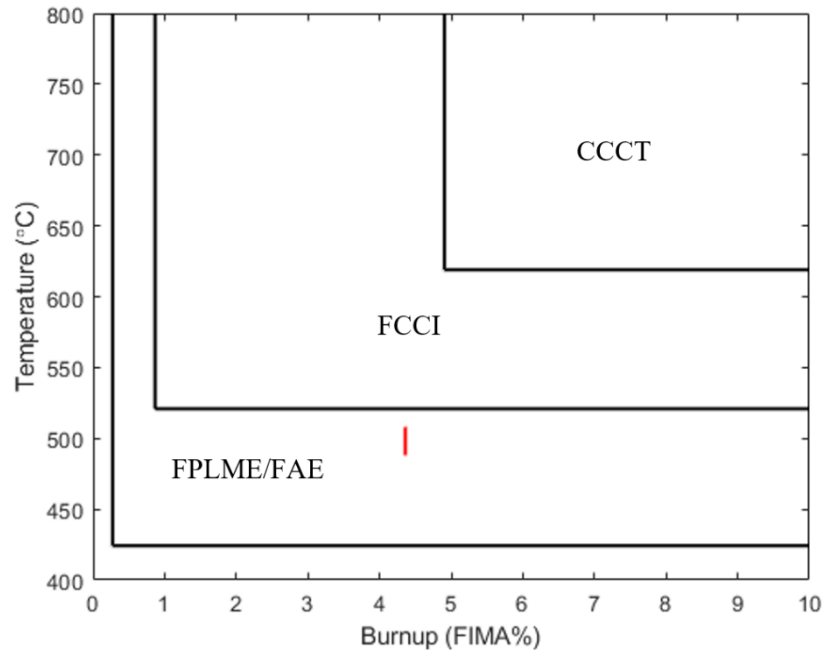
Figure 46. Comparison of the sample local conditions with the schematic of the primary environmental domains for the cladding interaction mechanisms. The red bar represents the range of expected temperature at the cladding inner surface for the current sample.

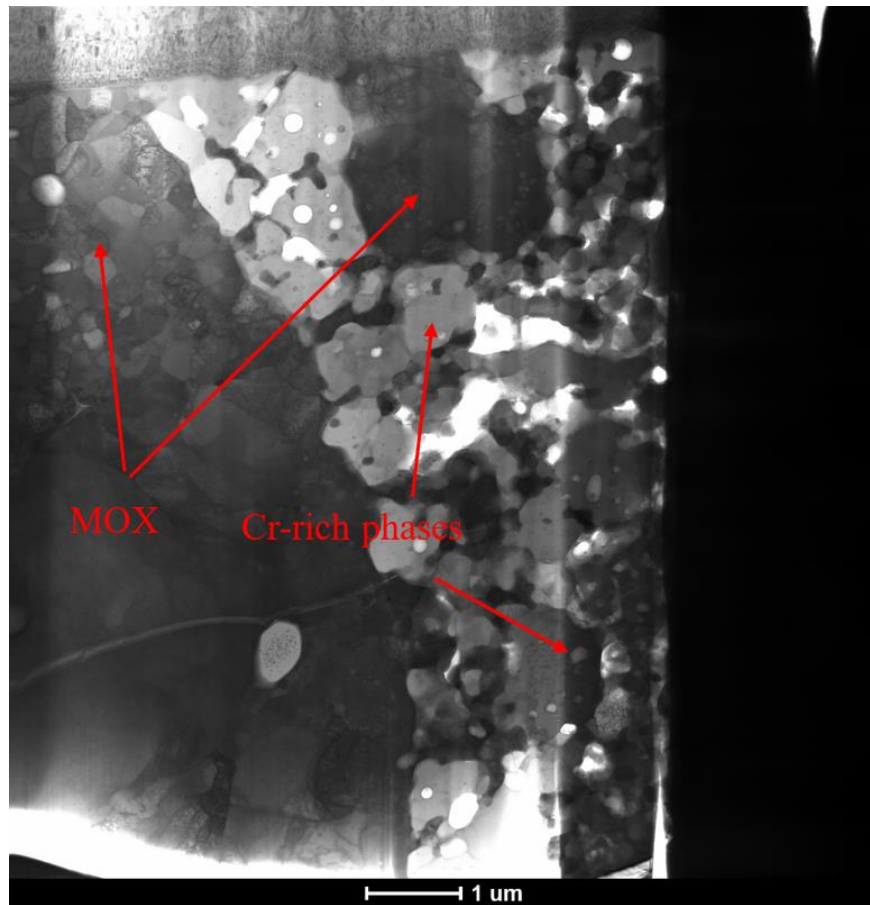
Figure 48. Overview of the lamella from Figure 47.

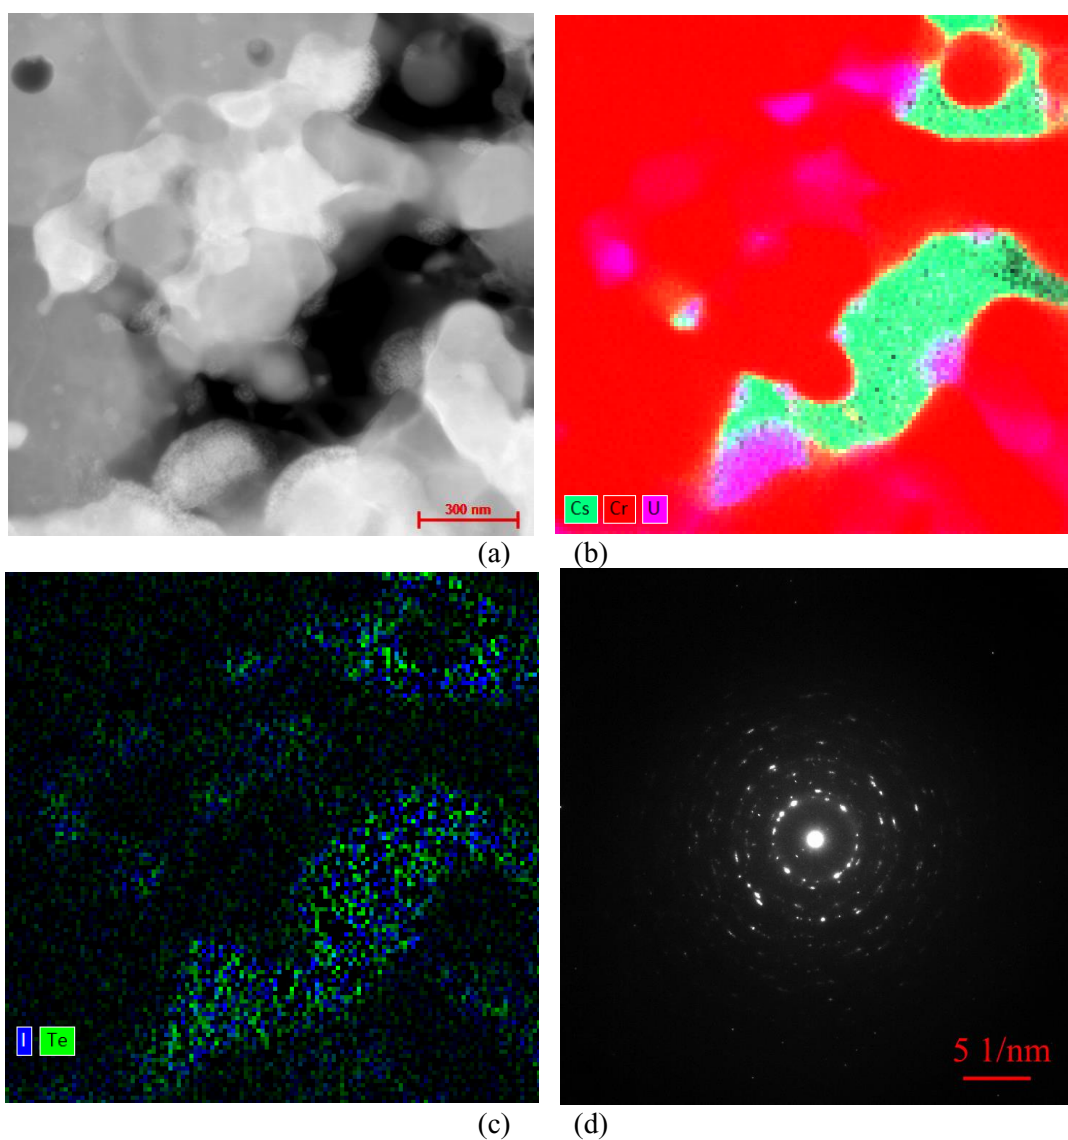
Figure 50. (a) HAADF from a second location containing the fission products. (b)-(c) Atomic maps of major components. (d) SAED pattern corresponding to the Cs-rich area.

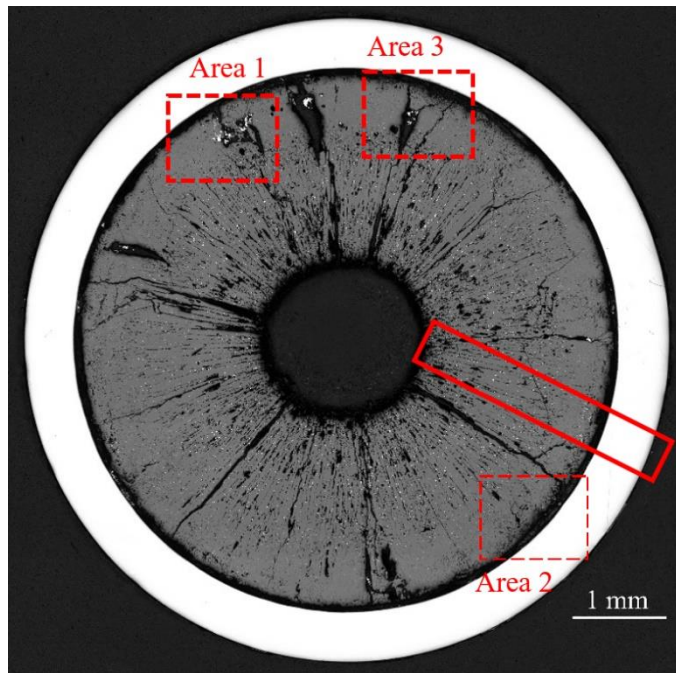
Figure 51. Optical microscopy overview of sample 3. The dashed boxes 1 and 3 indicate the areas where the SEM/TEM analyses were focused, while area 2 indicates an additional area analyzed by EPMA. The solid rectangle indicates the region where EPMA radial quantitative analyses were performed.

The overview of the sample is shown in Figure 51. First, chemical composition of fission product precipitates was measured across the radius, focusing on the five metal precipitates (FMPs). Representative micrographs are shown in Figure 52a, b and c for the center, mid radius (columnar grain region) and close to the edge, respectively. As can be seen from Table 6, close to the central void, the composition was constant among the precipitates, while in the columnar region the content varied significantly, as proved by the large standard deviation. At the edge, FMP could still be found (see arrow in the figure), but the larger precipitates like the one shown in Figure 52c contained Mo, Cs and U in oxide form. The different composition is documented in the spectra comparison in Figure 53. Complementary EPMA measurements have been performed along the radius shown in the solid red box in Figure 51. As already noted from the EDS measurements, the composition is scattered along the radius. Mo concentration is decreasing in the equiaxed grain region, while enriched precipitates have been measured at the fuel periphery, sign of radial migration of the specie.

Regions showing large agglomerations of fission products were seen already from the optical examinations (see boxes in Figure 51) and were further analyzed via SEM, EPMA and TEM. A BSE image of the area in box 1 is shown in Figure 55. Initial scoping analyses were performed via SEM/EDS. The composition showed predominantly Mo and Pd, but variations in the composition and segregation of the species was observed within the precipitates, which can be qualitatively appreciated from the maps in Figure 56. A larger area map is reported in the next figure, Figure 57. The initial observations regarding the composition variability of the metallic precipitates are further highlighted by the EPMA maps showing weight percent distributions. Minor elements like Te and Zr concentrated in specific precipitates or close to them were also detected. Association of Te with Pd or other metal phases has been already shown in previous work [2], and it is not surprising. Co-localization of metallic phases and grey phases (represented by Zr and Ba in Figure 57 (f and g) has also been observed in TEM, which is presented in the next section. The presence of Cs remains questionable, as it is distributed mainly along the cracked fuel grains, which could create spectrum distortion due to edge effects. However, the volatile nature of Cs could favor its distribution along boundaries, hence, the observed map could be partially accurate. Other species were detected by EPMA, specifically Fe, Ni and Cr. The intensity of the maps for each of these elements was precisely coincident with the broken areas exposing the epoxy. The signal from cracked bottom surfaces is considered questionable. The sample is mounted in a stainless steel 316 holder; hence, it cannot be excluded that residual debris from grinding were trapped into the fuel cracked region. It is, therefore, the opinion of the authors, that the extensive presence of these species is an artifact from sample preparation.

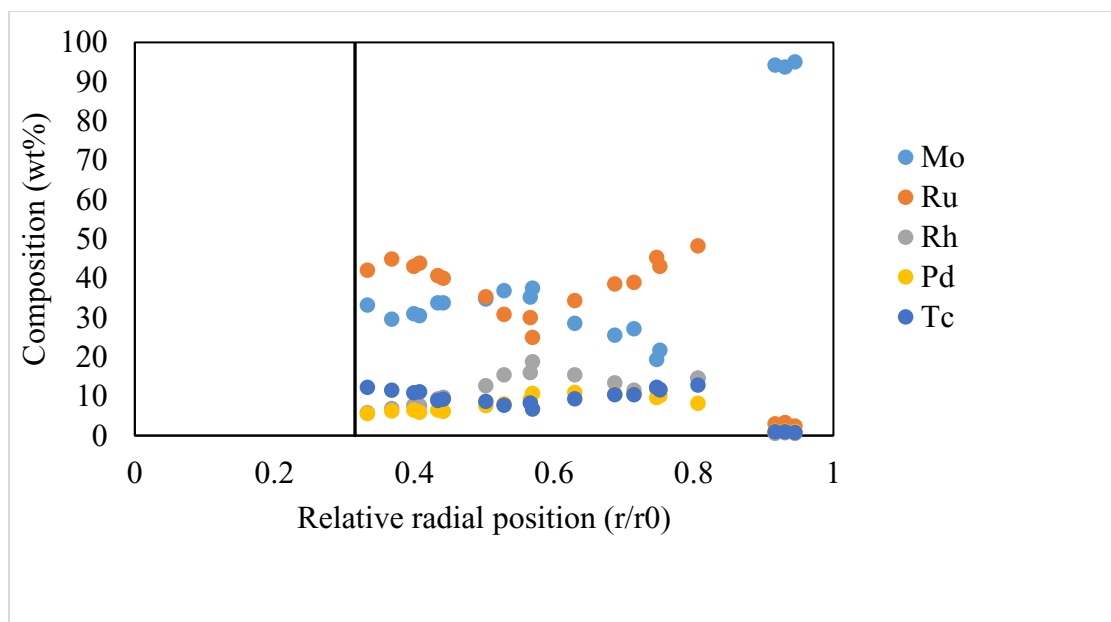
Figure 54. Additional compositional measurements of the FMP measured with EPMA.

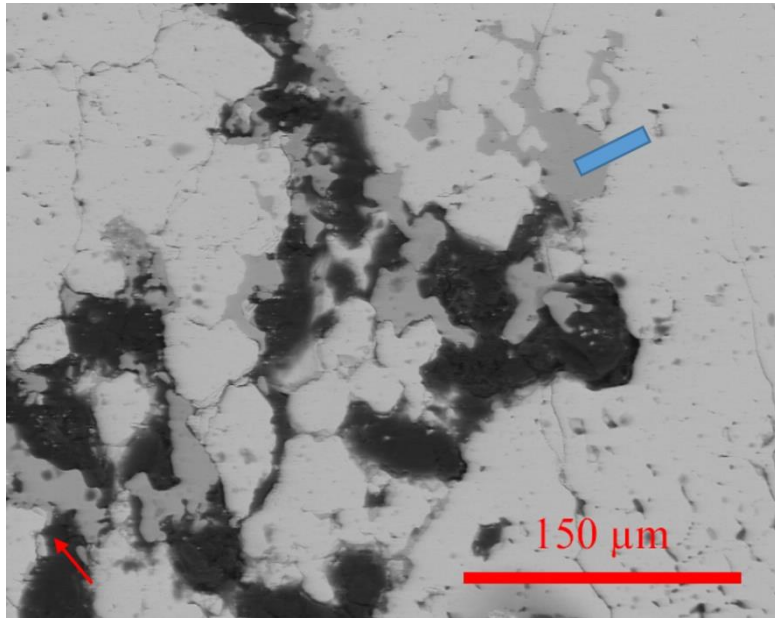
Figure 55, BSE image of the large metallic inclusions from area 1 in Figure 51. The rectangle indicates the location of the TEM lamella extracted in this region. The arrow indicates the region where species composition was observed.

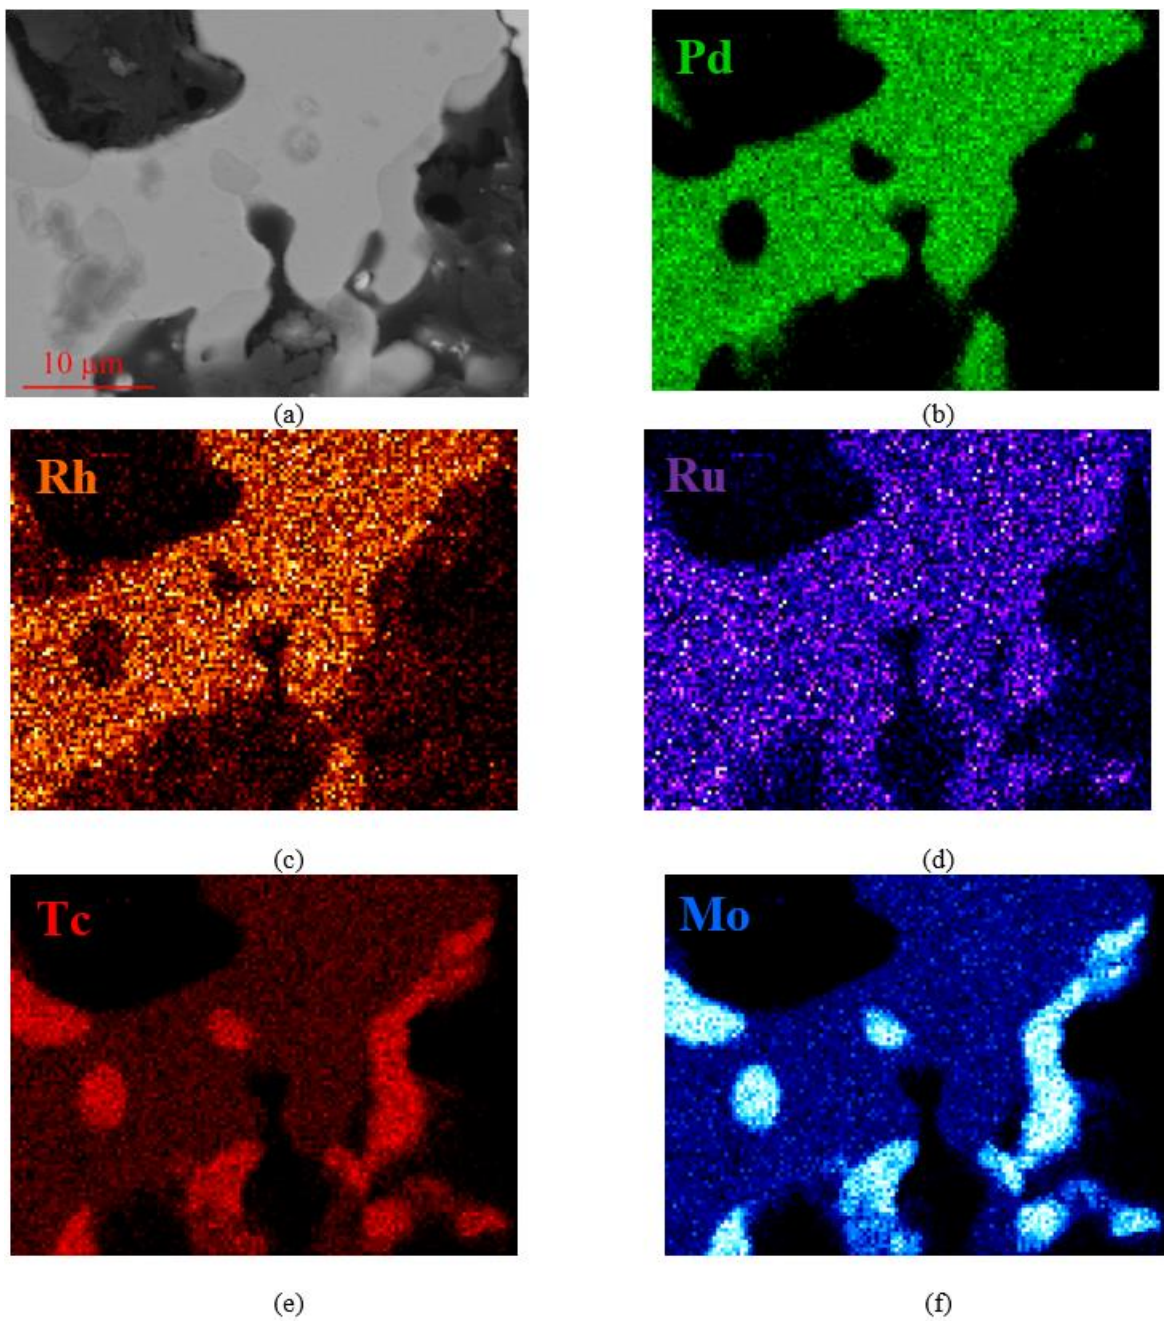
Figure 56. High magnification image of the region indicated by the arrow in Figure 55, showing metallic fission product segregation within the FMP. (a) BSE image, (b)-(e) EDS maps of the components of the FMP.

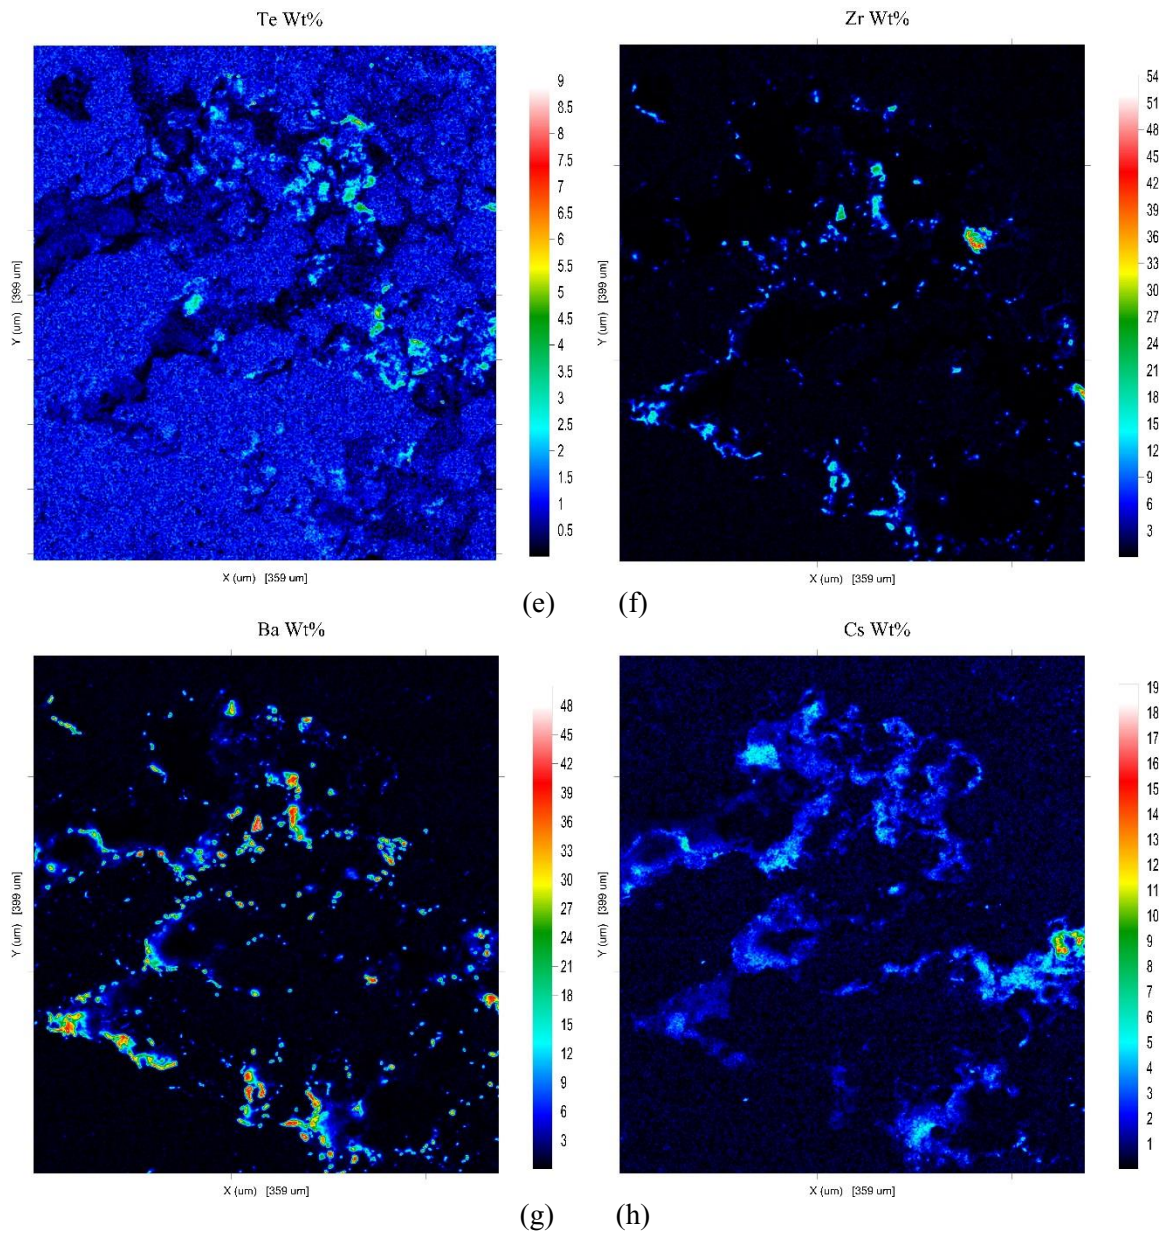
Figure 57. (a) BSE overview and (b)-(h) chemical maps from EPMA over the area showing extensive fission product precipitation at the fuel periphery.

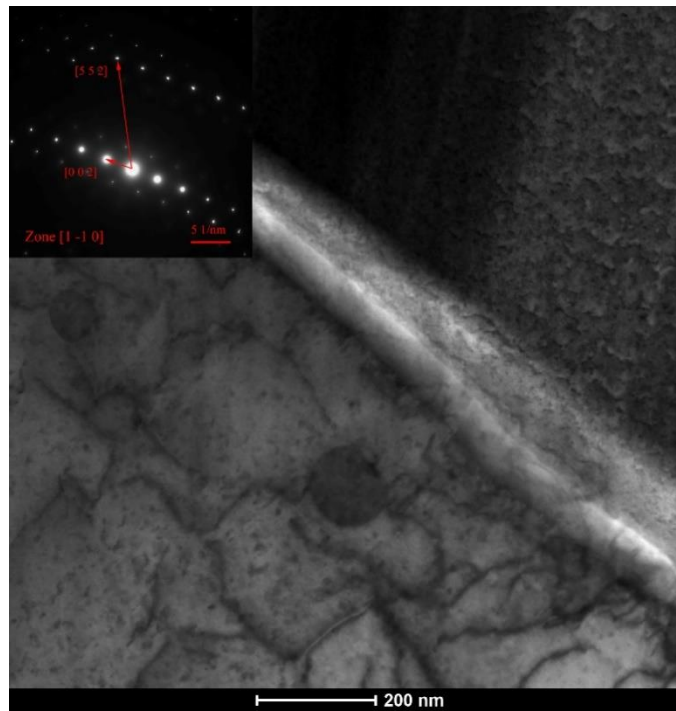
Figure 64. Images of the extended defects in the MOX phase. (a) dislocation loops, (b) dislocation lines pinned around the grey phase at the interface with the metallic phase.

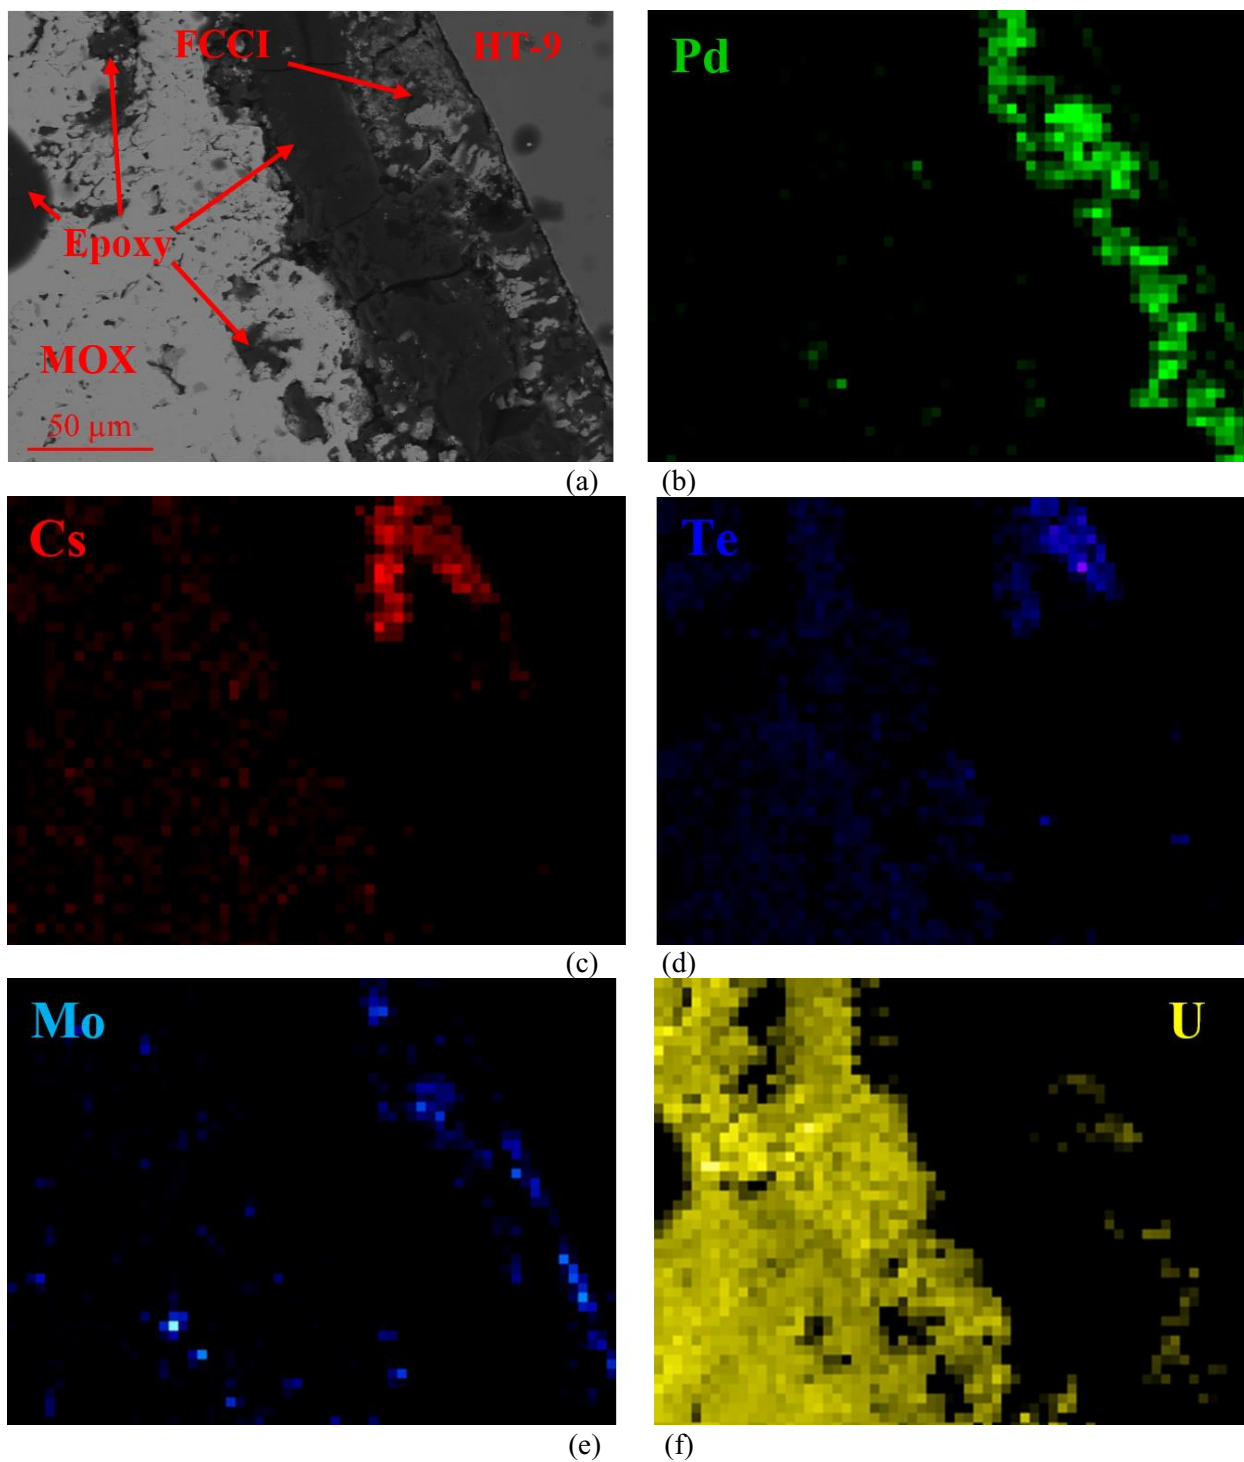
Figure 65. FCCI region. (a) BSE image, (b)-(e) most significant fission products, (f) U signal.

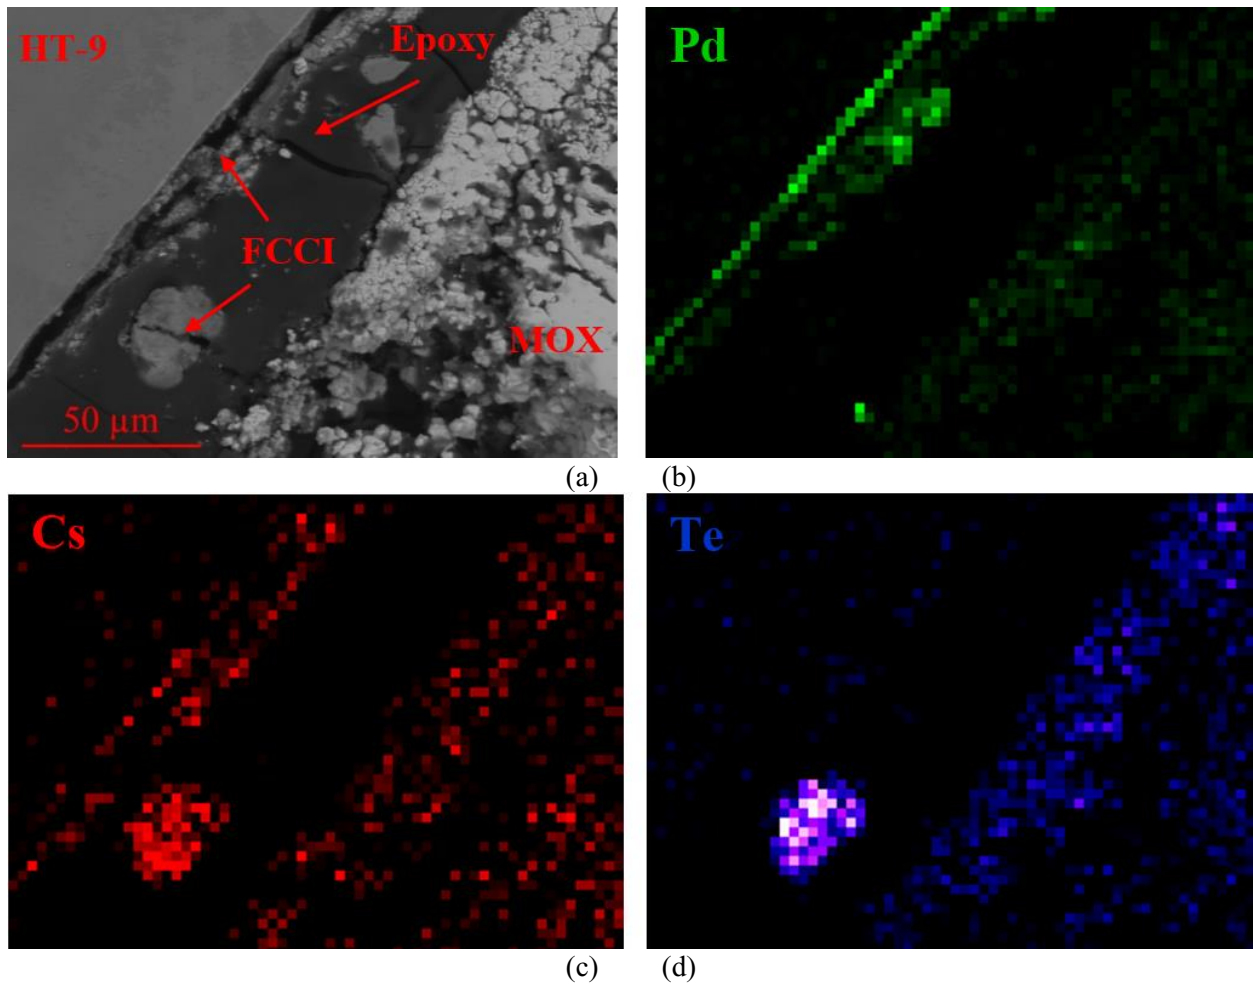
Figure 66. FCCI region. (a) BSE image, (b)-(d) most significant fission products.

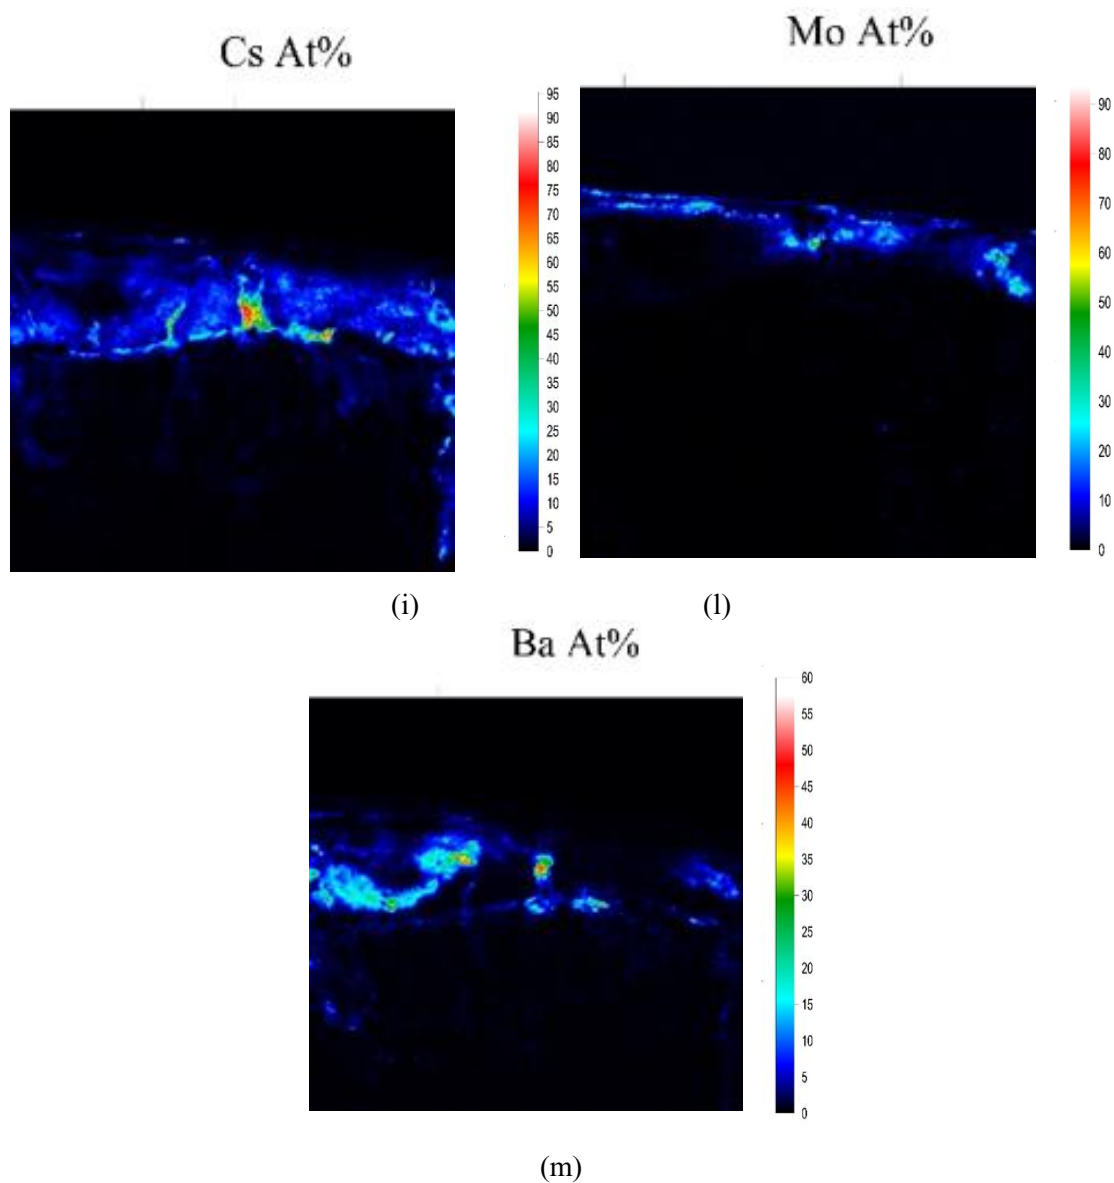
Figure 68. (a) BSE image of the FCCI from area 3 in Figure 51. (b)-(m) Atomic maps obtained with the EPMA.

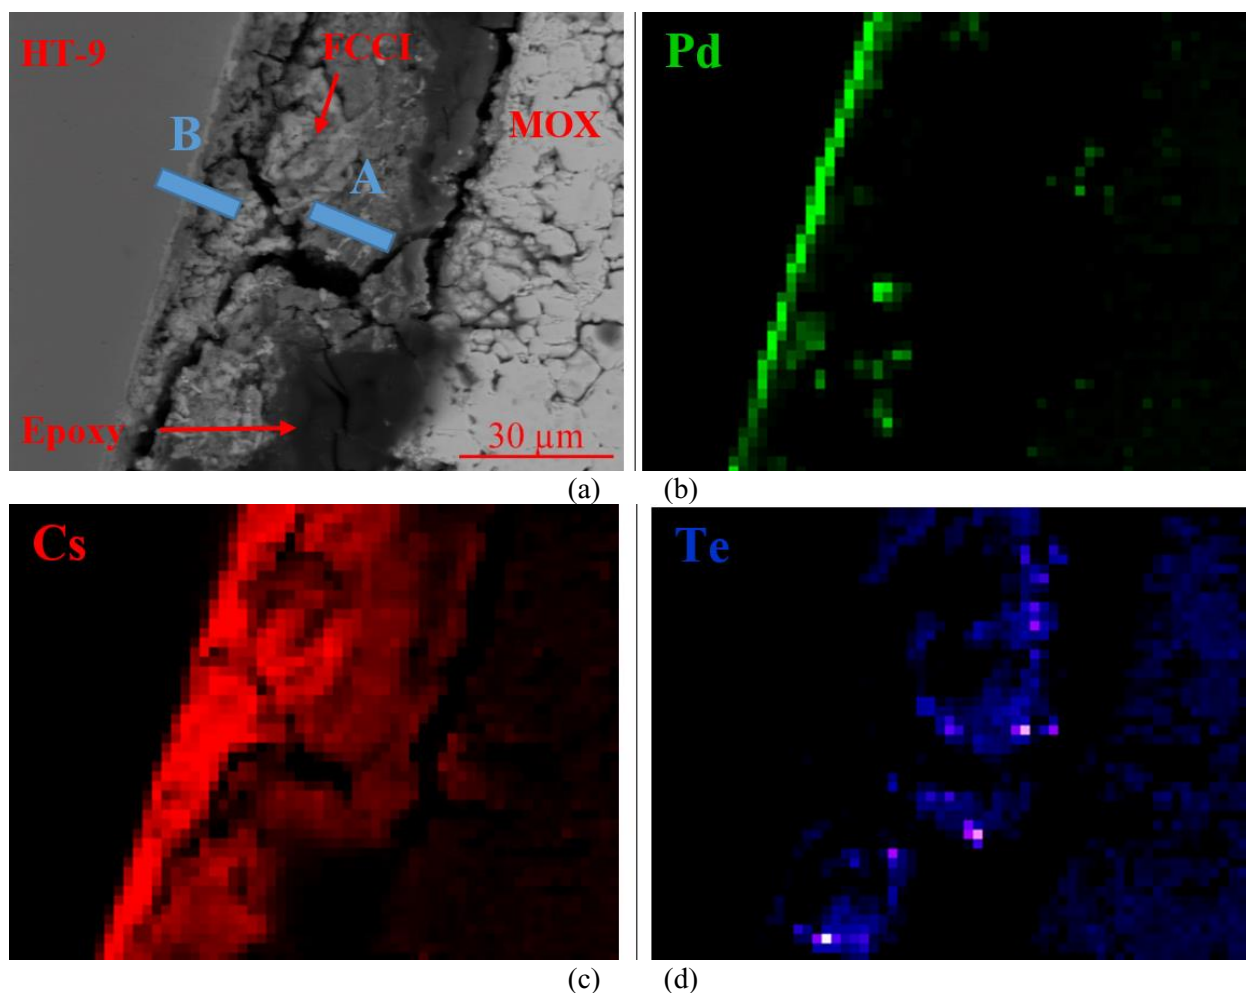
Figure 69. Higher magnification image of a thick portion of the FCCI in area 3. (a) BSE image with lamellae locations, (b)-(d) Most significant fission products (qualitative intensity maps).

The gap region of this sample was also examined to evaluate the onset of accumulation of fission products. The gap was open, but clear sign of contact between the fuel and the cladding with deposition of discontinuous layers of fission products was observed in various azimuthal locations. A large variety of locations have been investigated using EDS to gather qualitative data on the main components of the FCCI, followed by more accurate analyses using EPMA. Examples are displayed in Figure 65 through Figure 69. The morphology and composition of the FCCI was different from location to location. The migration of Fe and Cr towards the fuel varied not only from location to location, being more pronounced in area 3 (see Figure 67d and e), but not in the other areas analyzed (see for example Figure 68e and f). Part of the cladding chemical species that have migrated to the fuel might be oxidized, as shown by presence of oxygen (Figure 67c and Figure 68d). Despite the local variations, common features could be observed in each location, which are shared with the previous samples. First, a Pd layer or Pd deposit could be observed at the interface with the HT-9 cladding (Figure 65b, Figure 66b, Figure 69h, Figure 68g and Figure 69b), sometimes in conjunction with Mo (Figure 65e) and Ru, Tc, Rh or Ag. Iodine was measured occasionally only in traces (Figure 67o). Traces of U and Pu could be observed also attached to the cladding, as shown in Figure 65f. Cs, in conjunction with Ba, and Te deposits were commonly observed (Figure 65c and d, Figure 66c and d, Figure 69c and d). In one location in particular, the Cs and Te deposits were considerable, filling almost the entire gap (see Figure 69a).
