Microstructural and chemical characterization of medium burnup fast reactor MOX using electron microscopy

February 2021

Fabiola Cappia, Jason Harp

**Idaho National Laboratory
Characterization and Advanced PIE Division
Idaho Falls, Idaho 83415**

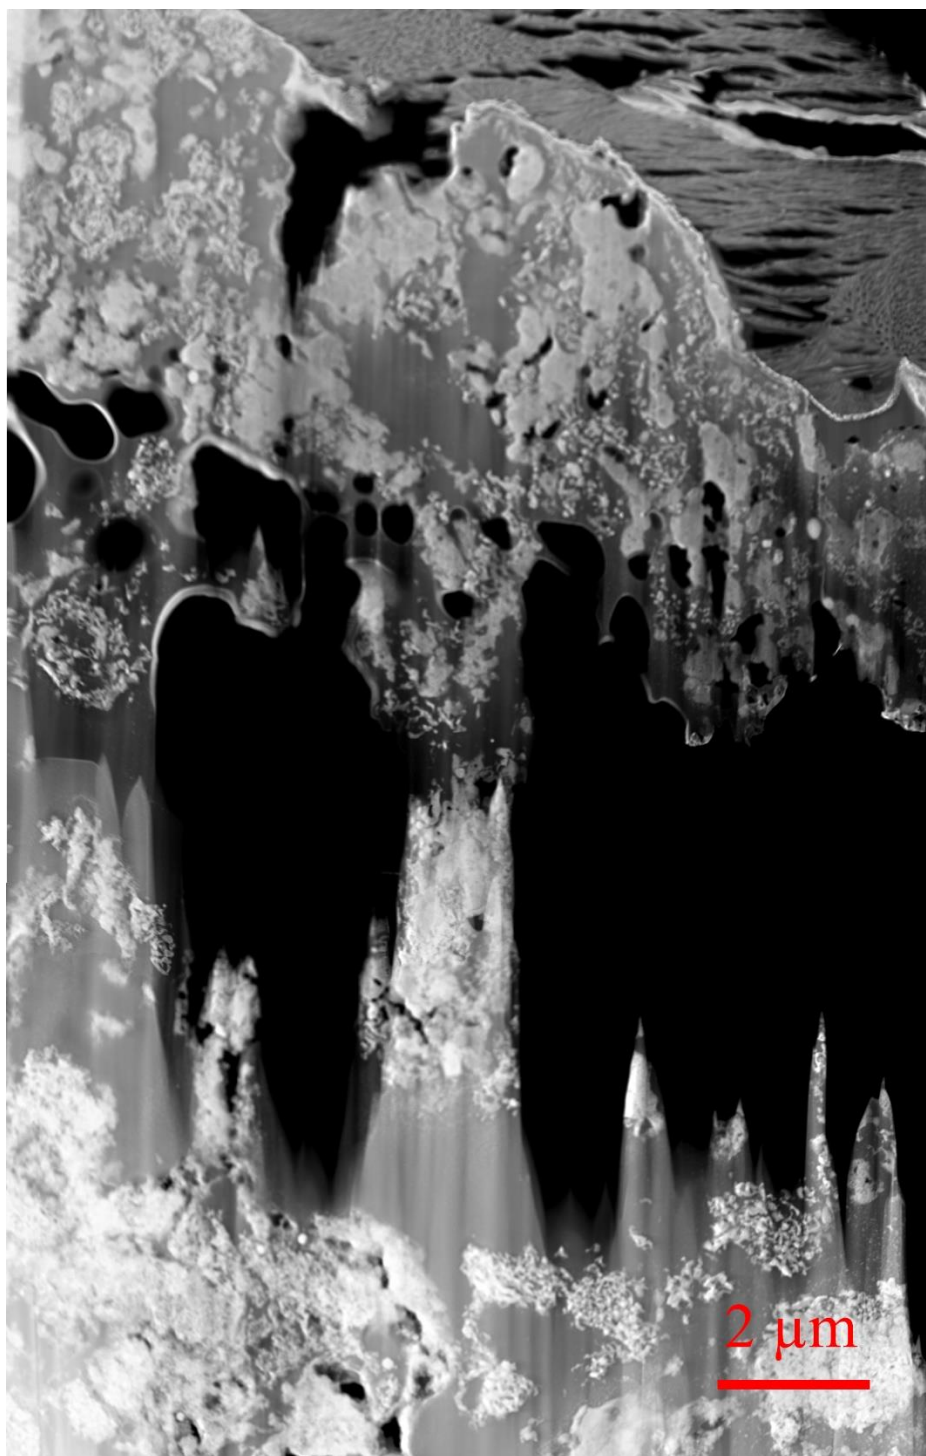
Figure 70. Overview of lamella A.

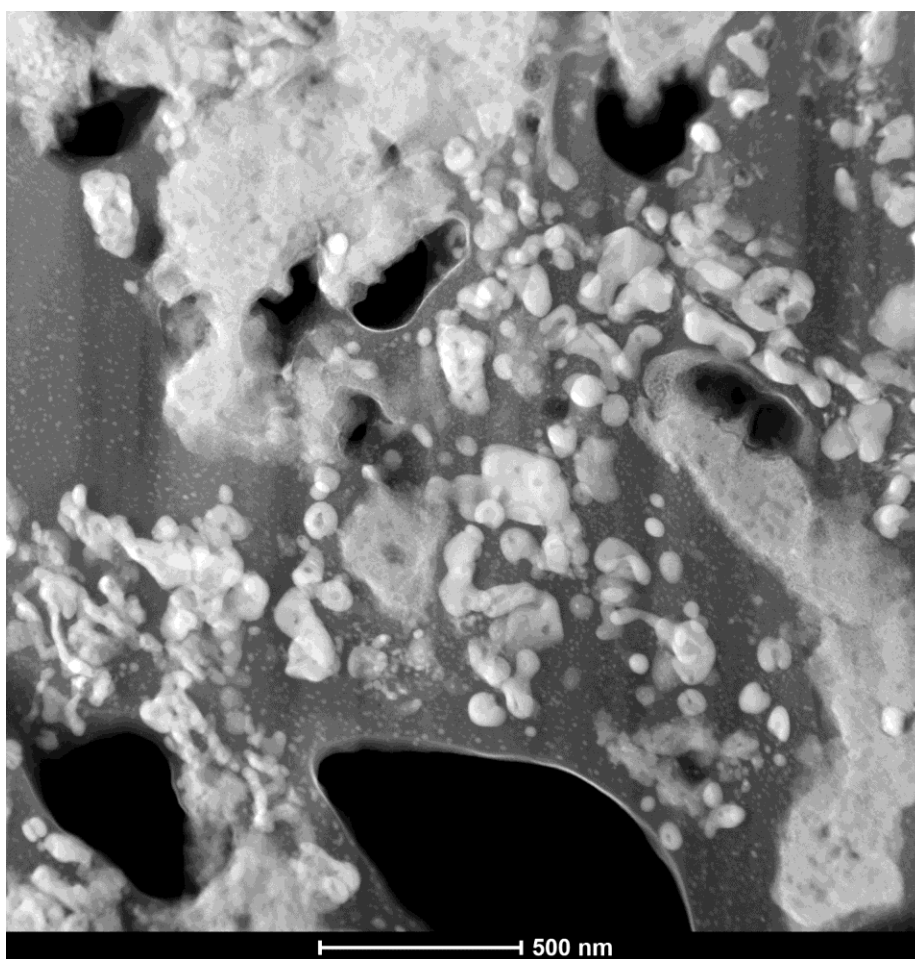
Figure 71. Enlarged view of the upper part of the lamella, highlighting the nano crystallites (white agglomerates) embedded in the epoxy matrix (mid-grey matrix).

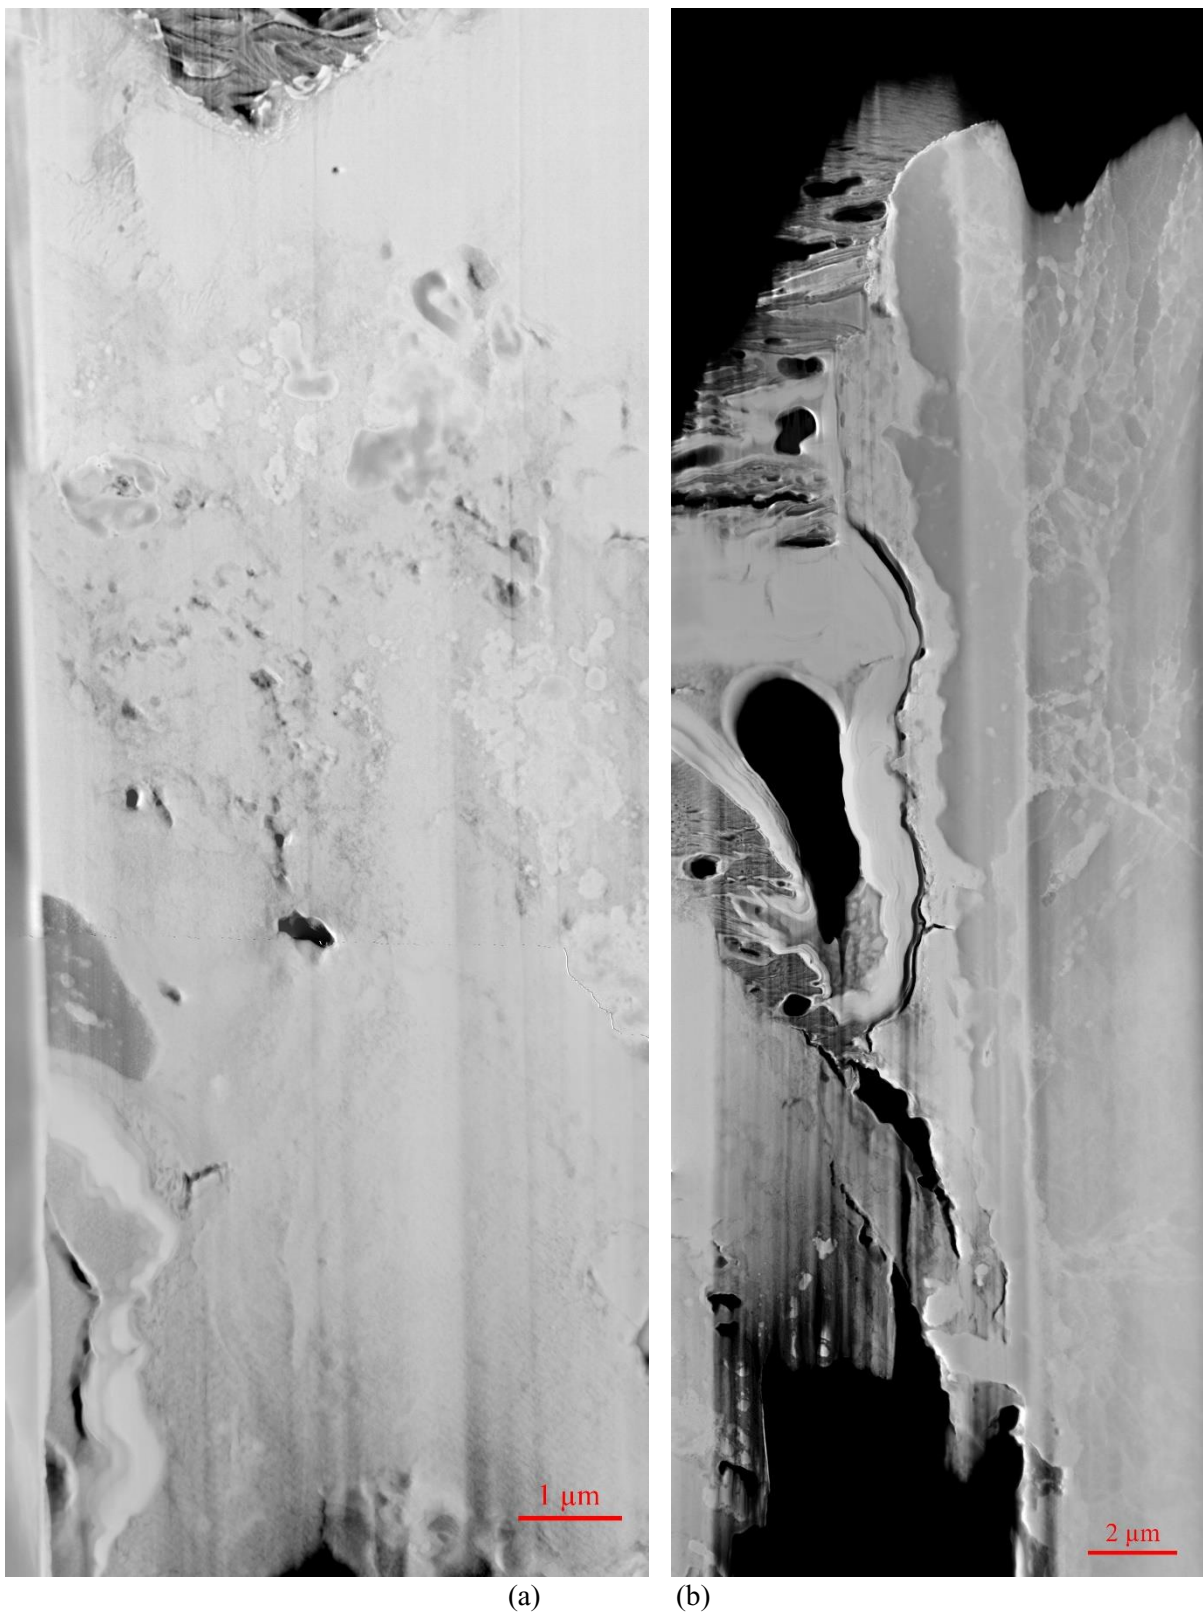
Figure 76. Overview of lamella B. (a) Side close to lamella A. (b) side capturing the interface with the cladding.

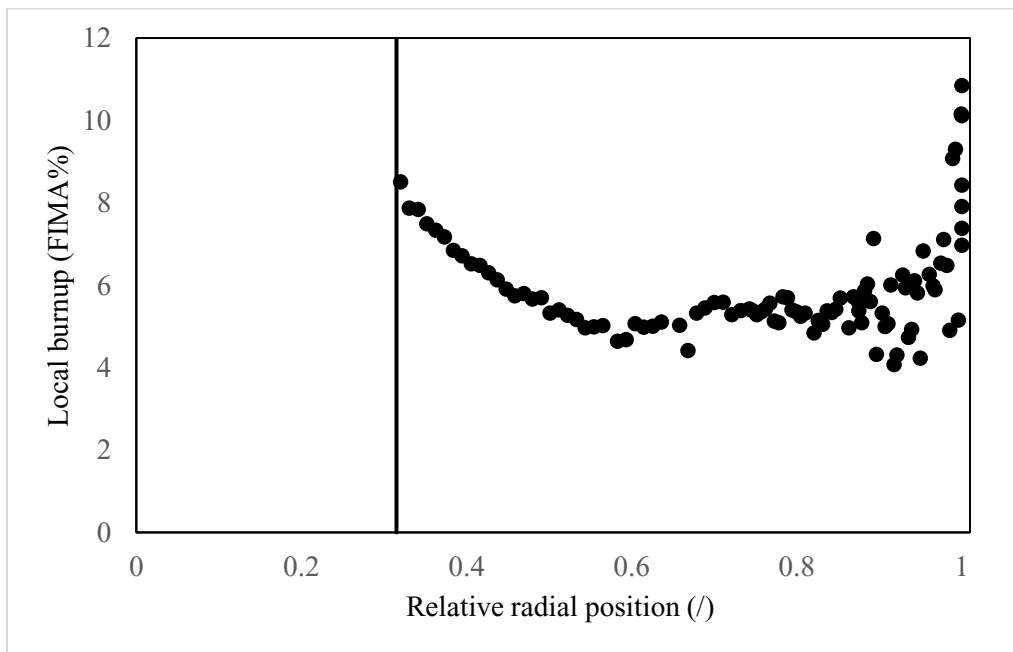
Figure 81. Radial burnup profile derived from Nd measurements.

The radial burnup profile derived from Nd concentration and assuming the fission split determined via wet chemistry methods (see Ref. [1]) is shown in Figure 81. The EPMA-based burnup calculations would predict a slightly lower pellet average burnup (5.65% FIMA vs 6.32% FIMA), but the burnup quantitative determination via EPMA is more sensitive to errors in the determination of the fission split; hence, it would be more advisable to use the EPMA data only for a radial qualitative estimation. The trend highlights the important consequences in Pu redistribution in terms of fission rate along the pellet radius.

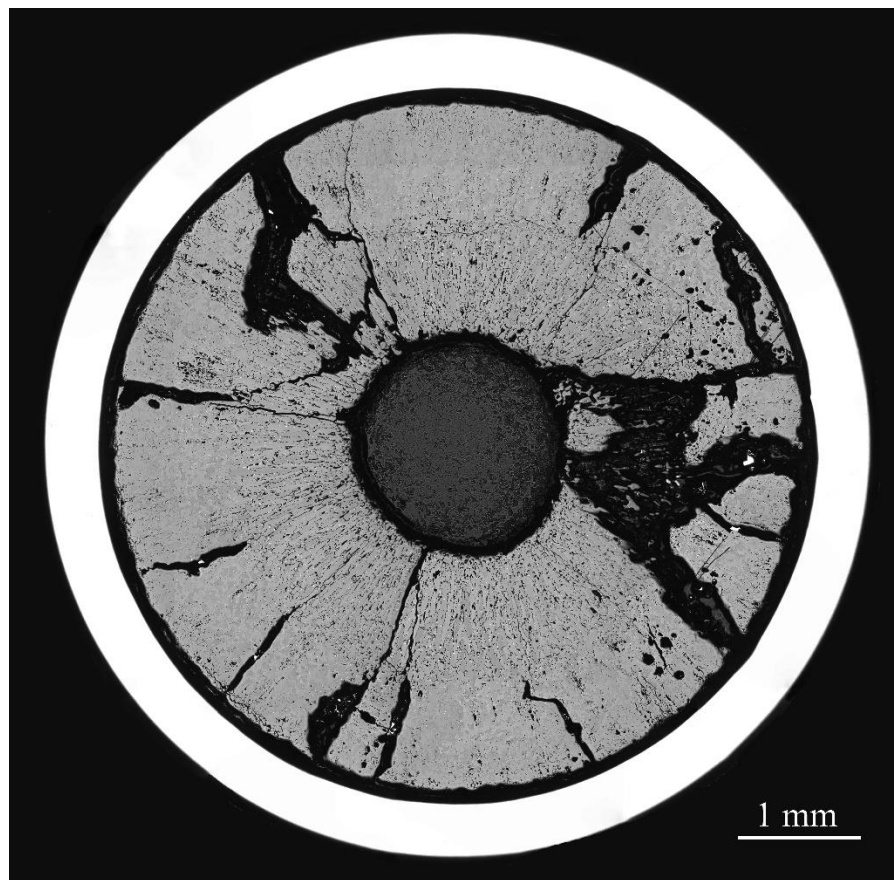
Figure 82. Overview of sample 4.

The overview of the last sample is shown in Figure 82. The observations made on this sample largely repeat what was reported for the previous samples. As can be noticed from the optical overview, a large portion of the structure pulled out, leaving areas of “fresh fracture” open to investigation. As seen for the other sample from K06, the grain surface of the grains close to the central hole is decorated with large metallic precipitate inclusions, often associated with porosity (Figure 83). Large tunnels have formed along the grain boundaries, consistently with the large fission gas release measured during the baseline PIE campaign. The secondary phases encountered were mainly five metal precipitates. Also in this case, the Mo/Ru ratio remained close to one, confirming that negligible portion of Mo have oxidized. The observation of grey phases was occasional. A large agglomerate, whose approximate composition is given in Table 10, was seen at the interface of the columnar and equiaxed region (see Figure 84), in agreement with the trend reported by Kurosaki et al. [39] for a sample with higher burnup, showing accumulation of Ba and Zr between the two regions.

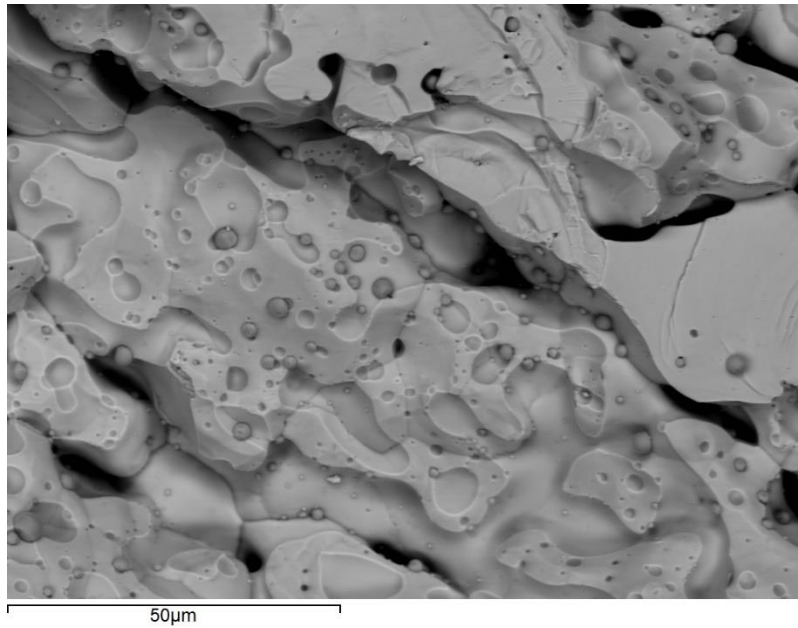
Figure 83. Fresh fracture image of the columnar grains close to the central hole.

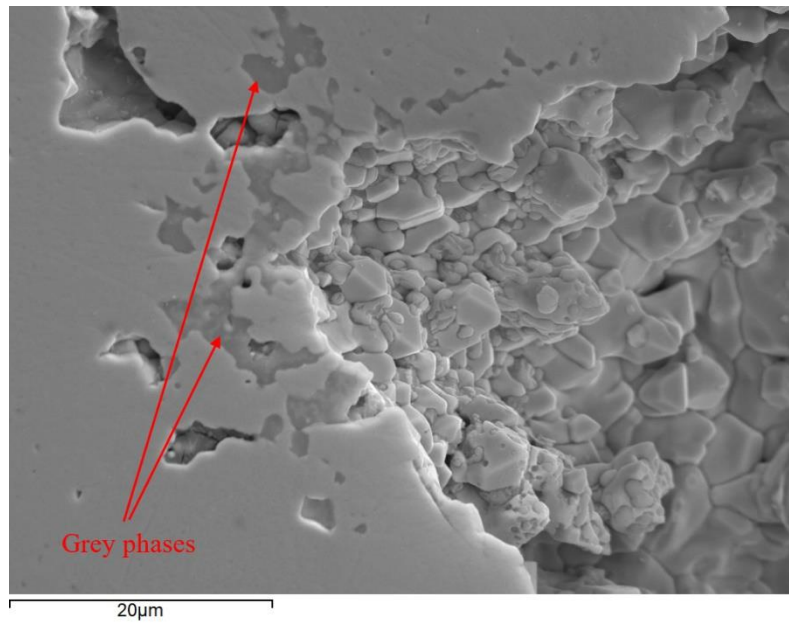
Figure 84. Grey phases observed between the columnar and equiaxed grain region.

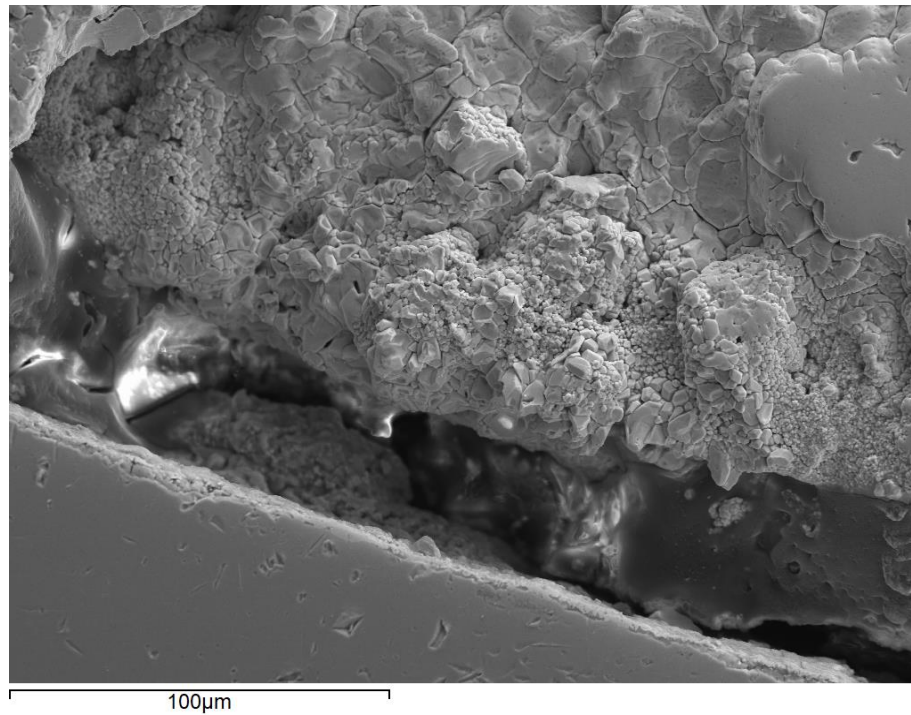
Figure 85. grain morphology at the fuel periphery.

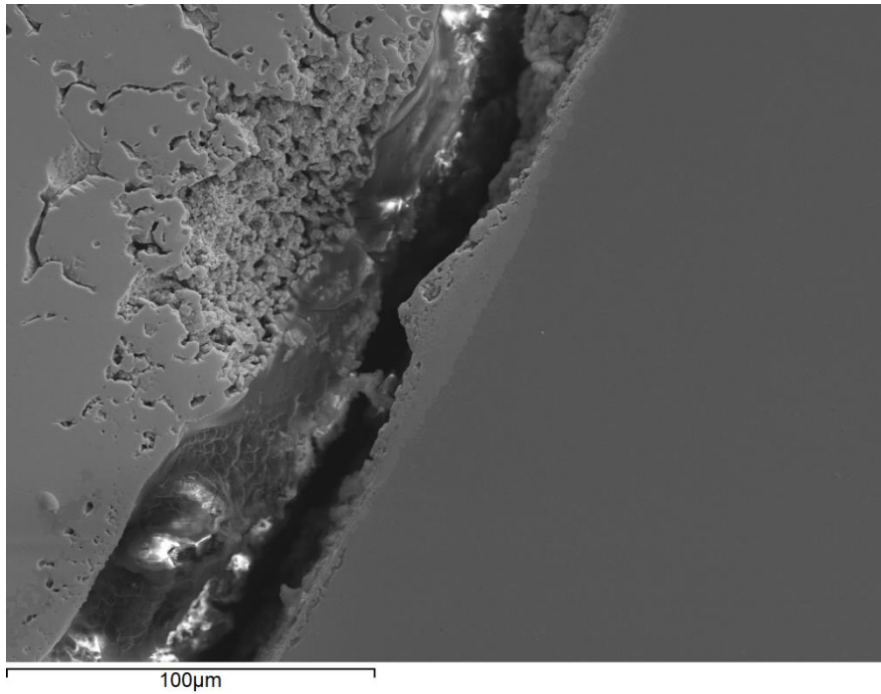
Figure 86. Other location where grain subdivision was observed. On the right side of the image, it can be seen that part of the fuel has remained attached to the FCCI.

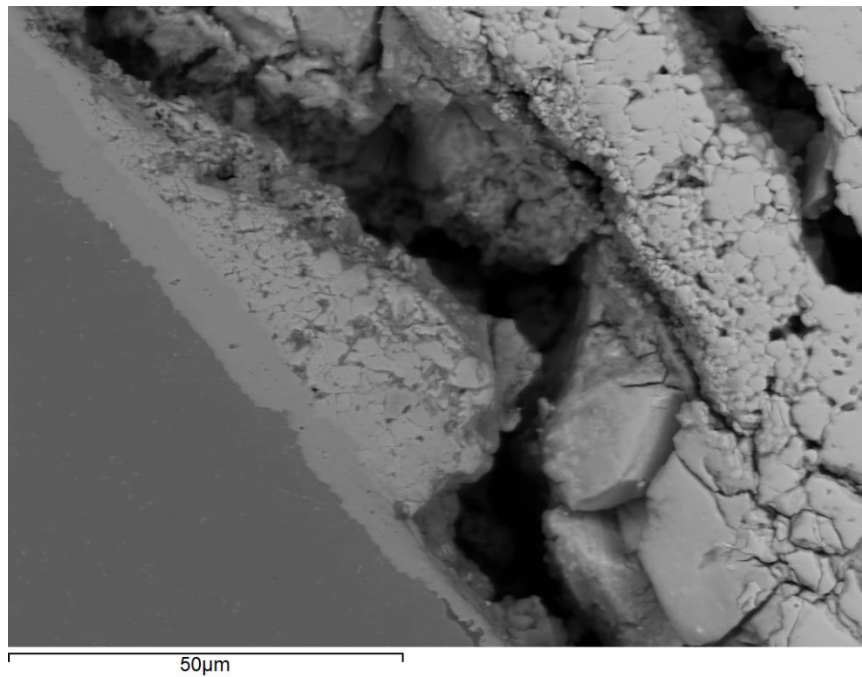
Figure 87. Region where a thick part of the fuel remained attached to the cladding.
