Light Water Reactor Sustainability Program Enhancement of the Structural Health Monitoring Framework by Optimizing Vibro-Acoustic Modulation Technique to Localize Alkali-Silica Reaction Degradation in Medium-Sized Concrete Samples

April 2018

U.S. Department of Energy
Office of Nuclear Energy

**Enhancement of the Structural Health Monitoring
Framework by Optimizing Vibro-Acoustic Modulation
Technique to Localize Alkali-Silica Reaction
Degradation in Medium-Sized Concrete Samples**

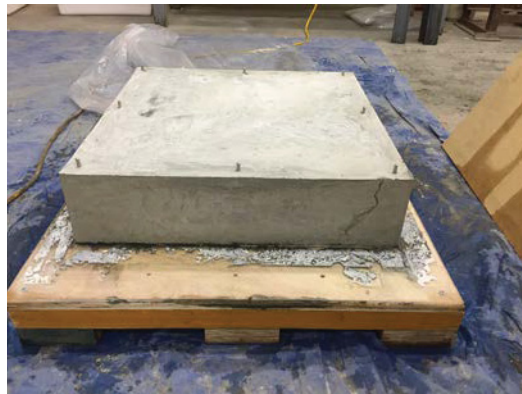
Figure 3. 2 ft × 2 ft × 6 in. dimension concrete slab.

In this section, we discuss a medium-sized concrete slab of dimensions of 2 ft × 2 ft × 6 in. casted on December 21, 2015, and cured at Vanderbilt University. The details on casting and curing process of this concrete sample is discussed in detail in the report by Mahadevan et al. (2016). Figure 3 shows an image of the slab immediately after the mold was removed.

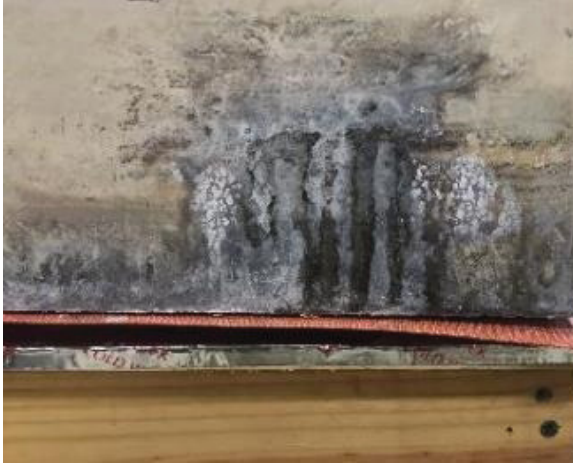
Figure 5. Damage location 1—cracking and powder effluence.

From December 21, 2015, to September 2016, the medium-sized concrete slab did not show visual signs of degradation due to ASR. In October 2016, first visual evidence of degradation due to ASR was observed. Since then, the degradation-related damage has become increasingly pronounced. The first indication of damage was detected by two vibration-based techniques, nonlinear impact resonance-acoustic spectroscopy and VAM. Then, hairline cracks were observed on the surface of the slab, and later, an ASR gel effluent and whitish powder seeped out of the slab. In Figure 4, the red squares identify the locations where seepage of ASR gel effluent was observed on the sides of the slab. The seepage corresponding to locations marked in red squares in Figure 4 is shown in Figure 5, Figure 6, and Figure 7, respectively.

The whitish powder or gel effluents detected in Figure 5, Figure 6, and Figure 7 (the figure captions indicate whether powder or gel was observed) were tested with inductively coupled plasma-optical emission spectroscopy at the Vanderbilt University Civil and Environmental Engineering Laboratory and it was confirmed that the substance was ASR gel (see Mahadevan et al. 2017 for details).

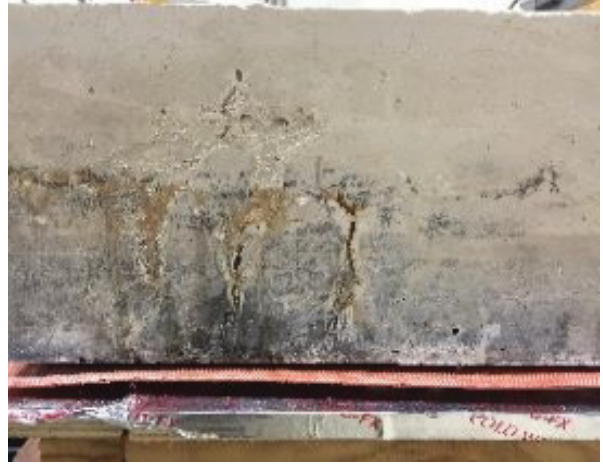
Figure 6. Damage location 2—clear gel effluence.

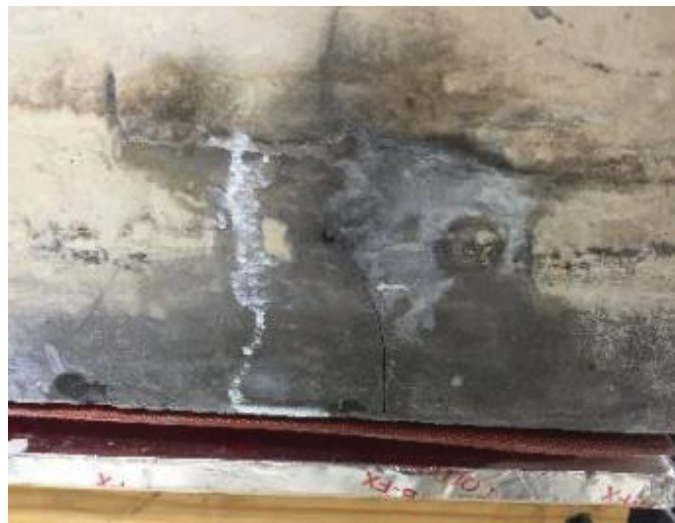
Figure 7. Damage location 3—cracking and powder effluence.

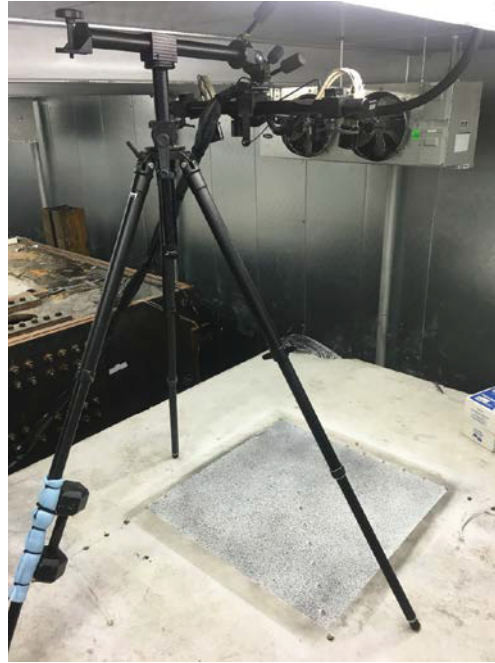
Figure 8. DIC camera support installation over the area of interest.

Vanderbilt University began performing DIC in late August 2016 on an ASR mockup concrete slab at UTK. Three slabs of dimensions $X \times Y \times Z$ were cast in 2016 and the progression of ASR will be studied over 3 years with a variety of monitoring techniques. For details on the UTK concrete slab, refer to the report [Z. Ma et al., 2016]. A black-background-white-speckle pattern using acrylic latex paint was applied to the slab for DIC analysis. Figure 8 displays a 2×2 ft area of interest on the large slab.

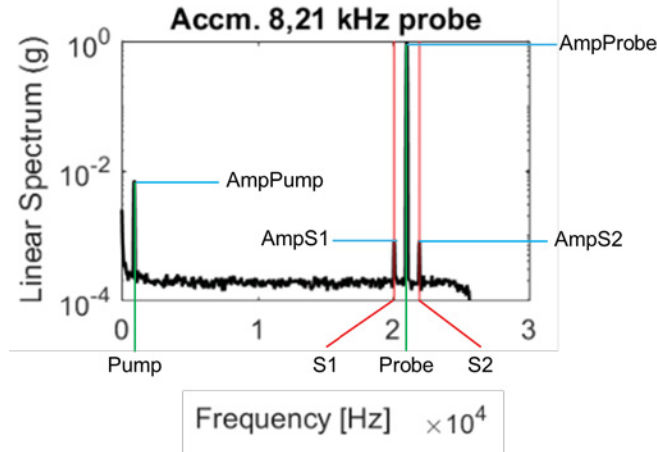
Figure 9. LS plot for an accelerometer labeled to show the values used in calculating SBSum. $SBSum = AmpS1 + AmpS2$.

In our laboratory experiments, multiple accelerometers were placed on concrete specimens cured in an aggressive environment (60°C and 100% relative humidity) to encourage ASR. The slab was excited using f_{pu} and f_{pr} frequencies, and the time history of accelerations is recorded at different locations on the surface of the slab. The PSD of the noisy acceleration time history was computed using the Welch’s method (Welch, 1967) and a Nuttall-defined, 2048-point, four-term, symmetric, Blackman-Harris window (Nuttall, 1981). Note that the spectrum of the steady-state dynamic response of the structural component for a few cycles (6 to 8) of the pump signal is sufficient for successful sideband-detection (Singh et al., 2017). Thus, the overlap for the Welch’s method can be decided based on the length (in time) of available data and the time period of the pump signal to ensure sufficient length of the signal is used to compute PSD. In our experiments, the length of the acquired signal contained about 180 cycles of the lowest f_{pu} (i.e., 920 Hz). Thus, we used the Welch’s method with zero overlap. Linear spectrum (LS) of the acceleration time history was computed from the PSD (Figure 9). The nonlinearity in the structural response, or the modulation of the f_{pr} by the f_{pu} , is seen as sidebands around the f_{pr} (“peaks” in the LS at frequencies equal to $f_{pu} \pm f_{pr}$). After computing the LS, the values of AmpS1 and AmpS2 (Figure 9) were used to calculate the sideband sums (denoted as SBSum). It has been hypothesized that the effect of nonlinear structural behavior is pronounced near the site of damage (Singh et al. 2017). Thus, comparison of SBSum values at various locations can help in ascertaining the relative severity of damage (ASR-cracks) at these locations. In this report, we discuss mapping of ASR-induced cracks based on the SBSum metric, i.e., SBSum metric, $SBSum = AmpS1 + AmpS2$, as shown in Figure 9.

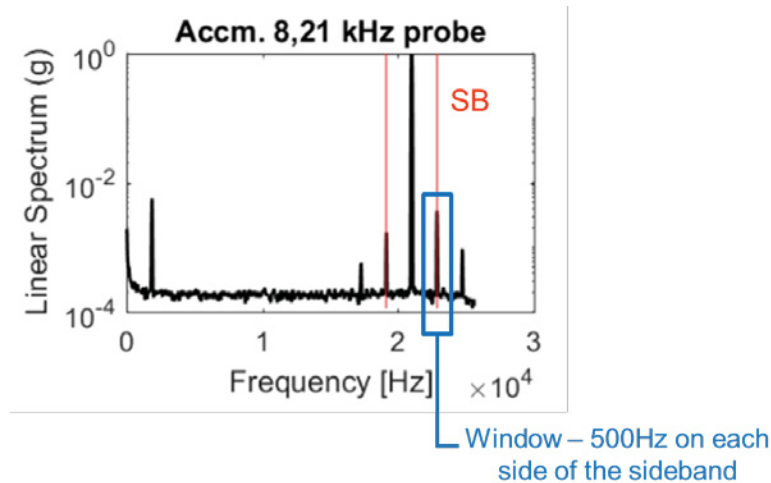
Figure 11. The blue box represents the 1000-Hz window being evaluated for local peaks for each sideband.

The SBSum metric can be computed by finding the ordinate of the LS at given values of frequencies. Thus, an automated SBSum calculation process may be misled by considering ordinates at given frequencies that are not peaks (and hence do not indicate nonlinear structural behavior). To ensure that the values being used to calculate SBSum are physically meaningful sidebands, a method for finding local peaks in the data was implemented. In this method, it was first determined whether the sideband value for a given frequency was a local peak. Next, it was checked whether the sideband was a maximum value within a 1 kHz window (Figure 11) centered at the frequency of interest. The ordinate value at a given frequency was selected as a sideband only if it satisfies both the conditions given above.

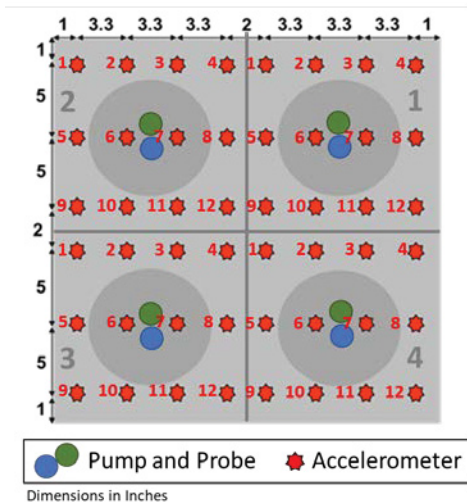
Figure 12. Pump, probe, and accelerometer locations for all four quadrant locations (labeled in gray).

In this section, we report the results of VAM tests performed on the VU slab. In order to test the damage mapping capabilities of VAM-based diagnosis methodology, we divide the slab in four quadrants, and perform VAM test with a grid of 12 accelerometers for each quadrant. The pump and the probe actuators are placed adjacent to each other at the center of each quadrant (as shown in Figure 12). The blue circles and the green circle represent the pump and probe actuators respectively. We used different probing amplitudes (50, 100, 250, and 500 mV) and probing frequencies (17, 18, 19, 20, and 21 kHz) for VAM testing. The pumping frequency was 920 Hz with a 500-mV amplitude. We conduct VAM tests using these parameters for each quadrant, collect the acceleration time series data at each accelerometer location, compute the corresponding LS, and obtain SBSum metric using the methods detailed in Sections 4.2.2 and 4.2.3. Next, we plot the variation of the SBSum metric over each quadrant using linear interpolation of the SBSum metric obtained at accelerometer locations. We juxtapose damage maps for the four quadrants to obtain a damage map for the entire slab. Figure 13, Figure 14, and Figure 15 show damage maps for three probing frequencies.

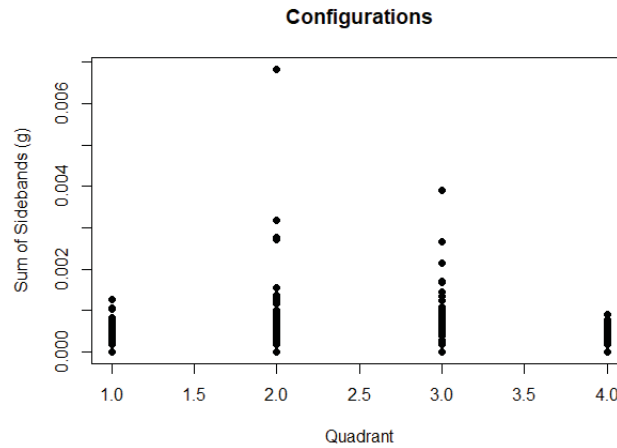
Figure 16. Scatterplot of the SBSum values for the configurations parameters each of the four quadrants.

Data analysis techniques are applied to better understand the results and the effects each variable has on the damage index (SBSum). The variation in the values of SBSum for different test parameters (location of the pump and probe actuators, probing amplitude, f_{pr}) can be displayed in the form of a scatterplot. A scatterplot shows the SBSum for every accelerometer for every test as a different point. The plots show visual correlations between high SBSum values and different test variables. These plots are shown in Figure 16, Figure 17, and Figure 18. In Figure 16, quadrants 2 and 3 show the highest values of SBSum. This supports the presumption of more ASR damage due to extremely reactive silica placed in quadrant 2. In Figure 17, the larger the probing amplitude was, the higher the SBSum values were experimentally. It is noted that, although a smaller f_{pu}/f_{pr} showed higher sideband values in these cases, it does not mean it enables better damage localization. Figure 18 shows the effects of probing frequencies on the SBSum. This plot shows the higher the probing frequency, the higher the SBSum values were for these experiments.

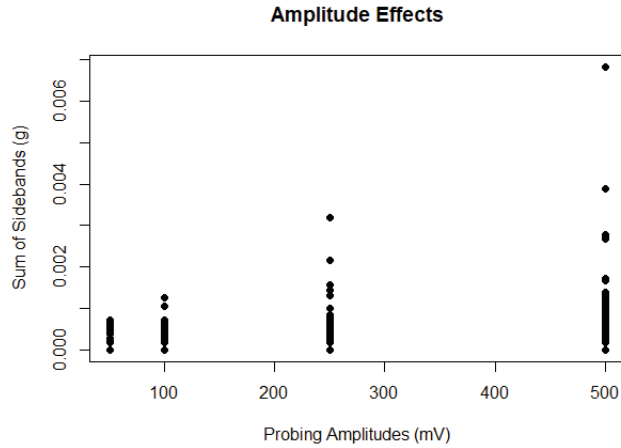
Figure 17. Scatterplot of the SBSum values compared to the different probing amplitudes.

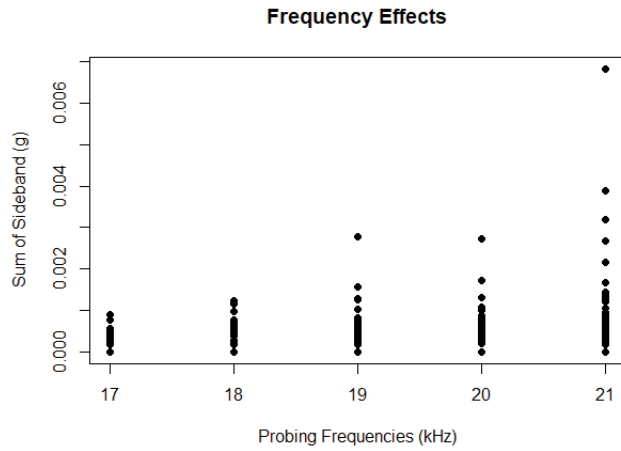
Figure 18. Scatterplot of the SBSum values compared to the different probing frequencies.

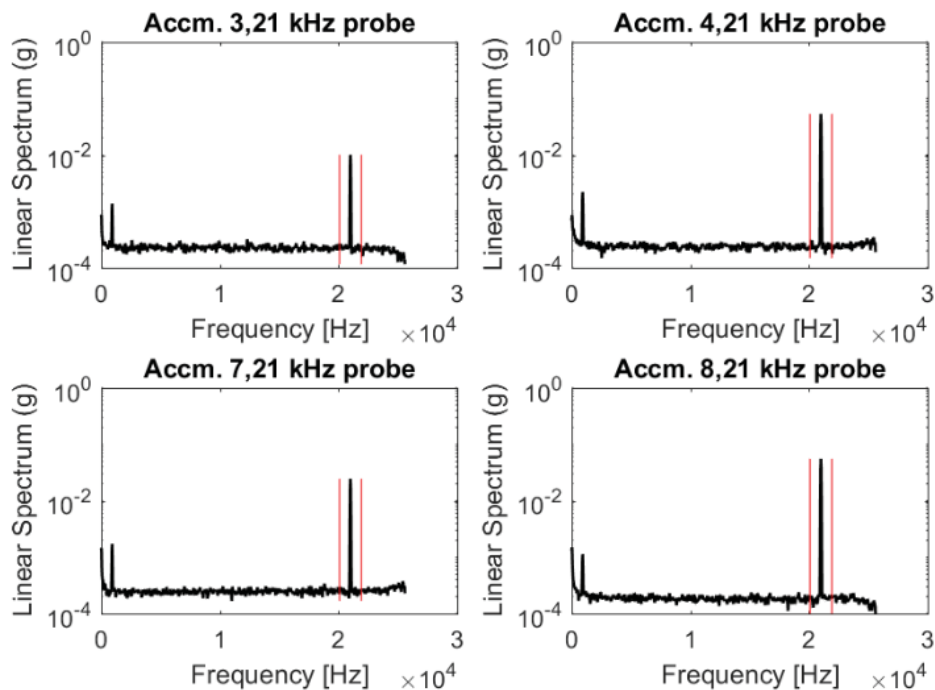
Figure 24. LS plots in terms of acceleration of the Gold Hill control (non-reactive) sample with a 500-mV and 920-Hz pump and a 250-mV and 21-kHz probe for four different accelerometers of the same location as shown in Figure 23.

The LS for acceleration shows high-magnitude sidebands for the reactive samples and no sidebands for the control (non-reactive) samples. This simple observation suggests that VAM tests can be used for detection of ASR damage in concrete. The reactive samples show surface cracking, whereas the control (non-reactive) samples for both Gold Hill and Grand Junction aggregates do not. Figure 23 and Figure 24 depict the LS plots of measured acceleration for the Gold Hill reactive and control (non-reactive) samples. The accelerometers are situated at the same locations (with respect to the centroid of the sample) on two different specimens. The magnitude and frequency for the pump excitation were 500 mV and 920 Hz, respectively, and those for the probe excitation were 250 mV and 21 kHz, respectively. Vertical red lines in all the plots indicate the abscissa (the possible locations) of the sidebands. It can be seen that high-magnitude sidebands are present the case of reactive slab. LS for acceleration for non-reactive slabs for both Gold Hill and Grand Junction aggregate samples do not, typically, show high-magnitude sidebands.

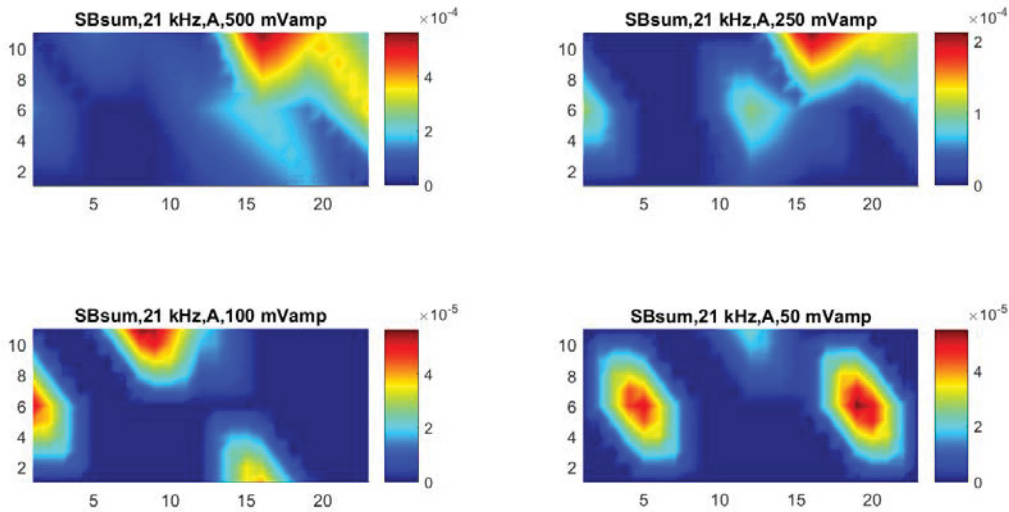
Figure 25. SBSum surface diagram for the Grand Junction reactive sample with a 1695-Hz and 500-mV pump and a 21-kHz probe of various amplitudes using a local peak filter.

We also performed the damage mapping for the University of Alabama samples using the method of filtering SBSum values explained in Section 4.2.3. Figure 25, Figure 26, Figure 27, and Figure 28 show damage maps for the pump magnitude of 500 mV, the pump frequency of 1695 Hz (Table 1), the probe frequency of 21 kHz, and four probe amplitude values (50, 100, 250, and 500 mV). The results for the Grand Junction reactive (Figure 25) do not show a consistent pattern for the distribution of SBSum values, and the SBSum magnitudes are similar to those observed for the Grand Junction control sample (Figure 26). The magnitude of SBSum in the Gold Hill reactive (Figure 27) is nearly ten times greater than that of the corresponding control (Figure 28). The Gold Hill reactive also shows consistently high sidebands for the same region for all probe amplitudes. In future work, this area will be further tested with a higher sensor density. The results for the reactive samples are more consistent for all probing amplitudes, whereas for the control samples, there is no consistency in the values of damage index at a particular region on the slab.

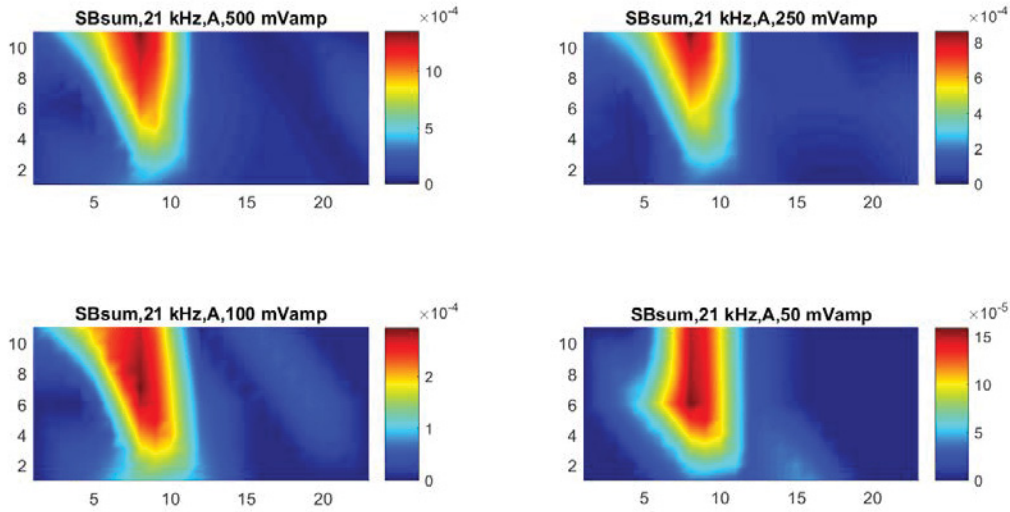
Figure 27. SBSum surface diagram for the Gold Hill reactive sample with a 1865-Hz and 500-mV pump and a 21-kHz probe of various amplitudes using a local peak filter.

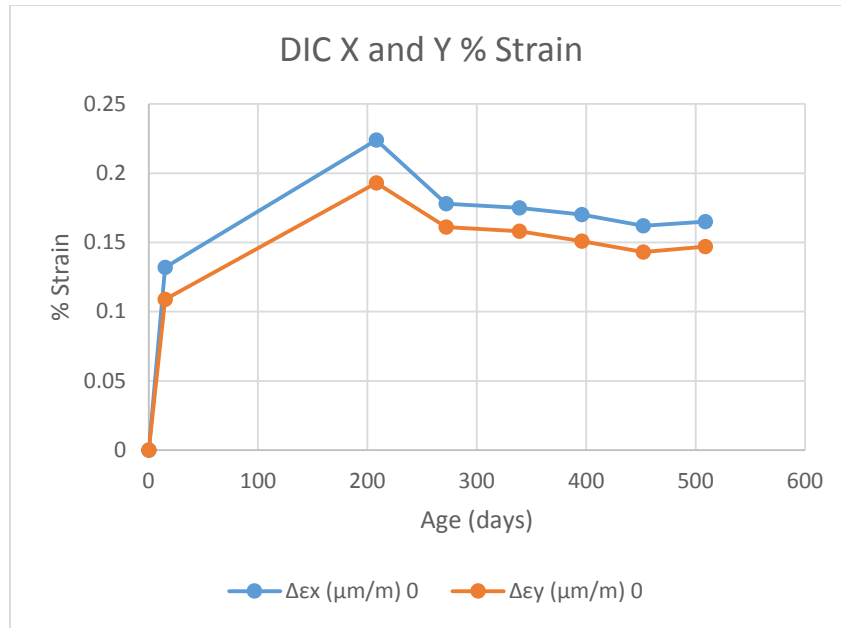
Figure 32. Plot of the average DIC strain in the X and Y directions over time.

For comparison with the strain data collected with the DEMEC gauges, Figure 35 shows the strain in the XY direction of the slab: normal to the direction of the DEMEC studs located on the XY axis. The average of the XY strain for the entire stage surface was equivalent to zero. For better comparison, only the strain values in between the DEMEC studs is analyzed. Figure 36 is a representation of the strain area between the DEMEC studs. The average values for strain in the X, Y, and XY directions between the studs are plotted in respect to time in Figure 37. The average strain in each direction between the studs follows a similar pattern as Figure 32, the plot for the entire stage surface.

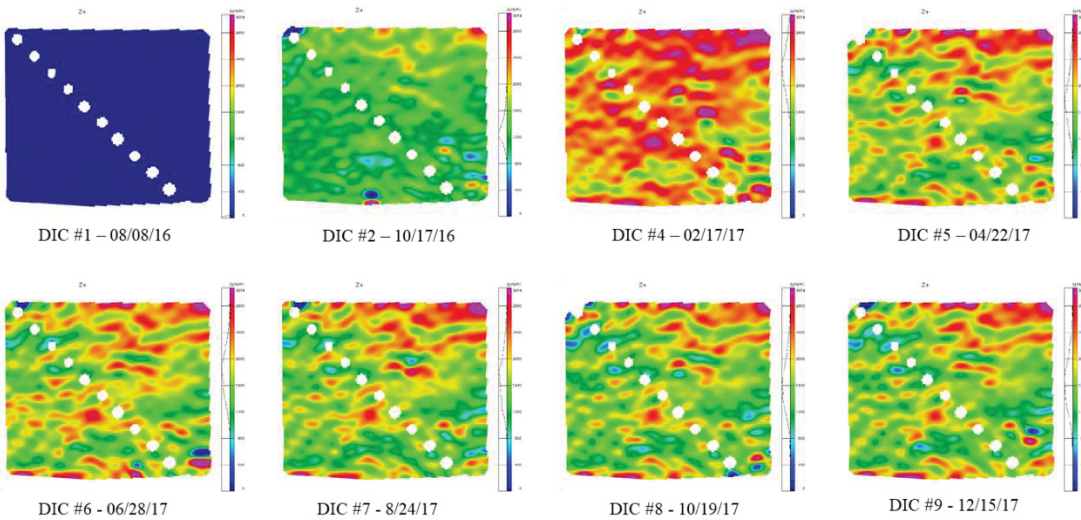
Figure 34. Strain distribution (normal strain in the Y direction).

The DIC results, namely strain distributions in the X and Y directions (along with the dates), are shown in Figure 33 and Figure 34, respectively. Figure 33 and Figure 34 show that DIC is effective in capturing the strain due to deformation in the large slab, caused by expansion with time. In addition, the color bars on the right of each image indicate the strain values corresponding to different colors, and also the frequency distribution of the strain values. In Figure 33, the normal strain in the X direction was zero everywhere in August 2016, then the average value increased to approximately $1150 \mu\text{m/m}$ in October 2016, and to approximately $1950 \mu\text{m/m}$ in February 2017. Similarly, in Figure 34, the normal strain in the Y direction was zero everywhere in August 2016, and then the average value increased to approximately $1250 \mu\text{m/m}$ in October 2016, and to approximately $2250 \mu\text{m/m}$ in February 2017. These results indicate that the large slab experienced significant expansion during the period from August 2016 to February 2017. Two issues were noted: (1) the data collected in December 2016 was unusable due to instrument malfunction; and (2) some damage to the speckle pattern was observed, as indicated by the white spots on the right-hand side of the diagonal (the white spots along the diagonal indicate the studs placed for visual measurement of deformation). The cause for the damage is suspected to be caused during the conduct of other NDE experiments on the slab. This damage and degradation of the facets has not affected the DIC results; the overall strain distribution is of importance and it is well captured by Figure 33 and Figure 34.

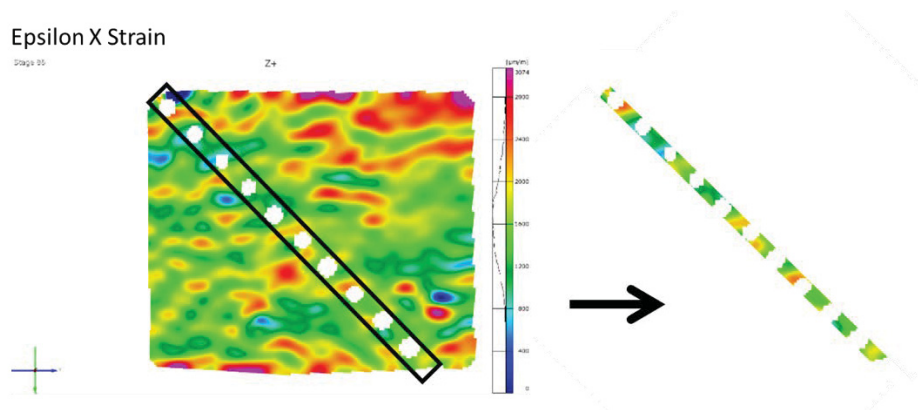
Figure 36. Visual representation of the facets used for the average calculations between the DEMEC studs.

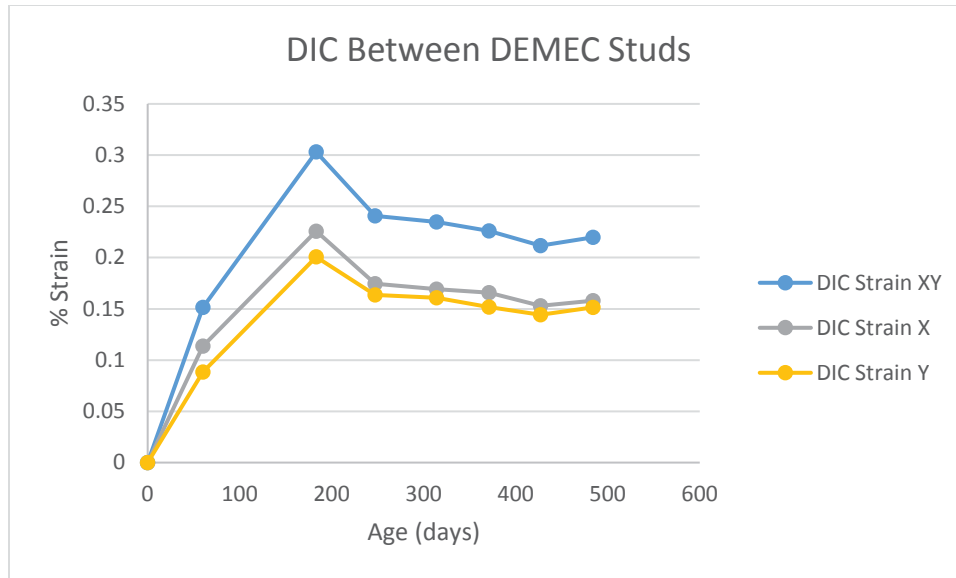
Figure 37. Average DIC strain values of the facets between the DEMEC studs.
