Management of the Three Mile Island Unit 2 Accident Corium and Severely Damaged Fuel Debris

*Contribution to
International Atomic Energy Agency
Coordinated Research Proposal T13015*

Philip L. Winston
Engineer

**Idaho National Laboratory
Idaho Falls, Idaho 83415**

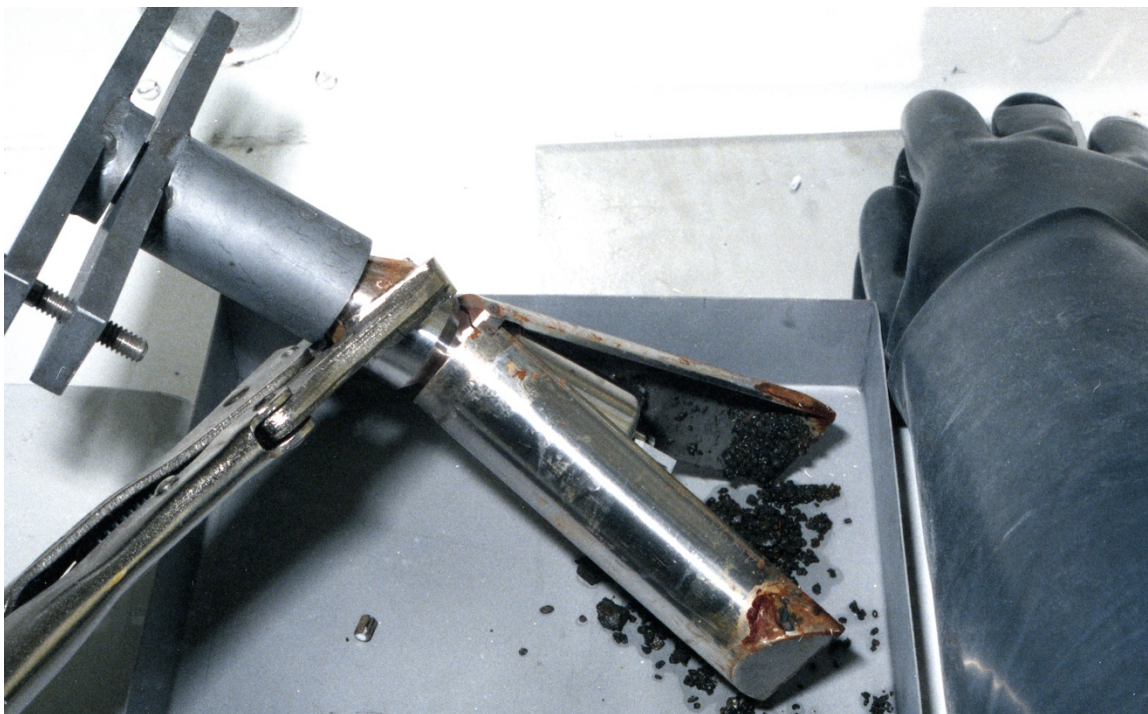
Figure 12. Clamshell Grab Sampler with Recovered Material. (Courtesy INL)

Eleven samples of loose material lying on the top of the melt were recovered before the reactor vessel head was removed. These grab samples provided indications of the highly varied nature of the loose debris. Material was acquired from the center and mid-radius positions normally occupied by fuel assemblies H8 and E9. In the center location, the sample tool was pushed into the loose debris to a depth of 77 cm from the top of the debris bed and to 94 cm at the mid-radius position. The sample tools included a clamshell device and a pointed penetrator with a cup into which loose material flowed. The samples were taken from the debris surface as well as at depths of 8 cm and 56 cm from the surface. (Akers, GEND-INF-075 Pt. 1, 1986.) Figure 12 shows one type of sampler with granular material recovered.

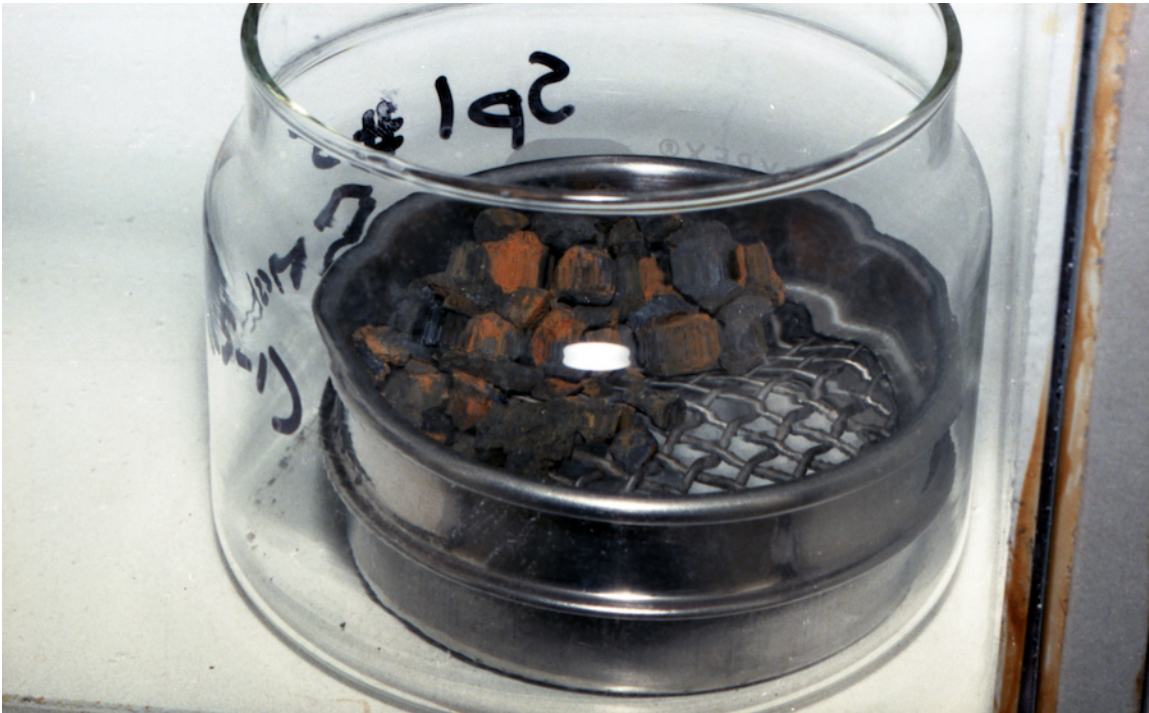
Figure 14. Loose material retained on sieve for size analysis. (Courtesy of INL, 1984)

Examples of the general size distribution, discrete character and shape recovered from samples of loose debris material are shown in Figure 14 and Figure 15.

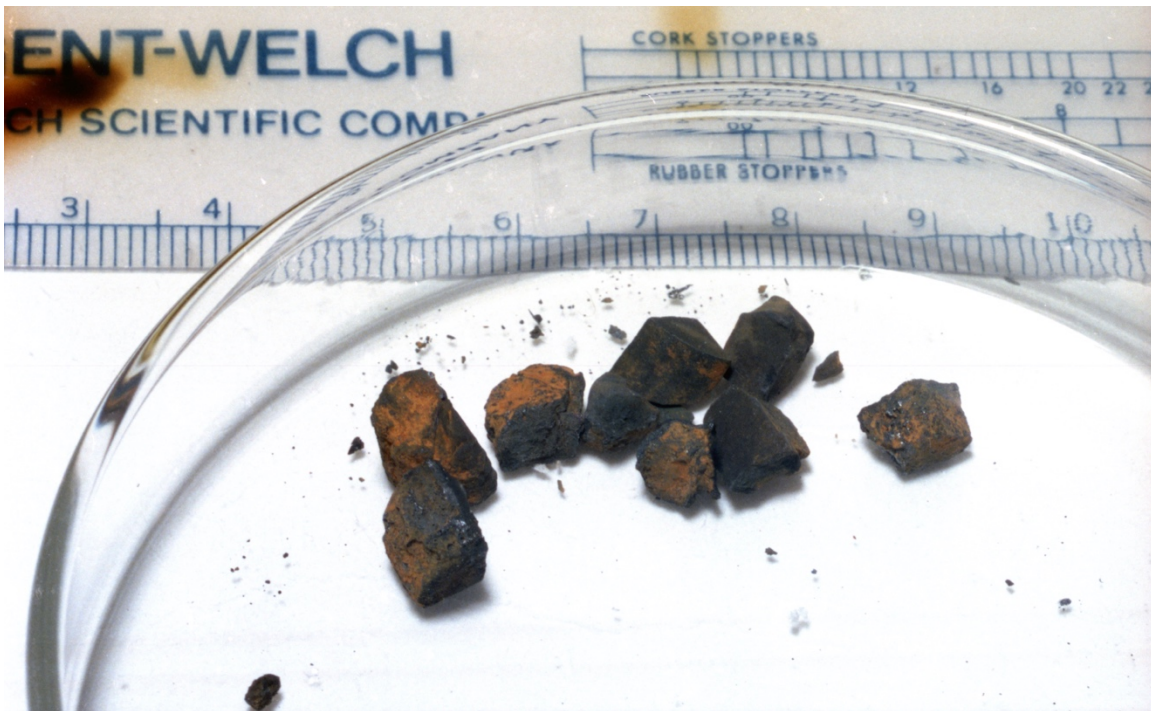
Figure 15. Typical Debris Pieces. (Courtesy of INL, 1984)

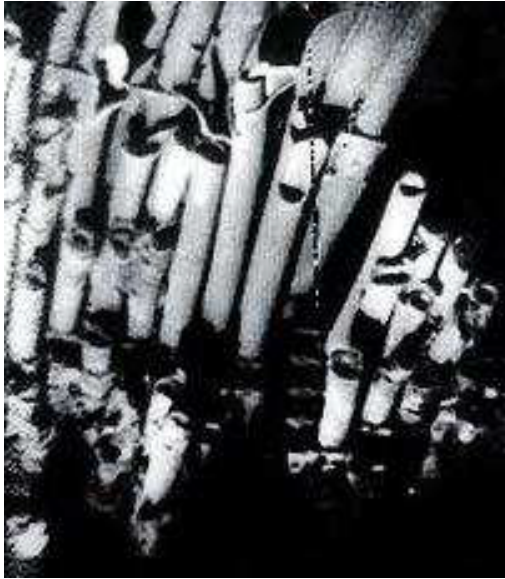
Figure 25 Remains of fuel assemblies (Upper view, hanging rods; lower view, rods fallen into debris bed, Courtesy NRC/INL <https://tmi2kml.inl.gov>)

Once the RPV upper head and plenum assembly were removed, it was possible to more completely evaluate the degree of damage. Around the perimeter of the vessel, forty-two percent of the 177 fuel assemblies were recognizable. Of the standing assemblies, all were damaged, with two that had damage to only ten percent of their rods. Various views of damaged fuel rods are shown as Figure 25.

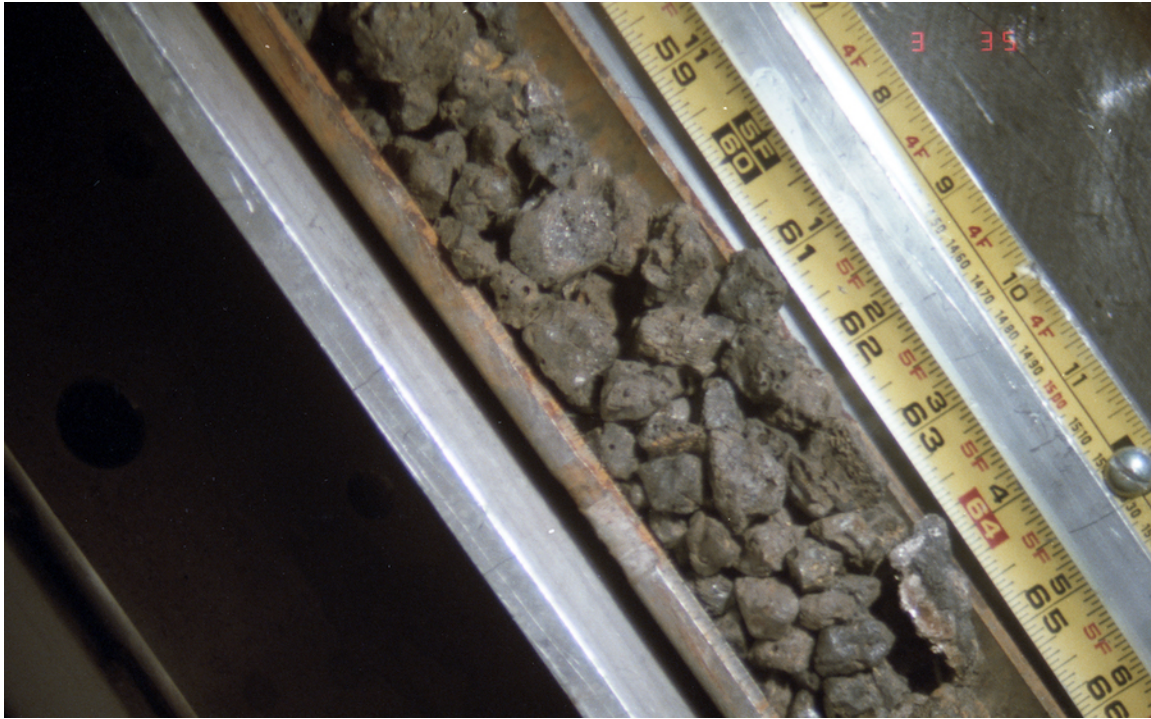
Figure 35 Core Bore Section with loose U-ZrOx gravel (Courtesy INL)

Metallic phases that had penetrated cracks in the ceramic melt included 1) silver and indium from control rods, 2) iron, nickel and tin from structural steel and zircaloy, and 3) inclusions of silver, indium, nickel and tin as individual elemental constituents. One investigator found nickel-tin alloy precipitates that were approximately 40% tin, and iron-nickel phases, both of which have specific formation temperatures of 1500 and 1700K, respectively. Some of the melt material broke up into granular fragments that can be seen in the core bore tube as Figure 35.

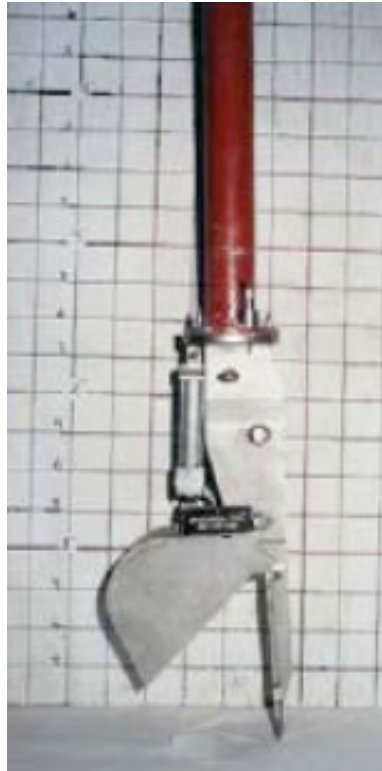
Figure 53. Clamshell tool, spade-bucket tool, spike tool, gripper tool, vise grip tools (GEND-INF-065)

More than 20 specialized tools were developed for debris retrieval and sectioning of the melted core, including a water jet cutter, an abrasive saw, bolt and bale cutters, hooks, pliers, (GEND-INF-065) and an underwater plasma torch. Numerous changes in tool design occurred as the core conditions became better understood. Early design bases assumed a degree of consistency in the material to be retrieved when, in fact, the diversity of melted, broken, and shattered material was significant. Only 15% of the fuel retained a recognizable rod and assembly configuration. Examples of the tools, including a clamshell tool, a spade-bucket tool, a spike tool, and a gripper tool, are shown in Figure 53.

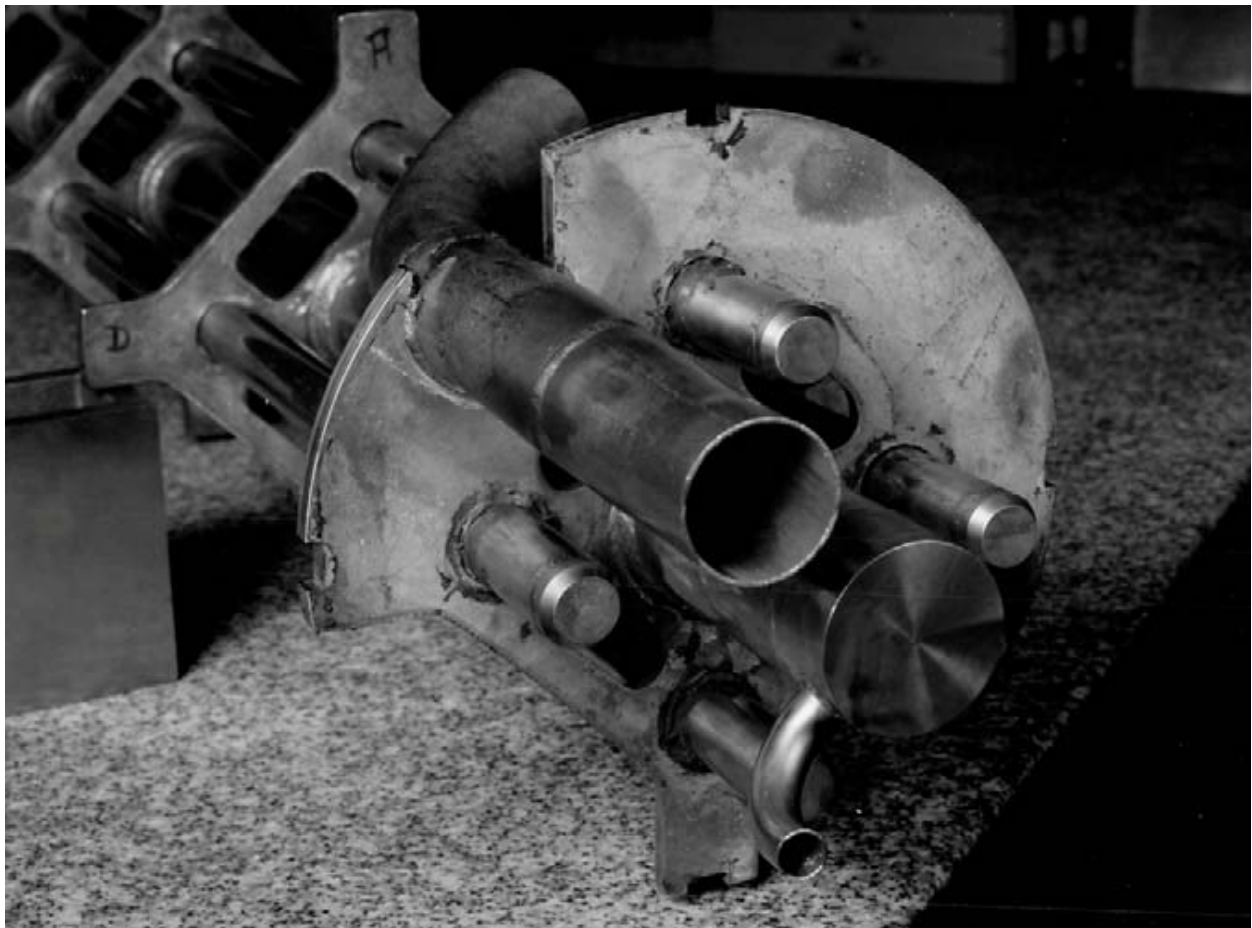
Figure 62. Internal structure of knockout canister. (Courtesy of INL, 2012)

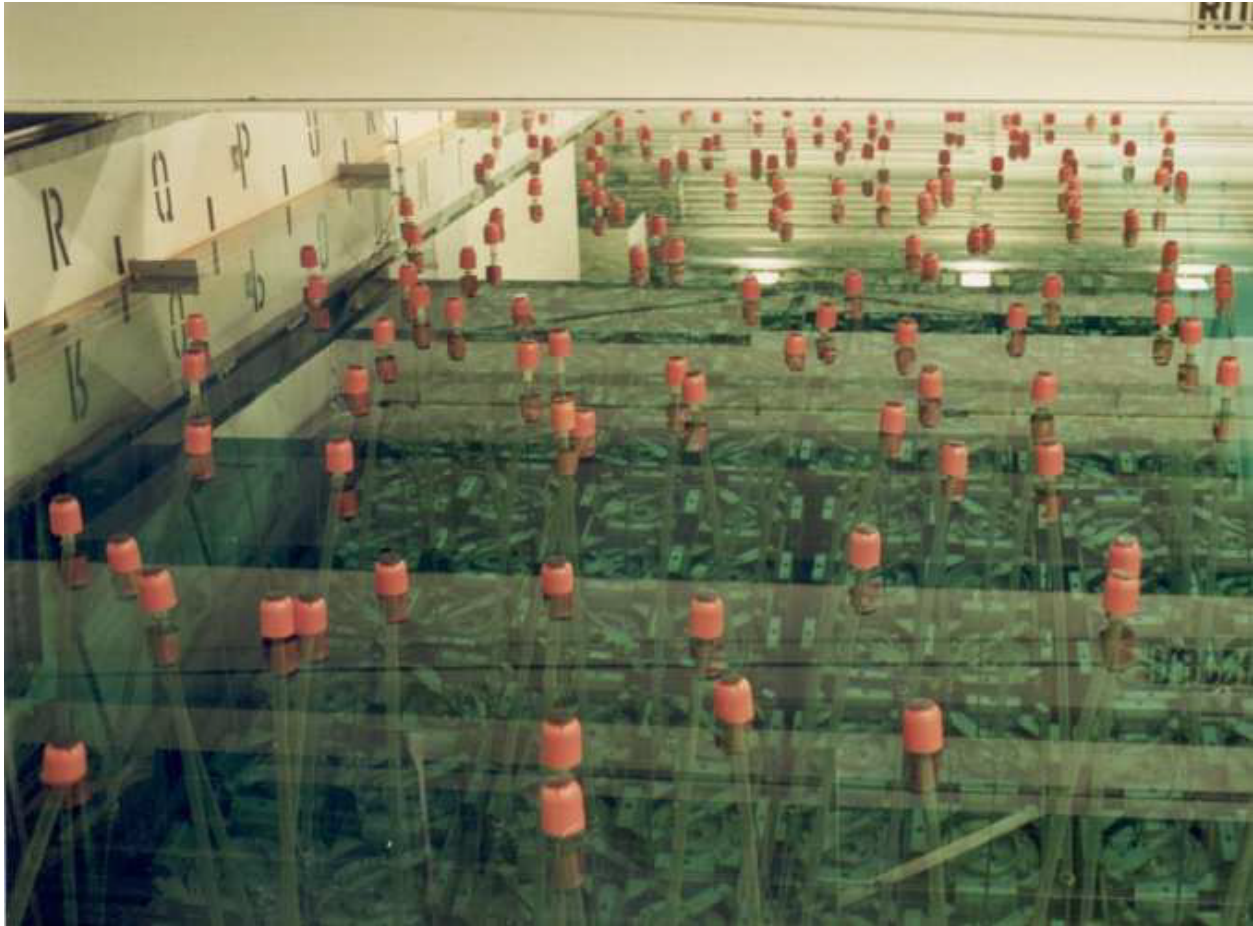
Figure 82. TAN-607 pool, showing six-pack racks and individual canister-vent ports (orange caps divert water back into pool). (Courtesy of NRC/INL tmi2kml)
