# Acceptance Test of WCTC with LEU Fuel at the IVG.1M Research Reactor Site in Kazakhstan

October 2022

**Idaho National Laboratory  
Idaho Falls, Idaho 83415**

## **Acceptance test of WCTC with LEU fuel at the IVG.1M research reactor site in Kazakhstan**

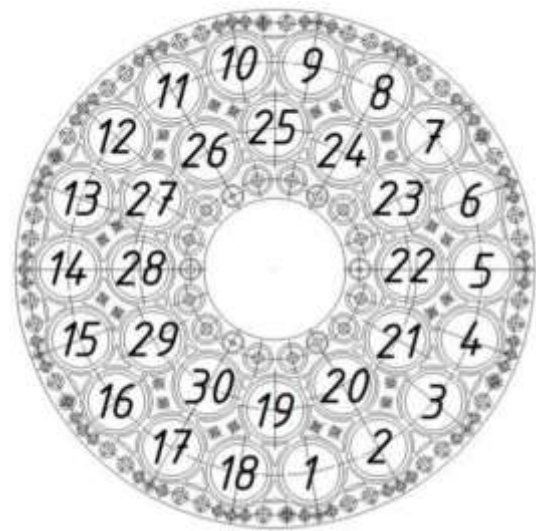
Fig. 2. Cartogram of the WCTC location in the IVG.1M reactor's core

Fig. 2, as a cartogram, shows the location of the WCTCs in the reactor core. As it can be seen in the drawing, the total number of channels are 30 and they are in two circles in the core.

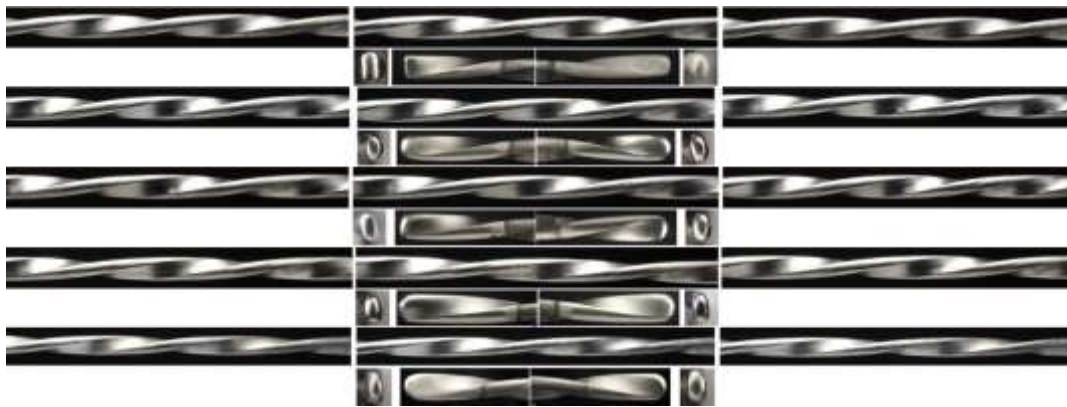
*Fig. 5.* Images of the appearance of the central sections and ends of fuel rods that complied with the requirements

First, as exemplar, *Fig. 5* below shows images of fuel rods that have met the requirements.

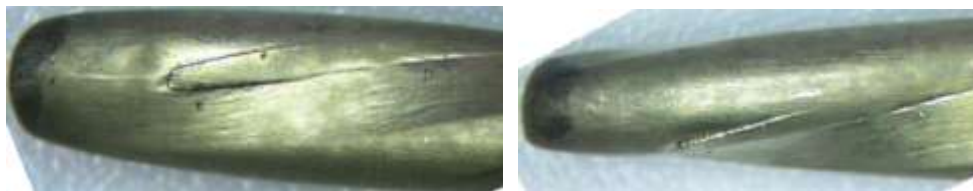
*Fig 6.* Images of the detected non-compliance with the technical requirements of the nickel coating on the lateral surface of the fuel elements

- Description of the nonconformities:
  - = At one end of a fuel rod, a crack with sharp transitions was observed (*Fig. 6*). Although the surface of the nickel coating appeared to be fissured, it was continuous and no delamination areas were visible. The phenomena was highlighted.

- Corrective measures initiated: since the two fuel rods belonged to the group of 52 pcs replacement fuel rods, and no other similar nonconformity was found in the group of 20 pcs randomly selected fuel rods, nor in the group of 52 witness rods, thus in terms of the quality of the coating made of nickel, were transferred to the group of witness fuel rods for further destructive testing.
- Follow-up action: NONE. They were not considered as nonconformant in the Joint Report [5].

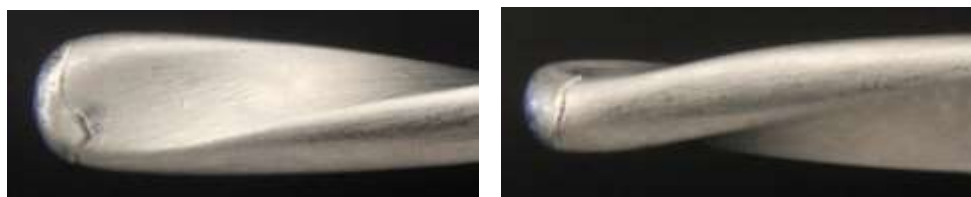
Fig. 7. Images of the detected non-compliance with the technical requirements of the nickel coating on the lateral surface of the fuel rods

- = At one end of a fuel rod the presence of an influx of nickel was detected. The discrepancies detected are shown in the images below (*Fig. 7*).

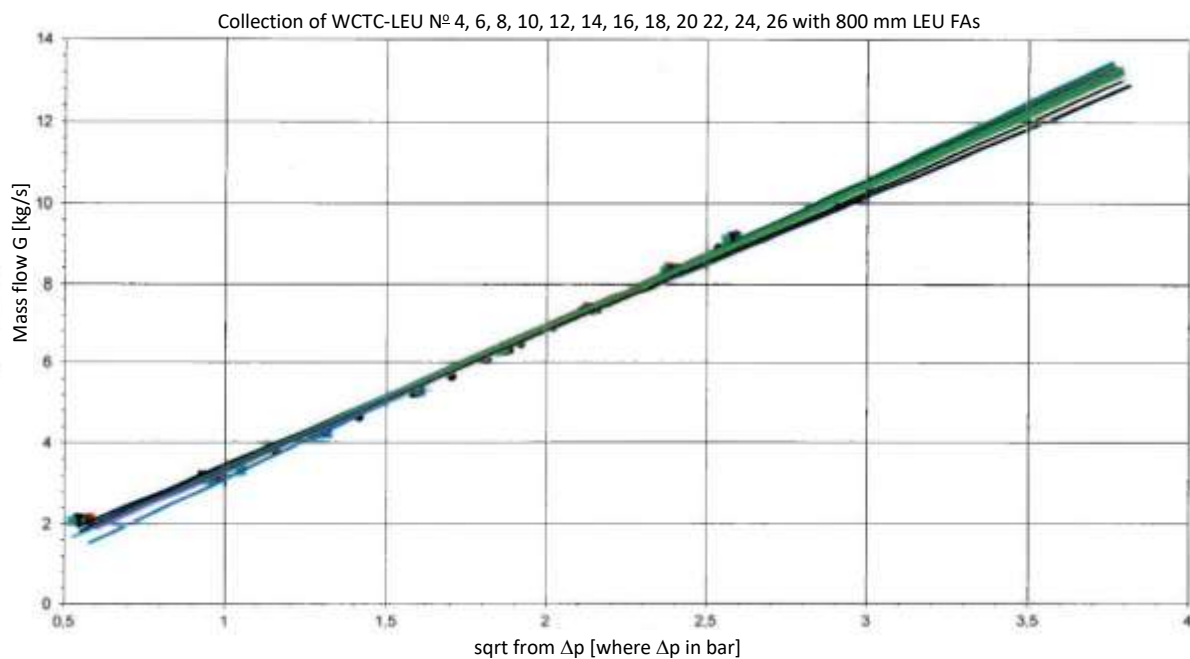
Fig. 12. Mass flow ( $G$ ) as a function of the square root (sqrt) of the  $\Delta p$ :  $G=f(\sqrt{\Delta p})$

Fig. 12 shows the measurement results of the WCTCs with 800 mm long LEU FAs, which, as it can be seen, complied with the requirements, like the 600 mm ones (they are not presented).
