# Slides on AFC-4C-R5 (MNT20E) destructive PIE :SEM, Micro-tensile testing, Post-test TEM Characterization

March 2024

Yachun Wang, Luca Capriotti

**Idaho National Laboratory  
Idaho Falls, Idaho 83415**

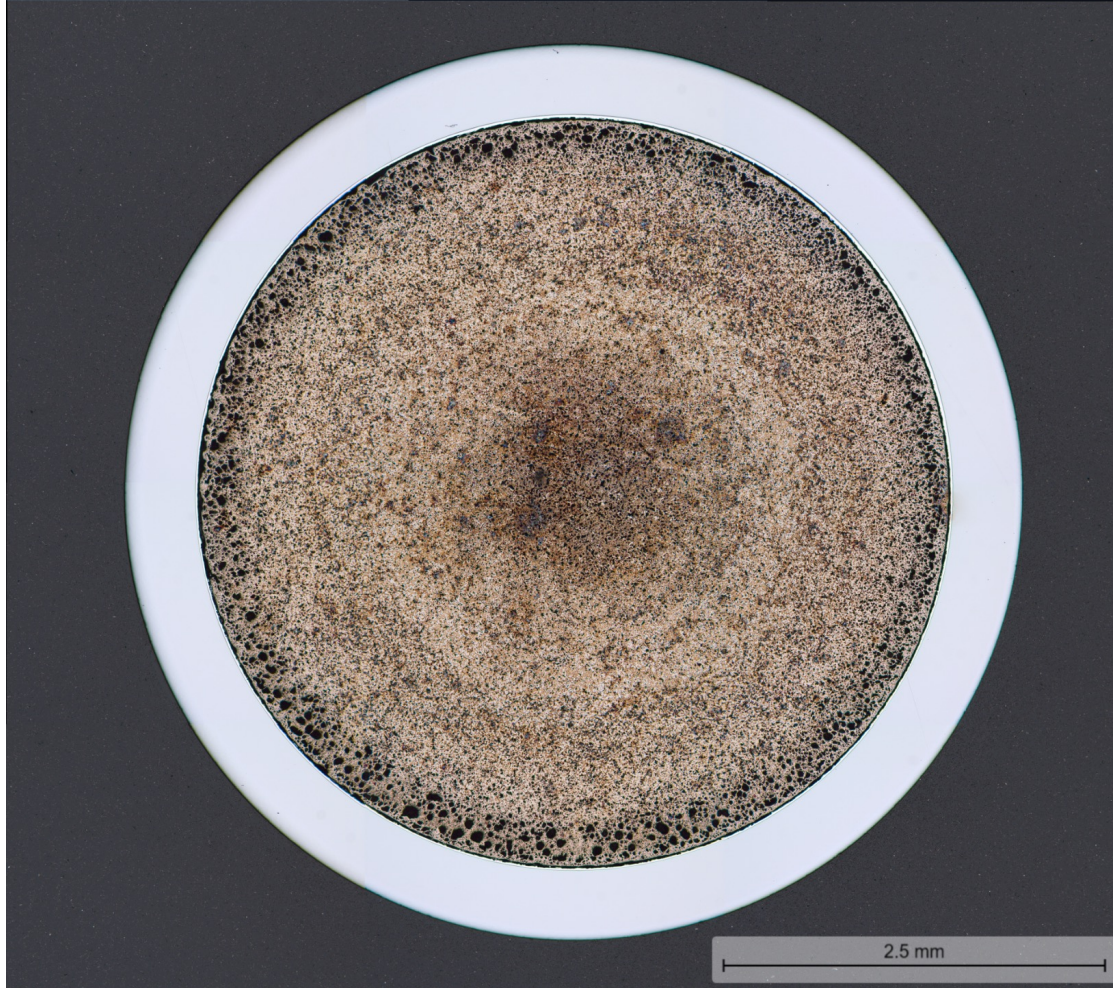
# Optical Microscopy Characterization of Cross Section

- OM image clearly revealed the cladding-Cr interface

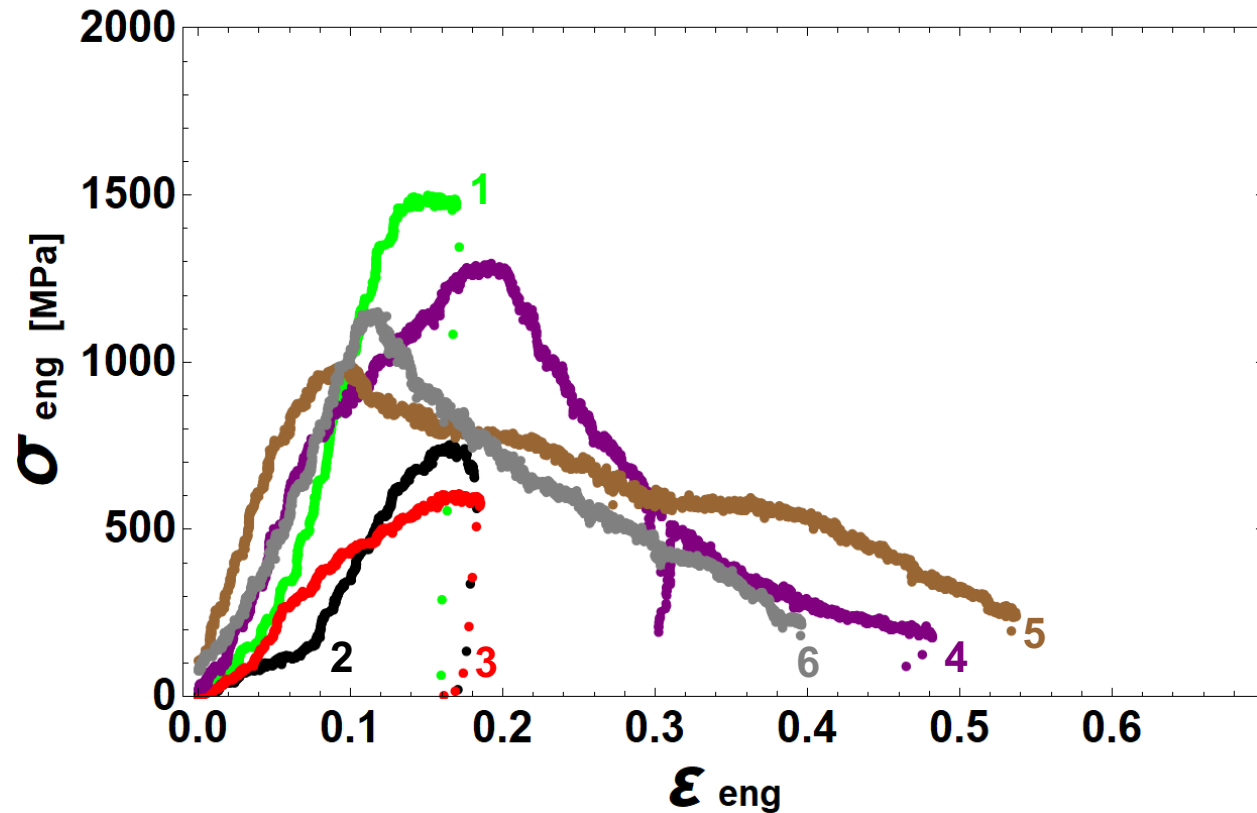
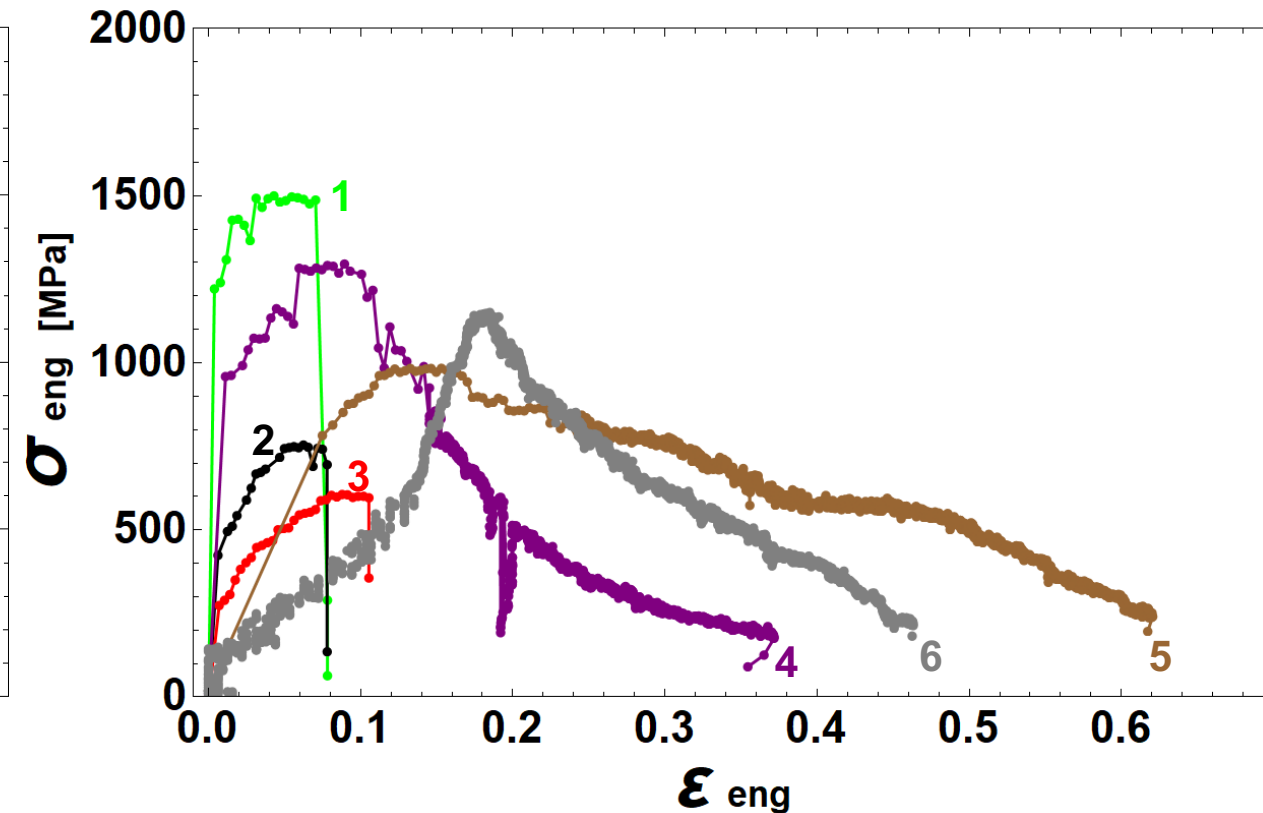
# Summary of Micro-tensile Testing (RT)

Raw Curves

DIC Corrected Curves

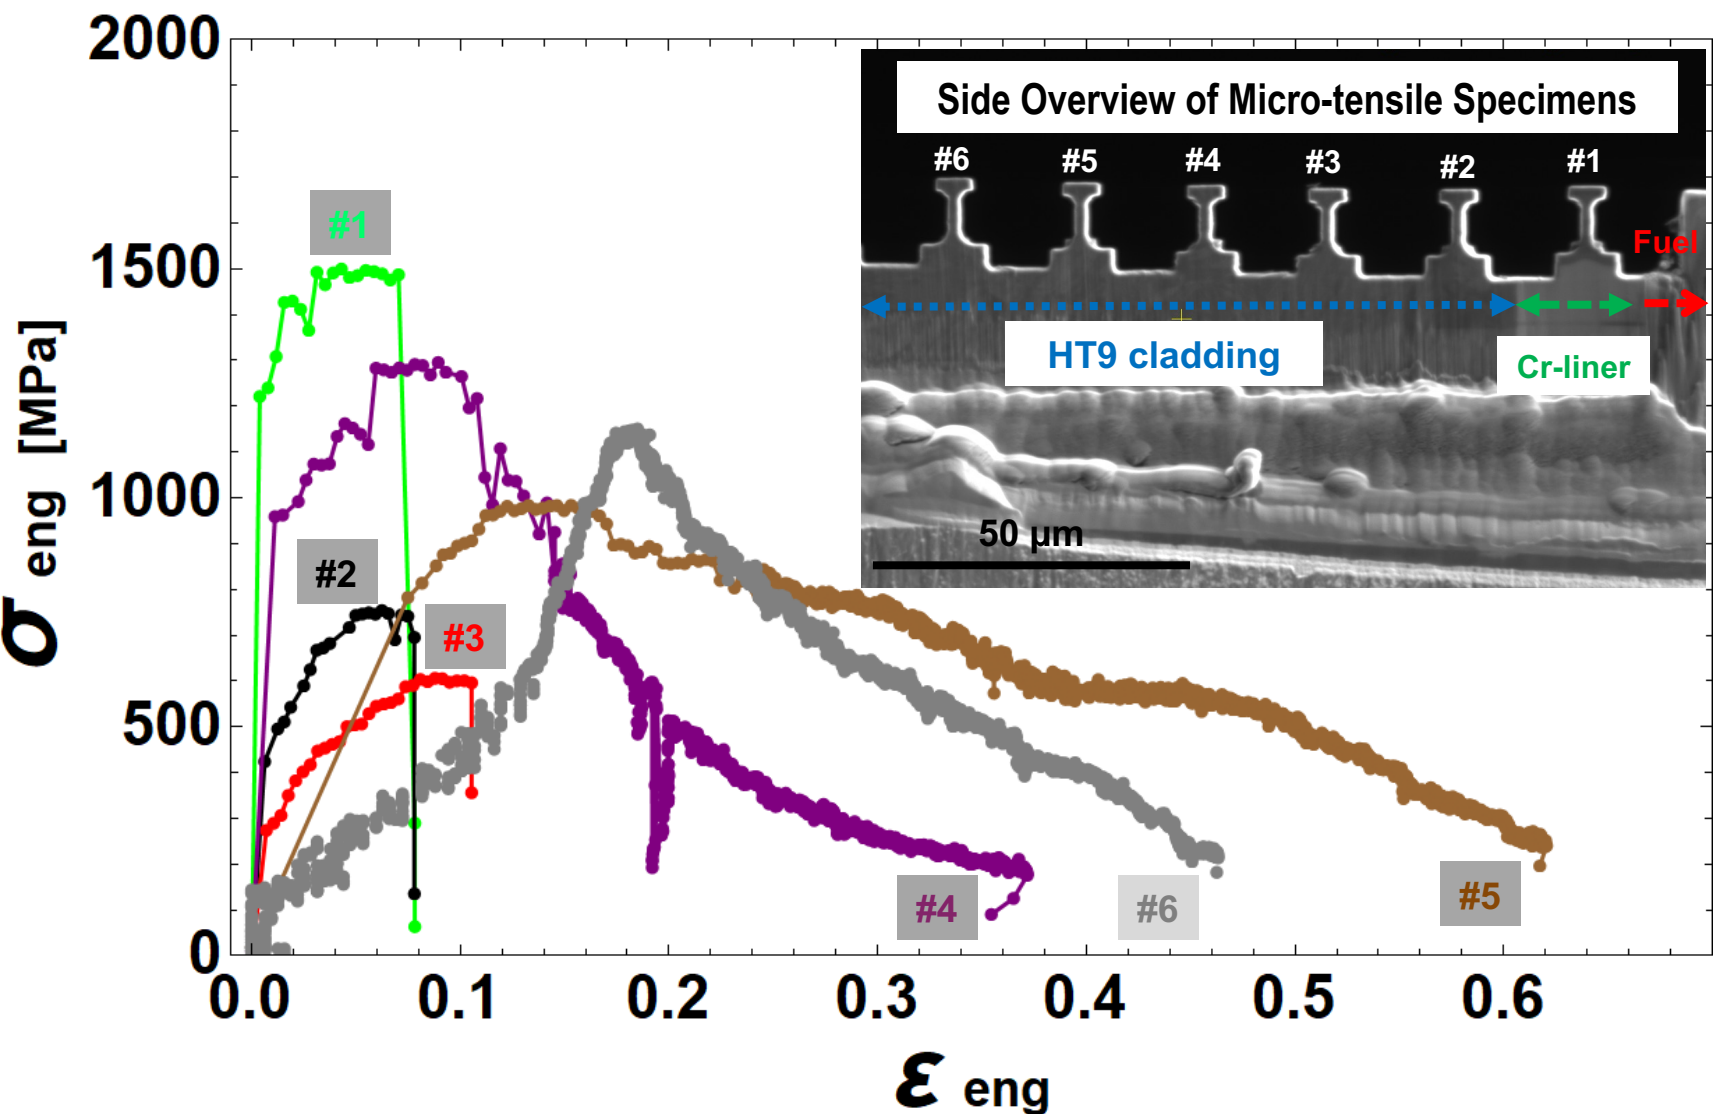
# DIC corrected stress-strain curves (RT)

Micro-tensile specimens	Material	$\sigma_{y-DIC}$ [Mpa]	$\sigma_{max}$ [Mpa]	$\epsilon_{total-DIC}$ [%]
#1	Cr-liner	1231	1500	7.8*
#2	HT9	451	754	7.8*
#3	HT9	284	606	10.5*
#4	HT9	961	1296	37.2
#5	HT9	799	984	61.7
#6	HT9	957	1151	46.3
HT9 Average (#2-6)		$690 \pm 275$	$958 \pm 252$	
HT9 Average (#4-6)		$906 \pm 75$	$1144 \pm 127$

Note: \*Stopped after yielding plus first observable deformation in tensile gauge

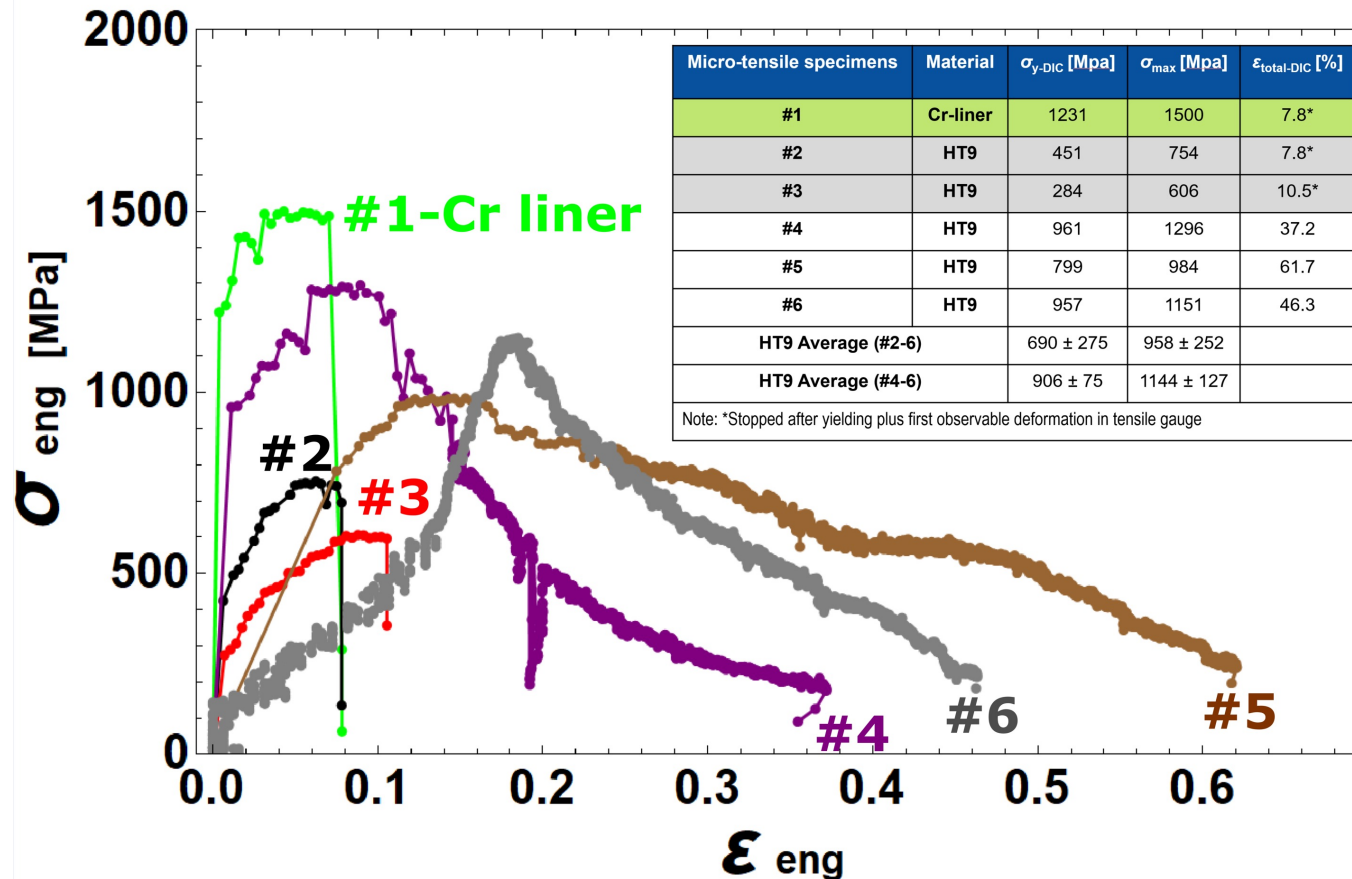
# Figure 4: Stress-Strain curves for In-situ SEM micro-tensile testing

In-situ SEM micro-tensile testing was conducted at RT:

1. One Cr-liner micro-tensile bar and five HT9 bars tested
2. Microtensile bar gauge geometry:  $3 \mu m * 3 \mu m * 8 \mu m$
3. The measured stress-strain results, together with yield strength and ultimate tensile strength results, were shown in the figure.
4. As expected, the Cr-liner bar exhibited much stronger strength than the HT9 ones
5. Among the five tested HT9 micro-tensile bars, the #2 and #3 showed remarkable mechanical softening as indicated by their much lower yield strength (284-451 Mpa) than that of the rest three HT9 tests (799-961 Mpa). Mechanical softening in reactor-irradiated HT9 cladding has been reported recently (33A work)
6. TEM characterization on tested bar3 and bar2 will add on insight into understanding the observed softening
