A617 Notch Effect and Crack Growth Testing Status

**Idaho National Laboratory
Idaho Falls, Idaho 83415**

Joint ART Materials/AMMT Program Review

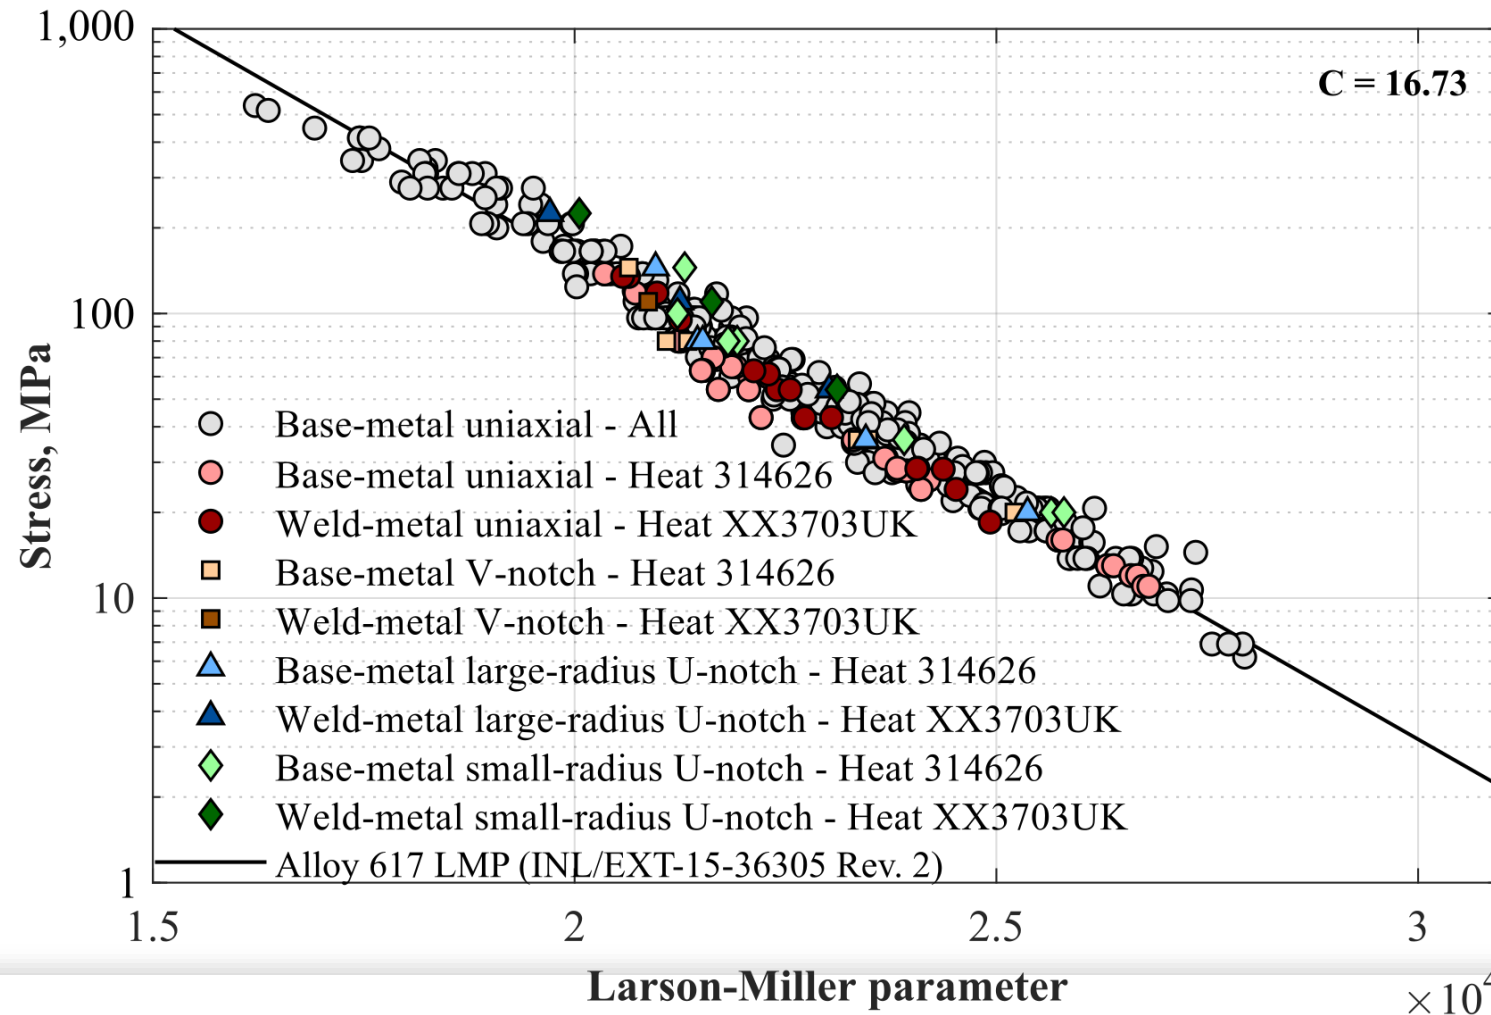
Alloy 617 base- and weld-metal short-term (aim 1,000 to 2,000-hour rupture life) creep-rupture properties were not degraded by geometric discontinuities nor multiaxial-stress states.

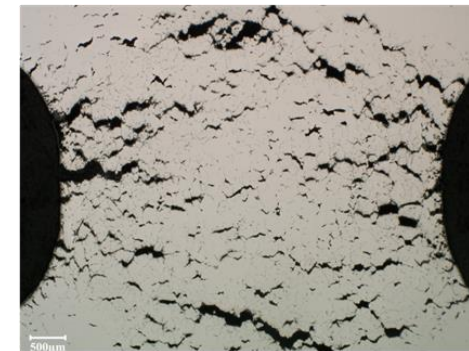
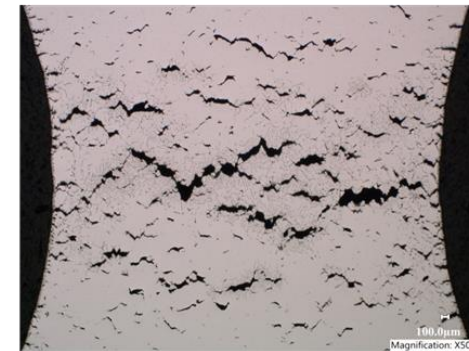
1,000°C, 20 MPa

Small radius

Large radius

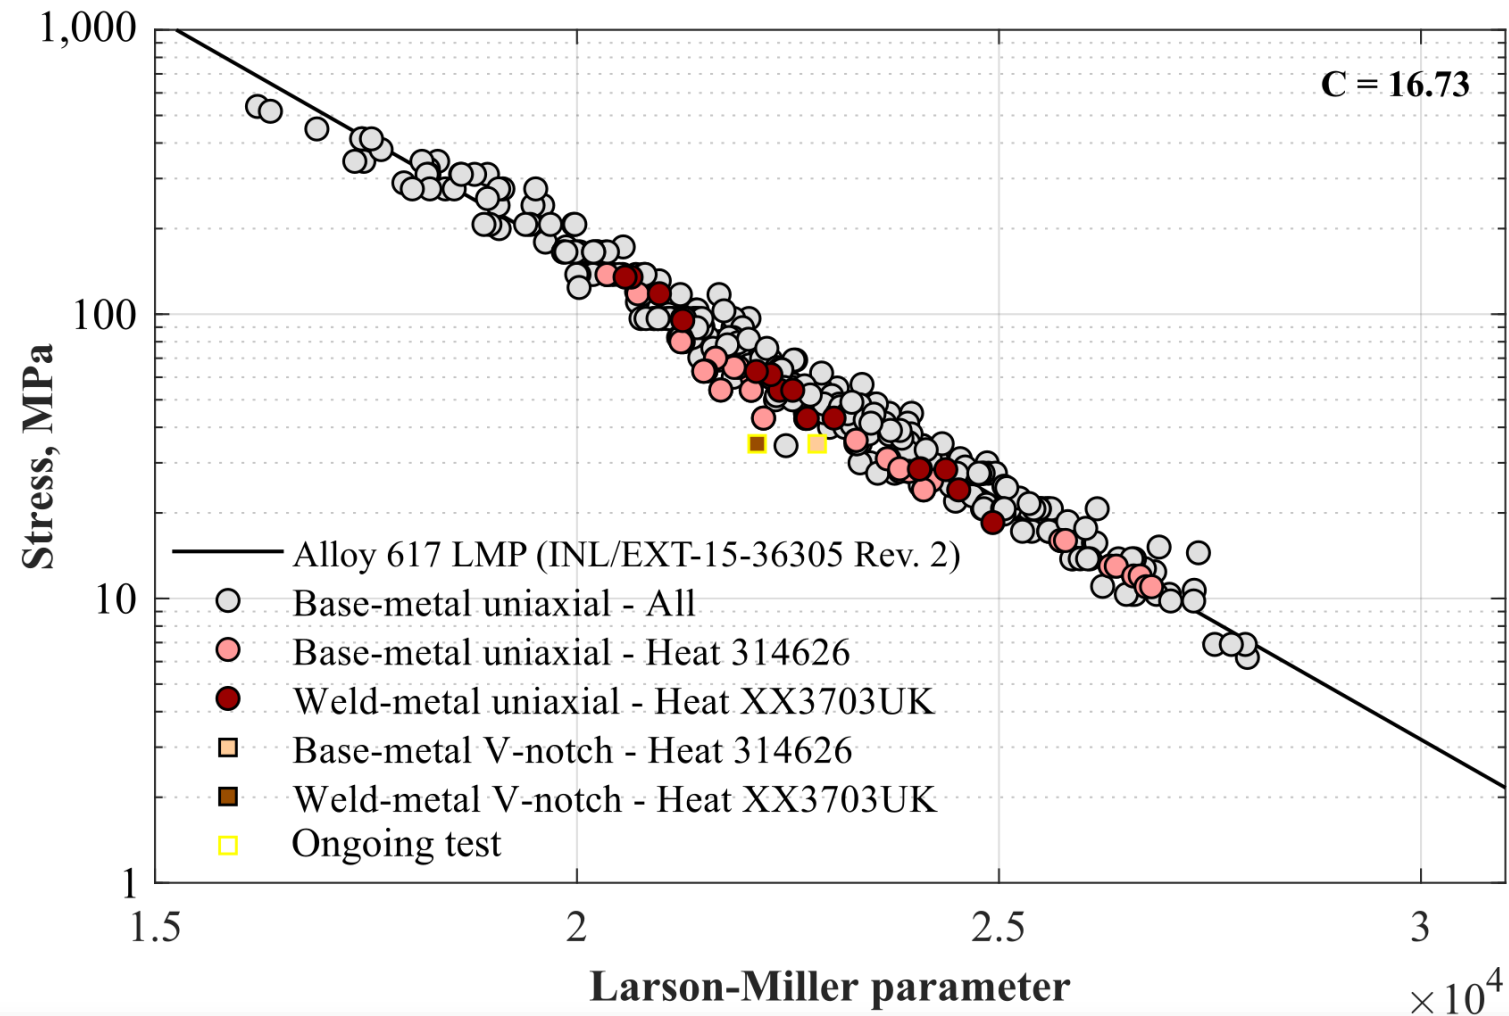
Long term

- A base- and a weld-metal V-notch creep-rupture test with an estimated 100,000-hour rupture life are in progress.

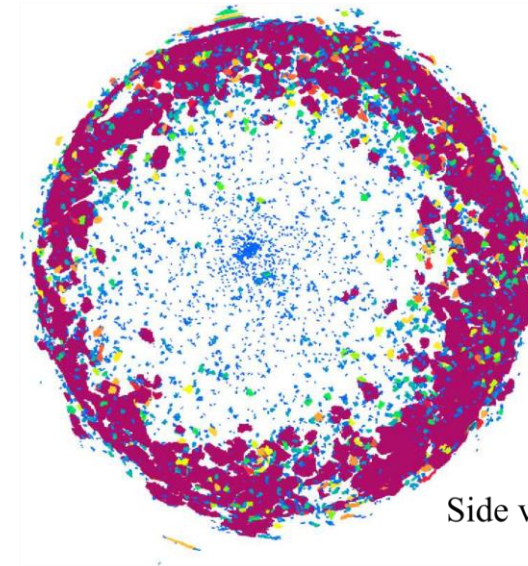
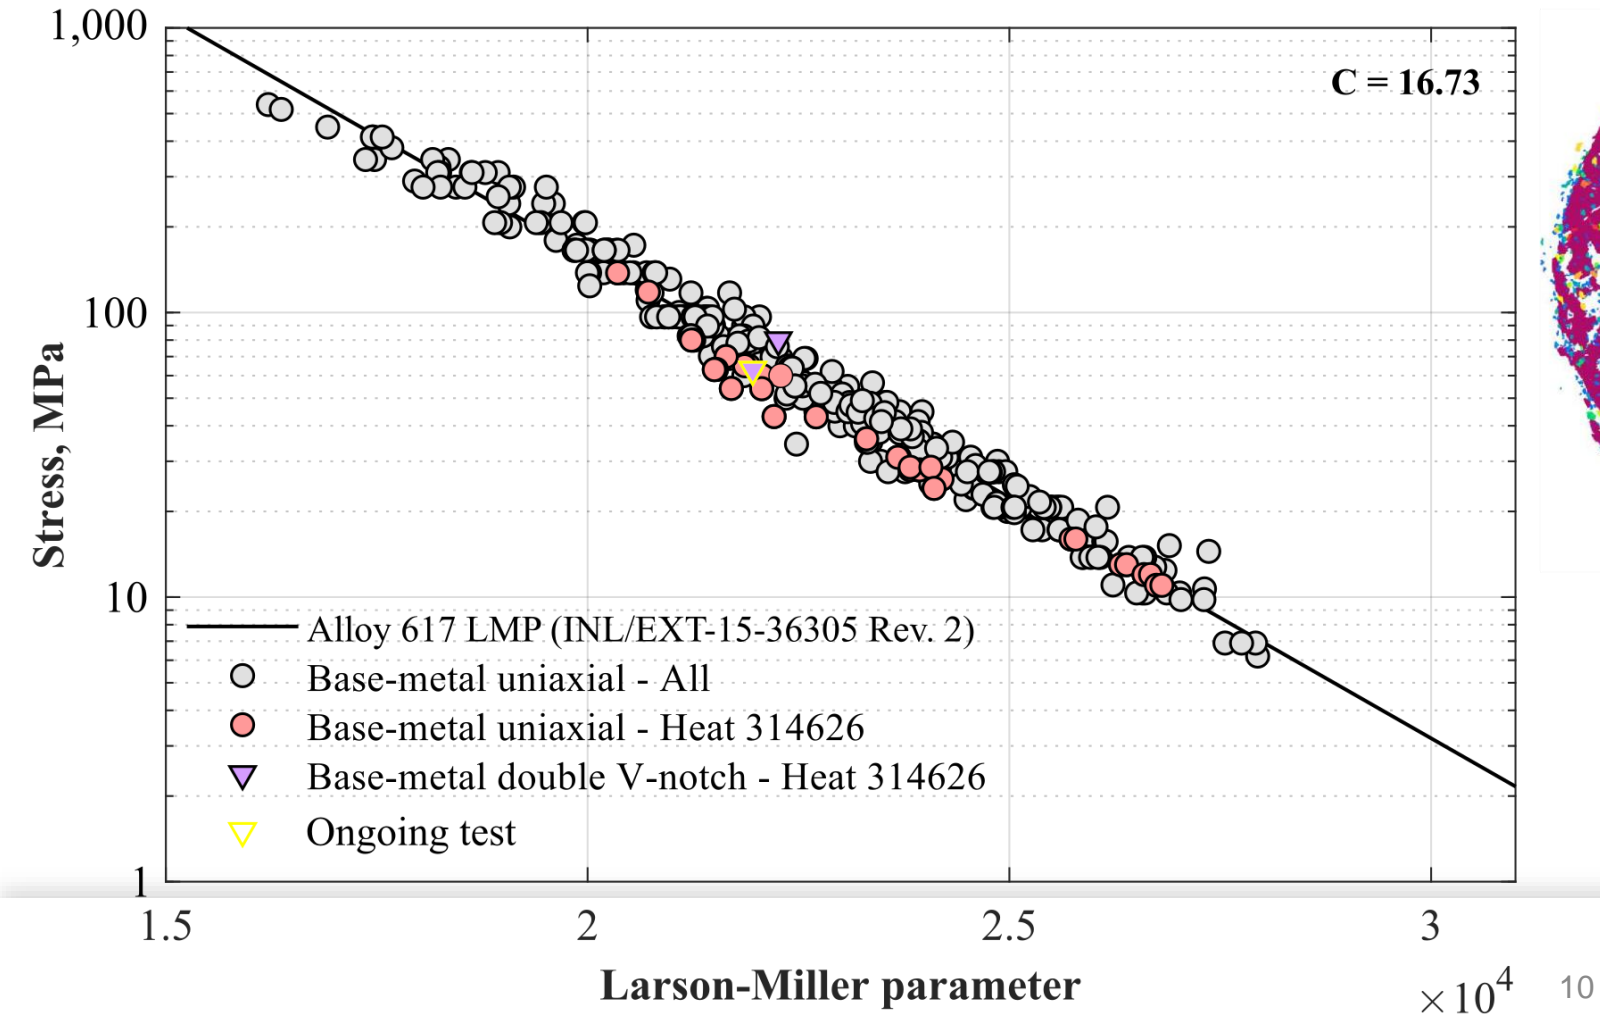
Double V-notch creep results

Top view

Side view

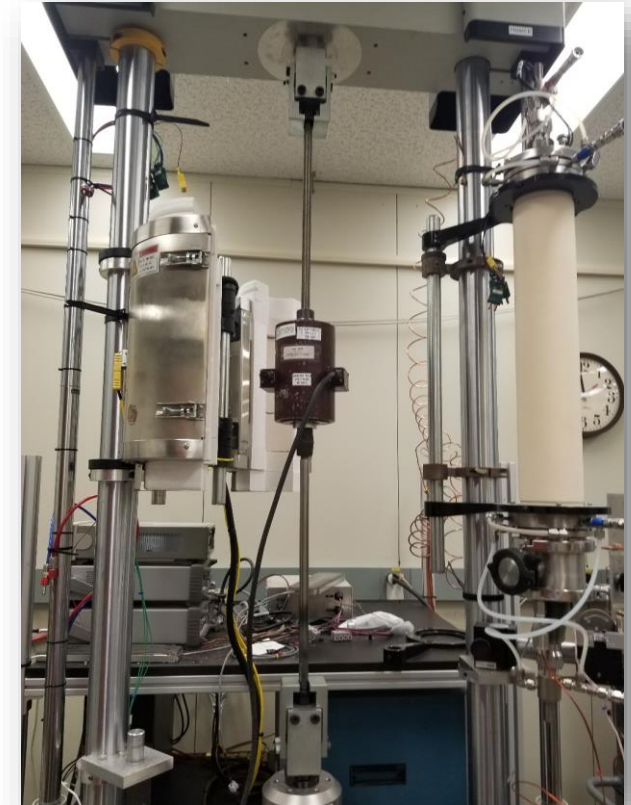
Setup (fatigue)

- A test frame with attached direction current potential drop (DCPD) system provides real time crack-growth information which allows for constant stress intensity testing (K) to be performed.
- Crack growth can be measured by the DCPD because as a crack propagates, the electrical resistance in a specimen increases and the resulting potential drop can be correlated to the crack length.
- Crack-propagation data can provide insights on fatigue, creep-fatigue, and creep behavior which are necessary in a component safety analysis.

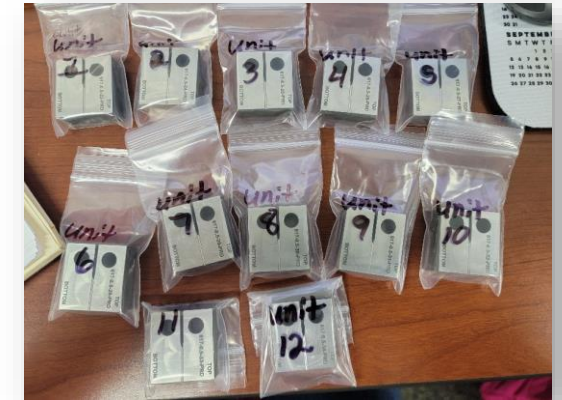
Alloy 617 CT Specimen

- Most of the 2022 fiscal year (FY-22) has been spent completing necessary preparatory work including:
- **Acquiring Components:**
 - Alloy 617 compact-tension (CT) specimens (0.5T) have been machined.
 - Laboratory equipment necessary to perform crack-growth testing in air using a DCPD to measure crack growth has been assembled.
- **Crack Growth Validation Testing:**
 - A test plan developed in a previous study at INL was implemented.
 - The results show good agreement with previous results for the same test plan.
 - A discrepancy of approximately 5 percent was observed between the computed crack length from the DCPD and the optical crack measurements.

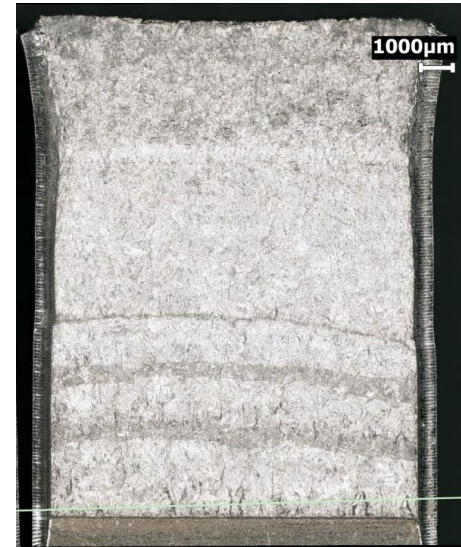
- Testing was performed to examine accuracy of direct current potential drop (DCPD) measurements
- The setup (left image) included an optical camera to image the crack during the test (top image), as well as the DCPD wire connections
- Test segments were run at changing K_{\max} and R values to create distinguishable crack sections on fracture surface (right image)

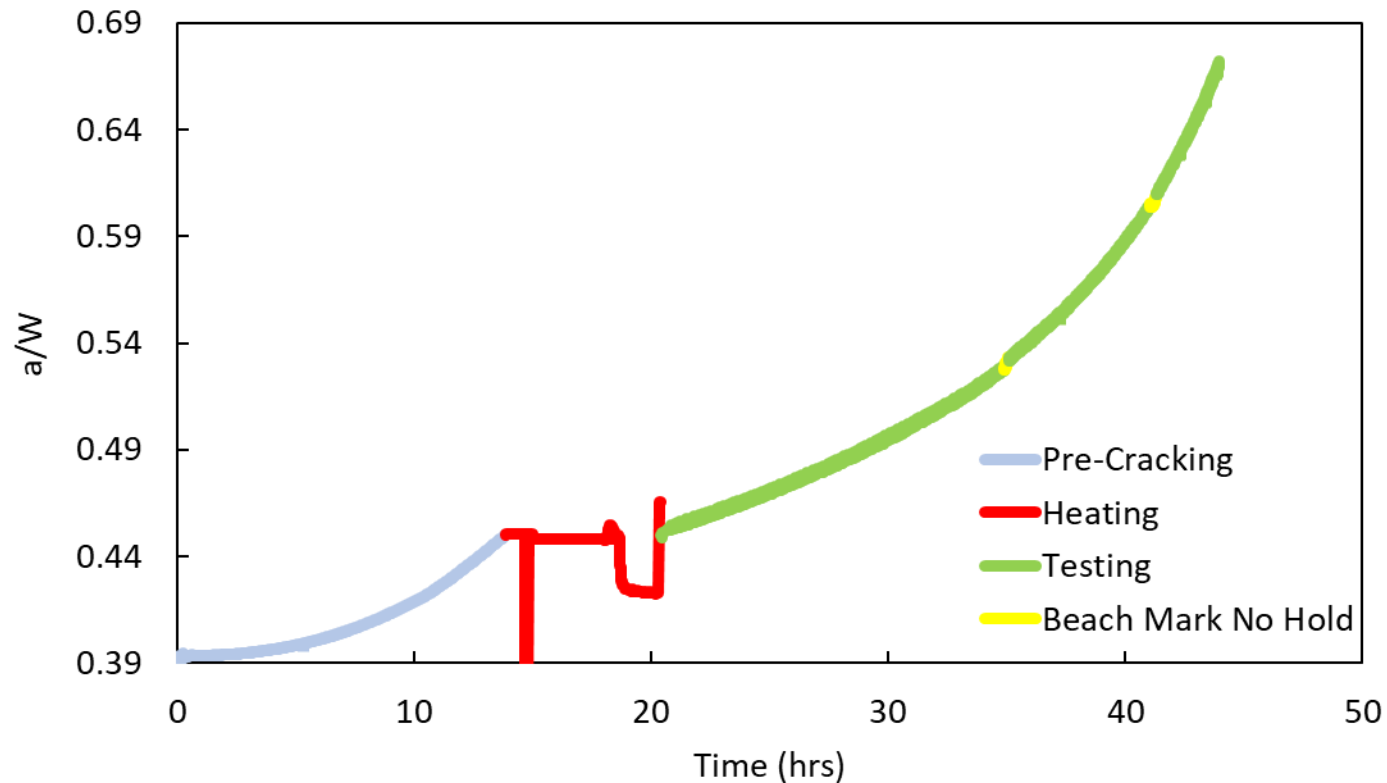
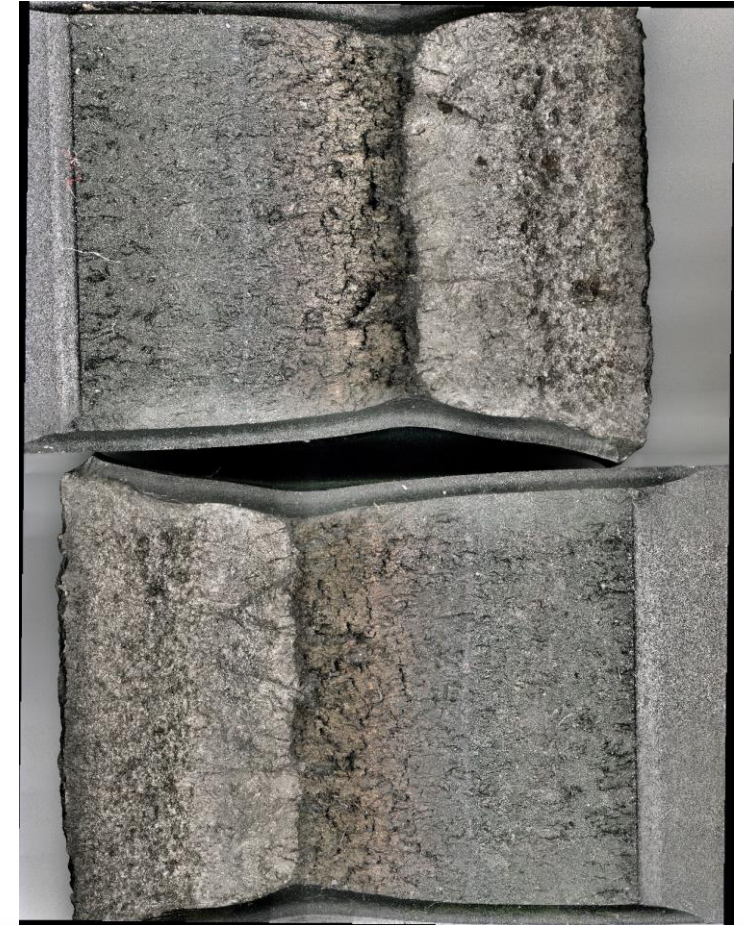
- Single test performed, using load line displacement, as measured by the actuator displacement
