July 2023

Initial results from electron microscopy from AGR-5/6/7 Capsule 1 fuel and applications of other microanalysis techniques to irradiated TRISO fuel

DOE ART Gas-Cooled Reactor (GCR) Review Meeting

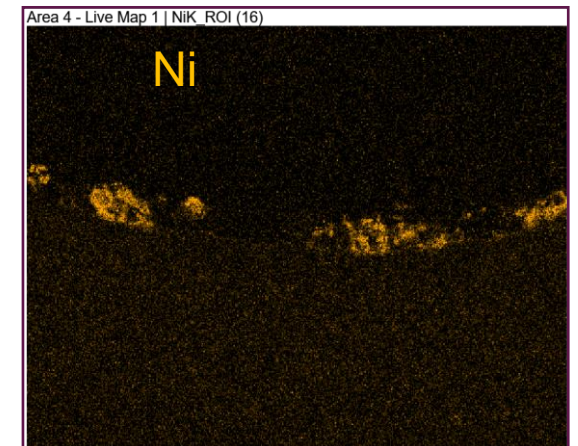
MNT-16G (Compact 1-7-9)

Element	Weight %	Error %
O K	1.9	10.5
Si K	81.9	3.6
Ni K	0.8	9.2
Pd L	3.3	5.1
Cs L	2.1	5.2
Ce L	0.9	11.5
U M	2.9	4.3
Pu M	6.3	4.3
