Irradiation-assisted Stress Corrosion Cracking of PWR Irradiated Type 347 Stainless Steel (NSUF CINR 19-16567)

Micheal R. Ickes, Gary S. Was, Kai Sun, Abdullah Sinjilawi, Lijin Dong

Final Report for NSUF Project 19-16567

RT-TR-22-25
Revision 0

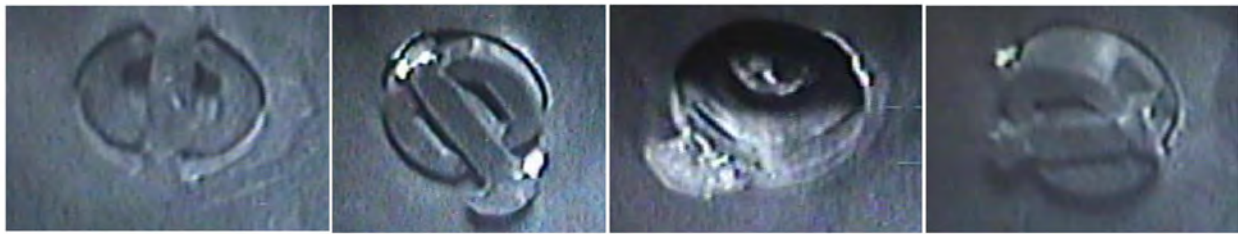
Figure 2-1: Intact Baffle-former Bolt (Left) and Failed Type 347SS Baffle-former Bolts in a U.S. 4-loop Down-flow PWR

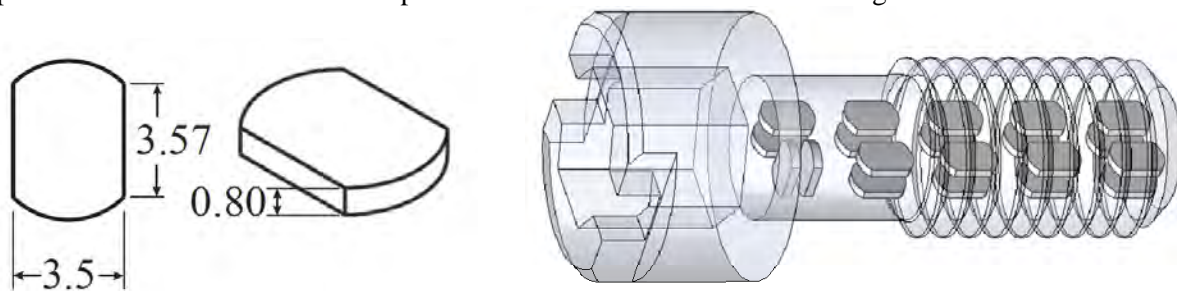
**Figure 3-1: Left - Specimen Geometry (Dimensions in millimeters)
Right – Specimens Inside 12.7mm Diameter Baffle-former Bolt Shank (conceptual sketch)**

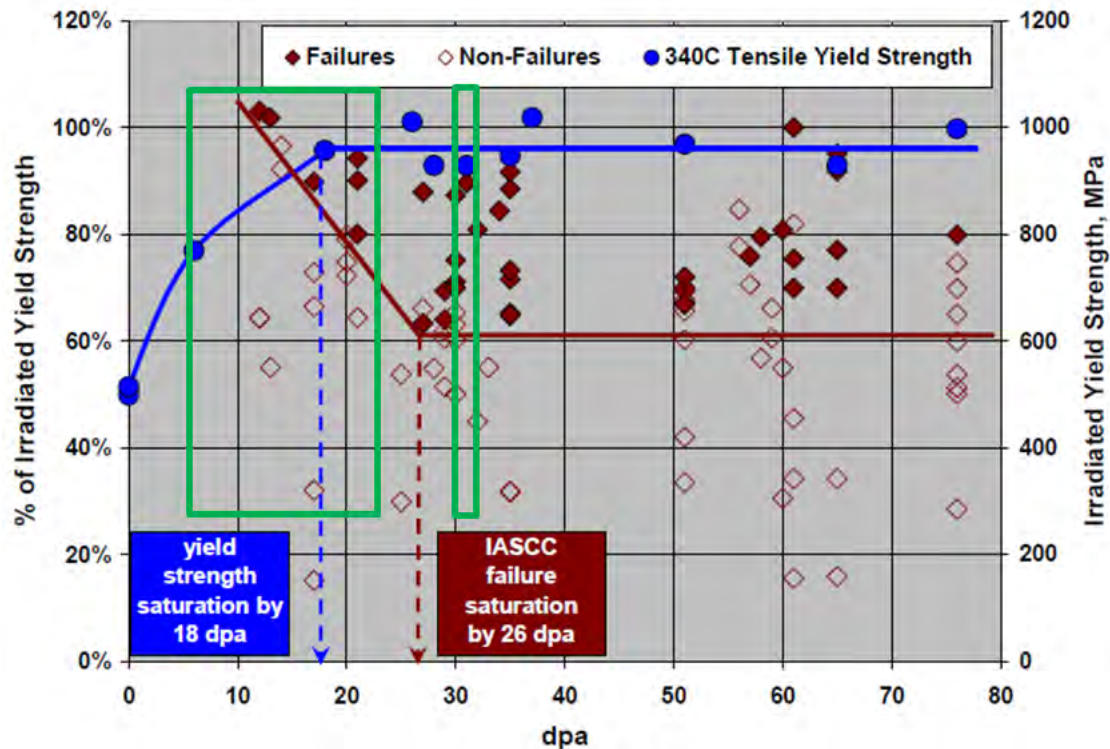
Figure 3-2: Areas to be investigated by this experiment shown in green boxes, relative to data generated by testing Type 316 O-rings irradiated in PWRs (Figure adapted from Reference 15)

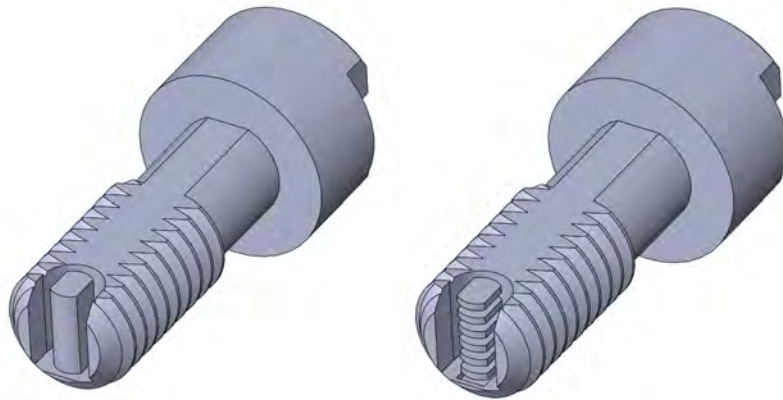
Figure 3-3: Baffle-former bolt (left) showing cross-section of 4-point bend specimen milled into the threaded end, and (right) the 4-point bend specimens cut free from the bolt.

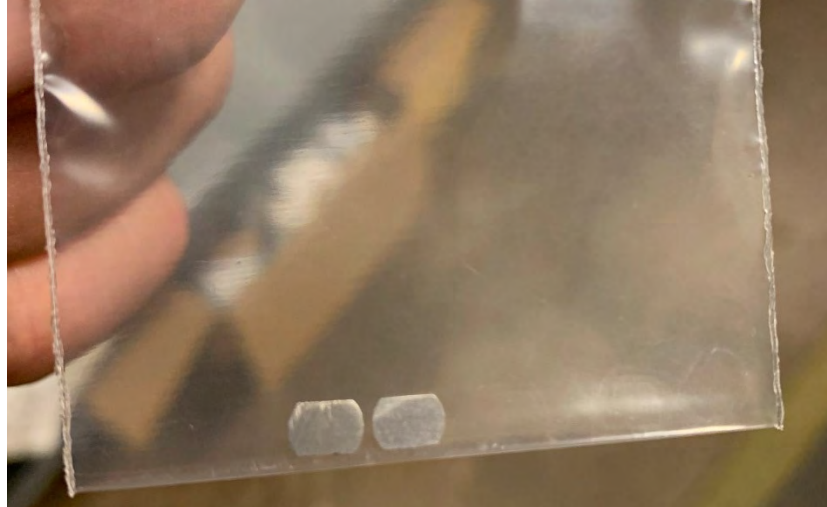
Figure 3-5: Practice 4-point bend samples (unpolished) from unirradiated practice bolt

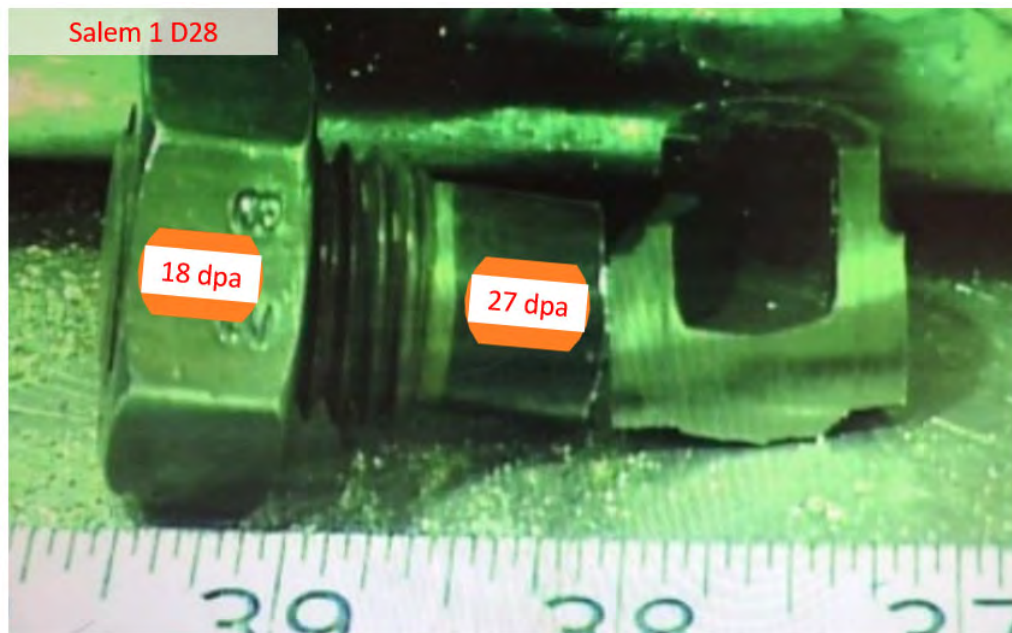
Figure 3-6: Approximate locations for specimen machining for Salem 1 bolt D28. The 18 dpa sampling location is at the end of the threaded portion of the bolt, obscured by the nut used for ID purposes.

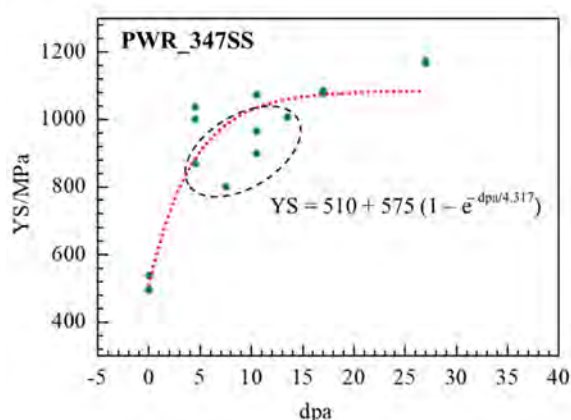
**Figure 3-12: Yield stress of 347SS as a function of dpa.**

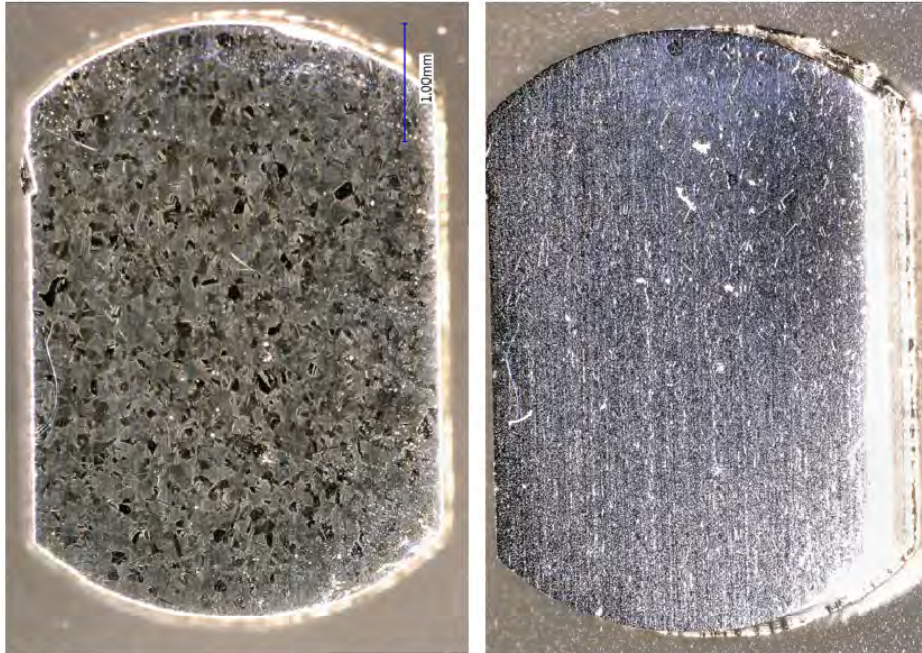
Figure 3-14: Effect of electropolishing showing difference between (left) as polished specimen and (right) specimen after 15 seconds of electropolishing

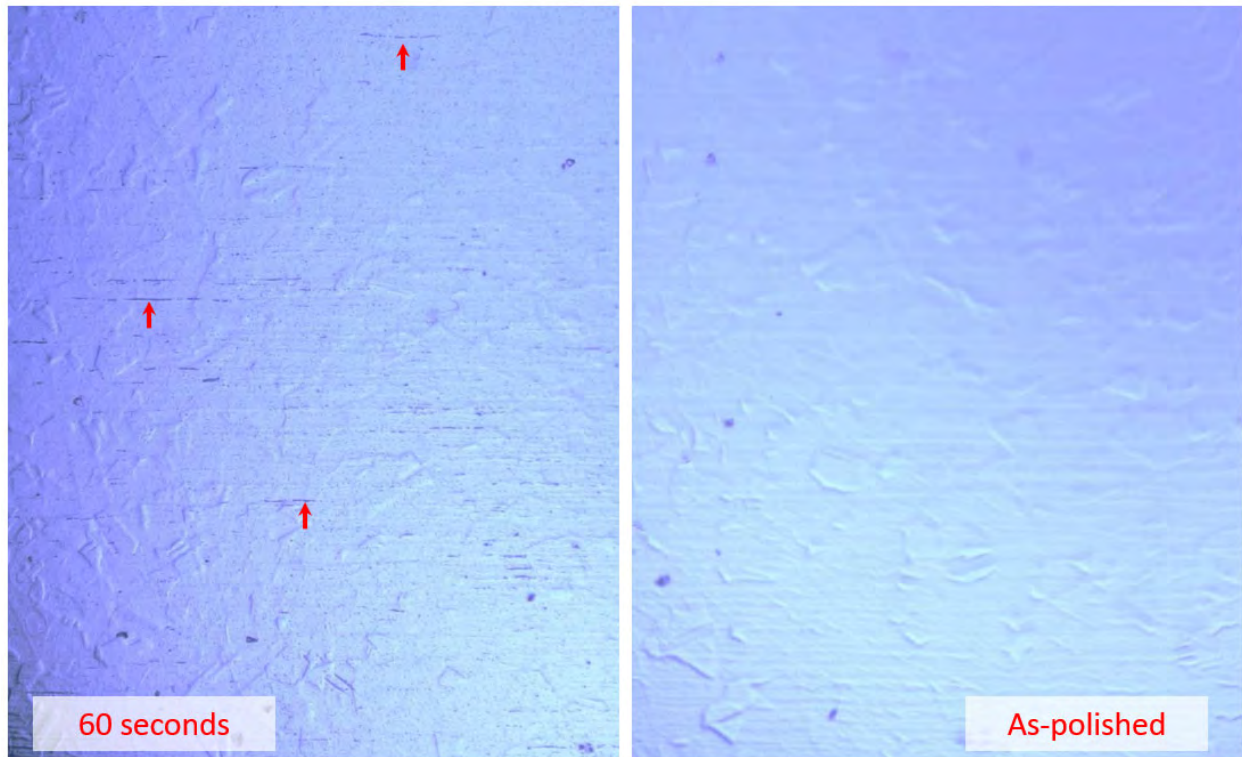
Figure 3-15: Effect of electropolishing showing difference between (right) as polished specimen and (left) specimen after 60 seconds of electropolishing, with the etching of stringers indicated by red arrows

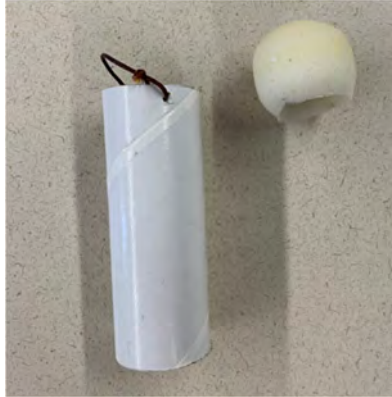
Figure 3-16: Tube to contain 5 4-point bend specimens in membrane boxes

The specimens remained in the Konductomet specimen holder during the electropolishing process. This allowed for easier handling during the electropolishing process. The specimens were then removed from the temporary mounts, cleaned in acetone, and subsequently placed in membrane boxes that were left open to facilitate photographing and minimize handling. The boxes were then closed and sealed to prevent exposure or contamination. First, the 5 specimens of each material condition were put into a tube (Figure 3-16). The five tubes of five specimens each were then placed into a piece of foam (Figure 3-17) used to center the materials when placed into the cask (Figure 3-18).

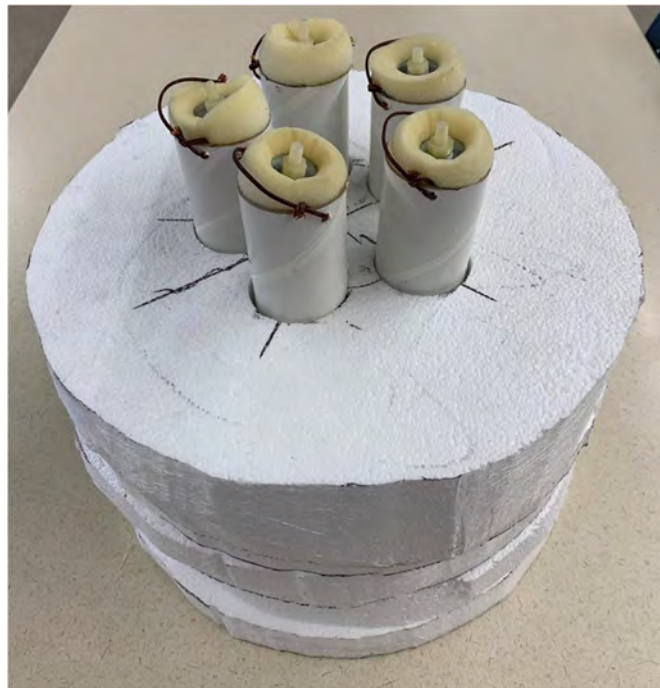
Figure 3-17: 5 Tubes (to each contain 5 4-point bend specimens in membrane boxes) Arranged in Foam for Insertion into Cask

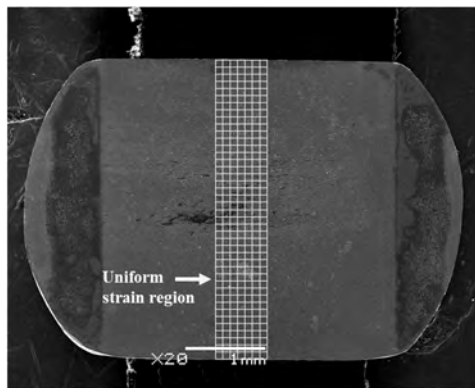
Figure 4-2: SEM image of one of the tested samples that showing the area that scanned with the SEM to detect the IASCC. Each box in the grid represents a $5.04 \times 3.78 \text{ }\mu\text{m}^2$ image and the grid contain 293 images.

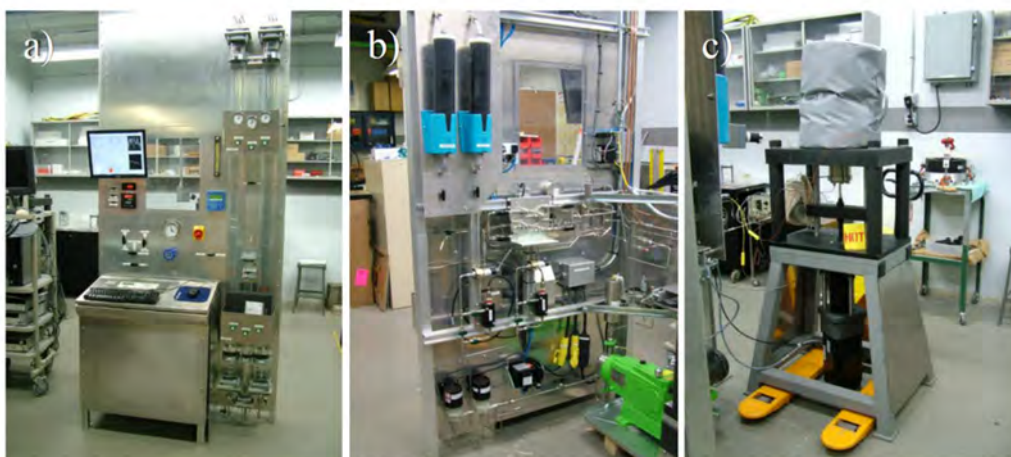
**Figure 4-3: Images of the autoclave test system and water loop. a) control panel front, b) control panel back with plumbing and sensors, and c) load frame, motor, and autoclave.**

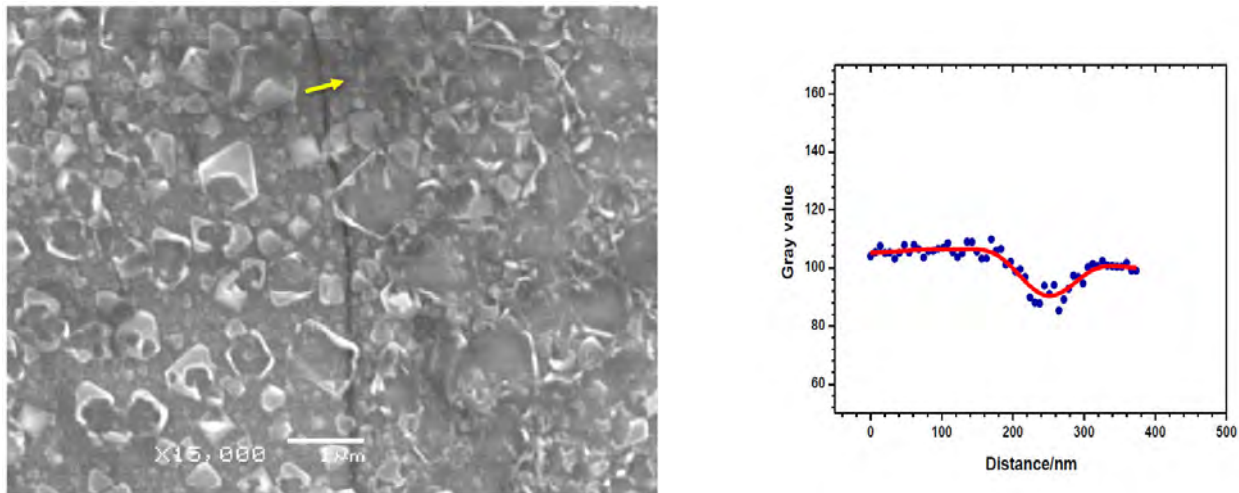
Figure 4-4: Intensity profile (right) across an oxidized grain boundary (left).

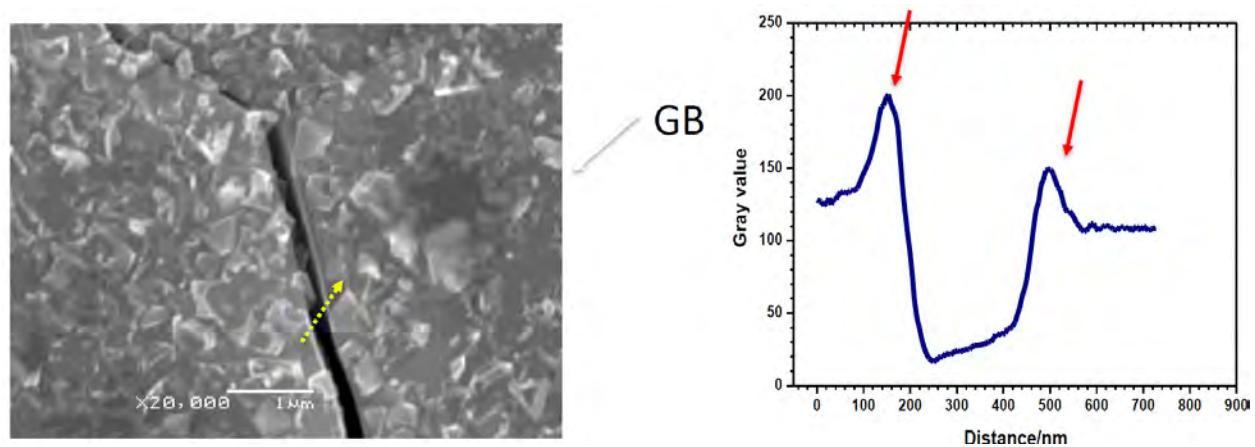
Figure 4-5: Intensity profile (right) across cracked grain boundary (left). Red arrows indicate intensity profile peaks associated with exposed corners of the grain.

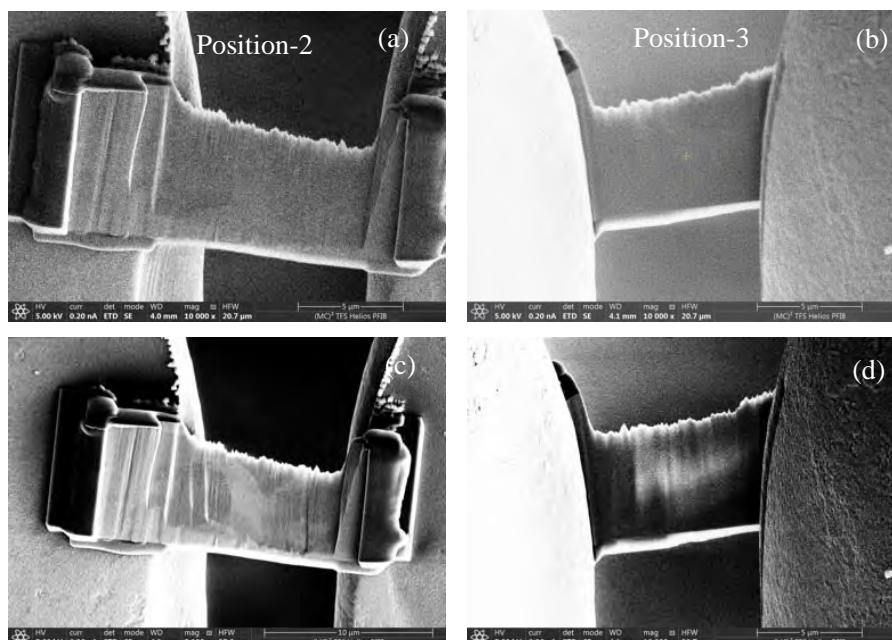
Figure 4-6: (a) and (b) show the two lamellas from the material D28H6 on the position 2 and 3 of the FIB grid; (c) and (d) show the two lamellas after having been further thinned.

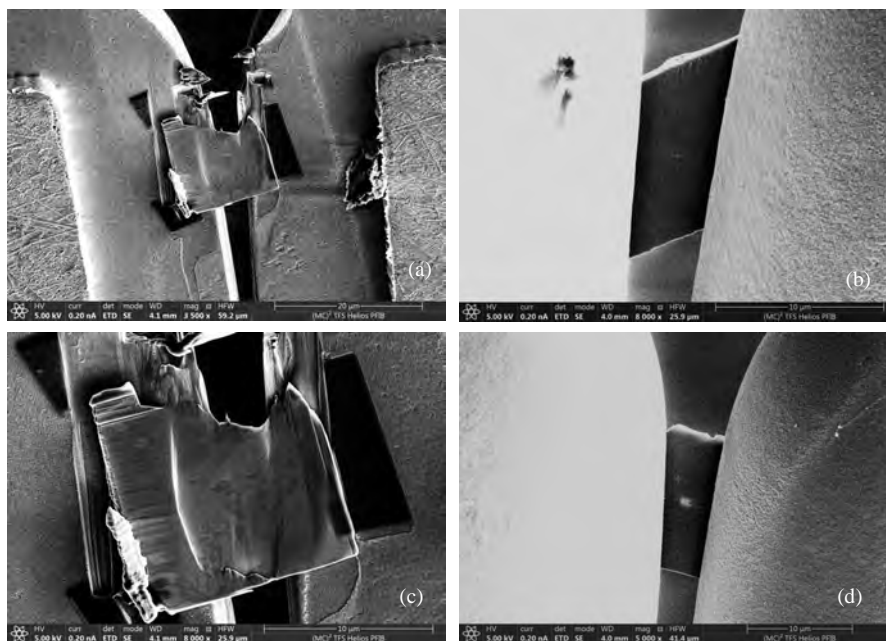
Figure 4-7: (a) and (b) show the two lamellas from the material R2C6T3 on the position 2 and 5 of the FIB grid; (c) and (d) show the two lamellas after having been further thinned (The liftout on the position 3 was missing).

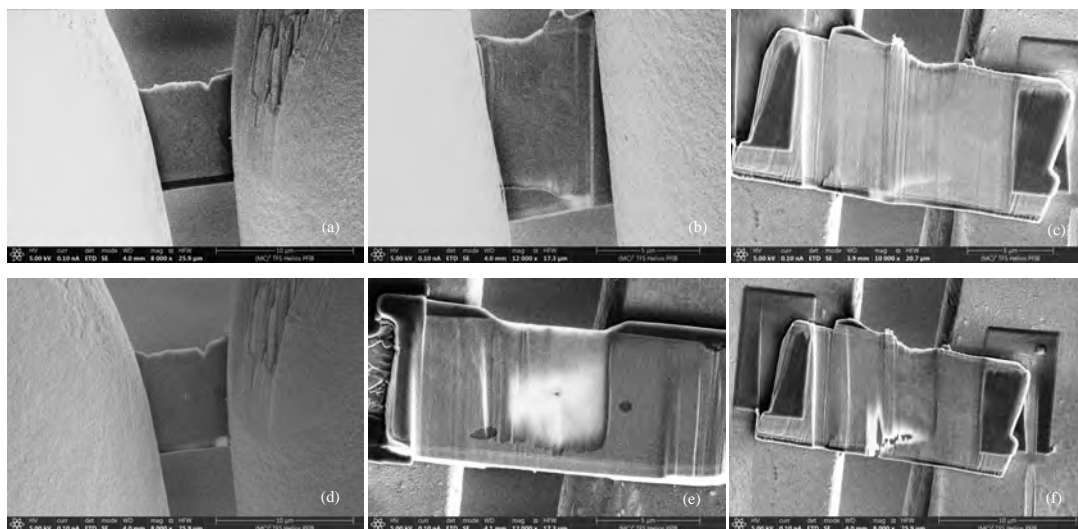
Figure 4-8: (a), (b) and (c) show the three lamellas from the material R6C6H5 on the position 2, 3 and 5 of the FIB grid; (d), (e) and (f) show the three lamella after having been further thinned.

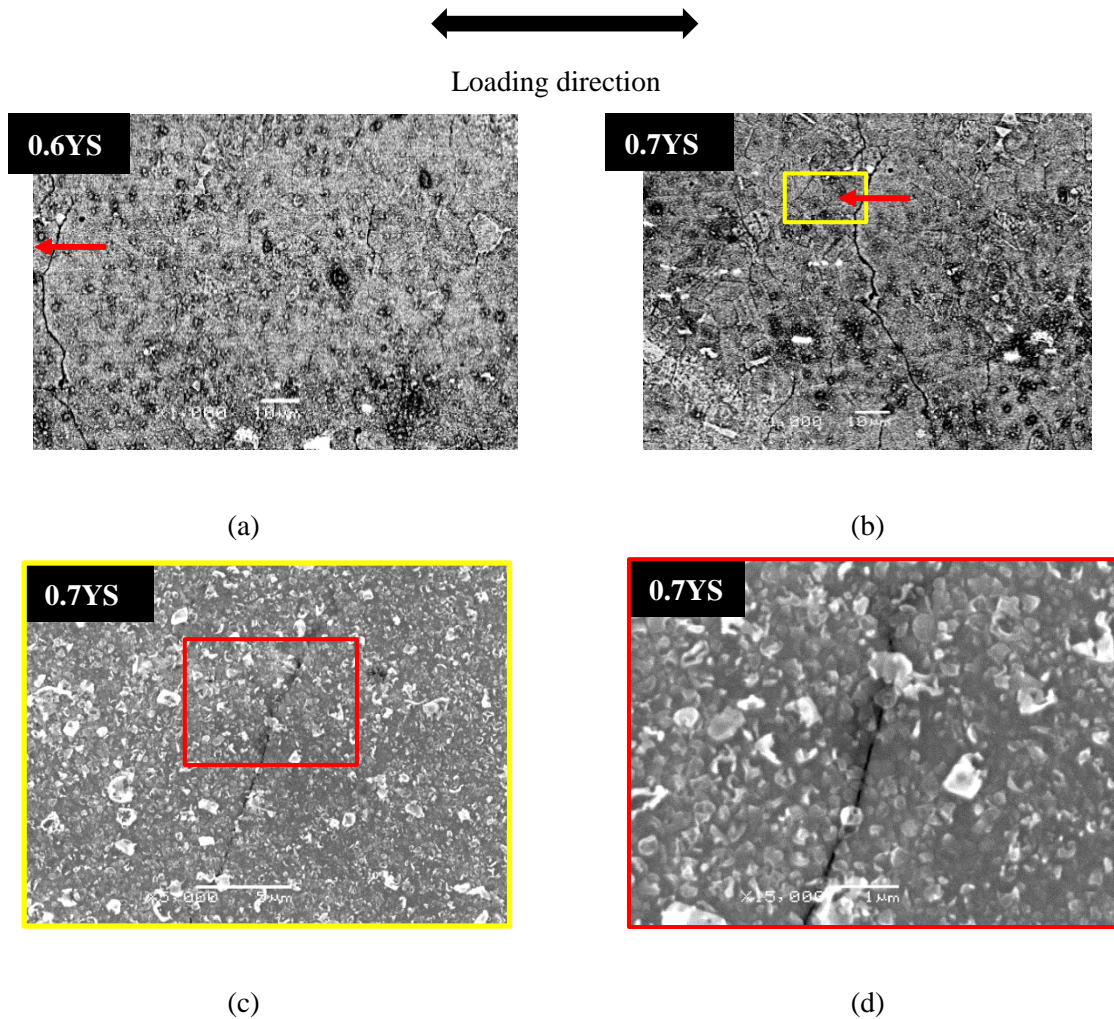
Figure 5-3: A representative crack from sample D28-H-3_26.4 (a) BSE image at 0.6 YS, (b) BE image of the same region at 0.7YS, (c) and (d) magnified SE image of the crack initiation site.

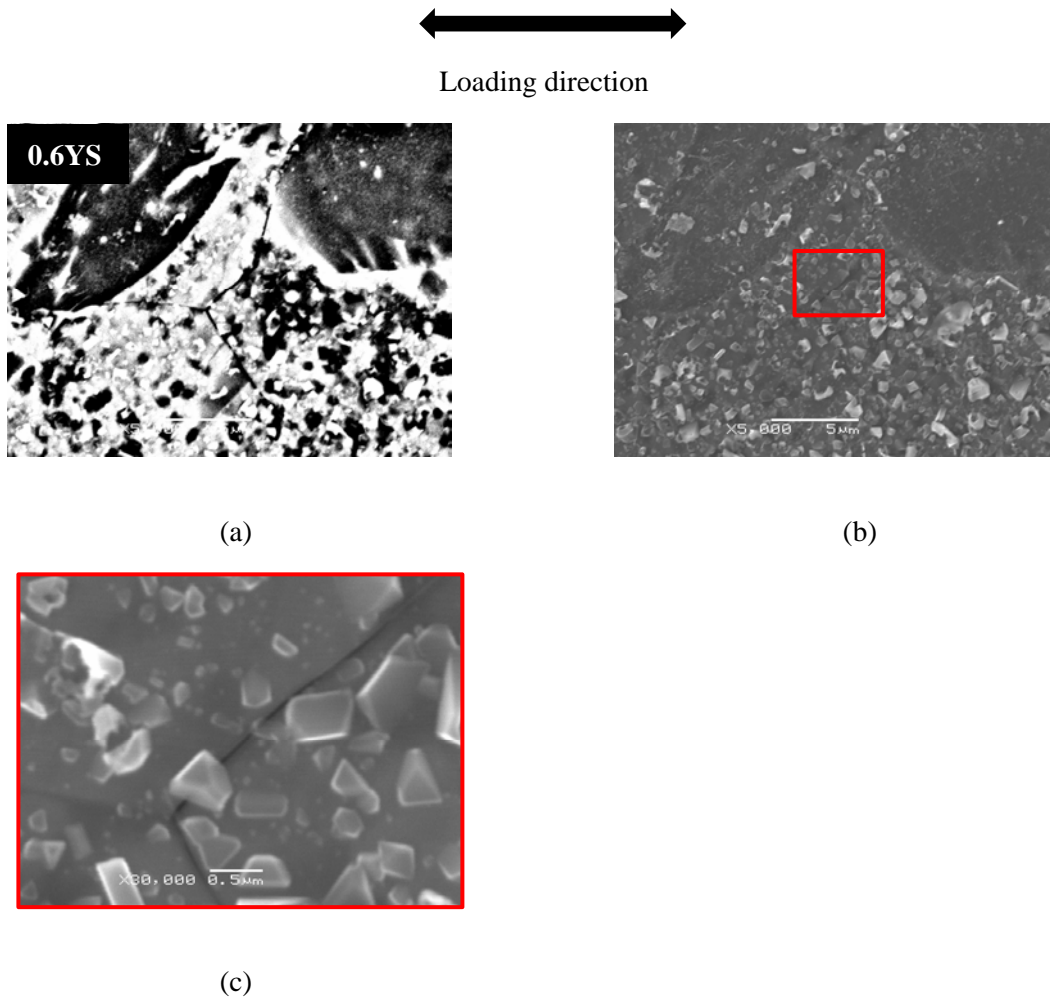
Figure 5-4: A representative crack from sample S-R6C6-H-4_18.4 at 0.6 YS. (a) BSE image, (b) SE image of the same region, (c) magnified picture of the crack initiation sites (Red Box in (b)).

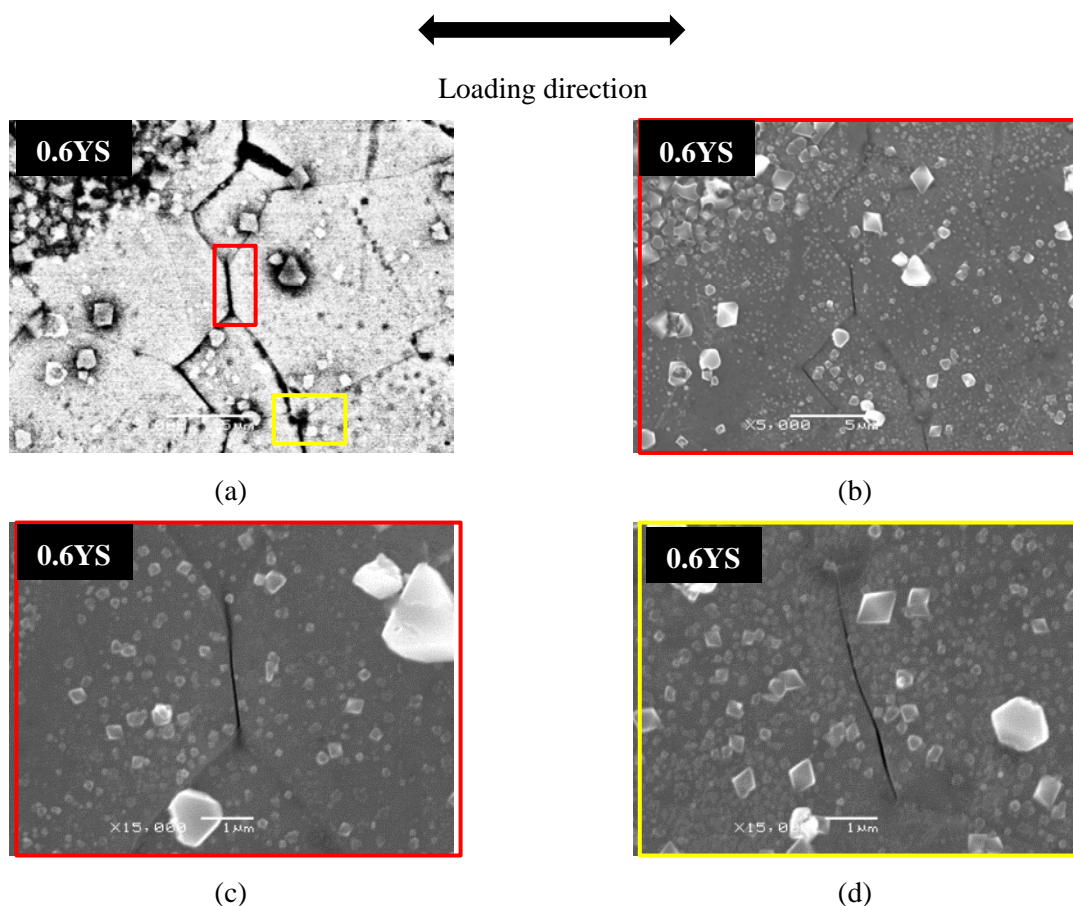
Figure 5-5: Representative cracks from sample S-R6C6-T-5_11.5 at 0.6 YS. (a) BSE image (b) SE image of the same region, (c) and (d) magnified SE image of the crack initiation sites.

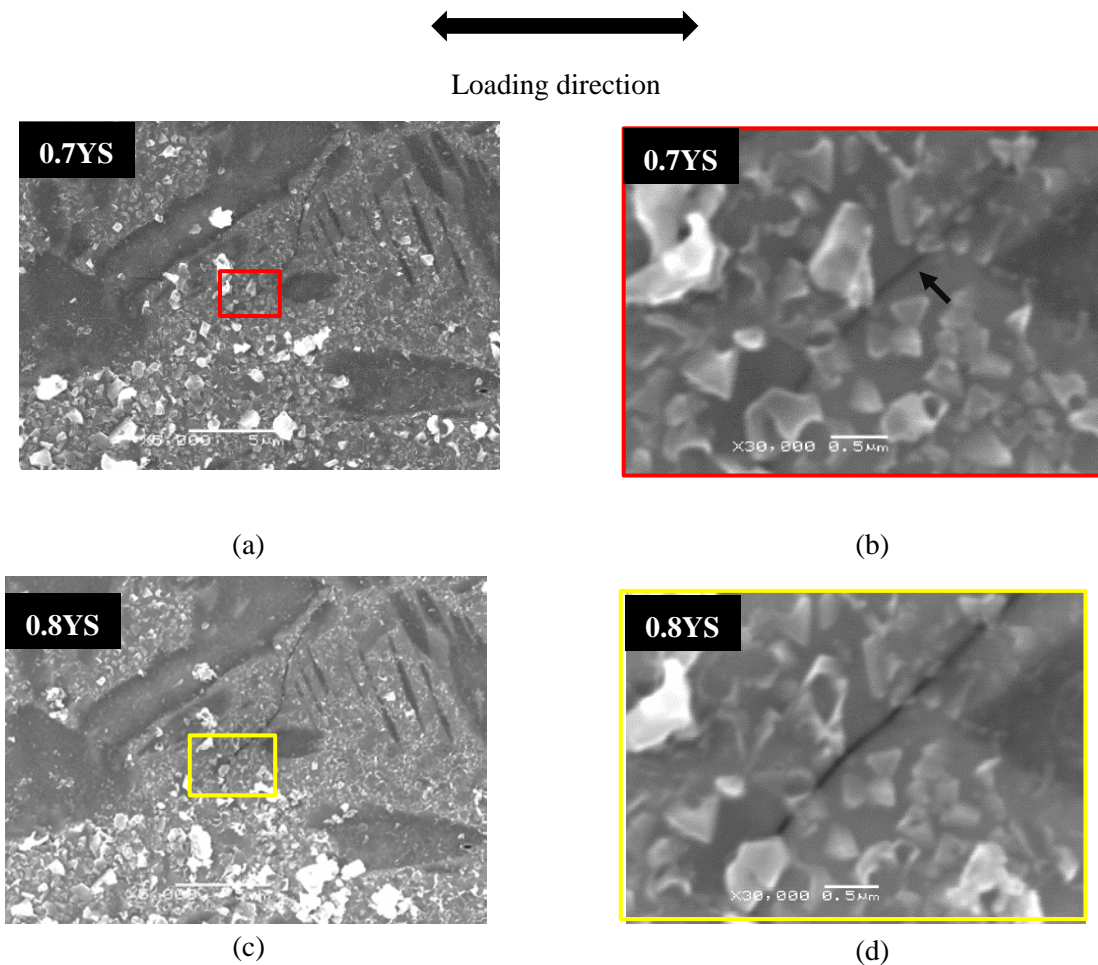
Figure 5-6: Representative cracks from sample S-R6C6-T-3_11.5 at 0.6 YS. (a) BSE image (b) SE image of the same region, (c) and (d) magnified SE image of the crack initiation sites.

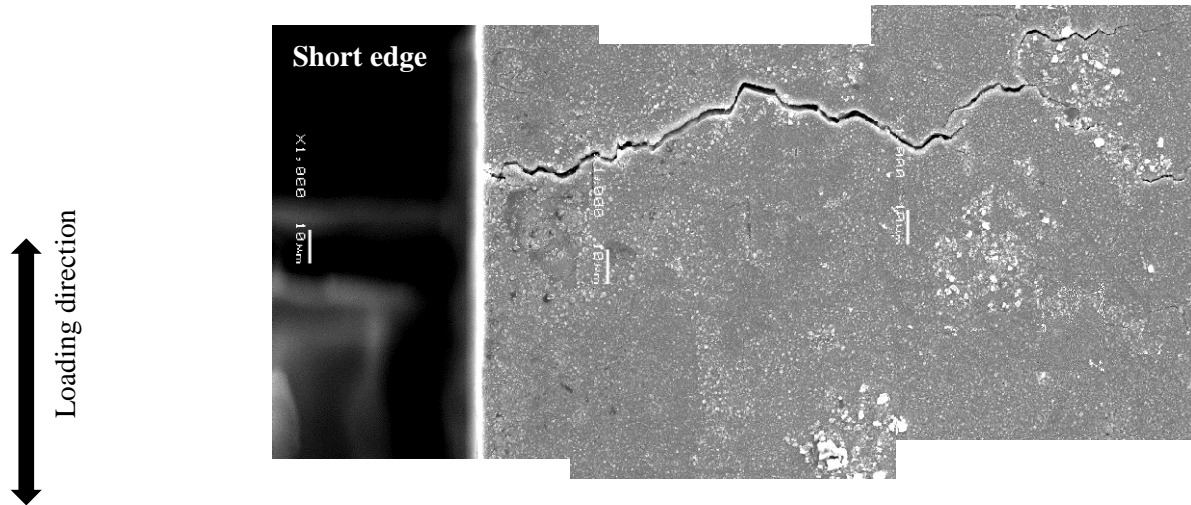
Figure 5-7: The largest crack from sample S-R2C6-T-1_7.8 dpa at 0.6 YS.

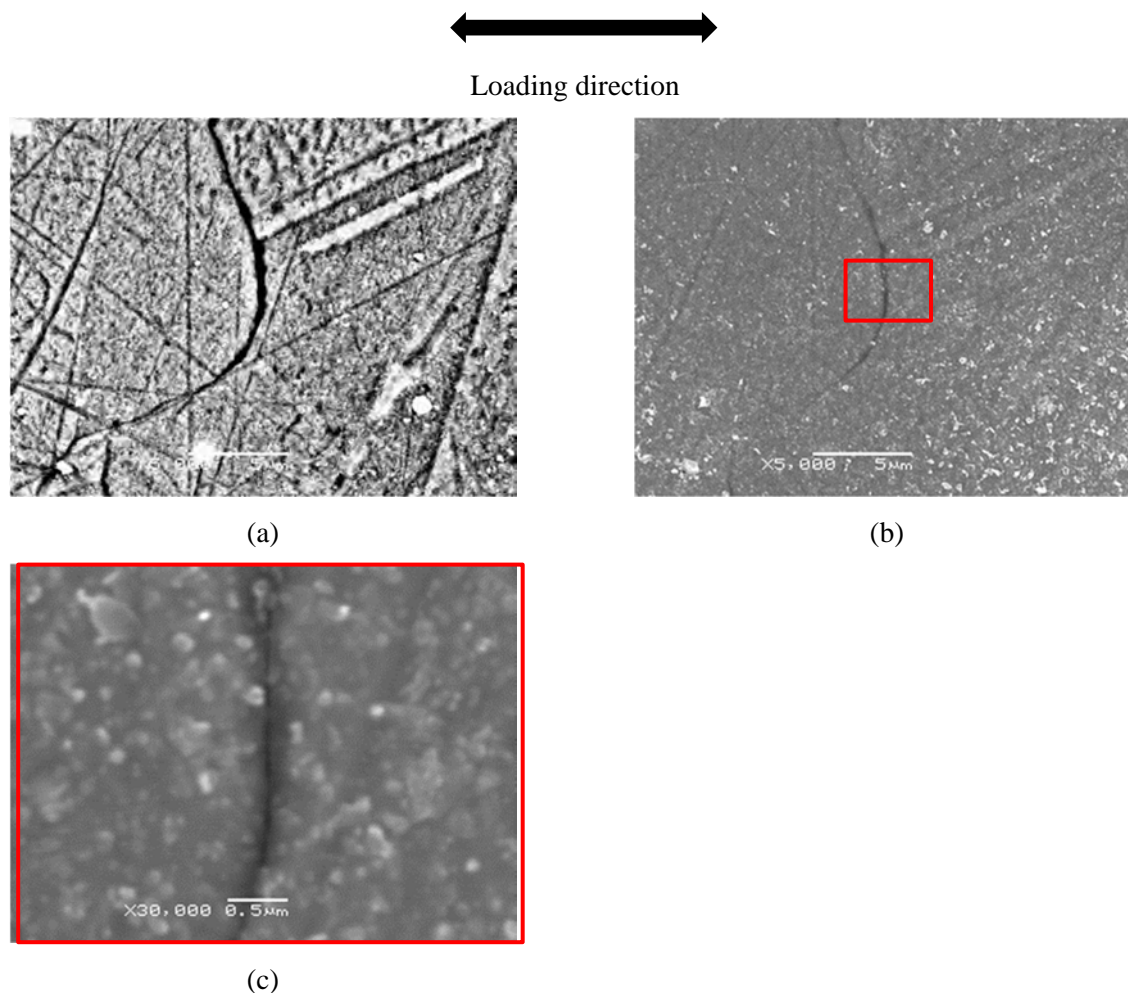
Figure 5-9: A representative crack from sample S-R2C6-T-2 at 0.8 YS. (a) BSE image, (b) SE image of the same region, and (c) a magnified SE image of the crack initiation site.

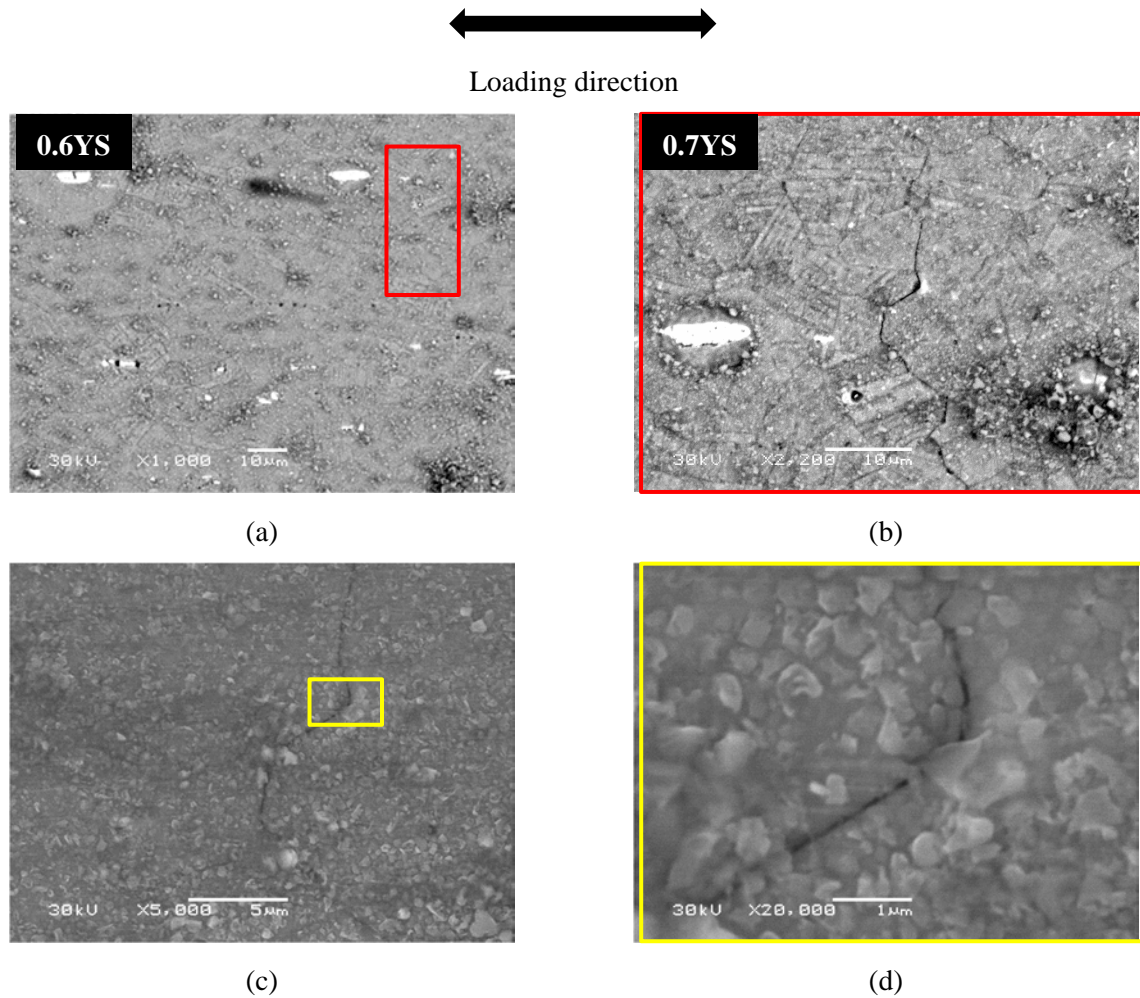
Figure 5-10: A representative crack from sample D28-T-2 at 0.7 YS. (a) BSE image, (b) magnified SE image of the same region, and (c) a magnified SE image of the crack initiation site, (d) a higher-magnification view of the yellow box in (c).

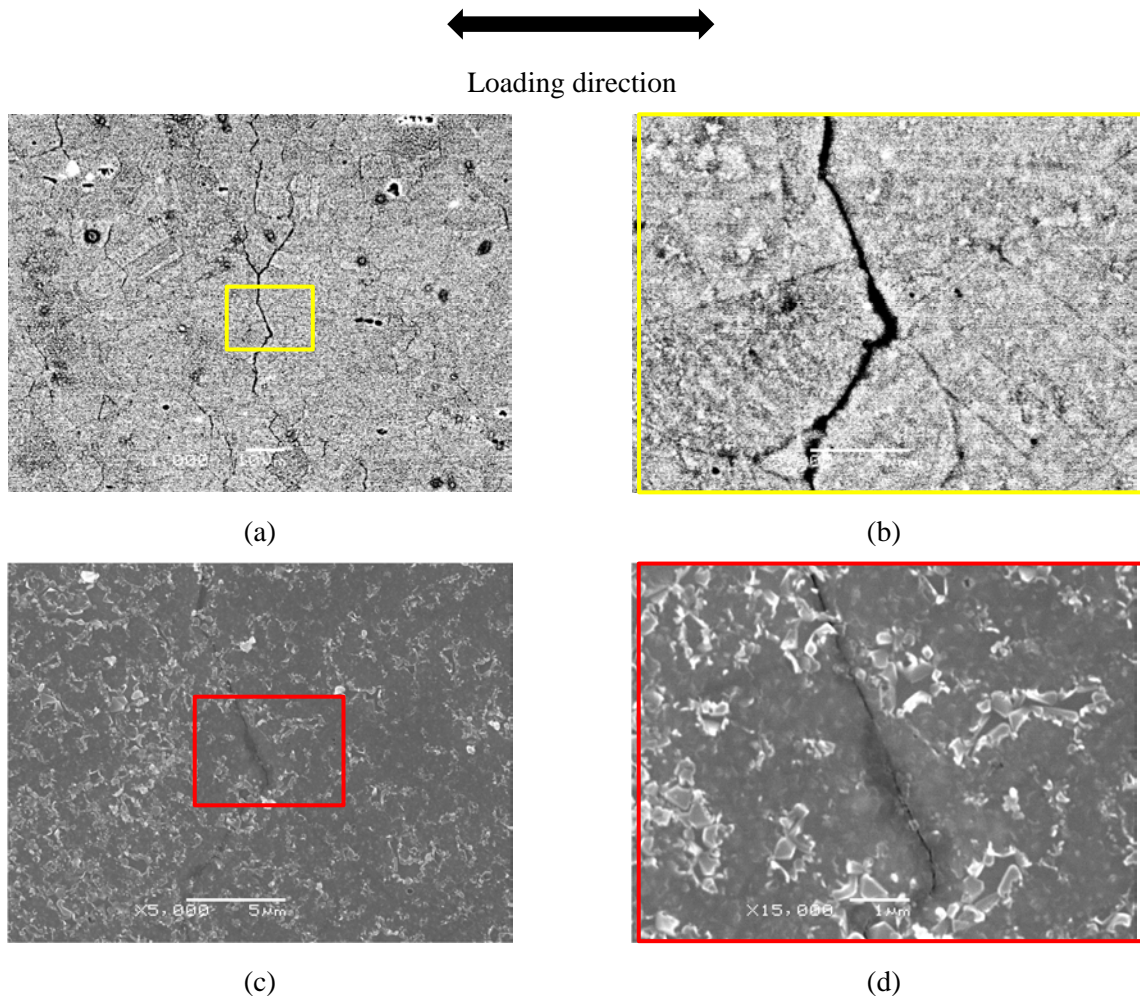
Figure 5-13: A representative crack from sample D28-H-2 at 0.8 YS in LiOH. (a) BSE image, (b) magnified BSE image, (c) SE image of the same region, and (d) magnified SE image of the crack initiation site.

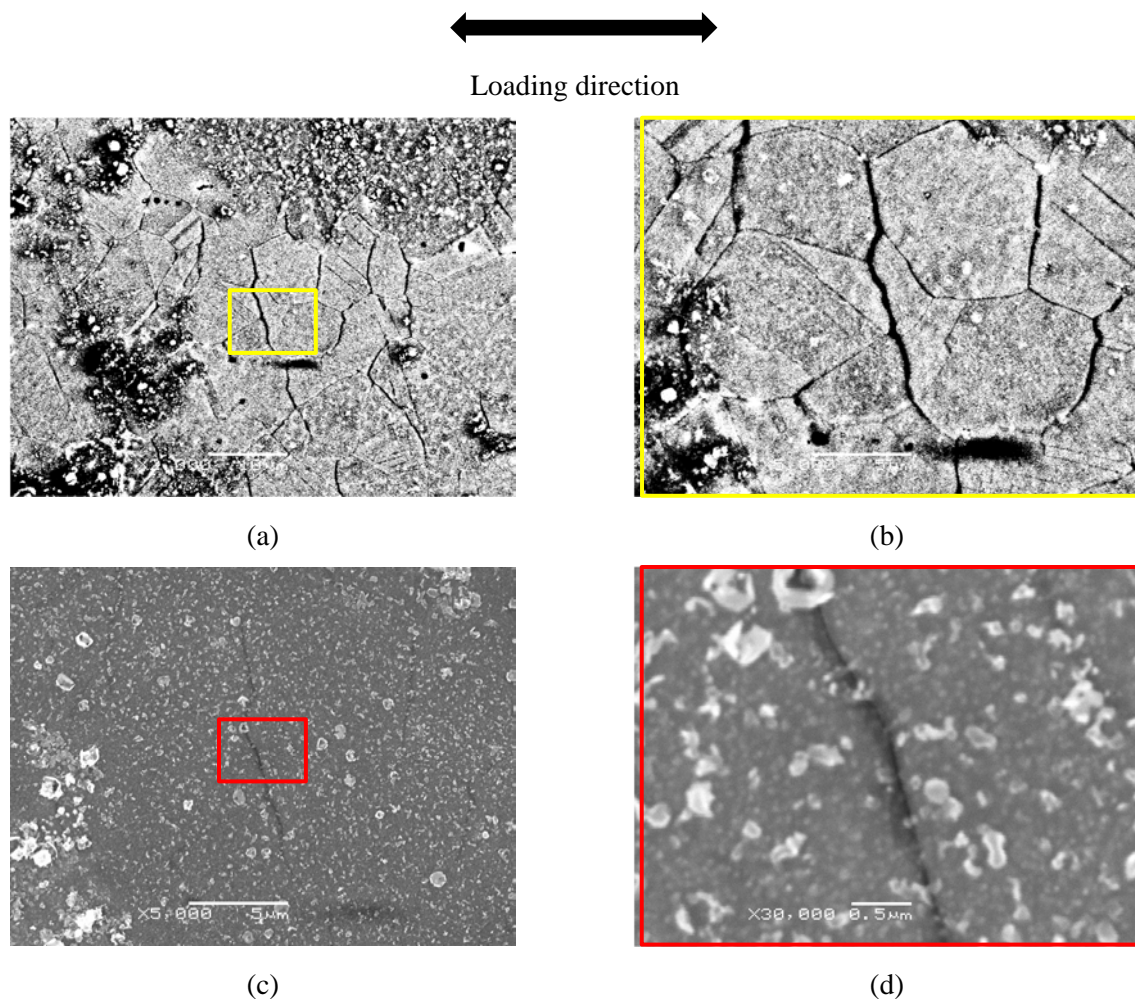
Figure 5-14: A representative crack from sample D28-H-1 at 0.8 YS in LiOH. (a) BSE image, (b) magnified BSE image, (c) SE image of the same region, and (d) magnified SE image of the crack initiation site.

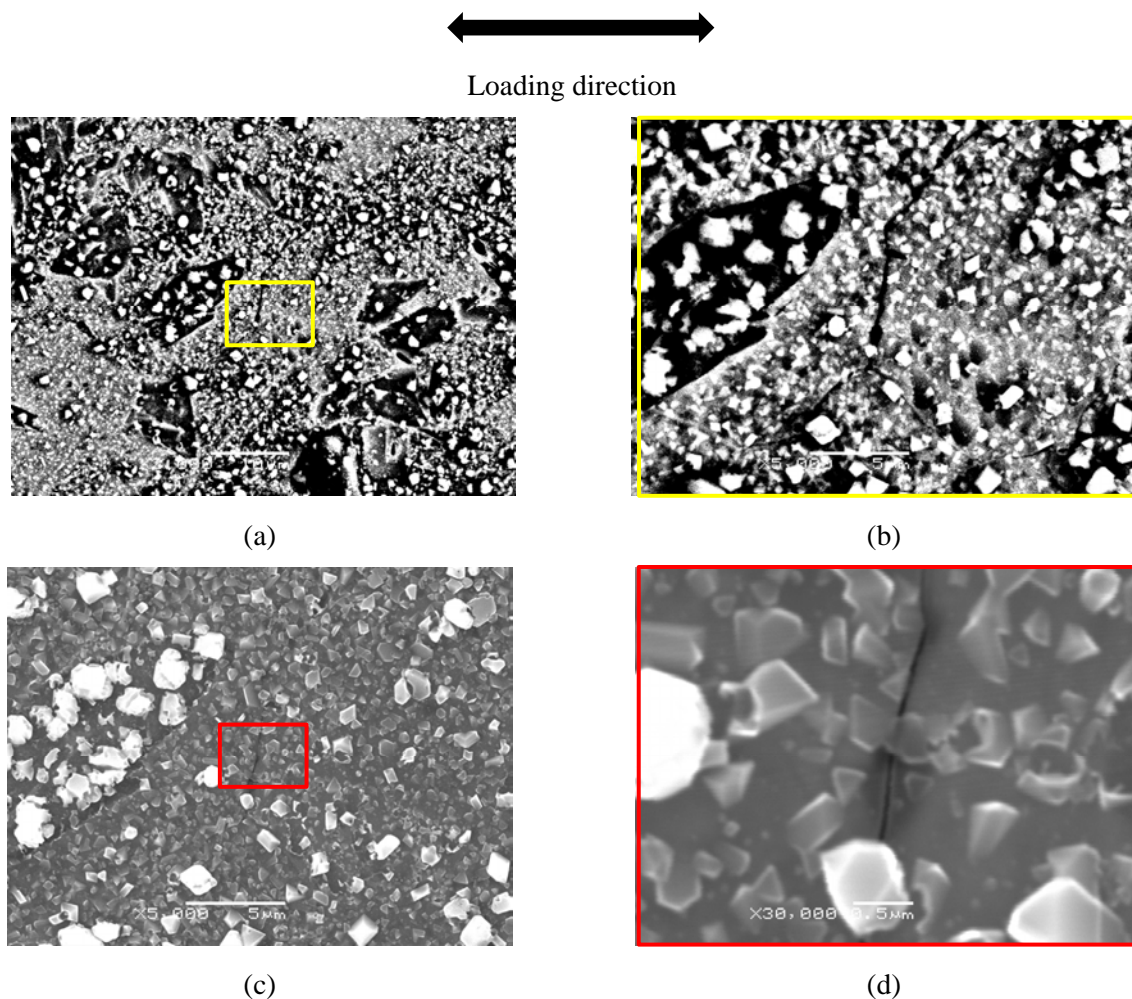
Figure 5-15: A representative crack from sample S-R6C6-H-3 at 0.6 YS in LiOH. (a) BSE image, (b) magnified BSE image, (c) SE image of the same region, and (d) magnified SE image of the crack initiation site.

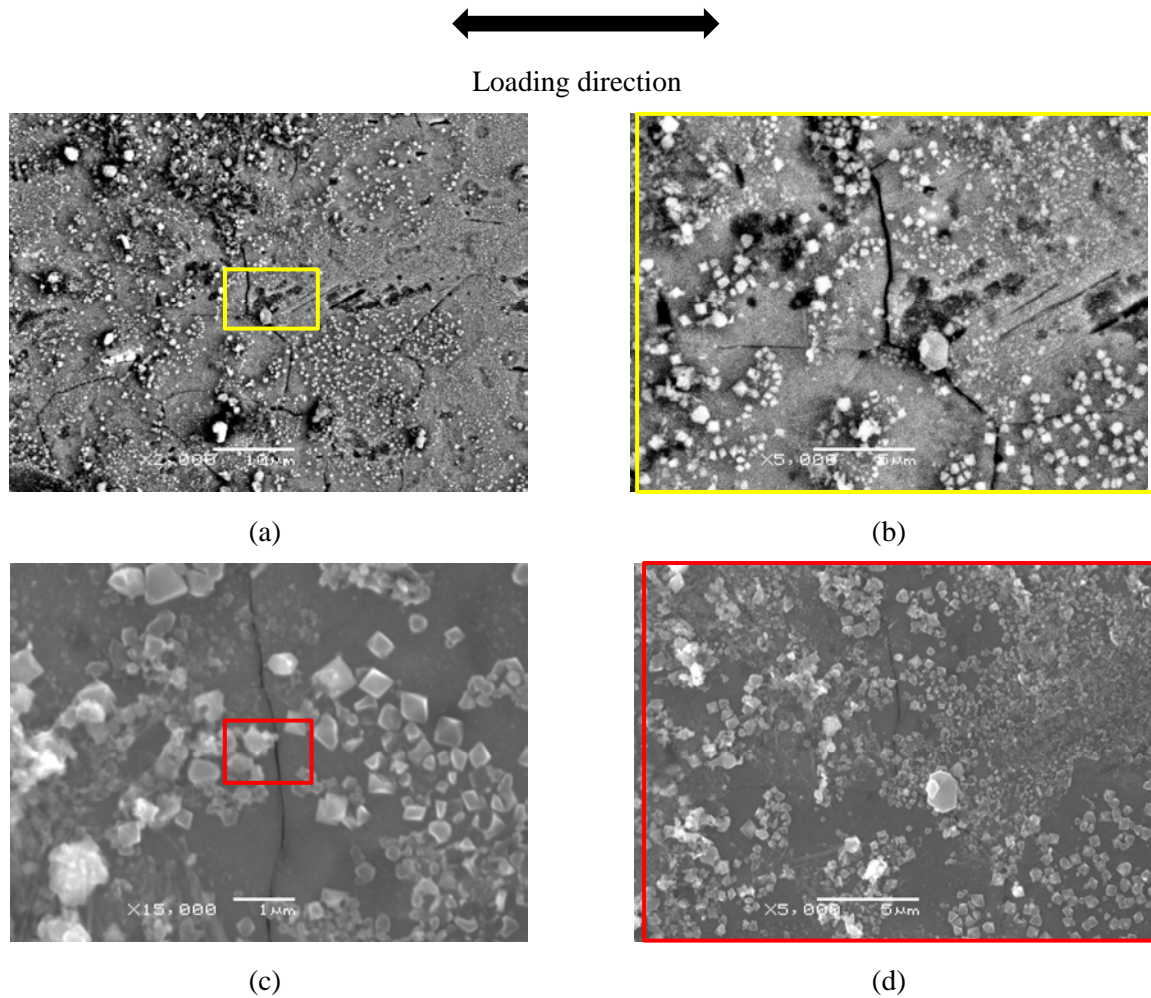
Figure 5-16: A representative crack from sample S-R6C6-H-6 at 0.6 YS in LiOH. (a) BSE image, (b) magnified BSE image, (c) SE image of the same region, and (d) magnified SE image of the crack initiation site.

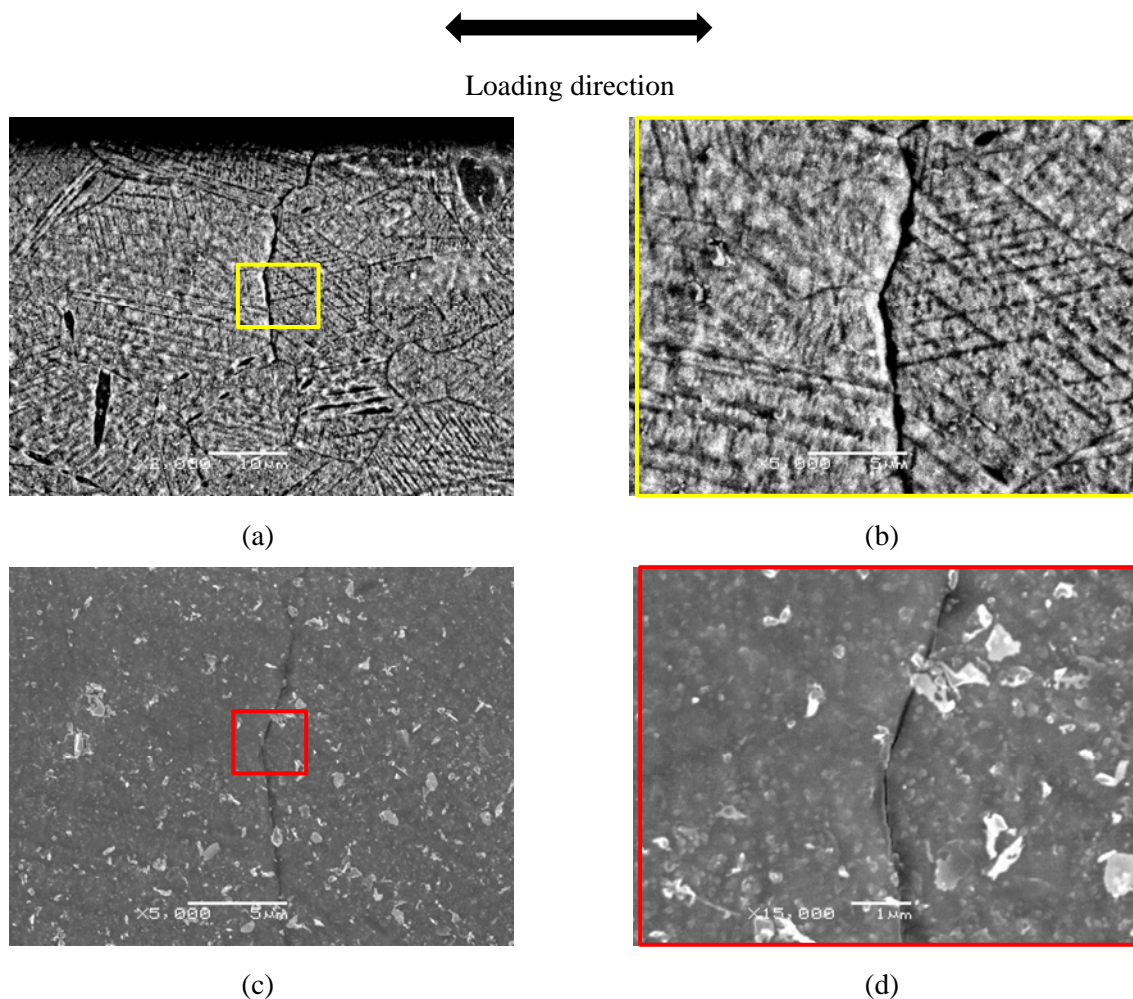
Figure 5-17: A representative crack from sample S-R6C6-T-2 at 0.8 YS in LiOH. (a) BSE image, (b) magnified BSE image, (c) SE image of the same region, and (d) magnified SE image of the crack initiation site.
