Irradiation-assisted Stress Corrosion Cracking of PWR Irradiated Type 347 Stainless Steel (NSUF CINR 19-16567)

Micheal R. Ickes, Gary S. Was, Kai Sun, Abdullah Sinjilawi, Lijin Dong

Final Report for NSUF Project 19-16567

RT-TR-22-25
Revision 0

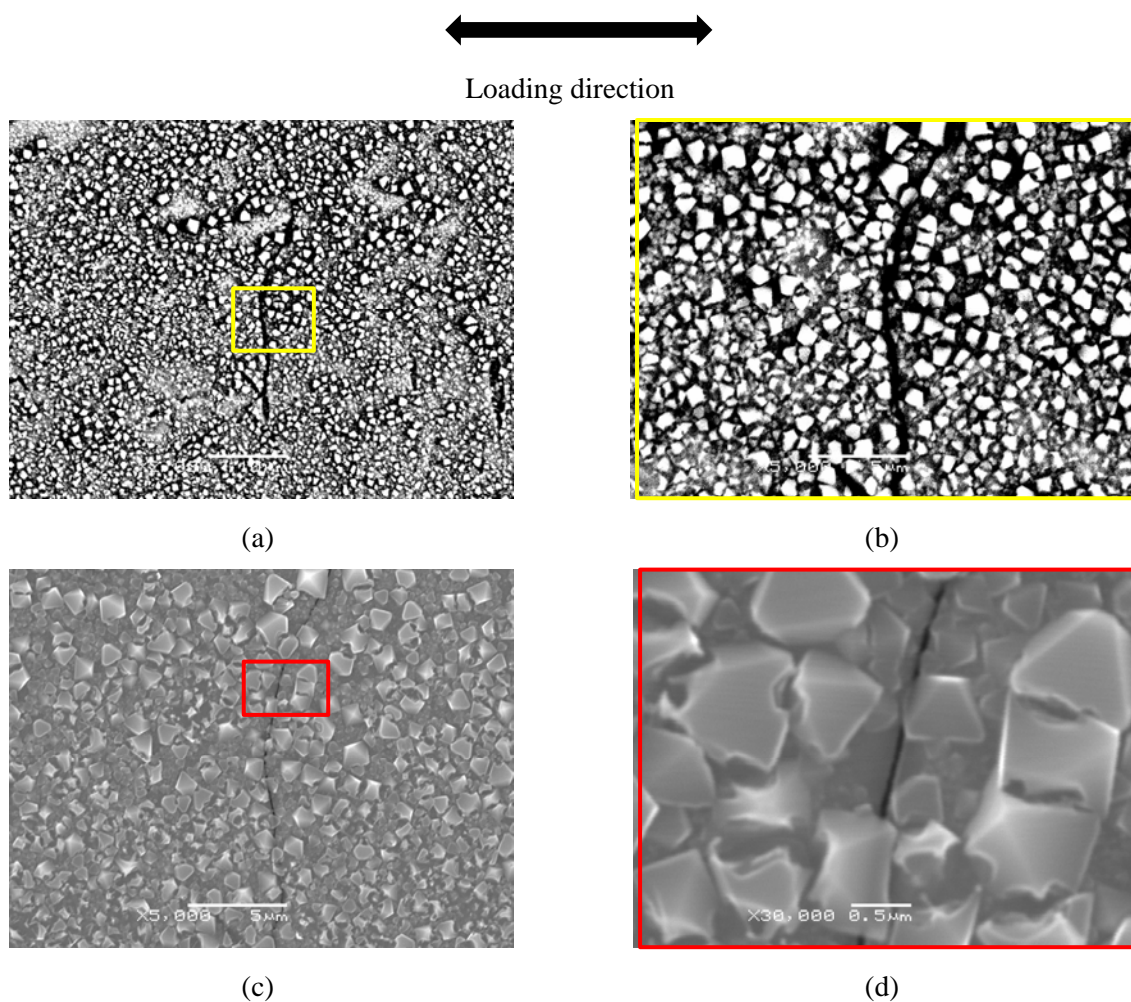
Figure 5-18: A representative crack from sample S-R2C6-T-4 at 0.7 YS in LiOH. (a) BSE image, (b) magnified BSE image, (c) SE image of the same region, and (d) magnified SE image of the crack initiation site.

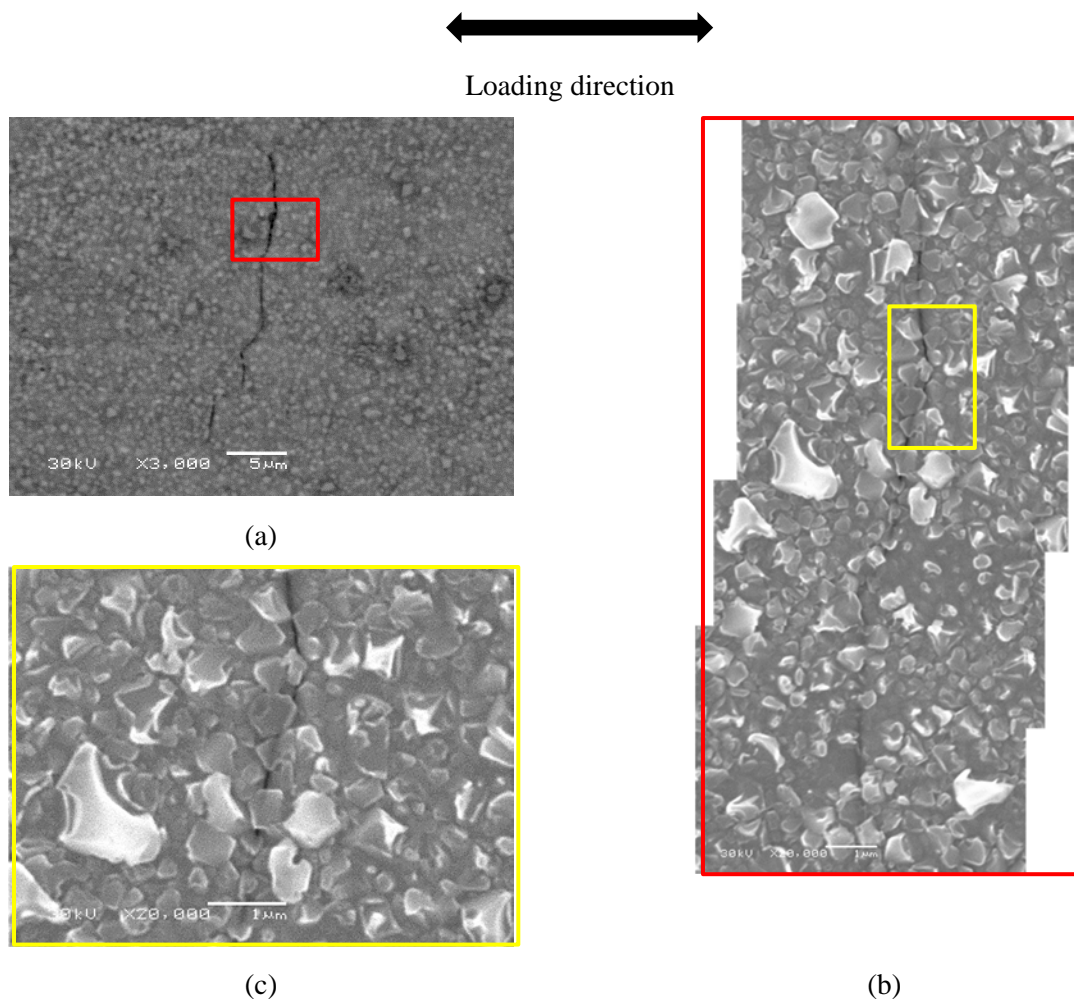
Figure 5-19: A representative crack from sample D28-T-1 at 0.8 YS in LiOH. (a) BSE image, (b) SE image of the same region, and (c) a magnified SE image of the crack initiation site.

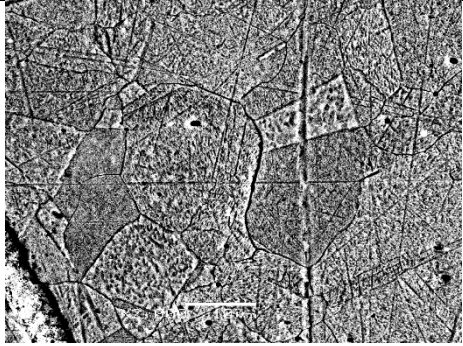
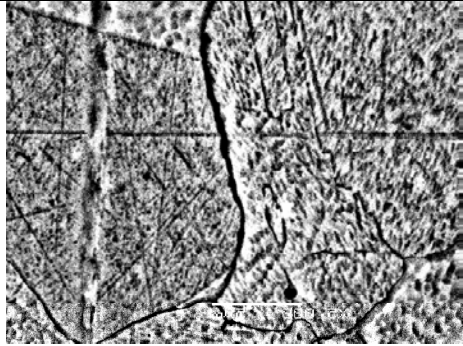
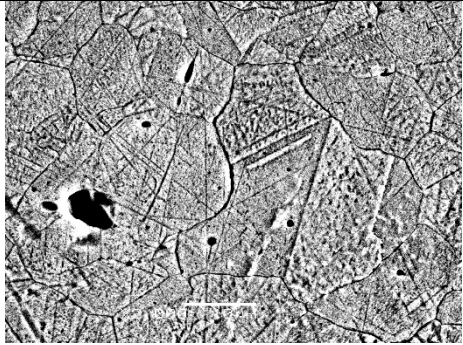
Figure 5-20: BSE (left) and SEM (right) images of specimen S-R2C6-T2 after oxide removal.

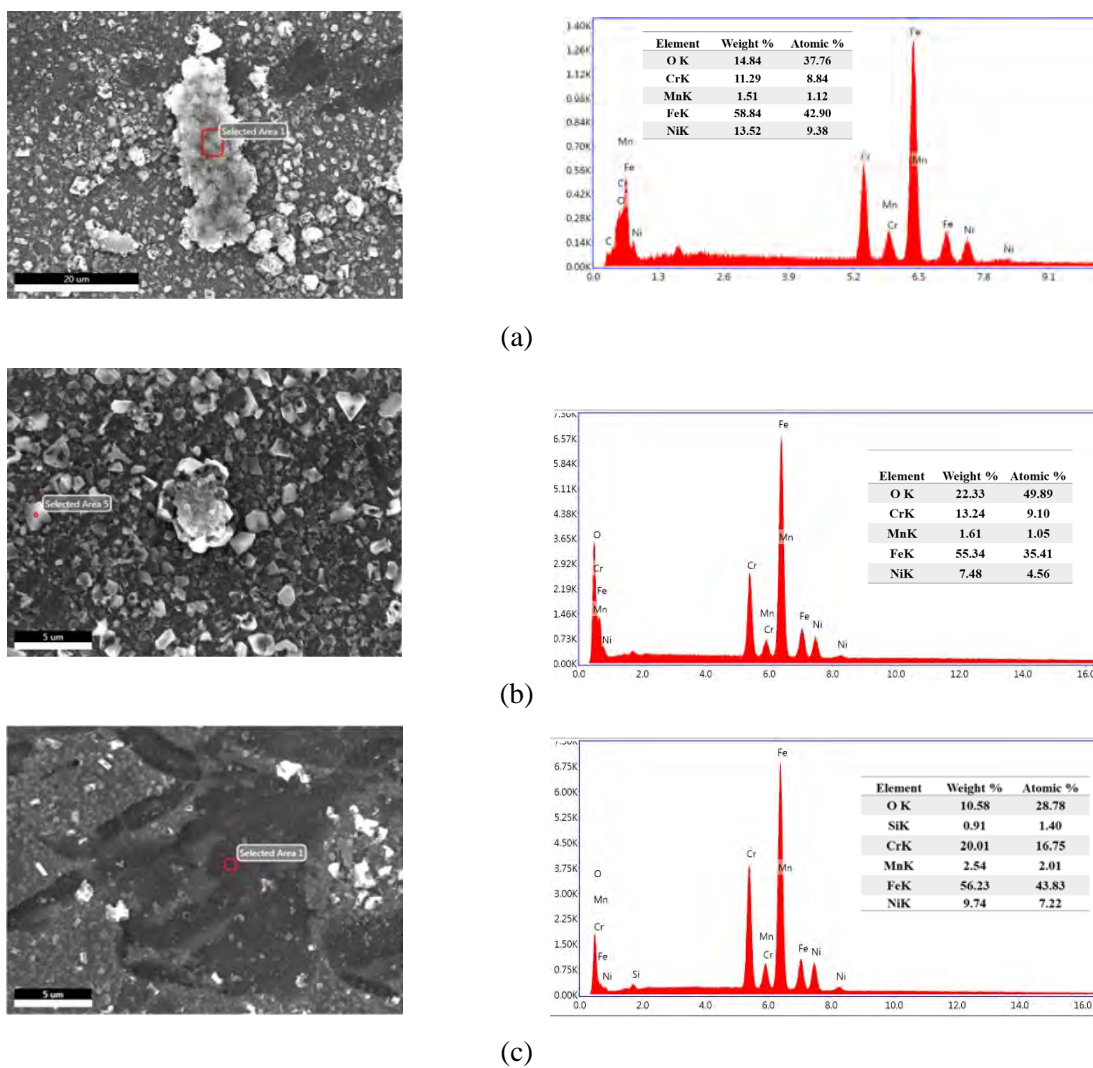
Figure 5-22: The surface morphology and EDX analyses of the surface oxides of the sample S-R6C6-T-3 in KOH water chemistry.

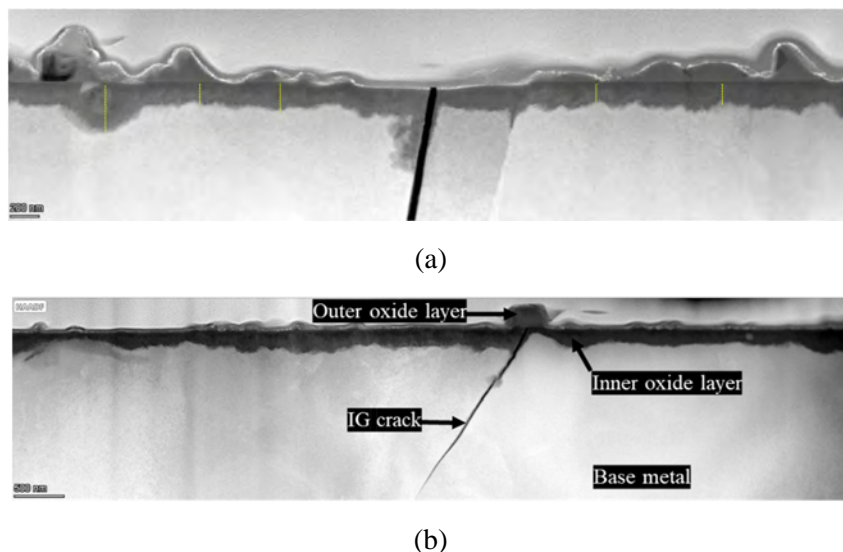
Figure 5-24: TEM-HAADF analysis for the inner layer surface oxide film thickness measurement of (a) D28-H-1_26.5 in LiOH and (b) D28-H-3_26.5 in KOH. The dashed yellow lines indicating the locations of measurements.

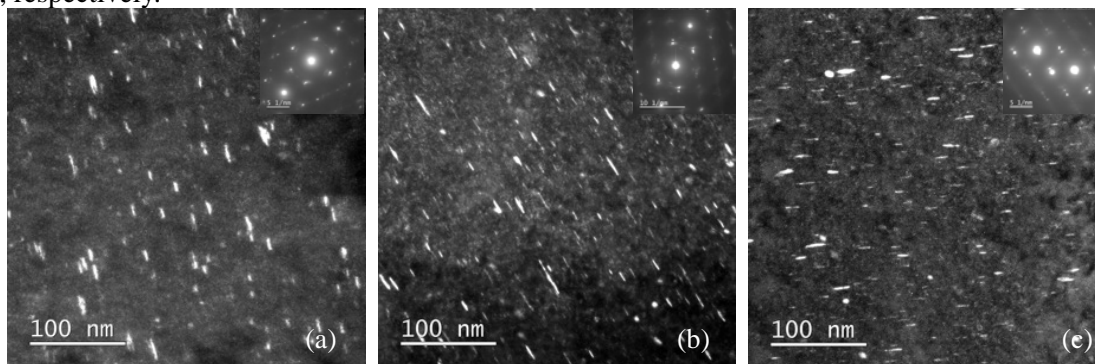
Figure 5-25: (a), (b) and (c) are rdDF images taken from the 8 dpa, 18 dpa and 26 dpa irradiated samples, respectively, using the $\frac{1}{2}\{311\}$ diffraction showing dislocation loops in the materials. The insets are SAED patterns showing the $\{311\}$ 2B condition for the rdDF imaging.

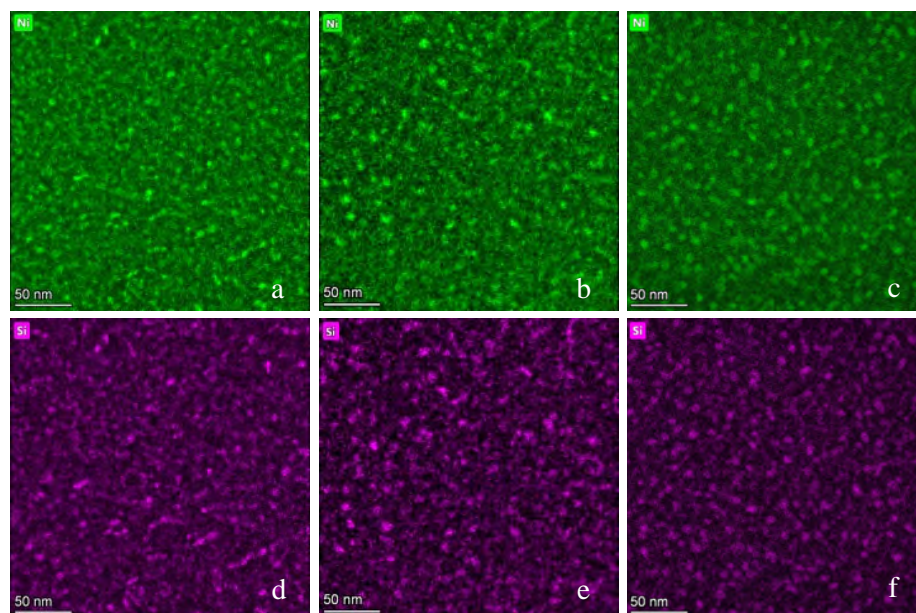
Figure 5-26: Ni-maps (a-c) and Si-maps (d-f) collected from the 347-alloy materials irradiated by neutron at dose levels of a-d: 8 dpa, b-e: 18 dpa and c-f: 26 dpa, respectively.

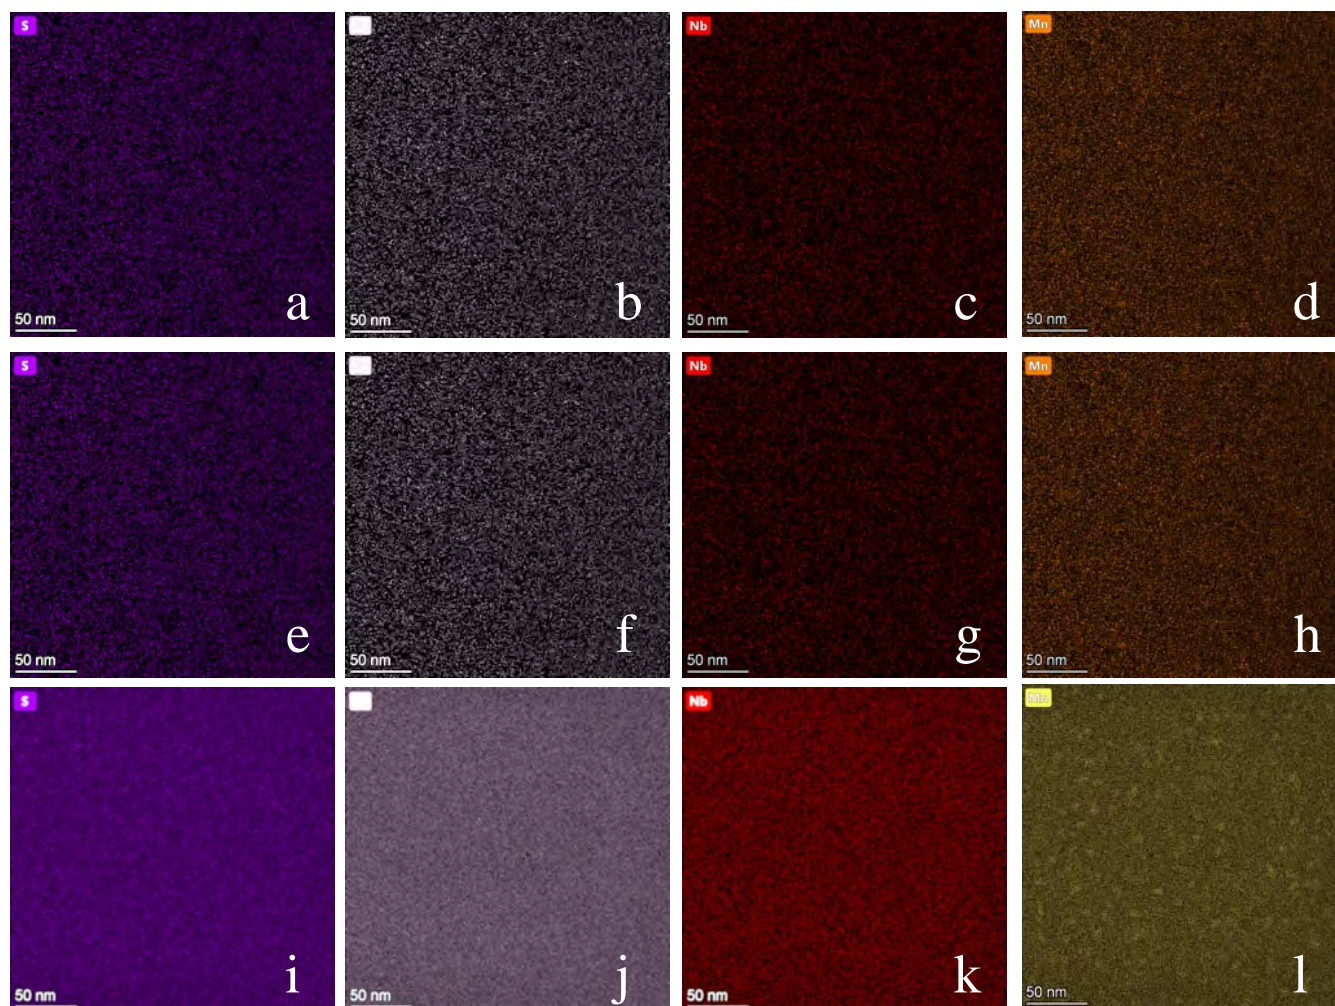
Figure 5-27: S-, P-, Nb-, and Mn-maps collected from the 347-alloy material irradiated to neutron at dose levels of a-d: 8 dpa, e-h: 18 dpa and i-l: 26 dpa, respectively.

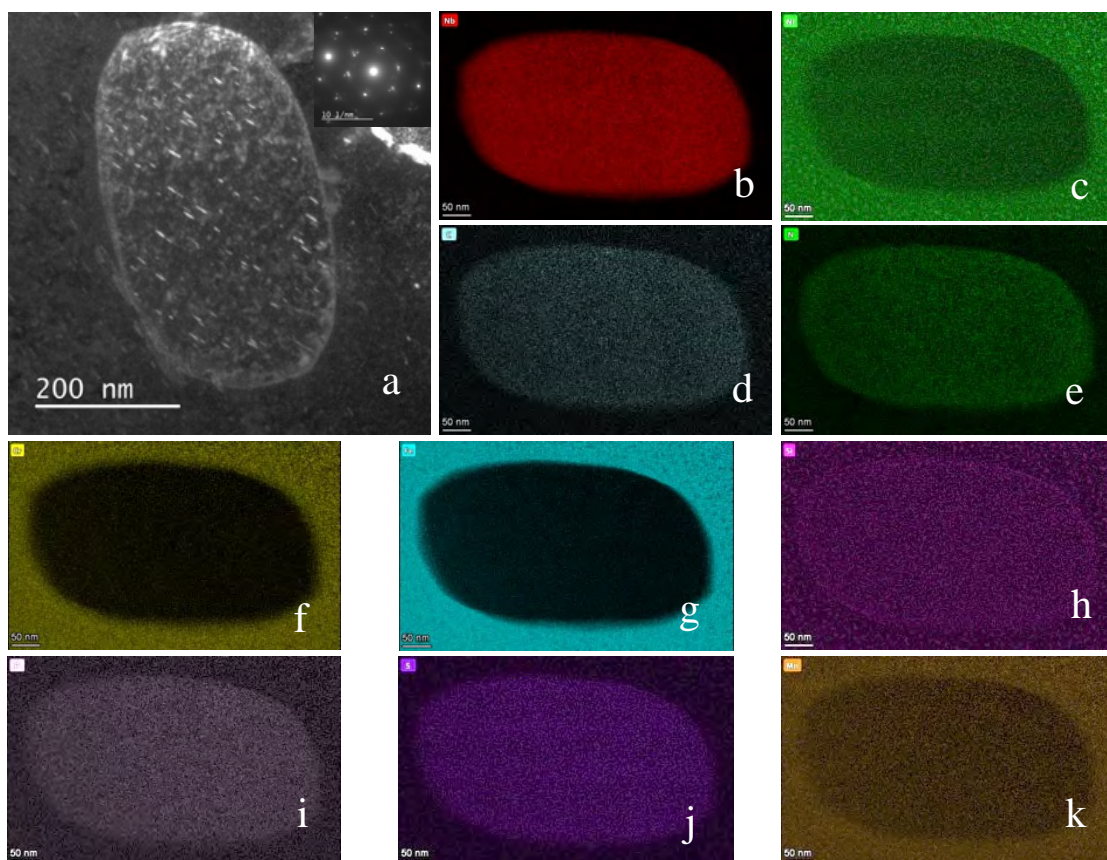
Figure 5-28: (a) rdDF image of a large precipitate in the 26 dpa irradiated sample, (b)-(k) are Nb-, Ni-, C-, N-, Cr-, Fe-, Si-, P-, S- and Mn-maps collected from the precipitate, respectively.

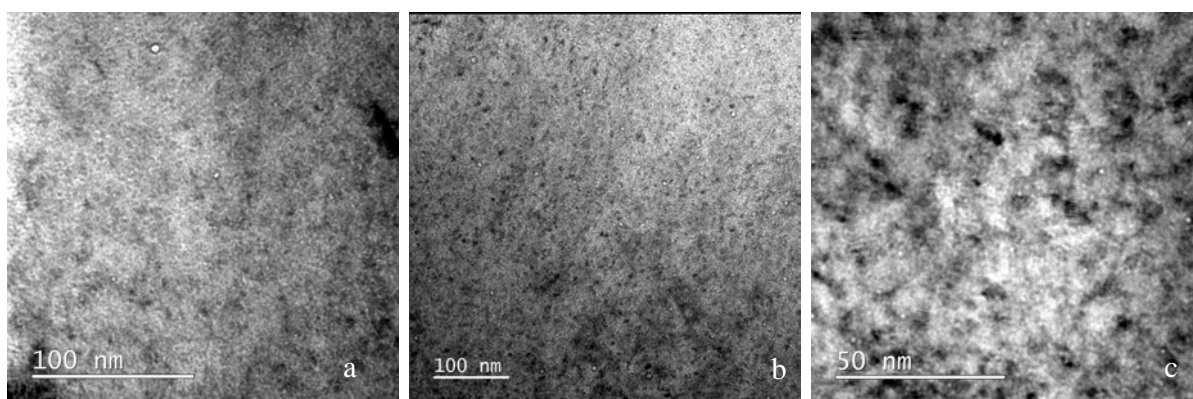
Figure 5-37: (a) –(c) BF images showing voids in 8 dpa, 18 dpa and 26 dpa irradiated samples, respectively.

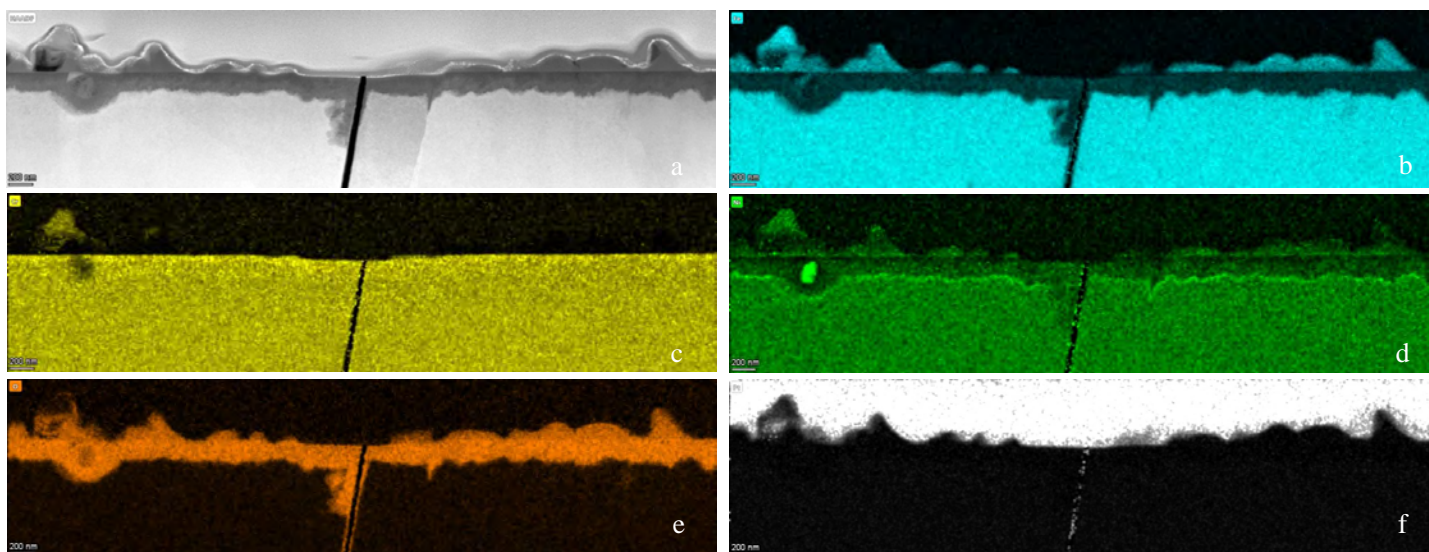
Figure 5-38: (a) is a STEM-HAADF image of a cracked GB in the 26.4 dpa irradiated and strained in LiOH sample, (b)-(f) are corresponding Fe-, Cr-, Ni-, O-, and C-maps, respectively.

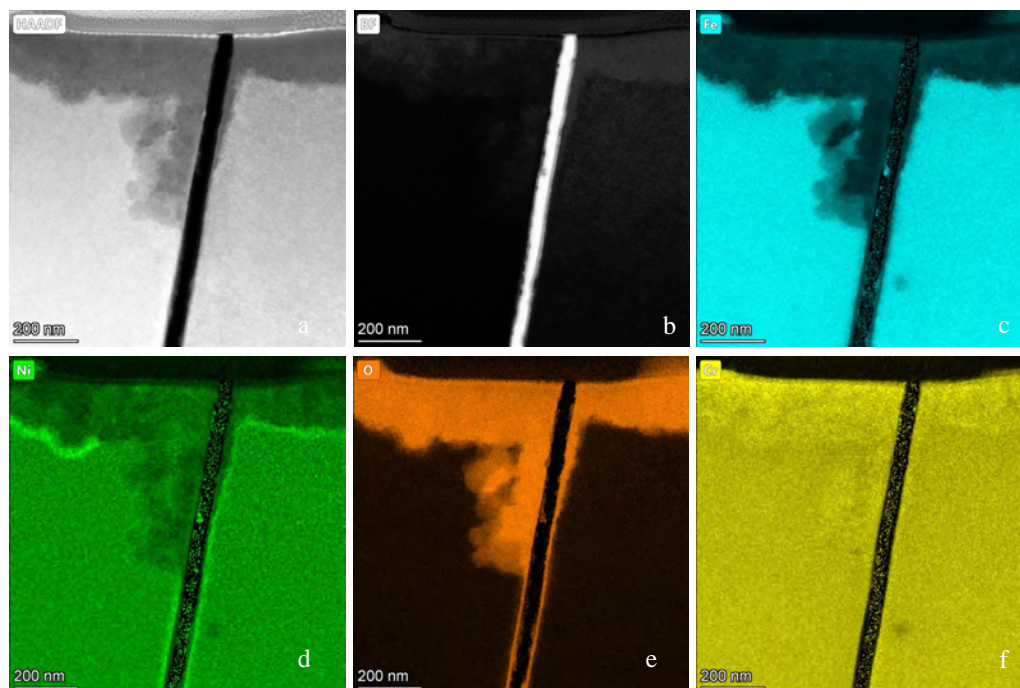
Figure 5-39: (a) and (b) are STEM-HAADF and BF images of the cracked GB shown in Figure 5-38 in the 26.4 dpa irradiated and strained in LiOH sample, (c)-(f) are corresponding Fe-, Ni-, O-, and Cr-maps, respectively.

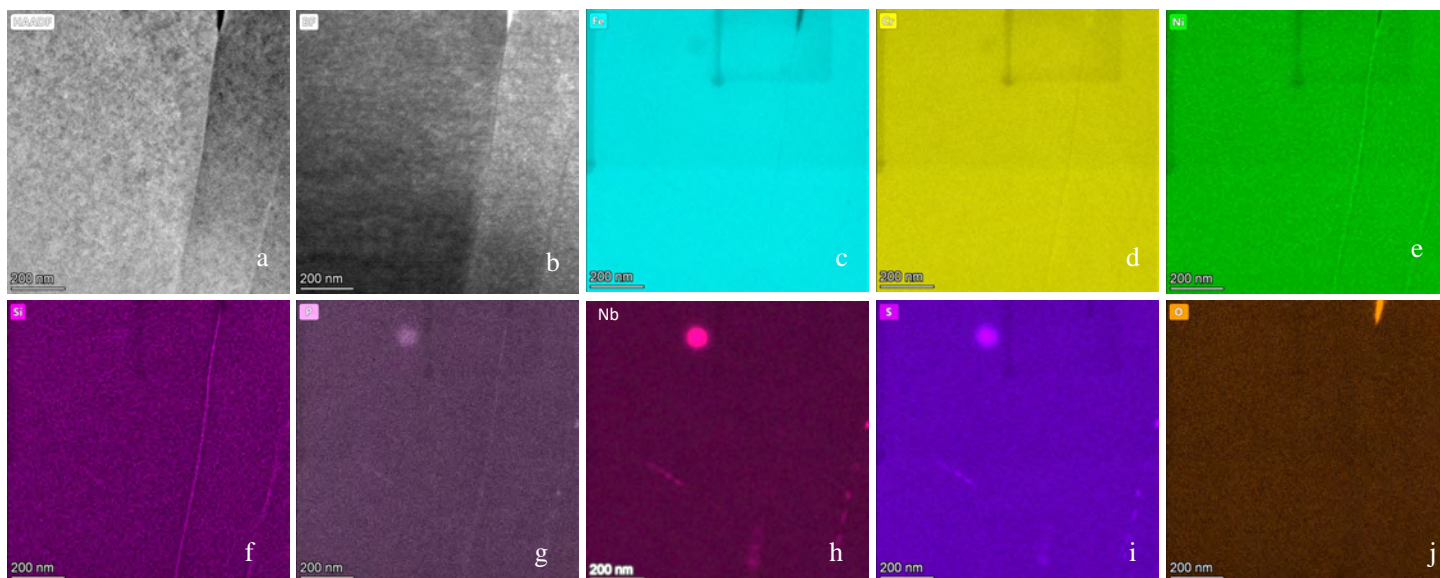
Figure 5-40: (a) and (b) are STEM-HAADF and BF images of the crack-tip region of the cracked GB shown in Figure 5-38 in the 26.4 dpa irradiated and strained in LiOH sample, (c)-(f) are corresponding Fe-, Cr-, Ni-Si-, P-, Nb-, S- and O-maps, respectively.

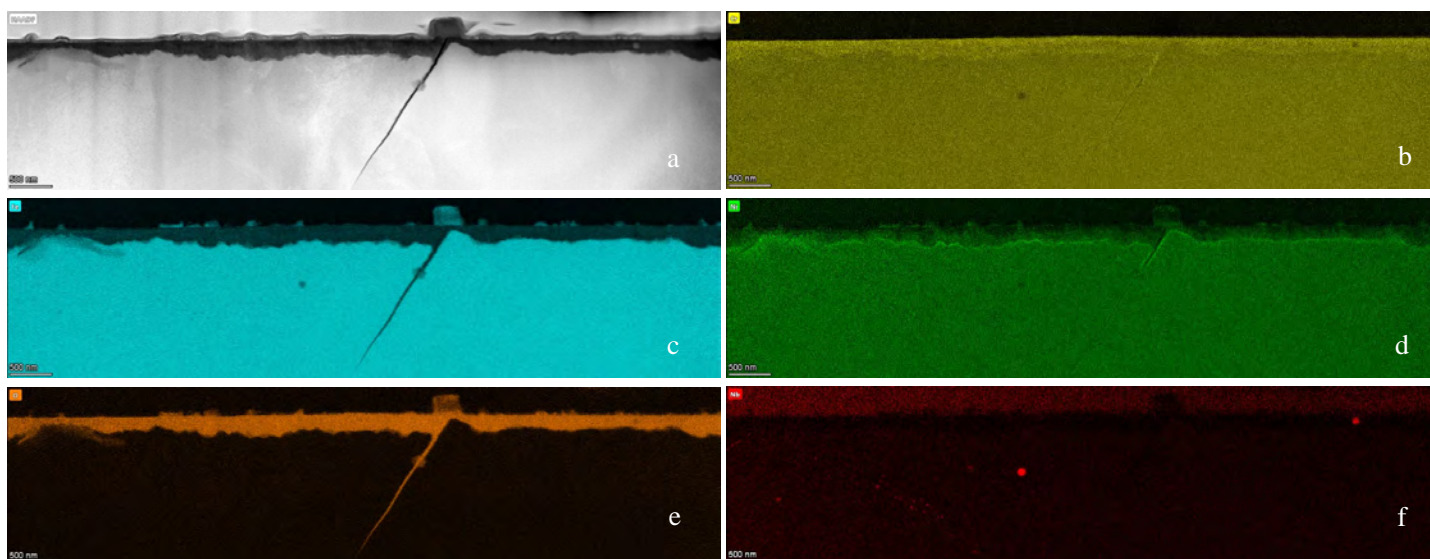
Figure 5-41: (a) is a STEM-HAADF image of cracked GB in the 26.4 dpa irradiated and strained in KOH sample, (b)-(f) are corresponding Cr-, Fe-, Ni-, O- and Nb-maps, respectively.

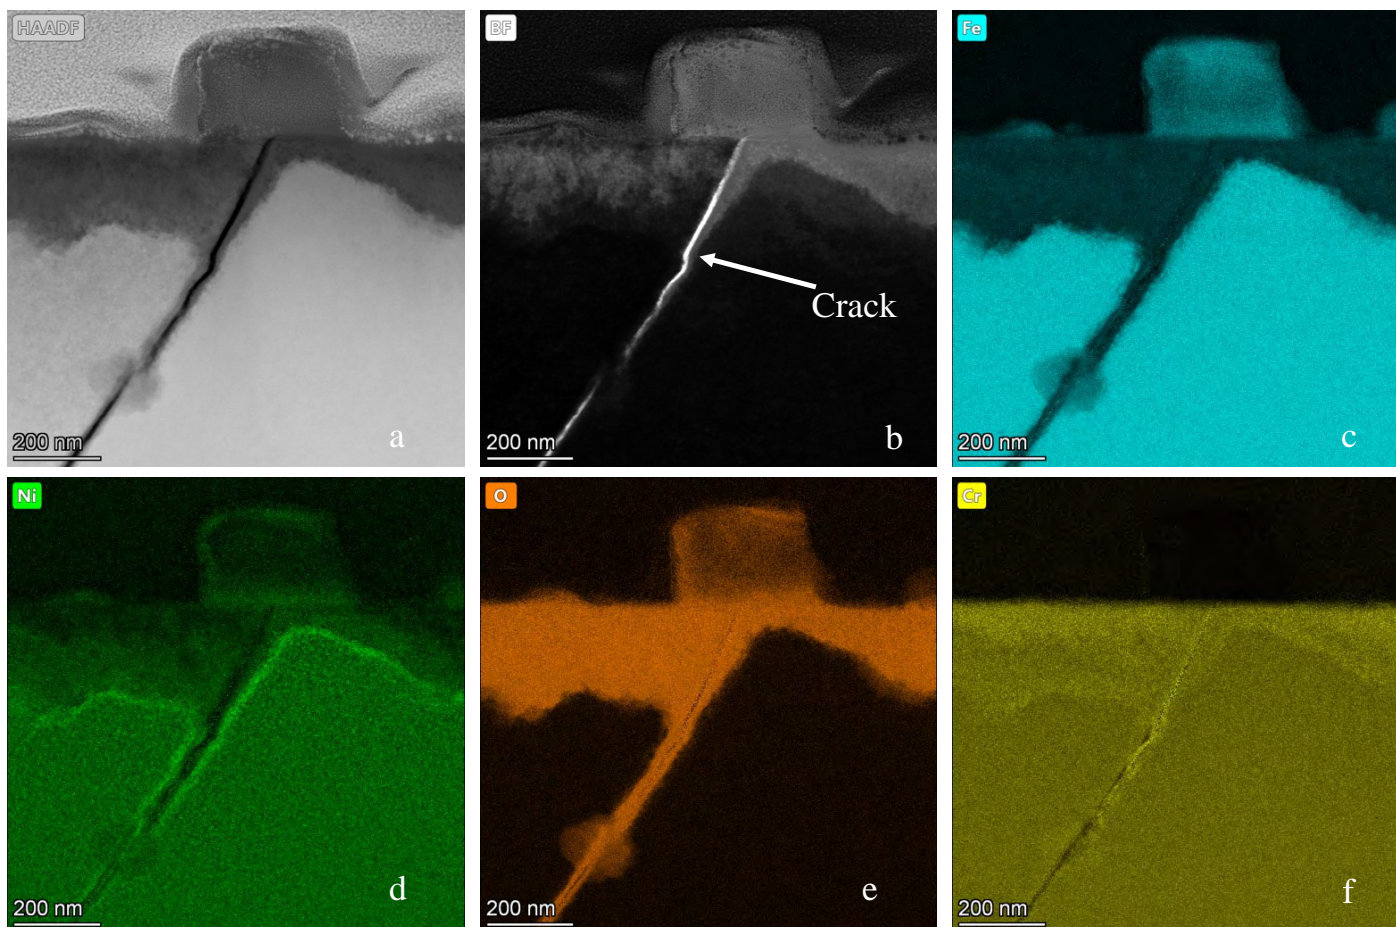
Figure 5-42: (a) and (b) are STEM-HAADF and BF images of the cracked GB shown in Fig. 19 in the 26.4 dpa irradiated and strained in KOH sample, (c)-(f) are corresponding Fe-, Ni-, O-, and Cr-maps, respectively.

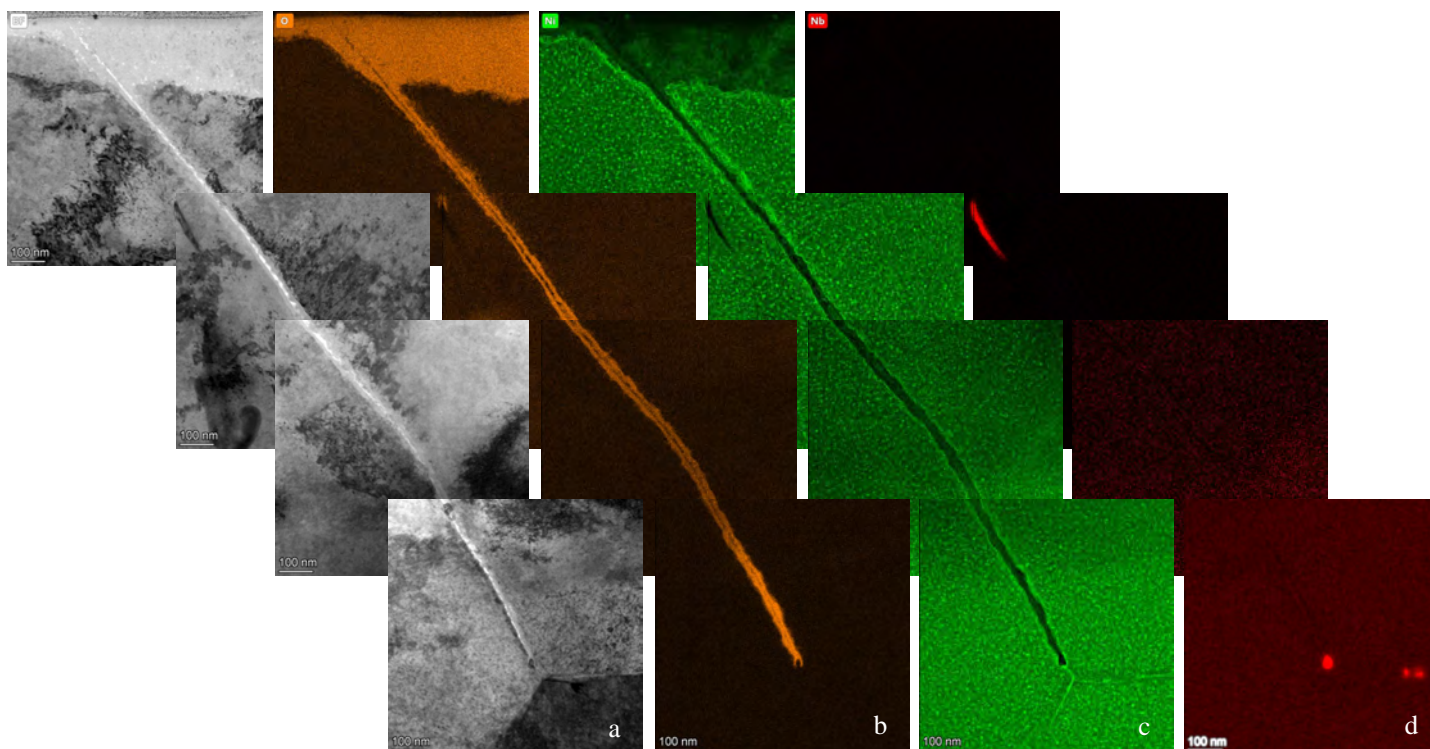
Figure 5-44: (a) is a series of STEM-BF images taken along a cracked GB in the 26.4 dpa irradiated and strained in KOH sample, (b)-(d) are corresponding series of O-, Ni- and Nb-maps, respectively.

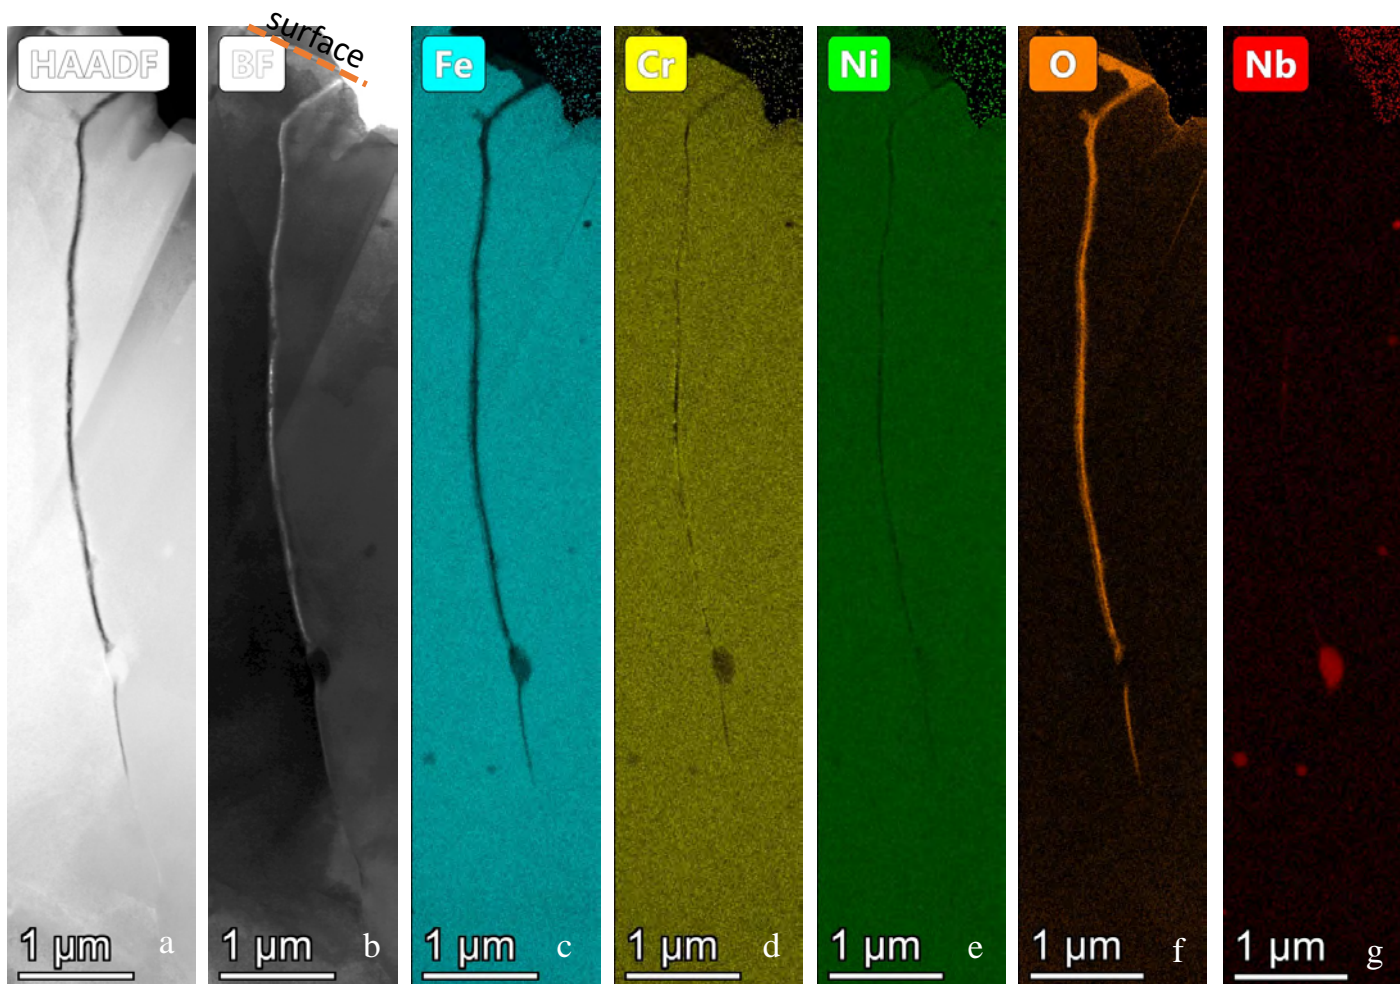
Figure 5-45: (a) and (b) are STEM-HAADF and BF images taken from a long-cracked GB in the 26.4 dpa irradiated and strained in KOH sample, (c)-(g) are corresponding series of Fe-, Cr-, Ni-, O-, and Nb-maps, respectively.

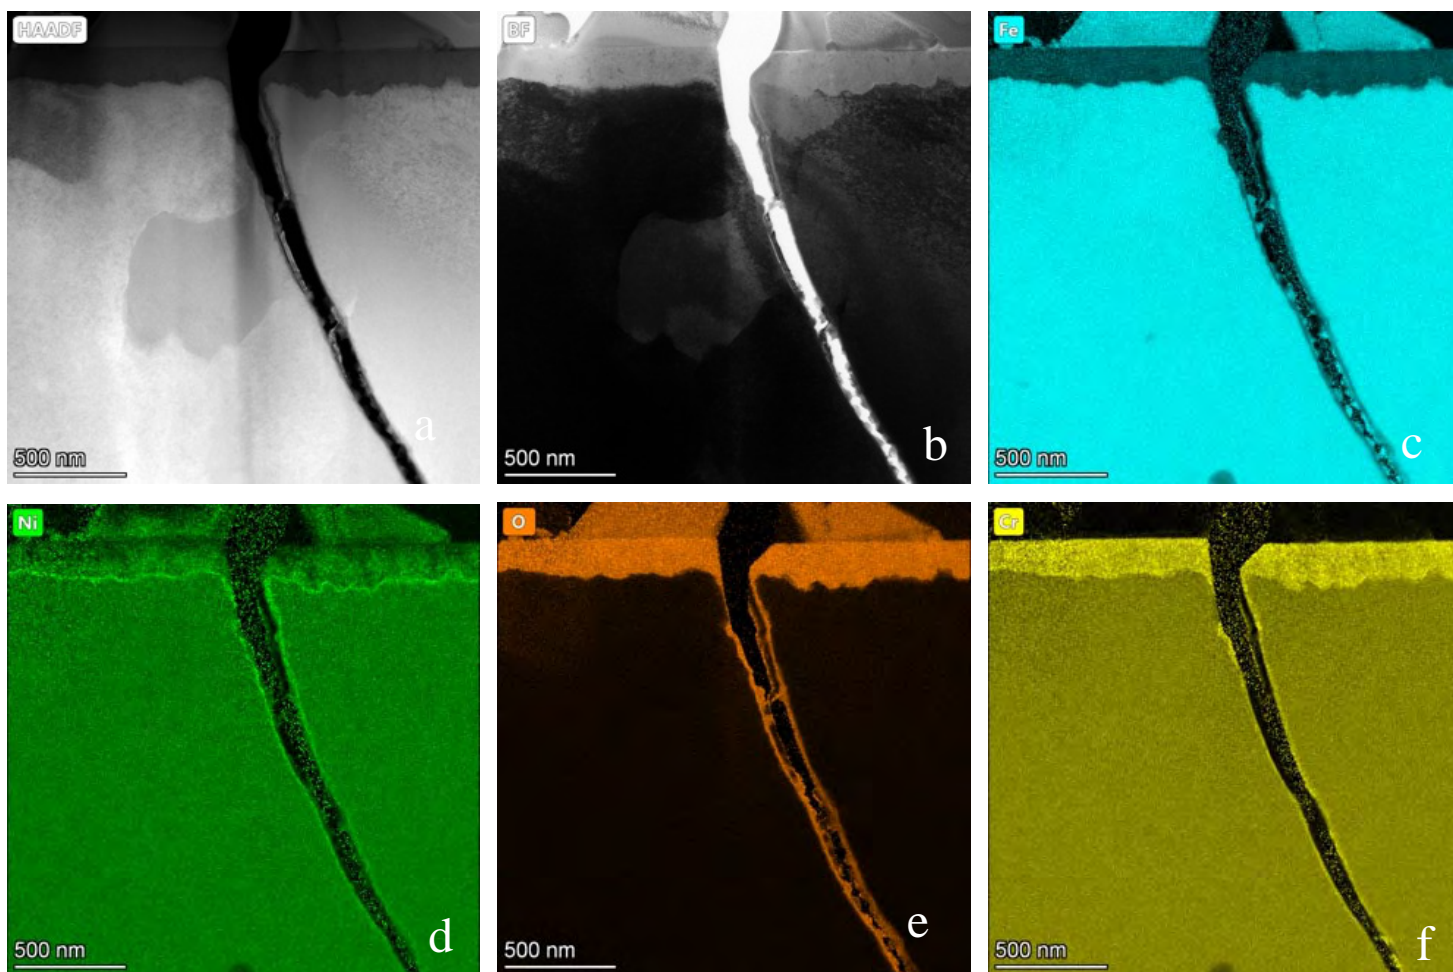
Figure 5-46: (a) and (b) are STEM-HAADF and BF images of a cracked GB in the 7.8 dpa irradiated and strained in KOH sample, (c)-(f) are corresponding Fe-, Ni-, O-, and Cr-maps, respectively.

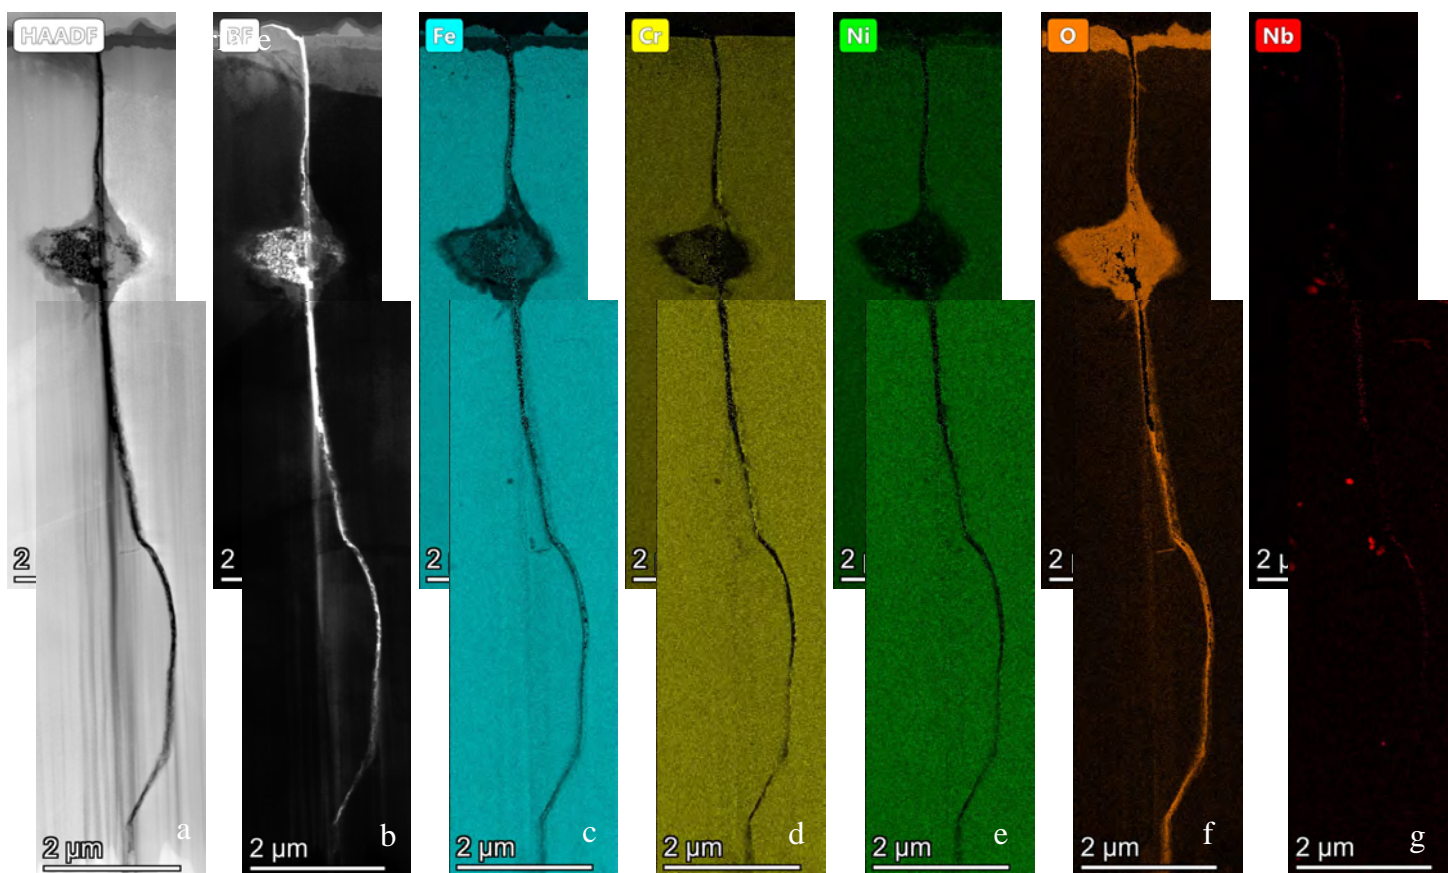
Figure 5-48: (a) and (b) are STEM-HAADF and BF images taken from a long-cracked GB in the 7.8 dpa irradiated and strained in KOH sample, (c)-(g) are corresponding series of Fe-, Cr-, Ni-, O-, and Nb-maps, respectively.

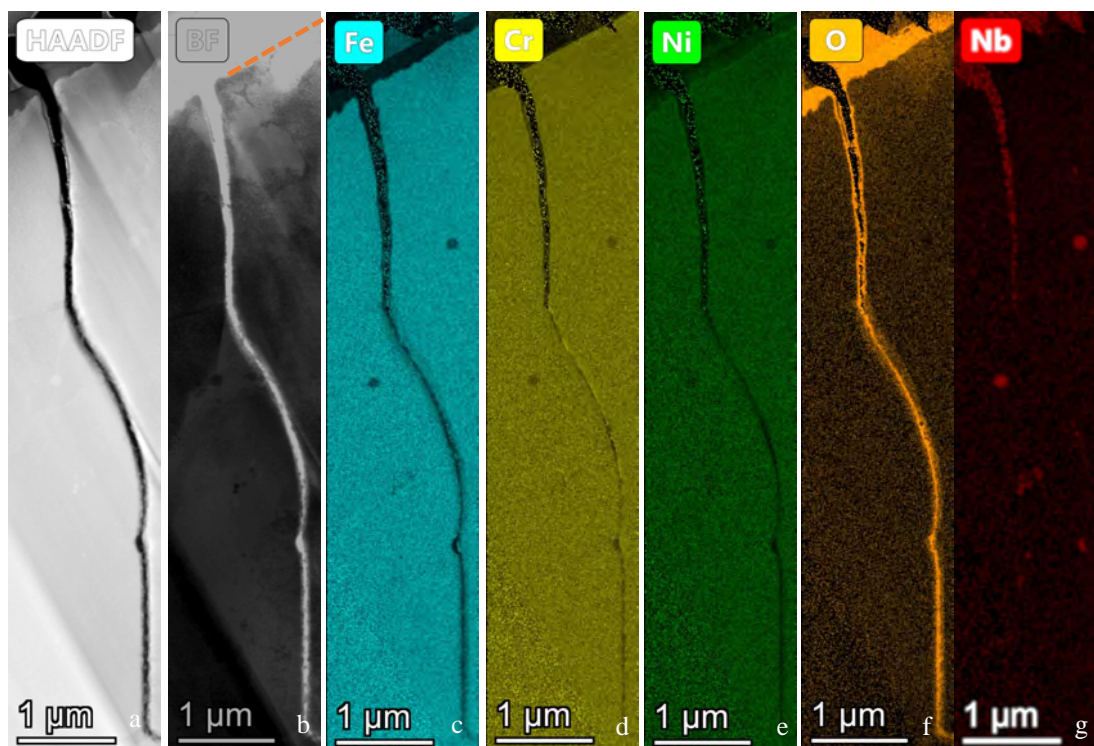
Figure 5-49: (a) and (b) are STEM-HAADF and BF images taken from a long-cracked GB in the 7.8 dpa irradiated and strained in KOH sample, (c)-(g) are corresponding series of Fe-, Cr-, Ni-, O-, and Nb-maps, respectively.

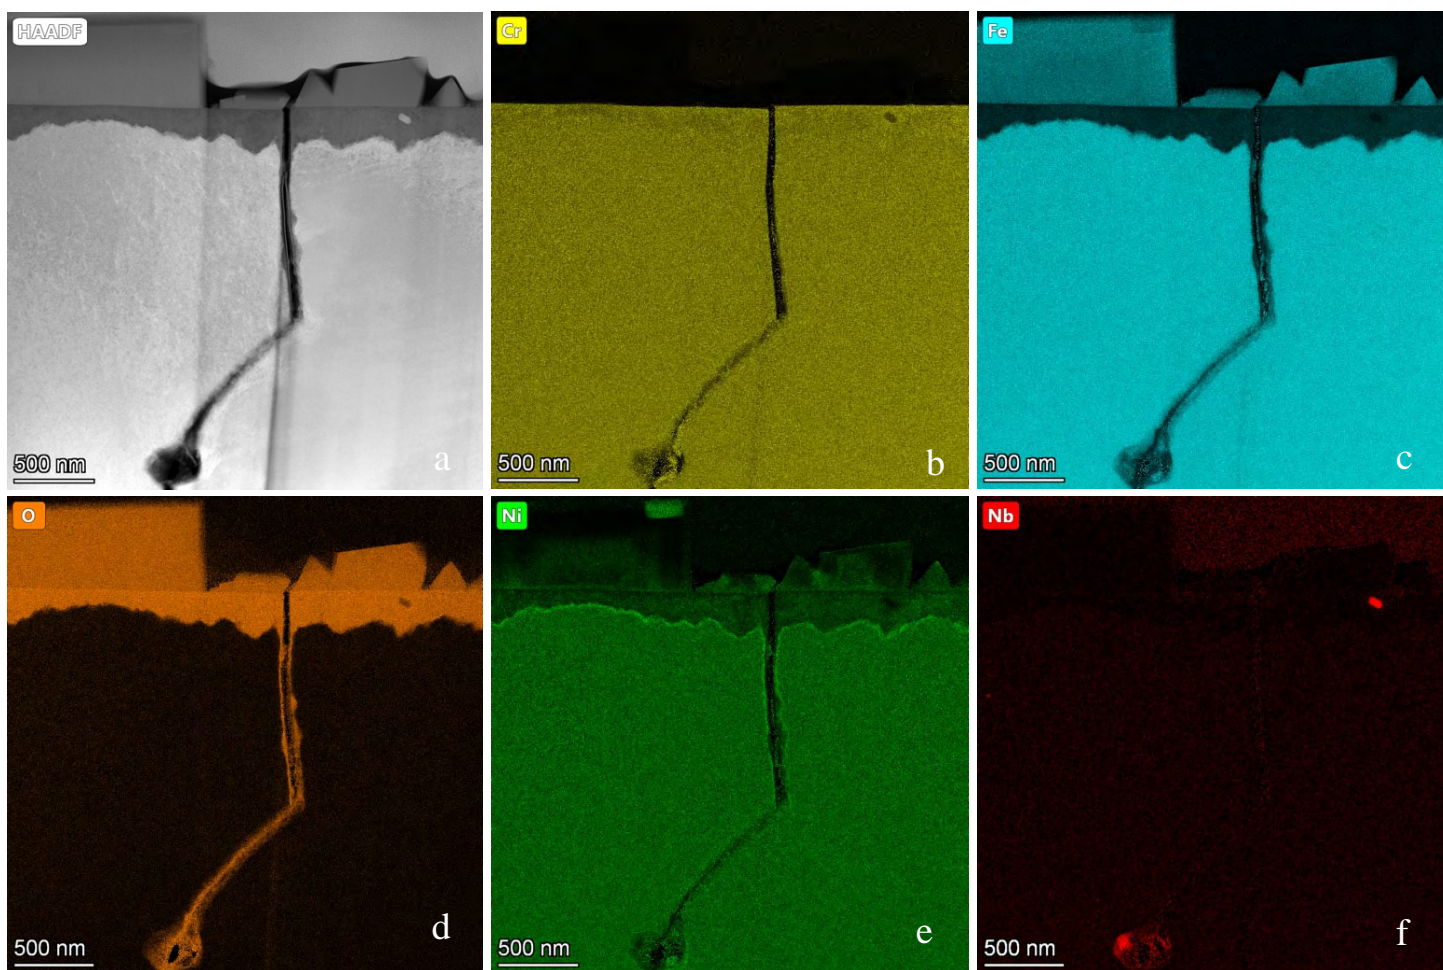
Figure 5-50: (a) is a STEM-HAADF of a cracked GB in the 7.8 dpa irradiated and strained in LiOH sample, (c)-(f) are corresponding Fe-, Ni-, O-, and Cr-maps, respectively.

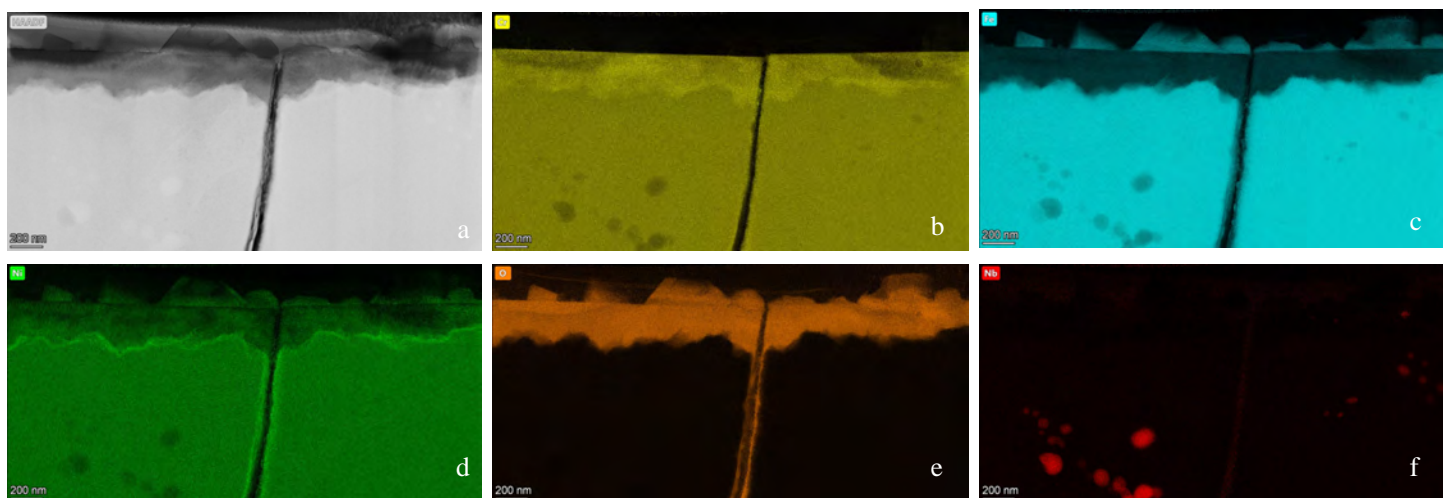
Figure 5-51: (a) is a STEM-HAADF of a cracked GB in the 7.8 dpa irradiated and strained in LiOH sample, (c)-(f) are corresponding Fe-, Ni-, O-, and Cr-maps, respectively.
