Irradiation-assisted Stress Corrosion Cracking of PWR Irradiated Type 347 Stainless Steel (NSUF CINR 19-16567)

Micheal R. Ickes, Gary S. Was, Kai Sun, Abdullah Sinjilawi, Lijin Dong

Final Report for NSUF Project 19-16567

RT-TR-22-25
Revision 0

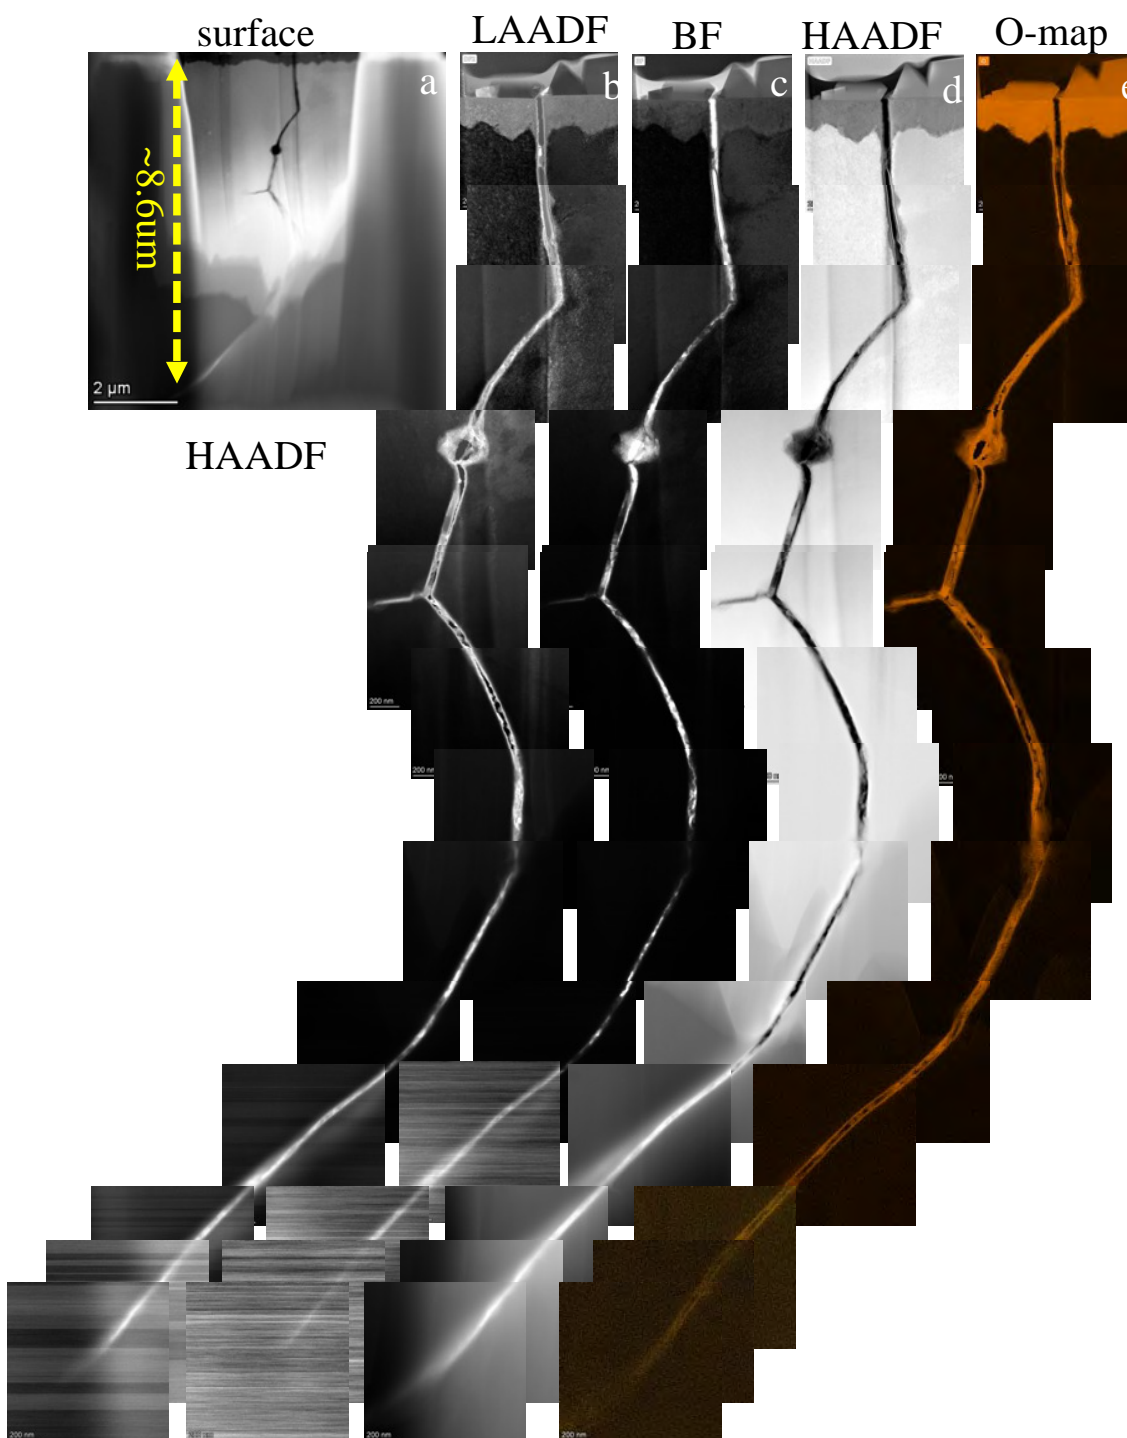
Figure 5-52: (a) a STEM-HAADF image showing a long-cracked GB; and (b)~(e) are STEM-LAADF, BF, and HAADF images and O-map, respectively, taken from a long-cracked GB in the 7.8 dpa irradiated and strained in LiOH sample.

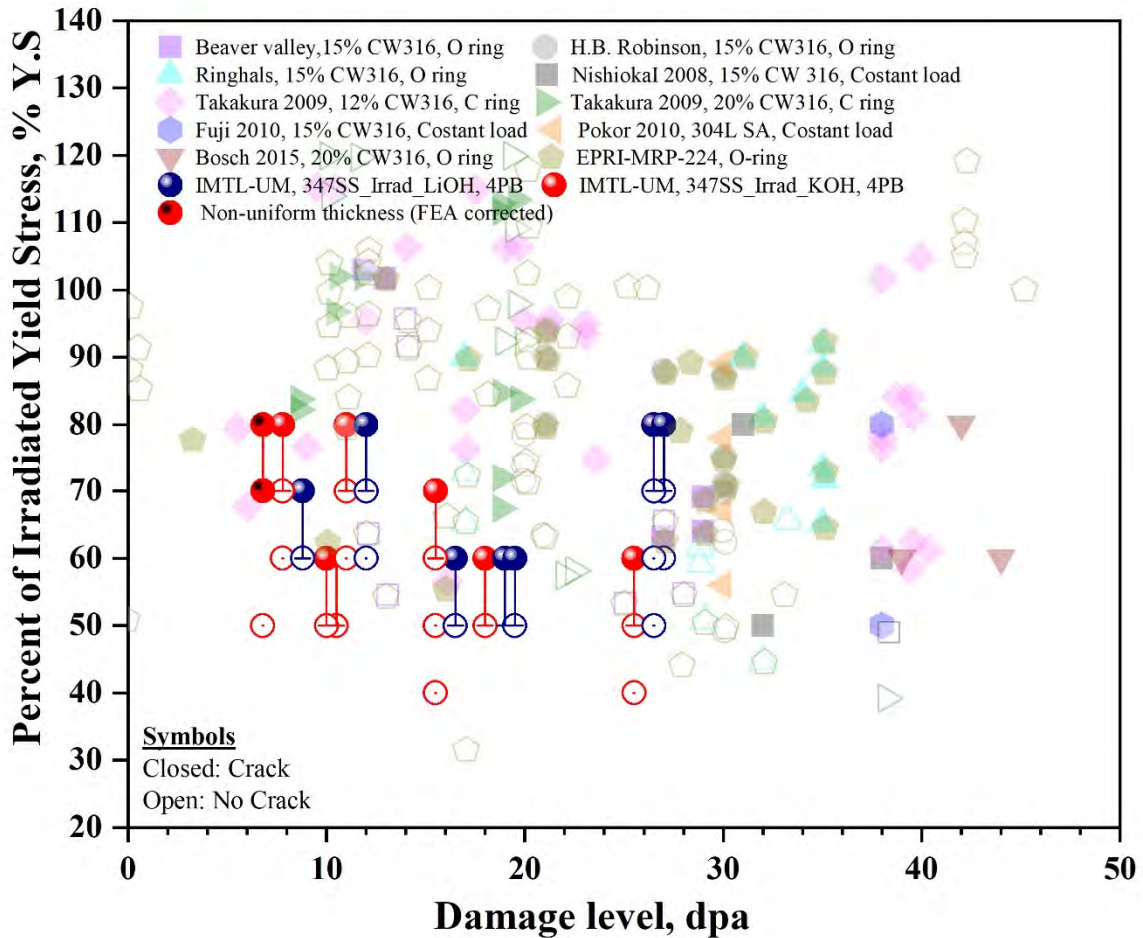
Figure 6-1: Stress as a percent of the irradiated yield strength versus displacement damage for crack initiation in austenitic stainless steels in PWR primary water environments. Data for 347SS in this study are offset along the abscissa to avoid overlap. The solid line is a power-law fit of this study data points and the dashed line is the literature data points.
