# **Creep-Fatigue Behavior of Alloy 617 at 850 and 950°C**

**Idaho National Laboratory  
Idaho Falls, Idaho 83415**

INL/EXT-13-28886

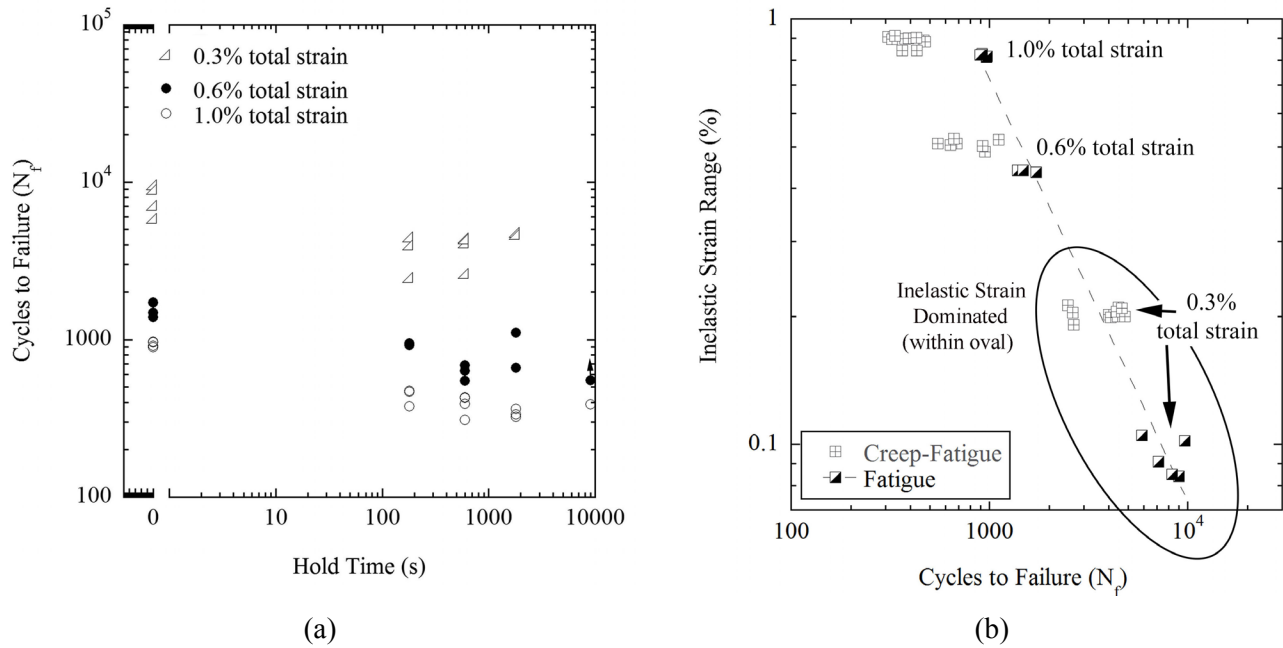
For the fatigue and tensile-hold creep-fatigue testing of Alloy 617 conducted at 950°C at the three defined strain ranges, Figure 1(a) shows the cycles to failure as a function of hold time. As previously observed for Alloy 617 [2, 3, 8], the addition of a tensile hold time in creep-fatigue decreased the total cycle life. For the specific conditions studied here, the cycle lifetimes for creep-fatigue versus continuous-cycle fatigue are reduced by roughly a factor of 2 for all strain ranges. Increasing the duration of the hold time beyond the 180 s minimum value tested had no further influence on the number of cycles to failure. Also noted was that more scatter is present in the fatigue lifetimes at the 0.3% strain range than at the higher strain ranges. A further characteristic unique to the 0.3% strain range is that the detriment in creep-fatigue cycle life is directly related to the increase in inelastic strain range with the addition of a tensile hold, as illustrated in Figure 1(b). In other words, the creep-fatigue behavior at 0.3% total strain follows the Coffin-Manson relationship,  $N_f^\beta \times \epsilon_{in} = C$ , typically only observed for the continuous-cycle fatigue behavior. In the equation shown,  $N_f$  is the number of cycles to failure,  $\epsilon_{in}$  is the inelastic strain range (defined here as width of the hysteresis loop at zero stress), and  $\beta$  and  $C$  are constants. An important distinction, however, is that the 0.6% and 1.0% total strain range tensile-hold creep-fatigue data do not follow Coffin-Manson fatigue behavior.

Figure 1. Plot of the total strain range (a) and inelastic strain range (b) as a function of cycles to failure for Alloy 617 in fatigue and creep fatigue at 950°C at three strain ranges, 0.3%, 0.6%, and 1.0%, for hold times of up to 9000 s (150 minutes). The appropriate Coffin-Manson relationship for the fatigue data is plotted as the dashed line in (b).

the apparent saturation in creep-fatigue life with increasing hold times (Figure 1[a]). Previous work strongly supports these assertions, as it identifies a negligible influence of VHTR-based helium environment on the fatigue and creep-fatigue cycle life of Alloy 617 under otherwise similar test conditions [9]. The importance of this finding for reactor operating conditions cannot be overemphasized from a practical application standpoint, as an IHX material will likely be subjected to low strain range conditions for which the 0.3% total strain range is most representative [1]. This Coffin-Manson type behavior is not present at the higher strain ranges.

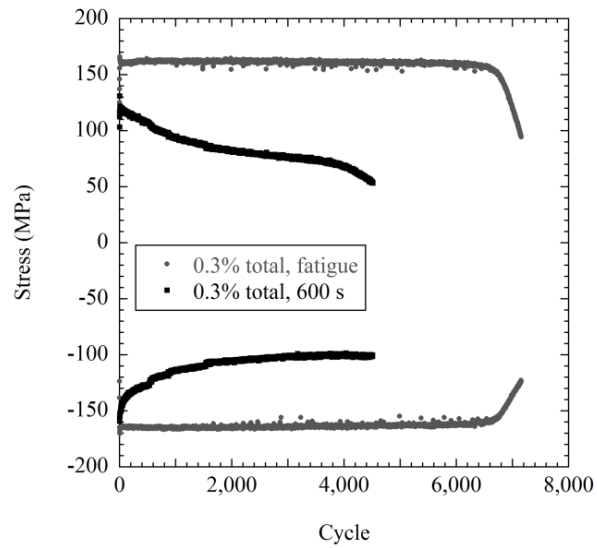
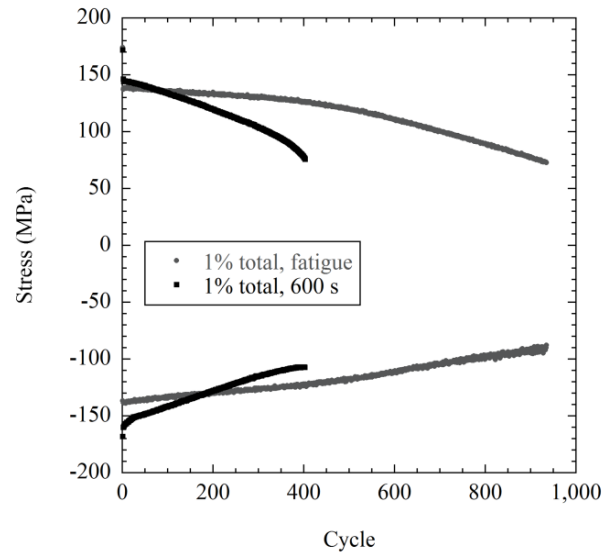
Figure 2 shows the individual peak stresses as a function of cycle for specimens tested at the 0.3% and 1.0% total strain range. In fatigue, the peak stress versus cycle trends at all three strain ranges exhibit a region in which there is a plateau in stress. This plateau is reached early in cycling and extends until the macrocrack initiation, designated as  $N_i$ . For creep-fatigue cycling, illustrated for the 600 s hold time condition at the lowest and highest strain range, cyclic softening is observed very early in cycling and persists until the rapid stress drop near failure. The duration of the hold time did not appear to substantially influence the peak stress versus cycle curve, specifically with regard to the amount of cyclic softening. At the 0.3% strain range shown in Figure 2(a), there is an initial rapid decrease in peak tensile and compressive stress that later steadies at a slower, more constant softening rate. At the higher 1.0% total strain range illustrated in Figure 2(b), a relatively constant rate of cyclic softening is maintained during creep-fatigue, and it is again observed that the softening is more severe than in the case of continuous-cycle fatigue deformation over the same strain range.

Figure 2. Peak stress versus cycle curves for selected specimens at the 0.3% (a) and 1.0% (b) total strain range for fatigue and 600 s hold time creep-fatigue at 950°C.

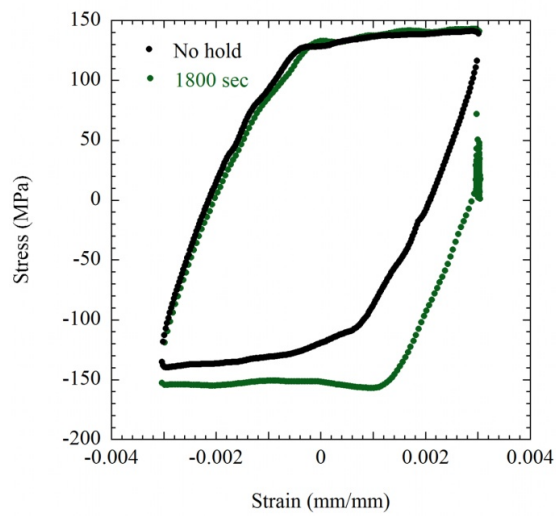
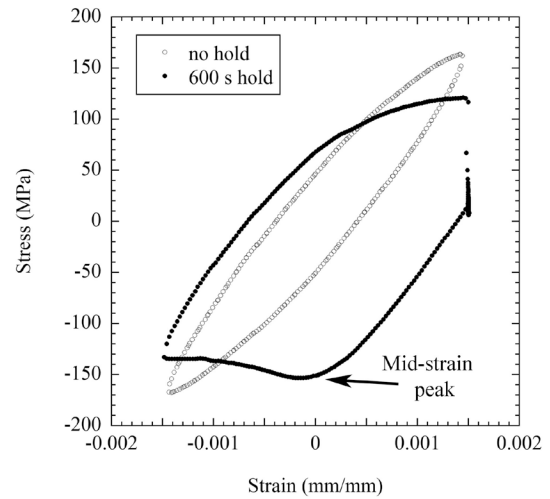
Fatigue and creep-fatigue midlife hysteresis loops are shown in Figure 3(a) for a test with 0.6% total strain and Figure 3(b) for a test with 0.3% total strain, in each case illustrating that the addition of a hold period increased the amount of inelastic strain and resulted in a decay in the measured stress level to less than 20 MPa over the strain-controlled hold. Stress relaxation during the hold is shown in more detail for the 0.3% strain range in Figure 4(a); the stresses relax rapidly, and although not shown in this figure, the stress relaxation occurs at the same rate regardless of the strain range. A constant low stress (less than 20 MPa) is achieved within about 600 s of the hold initiation. The approximate relaxed stress for selected cycles, along with the peak tensile and compressive stresses, is shown in Figure 4(b) for the 1.0% total strain range at each hold time. The relaxed stresses are also similar for all three strain ranges regardless of hold time.

Figure 3. Hysteresis loops for specimens tested at 0.6% total strain and no hold and an 1800 s hold (a) and 0.3% total strain and no hold and a 600 s hold (b).

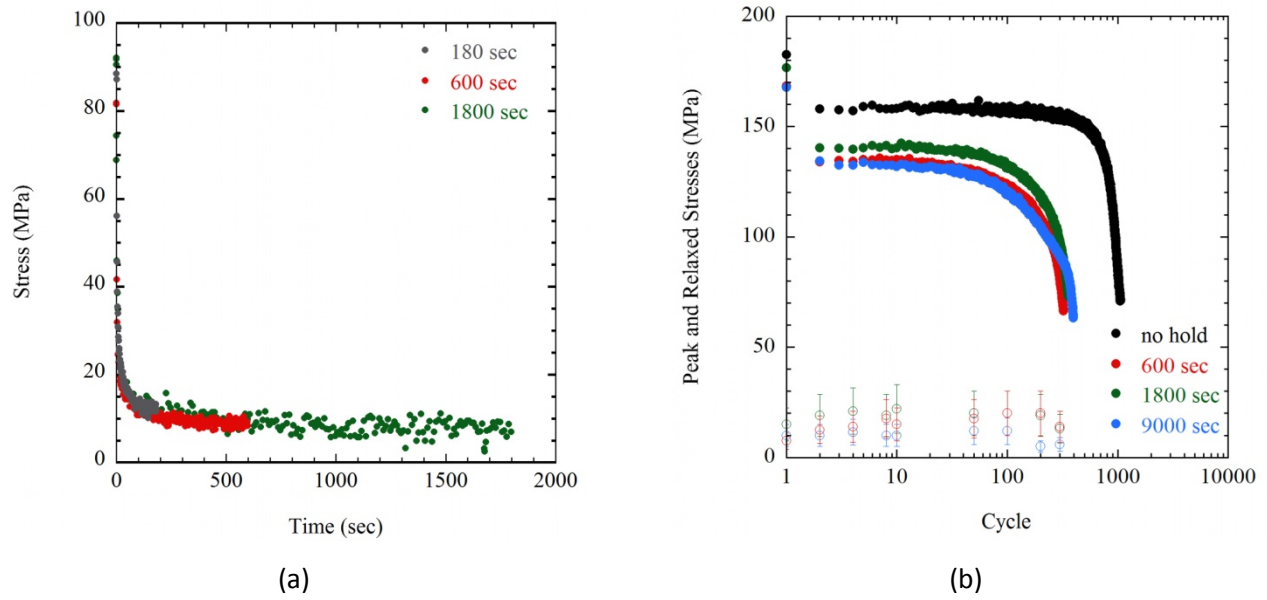
Figure 4. Plot of the rapid stress relaxation occurring during the tensile hold during creep-fatigue at 0.3% total strain (a). Plot of the peak tensile stresses and the relaxed stresses (open circles) versus cycle at 1.0% total strain (b).

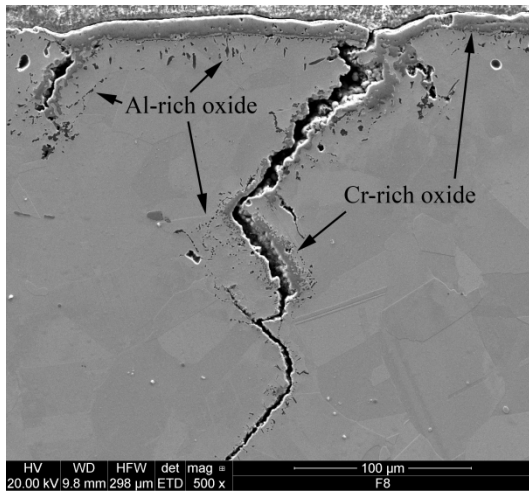
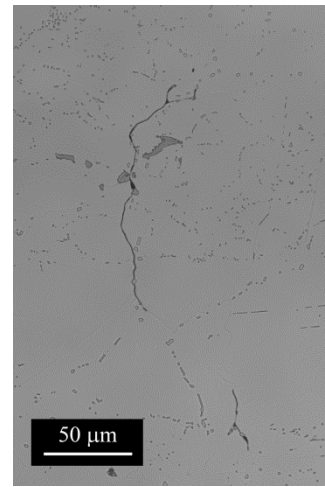
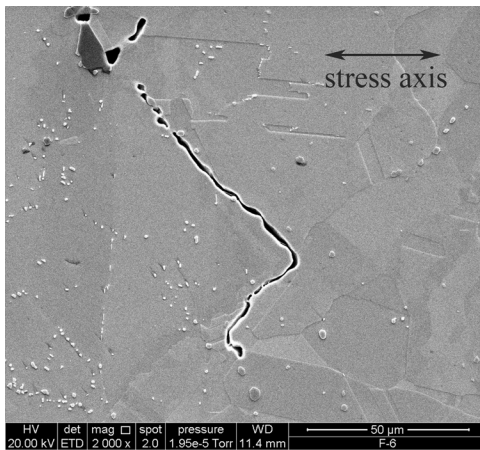
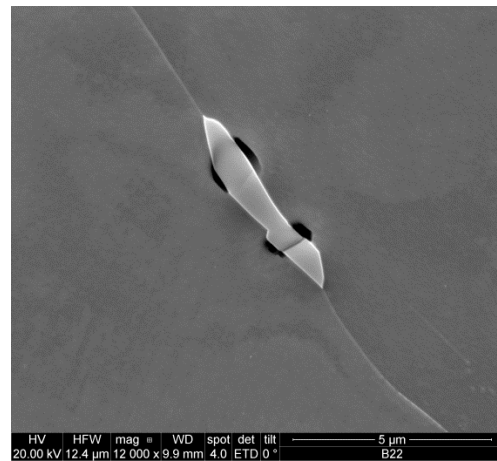
Figure 5. Surface cracking in creep-fatigue of Alloy 617 cyclically deformed at 950°C and 0.3% total strain with a 600 s hold (a). Interior grain boundary cracking (b, c) and cavitation (d) in Alloy 617 cyclically deformed at 950°C and 0.3% total strain with a 180 s hold (b, c) and 0.6% total strain with a 1800 s hold test interrupted at 20% of life (d). The stress axis is horizontal in the plane of the page.

The surface cracking morphology is similar in each of the three strain ranges evaluated at 950°C. In continuous-cycle fatigue, the primary crack initiates and propagates in a transgranular manner and secondary intergranular cracks are not typically observed. In creep-fatigue, by contrast, the crack propagation mode is intergranular. As shown for the primary intergranular crack highlighted in Figure 5(a), a Cr-rich oxide forms along the adjacent flanks of the crack and the region surrounding the crack is depleted of grain boundary carbides. Fine Al-rich oxides also form at grain boundaries that intersect the exposed crack area. It is difficult to determine whether initiation of the primary crack occurs intergranularly or transgranularly in creep-fatigue, owing to the thick oxide layer that surrounds the cracks obscuring initiation features along with the depletion of grain boundary carbides that would otherwise delineate grain boundary locations. Based on the many shorter secondary cracks which start at oxidized grain boundaries, however, it is likely that the primary crack also initiated intergranularly. The addition of a hold time results in many of the grain boundaries that intersect the specimen surface evolving into secondary cracks. These secondary surface cracks extend deeper than the internal Al-rich oxides and are filled with a Cr-rich oxide.

No large creep voids, typical of those observed during tertiary creep in nickel-base alloys [9] and commonly described as round micrometric cavities at bulk grain boundaries, were observed in any of the failed specimens. Instead, as is shown in Figure 5(b) and 5(c), numerous cracks and small cavities are observed in the interior of the deformed creep-fatigue specimens. These interior cracks, with measured lengths varying from 5  $\mu\text{m}$  up to several grain diameters, are not surface connected and do not contain any evidence of an oxide. These features are not observed in any of the fatigue specimens.

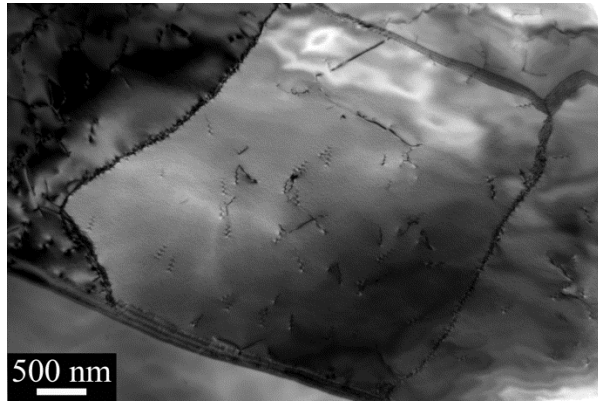
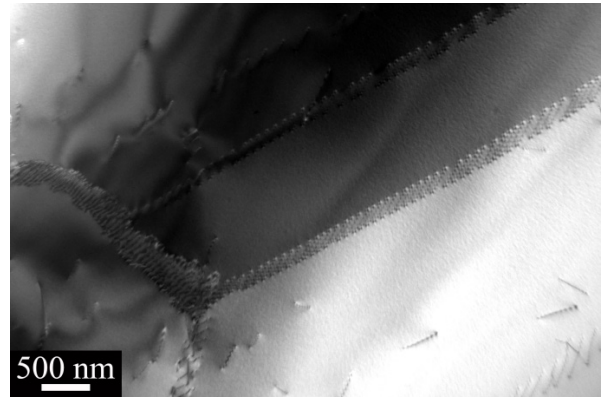
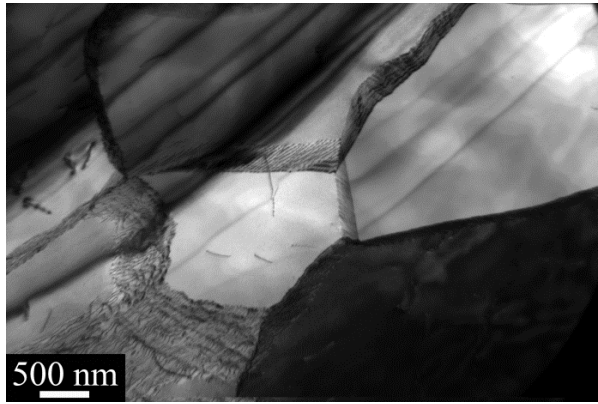
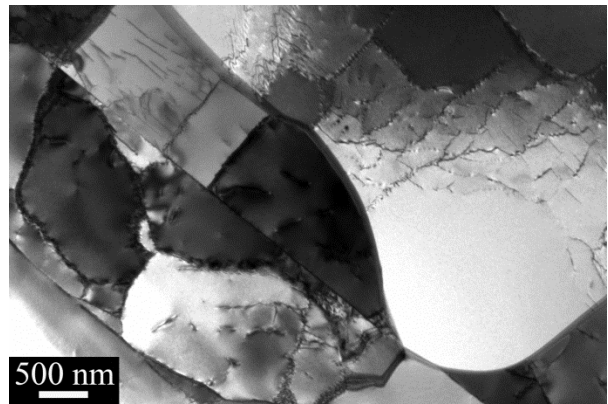
At failure in continuous-cycle fatigue, there exist regions consisting of cellular structures, as shown for a representative area in Figure 6(a), and other regions that are absent of any sort of cell structure. Cell walls consist primarily of tangled dislocations, although select boundaries are present that exhibit advanced dislocation rearrangement into more ordered structures. Numerous planar deformation bands and annealing twins (Figure 6[b]) are also present throughout the microstructure and often serve as a boundary for an adjacent cell. These planar deformation bands frequently terminate at carbides, essentially connecting proximate intragranular carbide populations in a single cell structure. Ordered arrays of dislocation pile-ups at both grain boundaries and at large precipitates are present throughout. Of particular note is the overall lack of mobile dislocations throughout the matrix relative to the amount of dislocations in the cell walls, dislocation pile-ups, and planar deformation bands.

Figure 6. TEM images of specimens cycled at 1.0% total strain (a) and 0.3% total strain (b) in fatigue at 950°C showing a cellular structure and planar deformation bands and annealing twins. A creep-fatigue specimen cycled at 950°C with a 600 sec hold at a 1.0% total strain (c) and a 0.3% total strain (d) showing a subgrain structure with boundaries comprised of ordered dislocation networks and a lower dislocation density in the cell interiors.

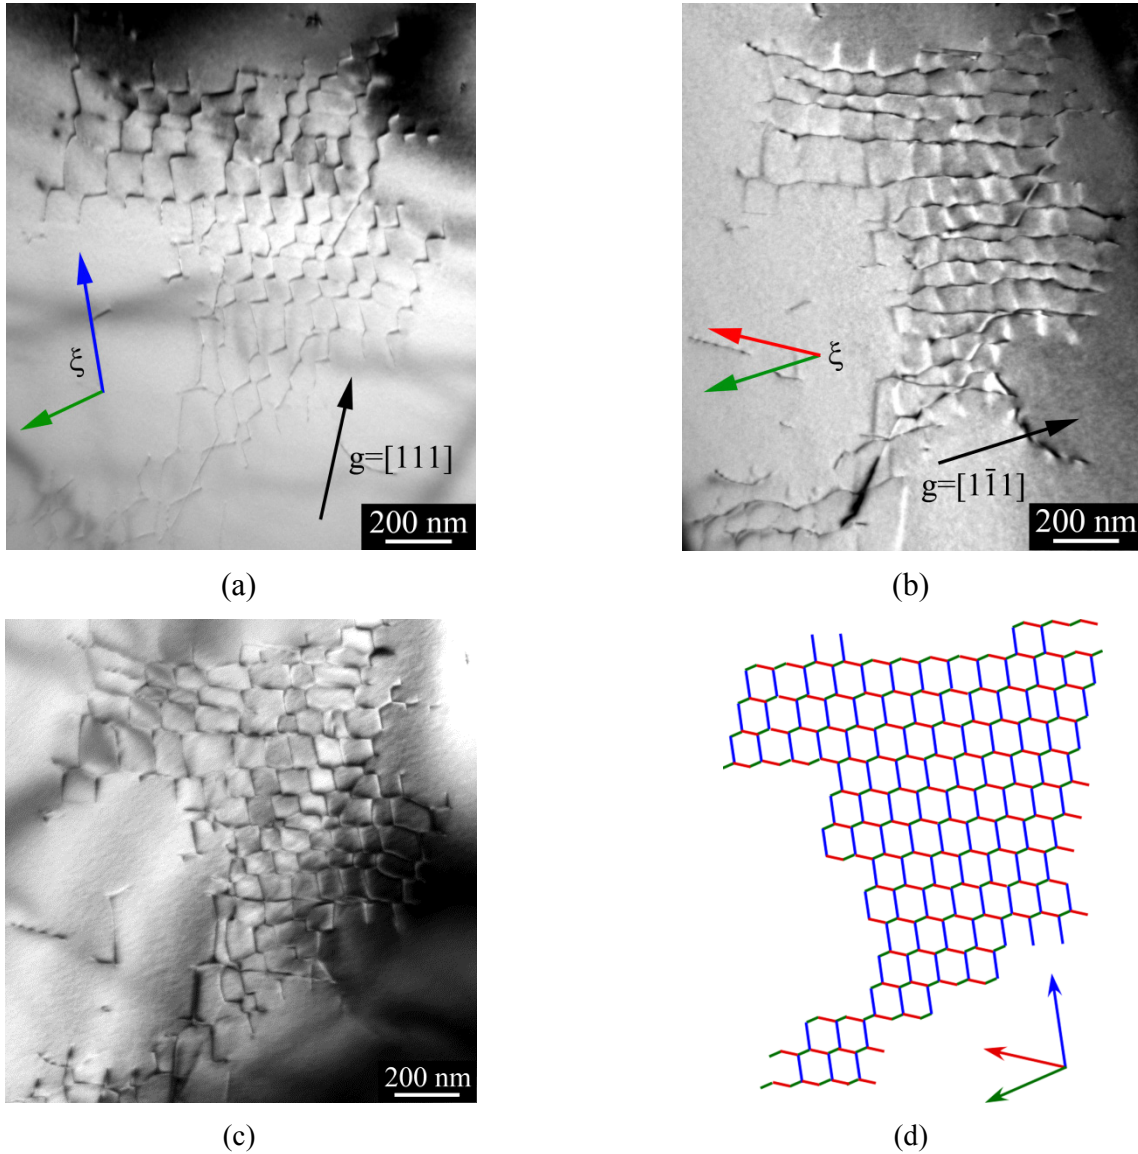
The creep-fatigue substructure at failure consists of subgrains with even fewer mobile dislocations within the subgrain interiors along with well-organized boundaries of arrays or networks of dislocations, as shown in Figure 6(c) and 6(d), respectively. The size of the subgrains can vary even within a single grain, although they are generally on the order of 1  $\mu\text{m}$  along any major dimensional axis. The dislocations forming the subgrain boundaries are arranged into distinct and well-organized networks; the spacing between dislocations visible in a single  $g$ -vector is on the order of 5–10 nm for the 0.3% and the 1.0% total strain range in the 600 s hold condition. TEM-based quantification of the  $\alpha/\beta$  tilt offset between adjacent zone axes was employed to evaluate misorientation between subgrains, and indicates approximately 1-2° of rotation between adjacent boundaries in specimens at both strain ranges. The boundary dislocations contain numerous jogs and kinks, indicative of considerable dislocation interaction prior to or during their arrangement into ordered networks. Figure 8 shows in more detail a commonly observed type of dislocation network that forms a subgrain boundary. The boundary dislocations rearrange into typical hexagonal networks consisting of  $\langle 110 \rangle \{111\}$ -type dislocations as depicted through representative 2-beam (Figure 7[a] and [b]) and multiple-beam (Figure 7[c]) imaging conditions. The configuration of sense vectors of the individual dislocation types that comprise the well-ordered networks is illustrated schematically in Figure 7(d).

Figure 7. Low-energy hexagonal dislocation network in a tensile-hold creep-fatigue specimen tested at 950°C, 0.3% total strain, and a 600 s hold time. Two of the 2-beam conditions that render one dislocation segment type invisible are shown in (a) and (b) along with a multi-beam imaging condition (c) to provide contrast for the entire network. A schematic (d) illustrates the individual sense vectors comprising the imaged hexagonal network.

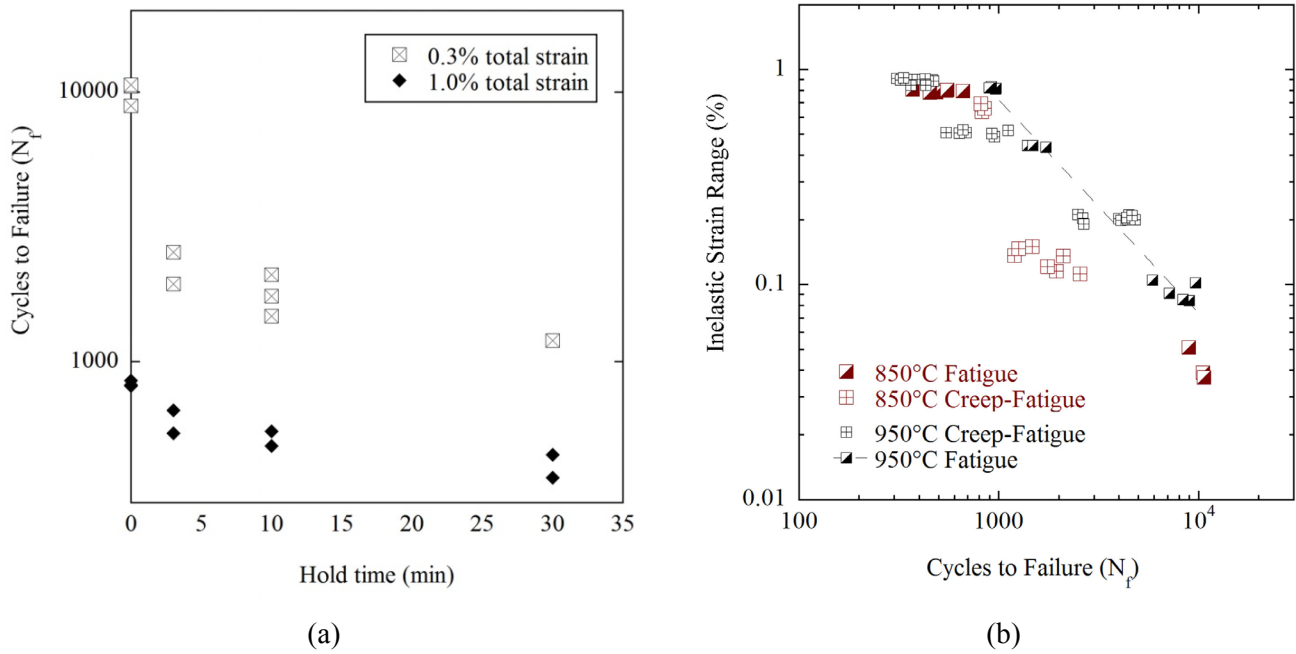
The cyclic behavior at the 0.3% and 1.0% total strain ranges was also investigated at 850°C with hold times of up to 1800 s (30 minutes). Figure 8(a) shows the number of cycles to failure at this temperature as a function of hold time. As was observed at 950°C, the addition of a tensile hold time decreased the total number of cycles to failure relative to the continuous-cycle fatigue condition. A particularly dramatic effect occurred at the 0.3% total strain range, in which a decrease of nearly an order of magnitude in the number of cycles to failure was observed in creep-fatigue relative to continuous-cycle fatigue. The number of cycles to failure at the 0.3% total strain range decreased from approximately 10,000 cycles in fatigue to roughly 2000 cycles depending on the hold time duration. This degradation in life is more dramatic than at any strain range at 950°C or the 1.0% strain range at 850°C. The number of cycles to creep-fatigue failure at the 1.0% strain range decreased by less than a factor of 2 relative to the continuous-cycle fatigue tests. In contrast to the creep-fatigue behavior at 950°C, the duration of the hold time at 850°C appears to continue to degrade the cycle life at each of the strain ranges being evaluated, as is evident from Figure 8(a). At the present time, the compiled data set is not sufficient to accurately determine whether the number of cycles to failure saturates at longer hold durations.

Figure 8. Plot of the total strain range (a) and inelastic strain range (b) as a function of cycles to failure for Alloy 617 in fatigue and creep-fatigue at 850°C at three strain ranges, 0.3% and 1.0%, for hold times of up to 30 minutes. The plot in (b) also includes the 950°C fatigue and creep-fatigue data for comparison and the dashed line represents the Coffin-Manson relationship for the 950°C fatigue data.

It was previously discussed that at 950°C and 0.3% total strain, the detriment in creep-fatigue cycle life is directly related to the increase in the midlife inelastic strain range when a tensile hold is added to the continuous-cycle waveform. The Coffin-Manson plot in Figure 1(b) is shown with the addition of the 850°C fatigue and creep-fatigue data in Figure 8(b). The 850°C fatigue and creep-fatigue data points fall to the left of the Coffin-Manson line that was fit to the 950°C fatigue data, which strongly suggests that the 850°C creep-fatigue failure mechanisms differ from those dominating at the 0.3% strain range at 950°C. Despite not being illustrated graphically due to the lack of data at an intermediate strain range, the 850°C fatigue data may also follow a Coffin-Manson relationship. If it follows the trend established by the other data at 850°C, this relationship would clearly differ from that of the higher temperature fatigue data.

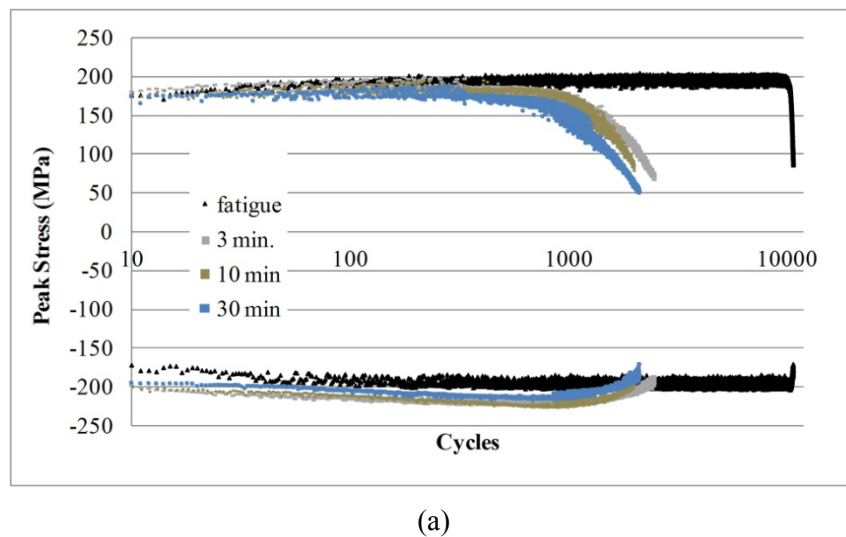
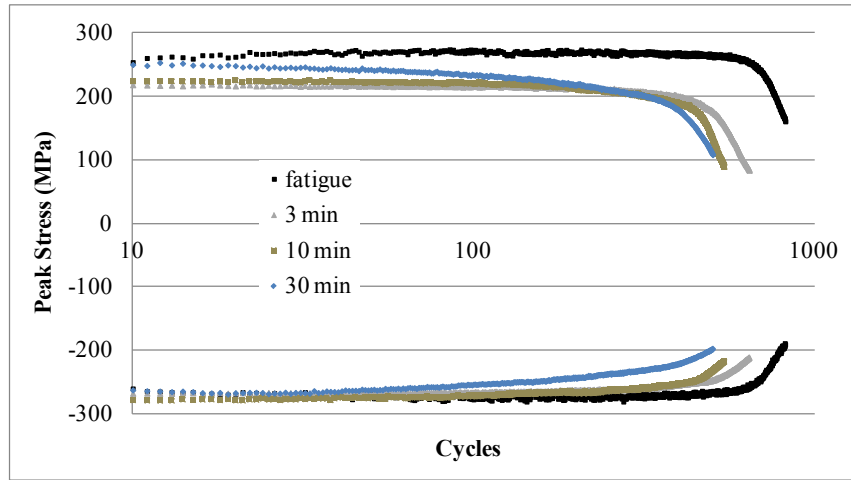
In fatigue, a small amount of cyclic hardening is observed at the 0.3% strain range (Figure 9[a]), whereas at the 1.0% strain range (Figure 9[b]) the peak stress versus cycle plot exhibits a relatively constant stress. Higher stresses are achieved at the 1.0% strain range than at the 0.3% total strain, which is reflective of the additional hardening occurring at the lower temperature [15]. In creep-fatigue testing, slight cyclic hardening that closely resembles the fatigue behavior is observed at the 0.3% strain range. The creep-fatigue tests at 1.0% strain with 3 minute and 10 minute hold times also nearly follow the behavior of the associated 1.0% fatigue test, although the 30 minute hold condition exhibits a significantly larger degree of cyclic softening.

Figure 9. Peak stresses as a function of cycle for a typical fatigue and creep-fatigue tests at 850°C and 0.3% total strain (a) and a 1.0% total strain (b).

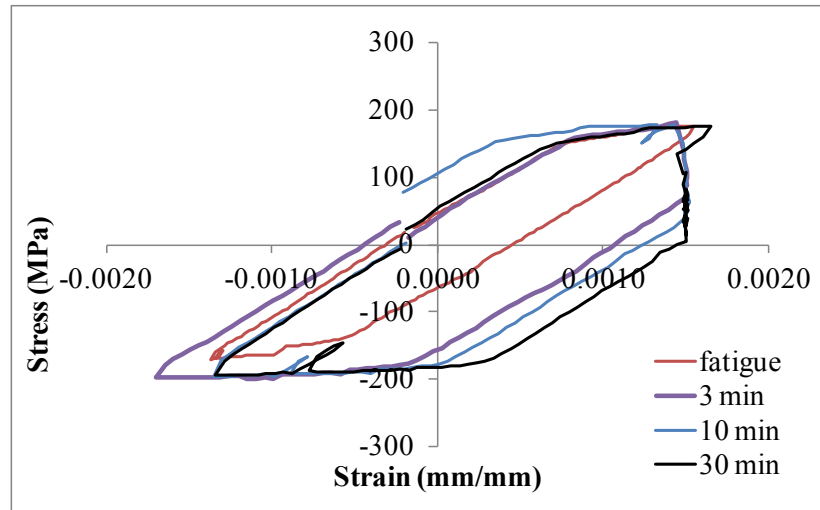
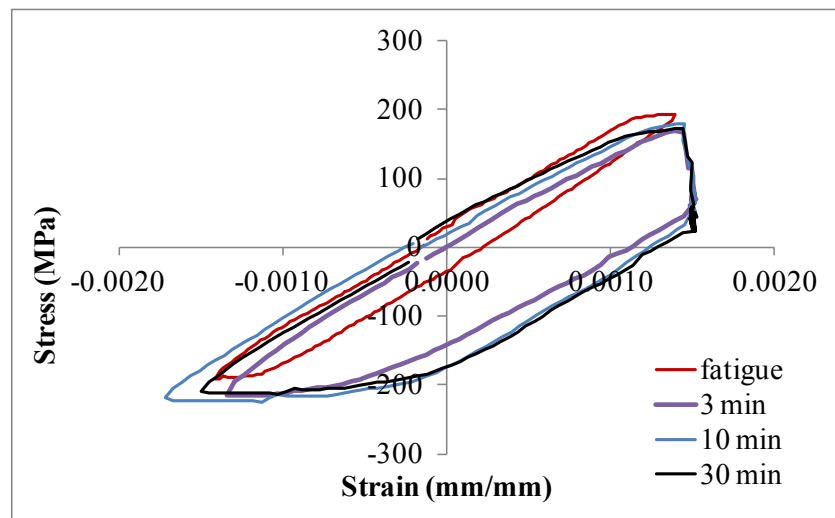
Fatigue and creep-fatigue hysteresis loops at both the tenth cycle and midlife cycle are shown for the 0.3% total strain range in Figure 10. At the tenth cycle (Figure 10[a]), increasing durations of the strain-controlled hold result in a lower “relaxed” stresses, or stress at the end of the strain-controlled hold. The lower relaxed stresses result in increasingly wider hysteresis loops or larger inelastic strains. This increased width is evident from the segment of the hysteresis loop following the tensile hold, but is less clear on the compressive side of the loop due to the strain overshoot commonly observed early in cycling. This overshoot of the target strain values is illustrated through a plot of the peak tensile and compressive strain values shown in Figure 11 for a 3 minute hold creep-fatigue specimen. The peak strains frequently exceed the target command strain on both the compressive and tensile side of the waveform during cycling as a result of the onset of dynamic strain aging (DSA) [16], a phenomenon evident from the distinct serrations in the plotted loops. The absence of the serrations in the 0.3% hysteresis loops is a function of the low strain range; DSA begins to occur at some minimum plastic strain that happens to closely correlate with the target strain for this test conditions. The overshoot in strain at the point of strain reversal is thus a result of a serrated yielding event occurring at the peak tensile or compressive strain. More detail on this specific behavior is available in other studies for Alloy 617 and Alloy 230 at 800°C [16]. The serrated response attributable to DSA is also observed in the 1.0% total strain hysteresis loops shown in Figure 13.

Figure 10. Tenth cycle (a) and a midlife cycle (b) hysteresis loops from a typical fatigue and creep-fatigue tests at 850°C and 0.3% total strain.

An interesting feature of the 0.3% total strain hysteresis loops present by the midlife cycle is the absence of plastic behavior during the loading in tension. A large plastic region is observed in both the tensile and compressive side of the hysteresis loop at the tenth cycle but by midlife the loops have evolved to only exhibit a significant plastic region in the compressive side of the cycle. This “shifting” of the hysteresis loop does not occur at the 1.0% total strain range (Figure 12). Also absent at the 1.0% total strain range is the decreasing relaxed stress values with increasing tensile hold time; the relaxed stresses are approximately the same for each of the three different hold times.

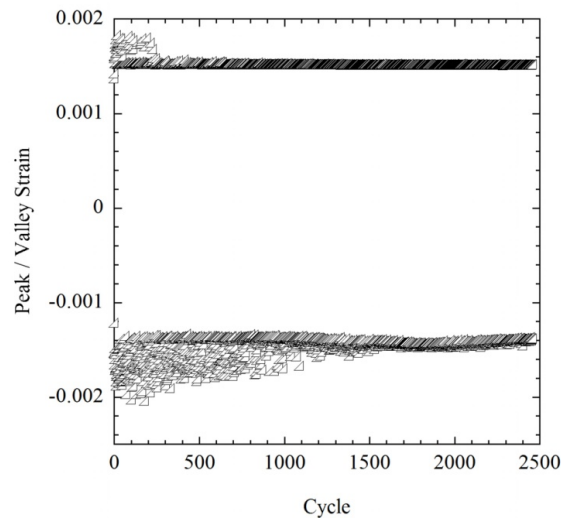
Figure 11. Plot of the peak and valley strain values from a 3 minute hold creep-fatigue test at the 0.3% total strain range and 850°C.

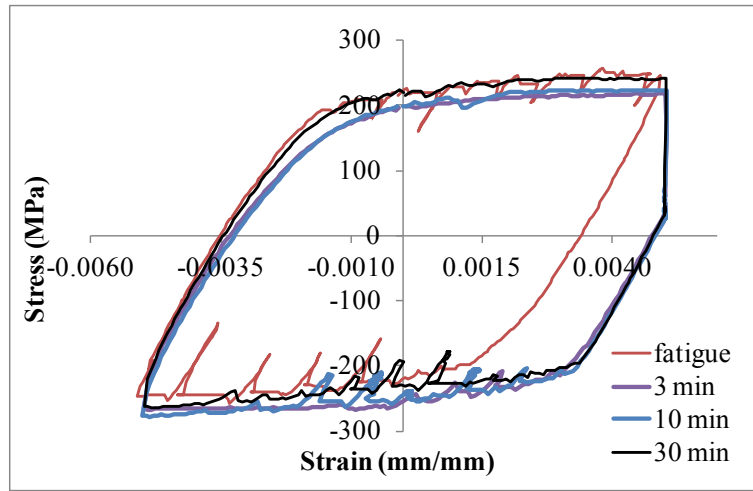
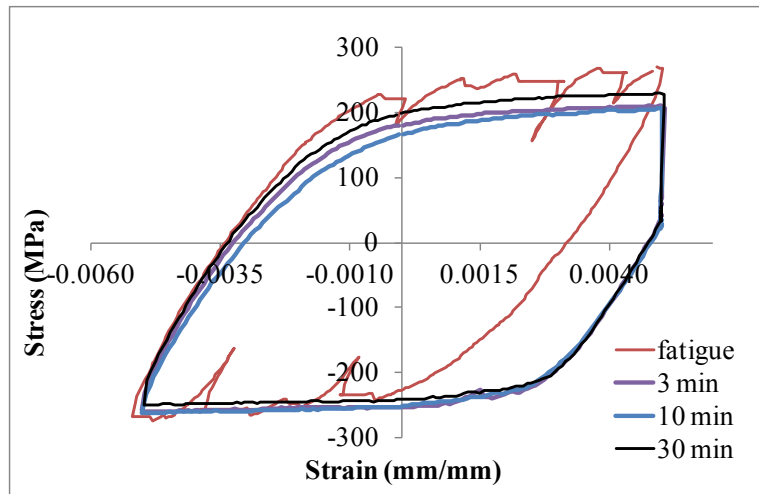
Figure 12. Tenth cycle (a) and a midlife cycle (b) hysteresis loops from a typical fatigue and creep-fatigue tests at 850°C and 1.0% total strain.

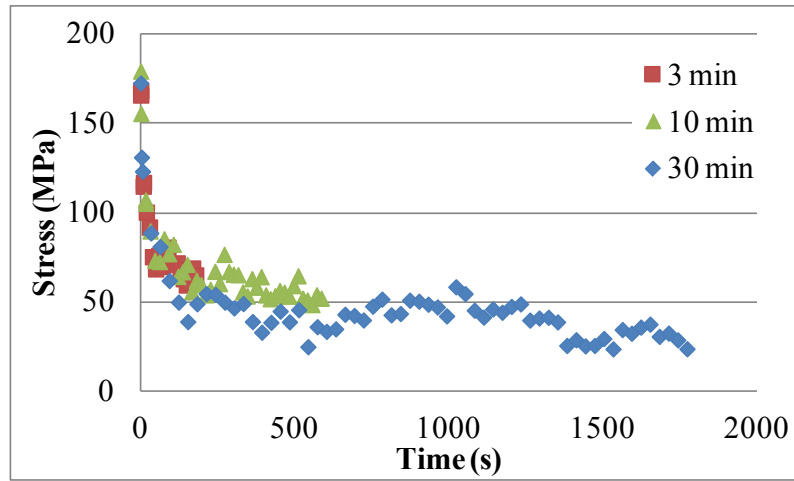
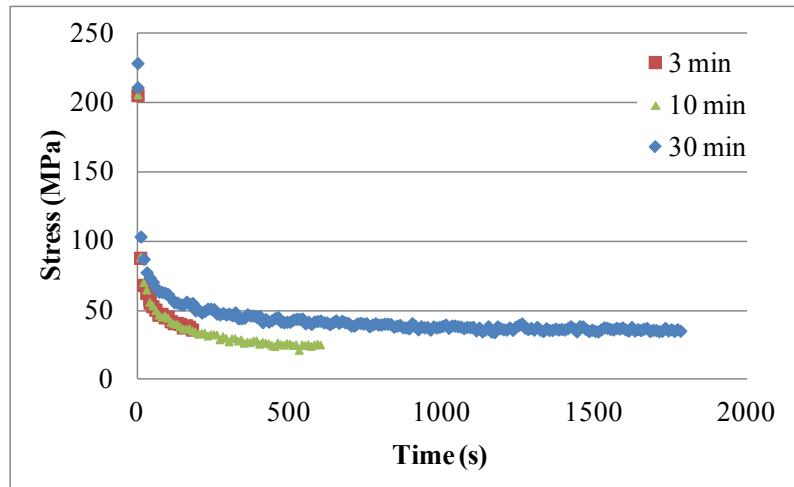
The stress relaxation curves are shown as a function of time for both strain ranges at 850°C in Figure 13. The initial relaxation is rapid, and at the 0.3% strain range the stresses continue to relax throughout the duration of the strain-controlled hold resulting in decreasing relaxed stresses. The trend is less clear at the higher strain range, as a longer hold time would be expected to result in a lower final value of relaxed stress. Either way, the relaxed stresses following the hold period are greater in magnitude than those observed for the 950°C creep-fatigue specimens.

Figure 13. Typical stress relaxation curves from a midlife cycle of creep-fatigue tests at 850°C and 0.3% total strain (a) and 1.0% total strain (b).

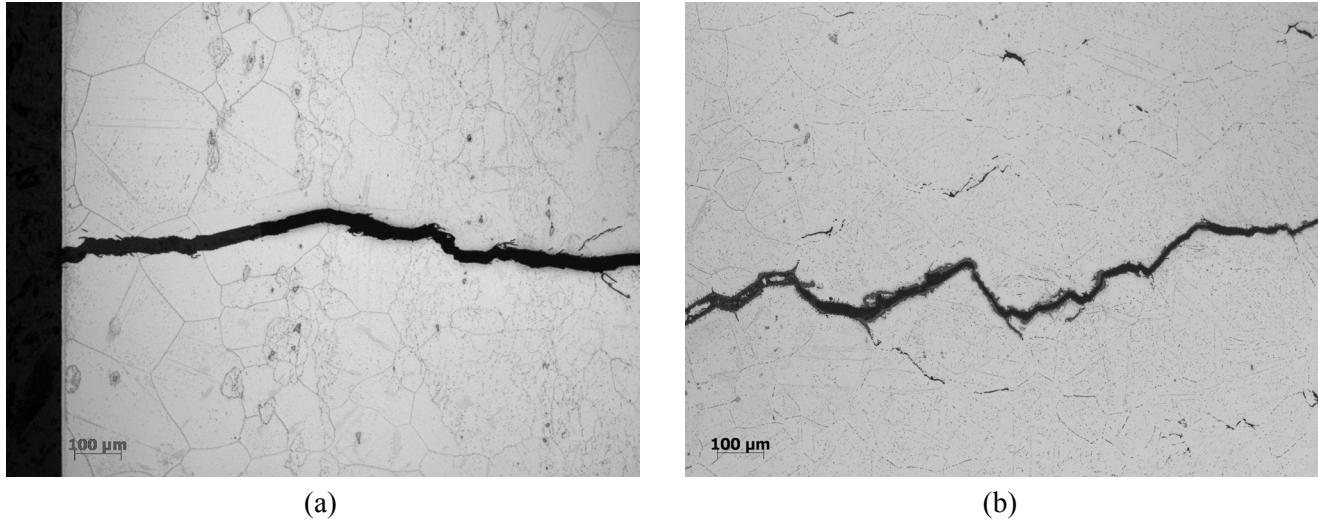
The deformed microstructures developed during continuous-cycle and creep-fatigue cycling at 850°C follow a relatively predictable trend given the corresponding cycle lifetimes. Recall that the 0.3% total strain range exhibited a large decrease in the number of cycles to failure with the addition of a tensile hold time. The cycles to failure decreased only slightly as the hold time was increased from 3 minutes to 10 minutes to 30 minutes. At this strain range, continuous-cycle fatigue deformation induced the primary transgranular surface cracking shown in Figure 14(a). There was no evidence of secondary surface cracking or intergranular cracking along grain boundaries in the specimen interior. In contrast, many secondary surface cracks are evident following creep-fatigue deformation with a character that is primarily intergranular in the 3 minute and 10 minute hold specimens. The cracking mode of some of the longer secondary surface cracks had transgranular components near the crack tip. After a 30 minute hold, the creep-fatigue specimen exhibited both intergranular primary cracking, as illustrated in Figure 14(b), and secondary surface cracking.

Figure 14. Transgranular surface cracking in a 0.3% total strain fatigue specimen cycled at 850°C (a). Intergranular surface cracking in a 0.3% total strain creep-fatigue specimen with a 30 minute tensile hold also cycled at 850°C (b). The stress axis is vertical and in the plane of the page.

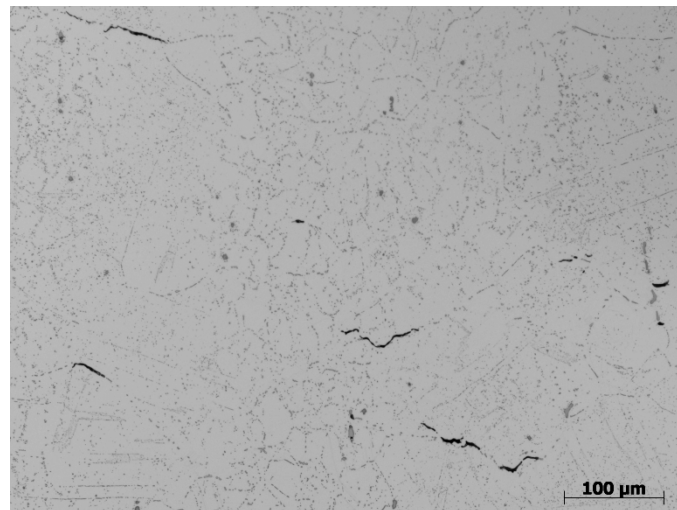
Figure 15. Internal grain boundary cracking (separation) in a specimen tested in creep-fatigue at 0.3% total strain and a 10 minute hold time at 850°C. The stress axis is vertical and in the plane of the page.

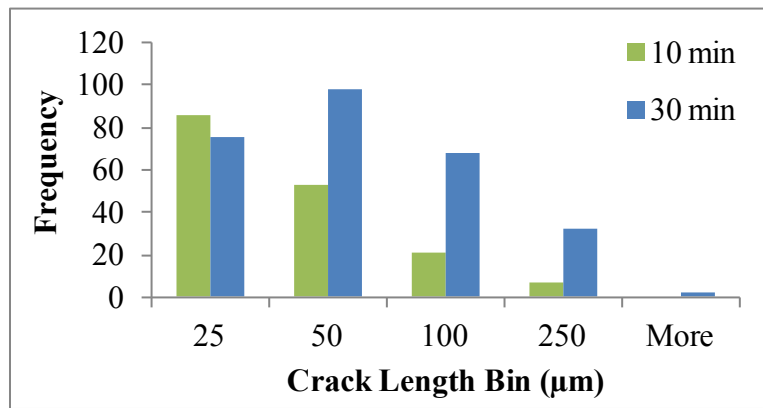
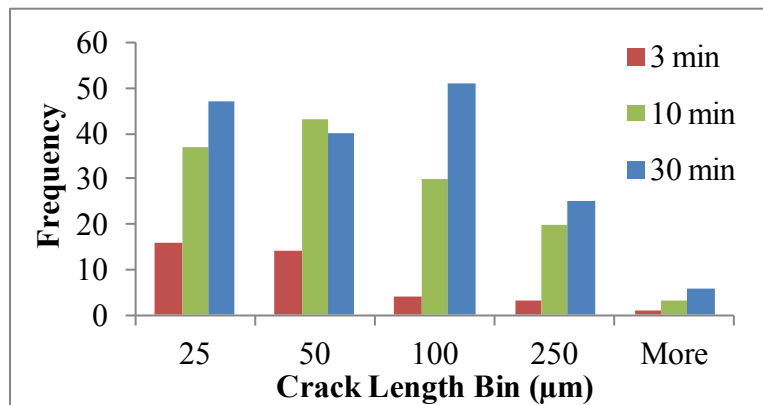
prominent in the specimens subjected to longer hold times. The cracking modes and presence of interior grain boundary cracking is summarized in Table 2 and the interior grain boundary cracking is shown for a 10 minute hold time specimen in Figure 15. The amount of grain boundary cracking in selected hold time specimens has been quantified and is shown graphically in Figure 16. Comprehensive characterization revealed that the number of interior grain boundary cracks and the total cracked grain boundary length increased by over a factor of two in the 30 minute hold time specimen relative to the 10 minute hold time specimen.

Figure 16. Length of individual internal grain boundary cracks in the gage section of specimens tested in creep-fatigue at 0.3% total strain (a) and 1.0% total strain (b) at 850°C for various hold times.

At the 1.0% total strain range, the total length and number of interior grain boundary cracks also increased with increasing duration of the tensile hold time and this is illustrated quantitatively in Figure 16. Despite the presence of interior grain boundary cracking, the mode of surface crack propagation was transgranular at 1.0% total strain regardless of hold time duration. A primary crack is shown in Figure 17 for the 3 minute hold condition. As expected, the cracking mode was also transgranular in fatigue. The relatively small decrease in the

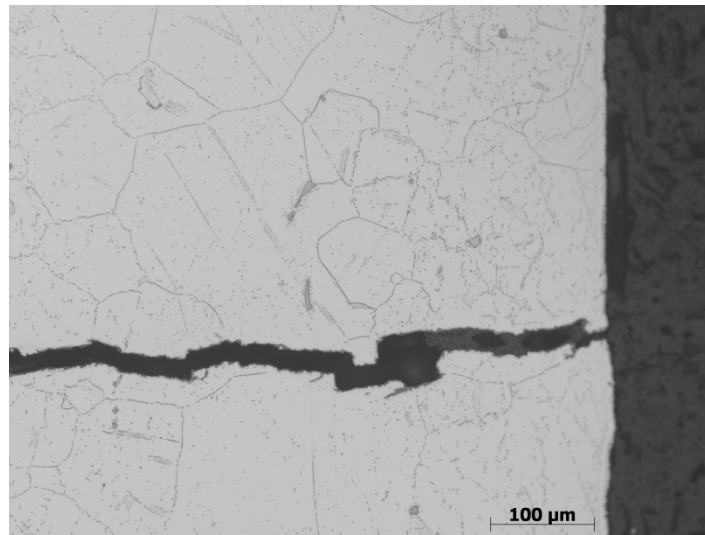
Figure 17. A primary crack propagating in a transgranular manner in a specimen tested in creep-fatigue at 850°C and a 1.0% total strain with a 3 minute hold time. The stress axis is vertical and in the plane of the page.
