GLOVEBOX BOOK

OU 7-13/14 Field Representative GEM Logbook

LOGBOOK NO: ER-038-2004

PROJECT: OU 7-13/14 Field Representative GEM

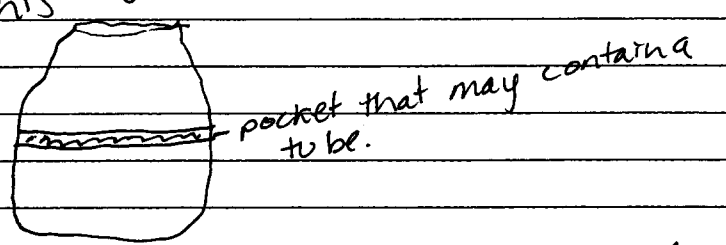
TIME	OBSERVATION
1503	6B#3 just ~~B~~ loaded drum w/ soil scoop. Excavation is focusing on sizing a drum at present. The drum is empty, bagged, great condition. You can see it's still yellow. The drum will go to 6B#2 after sizing, where the 85 gal. drums can be packaged. at 6B#3, items in tray are 50% metal (corroded) and 50% plastic, and paper debris, including intact "horsetails" (taped tops of ~~drums~~ bags) GLO 2-11-04
1517	6B#1 soil scoop arrives scoop# ~238 R= 8.73 A: 7 D= 13.45
	6B#2 Items tray: a bag discolored to 100K like pig ears that you buy for your dog; the bag is ~ 1ft long, ~9"-10" diameter, horse tailed w/ white tape on top, has a ~~rubber~~ GLO 2-11-04 "pocket" that contains a tube or something: May have one day looked like this

The tray containing this bag gives off some β γ ~20000 counts (no mR/hr ~~reading~~ detects)
1639	~~Mary~~ Mashed drum to 6B#1. Coordinates S, R, A, D= 1241 7.63 8 13.07

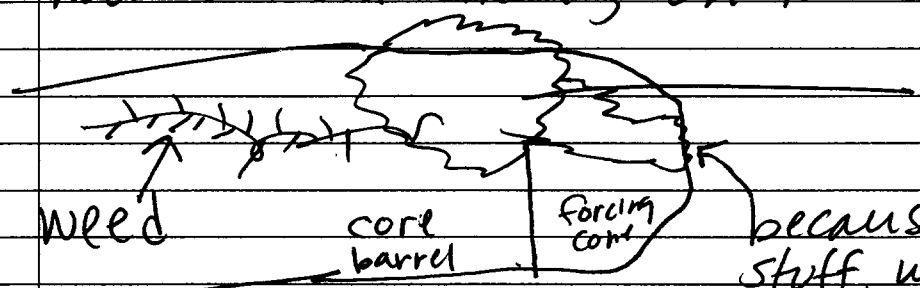
At the new location, there appeared to be surface contamination, but it ~~was~~ did not appear - or was assumed - to be only surficial. Contam on surface may be nitrate salts. (white in color, granular).
	The core barrel was caked w/ rust-colored sediment or sludge or stained soil, and had a weed sticking on it

because the orange stuff was here, it is deduced to have been a result of coring into, not pulling out of, the hole. At the bot of forcing cone, caked into it, was greyish colored soil poss indic. of calcic soil or near-refusal. Estimated core length ~ 47". See Studtay's notes in Excavator book.
	2-20-04
