TMI Unit 2 Technical Information & Examination Program

UPDATE

Volume 3, Number 2 August 15, 1983

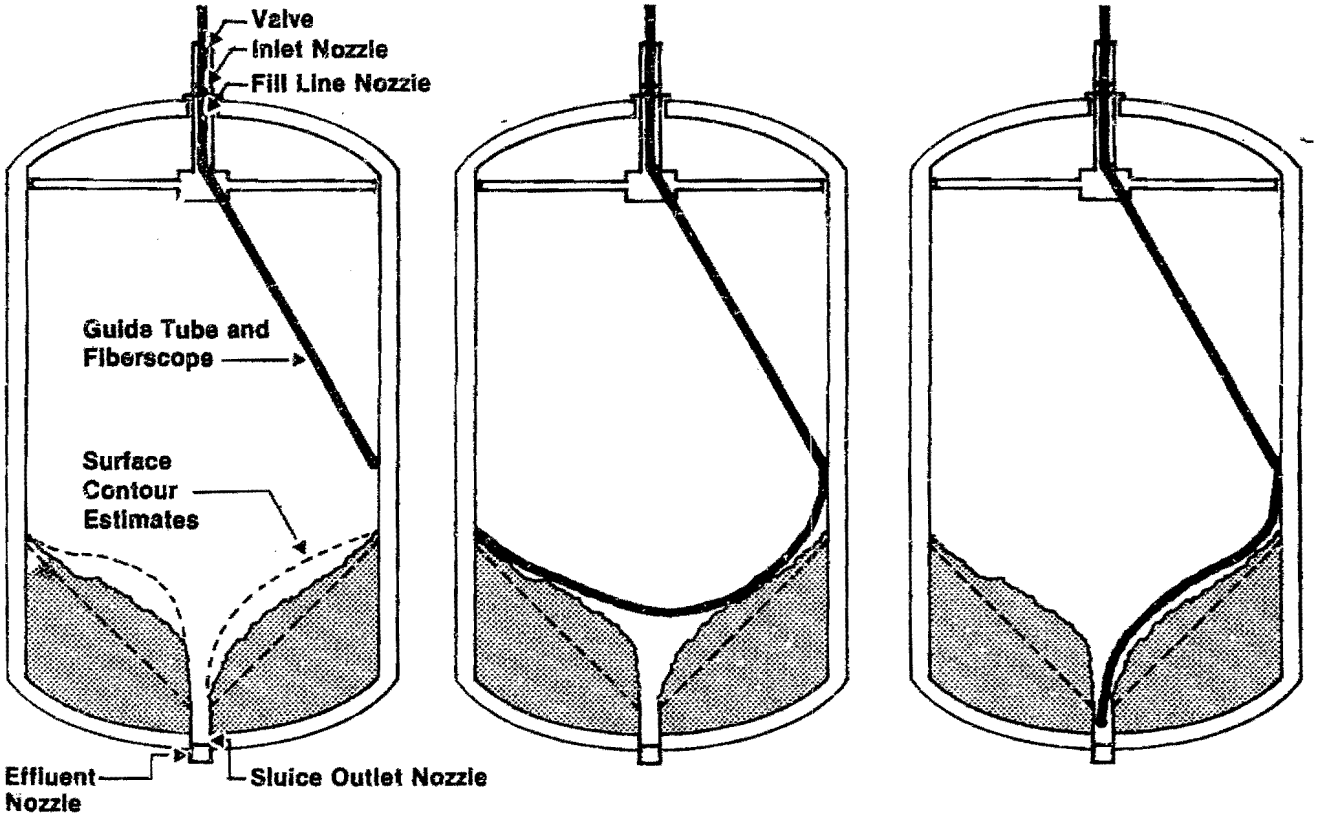
Figure 3. **Pathways of fiber optic horescope during examination of demineralizer A vessel internals.**

In April 1983, TI&EP engineers completed a successful examination of demineralizer A vessel using a 50-ft long, radiation-tolerant, fiberoptic scope. The scope, inside a polyethylene guide tube, was pushed into the vessel through the resin fill line and passed easily through the resin fill line diaphragm valve. The fiberoptic scope and guide tube paths are detailed in Figure 3. Observations by TI&EP personnel during the fiberscope inspection concluded that the A vessel contains a bed of resin with a crust of boron crystals coating the top of the bed. The center of the bed has a large void that appears to be above the resin sluicing outlet line. The resin in the bed is agglomerated and amber colored below the crystalline crust.

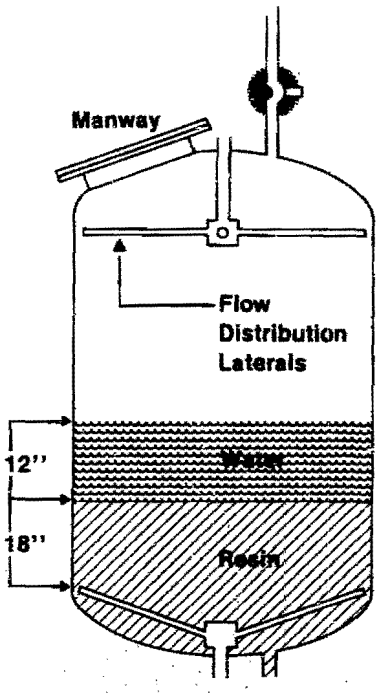
Figure 4. **Estimates of resin and water levels in B vessel.**

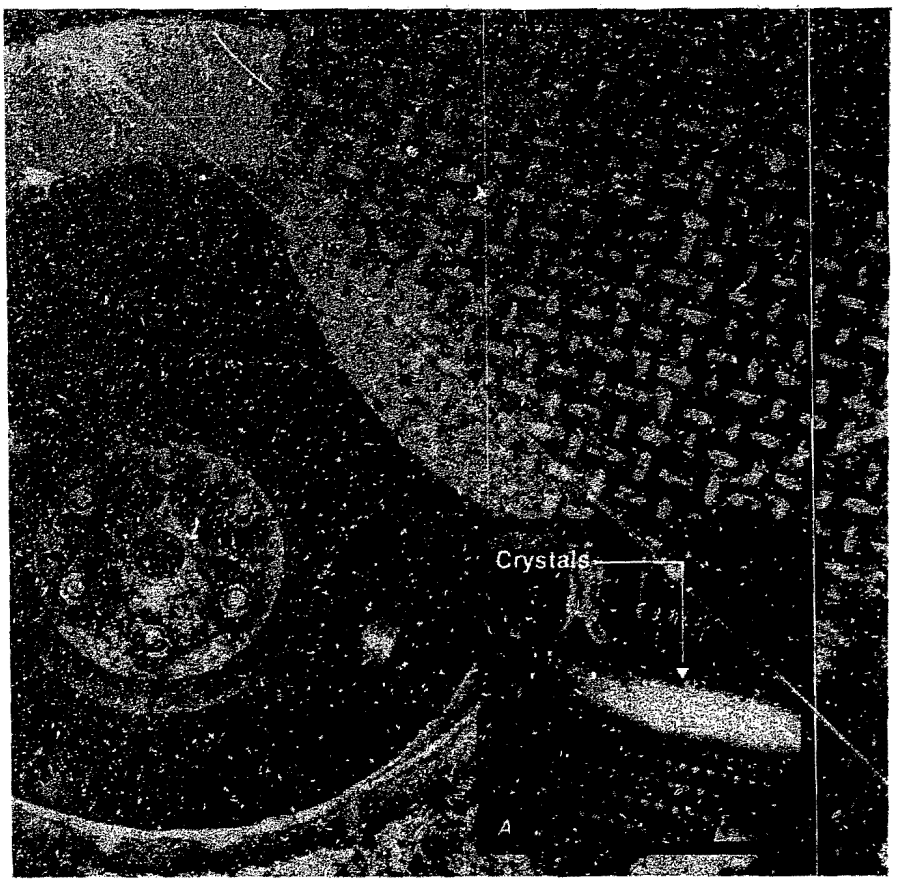
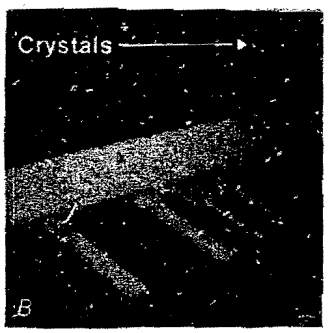
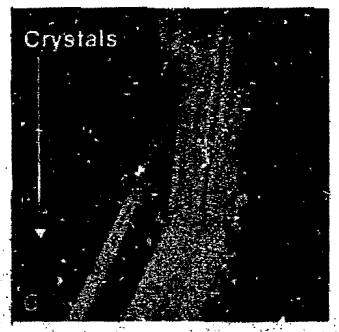
A. The top of the sump inlet trash rack in the Reactor Building basement. Evidence of extensive rusting is present on metal surfaces and boric acid crystals can be seen on piping.

C. I-beam support and pipe below ceiling show evidence of boric acid crystals.

Turning the camera toward the ceiling of the basement, the surfaces of pipes, conduits, electrical cables, cable trays were examined. Heavy deposits of agglomerated boron crystals were seen. A cable tray located approximately six feet below the ceiling is shown in Figure 6. As the camera rubbed or bumped surfaces and equipment, a "snow storm" of this loose debris fell from surfaces near the ceiling to the basement floor. Additional evidence of boron crystals is seen in Figure 6. The presence of this type of debris has added a new component to baseline cleanup and recovery consideration. The crystalline boron material, that is believed to have originated primarily as a precipitate out of accident water and decontamination water sprays, represents a potential source of airborne contamination.

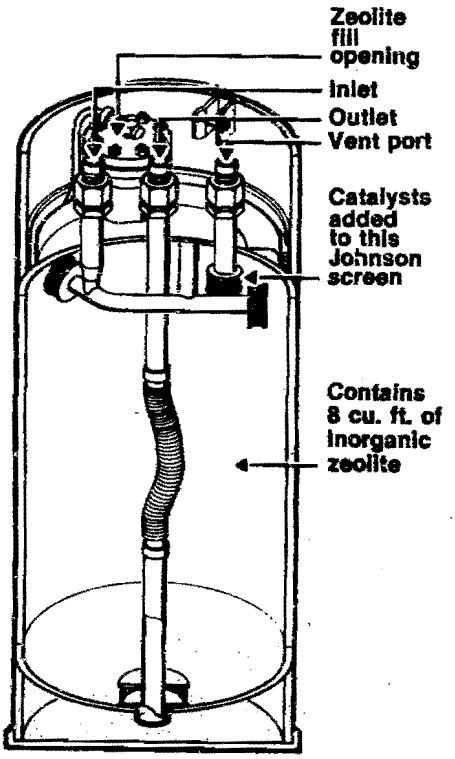
Figure 9. **Cutaway view of an SDS liner showing Johnson Screen to which catalysts are added.**

While GPUNC and the DOE TI&EP were preparing to ship the liners to DOE laboratories, technicians determined that the highly loaded liners were generating hydrogen and oxygen gases at rates which could produce unsafe concentrations during shipment. Technicians calculated gas generation rates of up to 1.1 liters per hour by monitoring the used liners both to assess the rate of increase in liner pressure and to analyze the composition of gases being generated. The data indicated that each liner's gas generation rate was proportional to both its curie loading and the amount of water remaining in it.

The TI&EP assembled a task force of technical experts to develop a solution to the radiolytic gas generation problem in SDS liners. After evaluating a list of possible solutions, the task force decided to test an approach in which catalyst pellets are placed inside each liner to recombine the radiolytic hydrogen and oxygen into water. Catalyst recombiners had been used successfully in homogeneous solution research reactors to recombine hydrogen and oxygen over long periods of time. The task force concluded that conditions for catalyst use in the SDS liners would have to be modified for successful application of the technique at TMI. Water would have to be removed from the liners to prevent possible catalyst submersion in the event of a shipping accident involving liner inversion, since catalyst action is inhibited when the pellets are submerged in water. Water removal was also expected to help reduce the radiolytic gas generation rate since those rates depended on the liner water content as well as the curie loading.

Actual vacuum outgassing and catalyst addition would have to be performed at TMI from a remote location in order to protect workers from the high radiation in the SDS liners. RHO designed a combination vacuum outgassing and catalyst addition tool to allow TMI technicians to perform both functions remotely. When using the tool for vacuum outgassing, technicians connect the tool's 1-1/2-in. diameter pipe to the SDS liner vent port through which residual water can then be removed. Tests using the tool to add catalysts to the liner concluded that the pellets could be added remotely through the vent ports to a filter assembly inside each liner. Figure 8 shows a technician carefully pouring the catalyst pellets into the portal on one end of the tool. The Johnson screen filter assembly, with an area of 770 mm^2, is located below the vent port and can hold 236 g of the platinum-palladium catalysts. From the Johnson screen assembly, shown in Figure 9, the catalysts experience enough gas flow to successfully recombine the radiolytic gases.

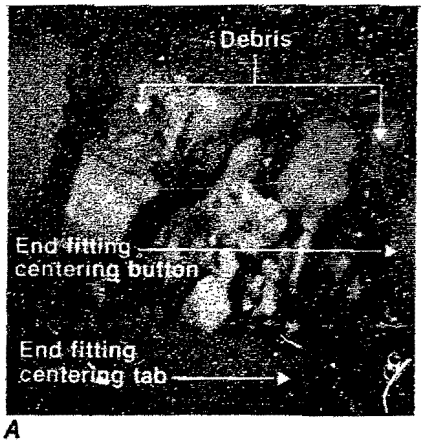
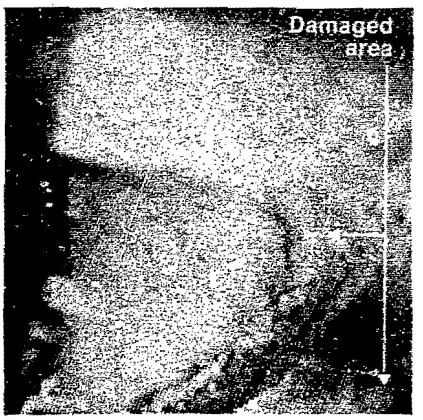
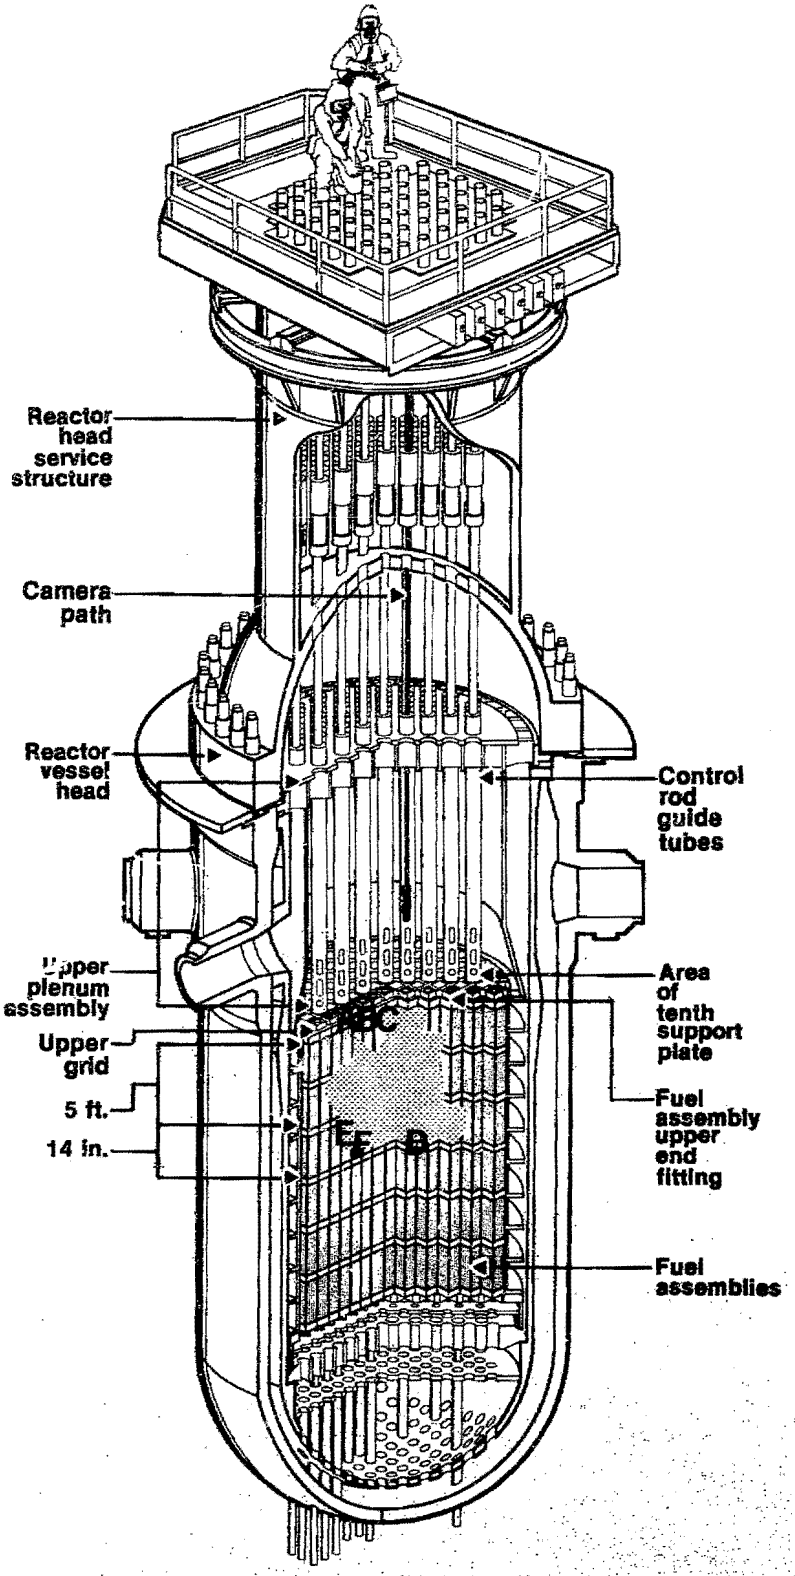
Figure 12. **Relative locations and views of damage inside the TMI-2 reactor.**

At the core center position, the entire upper end fitting was missing, as were all adjacent end fittings. The grillwork from the midradius upper end fitting was completely missing as was its control rod spider, spring, and spring retainer. The grillwork on each of the other upper end fittings visible from this location was present but partially melted and suspended from the plenum grid plate. One section of grillwork also had other identifiable components, such as a spacer grid, stubs of control elements, and partial fuel rods, suspended from it.

The insides of the midradius upper end fitting were scanned using the camera's right angle lens. The end fitting appeared to be in its normal position with respect to the grid structure. Metal chips and debris were found in the small space between the center tabs on the end fitting and the grid. In addition, some areas of the top portions of this upper end fitting have the appearance of having been cut by a torch, while adjacent areas appear to be in the as-manufactured condition.

B. Damage to E-9 upper end fitting looks like metal after it has been cut by a torch.

E. Unidentified rod on top of rubble bed at location E-9.

F. Pellet hold-down spring on top of rubble bed at location E-9.

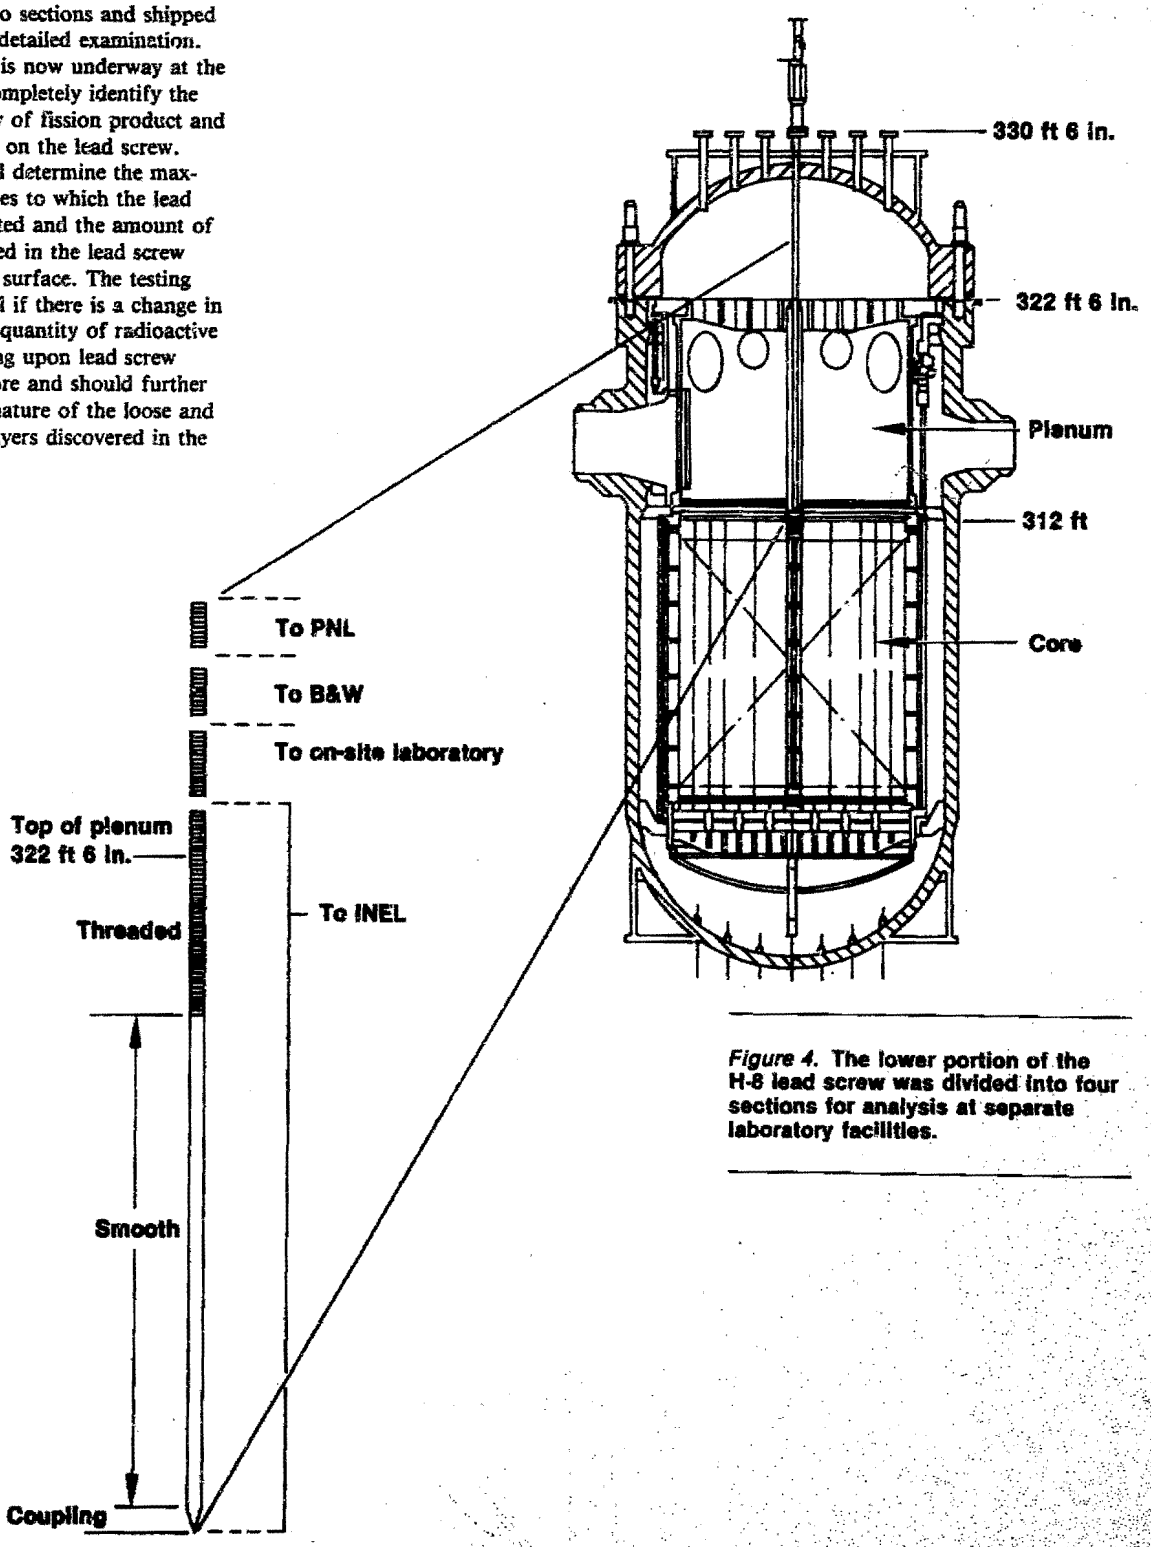
Metallography and microscopy revealed three distinct layers on the lead screw. An inner layer, approximately 3 μm thick, was identified as being a typical reactor water corrosion film. A second chromium-rich layer, 10 to 90 μm thick, was also identified. About 90% of the cesium on the lead screw sample was associated with this second layer. As noted in examination of the first lead screw section, the cesium could not be effectively removed from the lead screw by any decontamination solution except the nitric-hydrofluoric acid. This implies that a large concentration of cesium may remain on vertical underhead surfaces even after proposed flushing efforts. The third and outermost layer, which ranged in thickness from 25 to 75 μm, was readily removed with a wire brush. This layer contained approximately 85% of the ^{90}Sr and over 90% of the uranium on the lead screw section.

Figure 4. **The lower portion of the H-8 lead screw was divided into four sections for analysis at separate laboratory facilities.**

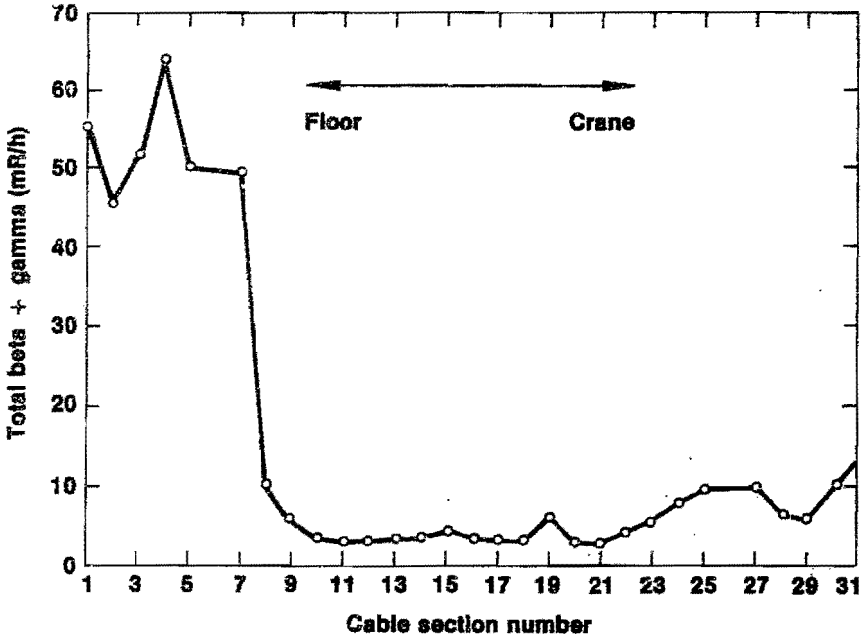
Figure 8. **Radiation levels on the polar crane cable were a function of location along the length of the cable from the crane to the floor. Radiation levels decreased as the distance of the cable from the floor increased.**

Visual inspection of the cable in place in the building provided the only in situ information obtained on the sample. In this visual examination, engineers observed the effects of the hydrogen burn on the cable sheath: greater burn damage occurred at higher elevations. The cable was removed as part of the polar crane refurbishment program, as reported in the related article in this issue of the *Update*. With the cable's building orientations carefully marked, the sample was cut into 30-in. sections. The measured radiation levels from the cable are shown in Figure 8. In this figure, an increasing section number corresponds to increasing elevation in the building. The relatively high radiation levels for lower elevations are attributed to the fact that these cable sections were lying flat in the building, thus exposing more surface area to settling contamination. In all studies of the cable sections, no significant difference in electrical properties was observed between the different cable sections.

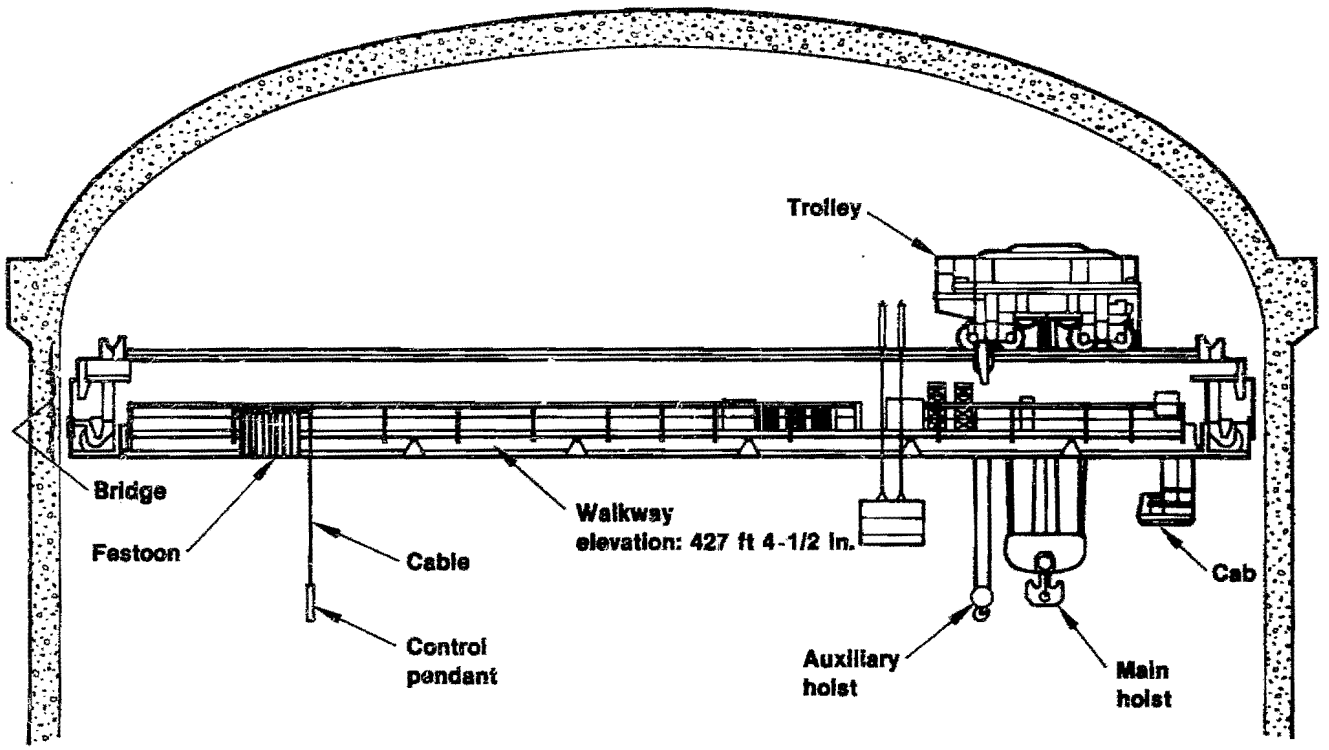
Figure 9. **Major components of the TMI-2 polar crane were refurbished during recent work preparing for reactor vessel head removal.**

Following nearly a year of inspections, analyses, repairs, replacements, and no-load operational testing, the polar crane at TMI-2 is structurally, mechanically, and electrically ready to undergo load testing—the final stage in preparation for reactor vessel head lift operations. The 500-ton Whiting polar crane installed in the TMI-2 Reactor Building became inoperable as a result of the March 1979 accident. Figure 9 shows the main components.

Among the electrical equipment that was replaced in kind were 15 electrical relays and contacts in various control cabinets, which were corroded or malfunctioning. Five trolley and bridge accelerating resistor banks, which were also corroded, showed low insulation resistance or had open circuits. In Figure 10, damage to resistor bank insulation and windings can be seen.
