EGG-TMI-7992
February 1988

TMI-2 ACCIDENT EVALUATION PROGRAM SAMPLE ACQUISITION AND EXAMINATION PLAN FOR FY-1988 AND BEYOND

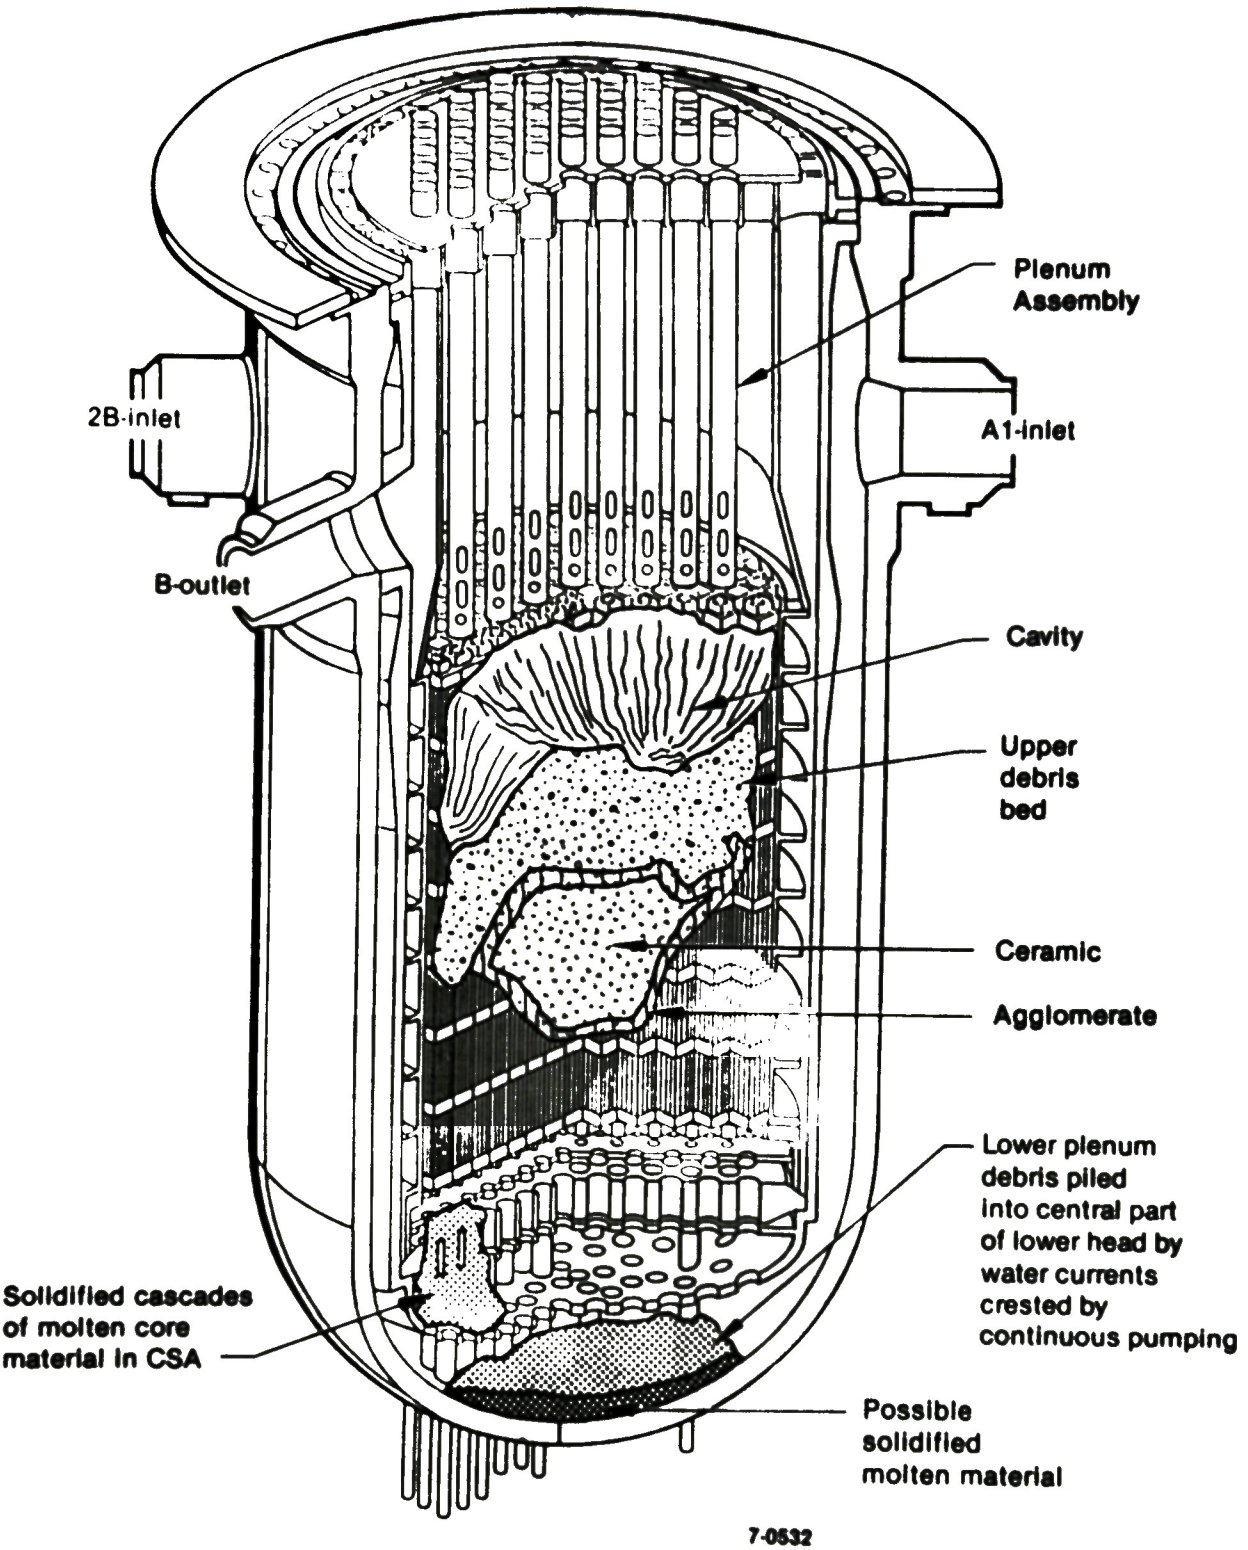
Figure 10. TMI-2 accident end-state core conditions.

The estimated end-state condition of the TMI-2 core immediately following the accident is shown in Figure 10. This figure was constructed using the cross sections of the upper debris bed region, molten core region (agglomerate and previously molten, homogeneous ceramic), and standing fuel rods for the B through P assembly rows described previously (see Figure 4). The upper debris bed surface is approximated in the cutaway view in Figure 10; note the low point of the debris bed near the "B outlet" (east quadrant of the core). The different material structures which currently exist within the core are illustrated approximately to scale. The estimated volumes and masses of the different types of core materials are listed in Table 7.

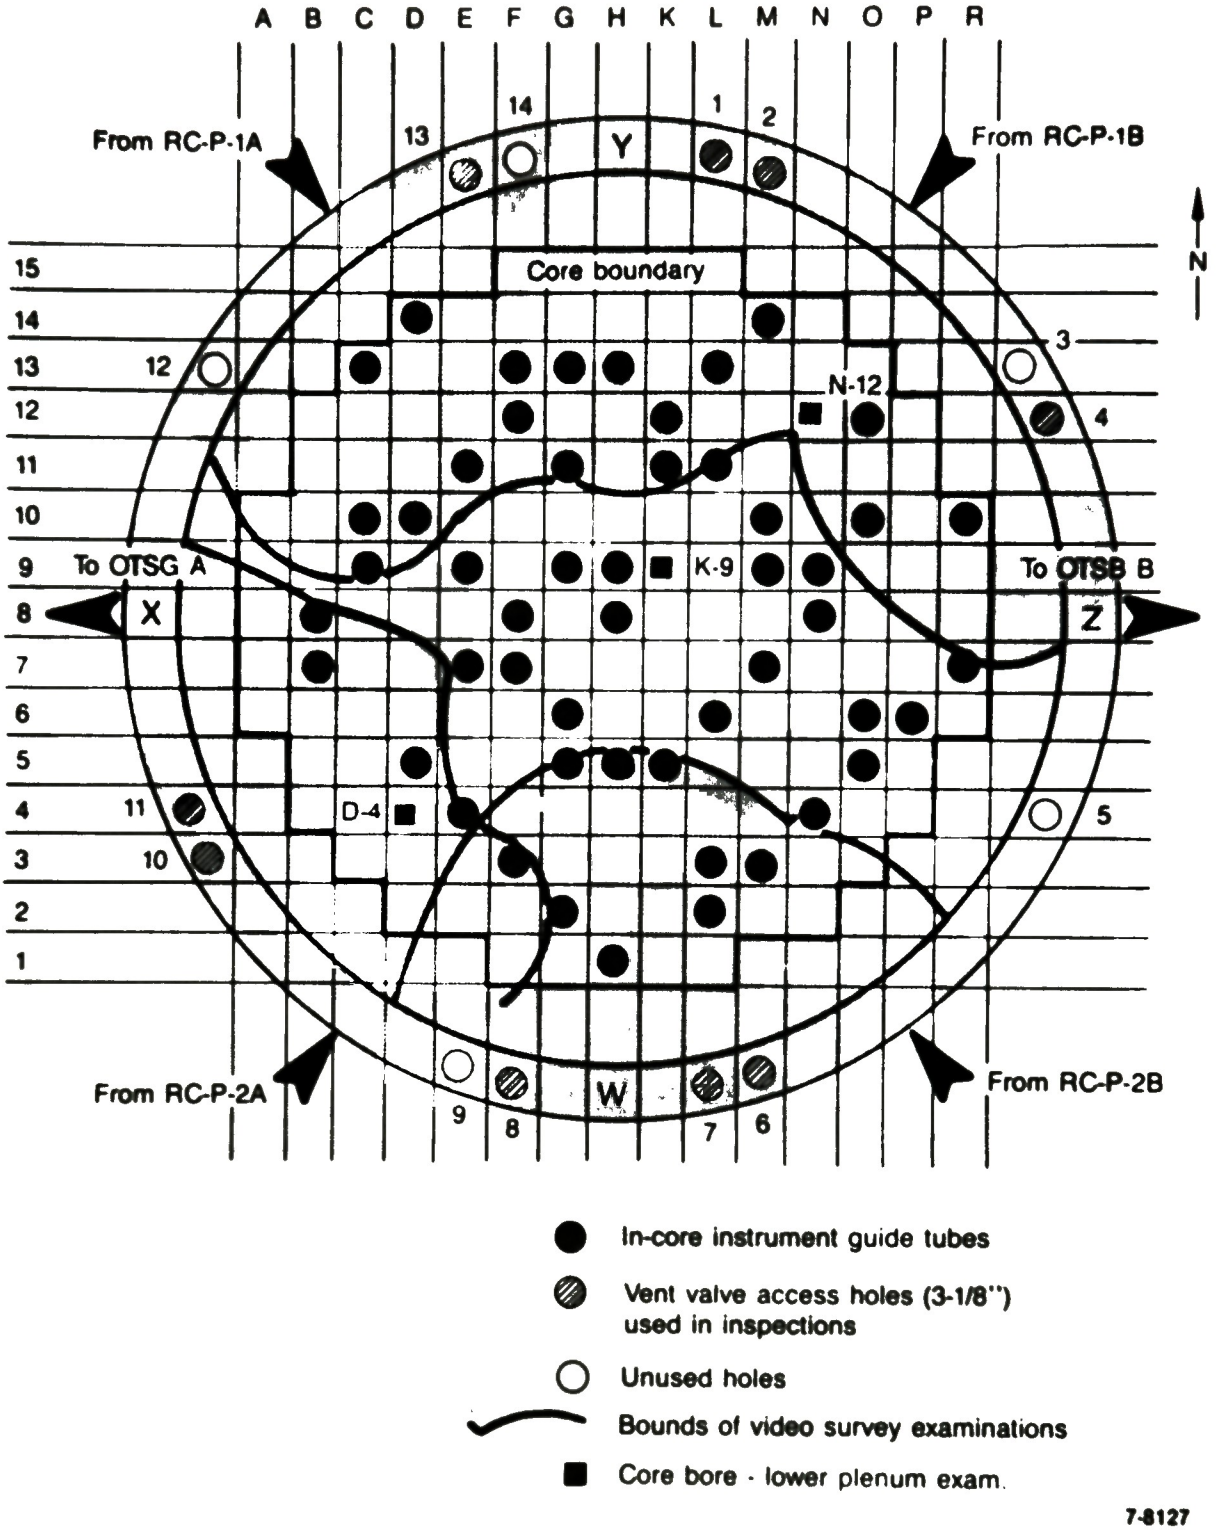
Figure 12. Reactor vessel lower head region video survey map.

- Both the guide tube lower end and the nozzle upper end of in-core instrument number 45 (below core position R7) are partially ablated.

- Possible "high water" marks and/or surface deposits from interaction with molten core material were observed on in-core instrument guide tube numbers 44, 45, and 47 (below positions P6, R7, and O10) below the flow distributor.

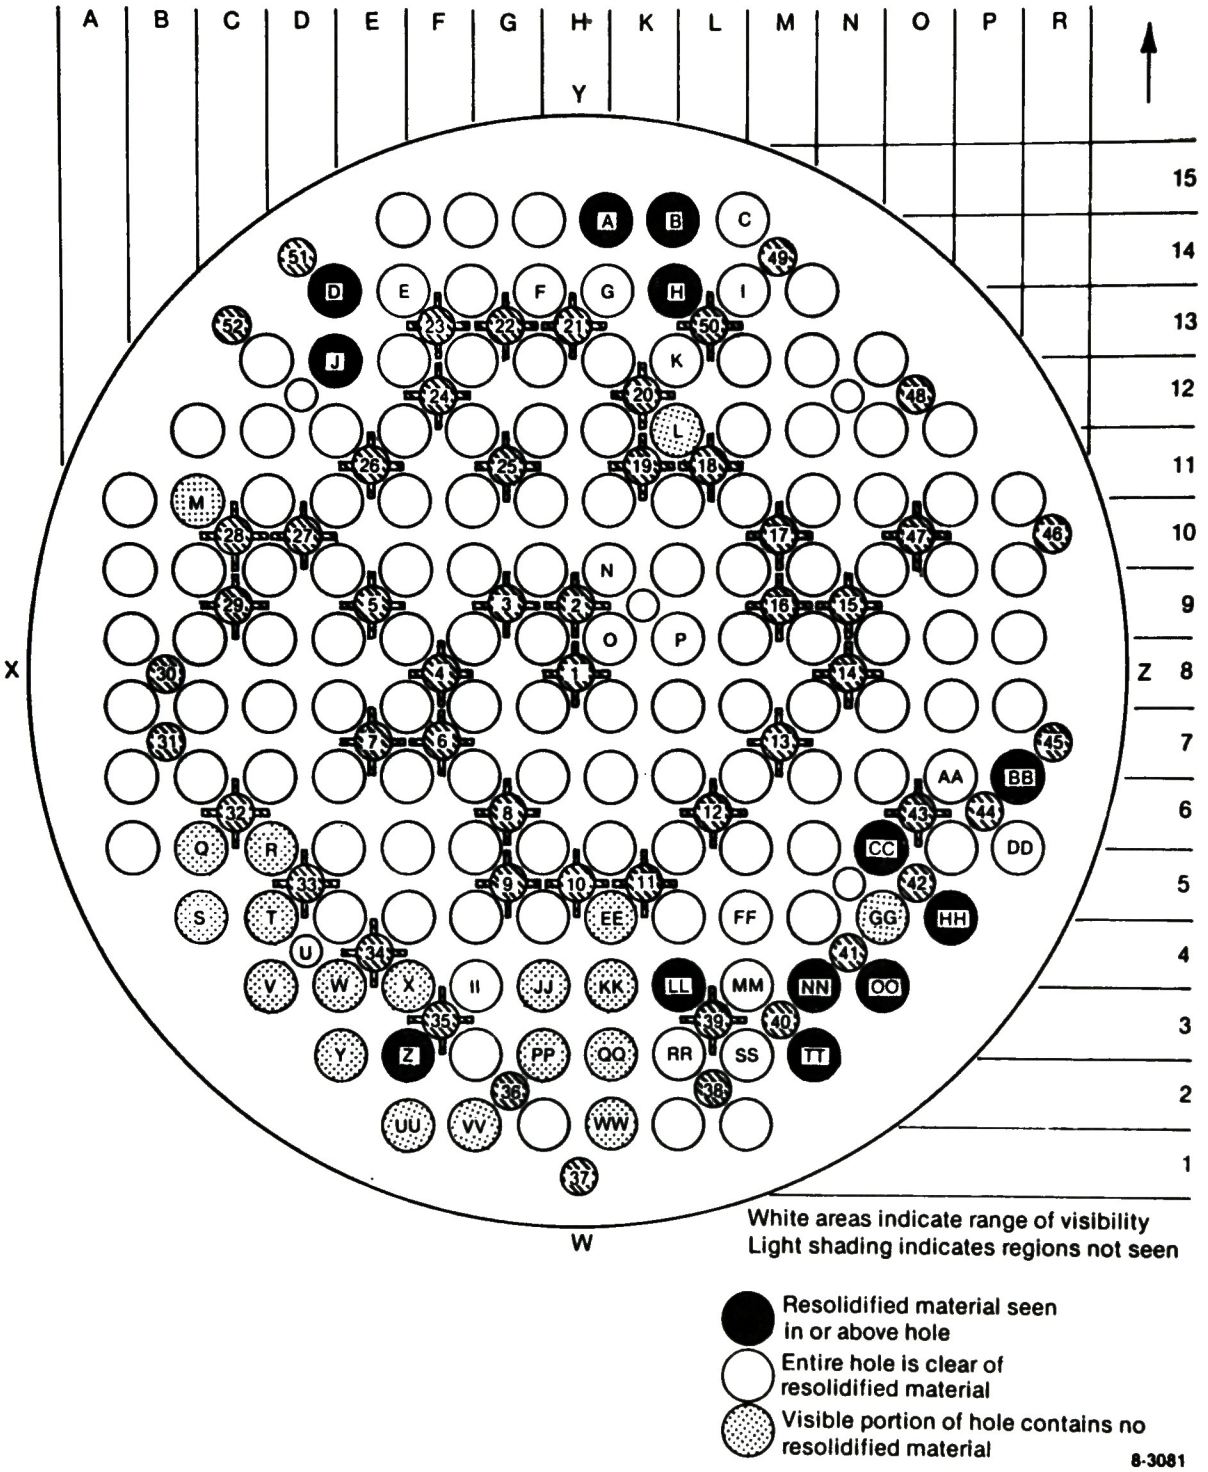
Figure 13. Resolidified material at bottom of flow distributor head.

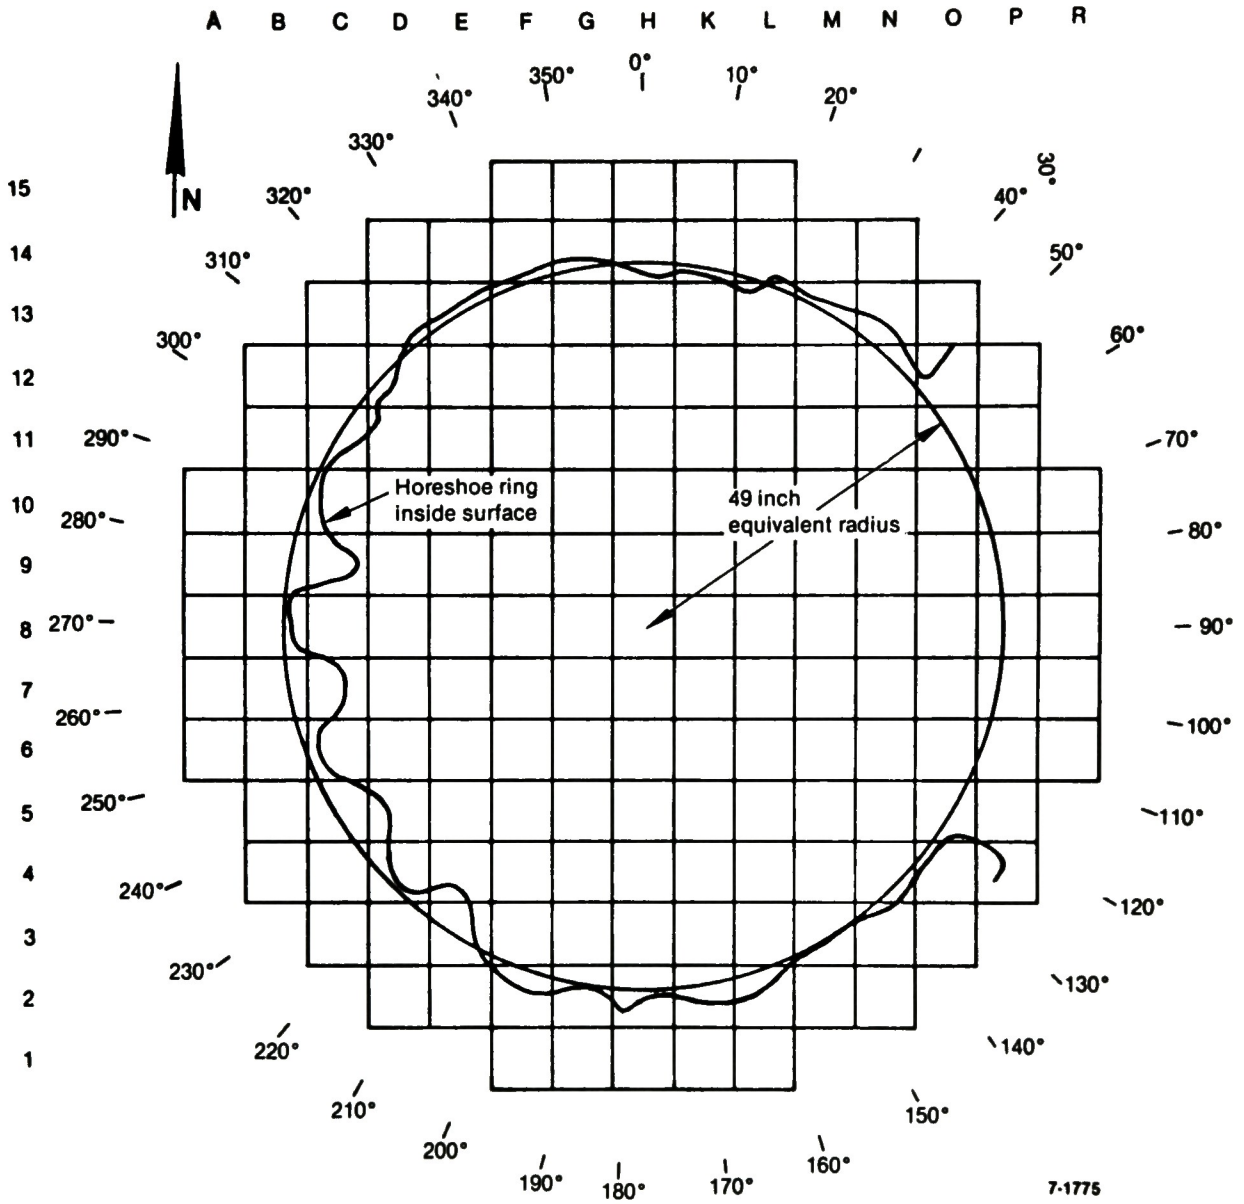
- Sufficient loose debris had been removed from the core cavity floor to expose (a) the hard crust near the 70-in. elevation above the original core bottom and (b) a horseshoe-shaped ring of agglomerated (cemented-together rod bundle remnants) core material projecting inwards from the standing fuel rods above the hard-crust surface, as shown in Figure 14. The ring extended from around the 100-in. elevation above the core bottom to the hard crust, where it receded, creating a cave-like geometry.

Figure 14. Estimated radial configuration of horseshoe-shaped ring of agglomerate core material.

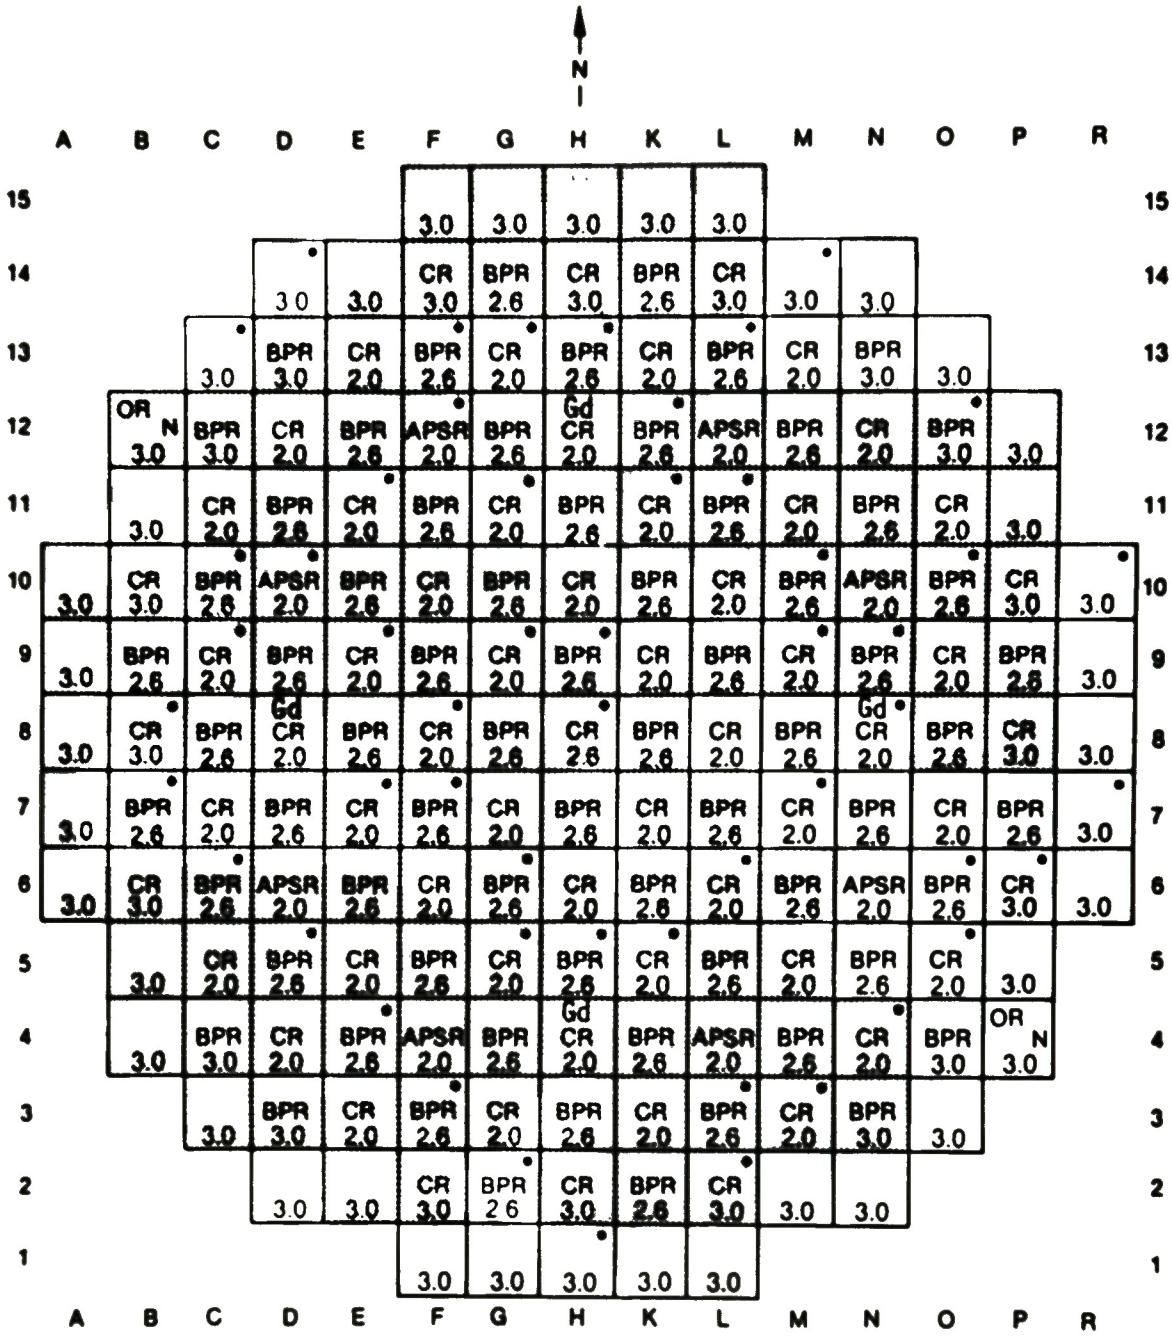
Figure 15. Status of fuel assembly lower end removal on October 6, 1987.

During FY-1987, fuel removal included most fuel assemblies still standing at the core periphery, the fused-together core material in the lower core region, and 140 of the fuel assembly lower ends projecting upwards from the lower grid (Figure 15). In November, the core-boring equipment was used by GPU[12] as a milling device to loosen and/or pulverize the fused-together core material in the core central region by drilling 409 holes with a 3.4-in.-diameter, solid-faced bit in the overlapping location pattern, as shown in Figure 16. Video surveys of exposed surfaces of the core cavity walls and floor and the lower CSA were made in all months except January and April.

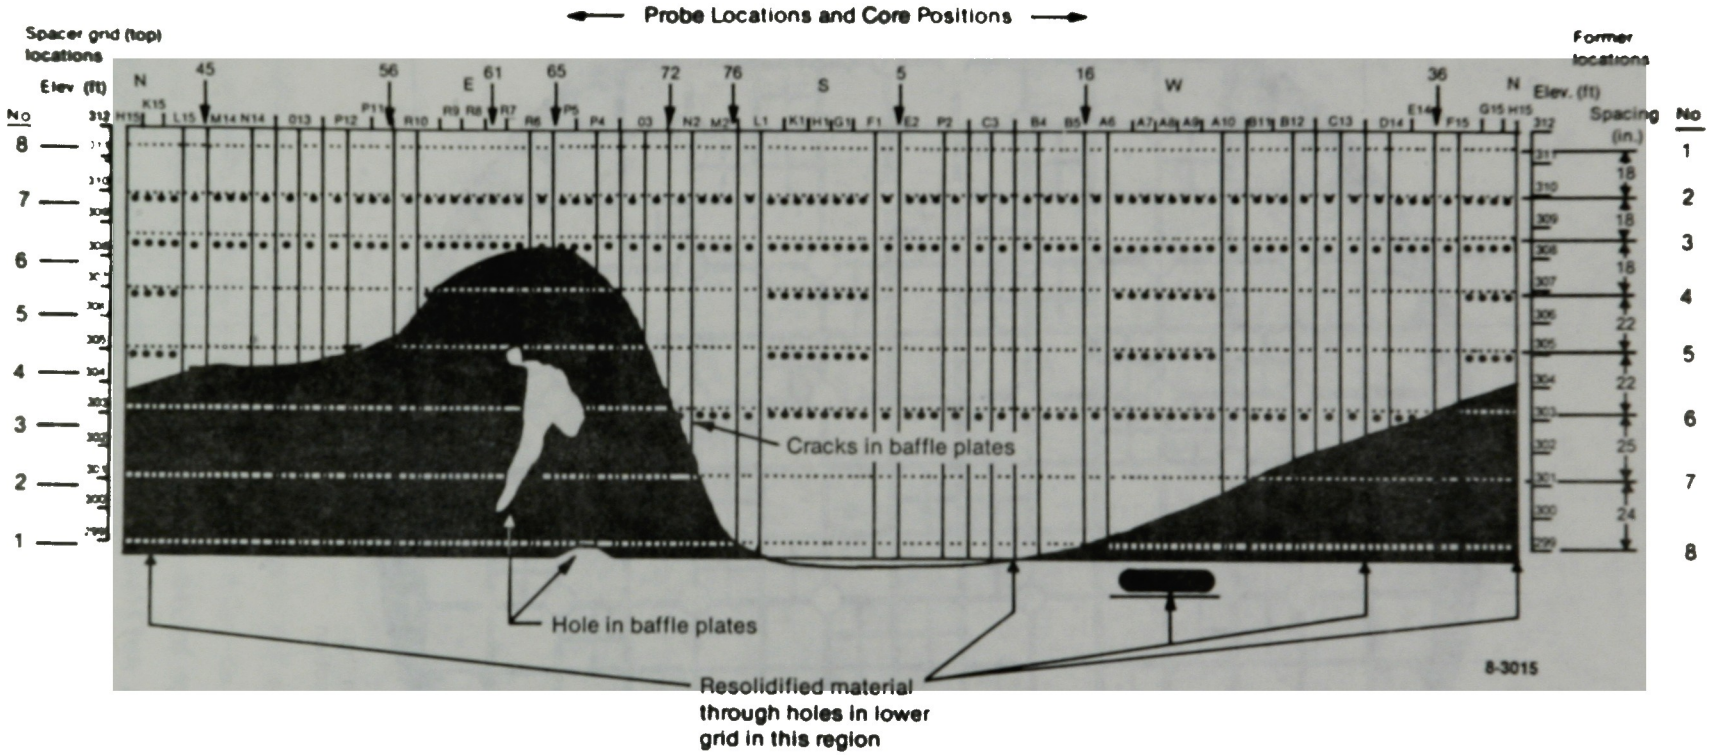
Figure 17. Fuel debris profile behind core baffle plate (laid flat).

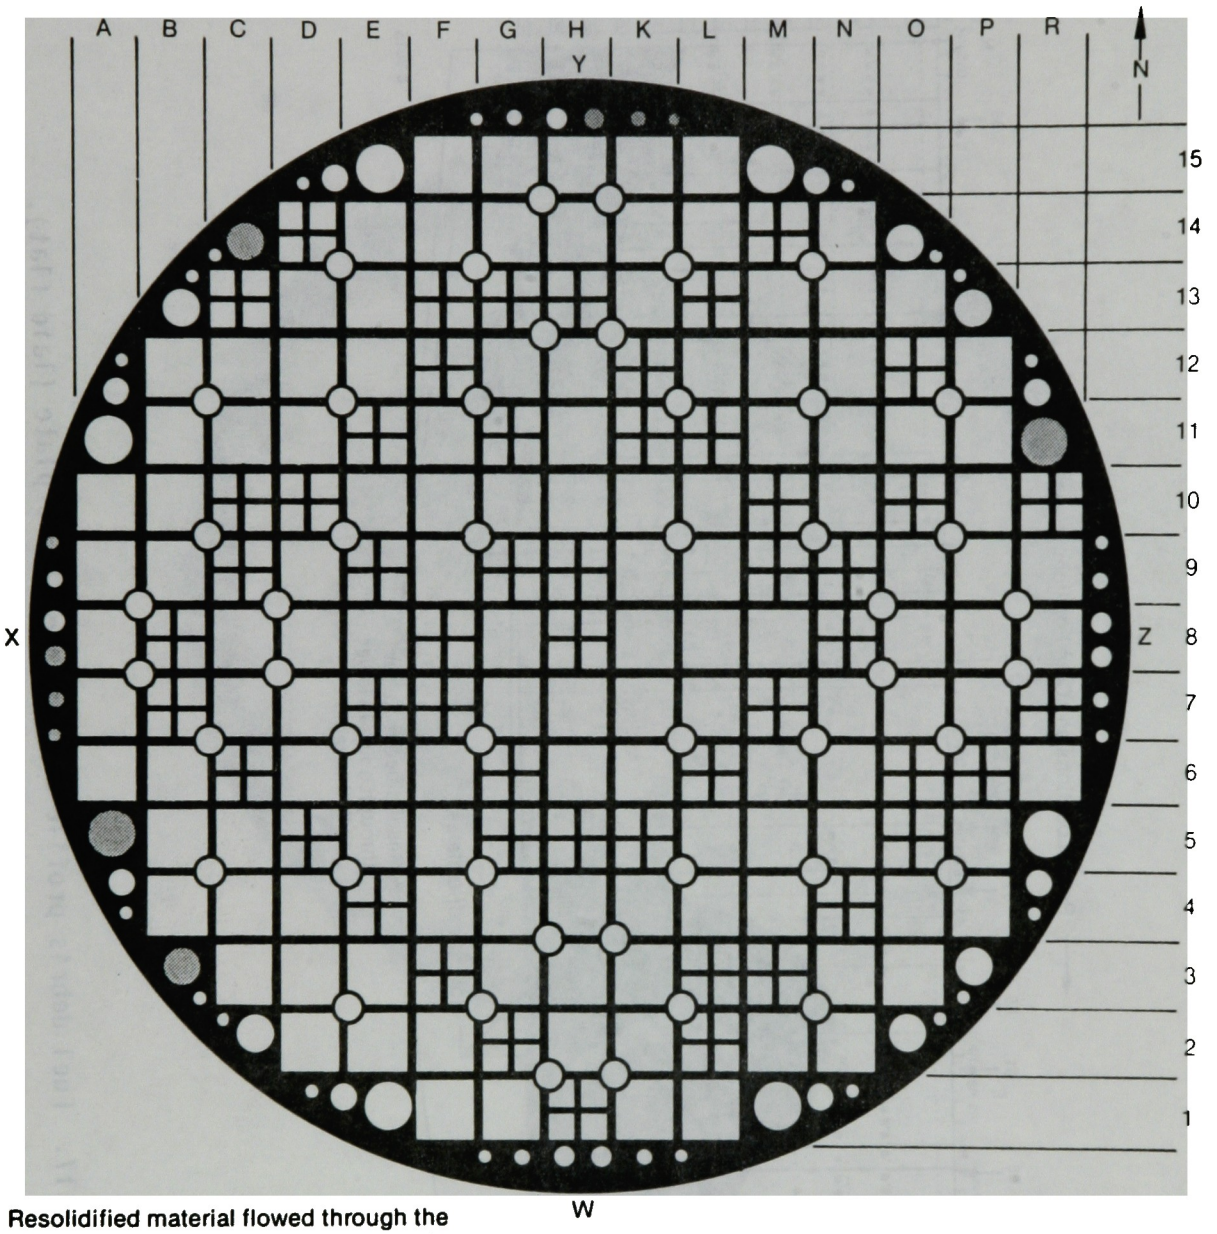
Resolidified material flowed through the shaded holes in the lower grid rib section

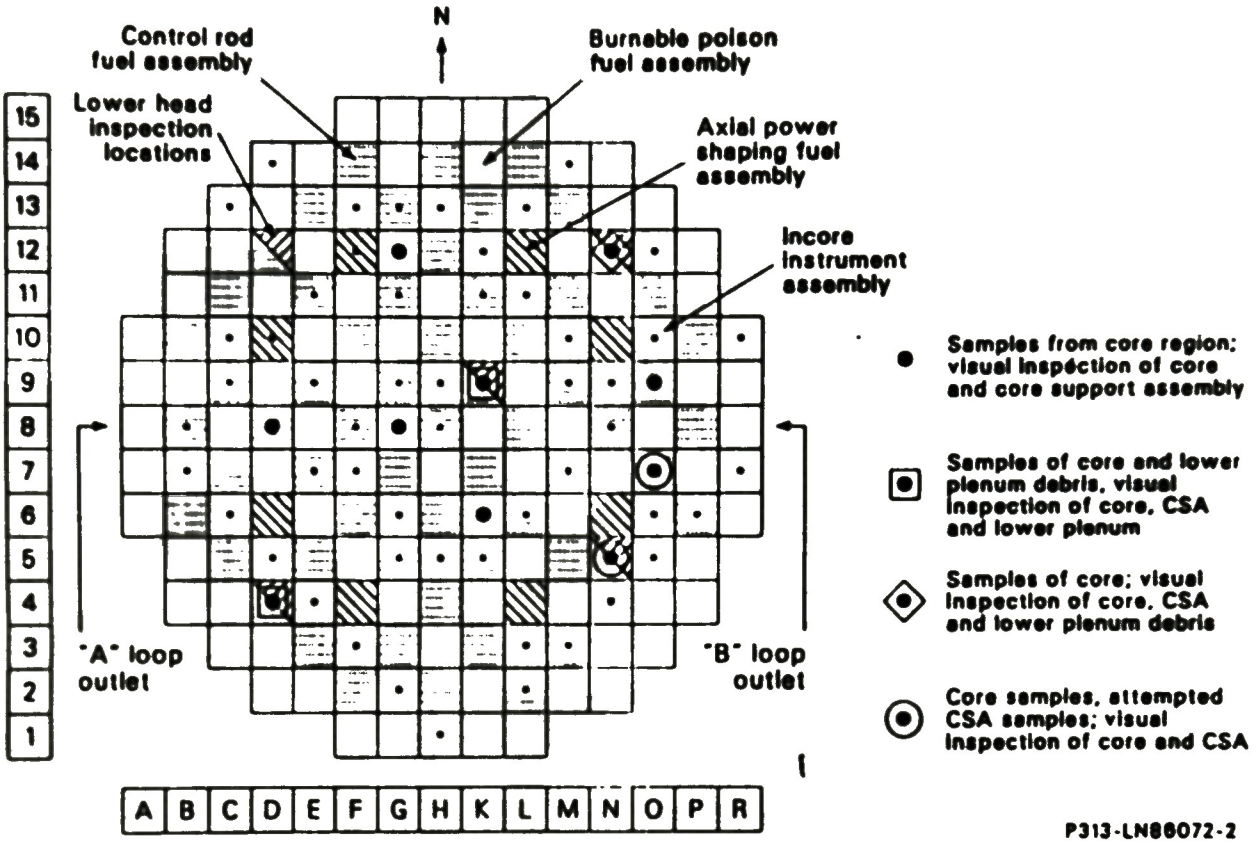
Figure 19. TMI-2 core bore locations.

The core-boring program produced the following information about the condition of the lower core region, the CSA region, and the core material deposited on the RV lower head.

- A region of previously molten, consolidated core materials estimated to be approximately 122 ft^3 (about 10% of the original core volume) was confirmed to be in the lower, central region of the core. This consolidated structure is approximately 4-ft thick in the center of the core and 1- to 2-ft thick near the core periphery and is roughly shaped like a bowl extending

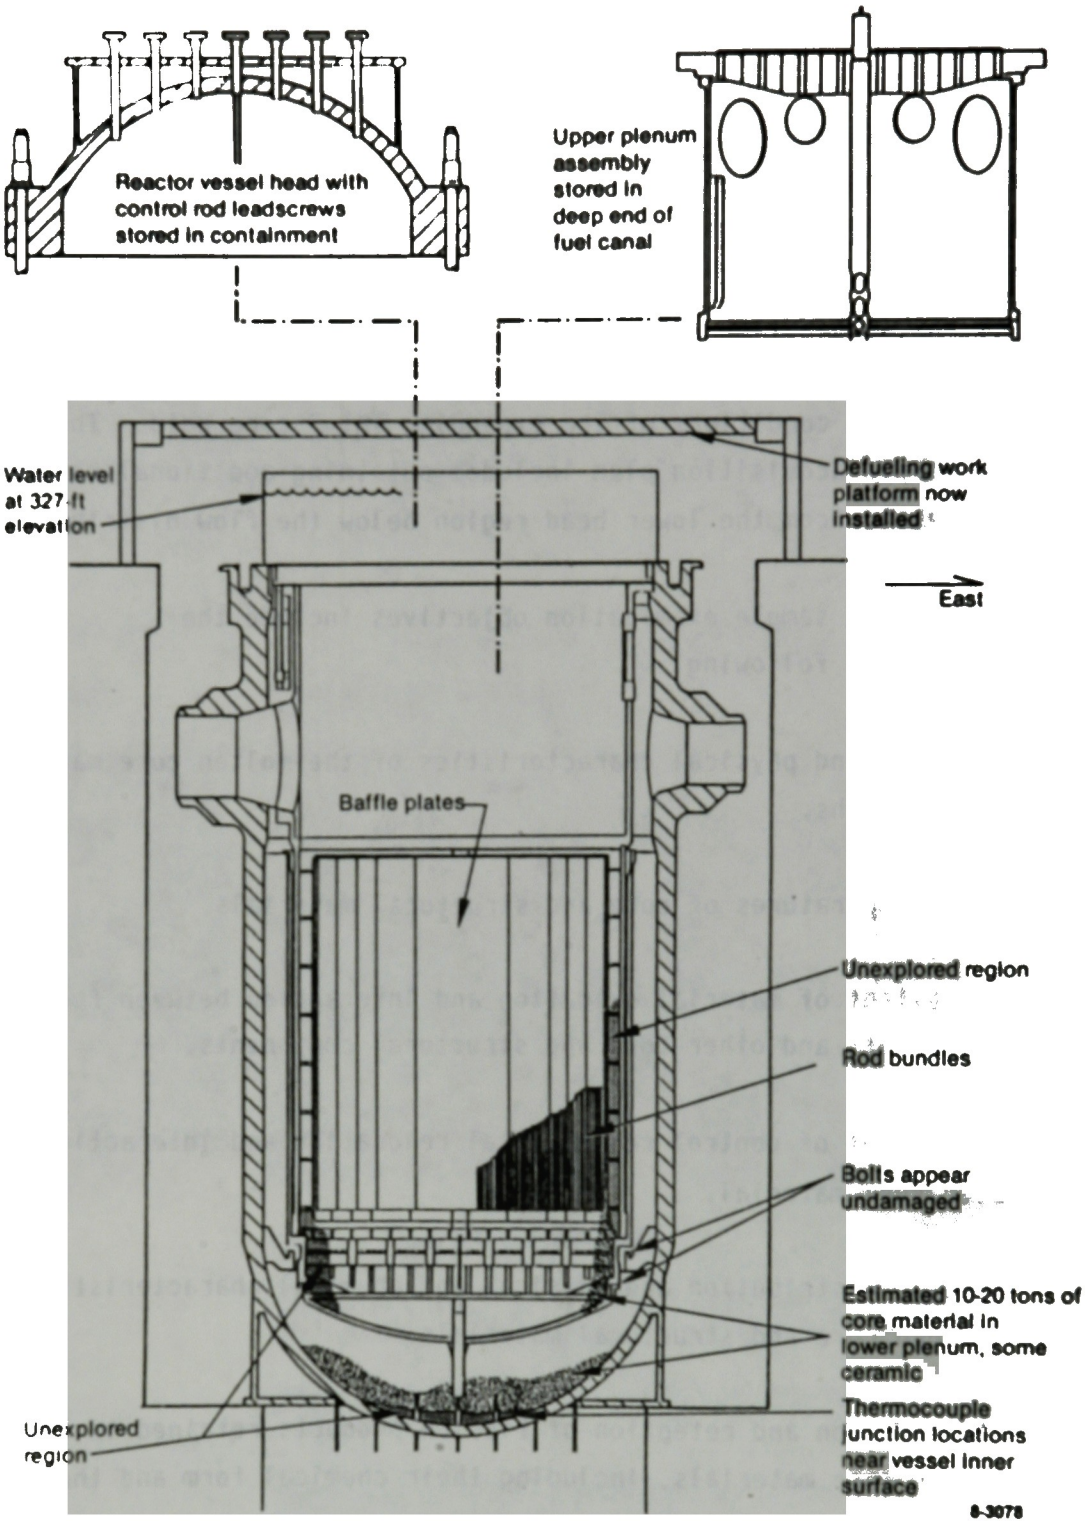
- The northeast, east, and southeast sections of the CSA where escaping molten core material has solidified.

- The lower region of core material resting on the RV lower head, where a region of nonfuel core material has been predicted to be.

Figure 20. Core and reactor vessel conditions in October 1987.

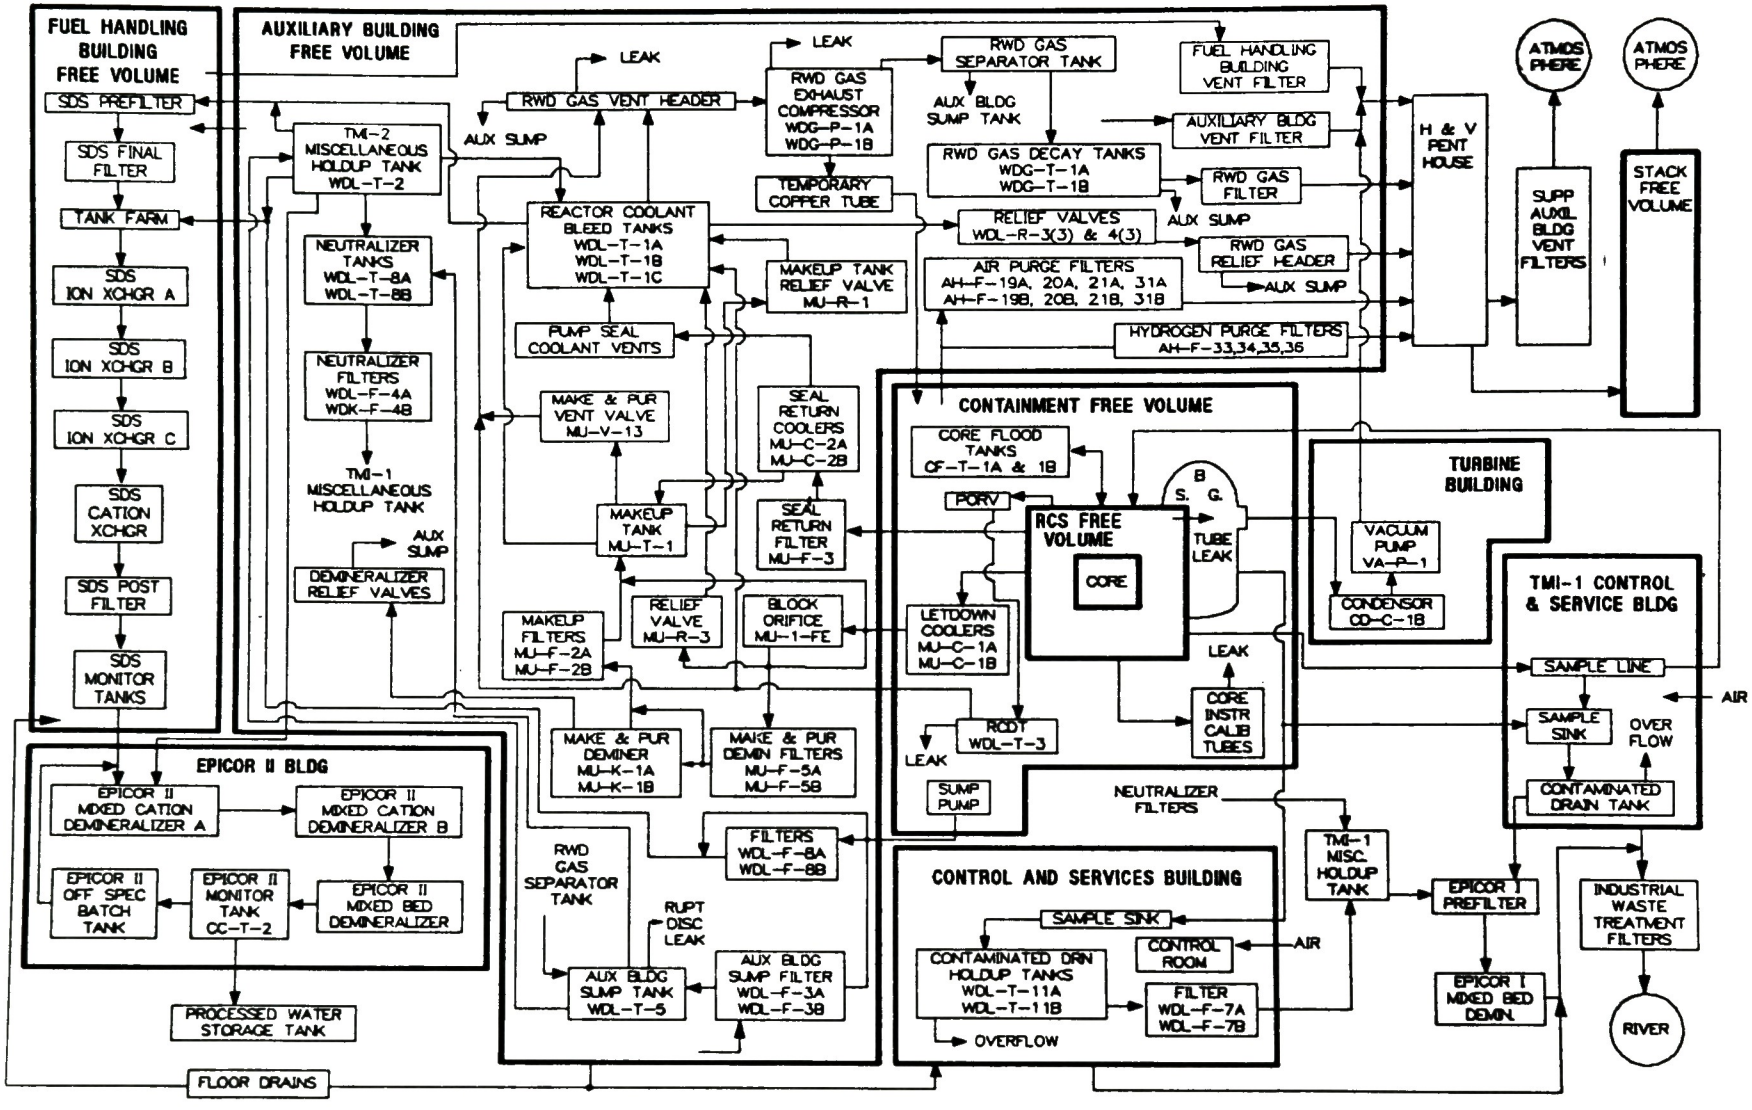
Figure 28. TMI-2 radioactive material location map.

- A preliminary map (Figure 28), showing schematically the equipment, buildings, and areas where fission products may be present.

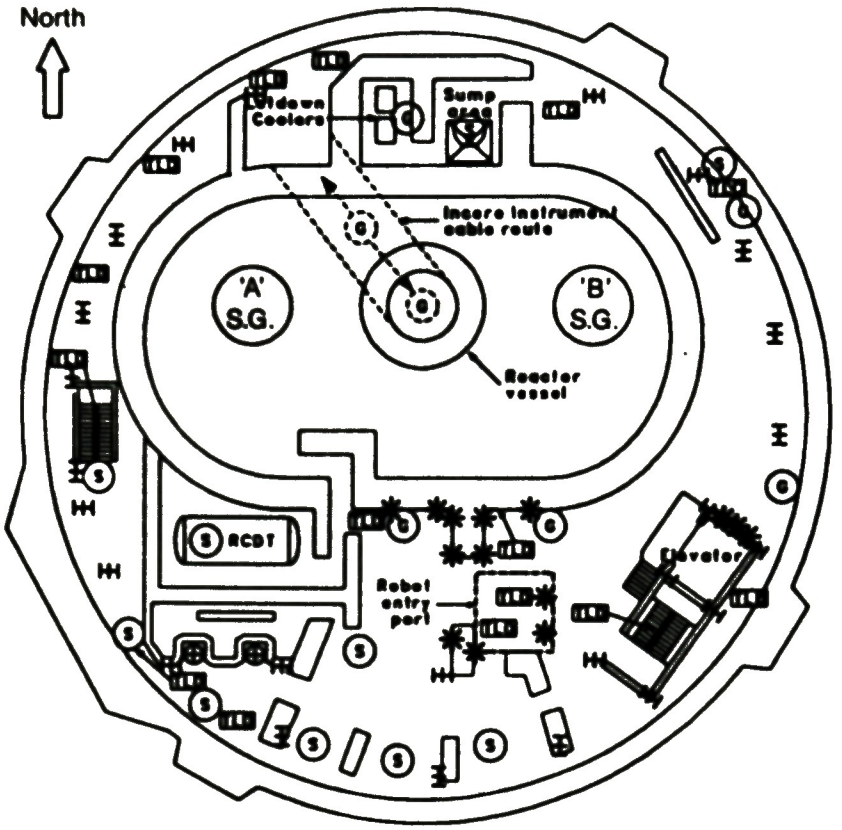
The additional in situ (gamma detector and thermoluminescent detector strings) measurements and sample (sediment and concrete bore) acquisition and examinations accomplished by GPU Nuclear in FY-1986 significantly improved the exploration and characterization of the reactor building basement for core fission products and materials. Figure 29 is a map of the basement with symbols showing locations of in situ measurements and sample acquisitions made since the accident.

Concrete bore locations

Sediment sample location
