TMI-2 INFORMATION AND EXAMINATION PROGRAM 1981 ANNUAL REPORT

Technical Integration Office

Published April 1982

EG&G Idaho, Inc.
Idaho Falls, Idaho 83415

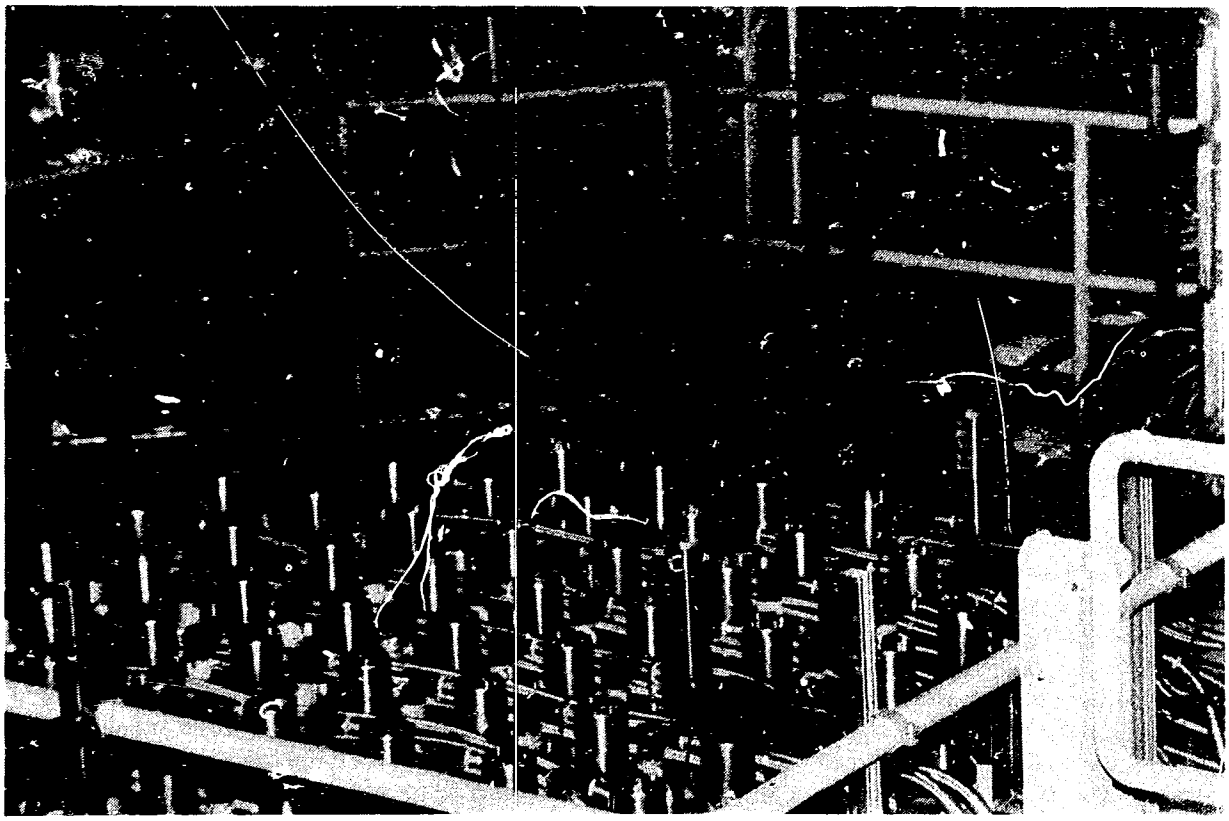
Figure 1. Relatively undamaged control rod drive mechanisms and associated cabling on the 347-ft elevation.

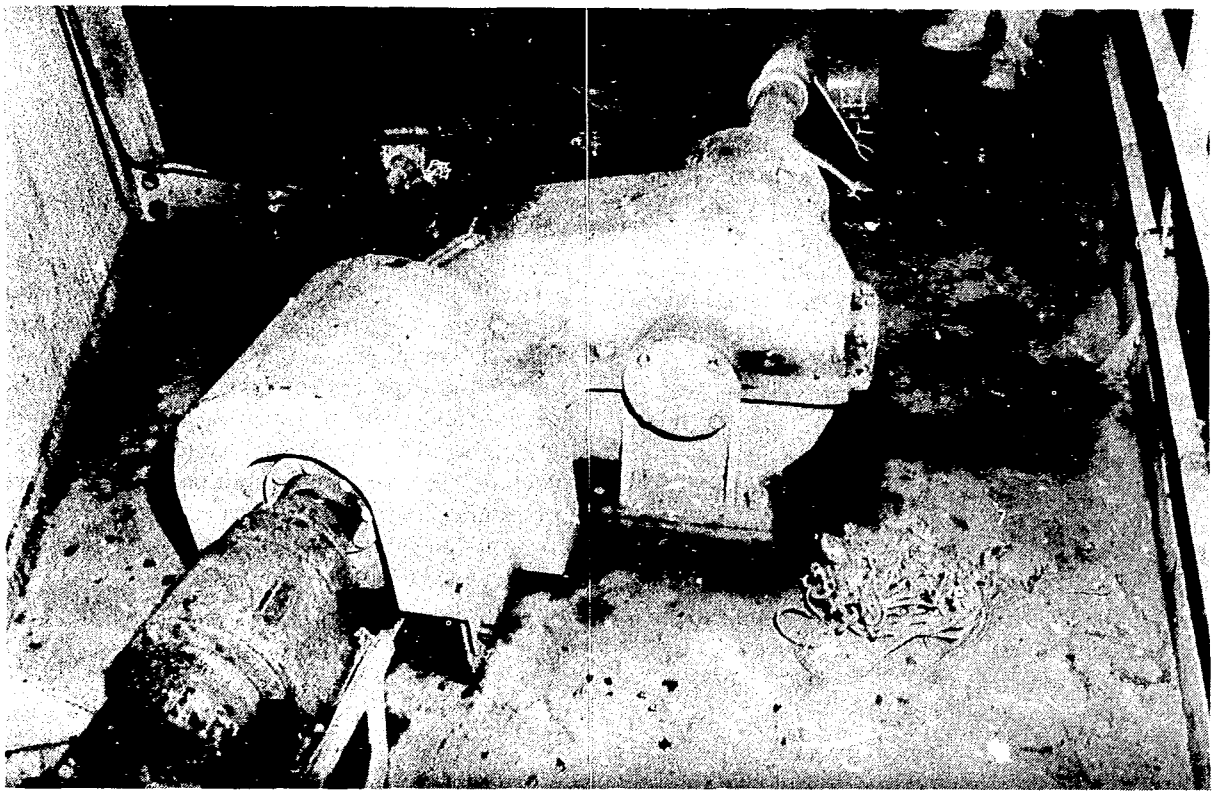
Figure 2. Corrosion and rust damage to polar crane motor and associated drive mechanism.

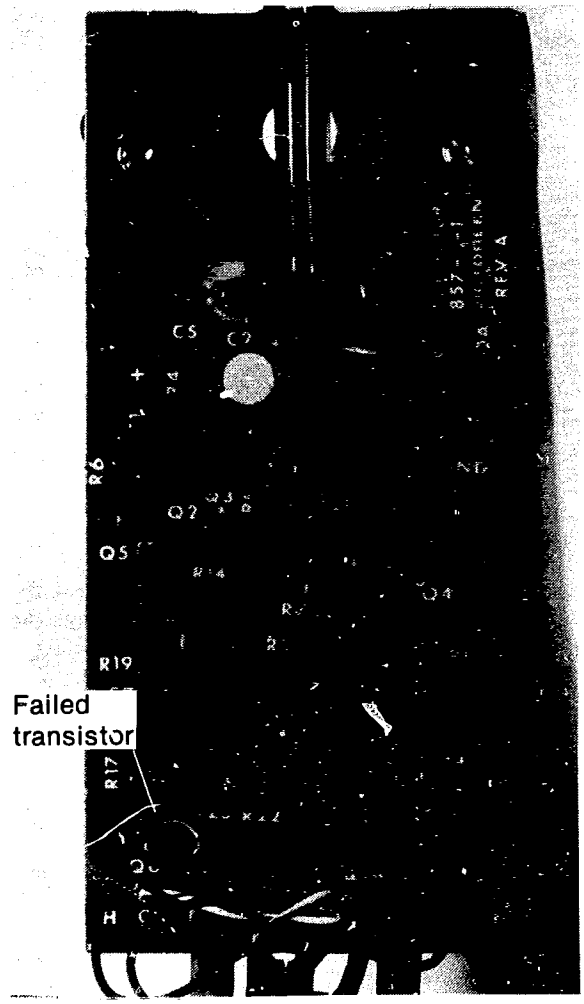
as received at SNL. A malfunction of the output drive transistor was suspected during in situ testing and was confirmed during examination of the circuitry. Figure 4 shows the HP-R-211 printed circuit board. The transistor failure was caused by a short between the 600-V anode and the signal output. The probable cause of the short was reactor building spray water entering the detector cable backshell. Two factors apparently contributed to this: first, the detector assembly was mounted with the connector on top, so water drained toward it; and second, the backshell was not properly tightened.

Figure 4. Area radiation monitor HP-R-211 printed circuit board.

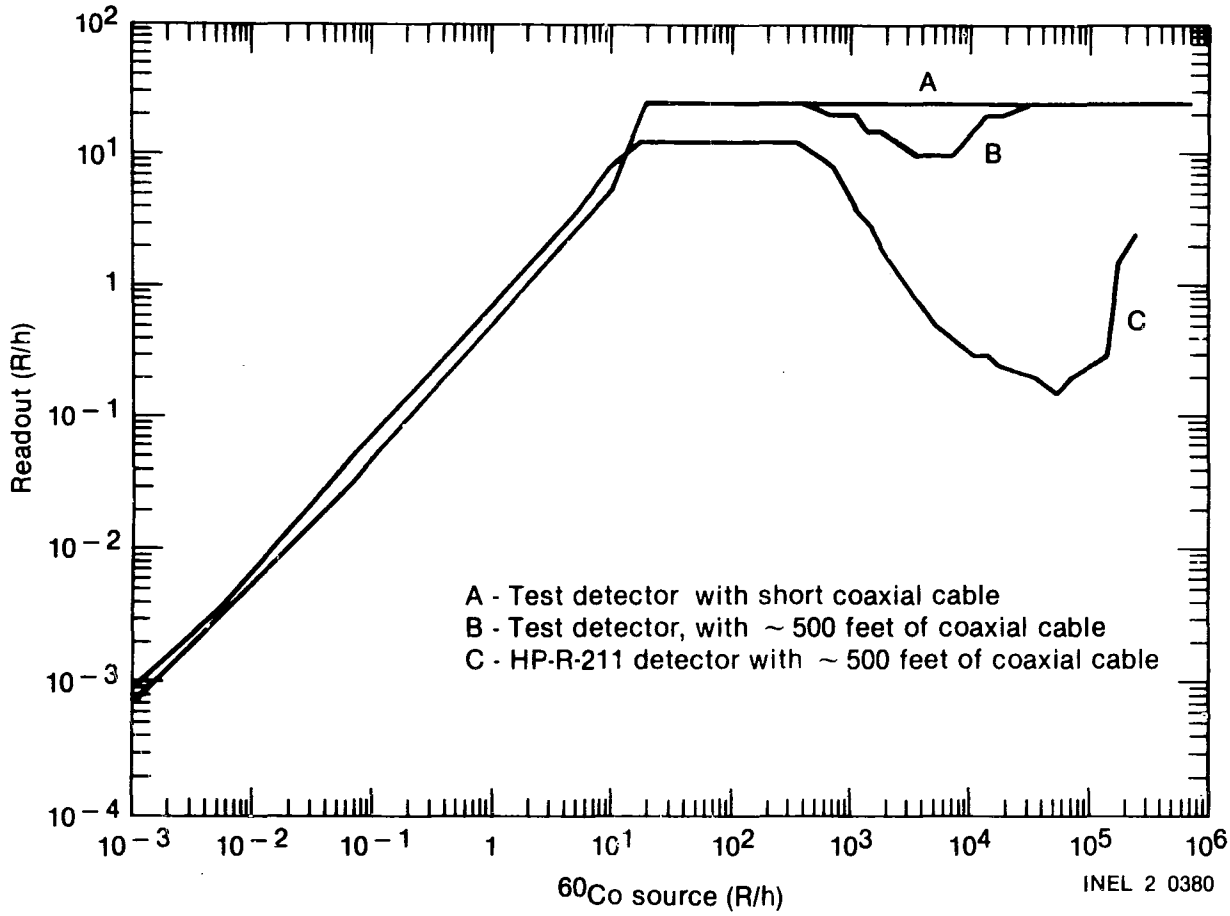
Further examination of this detector (after replacement of the failed transistor) revealed multivalued output behavior above about 10 R/h, a level well beyond the instrument's designed exposure range. This output behavior was caused by a detector-cable impedance mismatch, and interaction between two circuits. Figure 5 shows the multivalued readout data. Curve A shows a test detector's response to a ^{60}Co source when a short cable connected the detector to the ratemeter. Curve B shows the test detector's response when 498.7 ft of coaxial interconnect cable connected the detector to the ratemeter. Curve C gives the actual HP-R-211 response when 498.7 ft of coaxial interconnect cable connected the HP-R-211 to the ratemeter. The response is multivalued when long cables are used, especially for the HP-R-211 detector. Suggestions for circuit changes were published in GEND-INF-008, *Quick Look Report on HP-RT-0211 Multivalued Behavior*, July 1981.

Figure 5. HP-R-211 multivalued readout.

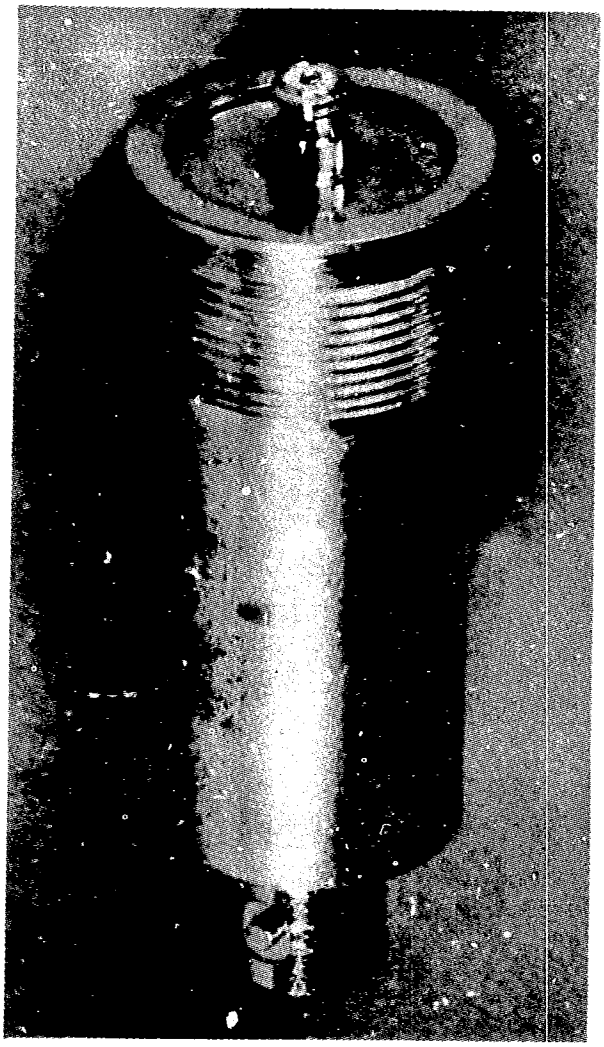
SNL. The examinations found the charge converters had failed during the course of the accident due to high radiation levels in the reactor building. A metal oxide semiconductor (MOS) field-effect transistor in the converter was removed and examined. Figure 7 shows the area of the charge converter potted device from which the faulty MOS transistor was removed. The examinations showed the MOS transistor was degraded by radiation until it failed at approximately 10^5 rd. These results were communicated to the nuclear industry via Nuclear NOTEPAD[a] message in November 1981 and to the device manufacturer. The manufacturer of these charge converters and two other firms who supply LPM systems to the industry have either redesigned their circuits or designed new ones, primarily in response to the I&E Program findings.

Figure 6. Charge converter YM-AMP-7023 as received at SNL.

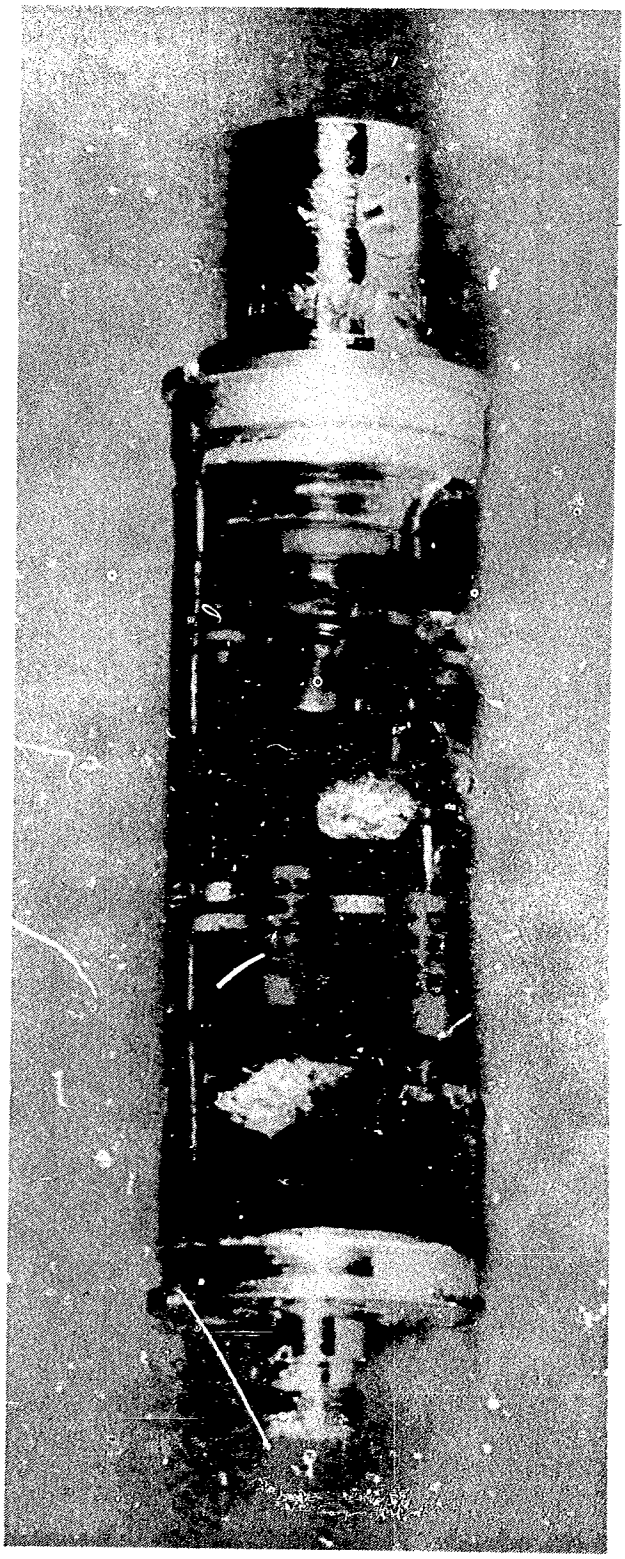
Figure 7. Gouges in charge converter potted device resulting from the removal of the MOS transistor.

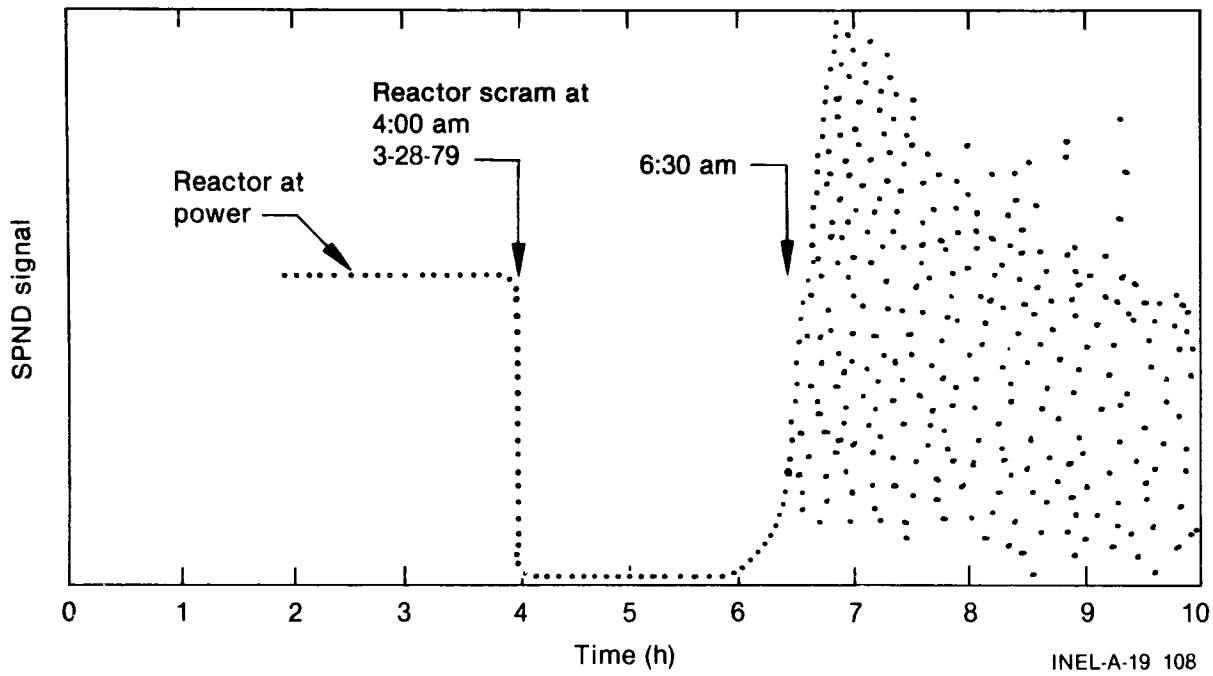
Figure 8. Backup recorder's tracing of in-core detector signals.

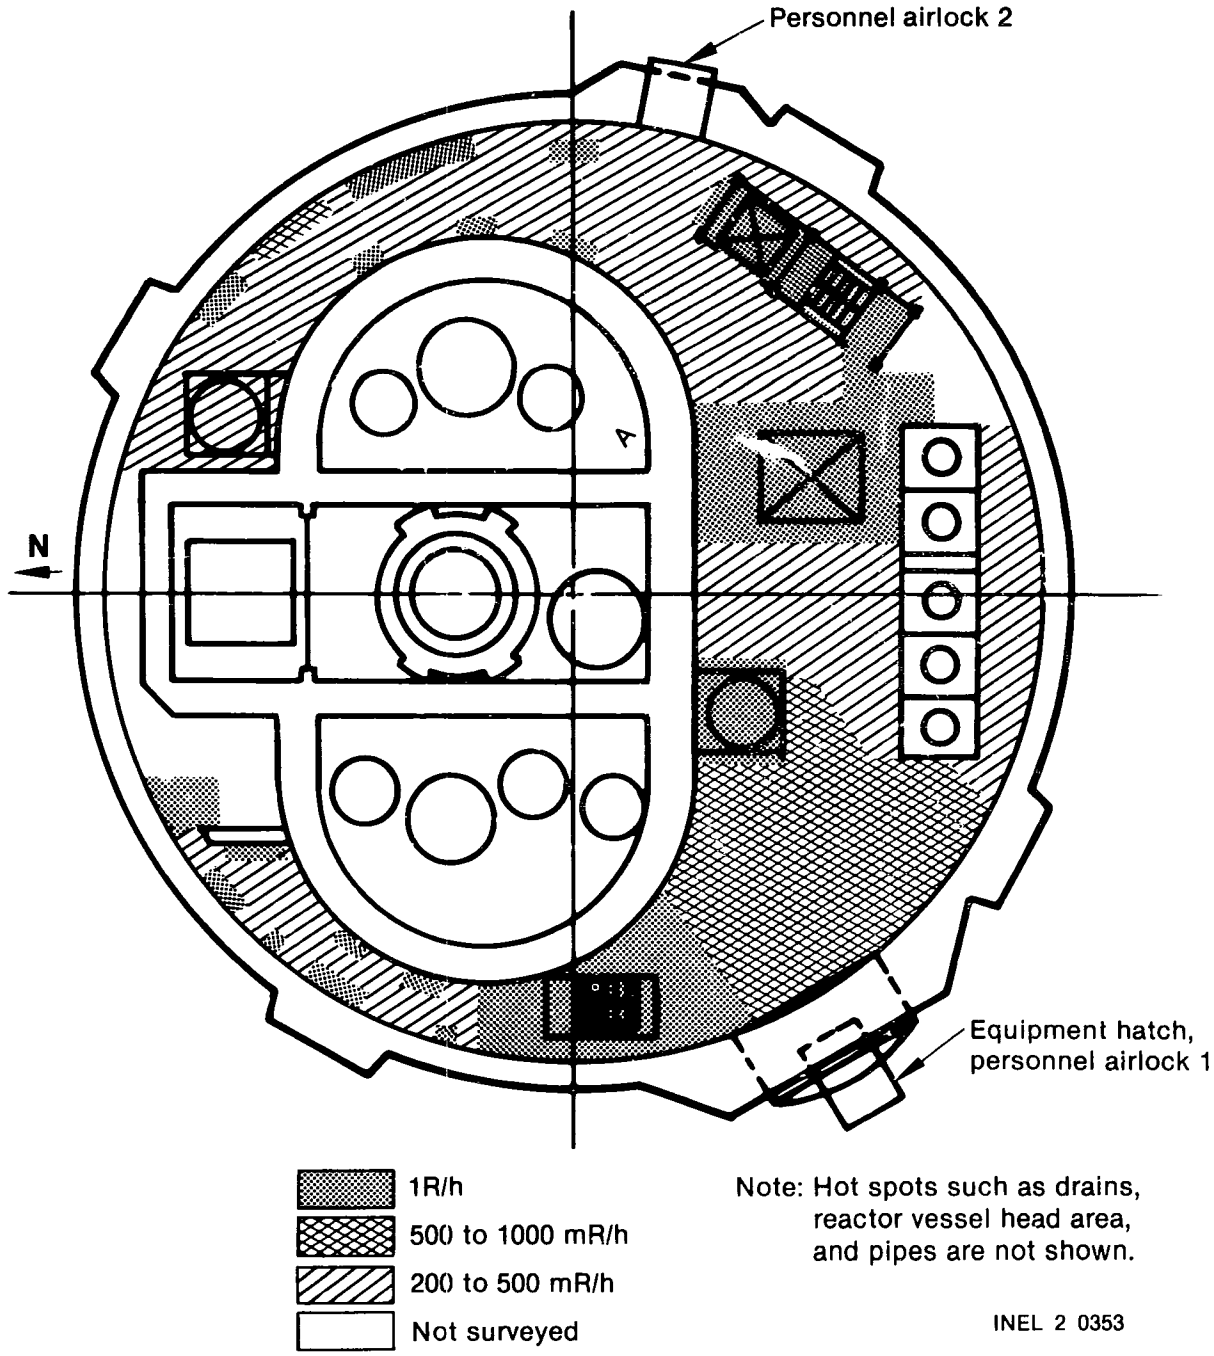
Figure 12. General radiation levels on 305-ft elevation.

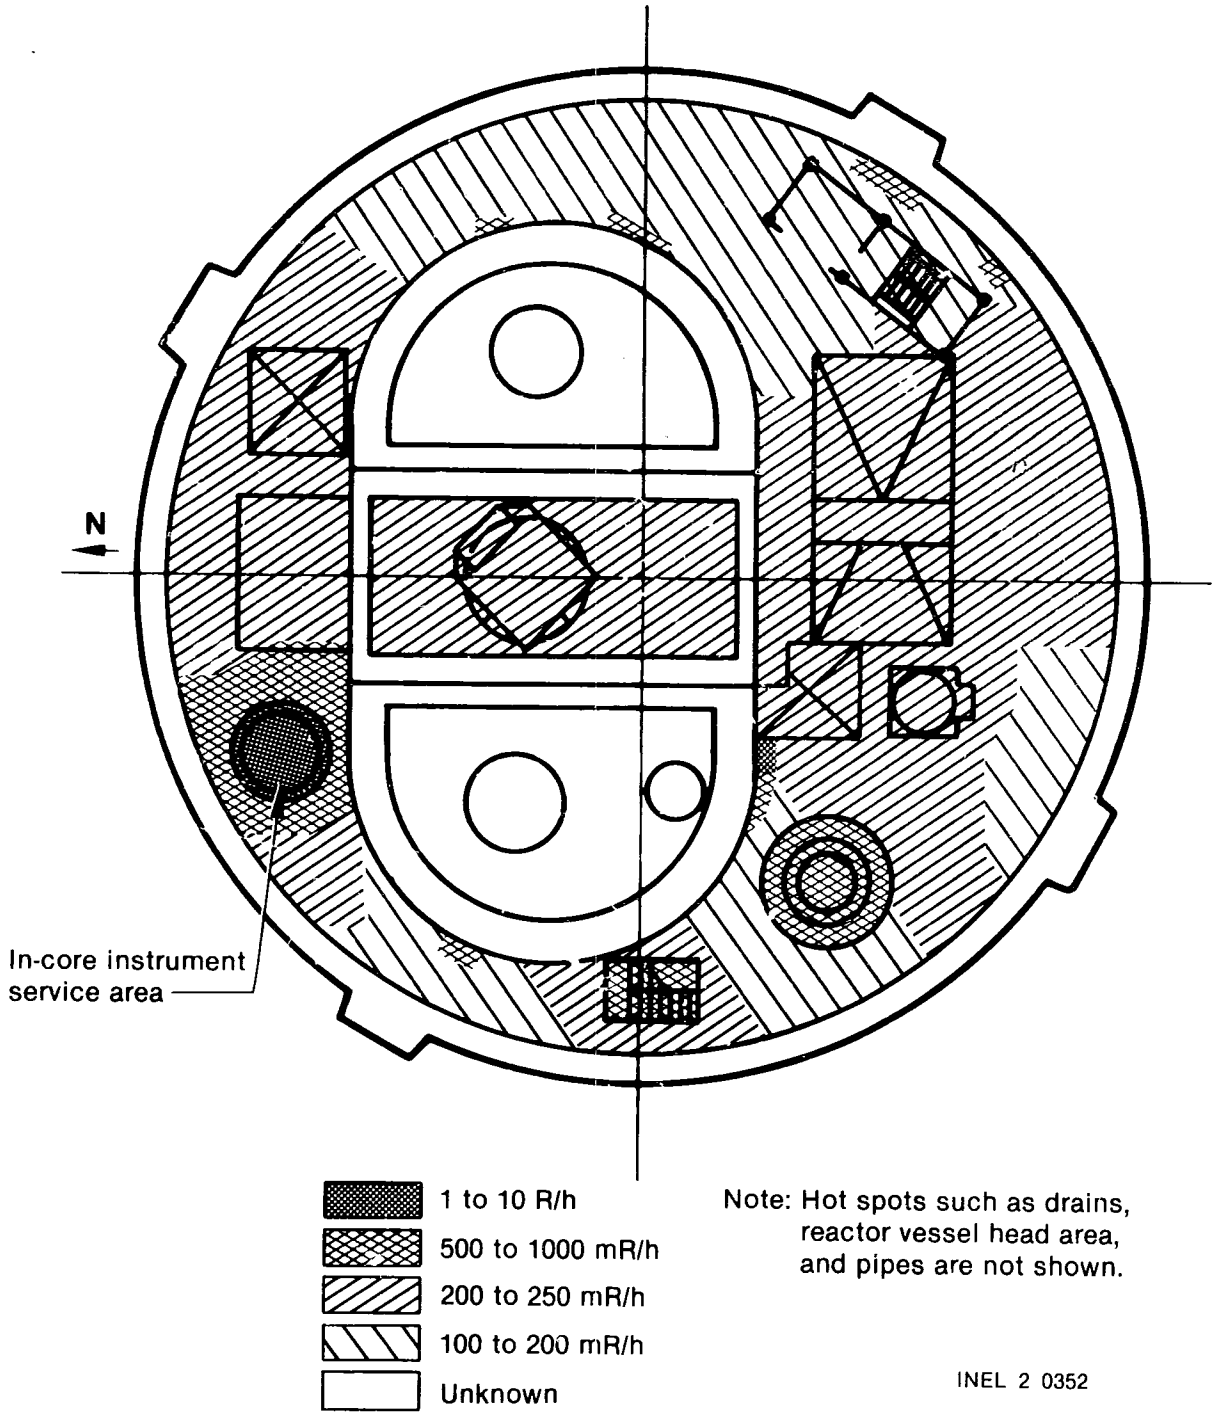
Figure 13. General radiation levels on 347-ft elevation.

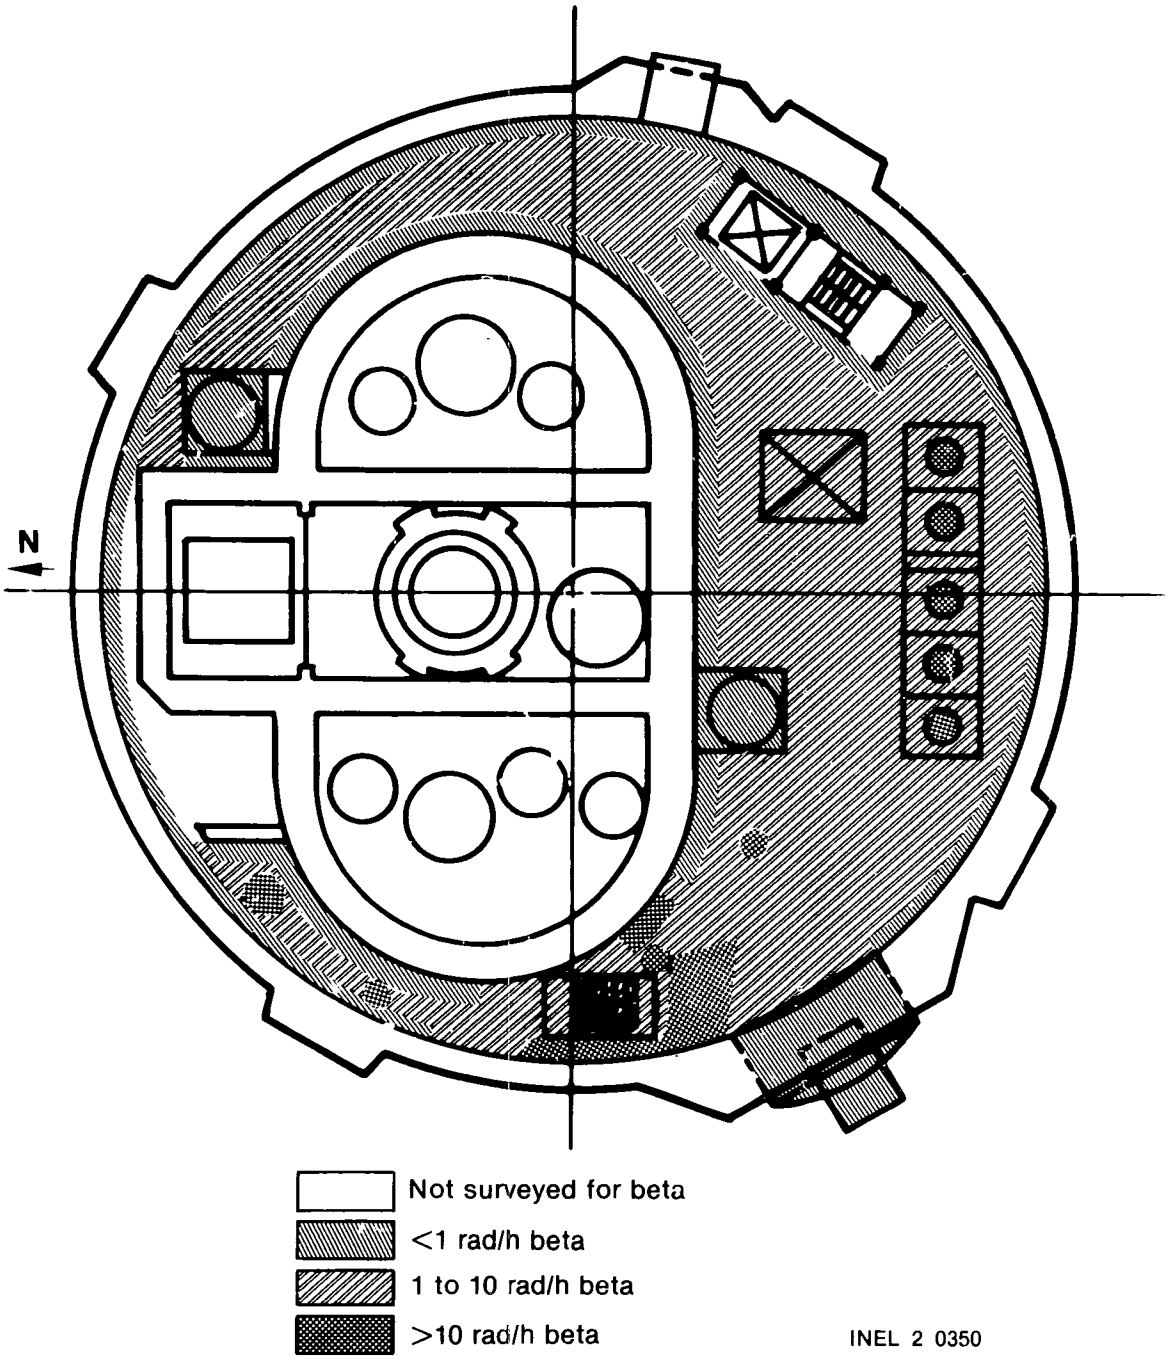
Figure 14. Beta radiation levels on 305-ft elevation.

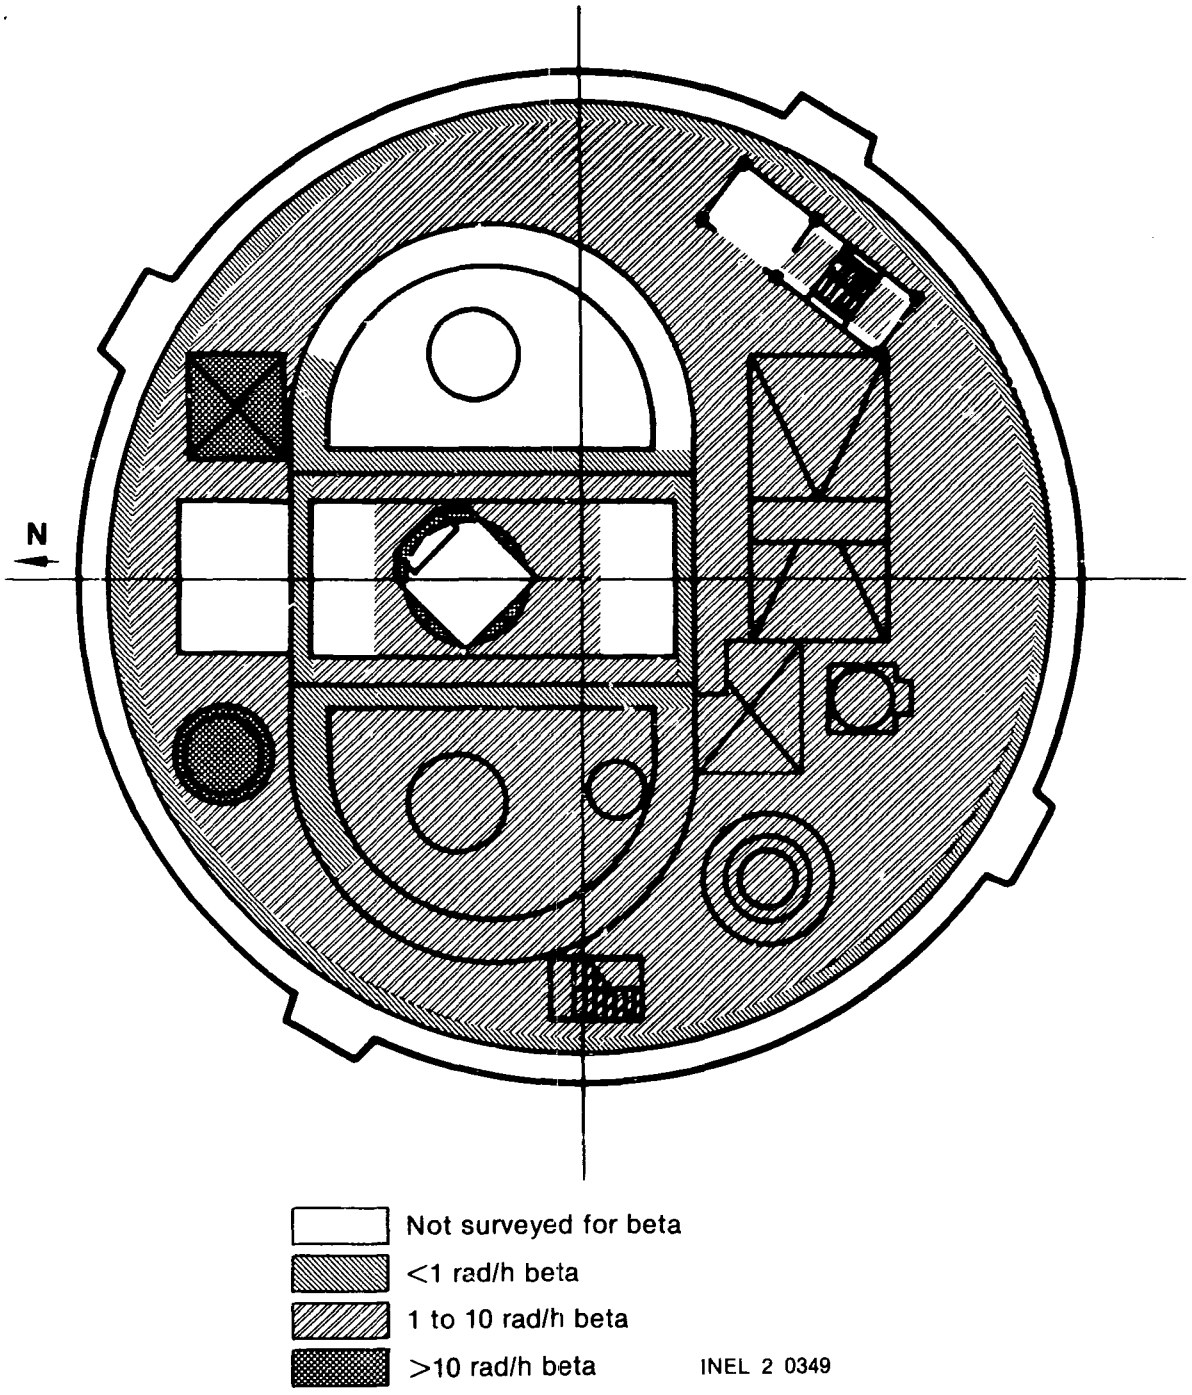
Figure 15. Beta radiation levels on 347-ft elevation.

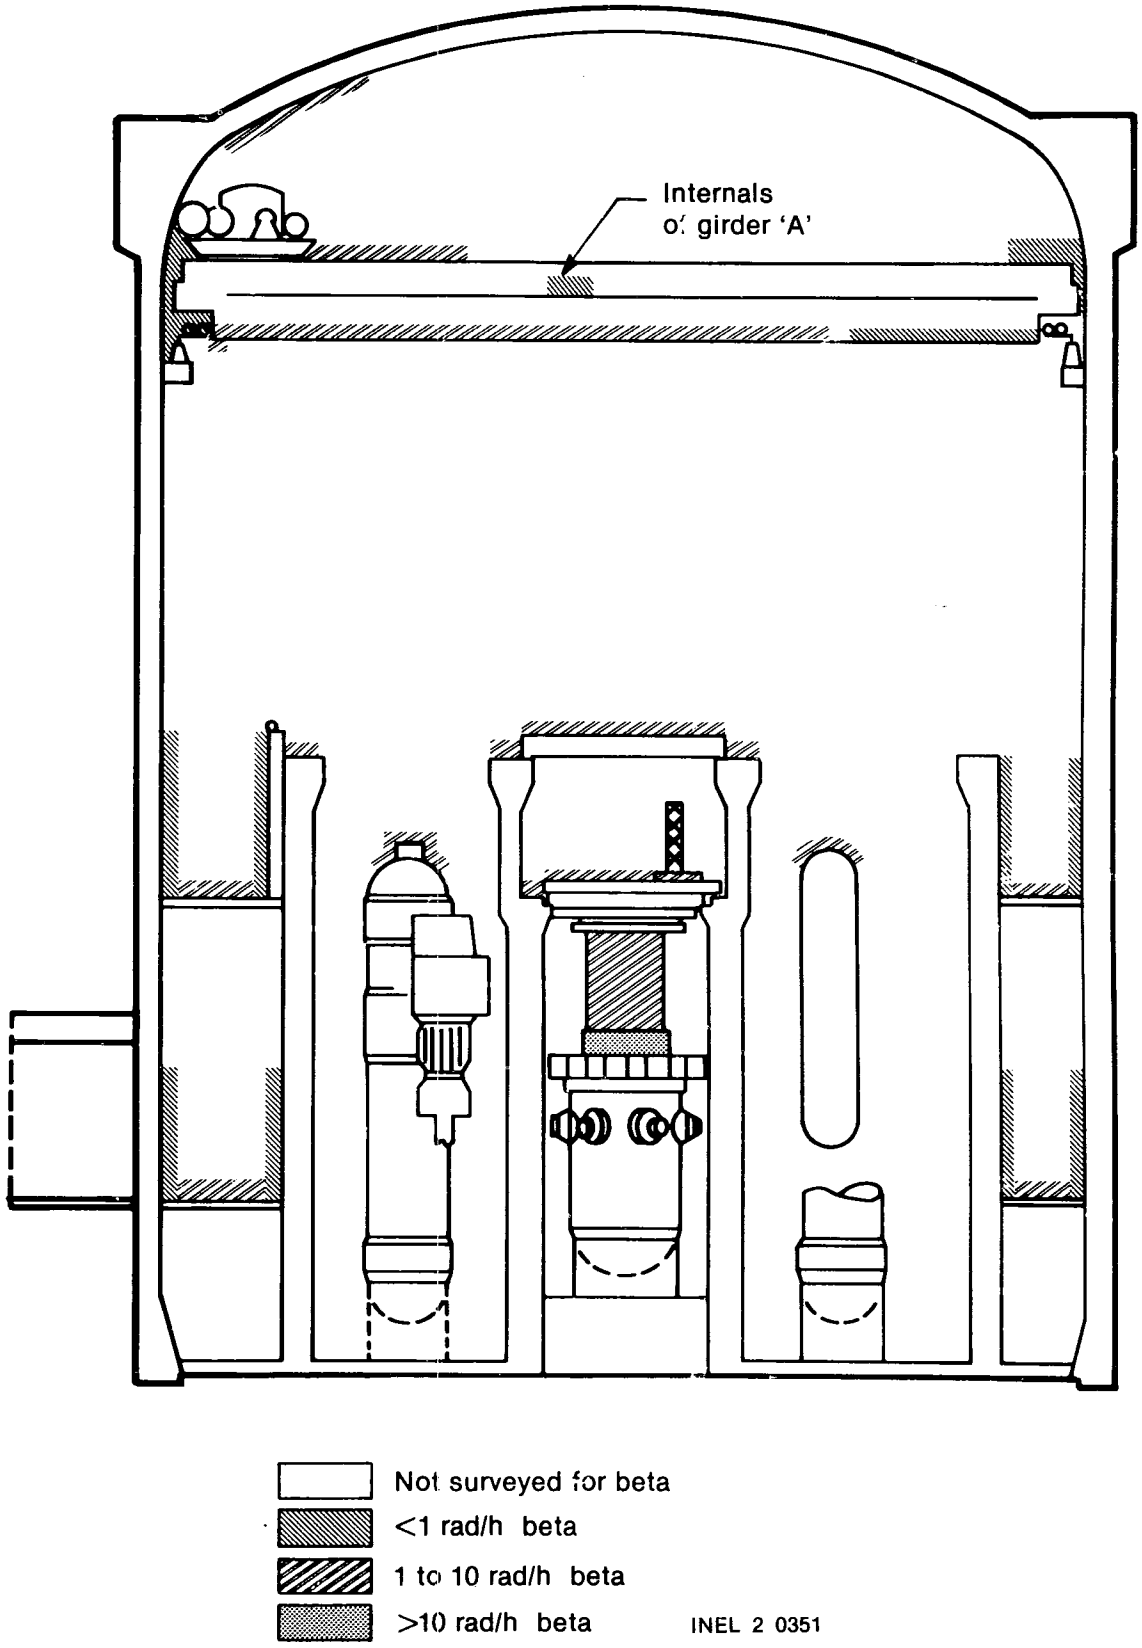
Figure 16. Surface contamination beta radiation levels.

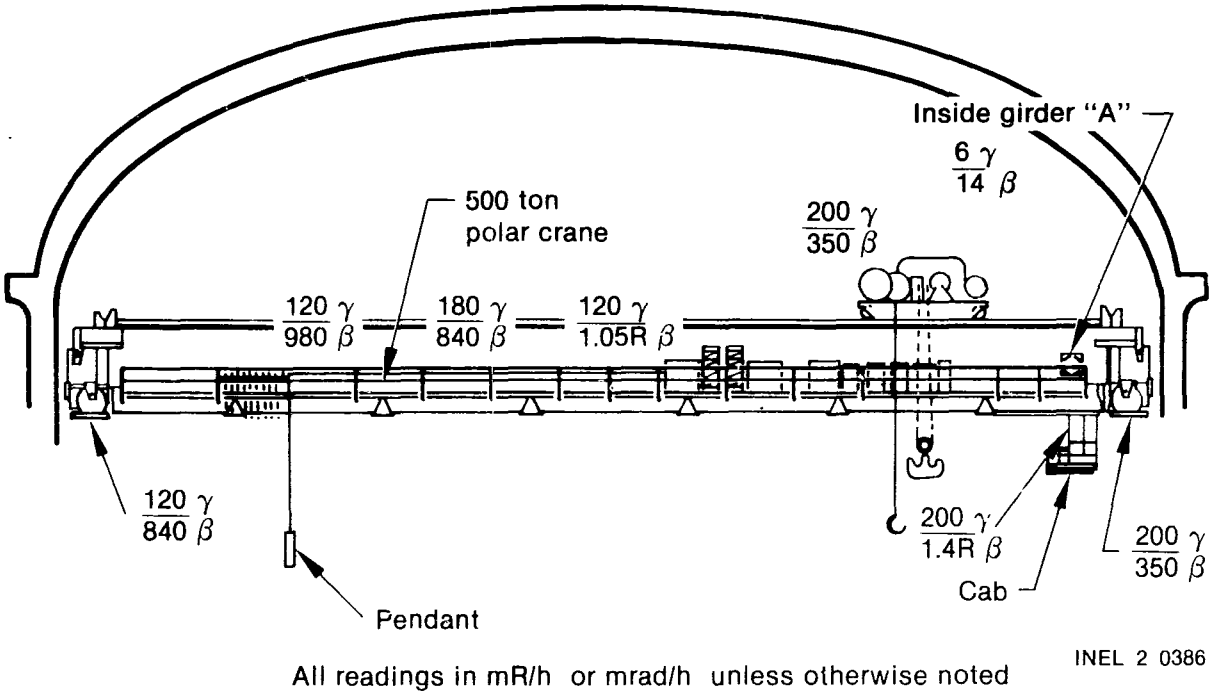
Figure 17. Polar crane radiation map of surface deposition.

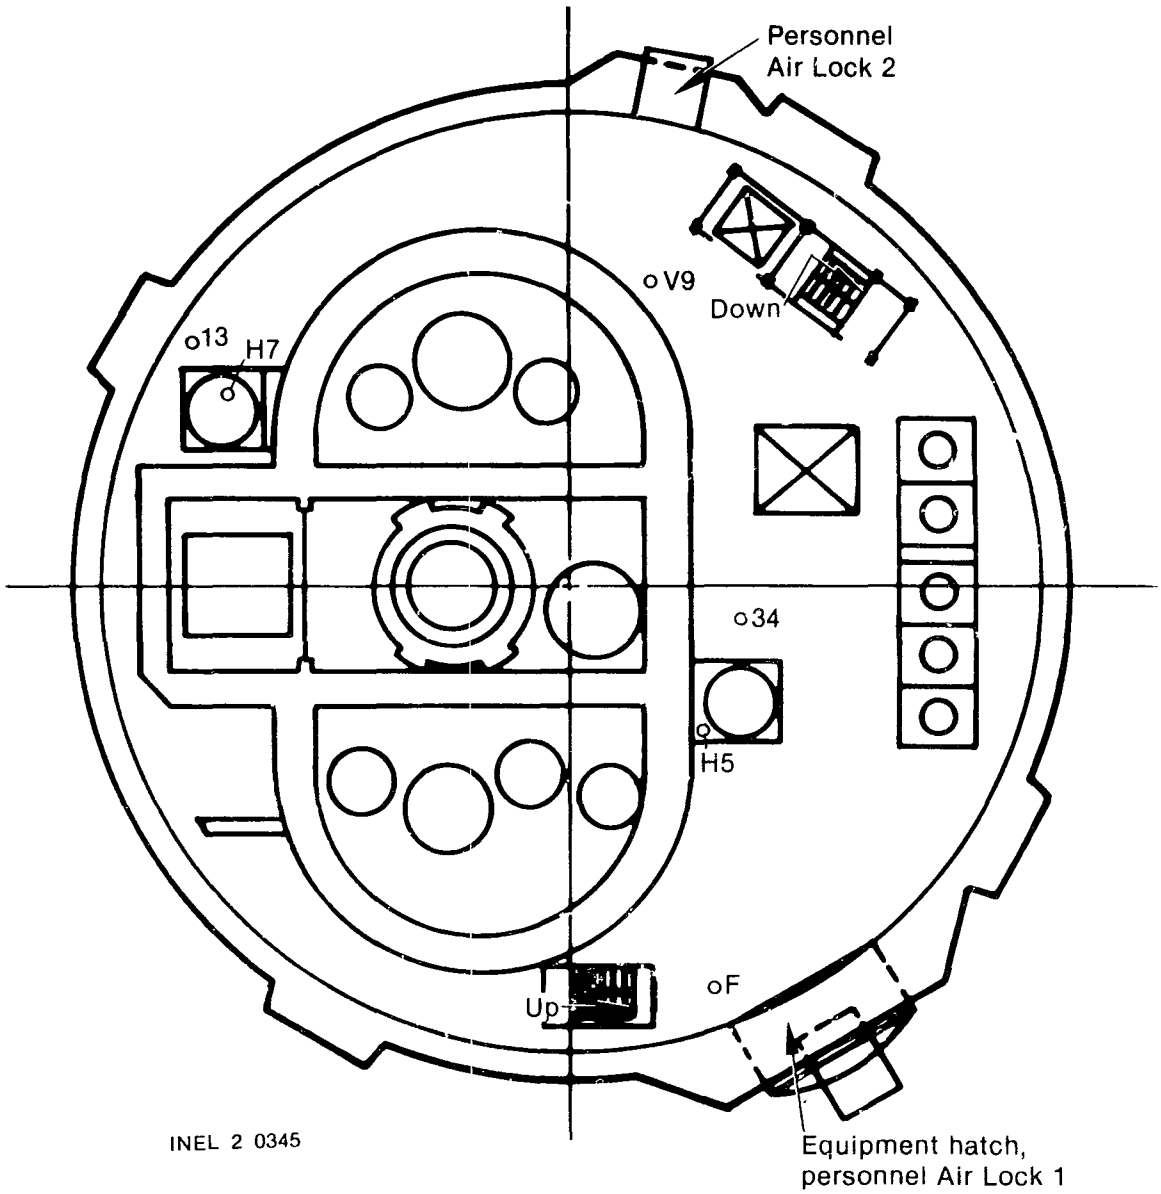
On December 15, 1981, an entry was made into the reactor building to obtain gamma spectra of surfaces on the 305-ft elevation. Five areas were selected for these measurements: two wall surfaces, two floor surfaces under the reactor core flood tanks, and one general-area floor surface. The relative locations and surface contamination levels for the gamma scans are shown in Figure 20. The results show general contamination levels of less than 1 $\mu Ci/cm^2$ for all of the surfaces, horizontal surfaces being higher than vertical surfaces. Two of the areas show no net detectable activity; minimum detectable limits are shown as less than 0.3 $\mu Ci/cm^2$.

Area designation	Net ^{137}Cs counting rate (c/s)	^{137}Cs surface contamination (μ Ci/cm^2)
13-wall	<0.6	<0.2
H7-floor under CF-T-1A	4.5 ± 0.5	0.96 ± 0.10
V9 - wall	1.7 ± 0.9	0.5 ± 0.3
34 - floor	4.1 ± 0.8	0.9 ± 0.2
H5- floor under CF-T-1B	<1.5	<0.3
*F - floor	136.6 ± 1.0	28 ± 2

Figure 20. Gamma spectrometer measurement locations and readings on 305-ft elevation.

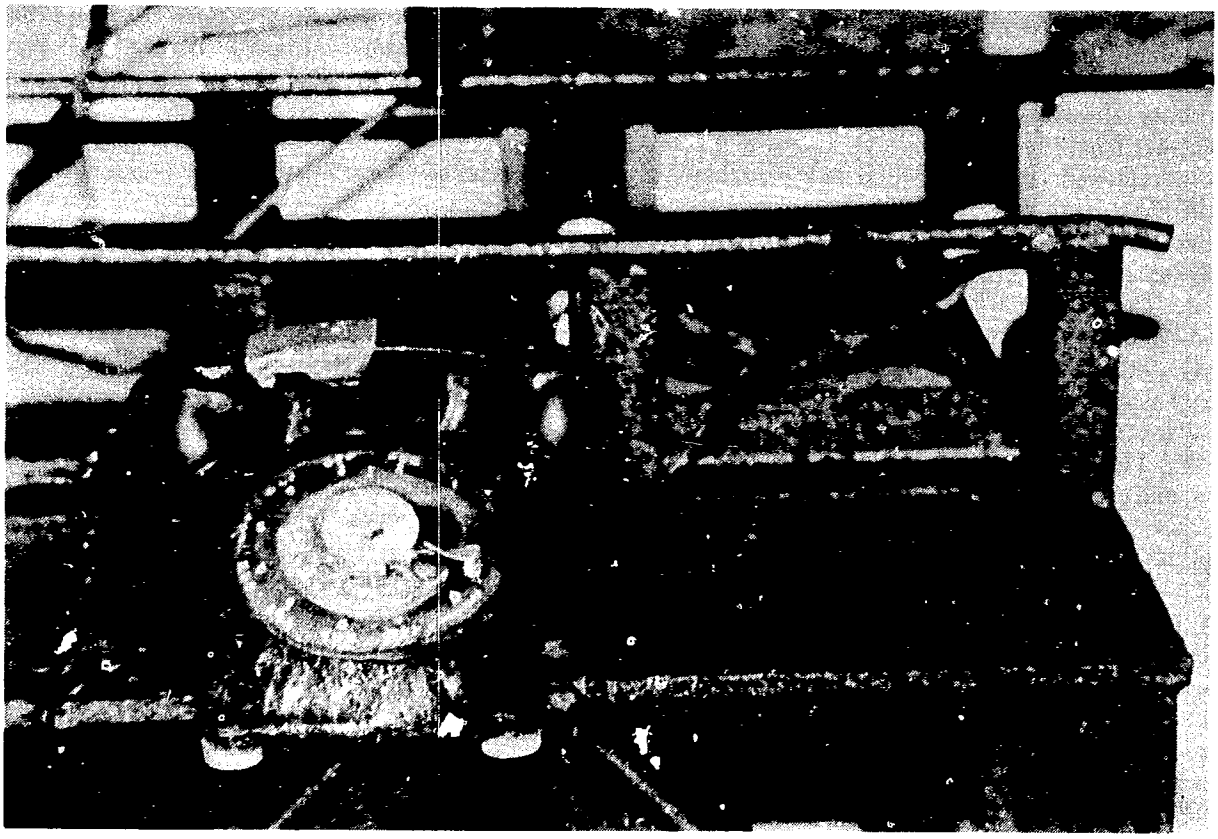
During Entry 6, samples were obtained from inside the reactor building including radiation barrier rope, nylon rope, a plastic radiation sign, paint chips, plastic buttons from the auxiliary fuel handling bridge control panel, and a telephone and cord. Experiments were performed to determine the amount of heat required to cause the observed damage. As an example, experimental results and manufacturer's data for the telephone headset body indicate that a temperature of 221°F would cause a telephone to deform under its own weight. The damaged telephone is shown in Figure 24. The estimated temperature for the telephone location in the building is at least 221°F.

Figure 24. Damaged telephone on 347-ft elevation.

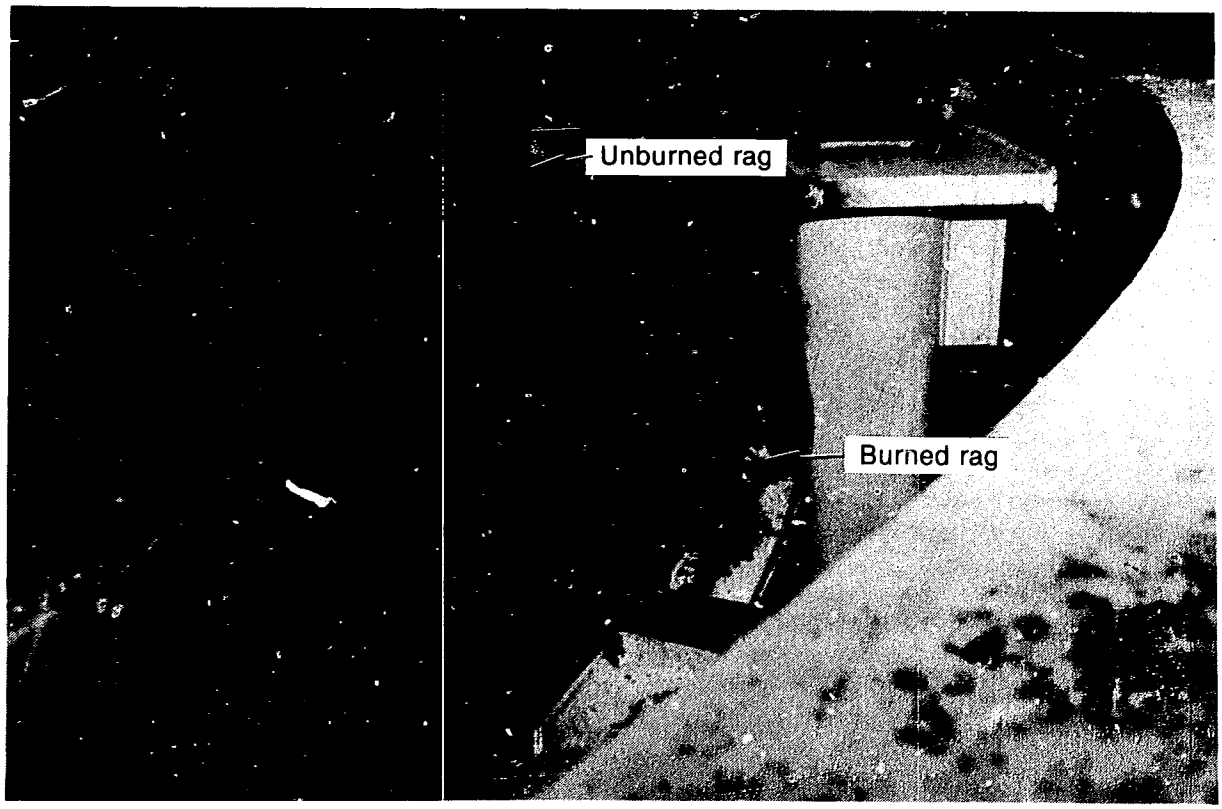
Figure 25. Burned and unburned rags inside the head storage area.

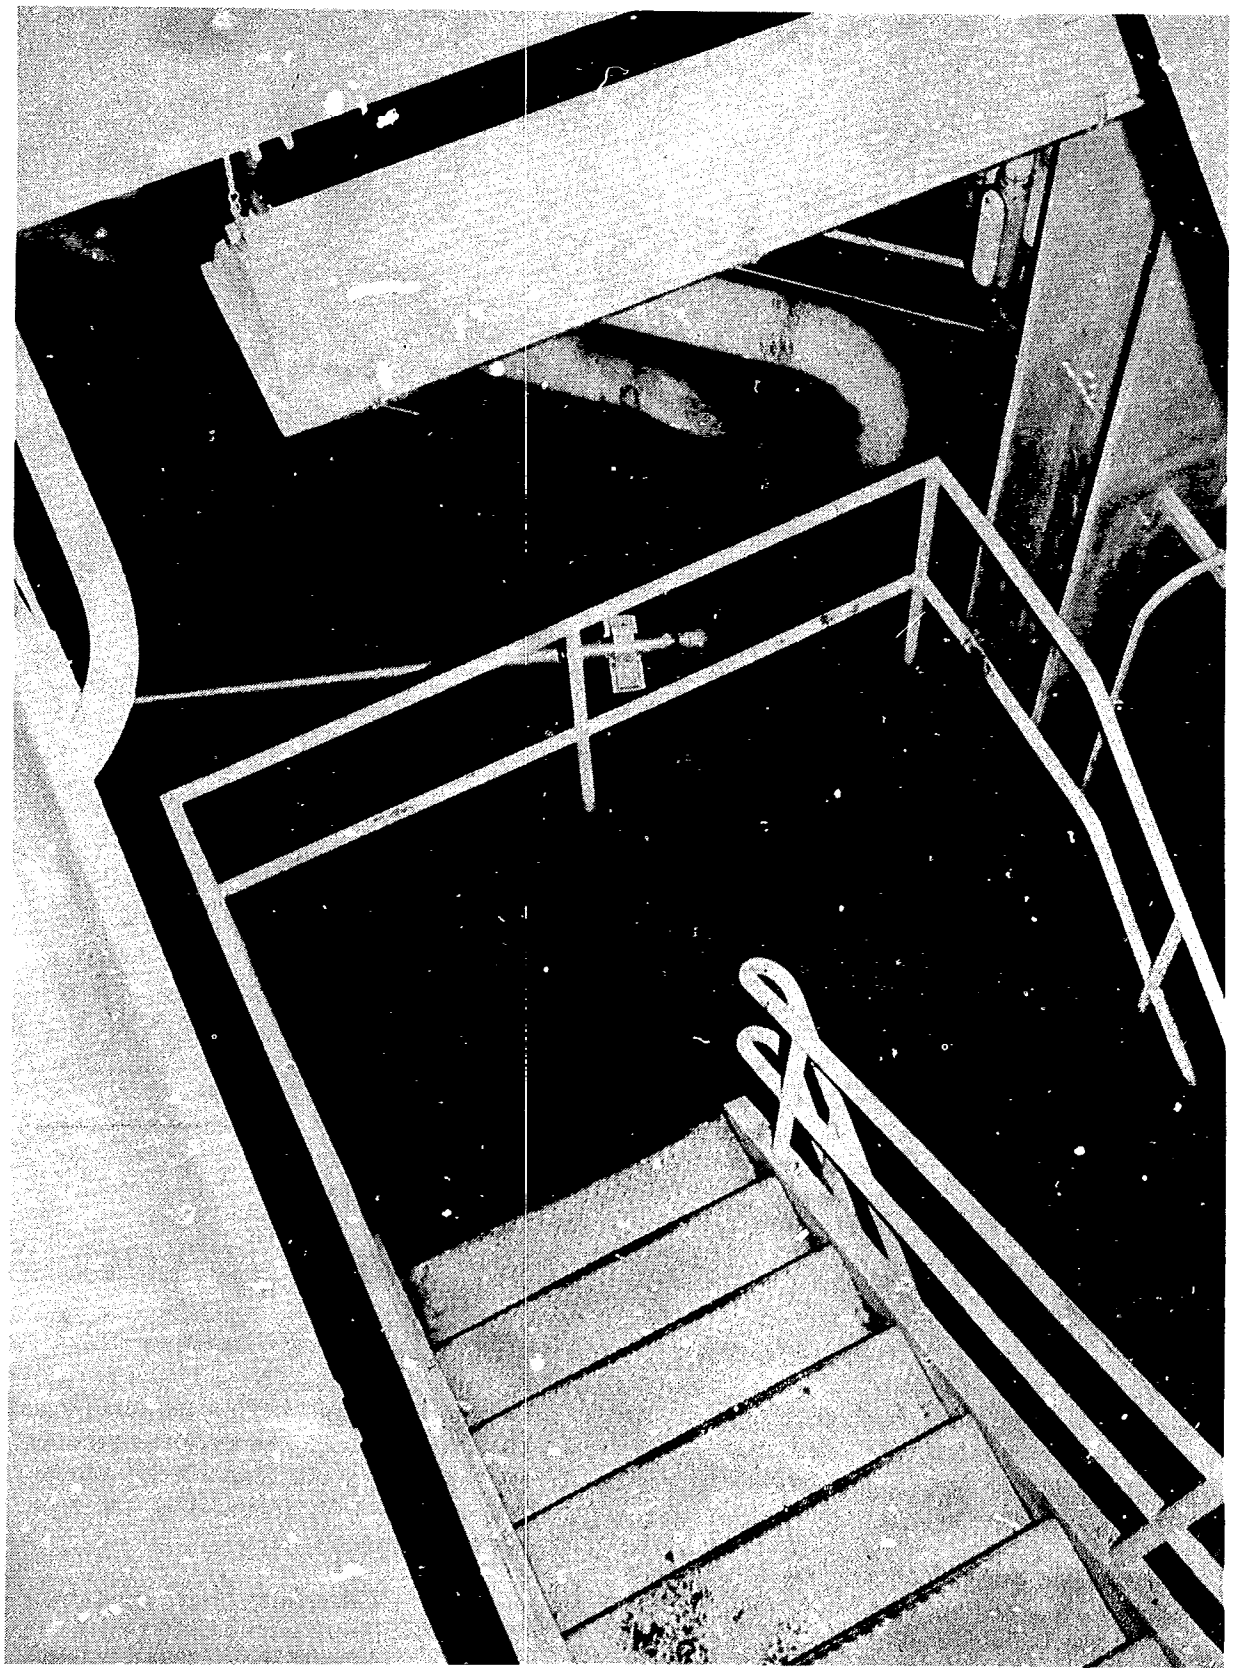
Figure 28. Water in reactor building basement as seen from the open stairwell.

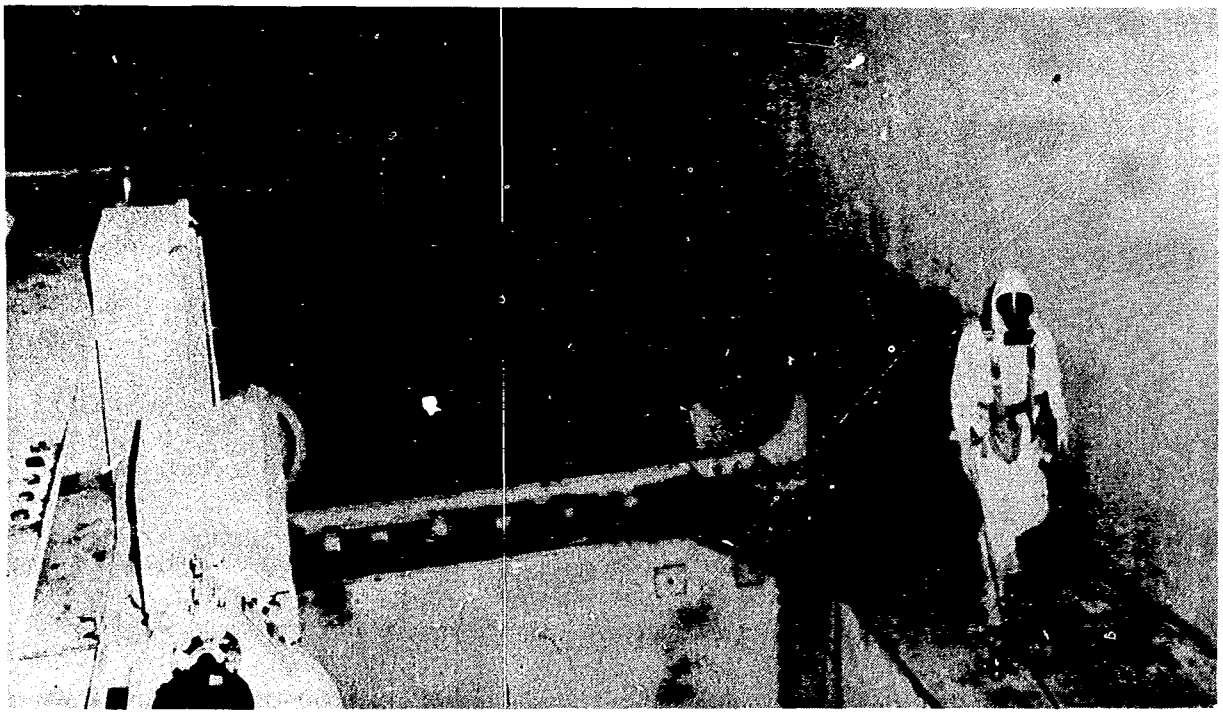
Figure 31. Technician inspects polar crane.
