TMI-2 INFORMATION AND EXAMINATION PROGRAM 1981 ANNUAL REPORT

Technical Integration Office

Published April 1982

EG&G Idaho, Inc.
Idaho Falls, Idaho 83415

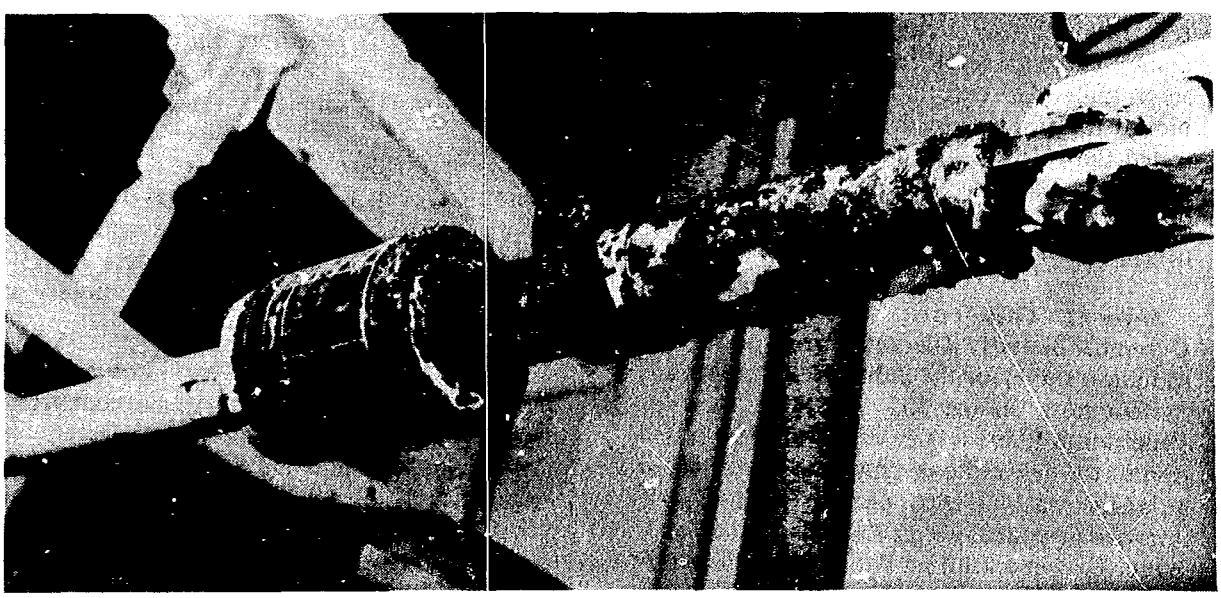
Figure 33. Corroded mechanical snubber on 305-ft elevation.
