GEND-044
Distribution Category: UC-78
TMI Supplement

TMI-2 REACTOR VESSEL HEAD REMOVAL

Published September 1985

GPU Nuclear Corporation
Middletown, PA 17057

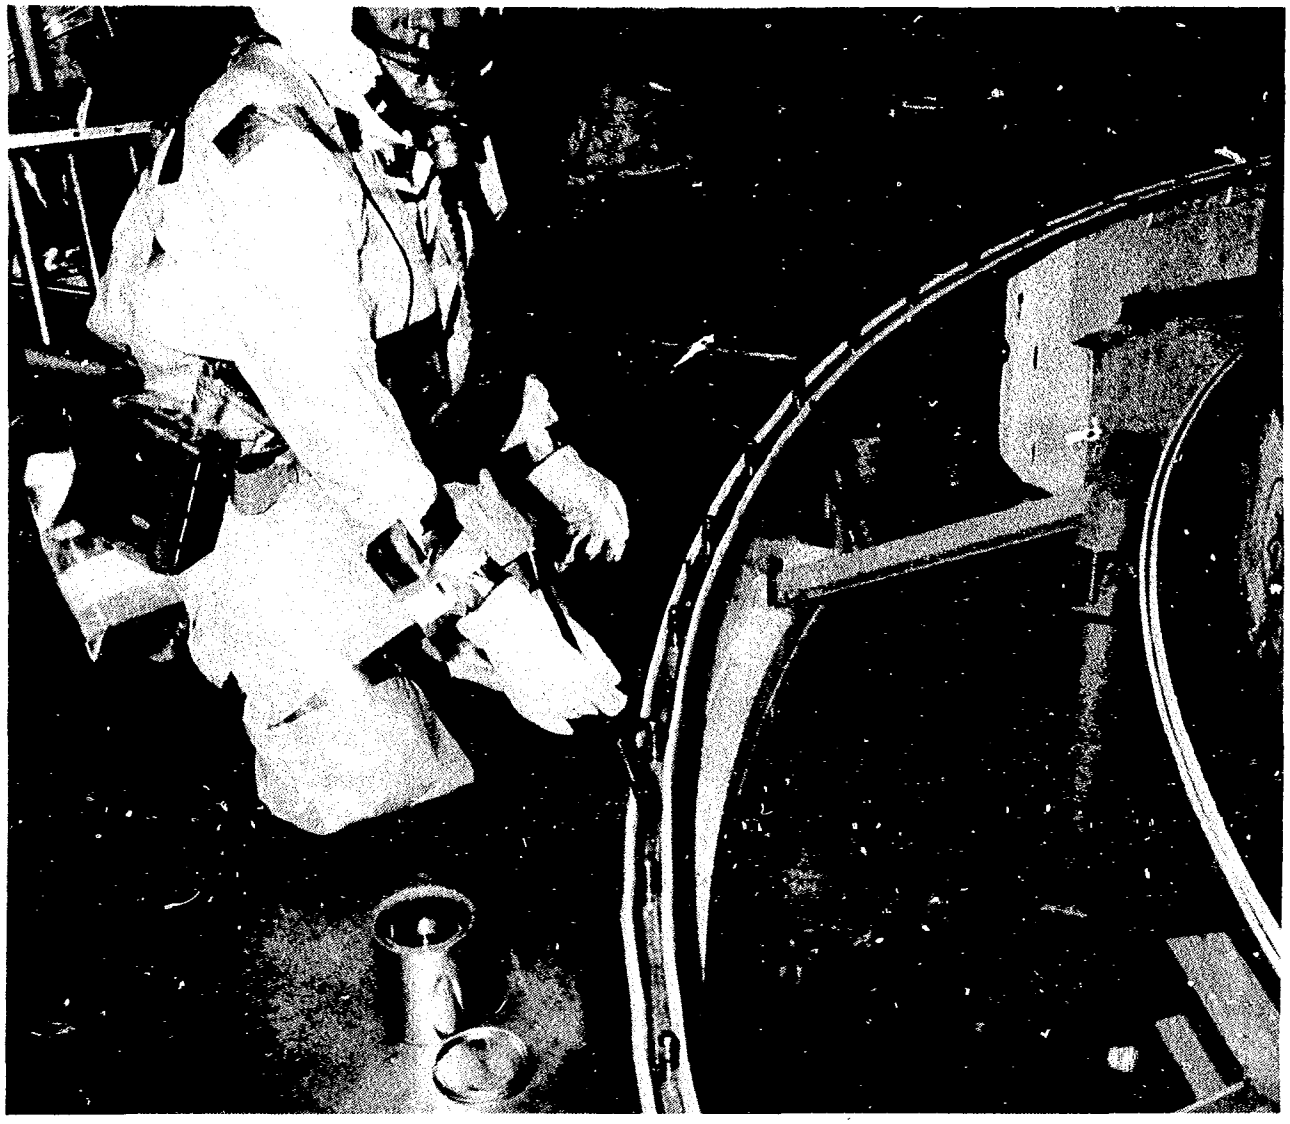
Figure 10. Canal seal plate cleaning and gasket installation.

Mockups and training sessions were conducted to prove methods for installing the gaskets (Figure 10), injecting the sealant into the small (less than 3 mm) cracks (Figure 11), and pouring the sealant into the barrier angles. Tests were conducted on the sealant primer using cure times varying from one hour up to four days. The best adhesion occurred when the primer was at least two days old. This information allowed the schedule of work activities to fit normal entry schedules without any impact on the quality of the seal.

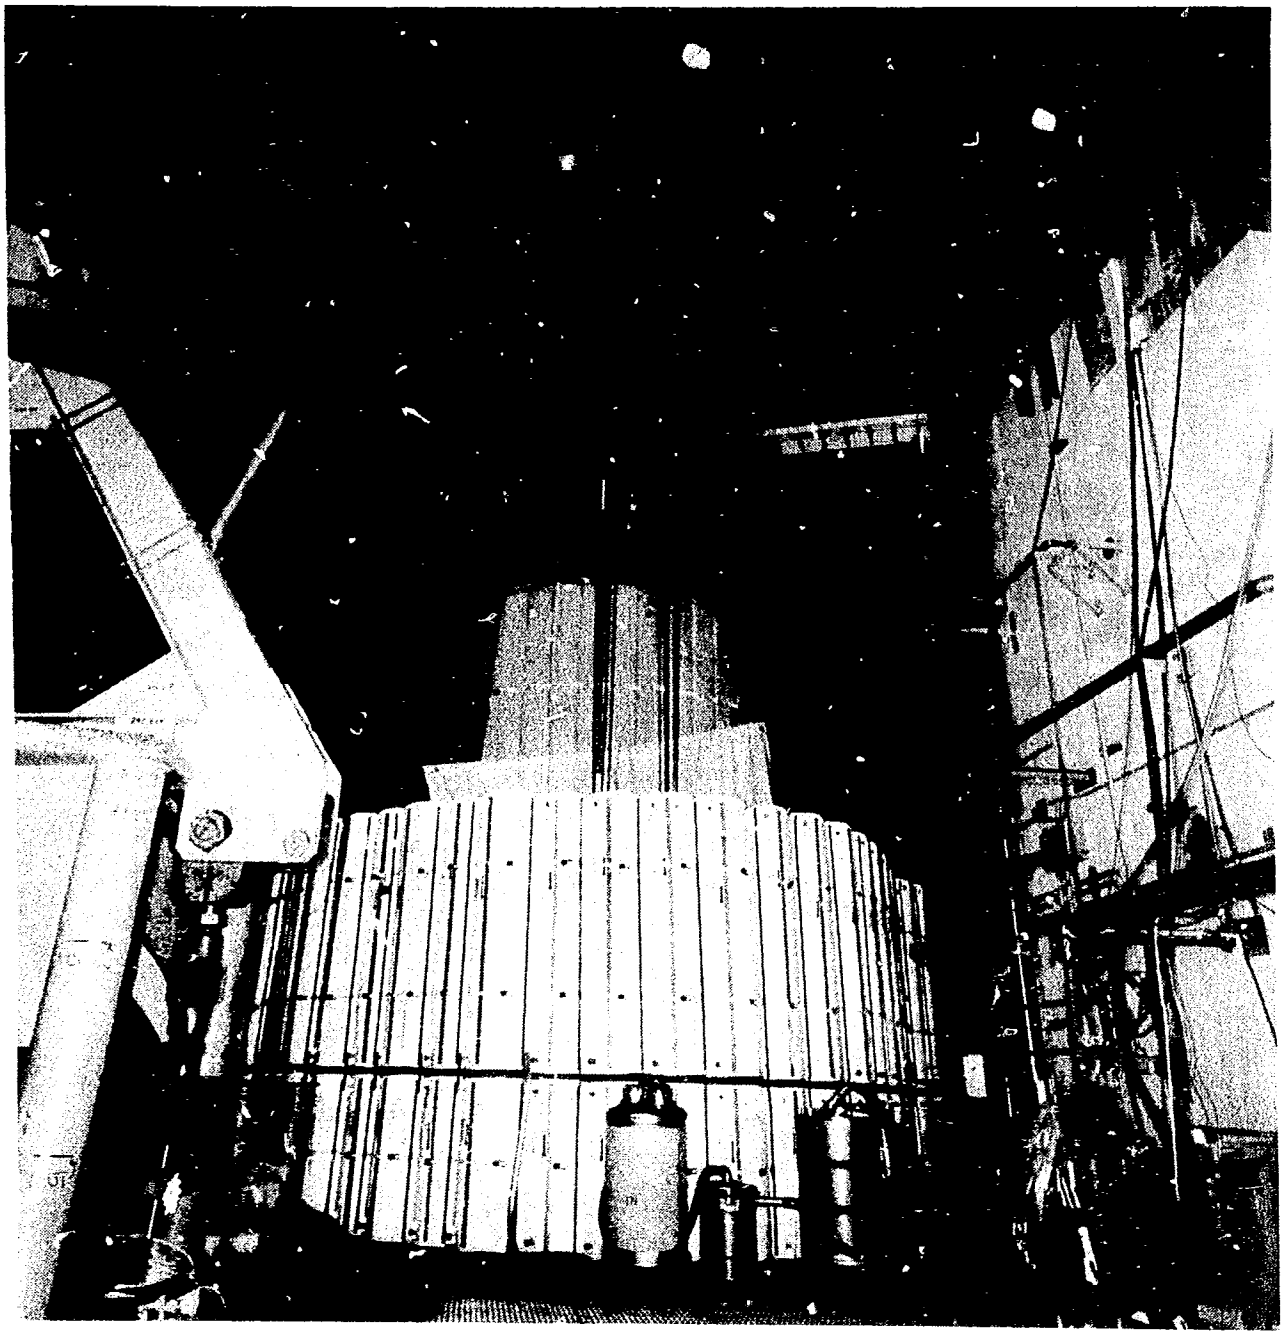
Figure 14. Shielded work station (upper right), walkway to service structure, tripod with turnbuckles (lower left), and 3.5 m sand column shielding.

3.5.1 Head Lift Tripod and Turnbuckles Inspections. As part of the lifting assembly inspection, the head lift tripod was cleaned and inspected (magnetic particle inspection) before and after the polar crane load test. Undersize weld lengths, discovered during the initial visual inspection, prompted a thorough re-evaluation of the tripod using sophisticated analytical techniques. Additionally, three of the more highly stressed welds were examined before and after the load test by magnetic particle testing and found to be acceptable. Both the analyses and the inspections verified that the tripod was qualified for lifting the head (Figure 14).

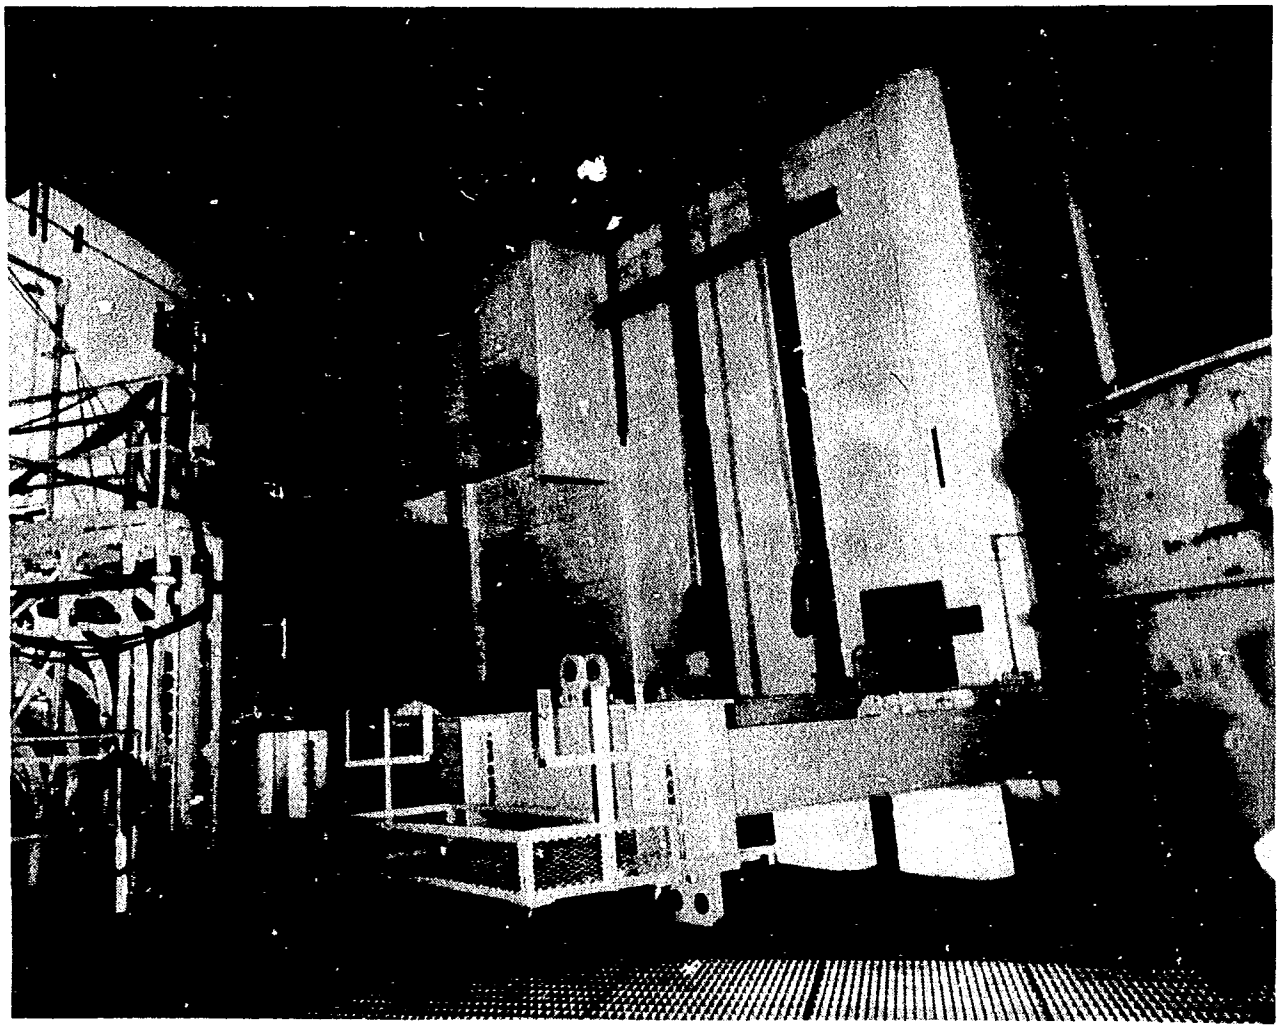
Figure 15. Polar crane lifting frame.

3.5.2 Polar Crane Load Test. Load testing the polar crane in March 1984 resulted in a rated capacity of 170 tn, well below the design rating of 500 tn (Figure 15). The 170 tn rating was sufficient to lift the head and its rigging with a 14 tn margin; no heavier lifts were planned for the polar crane during the recovery program. To provide a test load, the four reactor missile shields and the pressurizer missile shield (total weight 173,000 kg) were stacked in a steel beam framework (rigging and framework—22,000 kg). Following the test, the missile shields were stored over the B D-ring and the pressurizer shield was placed in its original position over the pressurizer.

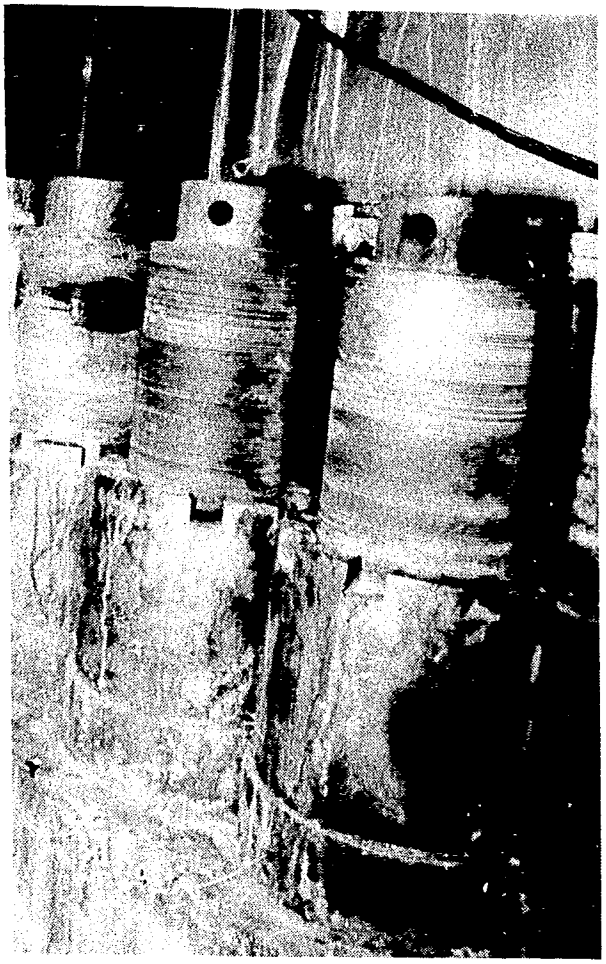
Figure 16. Reactor vessel studs before cleaning.

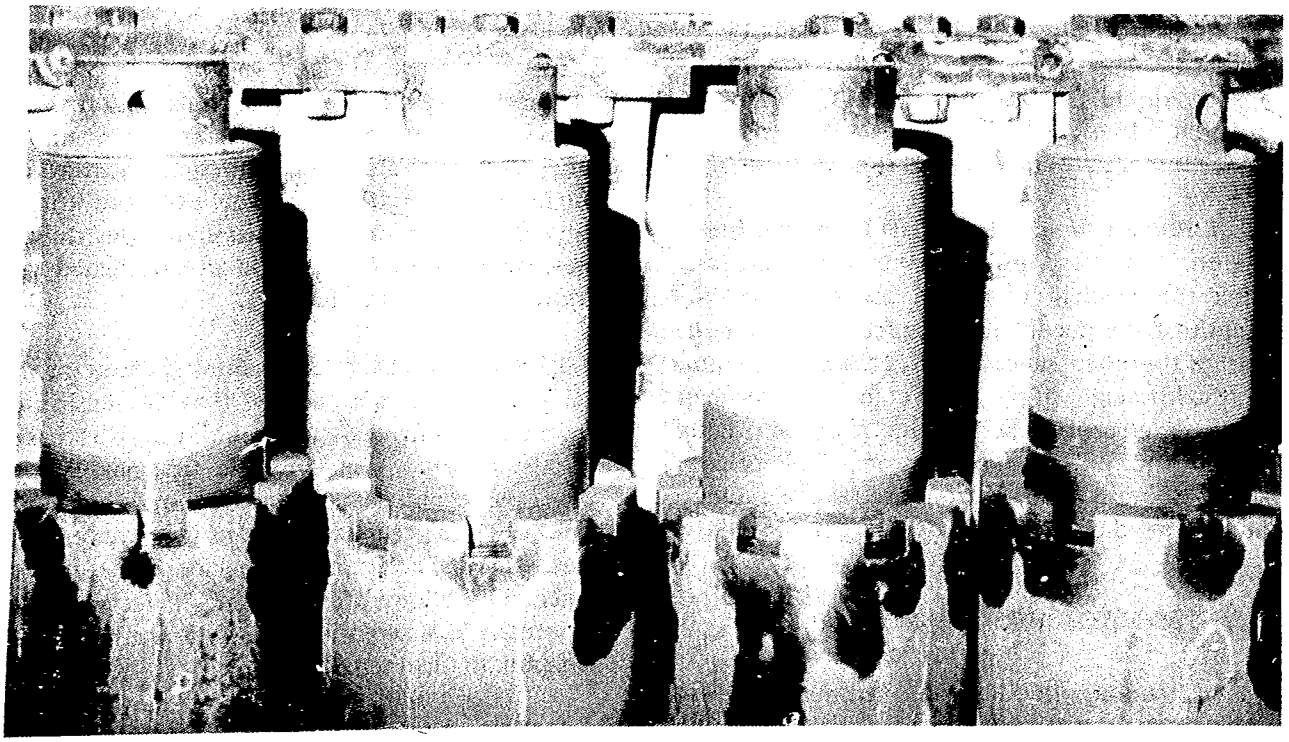
Figure 17. Cleaned and lubricated reactor vessel studs.

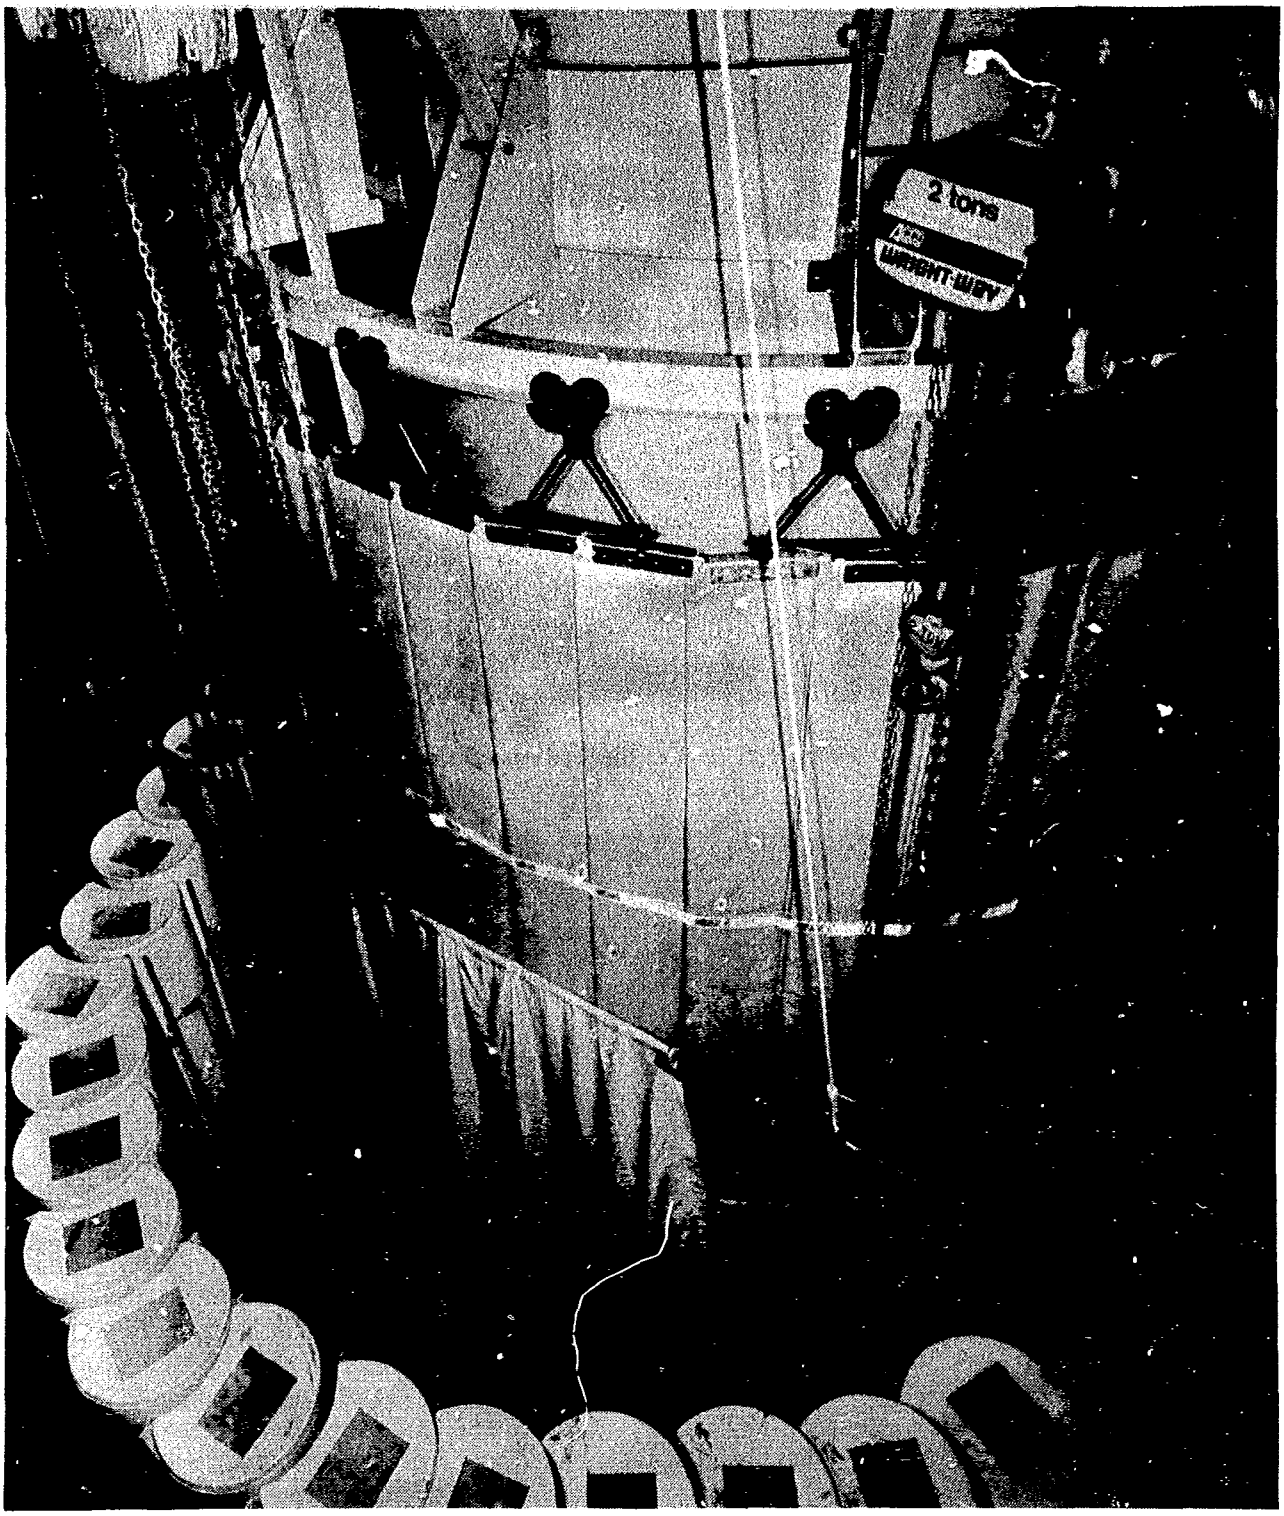
Figure 20. Service structure lead blanket shielding, head boot, and sand column shielding around storage stand.

3.7.3 Reactor Head Storage Stand Shielding. The primary purpose of the shielding around the head storage stand was to attenuate radiation emanating from the underside of the head. It also blocked radiation from the lower portion of the service structure that contains the 66 parked lead screws (Figure 22). The wall consists of 49 2.5 m fiberglass cylinders and 43 1.2 m fiberglass cylinders, each 0.6 m in diameter and stacked 3.6 m high. Each cylinder has a concave interlocking pattern for maximum shielding effect. Initially, these cylinders were filled with water; however, leaks occurred and the cylinders were filled with sand.

Twenty-three entries were required for installing, trouble shooting, and establishing the final configuration of the shield wall. The original plan specified only nine entries. The majority of the extra time was spent troubleshooting the leakage problem and replacing the water with sand. The sand increased the effectiveness of the shields by a factor of two compared to water, and the radiation levels in the vicinity around the storage stand actually decreased from their pre-head-lift values (section 5).
