PRELIMINARY CHARACTERIZATION OF EPICOR II PREFILTER 16 LINER

Battelle Columbus Laboratories

November 1981

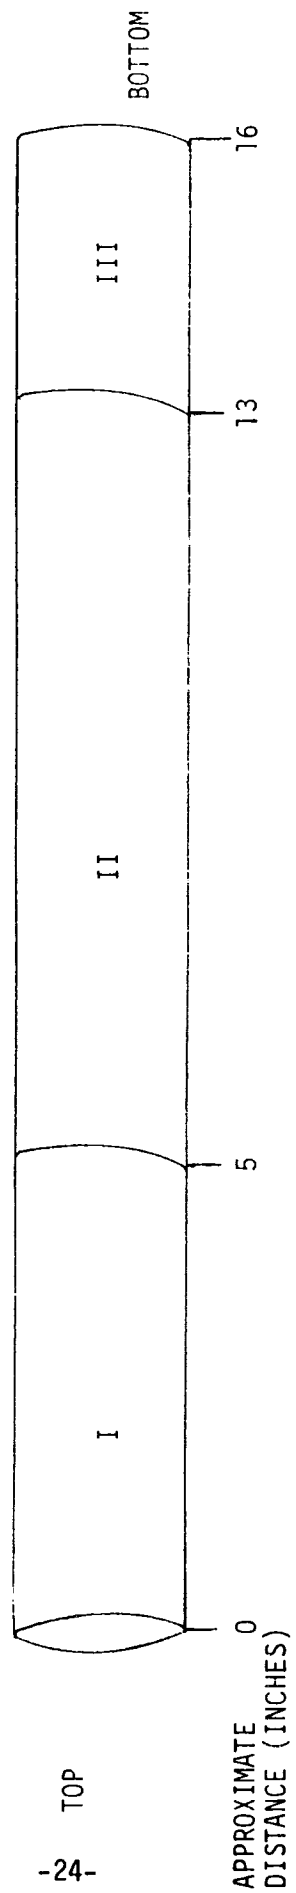
Some general observations may be made concerning the media bed. The total length of the core sample is approximately 16 inches. The total depth of the bed is approximately 31 inches and the shorter core sample may be an indication of media compaction, a failure to collect a complete core sample, or the sampling tube may have struck the underdrain system and did not extend to the bottom of the liner. A schematic of the core sample is shown in Figure 10. Three well defined regions were observed in the core. The top region (Region I) appeared to consist of brown, free-flowing, dry, granular, and irregularly shaped particles. This had an approximate length of five inches

and is presumed to be an inorganic medium. Region II was approximately eight inches long and consisted primarily of regularly shaped spherical particles that appeared translucent. A few broken particles were observed. There was some observed mixing with the top layer and the moisture content increased with increasing depth. Near the bottom of this region there appeared to be some agglomerates and occasional opaque and spherical particles. Region III appeared extremely moist and consisted of both opaque and translucent particles with some apparent opaque agglomerates and the opaque particles constituting greater than 50% of the region. It should be noted that the apparent agglomerates may be an artifact resulting from moisture and particles adhering to the side of the tube. The length of this region was three inches but it appeared that some of the core bottom had been lost during sampling. A contact pH of the Region III material was made using pH paper and had an approximate pH of 2.

The general observation is that the media appears not to be significantly degraded. However, this is only a tentative observation and must be verified by spreading media particles out in a single plane and closely examining them. No conclusions may be drawn until the more detailed examinations are completed.

FIGURE 10. Schematic of first core sample.

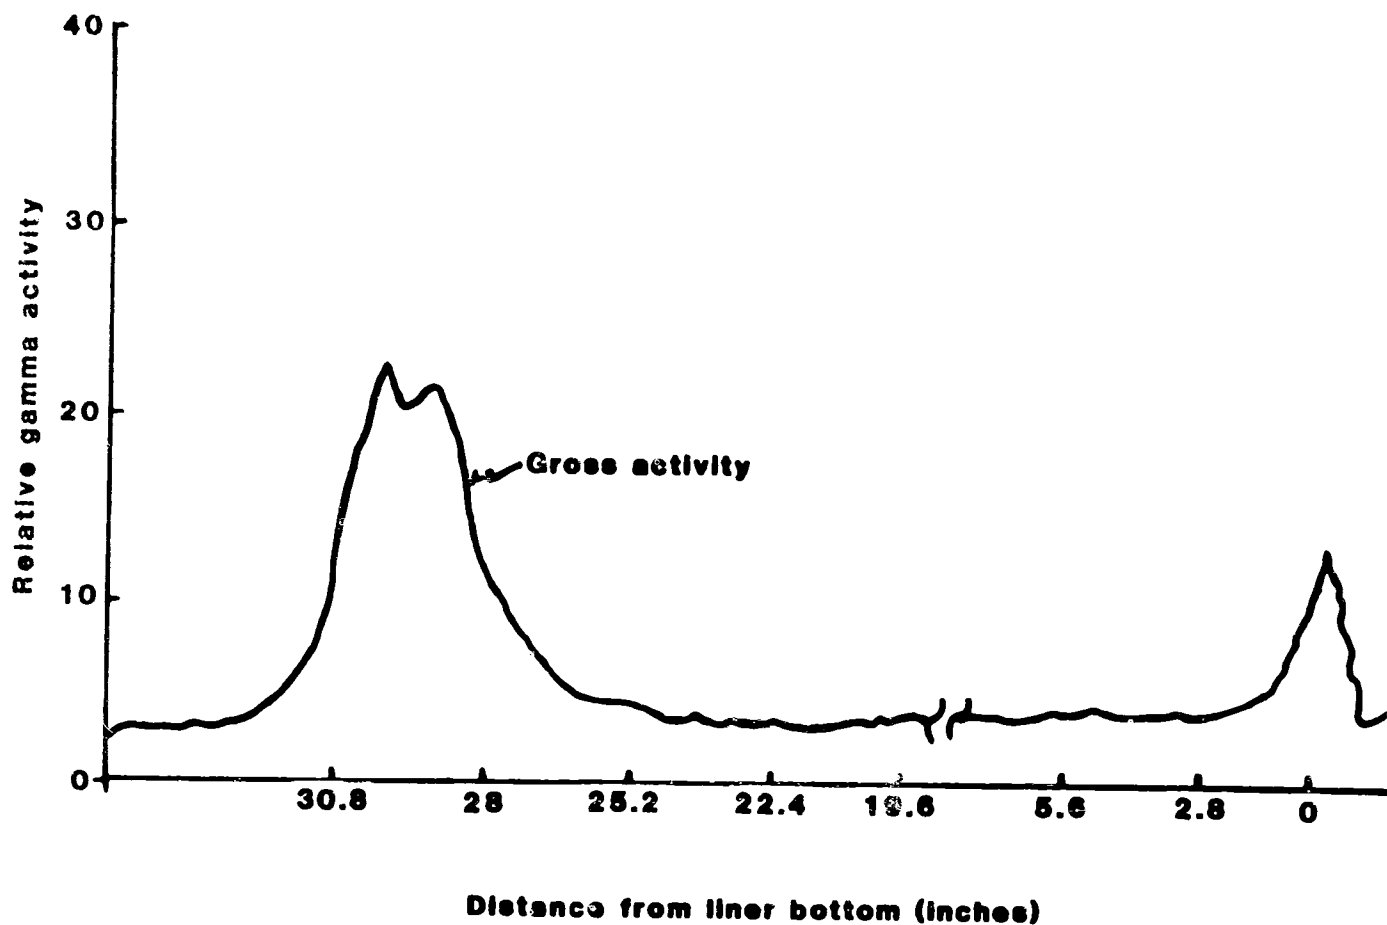
Figure 11 shows the gamma activity profile along the length of the liner. Gamma spectroscopy performed at the location of the peak activity showed that most of the gamma activity is Cs-137 and Cs-134. The gamma scans also showed that most of the gamma activity is concentrated in the top three to six inches of the ion exchange media bed. The peak at the bottom of the liner was caused by a gamma source attached to the outside of the liner for axial liner position reference and was not caused by the gamma level of the contained nuclides.

Figure 11   Gamma activity profile along outside of liner.
