GEND-INF--029-Vol.3

EXAMINATION AND EVALUATION OF TMI-2 TRANSMITTERS

CF-1-PT4 AND CF-2-LT4

Published January 1985

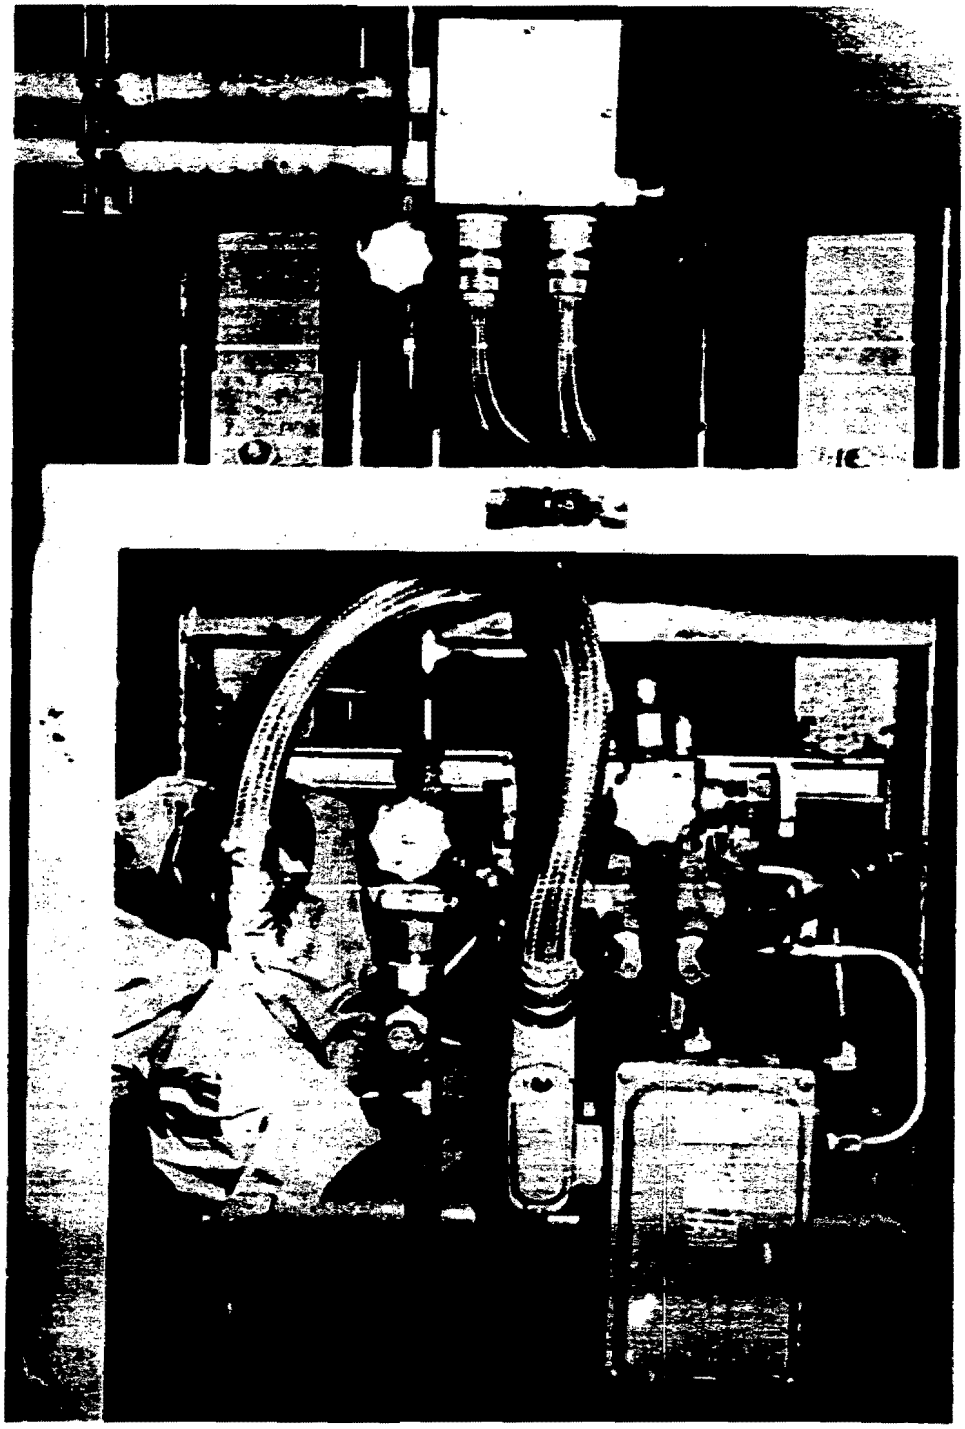
Photographs of several of the core flood transmitter installations at TMI-2 were taken during reactor building entries 92 and 342, and a general visual inspection by EG&G Idaho personnel was made of the Core Flood Tank B area during entry 499 (November 30, 1984).[7] Figure 1 shows the installations of transmitters CF-1-PT4 and CF-2-LT4 and their common junction box prior to their removal from the reactor building. This installation is typical of the core flood transmitter installations, in that a flexible conduit runs a short distance from each of the transmitters to a junction box where an in-line splice is made. A rigid conduit then connects the junction box (Figure 2) to the cable tray area, as shown in Figure 3.

Figure 1. Core flood instruments CF-1-PT4 and CF-2-LT4 prior to removal (entry 342-7).

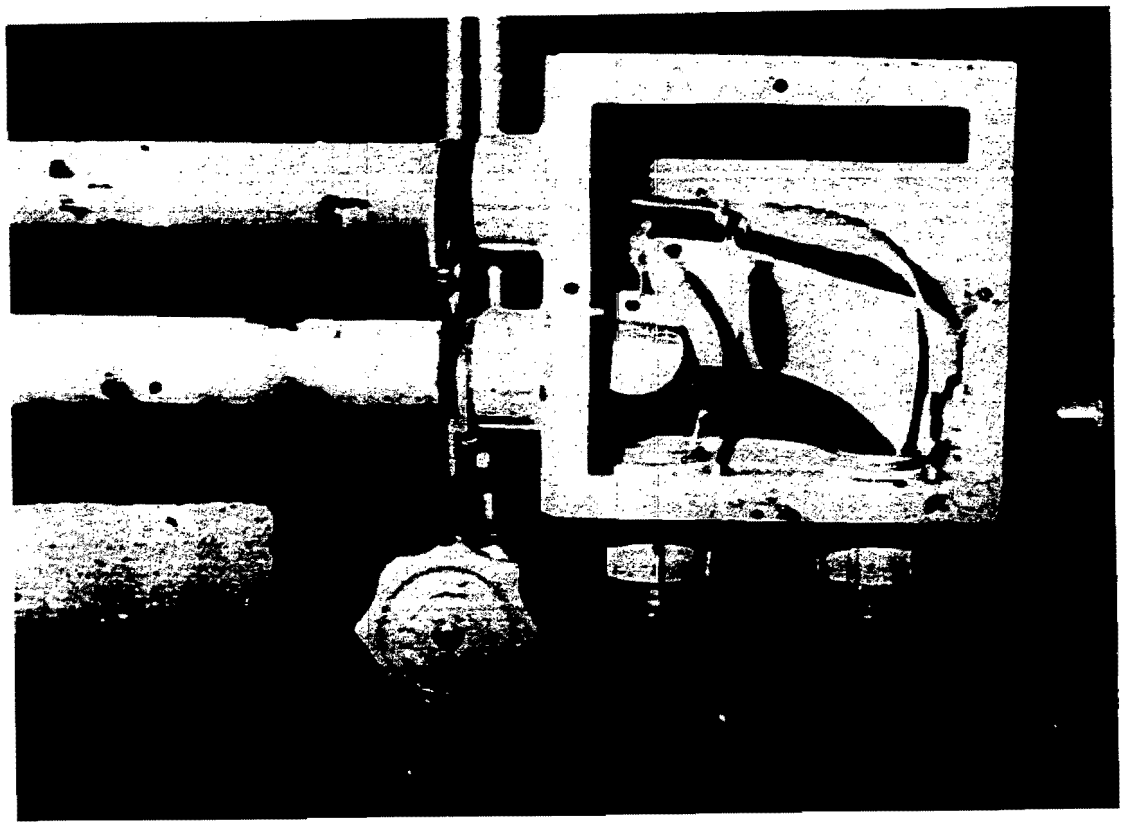
Figure 2. Junction box associated with CF-1-PT4 and CF-2-LT4 (entry 342-8).

In another installation involving CF-1-PT3 and CF-2-LT3, it was noted that the flexible conduits each entered separate Condulet conduit outlet bodies (Figure 4). The flexible conduits from CF-2-LT2 and CF-1-PT2 were also connected to a common junction box as shown in Figure 5; however, several differences were noted in the area of the junction boxes. The rigid conduit associated with the junction box shown in Figure 2 enters the box from the side, while the conduit enters the junction box shown in Figure 5 from the top. If water or condensate were to enter the conduits, the installation where the conduit entered the junction box from the side may have trapped a small amount of moisture in the junction box. The universal drains or breathers (Crouse-Hinds ECD15) were mounted on the junction boxes differently. In one case, an ECD15 was mounted as a drain, while in the other case the ECD15 was mounted on the side of the box, presumably as a breather. According to the product data sheet,[8] "ECD drains and breathers are installed in enclosures or conduit systems to provide ventilation to minimize condensation and (to) drain accumulated condensate," and "At least one breather should be used with each drain." It should be noted that the installation shown in Figure 2 did not have a breather installed on the junction box.

The junction box, fittings, and flexible conduits associated with CF-1-PT4 and CF-2-LT4 were examined in the Contaminated Component Test Facility at the INEL. The flexible conduit and fittings connecting the junction box to the transmitters were designed to be water tight; laboratory examination of these items indicated that they maintained their seal. An examination of the in-line splices indicated that adequate sealing had prevented moisture from entering the area of the electrical splices. The cover associated with the junction box had a gasket which would improve the seal; however, the seal was not water tight.

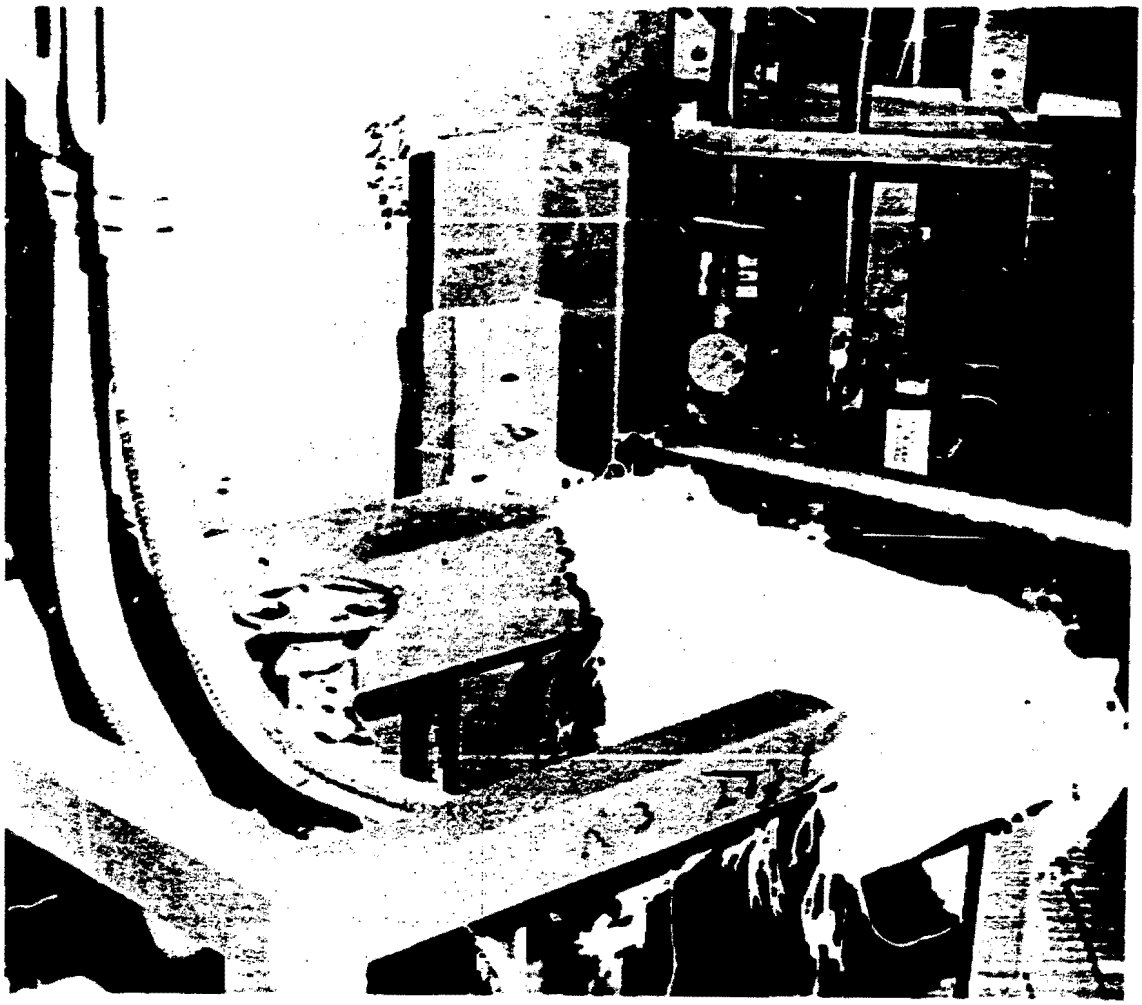
Figure 4. Condulet conduit outlet bodies associated with CF-1-PT3 and CF-2-LT3.

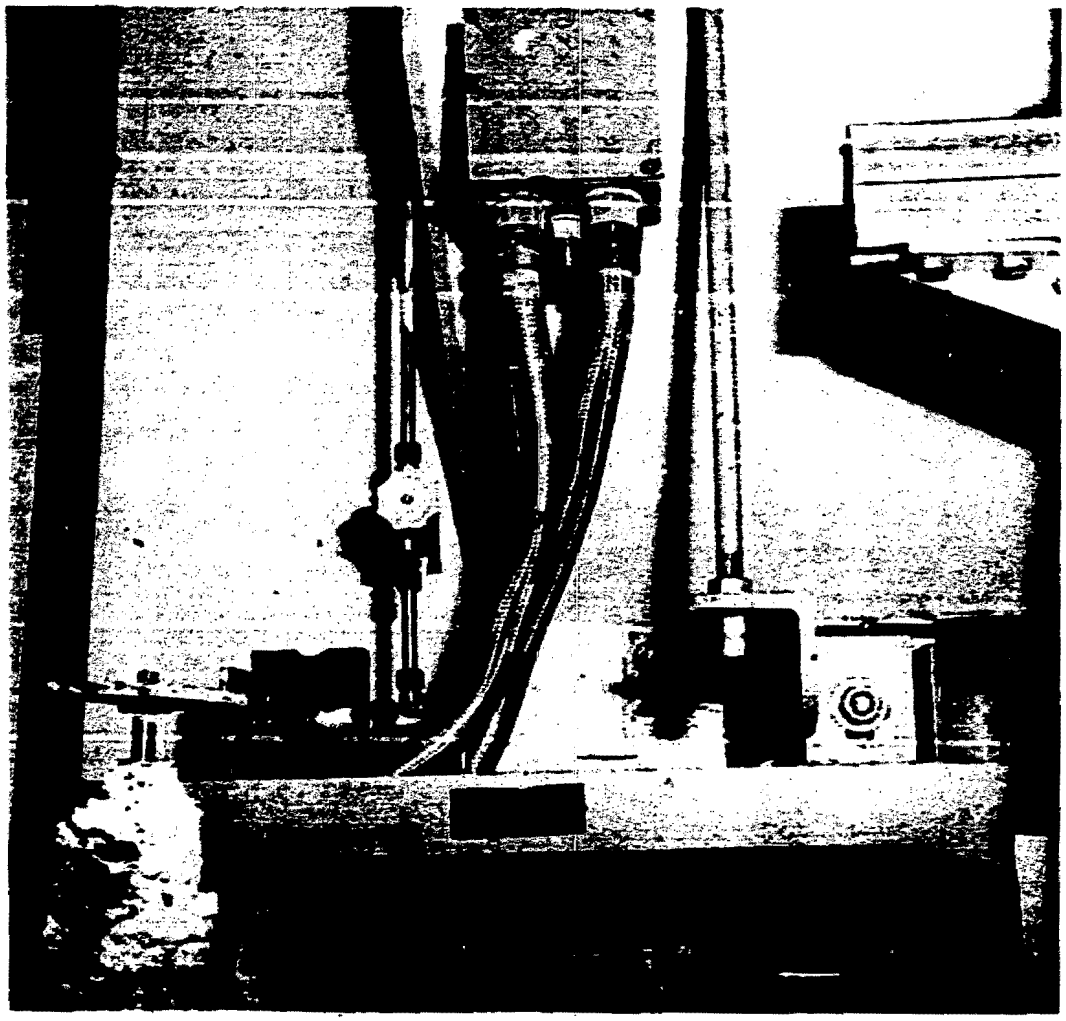
Figure 5. Junction box associated with CF-1-PT2 and CF-2-LT2 (entry 92 2-4).

An inspection of this junction box showed no internal moisture damage or mineral deposits, suggesting that the ends of the rigid conduit for these transmitters at the cable tray were more protected from moisture than were the other three installations, or, the breather installed in this junction box provided some ventilation which minimized condensation.

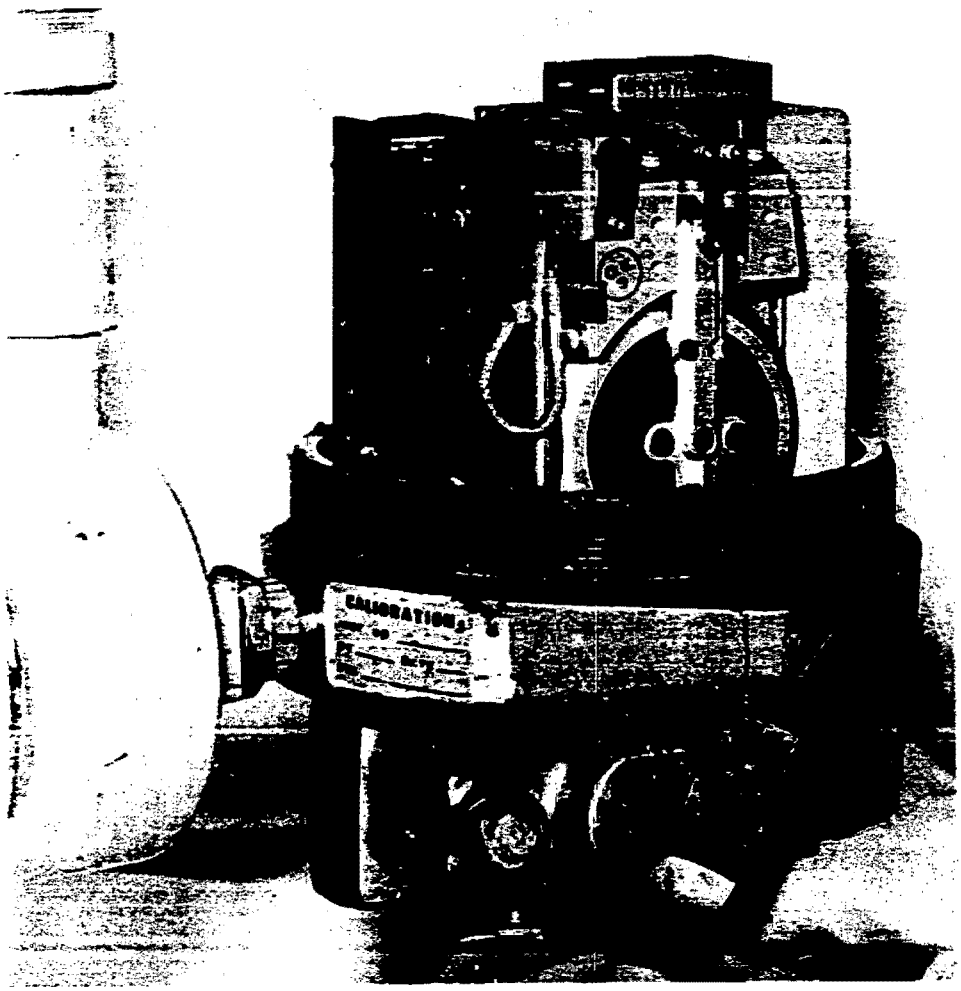
From initial visual examination at the INEL, it appears that the transmitter was in good condition except for some minor corrosion and rust on the exterior. The interior of the transmitter, including the sensor/electronic module assembly, was free from corrosion and radioactive contamination. The circular junction box showed no signs of corrosion; however, some mineral deposits were apparent, indicating that moisture had

Figure 6. Foxboro E11GM transmitter CF-1-PT4.

been in the junction box at some time. Radiation measurements indicated that the interior of the junction box was radioactively contaminated. Since the junction box seal appeared to be in good condition, it is likely that the water entered the junction box through the conduit. A seal located between the transmitter and the circular junction box prevented moisture from entering the transmitter itself.

The linearity for both sets of calibration data was better than 0.125%. The percentage change in both the zero and span occurring during the 81-month calibration interval was calculated. The zero shifted 1.34% of span, whereas a 0.2% increase occurred in the transmitter's sensitivity to pressure.

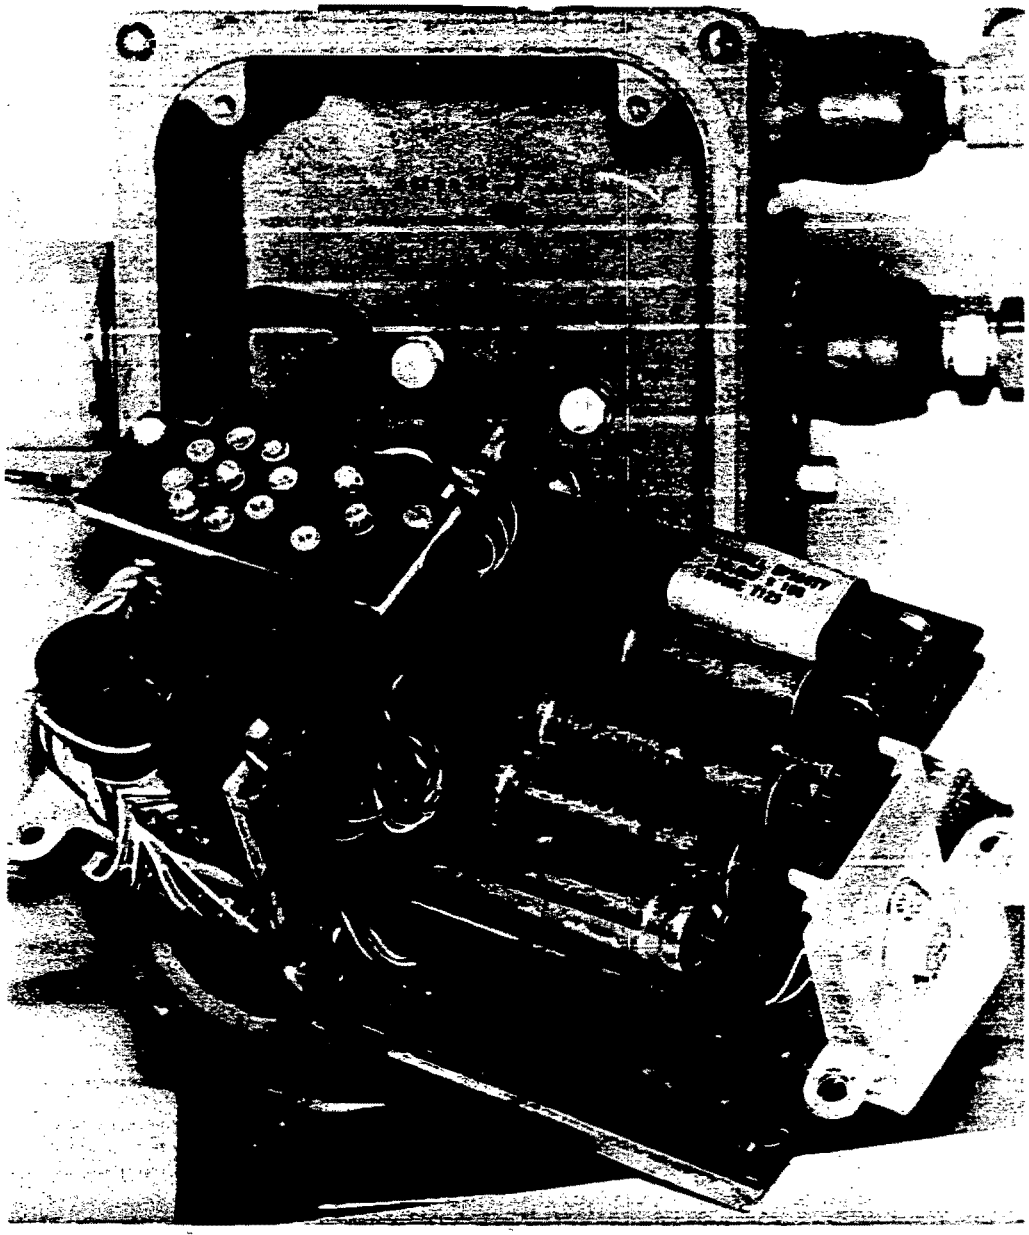
An initial visual examination of this transmitter indicated a heavy layer of rust on the unit's assembly nuts, while the remainder of the exterior surfaces had only minor or no indications of rusting. The interior of the transmitter, including the housing and the electronics, was free of corrosion and rusting (Figure 7). There was no evidence of moisture in the housing, in contrast to the other core flood level transmitters, CF-2-LT1, CF-2-LT2, and CF-2-LT3, which had extensive interior corrosion due to intrusion of water during the accident. An inspection of the transmitter housing and the conduit fittings connected to the housing indicated that no special installation or sealing procedures were used on this transmitter or on the other core flood level transmitters.

Measurements were taken to determine the extent of radioactive contamination on the interior surfaces of the transmitter. These measurements showed the contamination level was considerably higher in the area of the electronics than inside the conduit fitting. It is probable that the interior of the transmitter housing became contaminated at the

Figure 7. Bailey BY8231X-A transmitter CF-2-LT4.

The correlation coefficient for this data was 0.999947. An analysis of the pre-and postaccident data indicated that a zero shift of 2.9% of span had occurred during the time interval, while the gain had increased by 1.59%. A zero shift of approximately 0.4% of span occurred between each of the calibration cycles, while the gain increased an average of 0.5%.

Consideration should also be given by the manufacturer of the transmitters to providing a seal around electrical leads as they exit the transmitter housing, similar to the sealing technique used by Foxboro on their transmitters.
