EVALUATION RESULTS OF TMI-2 SOLENOIDS AH-V6 AND AH-V74

Florante T. Soberano

United Engineers and Constructors
Philadelphia, Pennsylvania

Published January 1984

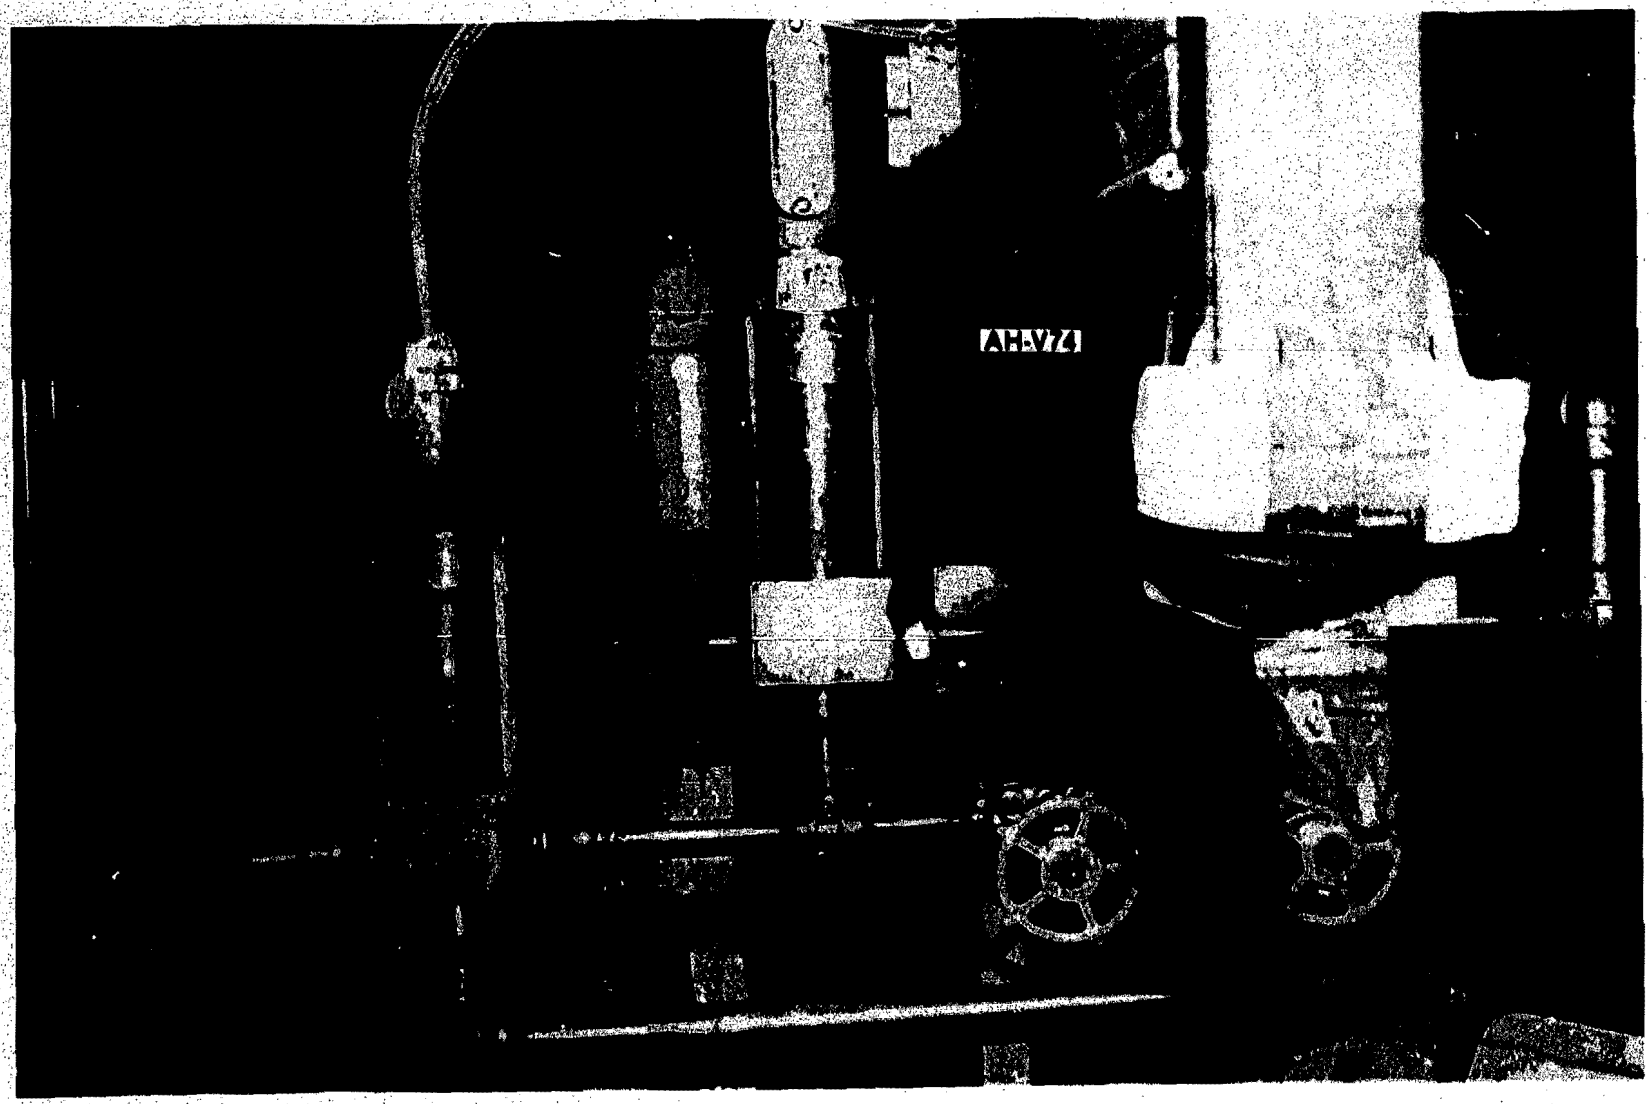
Figure 1. Installation configuration of solenoid valve AH-V6.

Both solenoid assemblies were removed from the Reactor Building without their associated valves. As seen in Figures 1 and 2, the valves are welded in place; consequently, their removal under the existing post-accident conditions was impractical.

Figure 1 is the installation arrangement of AH-V6. The solenoid and limit switch lead wires are brought out of the solenoid housing into the pull box through the flexible conduit. In the pull box, the lead wires and cables M835C and M836C are spliced. As seen in the figure, the pull box sits higher than the solenoid cover. It has a special two-way relief valve that acts as a pressure equalizer and drain. The flexible conduit that connects the solenoid to the pull box is attached on the lower side of the pull box. Analyzing the arrangement, the only possible way a significant amount of water could get into the solenoid is through the flexible conduit. The water may have gotten into the pull box through the two conduits connected on top. Because of the higher-than-atmospheric pressure setting and low drainage capacity of the pressure equalizer, the water level in the pull box may have risen to the level of the side opening and spilled over into the solenoid through the flexible conduit. The water settled on the top and bottom sections of the annulus between the solenoid shell and the enclosure. Due to the O-rings on the bottom of the solenoid, the fluid got trapped in the annulus for an extended period of time.

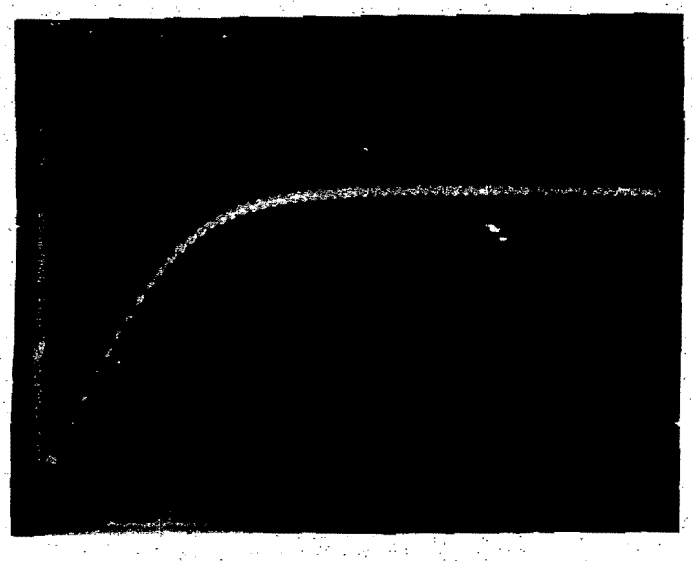
The response time test showed that all four solenoids operated the test valve with exactly the same response of about 260 milliseconds pickup time and 370 milliseconds dropout time (Figures 7 through 14). This consistent response time signifies that the velocity, and hence the

Figure 13. Scope trace of the opening response time test of the AH-V6 solenoid. Scope setting: 100 milliseconds per division.

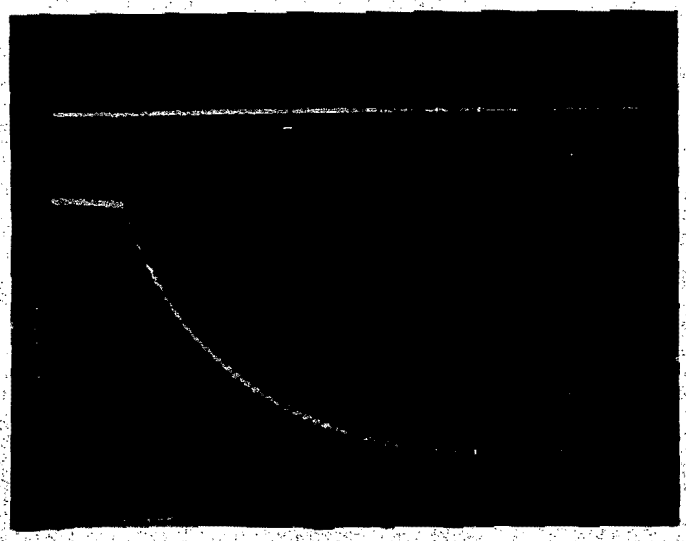
Figure 14. Scope trace of the closing response time test of the AH-V5 solenoid. Scope setting: 100 milliseconds per division.

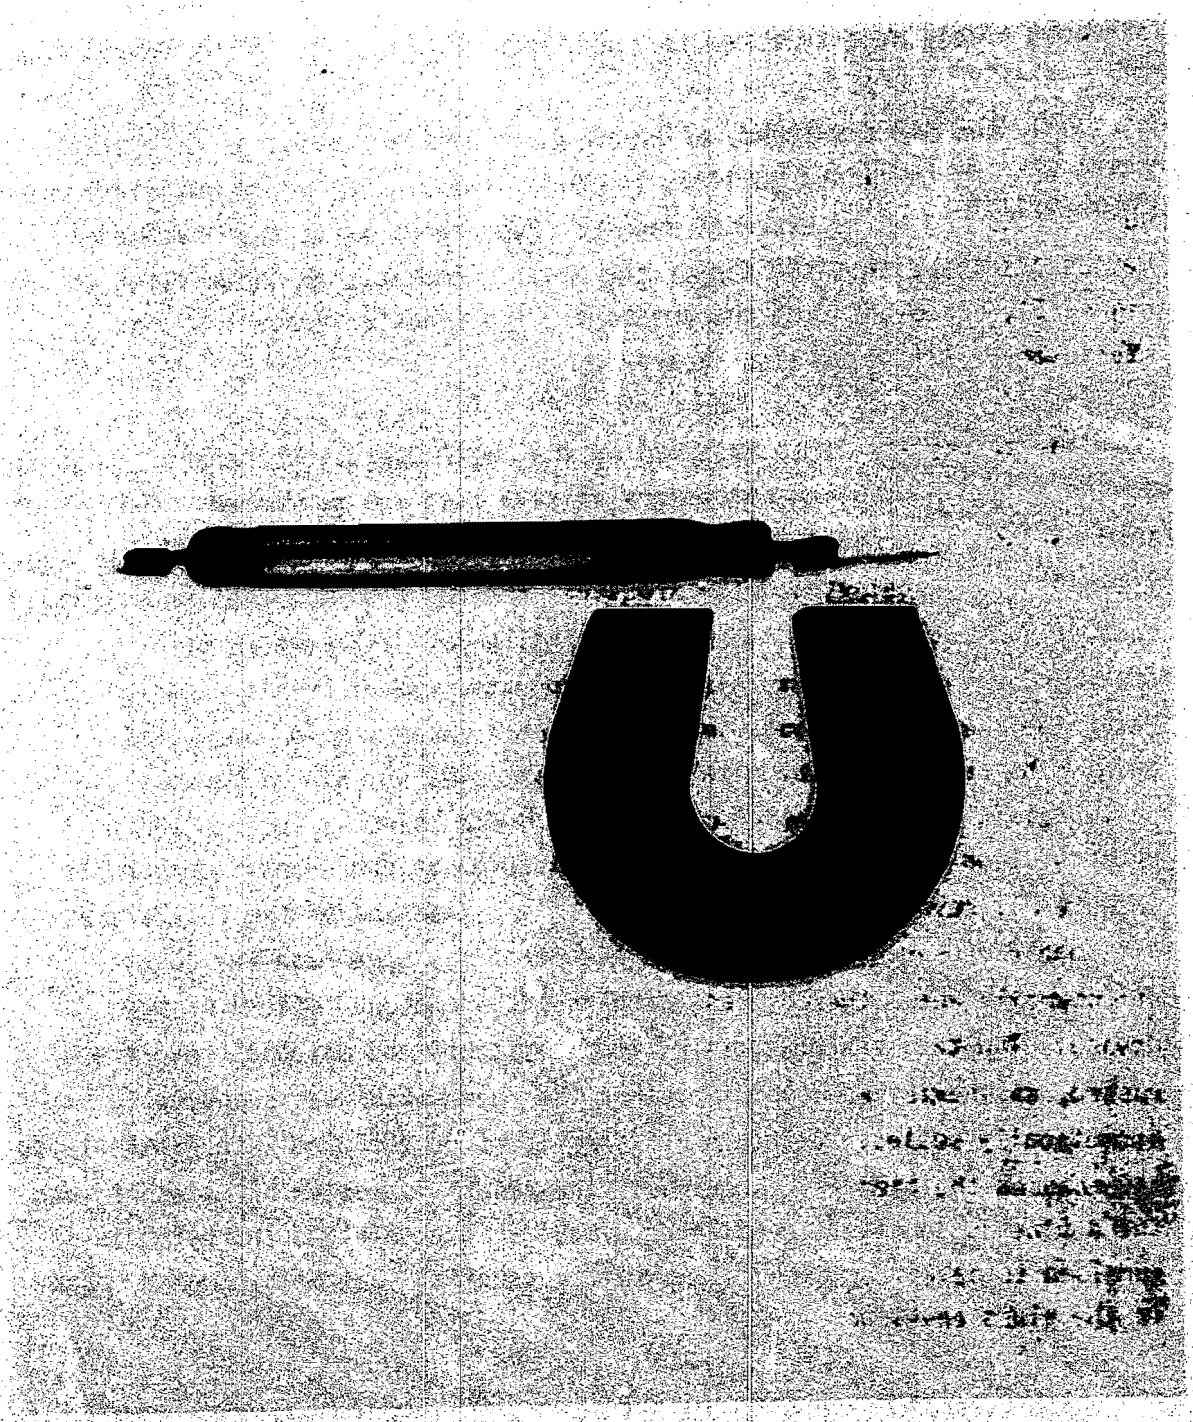
Only the limit switches of AH-V6 were examined; those of AH-V74 were not used. As mentioned earlier, the OPEN limit switch would not close even when influenced by an external magnet. Subsequent x-ray examination of the device disclosed that the tip of the movable contact, as illustrated in Figure 20, broke off from the armature. The tungsten contact of the stationary contact was also separated.

The switch was first observed by the TMI-2 Operations Department to be giving false information before any in situ test was performed. This false information was probably the result of loose parts getting wedged between the stationary contact and the armature, thereby giving a continuous closed contact indication. The loose parts finally got dislodged when the solenoid's orientation was altered during its removal from the valve. To determine the failure mode, the switch metal encapsulation was sliced open. The removal of the metal insulation revealed several facts. The switch glass envelope was discolored and broke apart as soon as the encapsulation was removed. Visual examination of the exposed components (Figure 21) revealed what appeared to be a burned end of the armature arm, presumably caused by a fabrication flaw that may have made the joint structurally weak, thereby resulting in the premature failure of the device. The tungsten contacts of the stationary and movable arms were also rusted, an unexpected condition since the reed switch was supposed to be hermetically sealed. Although rusting cannot be declared with certainty to have caused the reed switch to fail, the actual intrusion of moisture into the device is in itself considered a fault. The moisture intrusion is surmised to be either through the switch terminal seal or through a crack in the glass envelope.

Figure 20. Negative of an x-ray of the defective limit switch of AH-V6, with magnet used in an attempt to move the loose parts back to their proper positions.

Water intrusion inside the reed switch should be evaluated. The hermetic seal of the device could be improved by encasing the reed switch supporting terminal with qualified shrink-tubing from the neck of the reed switch glass encapsulation to and including a few inches of the connected lead wire. Furthermore, the present mounting design of the limit switch permits cracking of the glass encapsulation by overtightening the fastening set screw, a circumstance that may have occurred in AH-V6. To circumvent this problem, a new feature of mounting the limit switches without pinching the body should be incorporated.
