POST-ACCIDENT EXAMINATION OF PLATINUM RESISTANCE THERMOMETERS INSTALLED IN THE TMI-2 REACTOR

R. M. Carroll
R. L. Shepard

Published September 1985

Oak Ridge National Laboratory
Oak Ridge, Tennessee

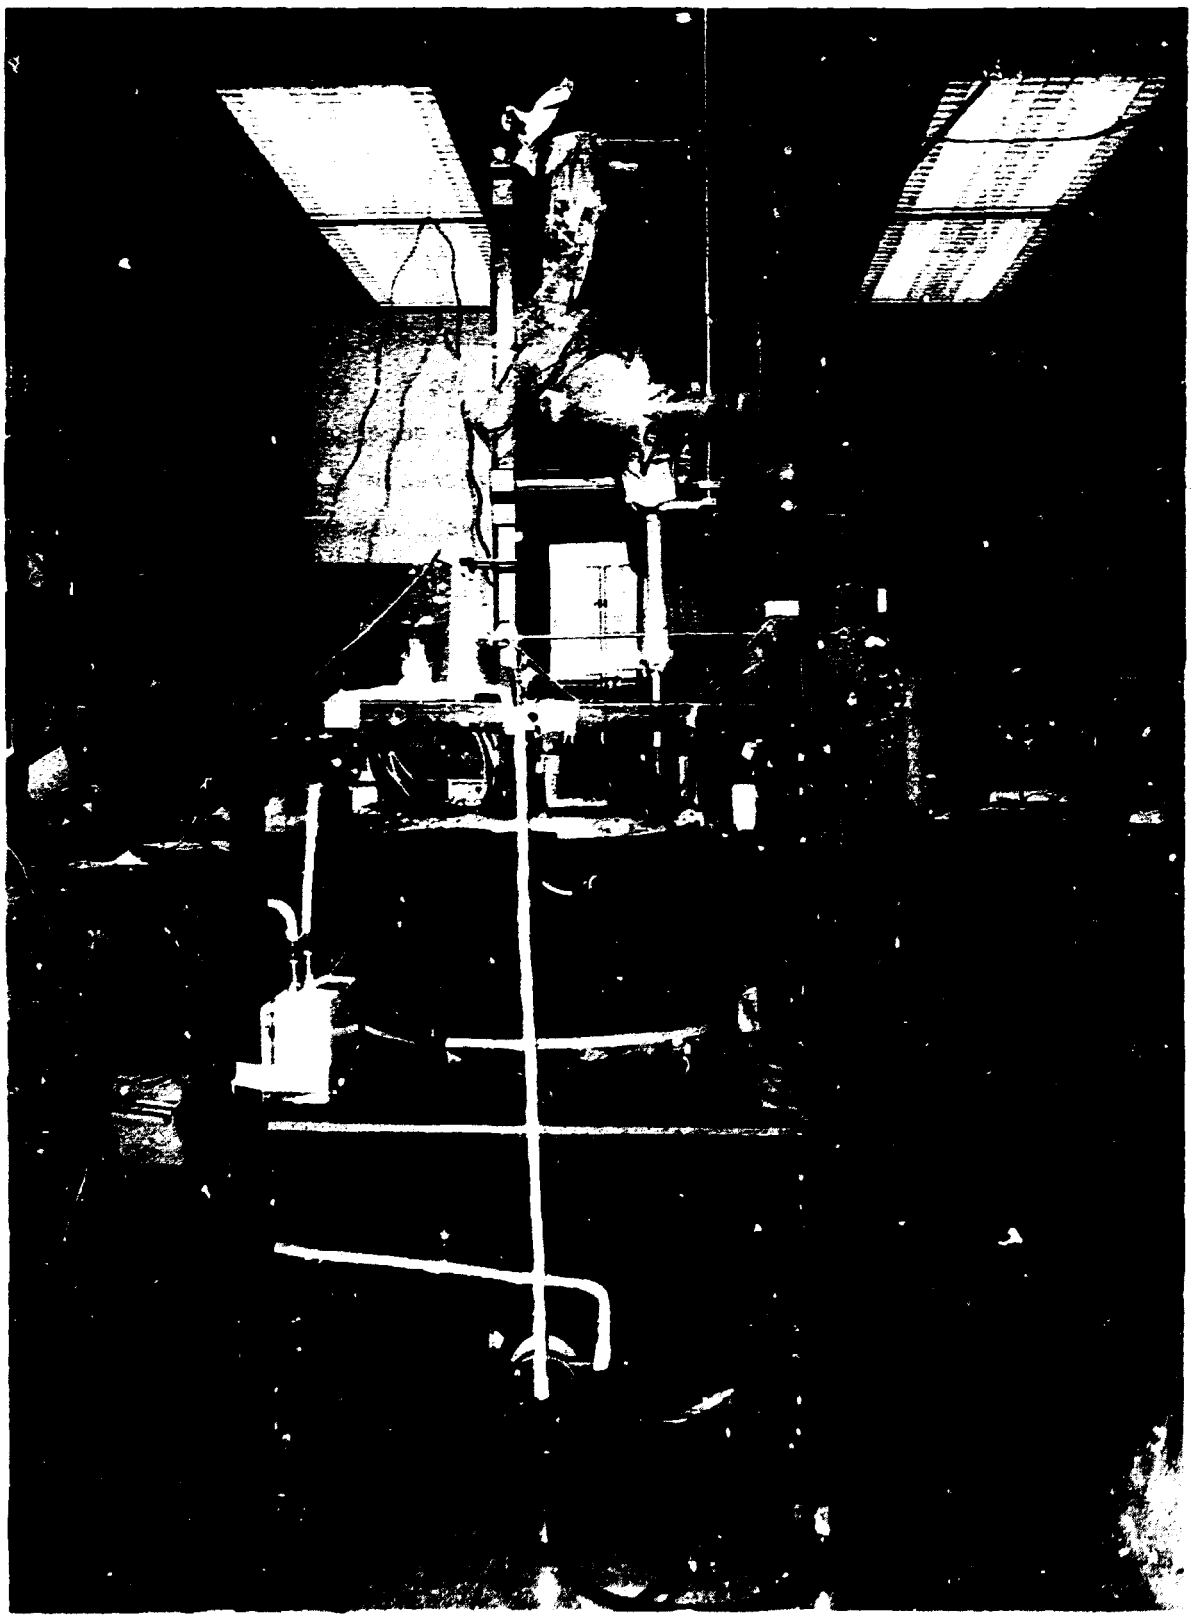
Figure 3. PRT S/N 3670 in position for response time tests under benchmark conditions.

3. The response time of PRT S/N 3670 under benchmark conditions lies between the two sets of measurements reported in the original factory certifications. Therefore, there appears to be no degradation of response time in this PRT.

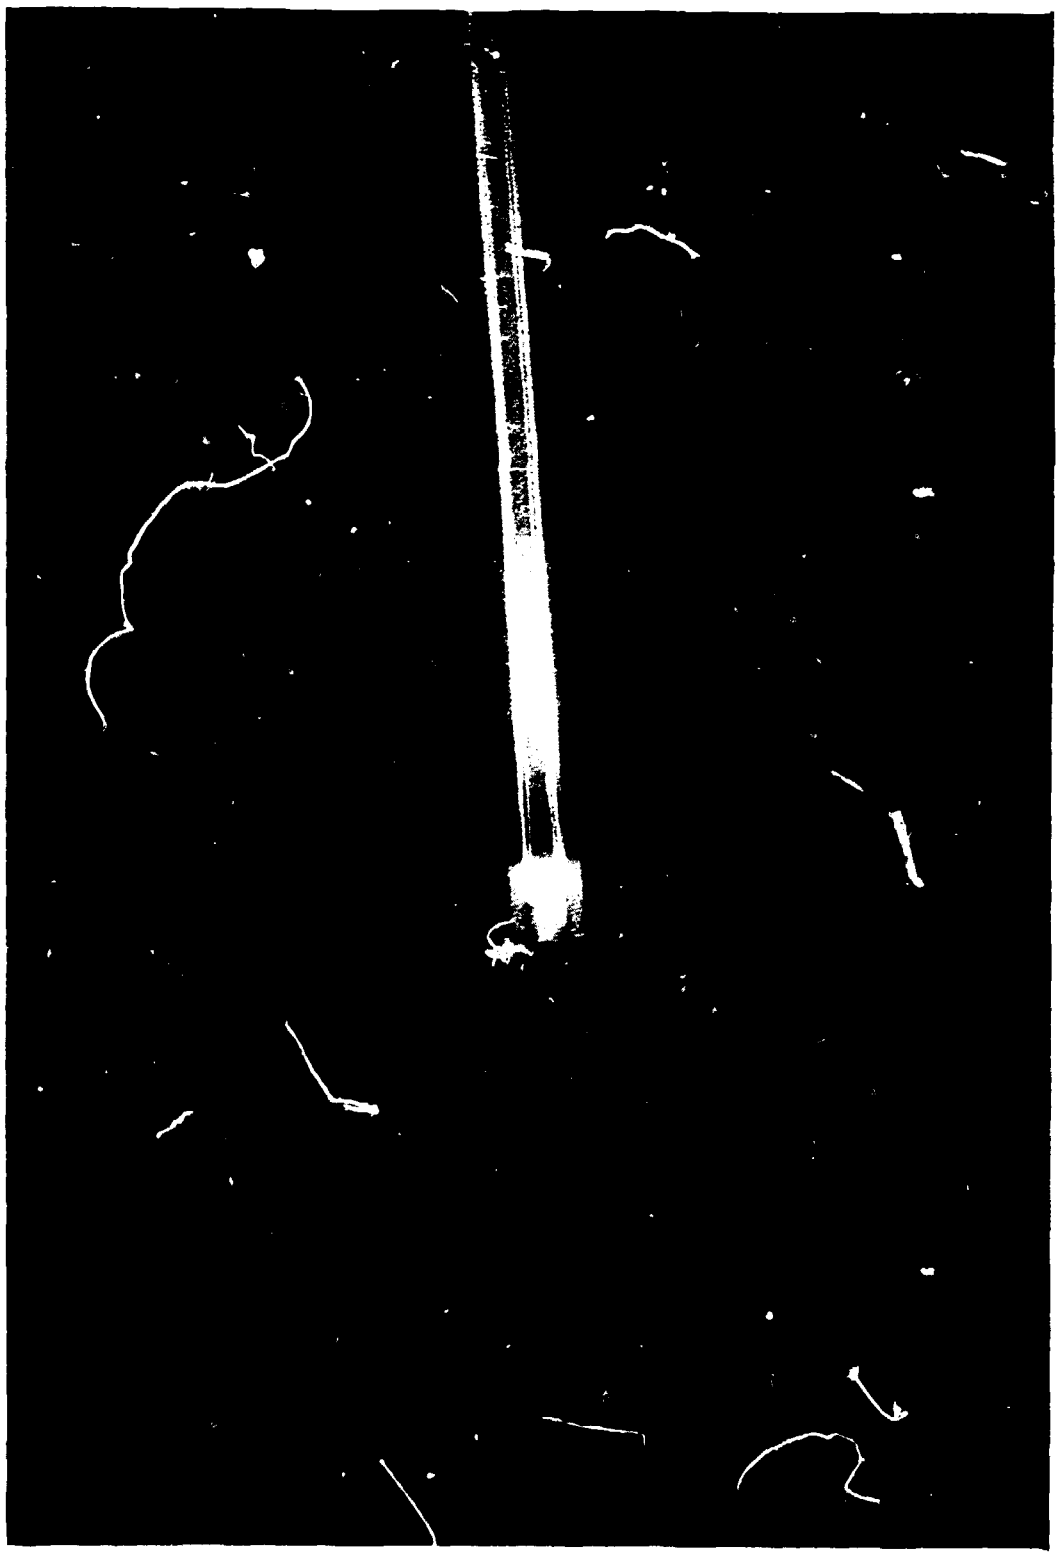
Figure 4. Radiograph of PRT S/N 3670 in the thermowell shows the relation of the silver bushing to the reduced section of thermowell.

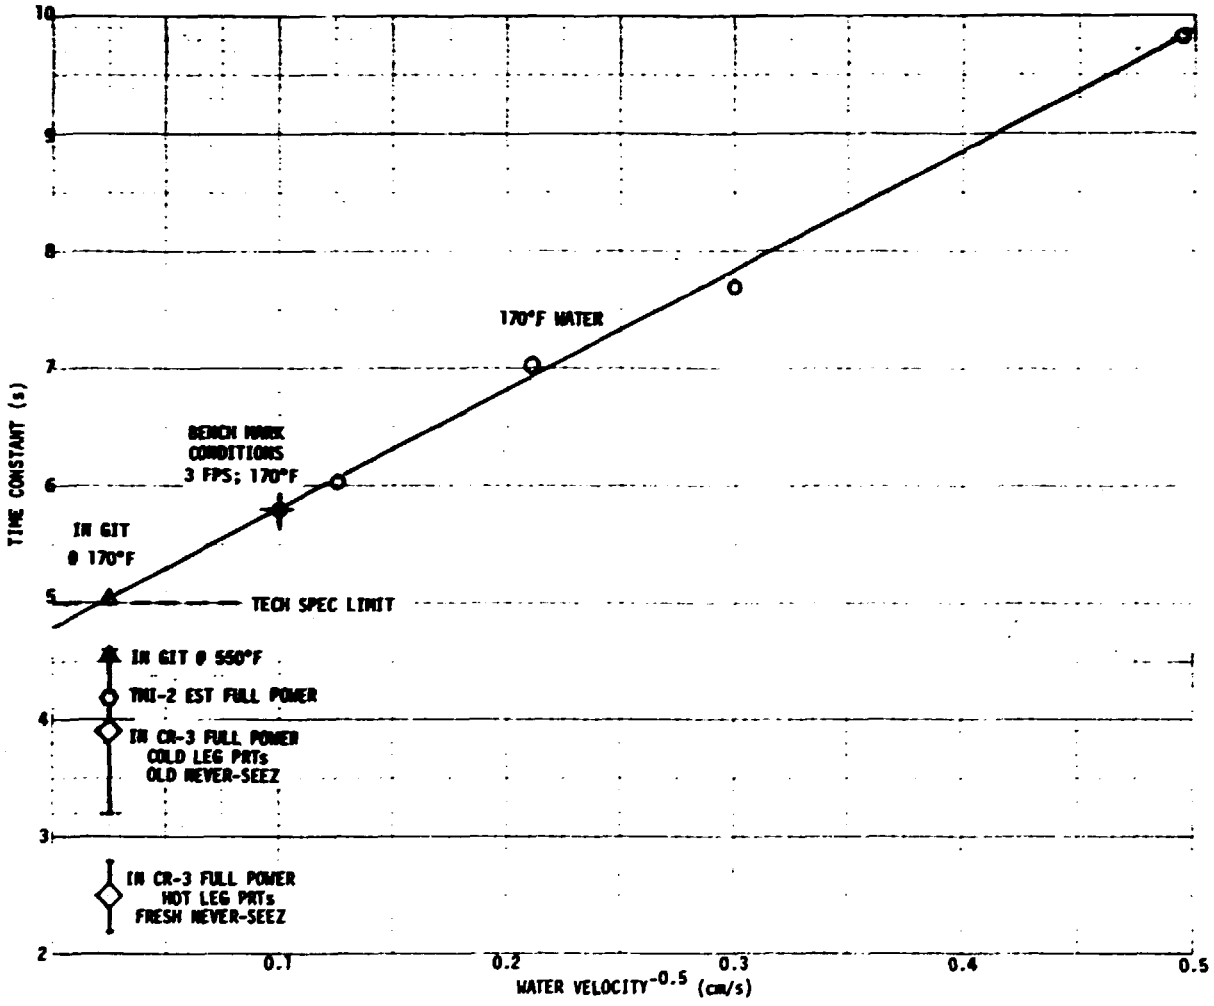
Figure 7. Time response of REC Model 177 HW in thermowell measured in laboratory tests and in TMI-2.

The ORNL data in Table 5 were plotted in Figure 7, and from the intercept a value of C_1 = 4.76 s was obtained for Equation (1). Using the data and method of Reference 12, the value of h at 76°C (170°F) and 1 m/s flow was calculated to be 0.295 (W/cm²-°C) and the measured τ was 5.80 s. Thus from Equation (1)

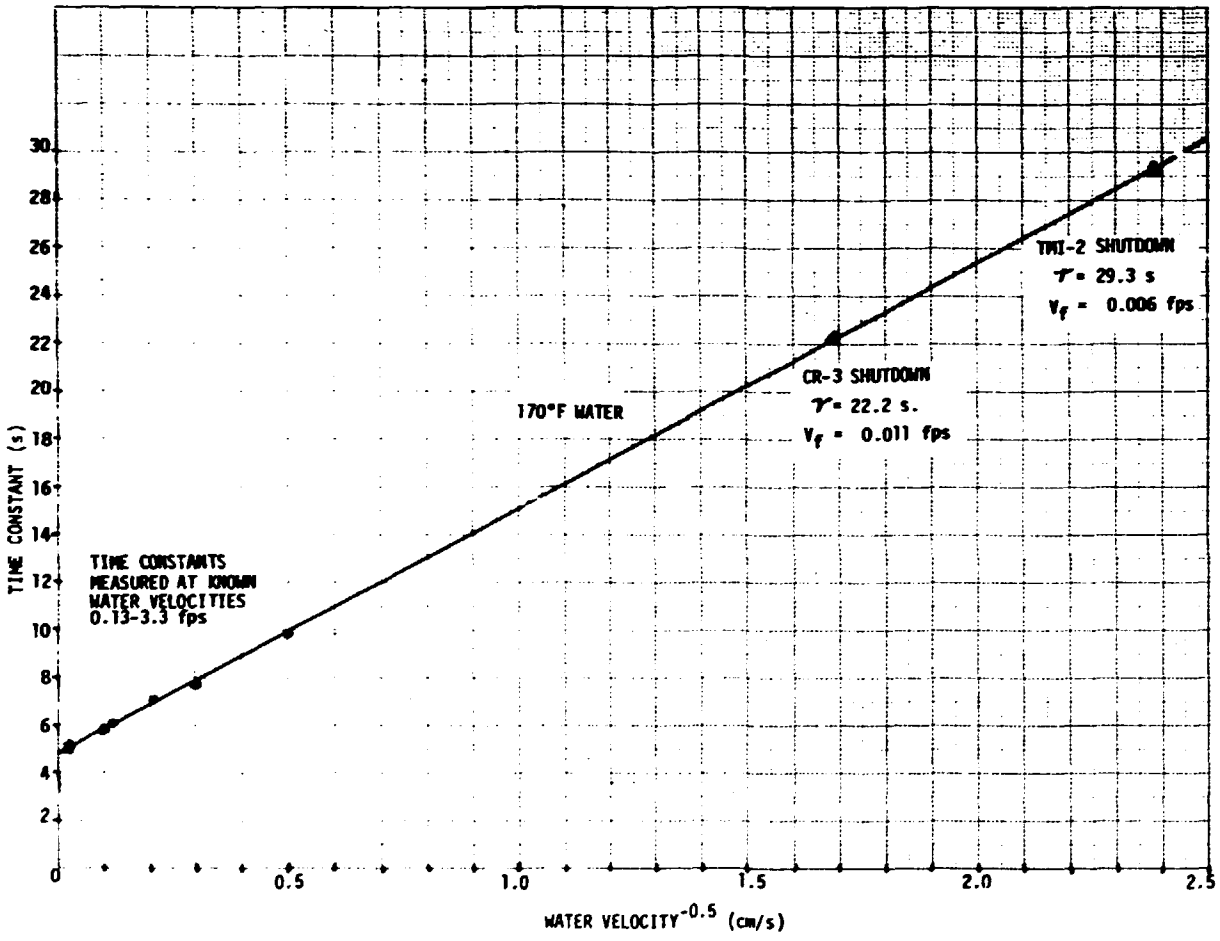
Figure 8. Estimates of still/natural circulation water flow velocities from PRT time response measured during shutdown in TMI-2 and CR-3.

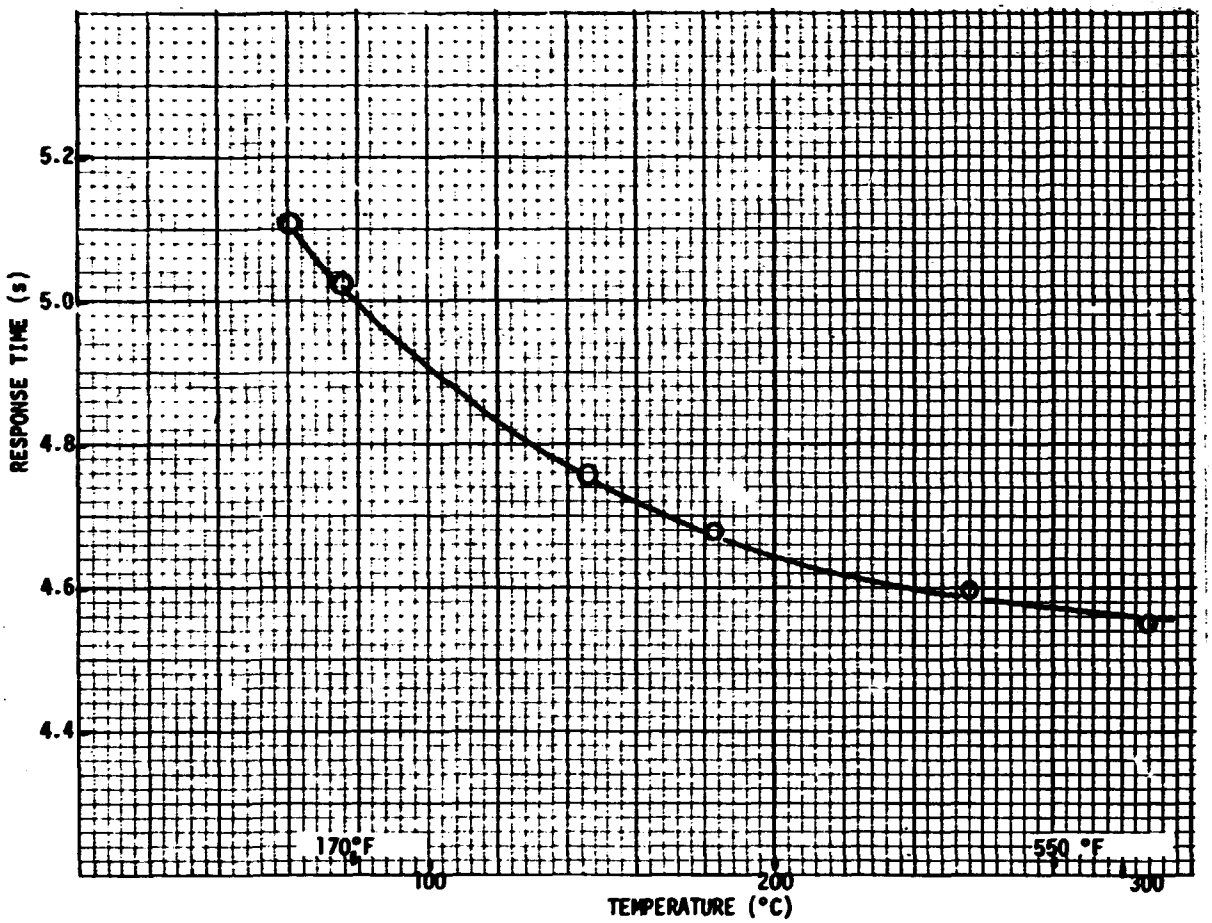
From Table 6 and Figure 9, the response time is seen to decrease as the temperature increases. If the GIT bath has the equivalent surface heat transfer of water at 40 to 80 fps, then at 585°F the response time would be 4.5 s. The response time at 550°F is obtained from Figure 9 and shown on Figure 7 for comparison to the measured response time in the CR-3 reactor.

Figure 9. Temperature dependence of response time of REC Model 177 HW PRT in thermowell when measured in GIT. (Equivalent to water at 170°F.)

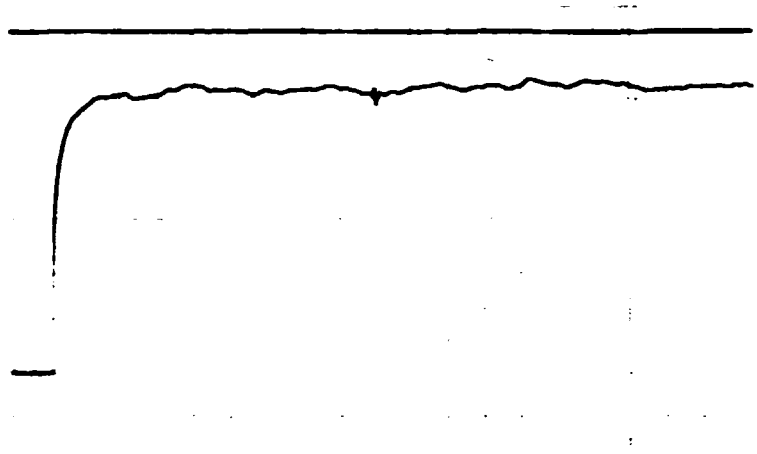
The LCSR test provided the in-service time constant of the RTDs and the self heating tests gave the self heating indices. Typical plots of raw data from LCSR and self heating tests are shown in Figures 1 and 2. A heating current of about 50 milliamperes was used to perform the LCSR tests. The LCSR test was repeated twenty times on each RTD. The twenty transients were averaged to obtain a smooth LCSR curve which was then analyzed to identify the time constant of the RTD tested. For the self heating tests, measurements were made at five different current levels ranging from about 10 to about 50 milliamperes.

Figure 1: A Typical LCSR Test Transient for a Crystal River RTD Tested At Full Power. Chart Speed: 1 mm/sec.

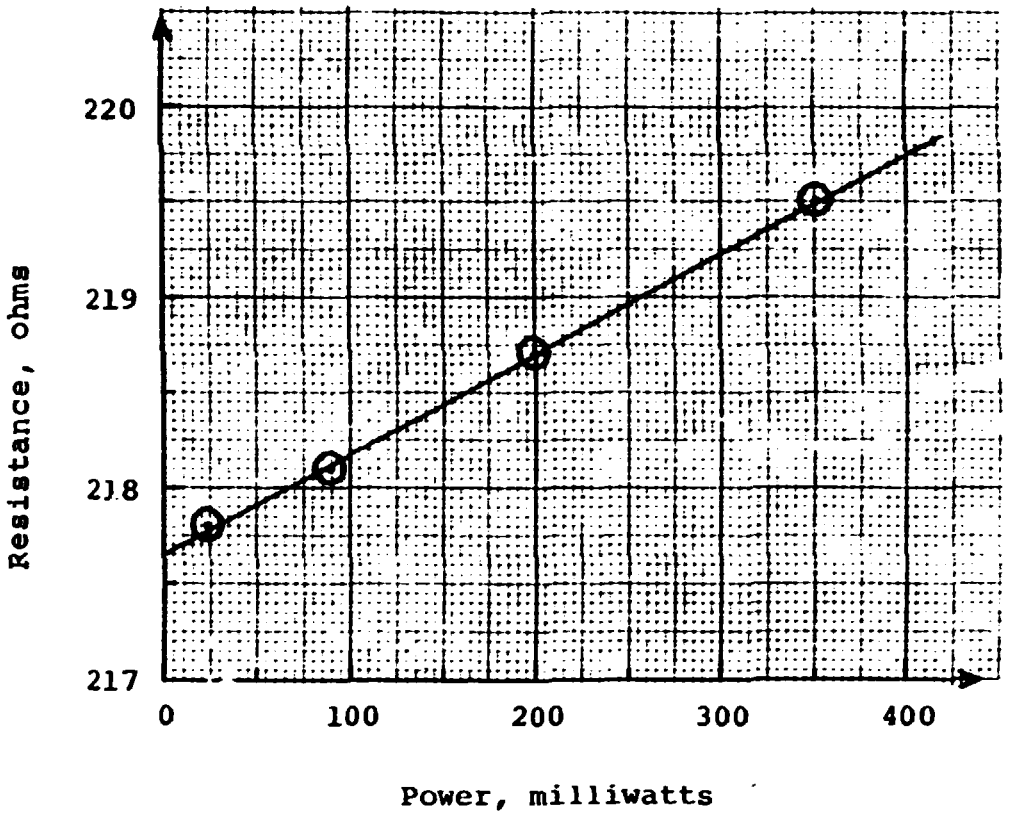
Figure 2: A Typical Self Heating Curve for a Crystal River RTD Tested at Full Power.

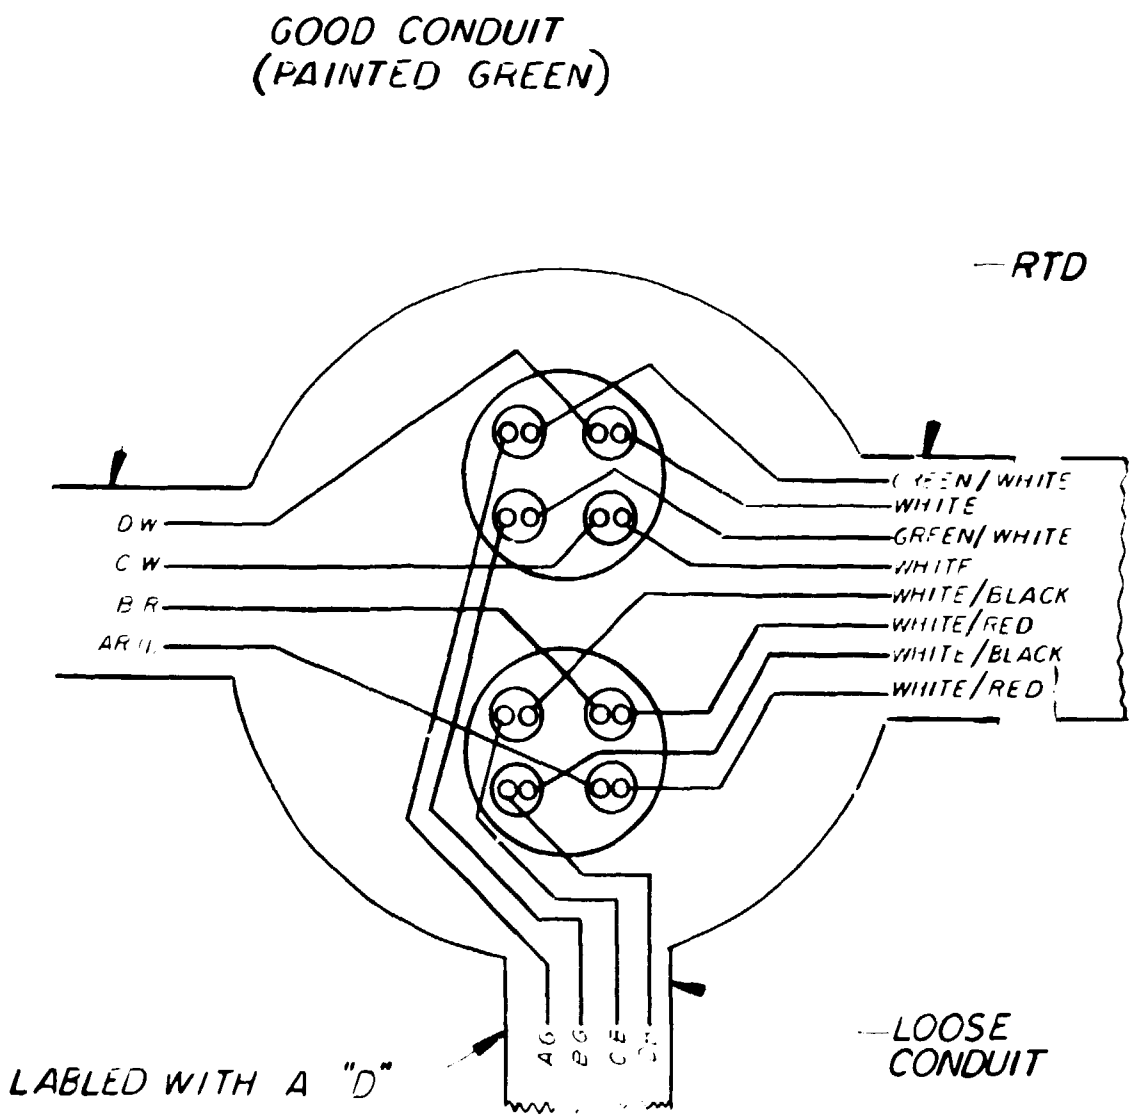
RTD WIRING
FIGURE 7a

Wiring in the connector head was as shown in Figures 7a and 7b.
