TMI-2 REACTOR COOLANT SYSTEM

SURFACE DEPOSIT EXAMINATION

TMI-2 REACTOR COOLANT SYSTEM SURFACE DEPOSIT EXAMINATION

January 1988

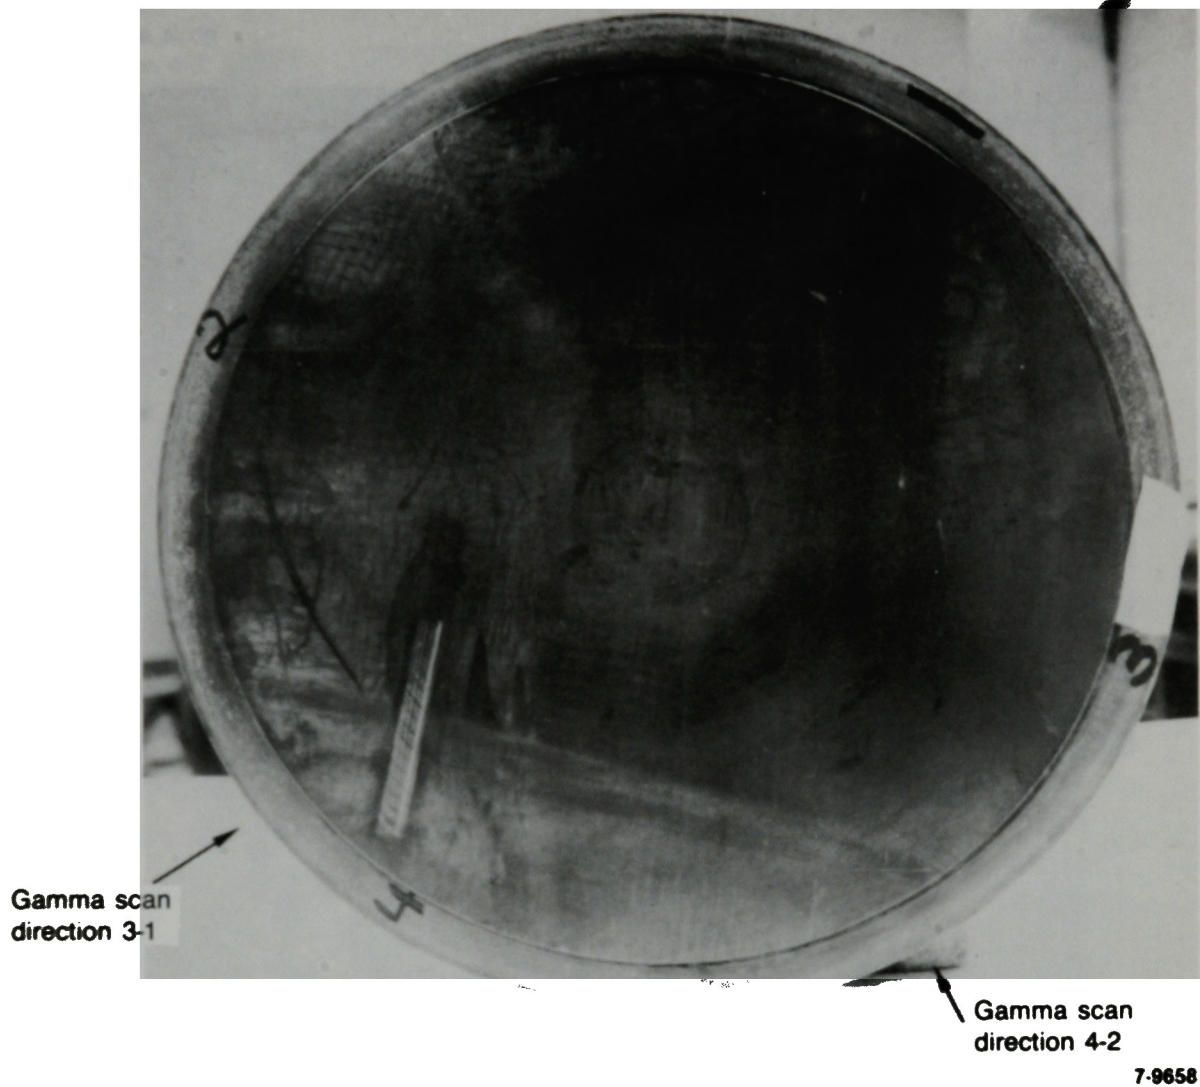
Figure 8.   View of active surface of Plate A.

The physical appearances of the samples varied. The manway backing plate from the A-loop steam generator and the handhole cover liner were similar in appearance. They were essentially gray with patchy white areas of surface deposition. The pressurizer manway backing plate sample was uniformly gray, and the manway backing plate liner from the B-loop steam generator was smooth and shiny. The RTD thermowell was remarkably different in appearance. The tip of the thermowell that extended into the coolant flow is orange.

Metallurgical examination of the manway backing plate samples indicated surface layers ranging from 0 to 12 μm. Although the A steam generator sample had the highest gamma scan activity, it had the thinnest surface layer. The surface layers found on the in-vessel leadscrew samples were much thicker, ranging to ~100 μm. The metallurgical examinations of the backing plate samples showed evidence of indium and tin in addition to the major constituents of the steel.

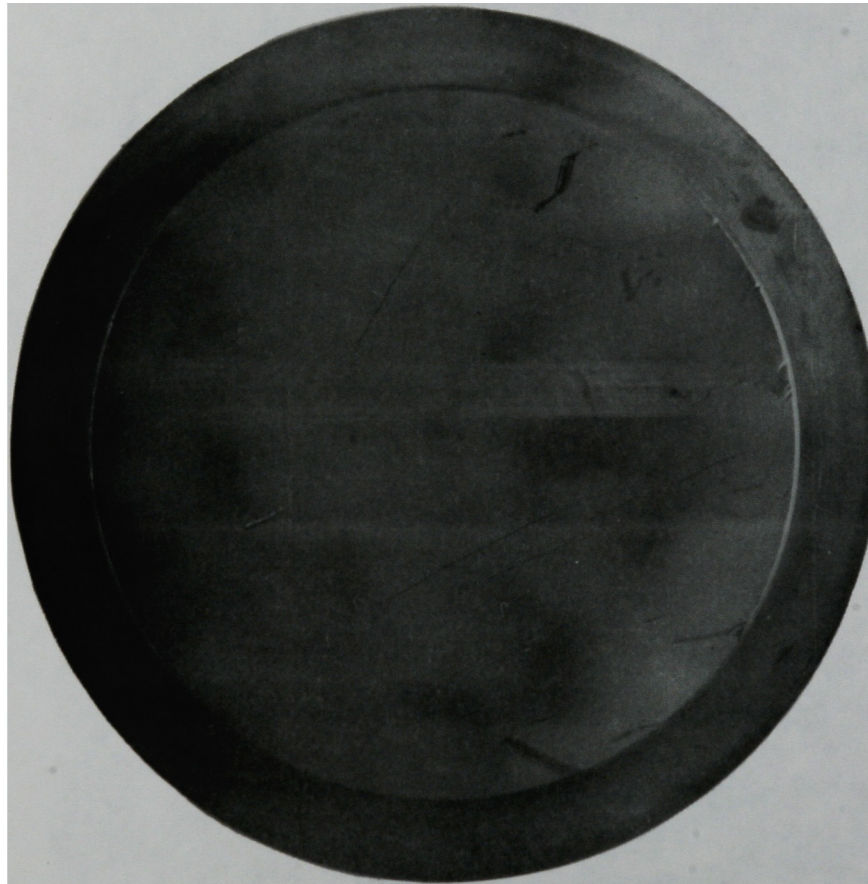
Figure 11. View of active surface of handhole cover liner.

The handhole cover liner was visually examined at the hot cell. The surface features were documented by means of black and white photographs, as illustrated in Figure 11. In general, the liner exhibited no unusual features on its active surface. The surface appeared to be covered by a uniform gray surface layer with patchy dark and light areas. These features are similar to those observed on Manway Cover Backing Plate A.

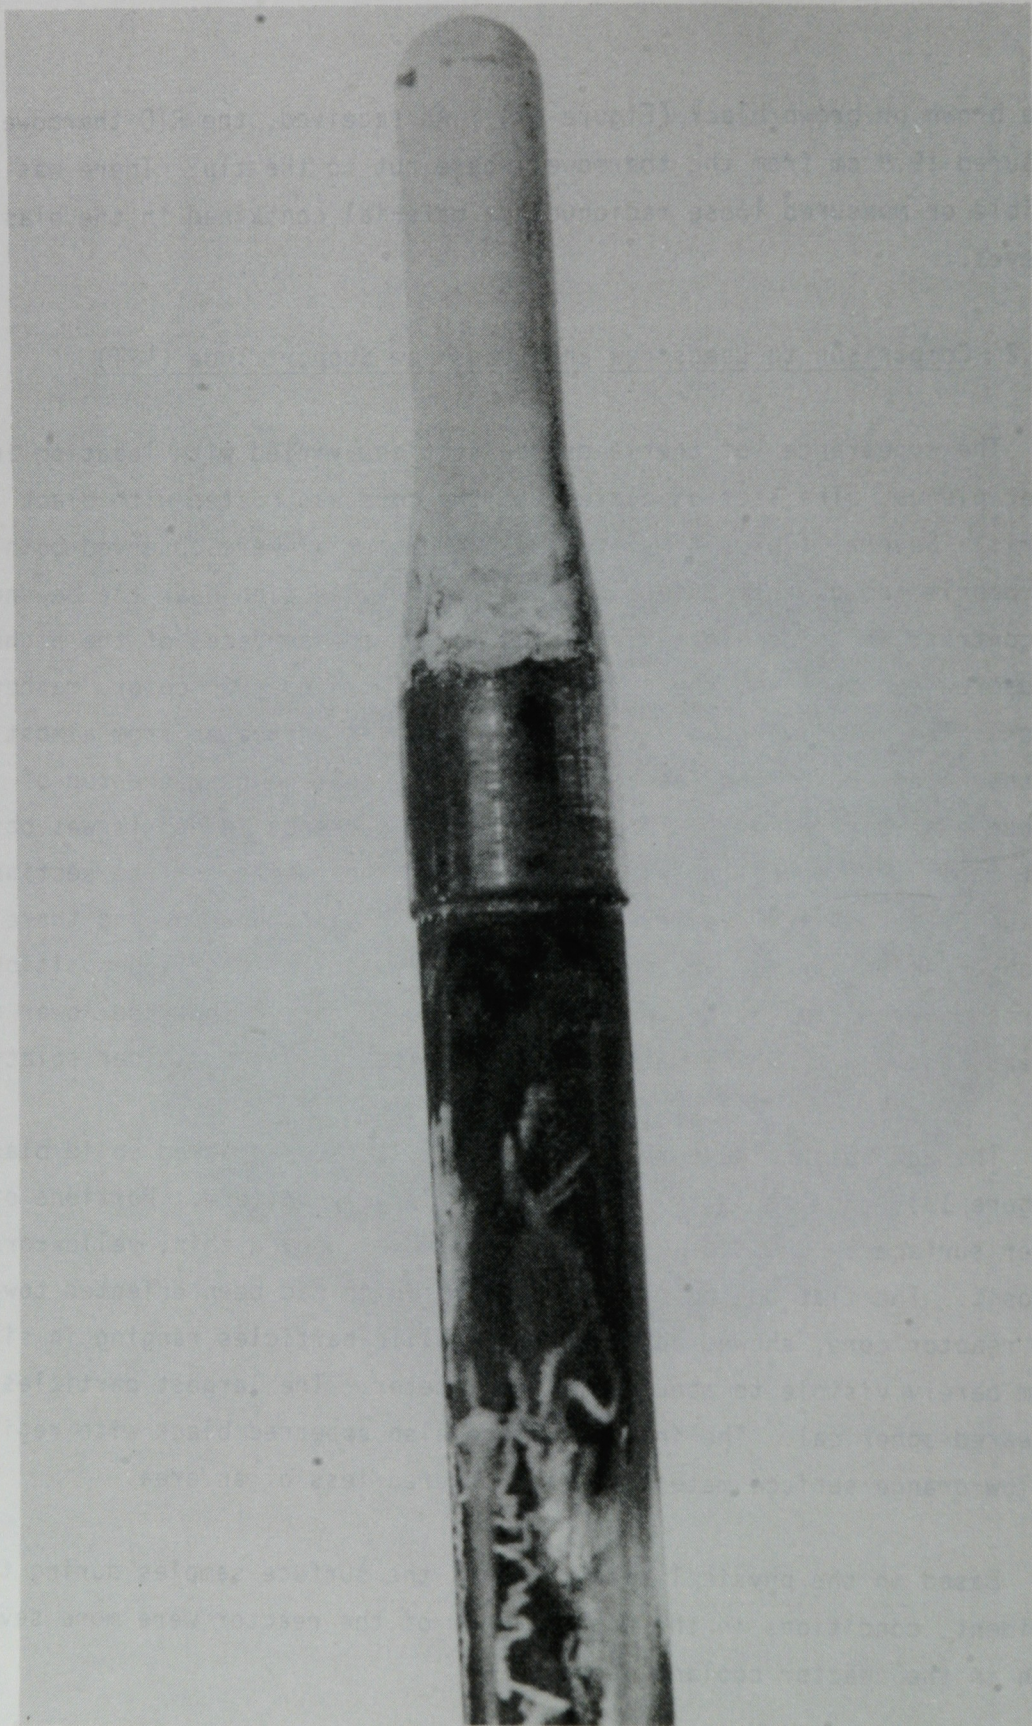
Figure 12. Overall view of the RTD thermowell.

were brown or brown/black (Figure 12). As received, the RTD thermowell measured 19.9 cm from the thermowell base nut to the tip. There was no visible or measured loose radionuclide material contained in the plastic sleeves.

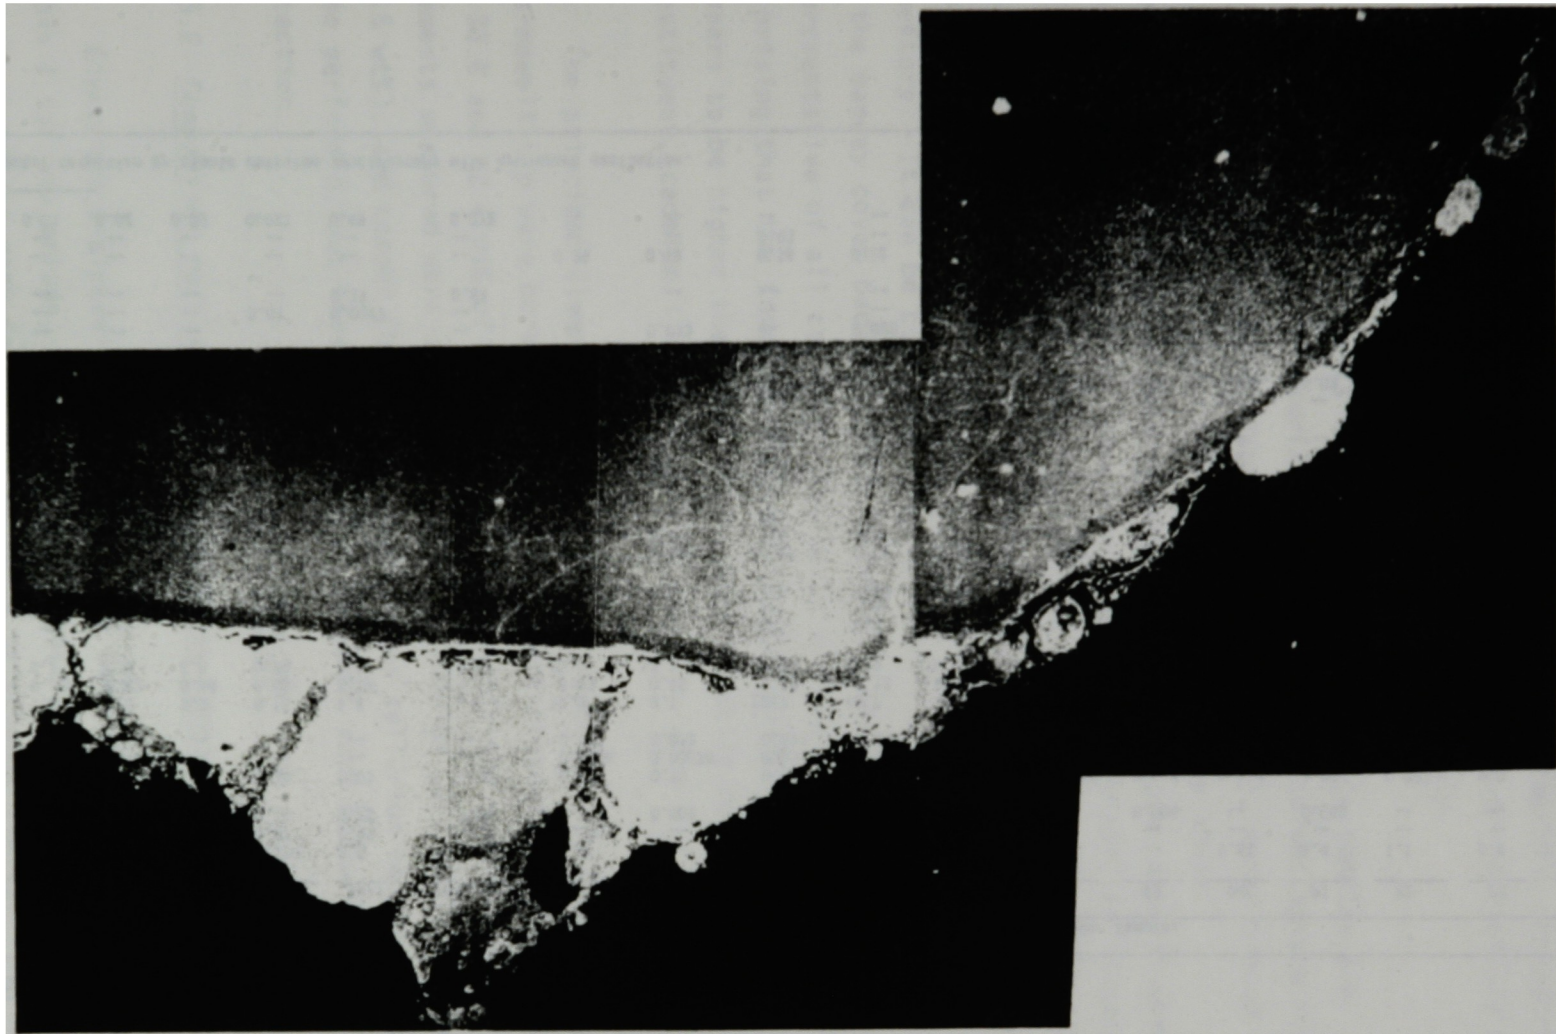
Figure 17. Appearance of the bright metallic globules at bottom end
of the LST section.

Only two surface layers were identified on the leadscrew support tube: an inner adherent layer and an outer loosely adherent layer. Unlike the leadscrews, which are made of Type 17-4 pH stainless steel, the support tube is made of 304 stainless steel. The loosely adherent layer varied widely in thickness. The adherent layers on the inside and outside surfaces of the annular tube were quite similar (ranging in thickness from 15 to 30 m and from 15 to 40 m, respectively) but the loosely adherent layer on the outside of the tube was better defined and thicker than on the inside surface (4 to 35 μm compared to 0 to 20 m on the inside surface). Metallic globules were also found on the outside of the tube but not on the inside surface. As indicated in Figure 17, the end of the tube facing the core had a large number of metallic globules. The globules were primarily composed of silver, indium, and some cadmium.[6]

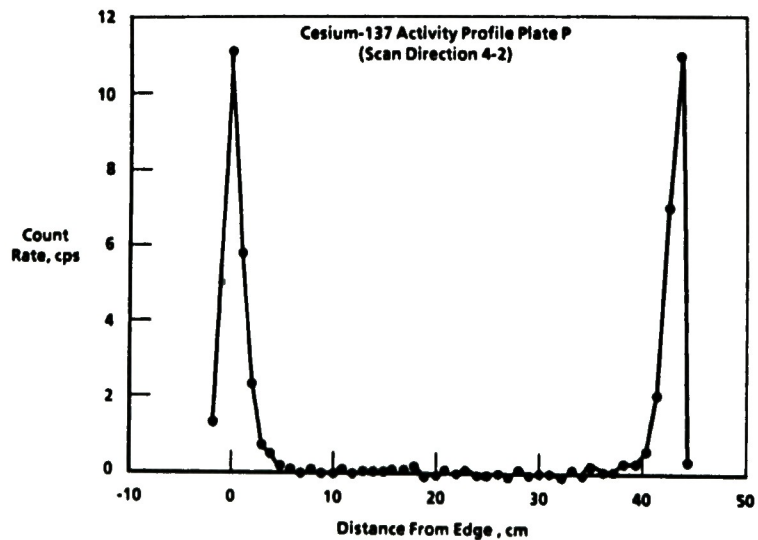
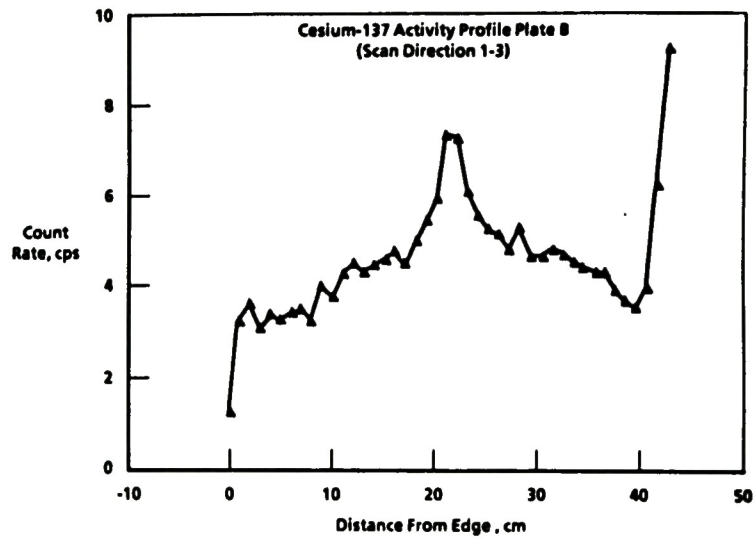
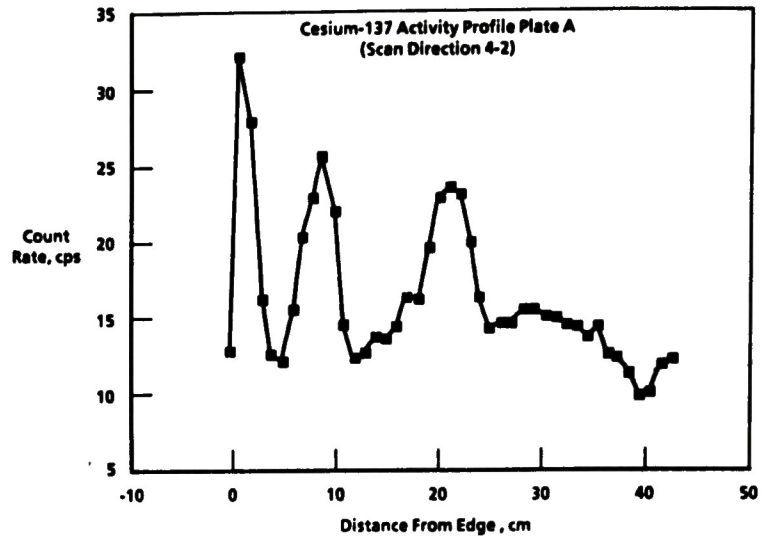
Figure 18. CS-137 activity profile of manway cover Plates A, B, and P.

The relative Cs-137 activity is plotted in Figure 18 as a function of distance from the edge of the manway cover Plate A (initial gamma scans had shown the surface activity to contain mainly Cs-137 with very minor amounts of Co-60 and Cs-134 present). Results for Plates B and P are also shown in Figure 18. The Cs-137 activity profiles show very low count rate for all scans except near the edges of the plates. In fact, Plate P shows significant Cs-137 activity only within 1 cm of the edge; the activity profile goes to near zero across the remaining surface. Plate B, on the other hand, exhibits a Cs-137 profile very similar to that obtained on Plate A, although the overall count rate was approximately five times lower tnar on Plate A.

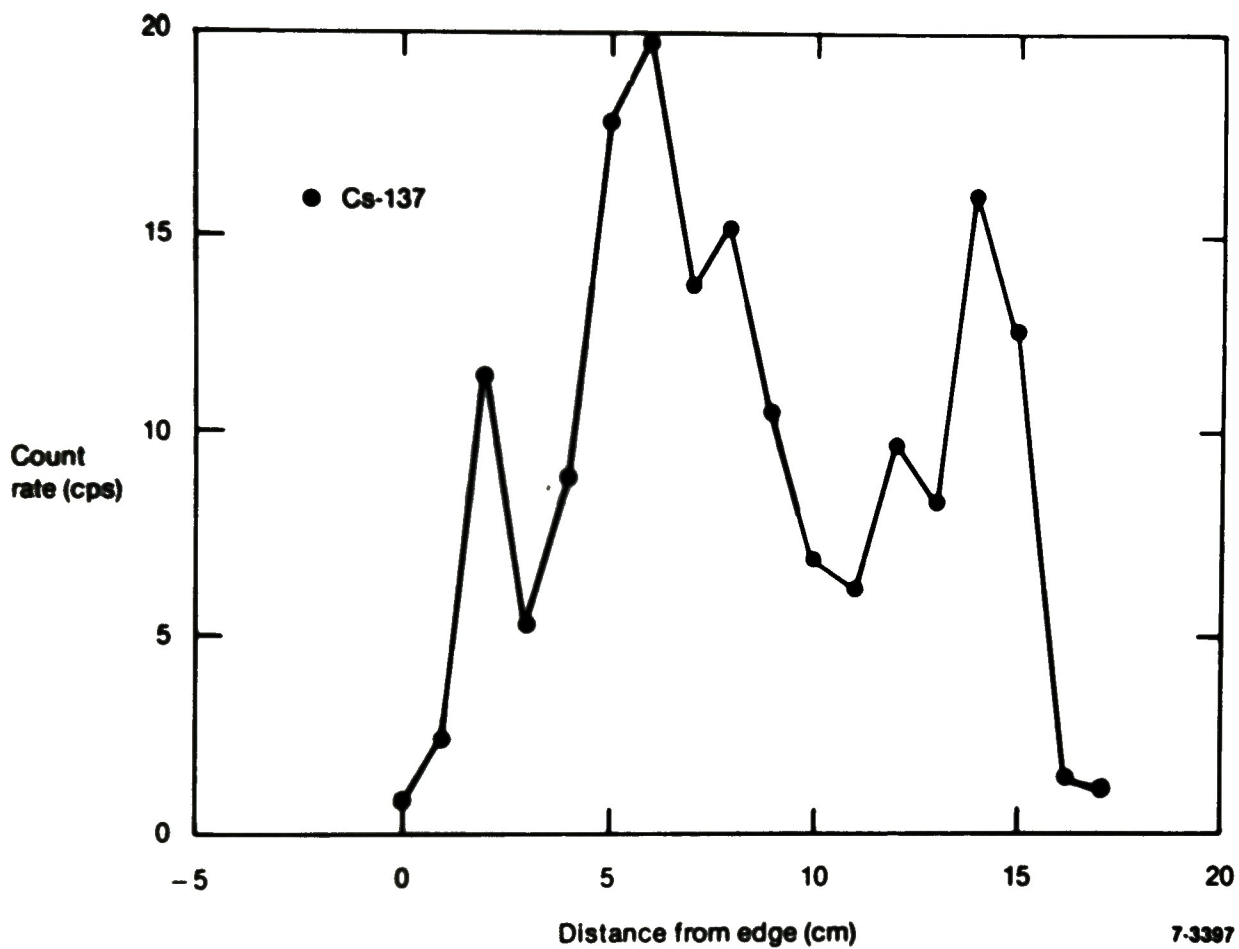
Figure 19. Activity profile of A-loop steam generator handhole cover liner.

Gamma scans were performed on the nandhole cover liner. The results are shown in Figure 19. The Cs-137 activity profile shows an uneven distribution across the liner surface, although there does appear to be a slight increase in activity near the edges of the liner. This Cs-137 activity distribution appears to be somewhat similar to that obtained previously on the manway cover backing Plate A.

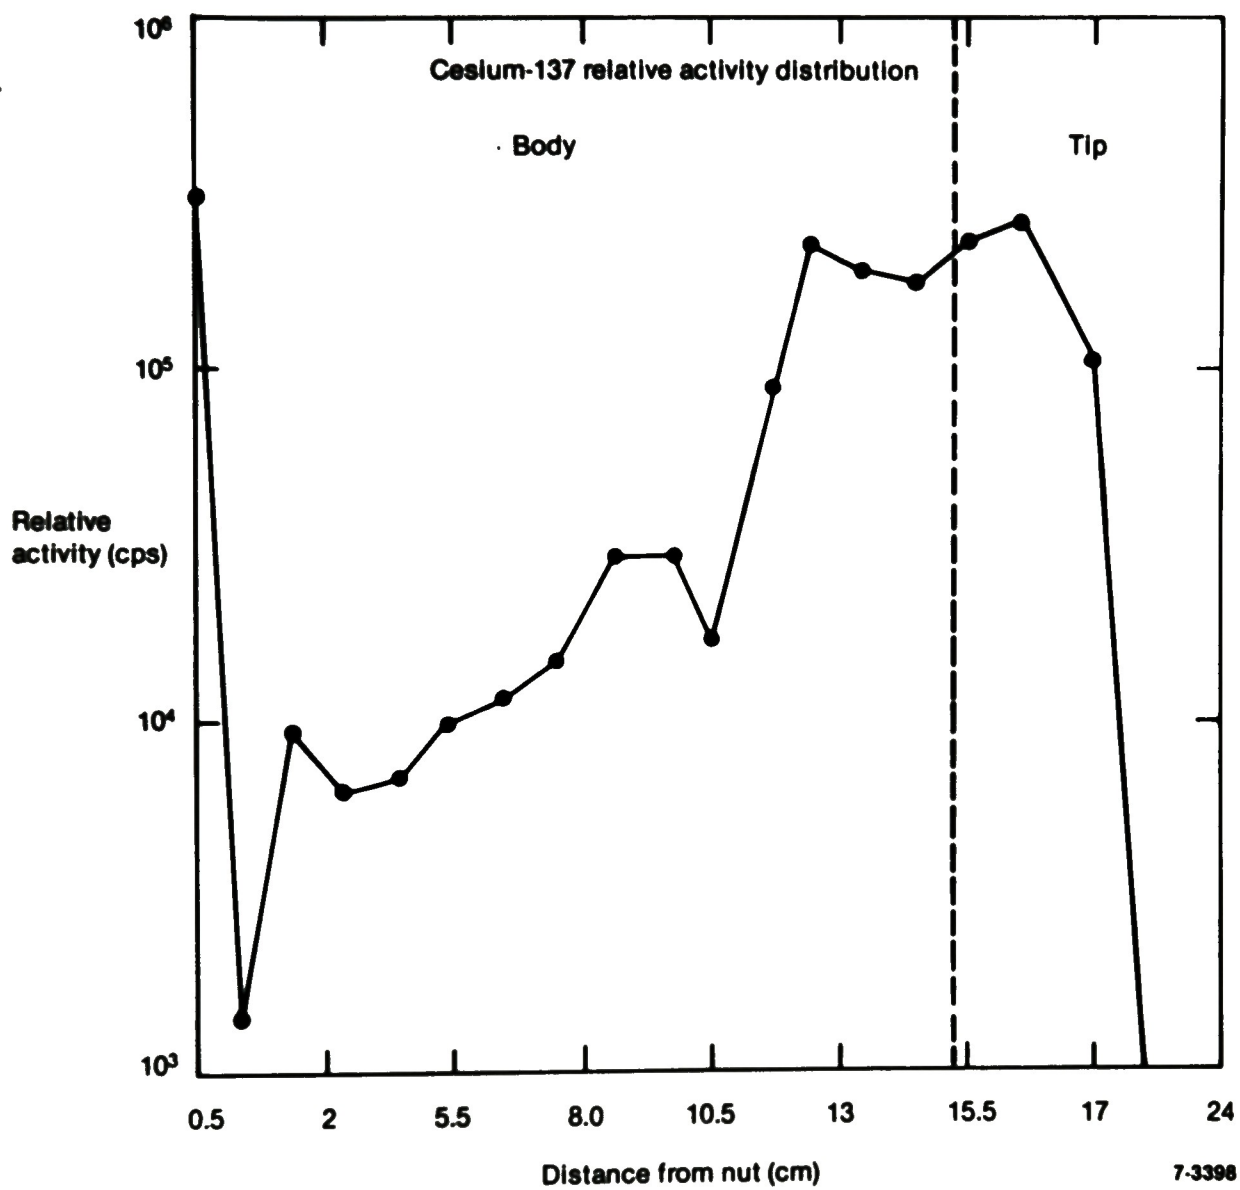
Figure 20.   CS-137 activity profile RTD thermowell.

The surface activity of the RTD thermowell is also shown in Table 6. The measured values for most of the radionuclides (I-129 is the exception) are higher than for the steam generator coupons, which is to be expected because the RTD thermowell was closer to the core.

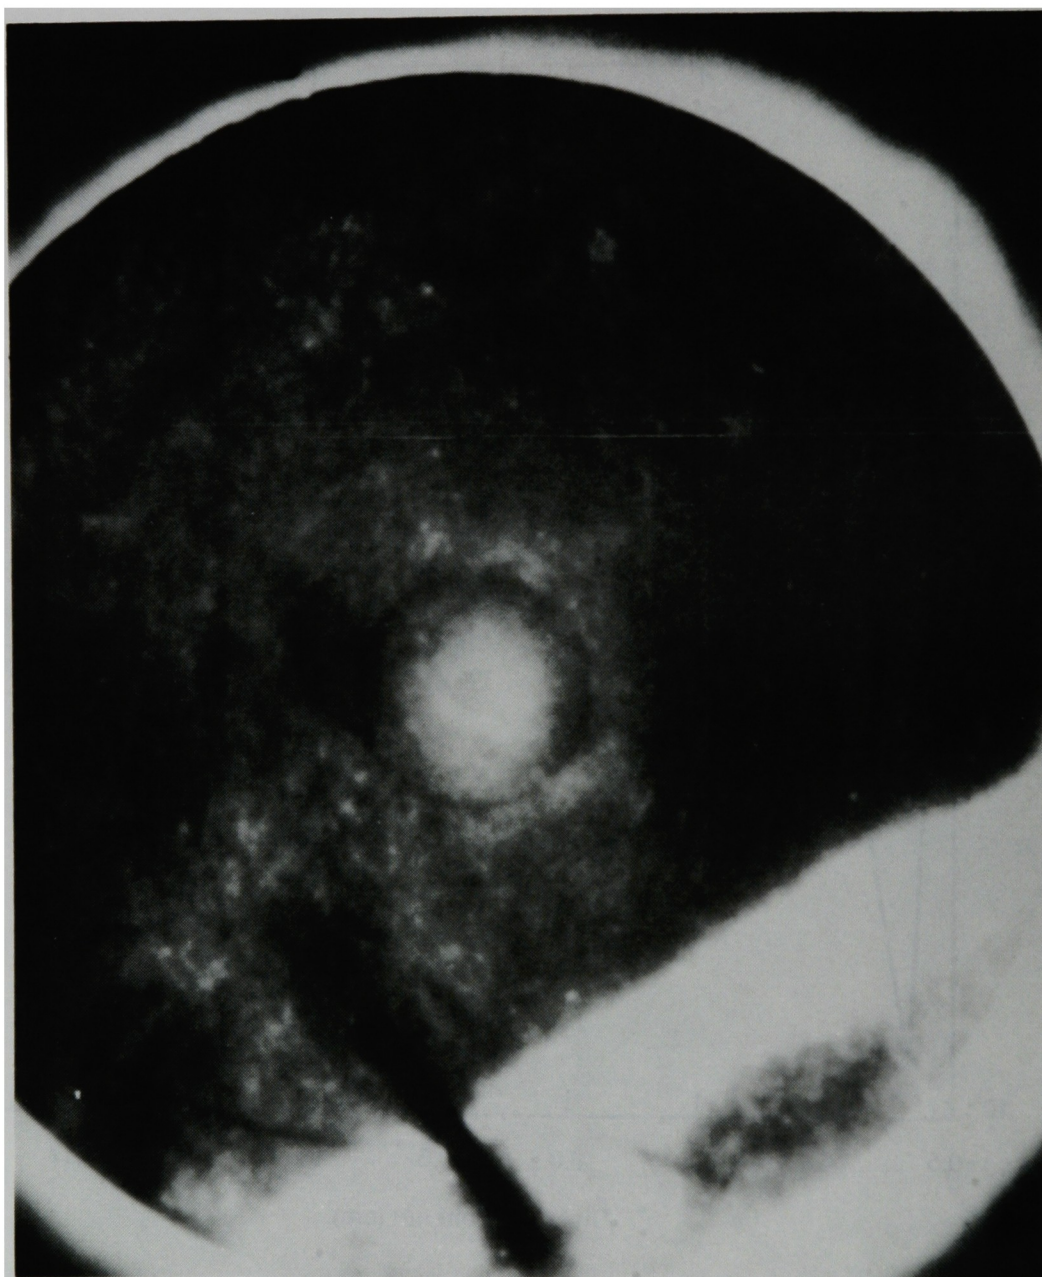
The autoradiographs of the manway cover backing plates are shown in Figures 21, 22, and 23. Very little gamma activity is evident in the autoradiographs, which is not surprising since the gamma scans had previously shown very little activity on the surface of the plates. Closer inspection of the radiographs reveals that the gamma activity is uniformly distributed over the surface, in agreement with the results of the gamma scans. The Plate P radiograph shows significant gamma activity only at the very edges of the plate.

Figure 21. Autoradiograph of Plate A.

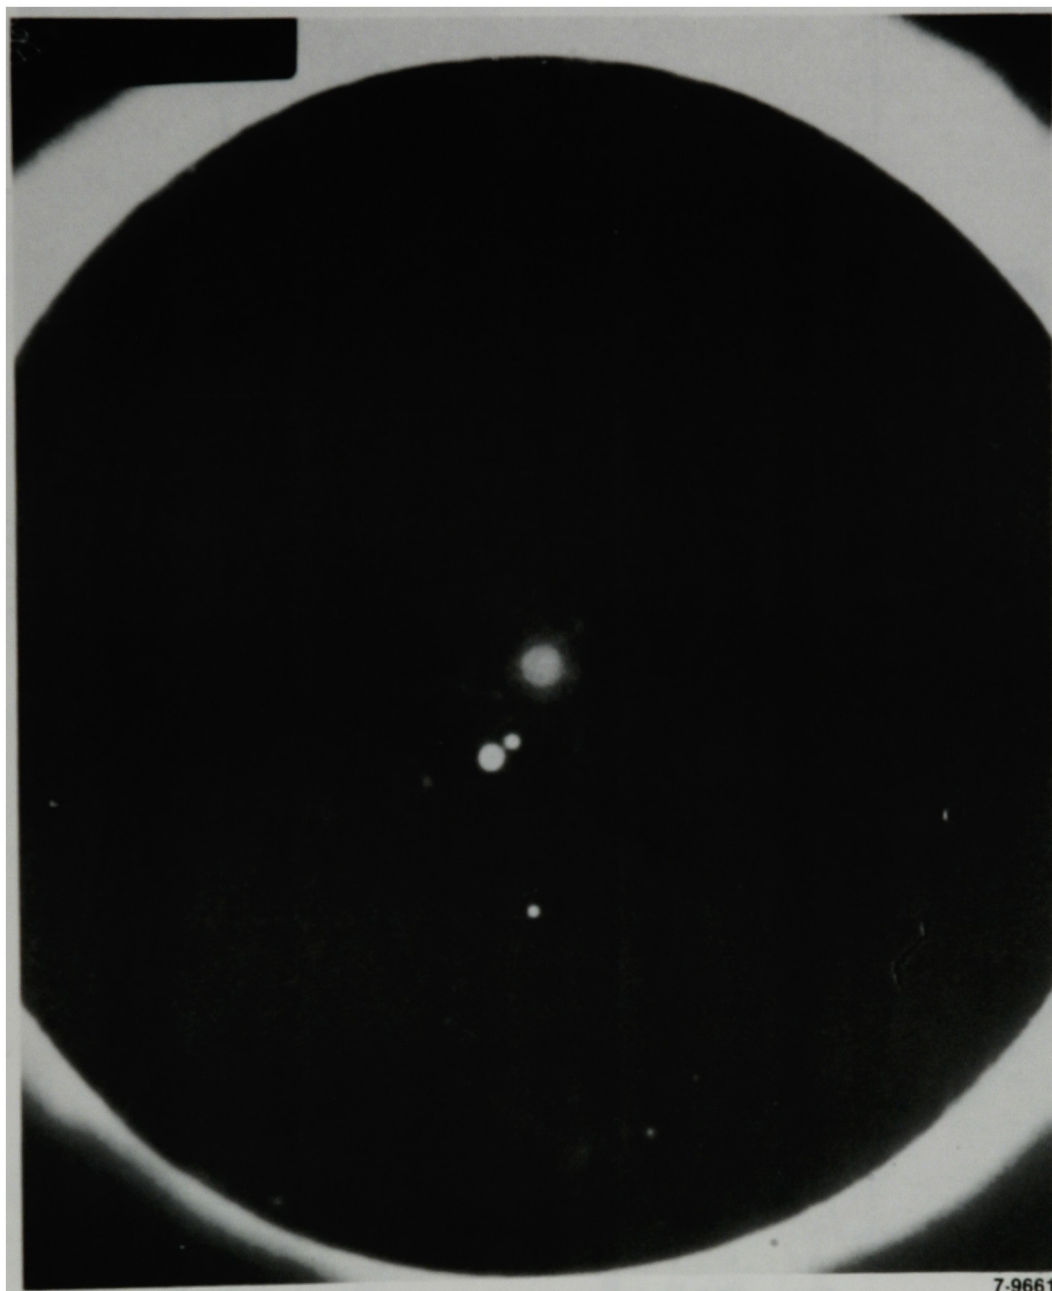
Figure 22. Autoradiograph of Plate B.

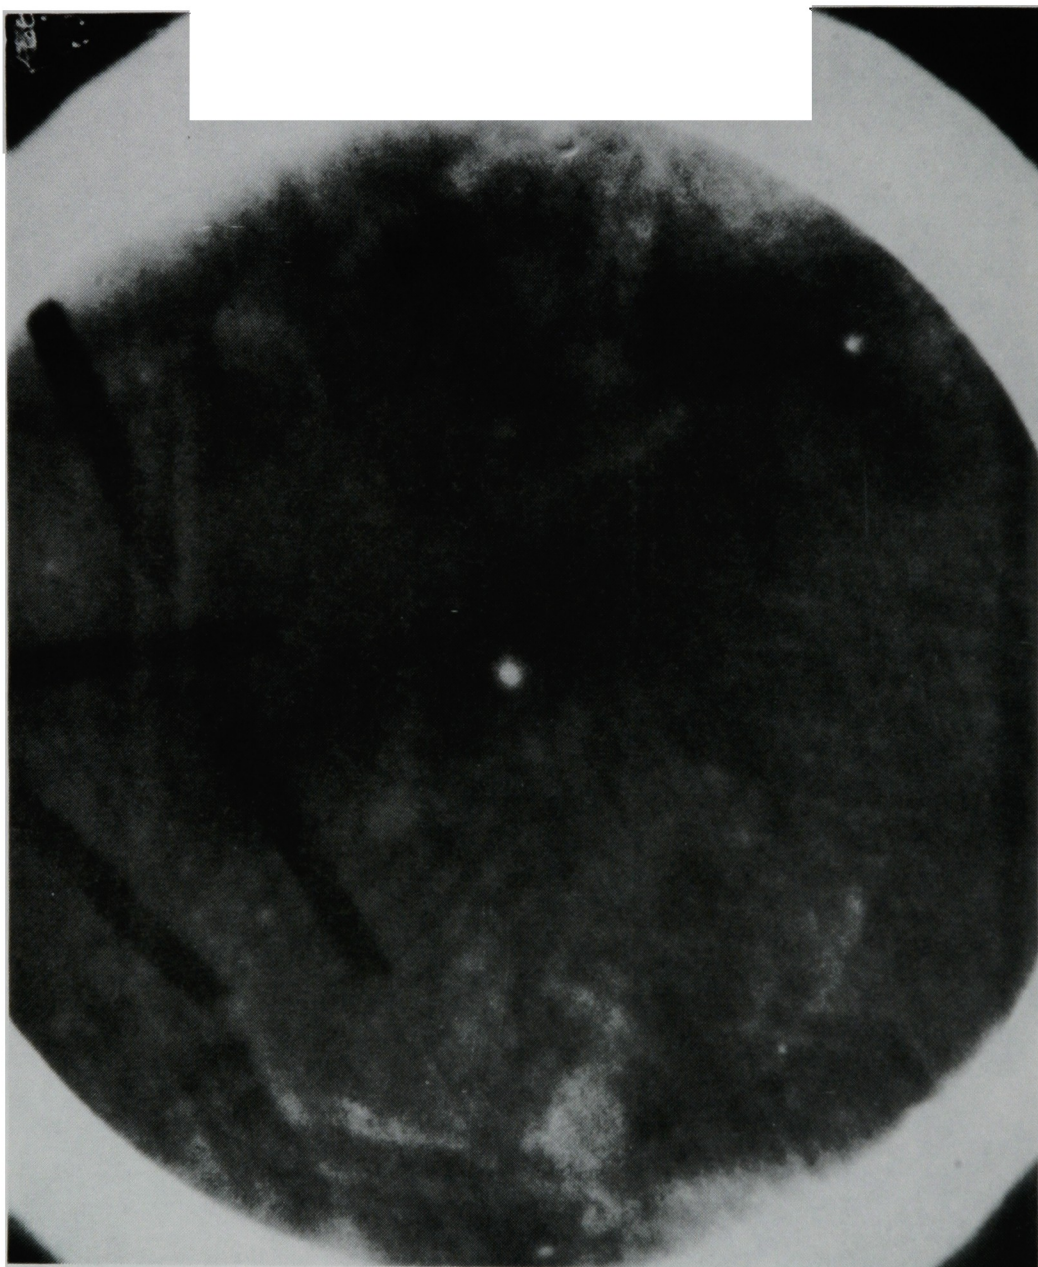
Figure 23. Autoradiograph of Plate P.
