INEEL/EXT-99-00669

June 1999

# Identification of the Specific Mechanism by which the CO<sub>2</sub> System in Building TRA-648 Accidentally Discharged

**Lockheed Martin Idaho Technologies Company  
Idaho Falls, Idaho 83415**

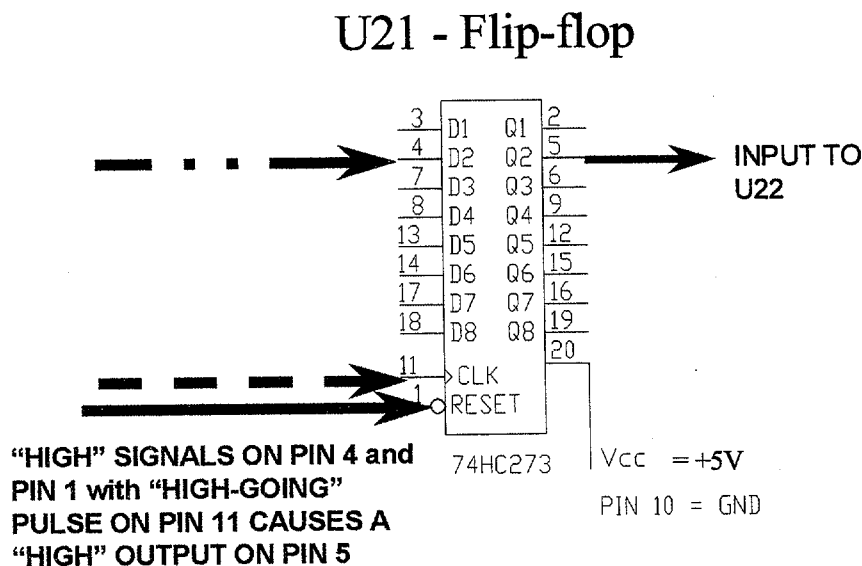
**Figure 2-3.** Operation of U21 flip-flop circuit

The operation of relay K2 is controlled by semiconductor chips labeled U21 and U22. Chip U21 is a 74HC273 Octal D flip-flop with common clock and reset, high performance silicon-gate CMOS logic chip. Operation of a flip-flop circuit in U21 is depicted in Figure 2-3.<sup>7</sup>

To activate a bell circuit, a high signal must exist on an input data pin of U21, simultaneously with a high signal on Pin 1 of U21, and simultaneously with a high-going pulse on Pin 11 of U21. With these three high pulses present, the voltage on the related output pin of U21 will go high and stay high until chip U21 is reset. In other words, the circuit latches. The high output signal from U21 is applied to the connected input pin of U22 causing the related transistor in U22 to operate. Key points of the U21 flip-flop chip include:

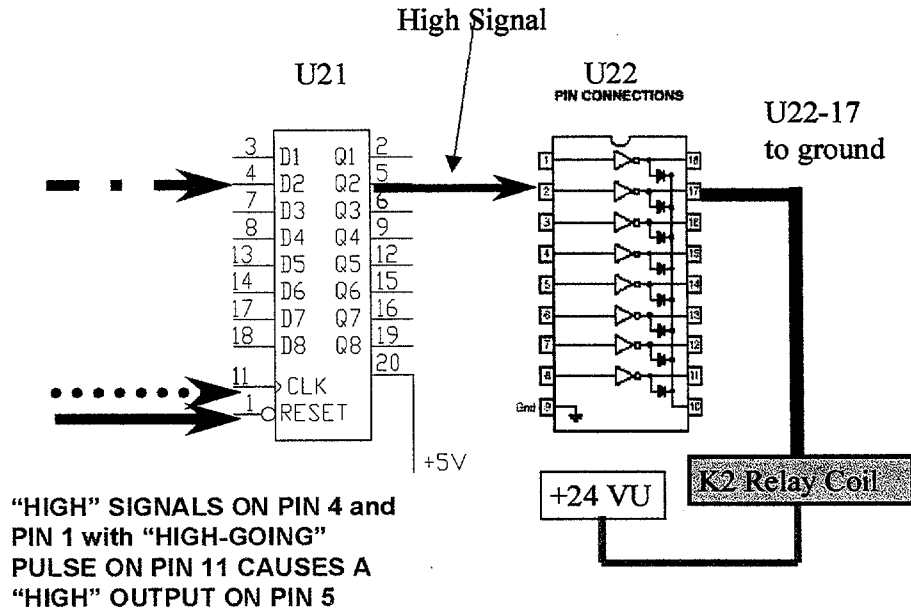
**Figure 2-4.** U21 and U22 activate Bell Circuit 2.

Figure 2-4 shows U21 and U22 activating Bell Circuit 2. High signals at U21 provide the input signal to U22. The U22 output lead is connected to ground. Current flows through the relay coil and the relay operates.

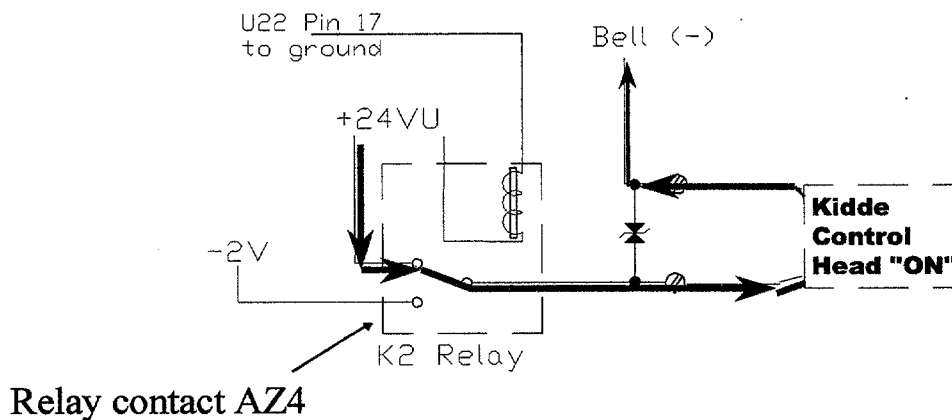
**Figure 2-5.** Relay K2 is energized activating Bell Circuit 2.

Figure 2-5 shows Bell Circuit 2 activated. When the Darlington transistor in U22 operates, Pin 17 pulls one side of the K2 relay coil to ground while the other side of the relay coil is connected to +24 volts (+24 VU). The coil is energized and the AZ4 relay contact is transferred. Terminal TB2.3 is now connected to +24 VU and the solenoid coil in the Kidde control head on Bell Circuit 2 is energized.

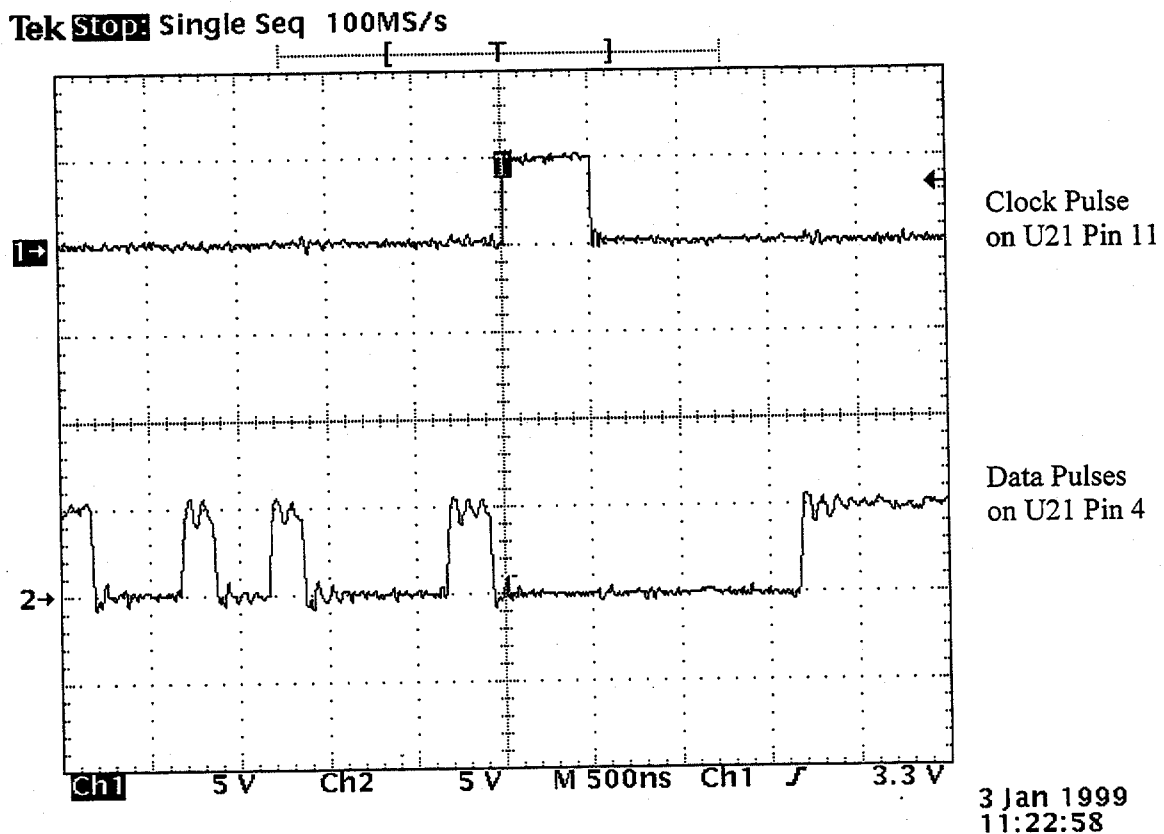
**Figure 2-6.** Oscilloscope recording of typical pulses in a normal (no alarm) condition.

**2.2.2.1 Normal Standby Operation.** Figure 2-6 is a recording of pulses from the clock pin (Pin 11) of U21 and a data pin (Pin 4) of U21. These pulses are typical of those recorded when the AFP-200 panel is in normal, standby operation with no alarm. The high-going clock pulses occur every 250 milliseconds but do not occur simultaneously with the data pulses.<sup>8</sup>

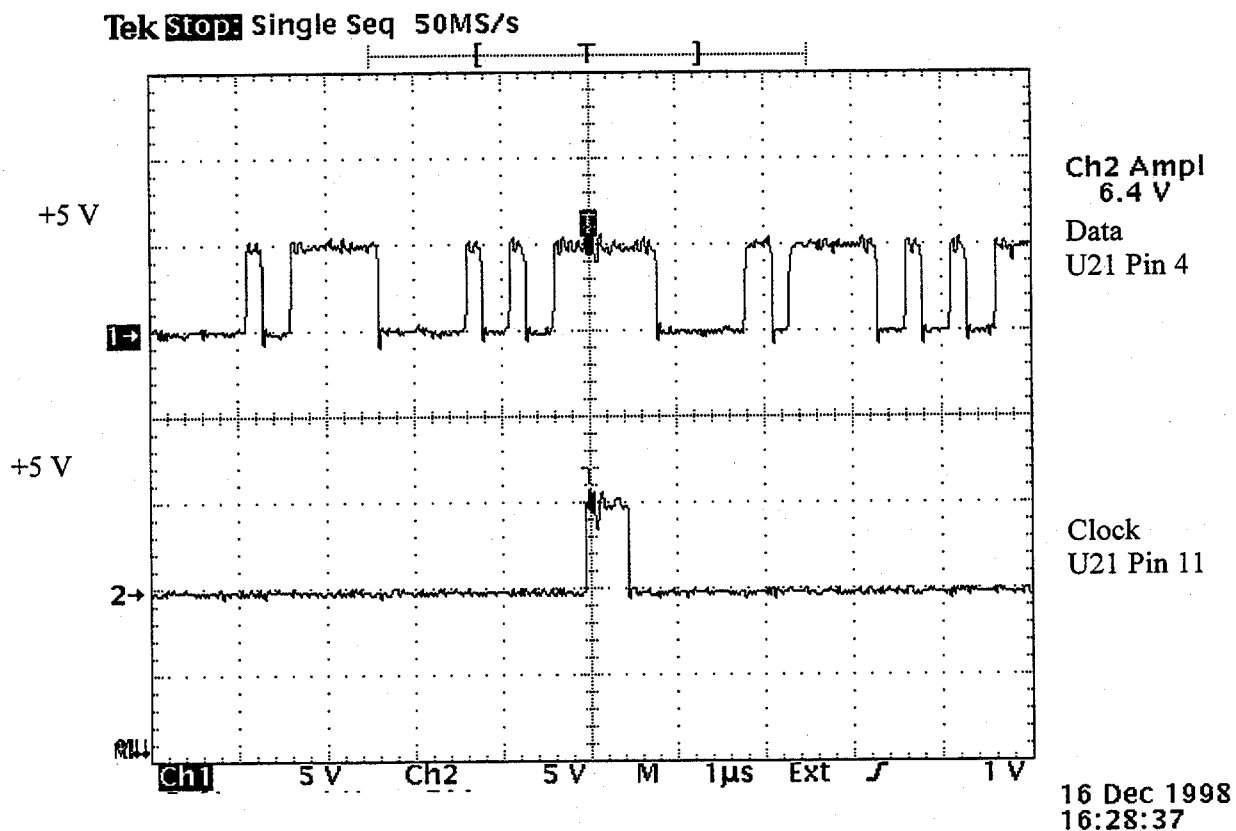
**Figure 2-7.** Oscilloscope recording of pulses during activation of Kidde electric release heads initiated by operation of a manual station.

Figure 2-7 is a recording of pulses on the clock pin (Pin 11) of U21 (lower trace) and a data pin (Pin 4) of U21 (upper trace). These pulses are typical of those recorded as a manual station or detection device activates a bell circuit. Note that the high-going clock pulse occurs simultaneously with a data pulse. Also note that the peak voltage on the pulses is approximately 5 volts. The reset pin of U21 (Pin 1) is also high and a high signal on the associated output, Pin 5, of U21 results. The transistor connected to Pin 17 of U22 operates, energizing Relay K2 to energize Bell Circuit 2. These pulses were recorded when the bell circuit was activated by operation of a manual station connected to the TRA-648 fire alarm control panel.

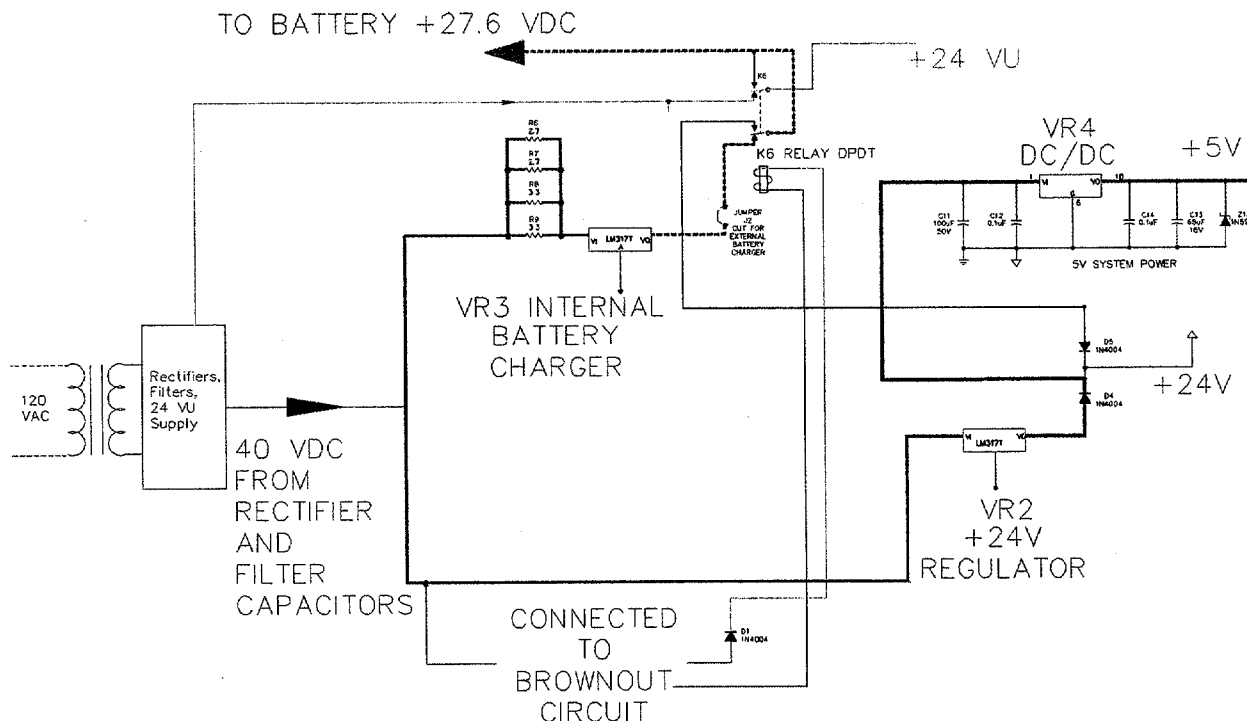
**Figure 2-12.** Simplified diagram of internal power supply section of AFP-200 panel.

**2.2.3.2 AFP-200 Power Supply Circuit.** If the required capacity of the standby batteries for the AFP-200 fire alarm system does not exceed 20 amp hours, the internal battery charger in the AFP-200 panel may be used. This arrangement is depicted in Figure 2-12. The components essential to the current discussion are included.<sup>14</sup> This figure shows the power supply condition with 120 volts AC power connected to the AFP-200 panel.

A power transformer reduces the 120 volts AC voltage, and sets of rectifiers convert the low voltage AC to DC. Some of the DC is filtered and supplied to the input side of voltage regulators VR2 and VR3. In Figure 2-12, this voltage is labeled "40 VDC FROM RECTIFIER AND FILTER CAPACITORS."

Voltage Regulator VR3 regulates the nominal 40 volts DC to approximately 27.6 volts DC and provides charging current to the standby batteries. This charging current is depicted by the line labeled "TO BATTERY" in Figures 2-12 and 2-13.

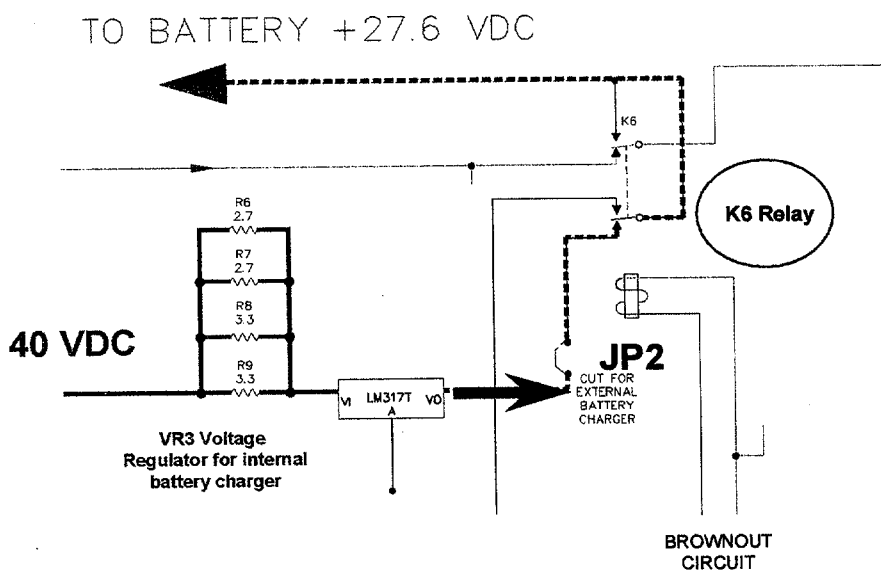
**Figure 2-13.** Enlarged view of the internal battery charger circuit.

Figure 2-13 is an enlarged view of the internal battery charger circuit showing the battery transfer relay K6 in an energized condition (sufficient AC power connected).

**2.2.3.3 Brownout Circuit.** When nominal 120 volts AC is supplied to the control panel, the brownout circuit keeps relay K6 energized. This condition is shown in Figure 2-13. If AC line voltage falls to an unacceptably low level (approximately 100 volts or 85% of the nominal rated voltage), a brownout circuit acts to de-energize relay K6 and permit its contacts to transfer. When K6 is deenergized, the relay contacts connect the standby battery to the internal power supply circuits in the AFP-200 panel.

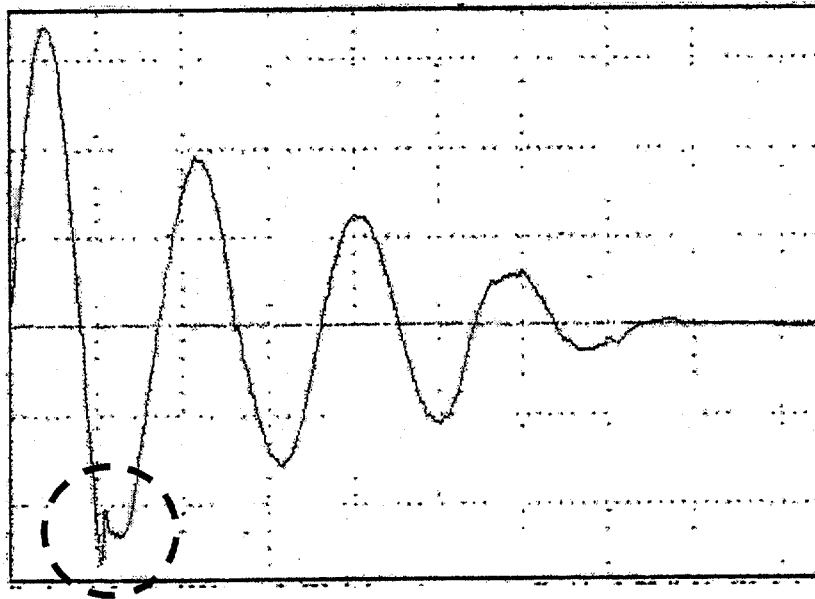
**Figure A-2.** Waveform during activation.

Based on preliminary information in the Investigation Report, the unintentional solenoid activations were thought to be caused by AC power transients. The hypothesis was tested by reproducing the power waveform recorded during the first successful reenactment. Figure A-2 shows the waveform recorded during the first successful reenactment of the activation.

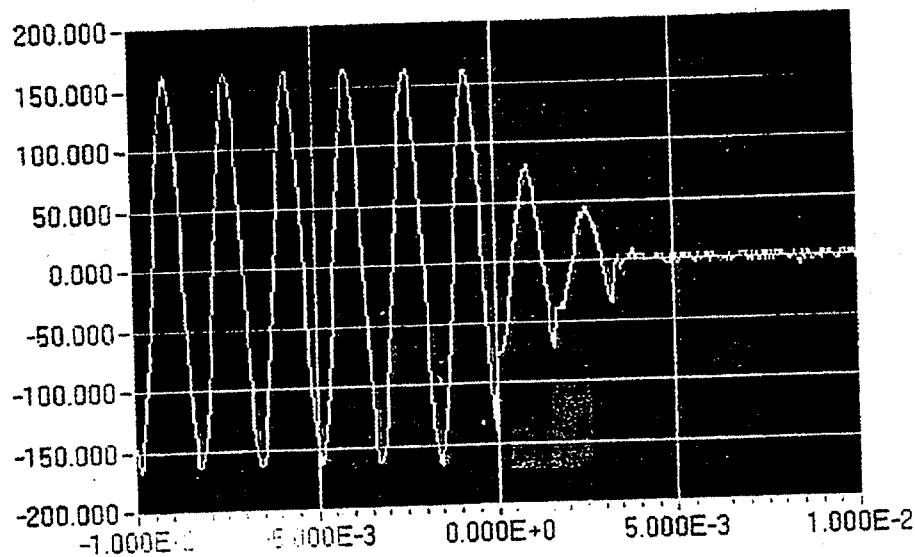
**Figure A-3.** Injected waveform.

The fire alarm control panel was repeatedly powered-down by the programmed injected waveform shown in Figure A-3, and variations of this waveform involving:

1. The position in phase at which the dropout occurs
2. The level and number of cycles that occur during the power-down
3. The presence of 500-volt spikes or surges on the waveform.

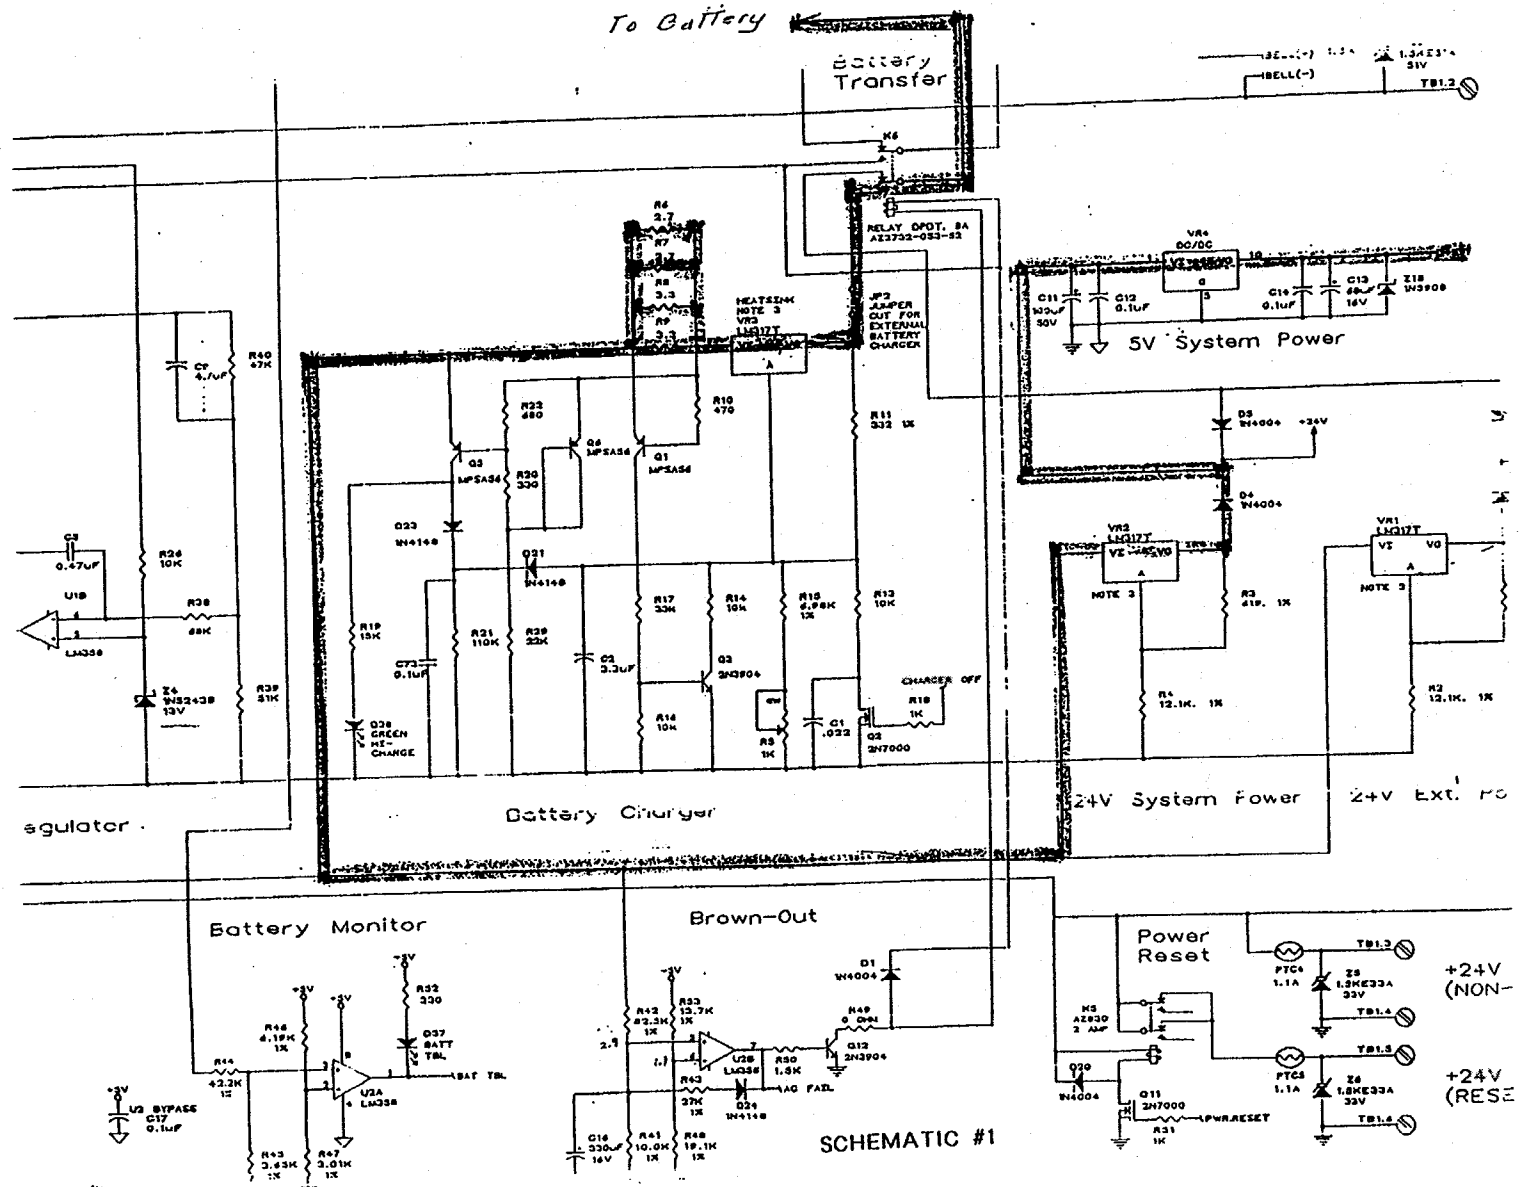
Figure B-1. Circuit analysis schematic.

With Jumper JP2 cut, the fire control system can falsely actuate the release solenoids.
