FINAL REPORT
OF
SL-1 RECOVERY OPERATION

SL-1 Project
Idaho Test Station
General Electric Company
July 27, 1962

United States Atomic Energy Commission
Contract No. AT (10-1) 1095

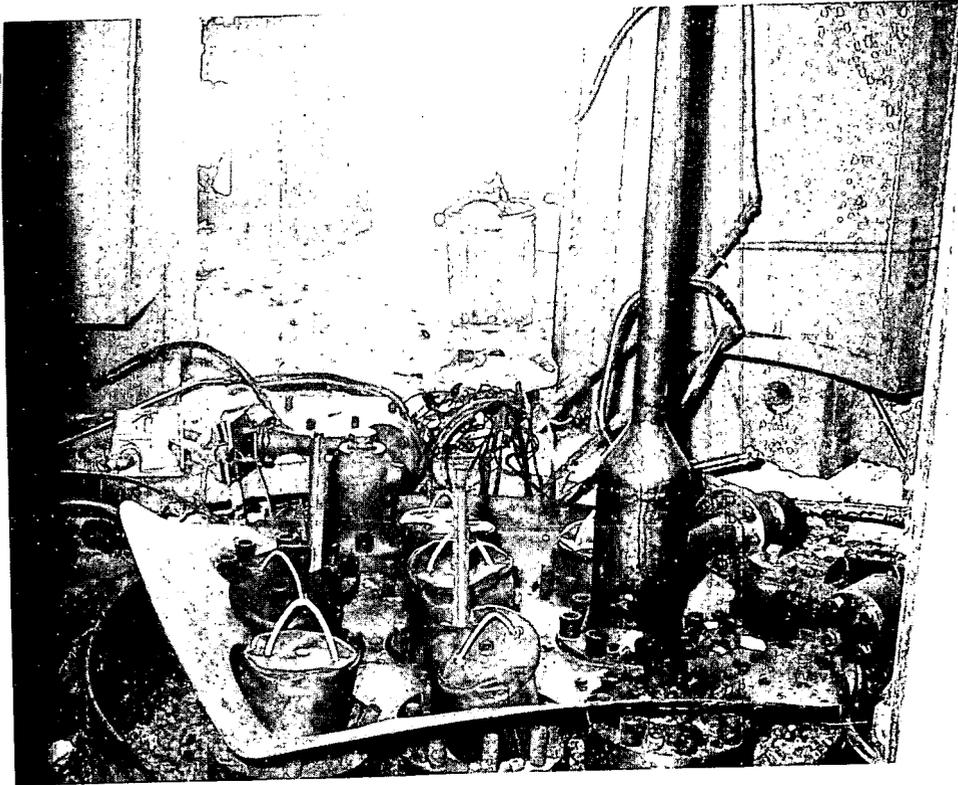
Figure II-1 Reactor vessel head after placement of shield bags

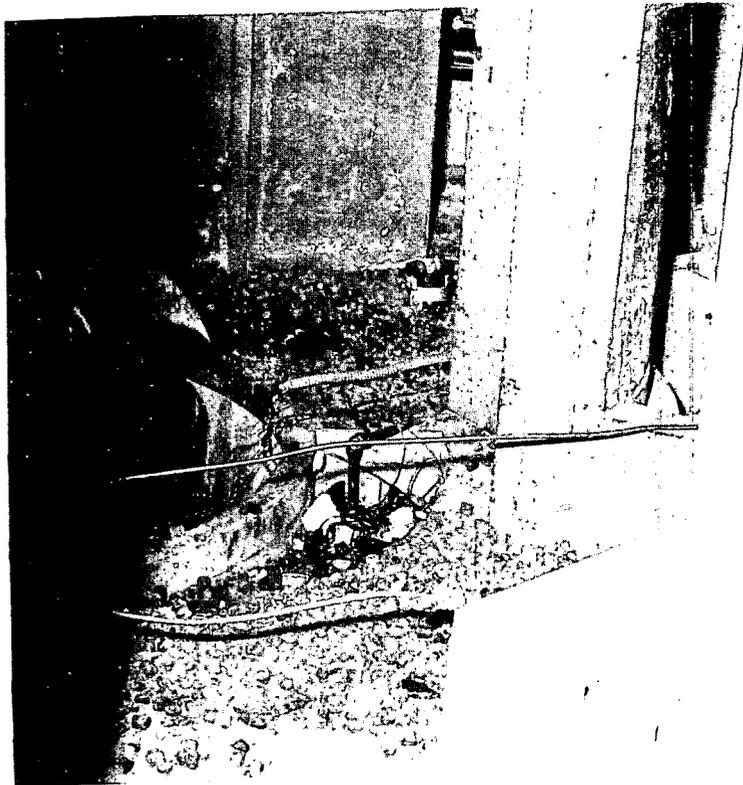
Figure II-2 Steel punchings near head of reactor vessel

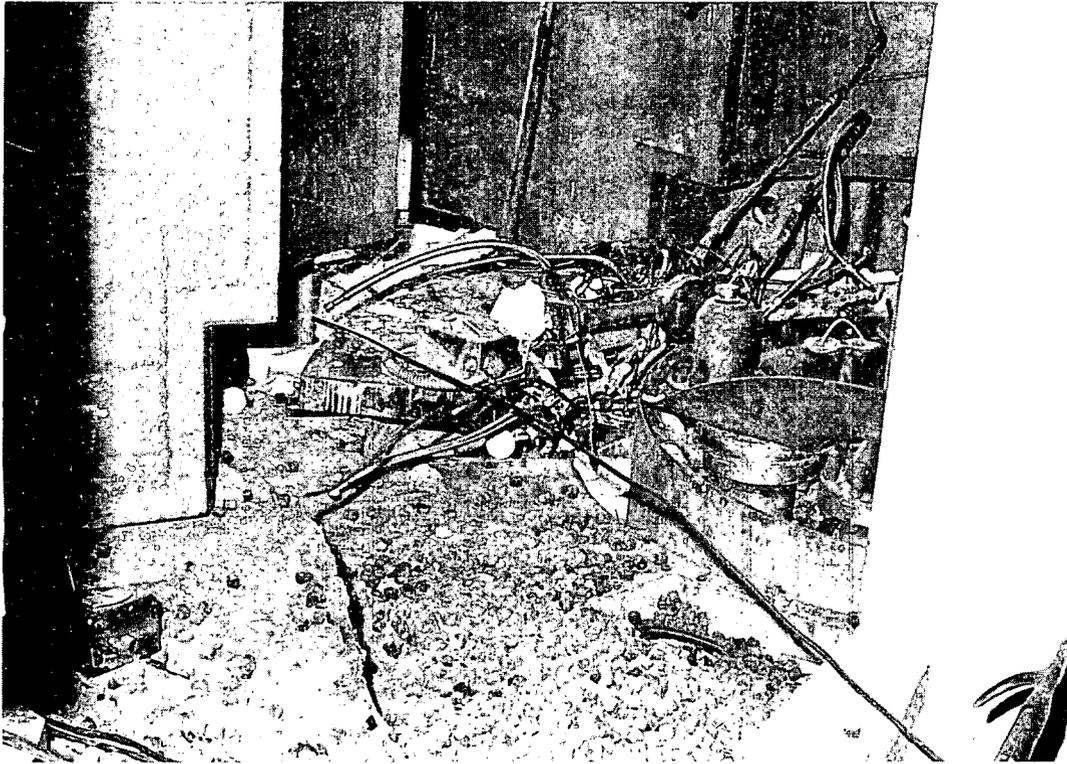
Figure II-3 Steel plate and cooling lines displaced by accident

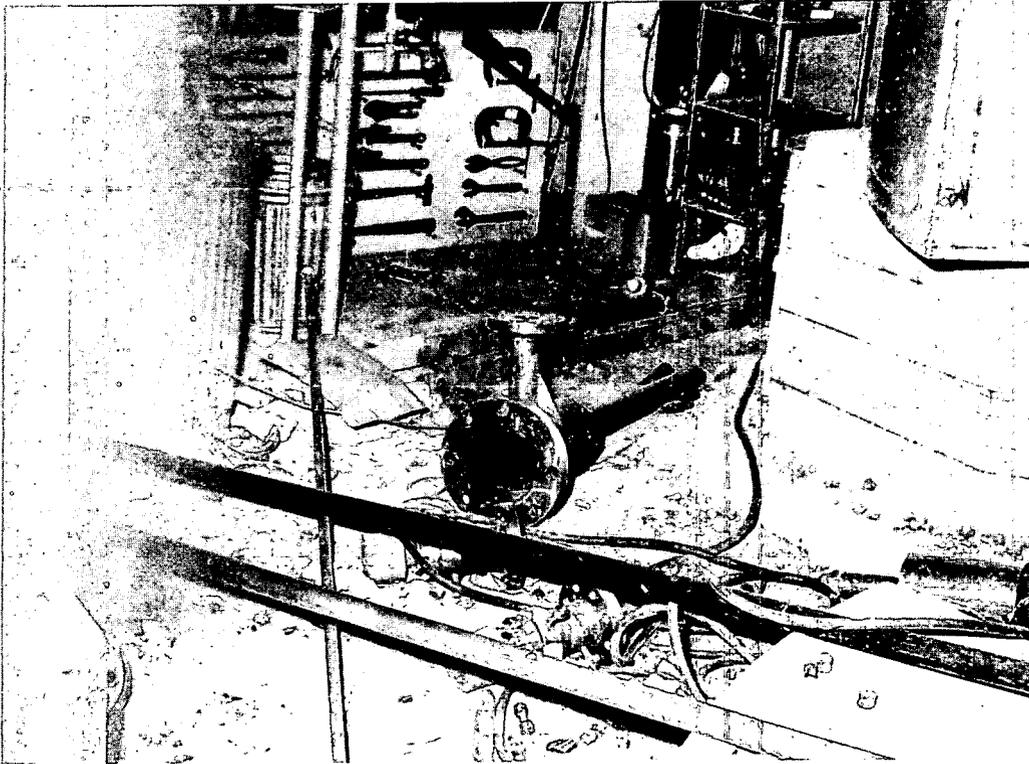
Figure II-5 Equipment and debris on floor of operating room

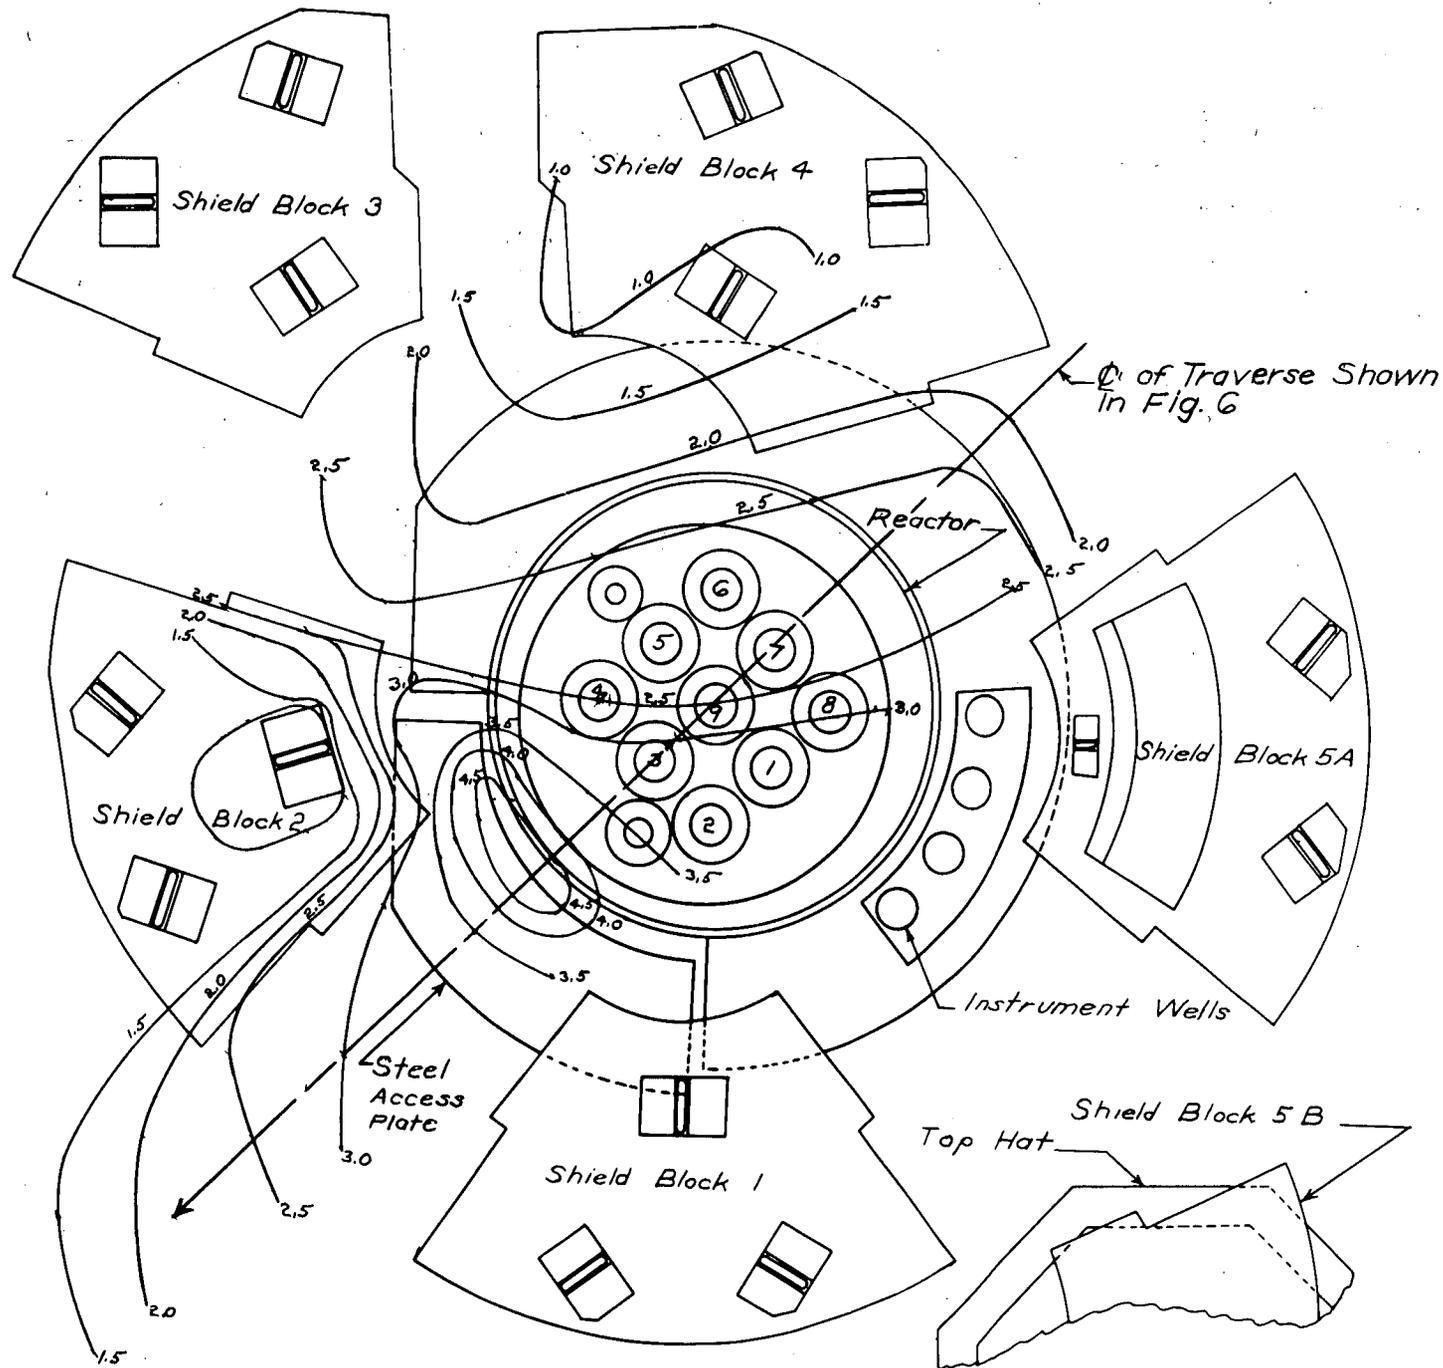
Figure II-11
ISODOSE MAP
OF ROOM FLOOR
SURVEY 6-14-61

An isodose map for the first radiation survey of the operating room floor is plotted in Figure II-11. This survey confirmed that the highest level source was within the area enclosed by the shield blocks. Within the confines of the blocks the source was fairly well distributed except for a peak in the area where the 3" thick steel access plate for the seal coolant header was blown back. The fact that the radiation level in this area had a fairly high, sharp peak imposed on a fairly broad base would indicate that there was a high intensity beam coming from the space between the pressure vessel head and the steel plate as well as a distributed source due to fission products being expelled through the opening as the plate was pushed back.

It is not possible to tell from the radiation survey if the beam was coming from fission products in the space between the support vessel and the pressure vessel or from the core itself. At the time of the survey this particular beam appeared to be the only one coming from the reactor itself, indicating that bags of shot that were placed on the control rod nozzles at the start of the cleanup were effective in stopping streaming from the nozzles.

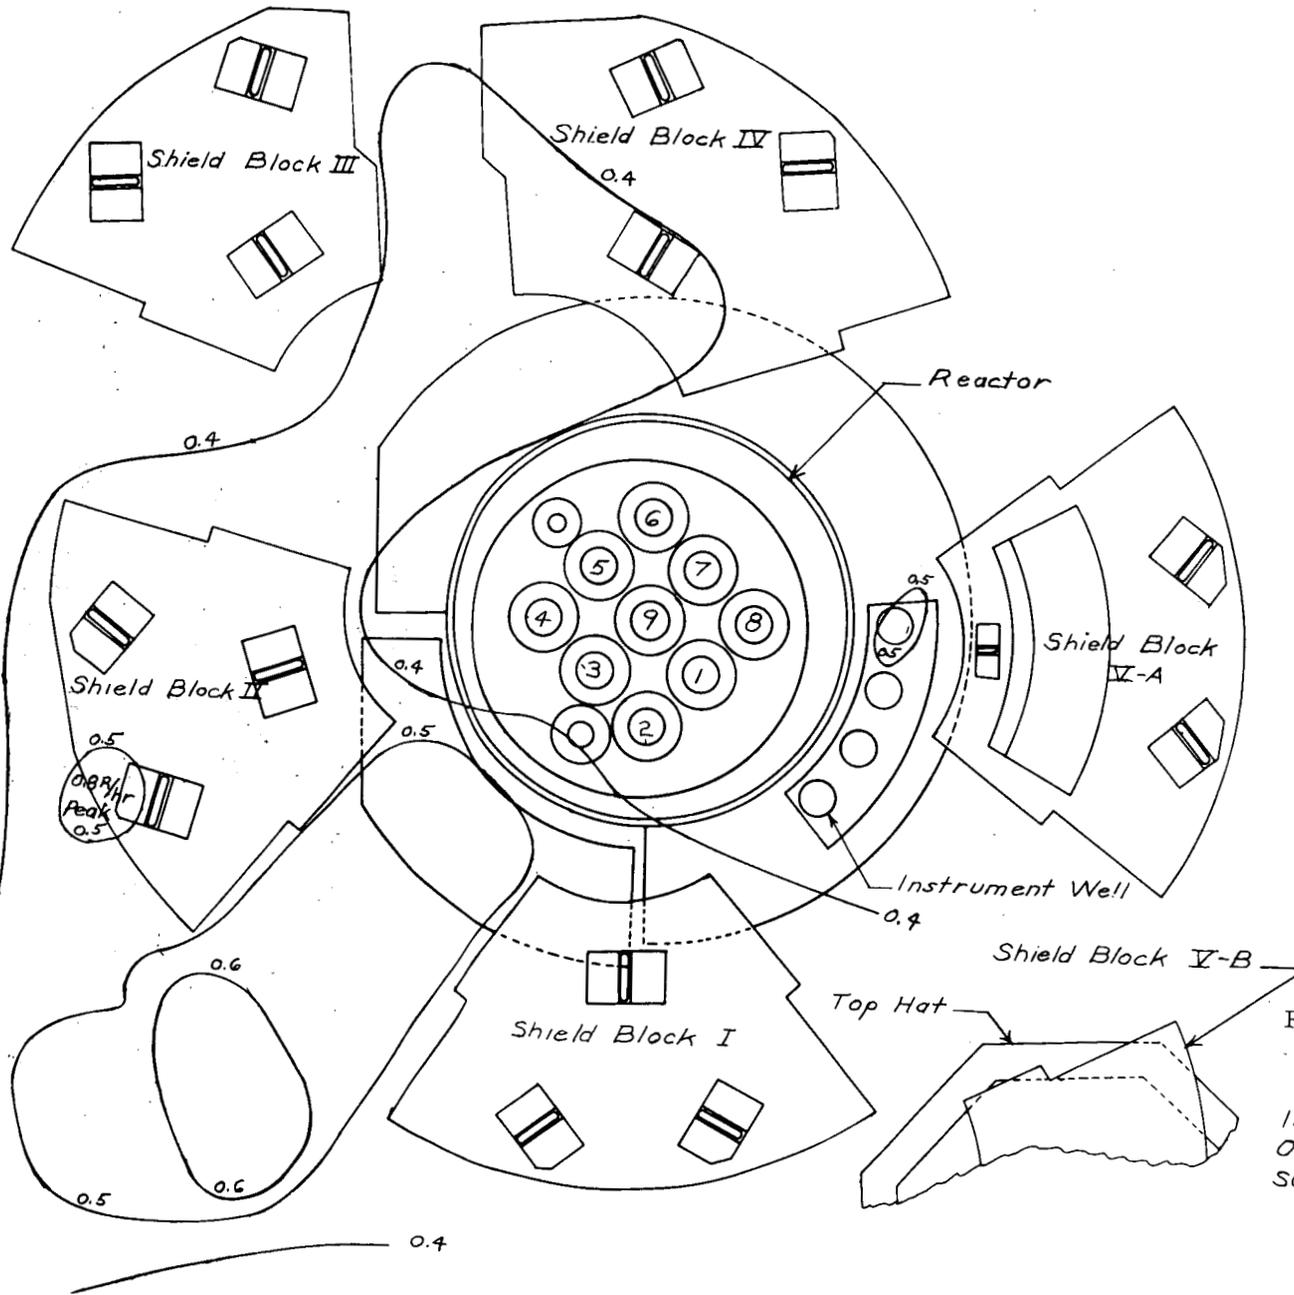
Figure II-14 is an isodose plot of the operating room floor after the debris had been scooped up and vacuumed from the floor around the reactor and bags of shot had been piled over the top of the reactor. A steel plate and bags of shot had been placed over the hot spot next to shield block 2. This shielding was responsible for the reduction in source strength in the area directly over the reactor. Cleaning reduced levels in the area surrounding the reactor by a factor of 6 in the hottest areas and by a factor of 1.5 in the areas that had been vacuumed previously.

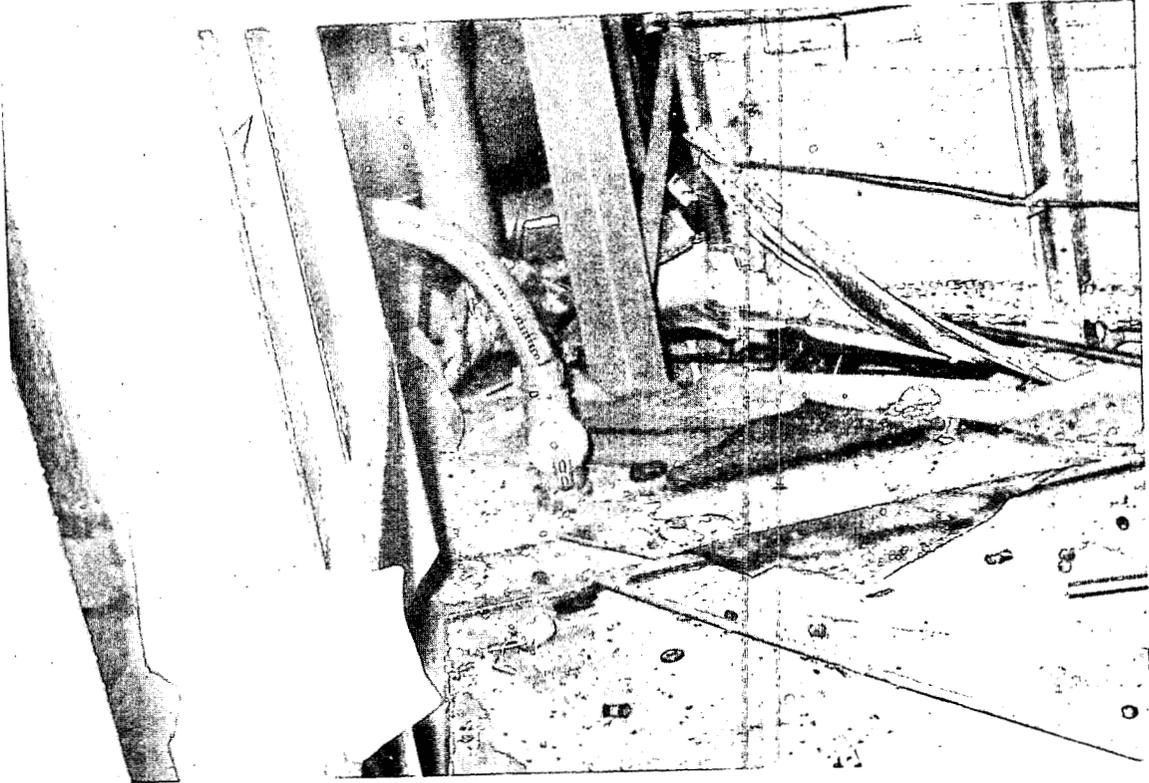
Figure II-17 Hole in Fan Room Floor

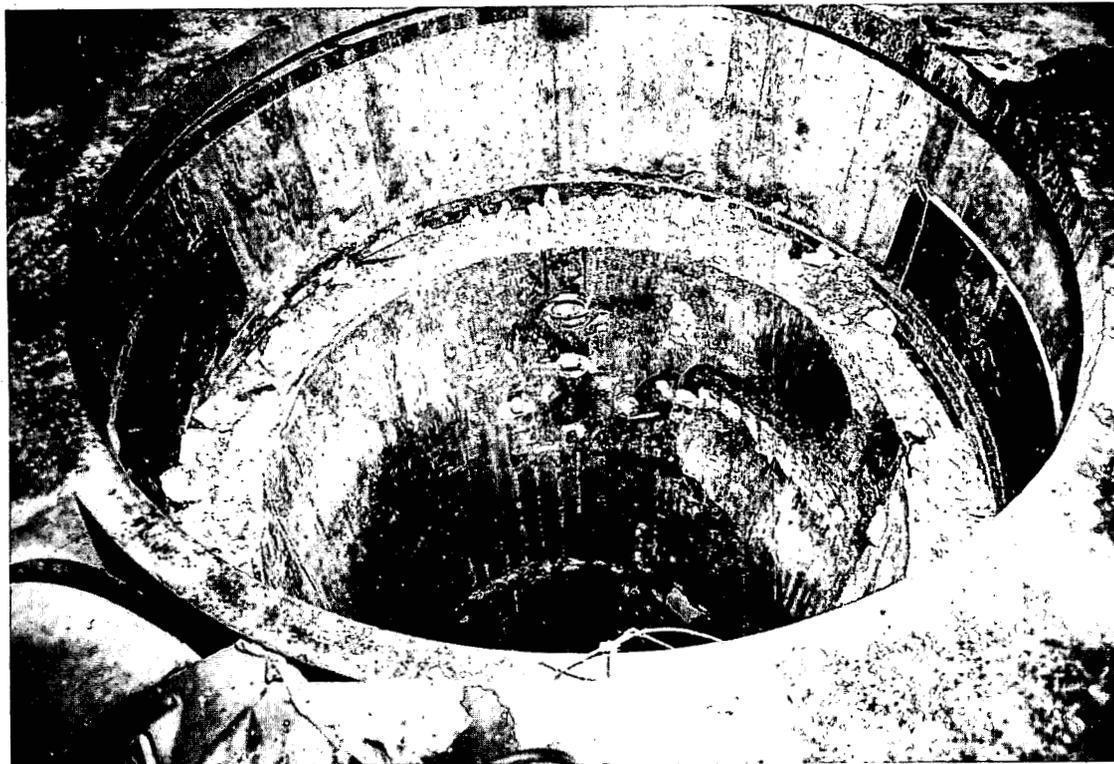
Figure II-25 Inside of Support Cylinder

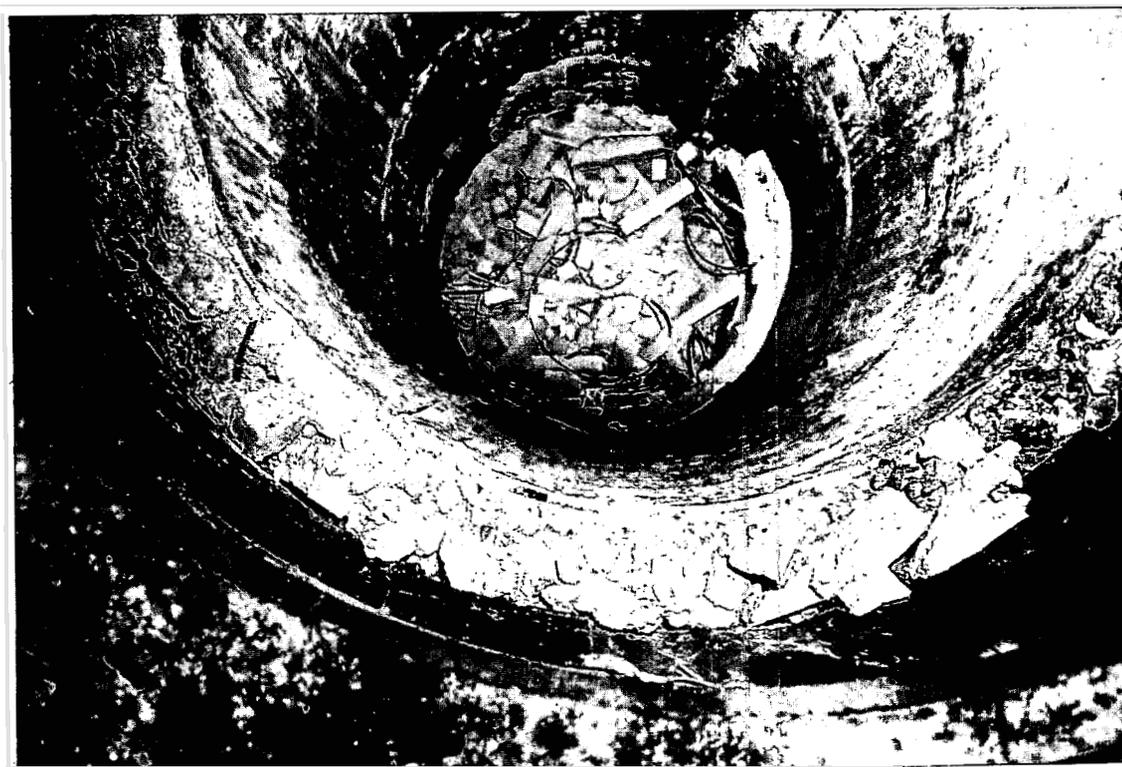
Figure II-26 Bottom of Support Cylinder

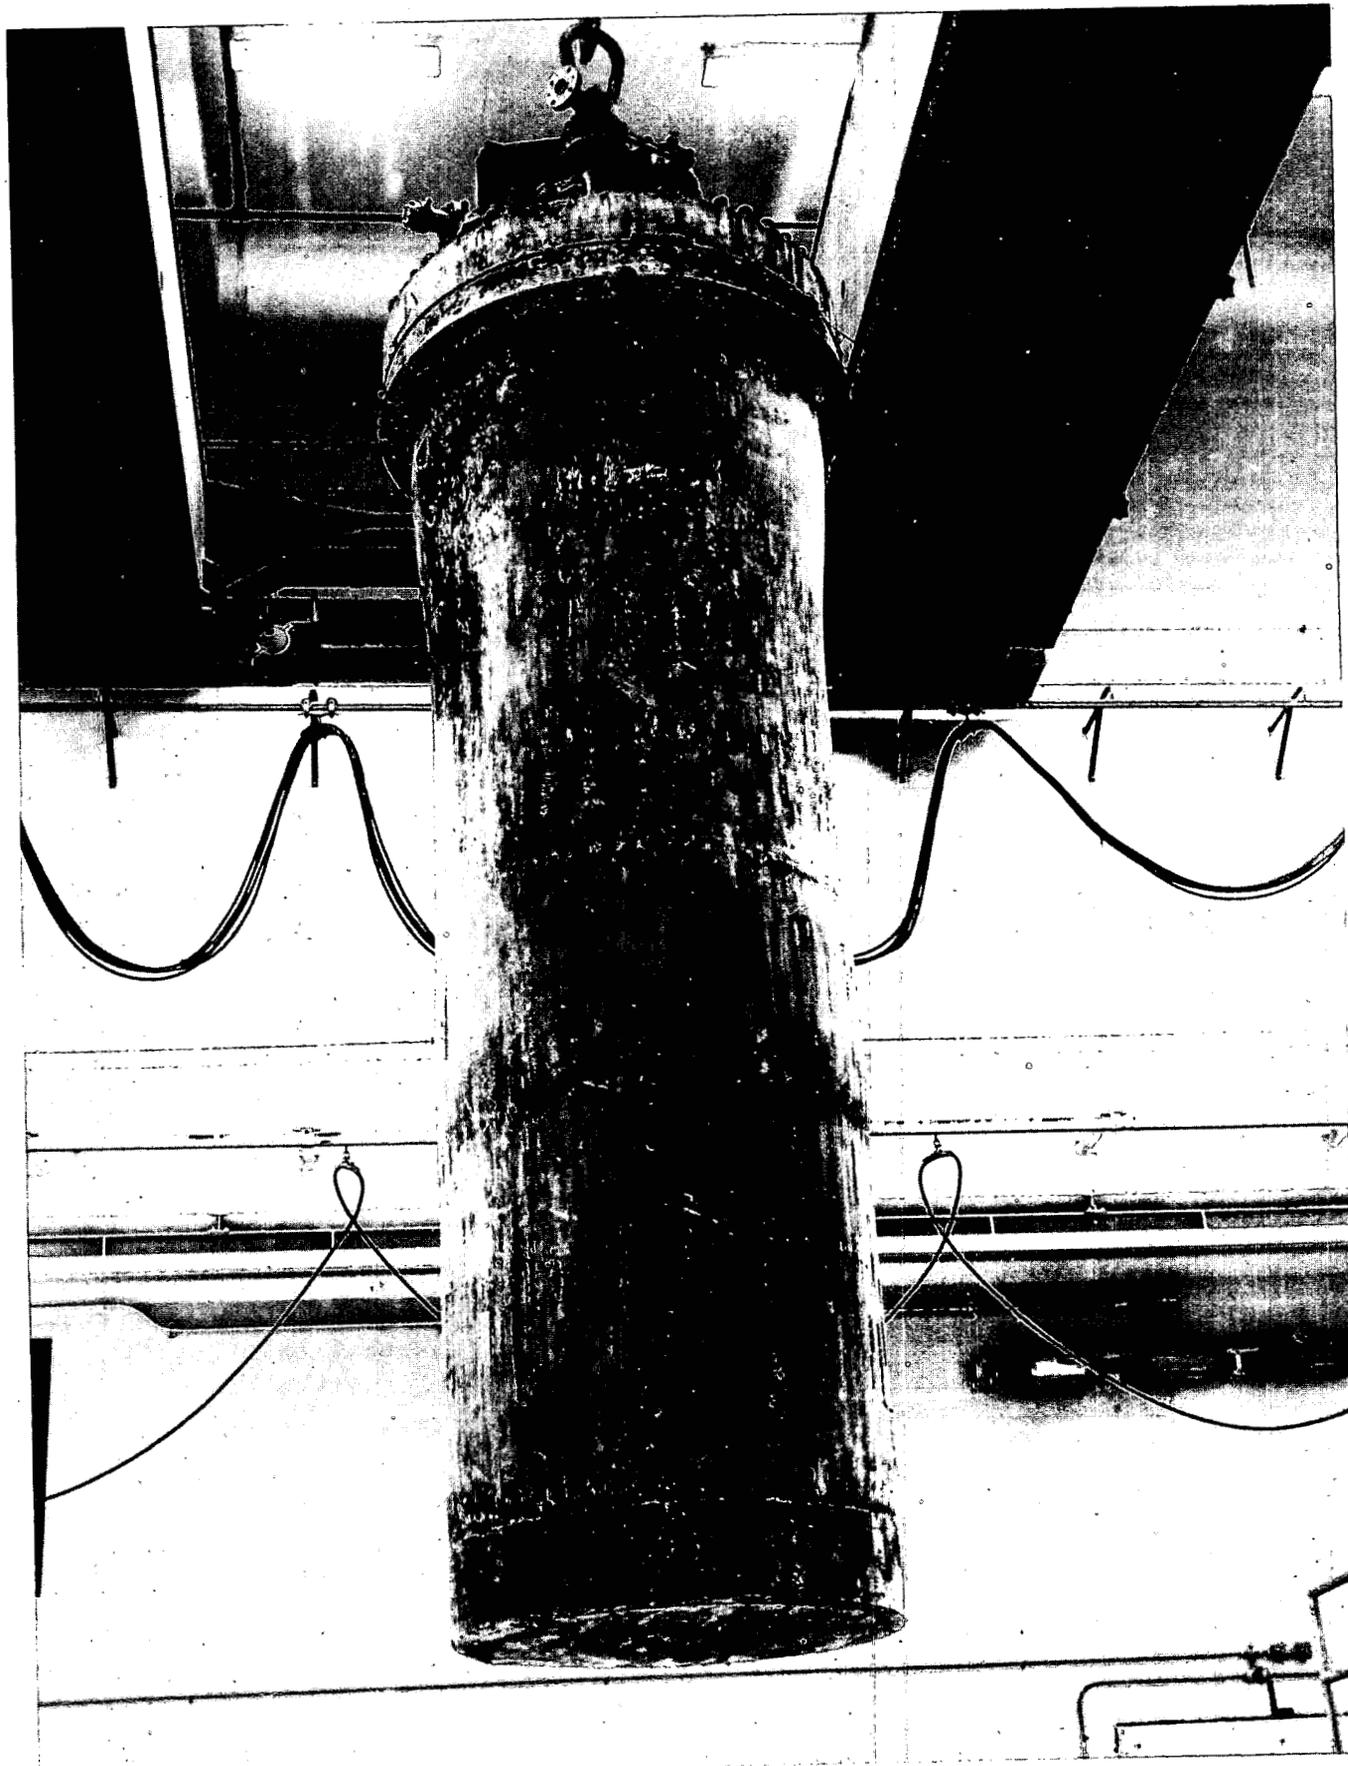
Figure II-30

SL-1 Pressure Vessel
II-56

The pressure vessel assembly was removed from the shielding cask, photographed and inspected. See Figure II-30. No marks which would indicate the height the vessel had risen were observed. The insulation fairing around the dished head was removed by grinding through the tack welds. This exposed the dished head, seen in Figure II-31, which appeared to be more spherical than the drawings indicated. The hole in the pressure vessel is the one drilled for boroscope inspection at the SL-1 Site.

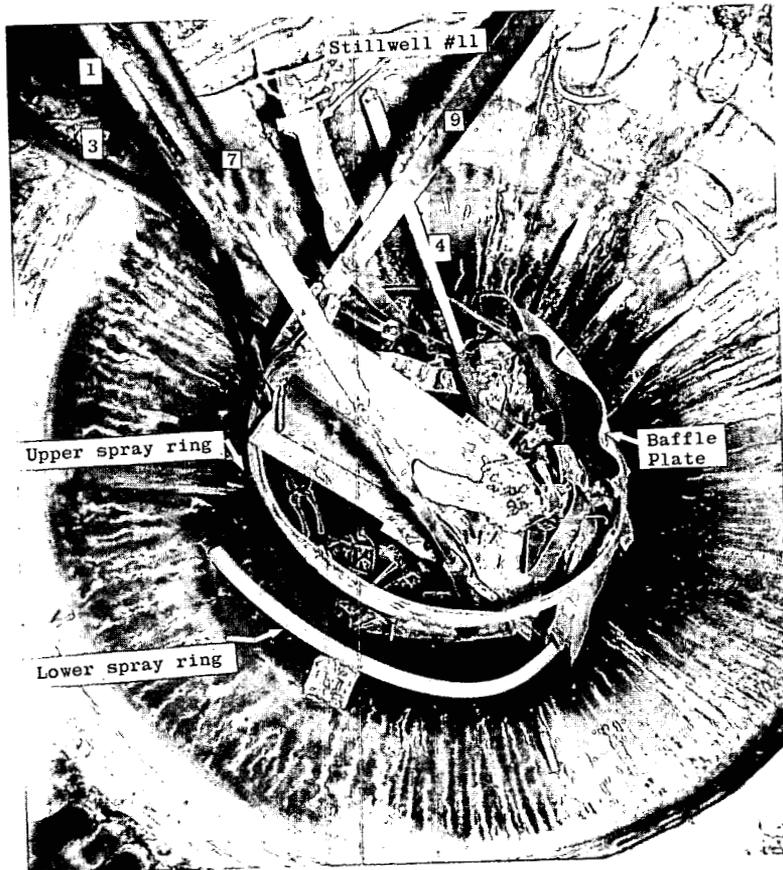
Figure II-33 SL-1 Core

The core condition when the pressure vessel head was removed is clearly shown in Figure II-33. The #9 control rod shroud, the spray rings, steam baffle, etc. can be clearly seen. The #1 and #3 control rod extensions and racks were still attached to the poison blades. All loose inert pieces and fueled pieces more than six inches above the remaining core volume were removed to make ready for a critical experiment. An inventory of all pieces removed was kept and checked off against photographs of the core. These operations were performed with a long armed manipulator while observing the work in a mirror. Photographs were taken at each significant stage of the dissection using a remotely operated 4 x 5 press camera and electronic flash held over the core with a manipulator. On several occasions two photographs would be made in such positions as to form a stereo pair. This assisted greatly in understanding the conditions inside the core.

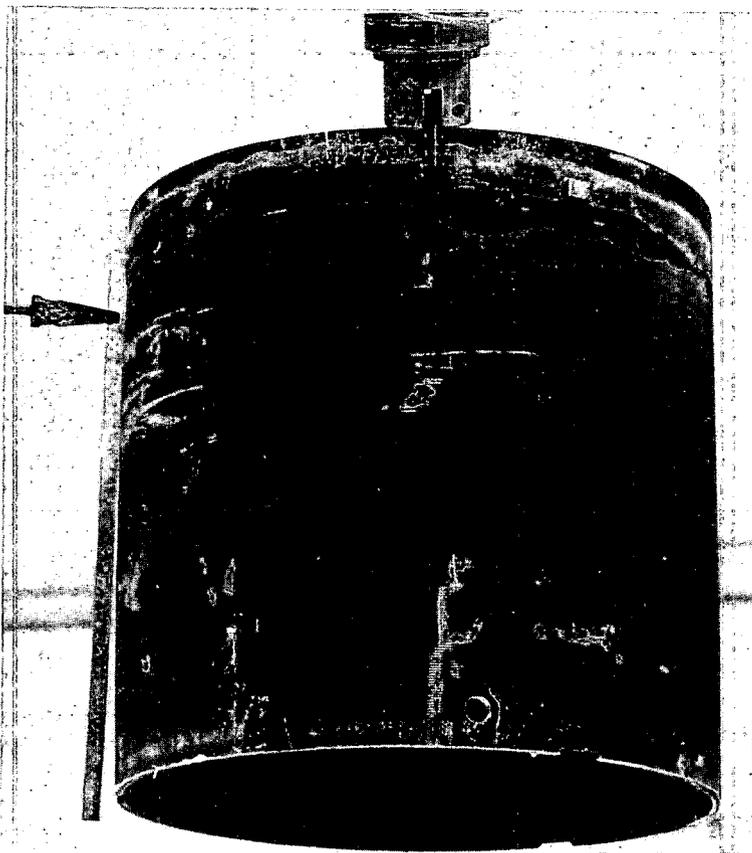
Figure II-53

The core support structure was removed. The thermal shield, Figure II-53, was lifted out with the manipulator and examined. The mid-point of the cylinder had increased its diameter by about 1/2 inch. There are eight support structure brackets attached to the inside of the thermal shield. Two of these have guide pins, three have broken hold-down studs and three have intact hold-down studs.

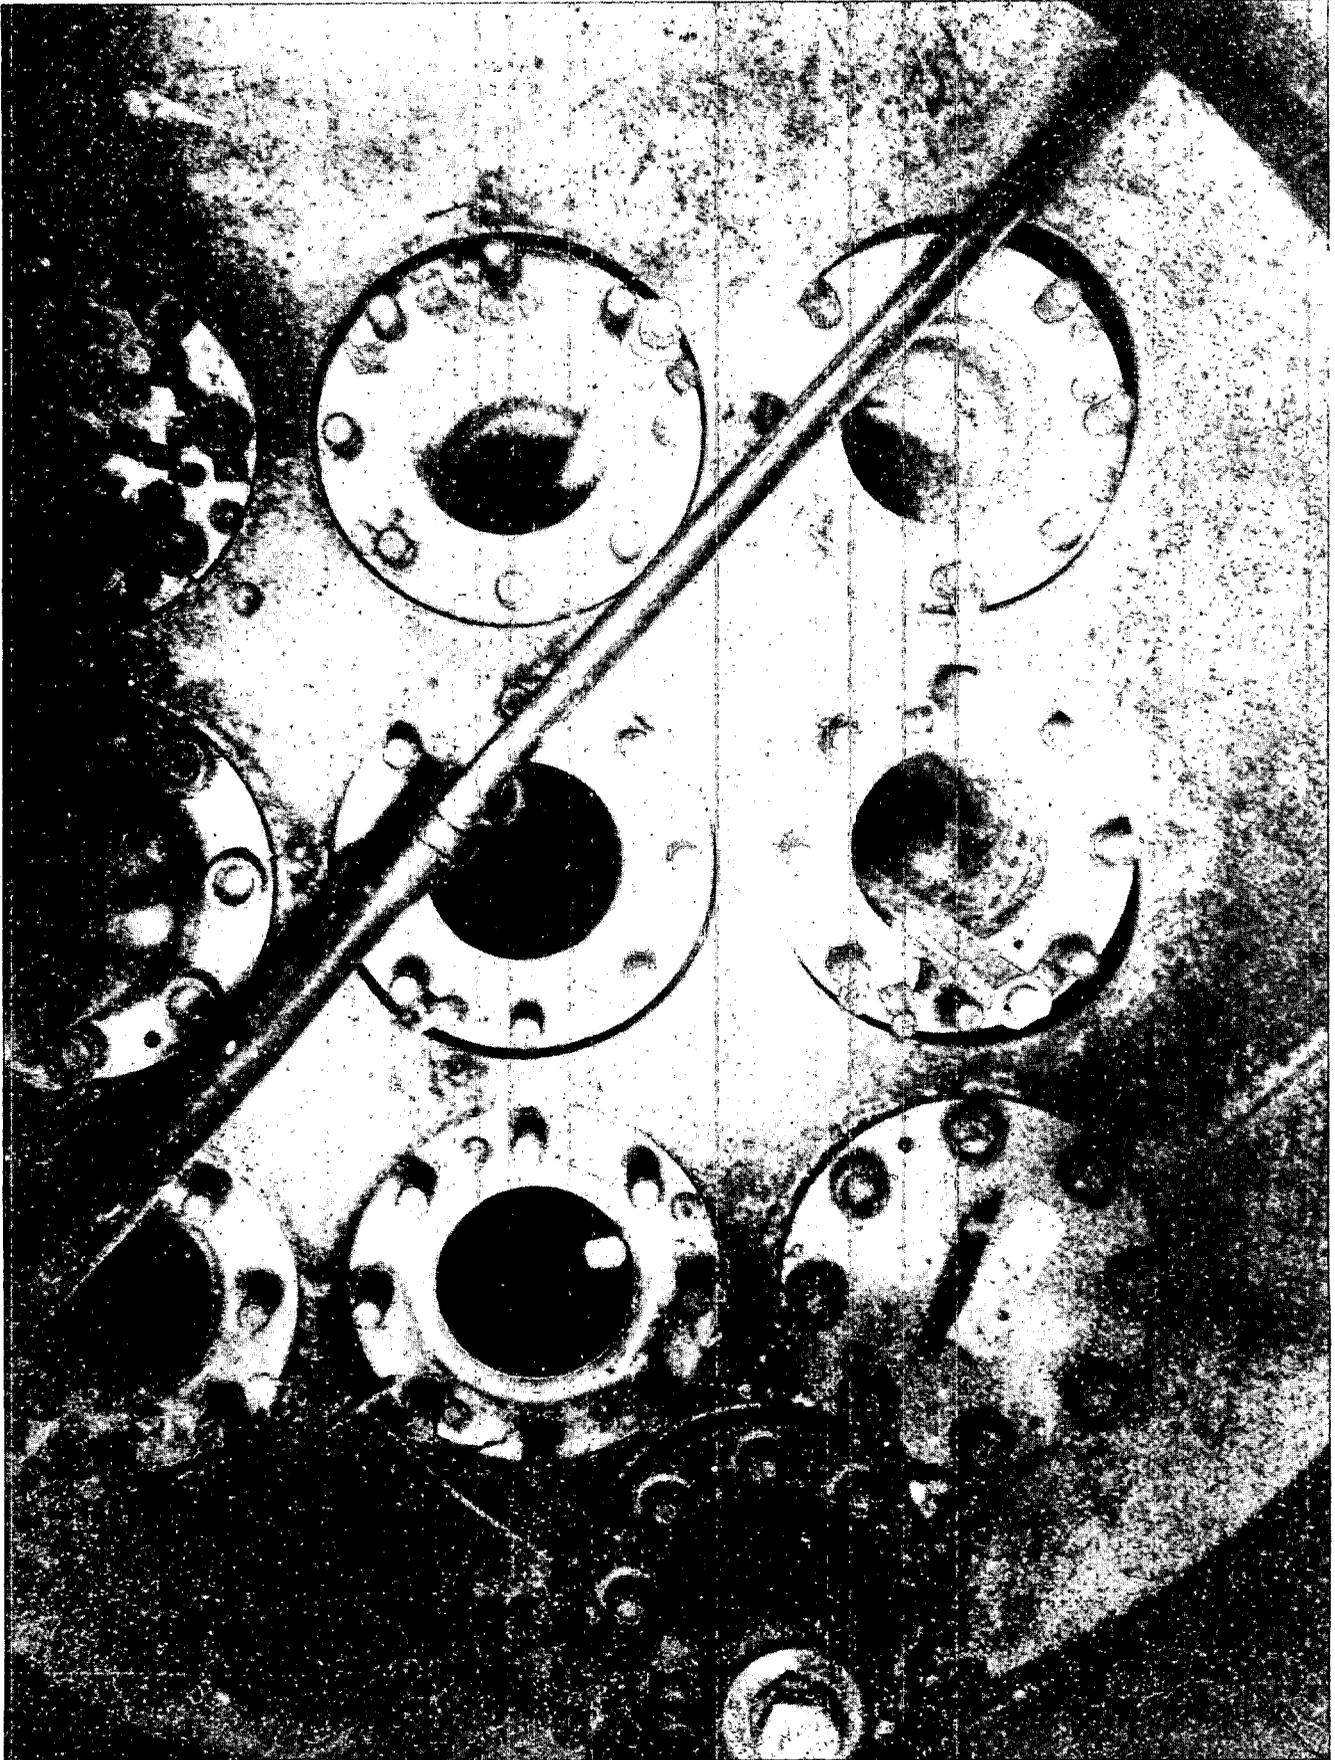
Figure III-2, Shield Plug Assembly #9 Lying
Across the Reactor Head Over Nozzles 4, 9 & 8

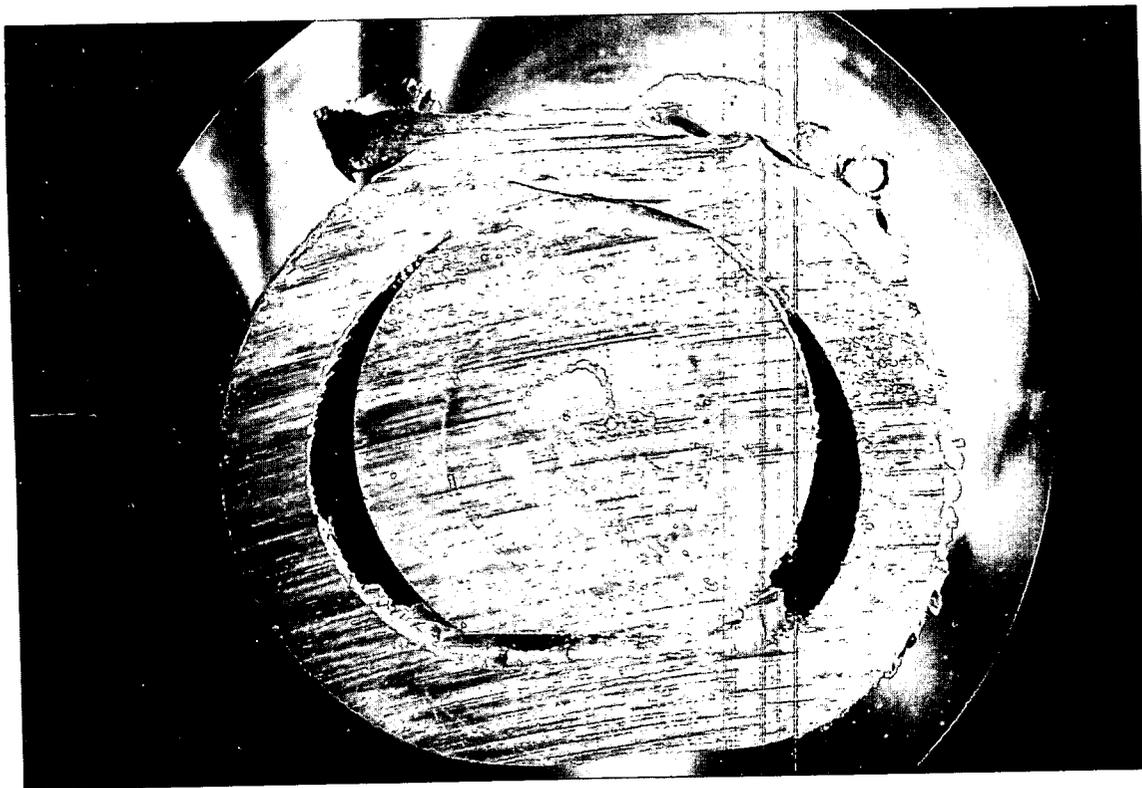
region as a 4-3/4" long section. The cut closest to the seized section revealed the pinched guide tube on the extension rod, seen in Figure III-5.

Fig. III-5, Shield Plug #9, cross section of seized extension rod by collapsed guide tube.

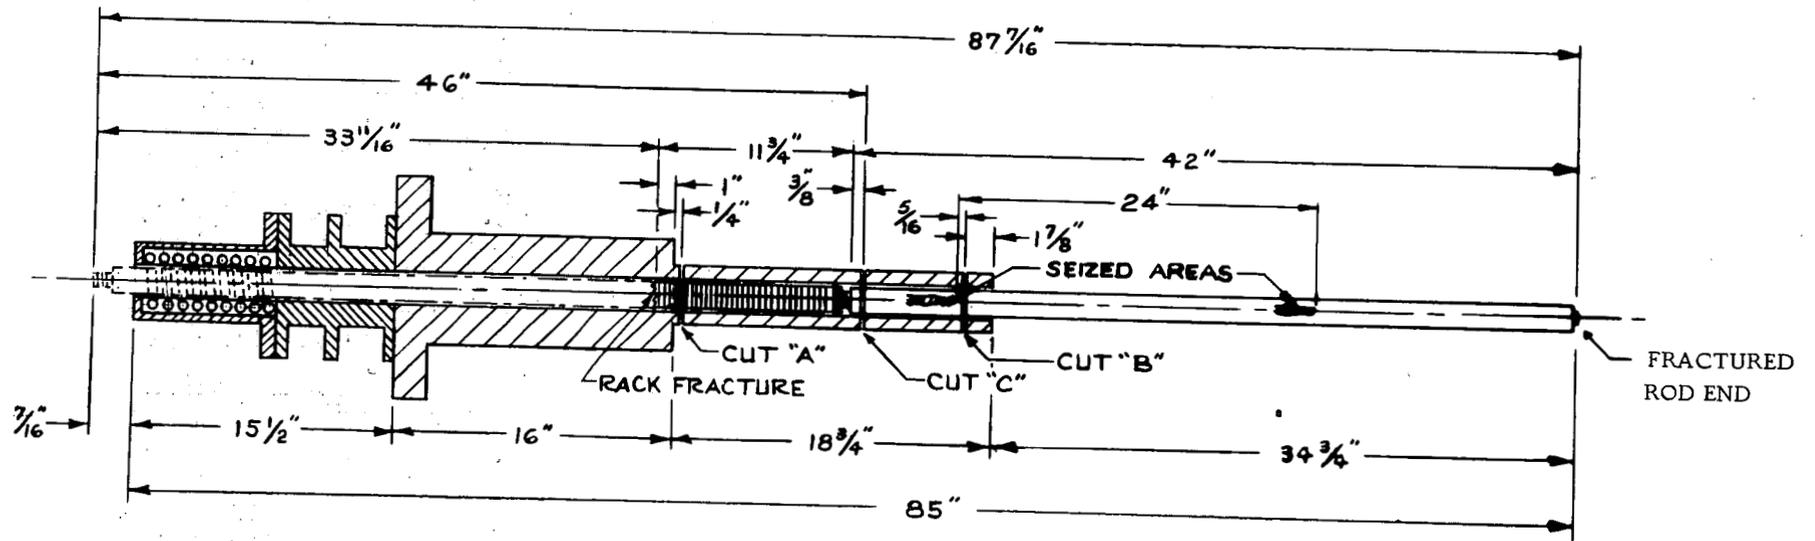
Figure III-8 Shield Plug #9 Assembly - Sectioning and positions of rod during seizure.

Reconstruction of the severed pieces of extension rod and guide tube (Figure III-8) shows that, at the time the mechanism was recovered, the control rod was $2\text{-}1/2" \pm 1/4"$ withdrawn from its normal scram position, relative to the plug mechanism. In addition, a broken C clamp was recovered from the fan floor (Figure III-18). The C clamp was open to the diameter of the rack. Had the clamp been in place on the rack for the rod assembly operation, the rack would have been raised approximately $2\text{-}1/2$ inches. The control rod handling tool was, at the time of the incident, attached to the rack of the central control rod. Figure III-13 shows the matching of the broken piece of stud found in the handling tool with the broken stud of the rack. The handling tool penetrated the fan room floor in the region above nozzles 5 and 6 (Figure III-30).

In view of the facts as discussed above, the extension rod and plug at the time the guide tube collapsed, were in a relative position corresponding to $26\text{-}1/2 \pm 1/4$ inches withdrawn.

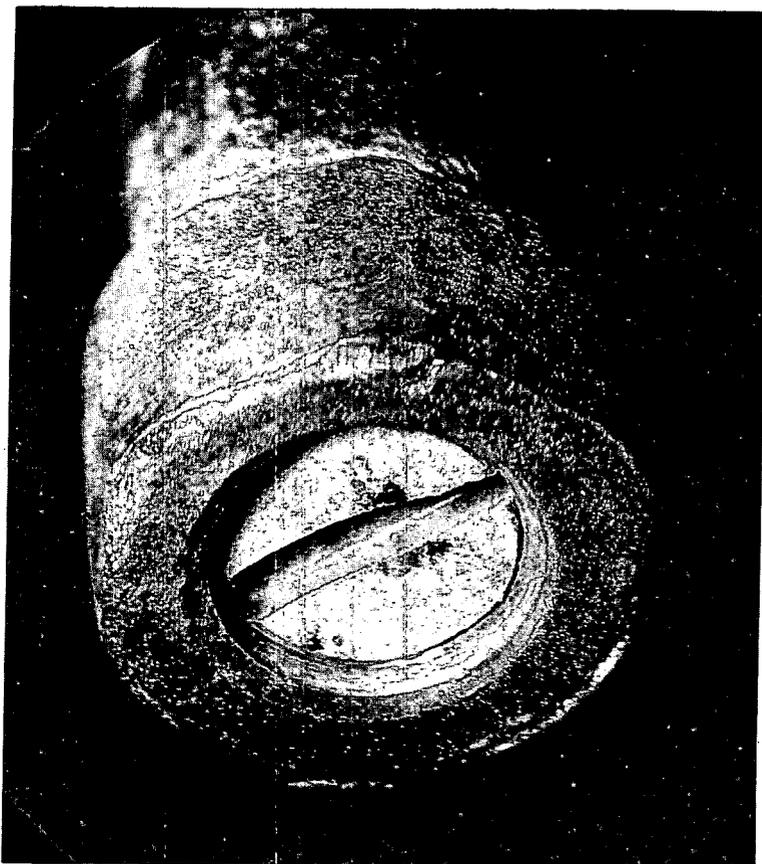
Stud section found
in control-rod
handling tool

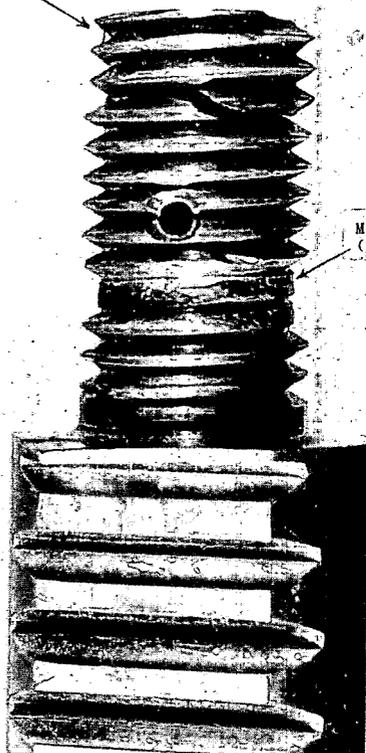
Missing thread
(pre-incident)

Fig. III-13, Matching of broken stud of central control rod rack.

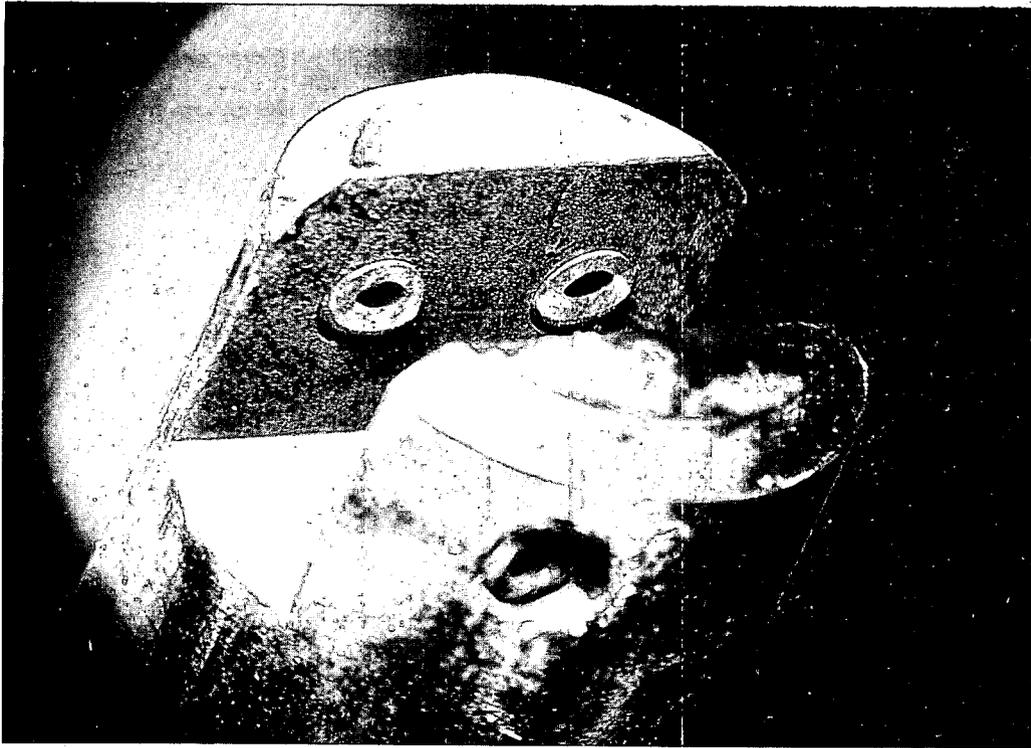
The connecting rod was recovered from the top of the reactor vessel. This rod was broken from the extension rod at the base of the threads on one end, and through the hollow pins which retain the ball joint latching fingers on the other end, Figure III-14.

Fig. III-14, Shield Plug #9, connector rod, showing sheared roll pins.

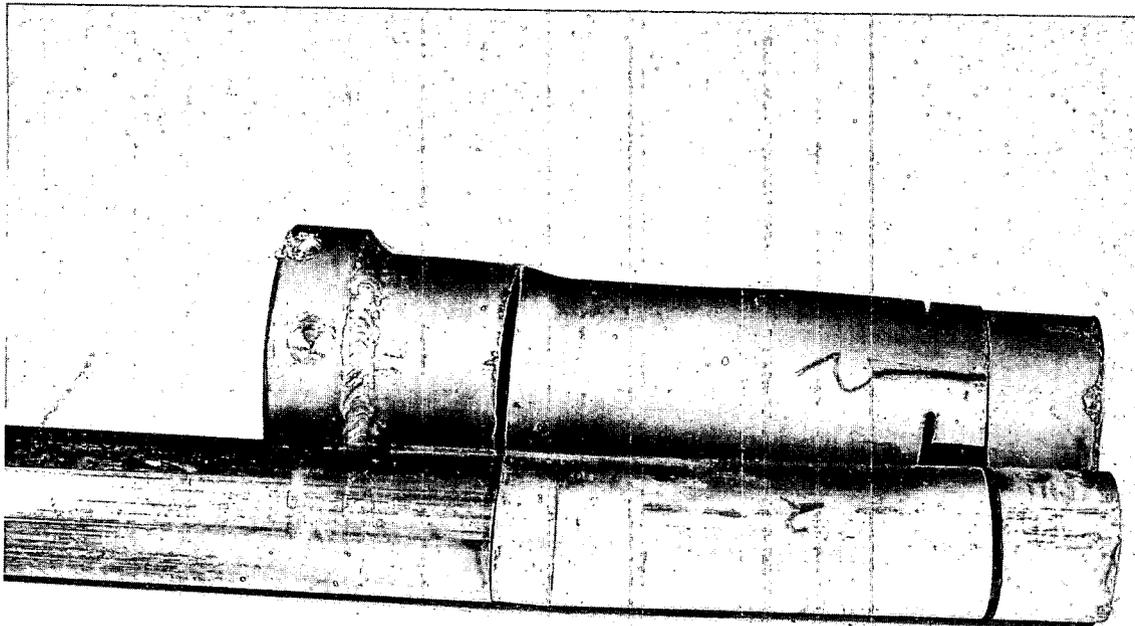
Slide marks are evident on the extension rod as it was found sticking out of the guide tube. It is apparent that there are longitudinal marks in the black chromous acid deposit. These are shown in detail in Figure III-15. Though it was originally thought that these marks were produced by the manipulator hands, Figure III-15 shows that the marks extend well beyond the end of the housing, up inside where the manipulator hands could not have reached. Therefore, it is evident that this slide mark (as well as two similar marks spaced approximately at 120° around the rod) was not made by the manipulator hands. There are other less well defined markings on the extension rod, markings which did not extend up inside the guide tube and which do not extend down the rod a uniform distance. These marks can be attributed to the manipulator hands.

Fig. III-15, Shield Plug #9, relative position of extension rod and sectioned guide tube showing sliding marks.

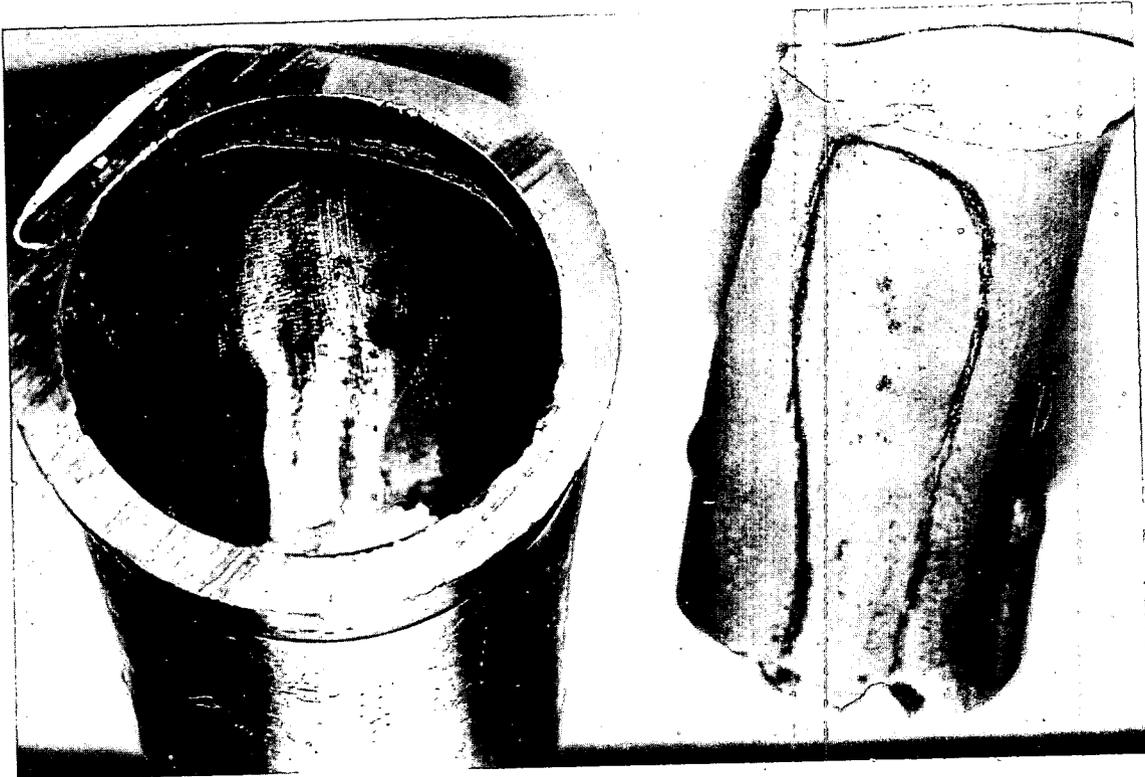
Fig. III-16, Shield Plug #9, seized region of the guide tube with plaster cast. Pencil line on plaster cast outlines impression area.
