FINAL REPORT
OF
SL-1 RECOVERY OPERATION

SL-1 Project
Idaho Test Station
General Electric Company
July 27, 1962

United States Atomic Energy Commission
Contract No. AT (10-1) 1095

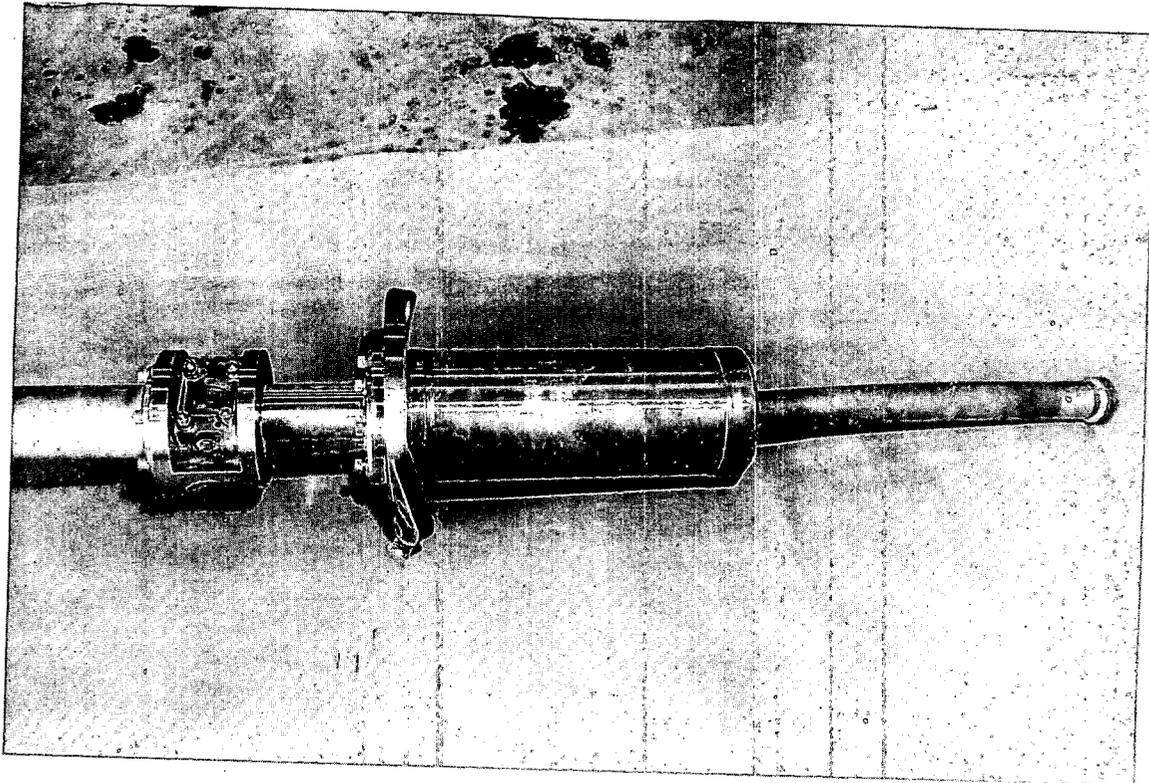
Figure III-22, Shield Plug #3, Showing Deformation of Flange and Collapse of Guide Tube

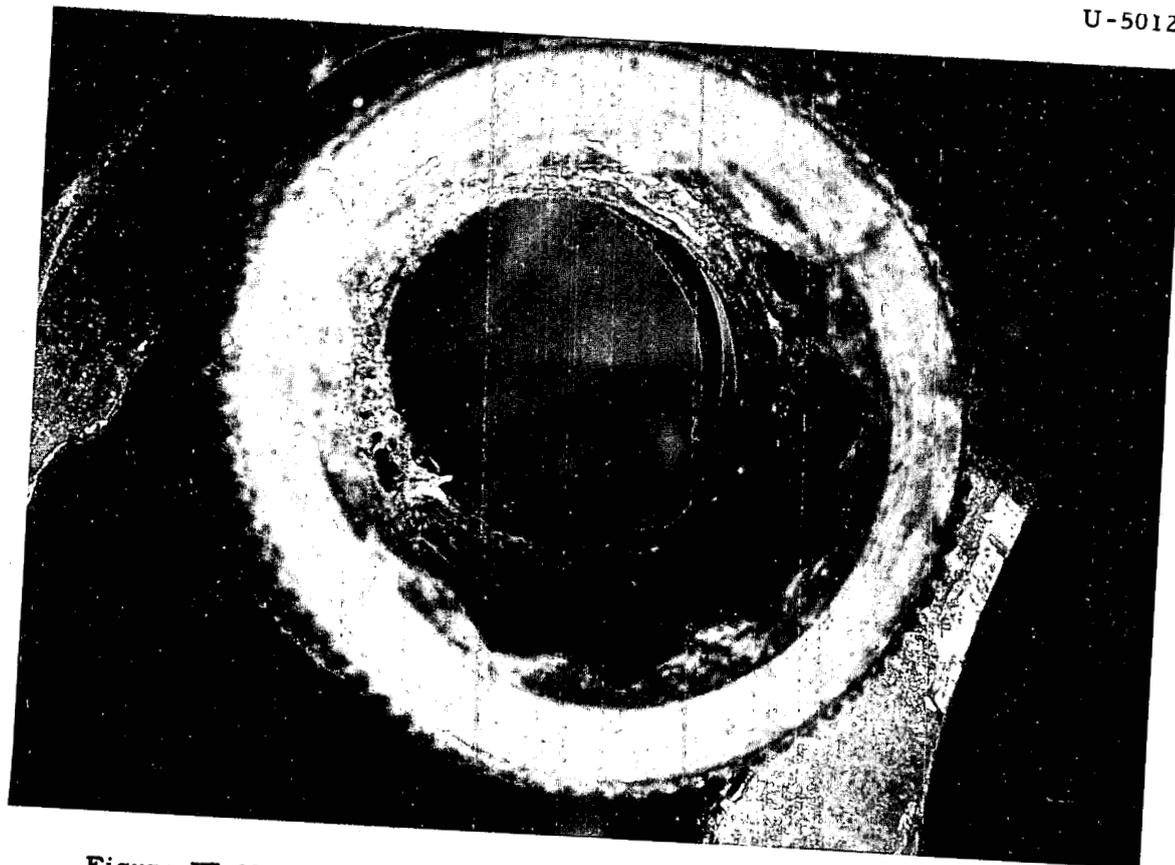
Figure III-27, Nut from Instrumented Flange #8, Showing Sheared Stud Threads Retained in Nut.

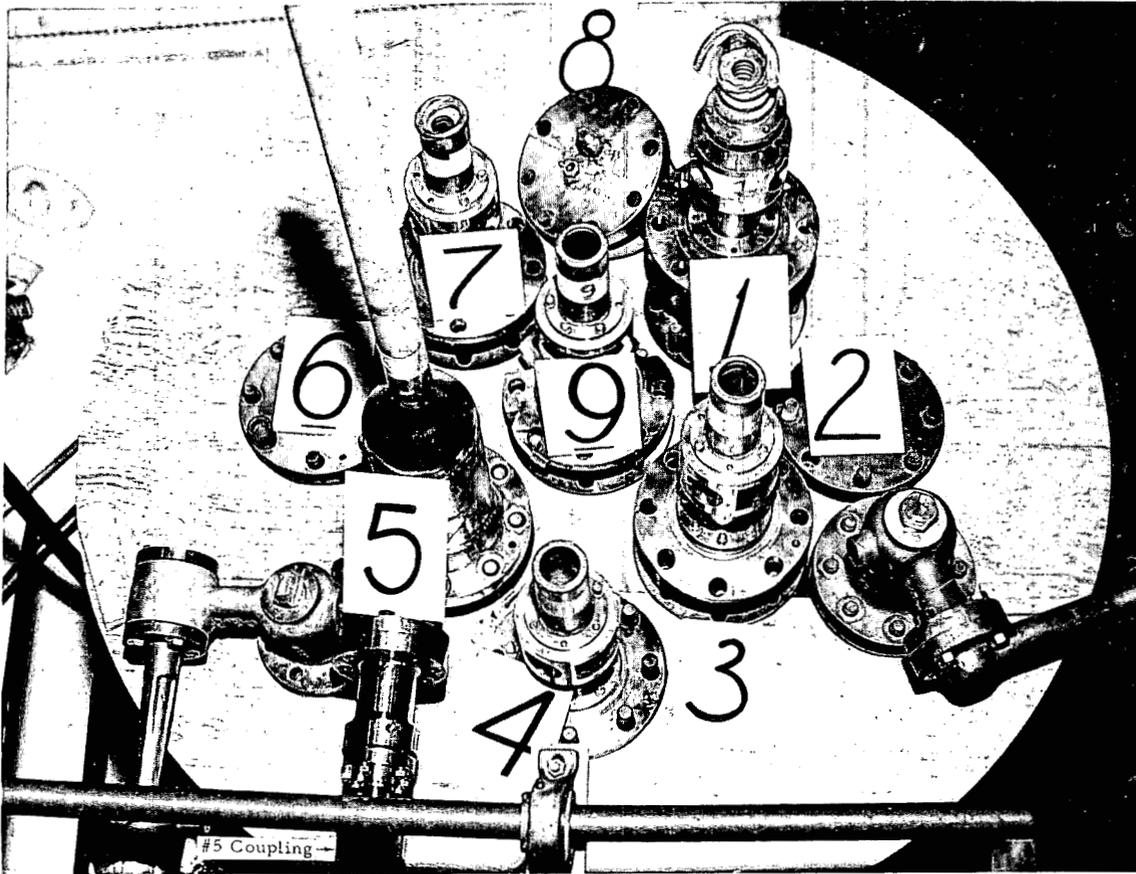
Figure III-29 Reconstruction of reactor head and plug assemblies

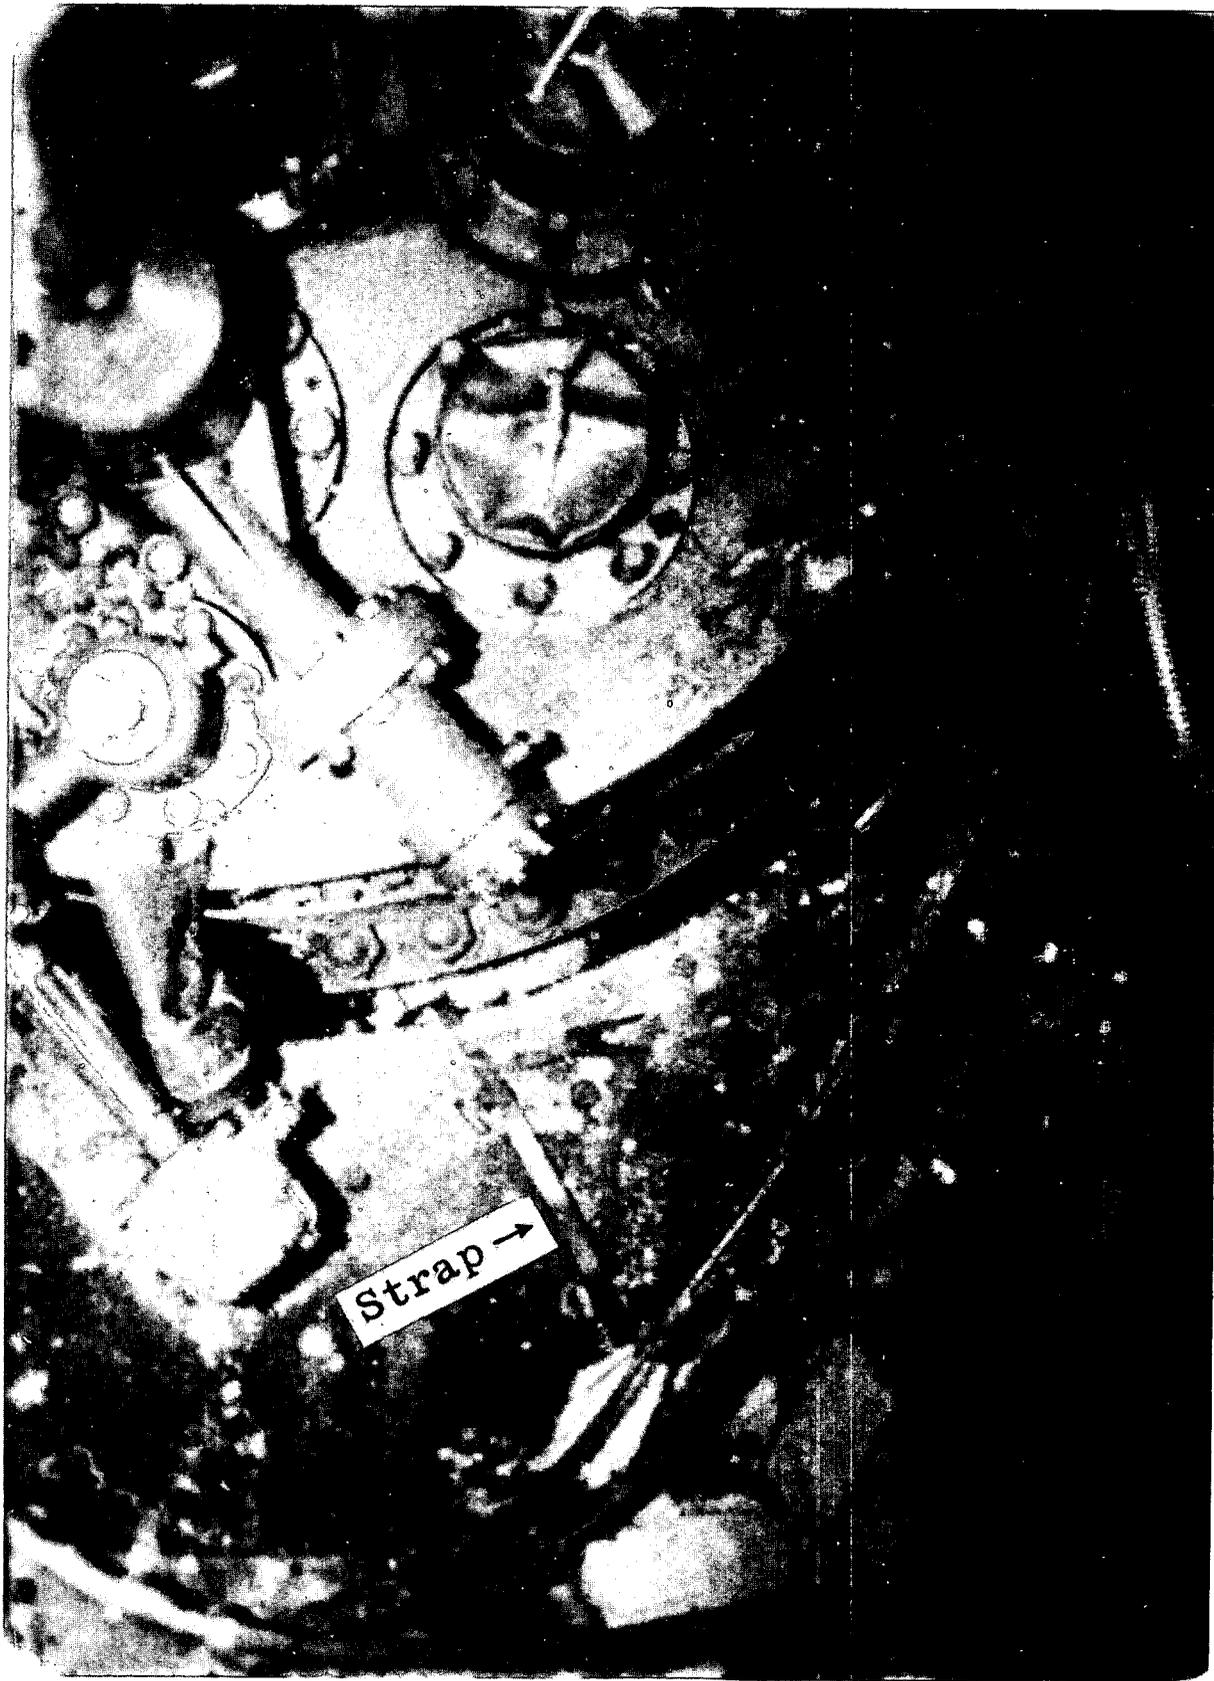
Fig. III-31, View of vessel head.

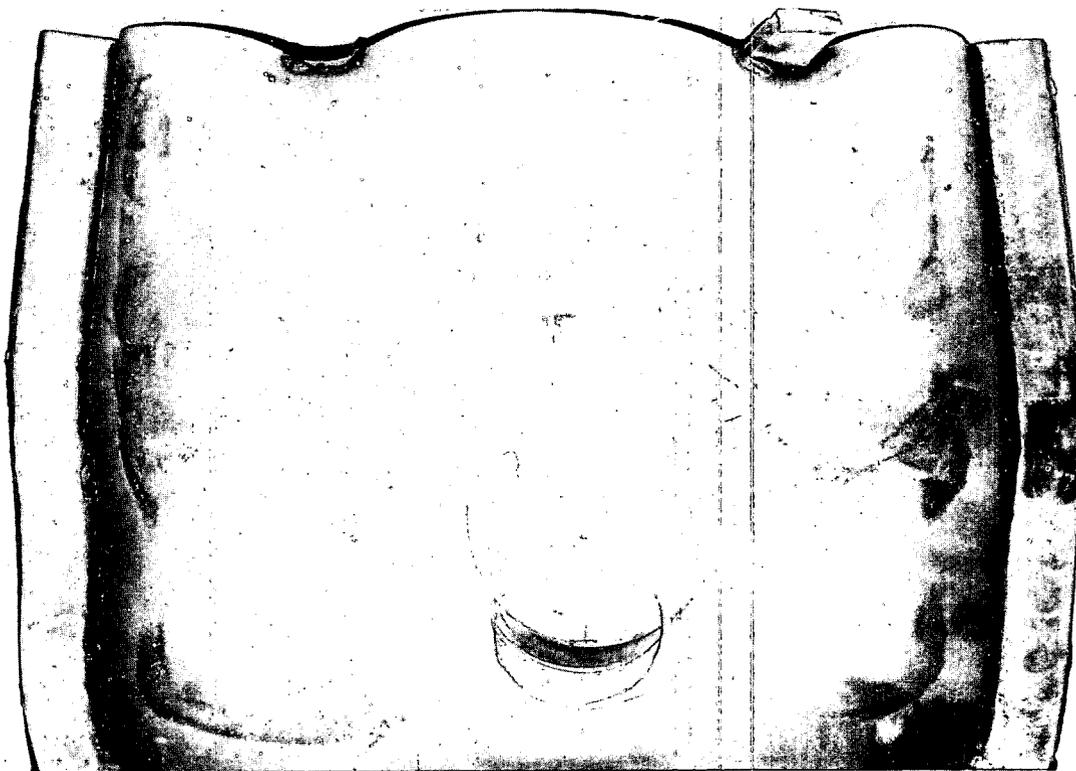
Fig. III-32, Baffle plate showing areas of impact and deformation.

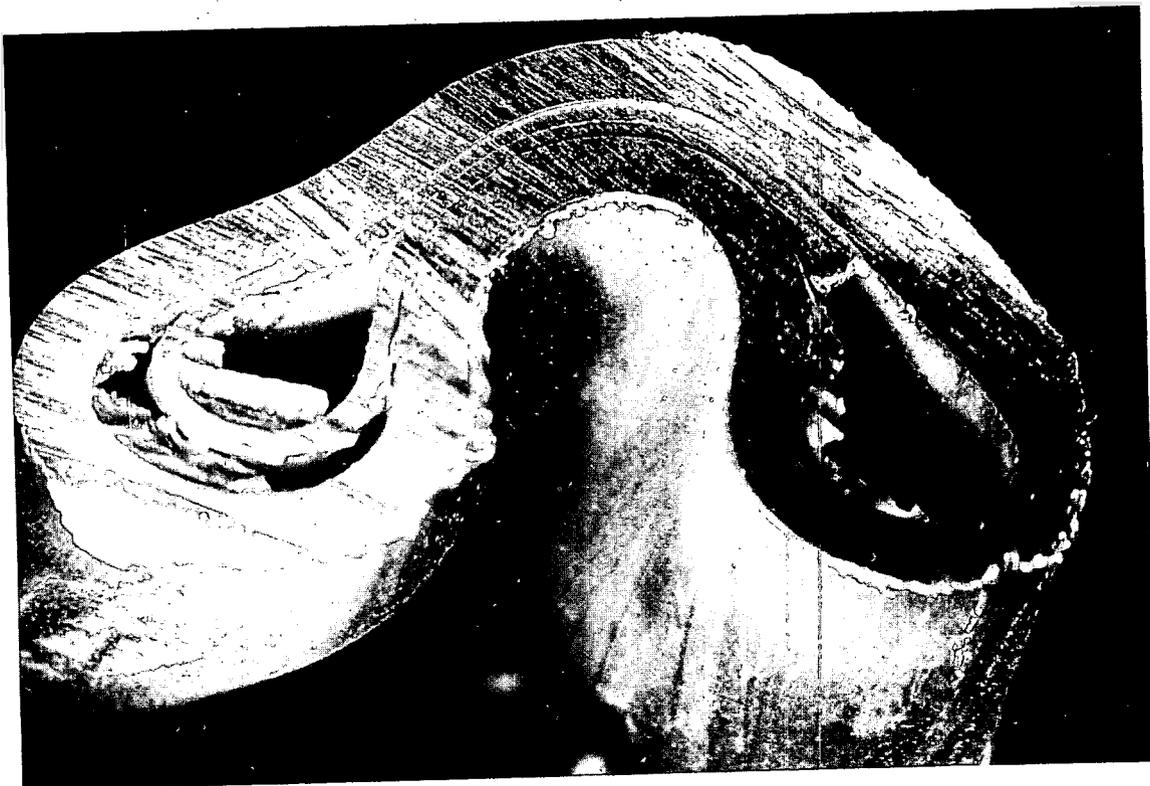
The compensating liquid level float was bound in the stillwell pipe and can be seen in the pipe where it was sectioned (Figure III-34).

Fig. III-34, Cross-section of stillwell pipe.

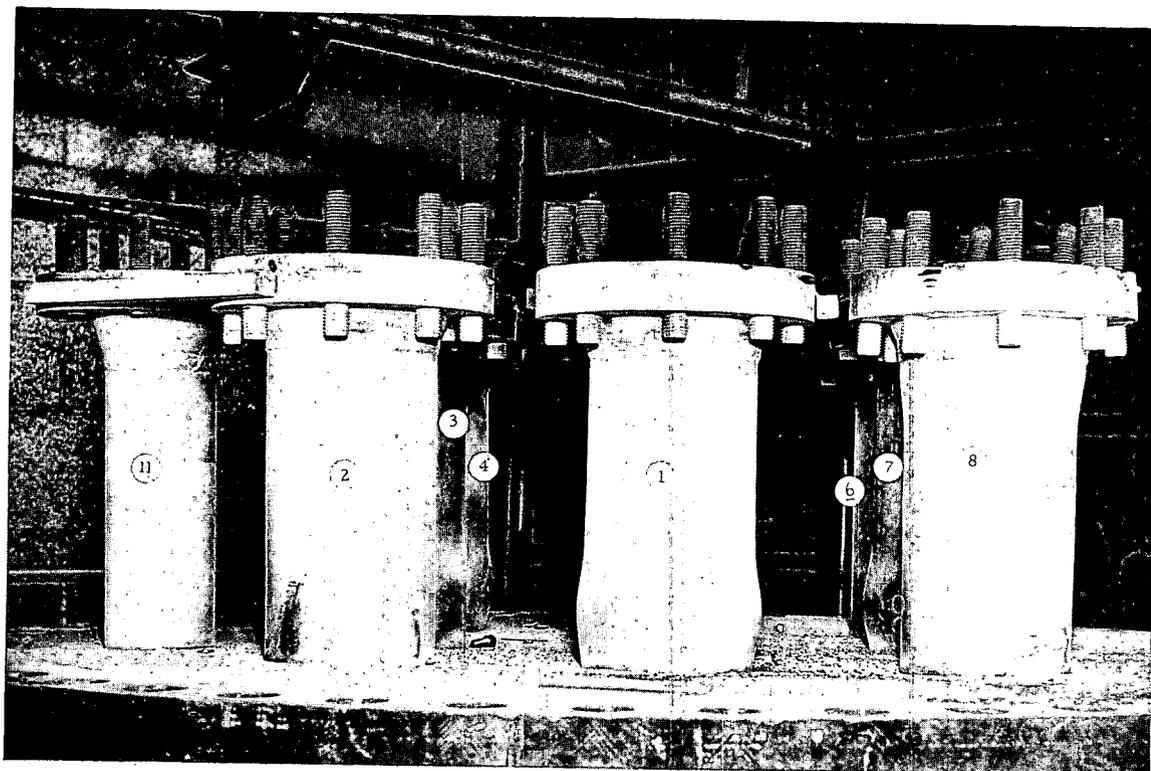
Figure III-38 Deformation of pressure vessel head nozzles

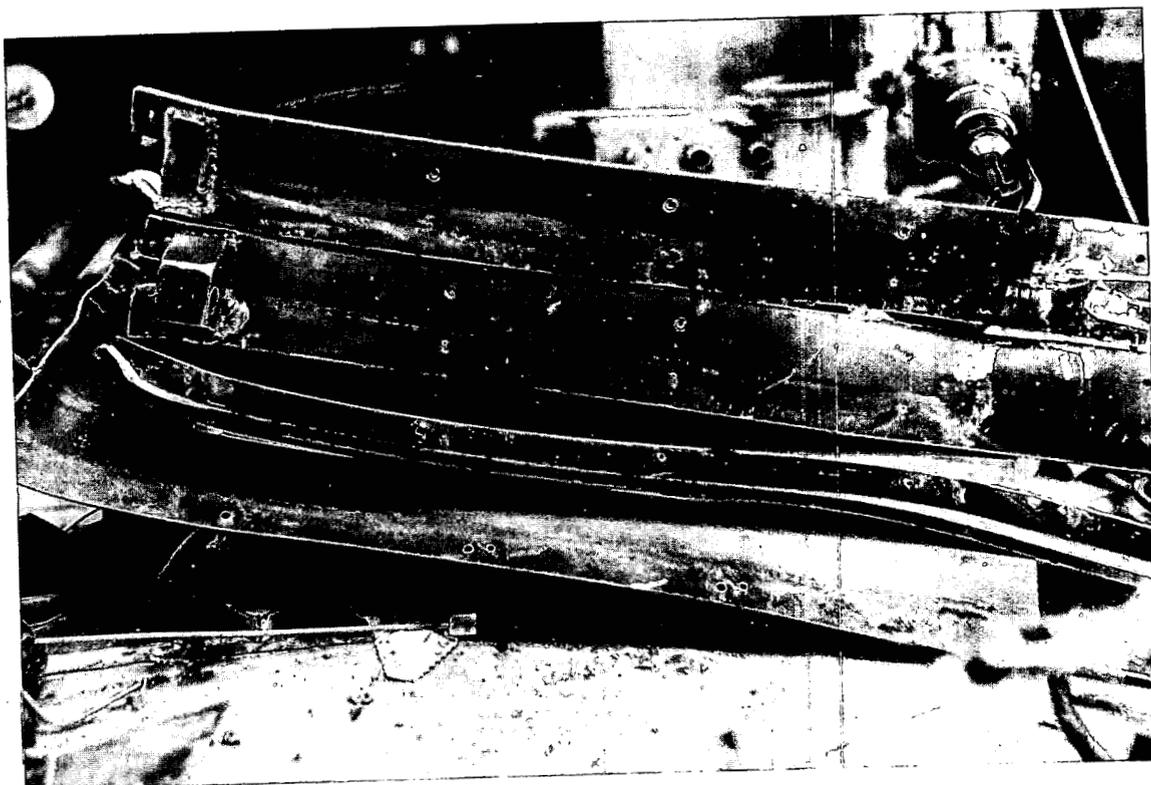
Observation inside the core (Figure II-52) shows vividly the results of the radial forces collapsing all the cruciform shrouds and binding a major number of the peripheral fuel elements between the shrouds and the thermal shield. Shrouds Nos. 1, 2 and 9 were removed from the core structure and revealed the damage to the lattice support structure which included the shearing of the bolt stud threaded to the core support bracket. A cross shaped stanchion was bent outward and the shrouds disengaged from the stanchion by the rivets which were sheared. Figure III-43 shows three tee-shaped stanchions, two with the lattice support pads sheared off and one still in place. All rivets on all stanchions, as shown in the figure, have been sheared.

Figure III-43, Core, Tee-Stanchions

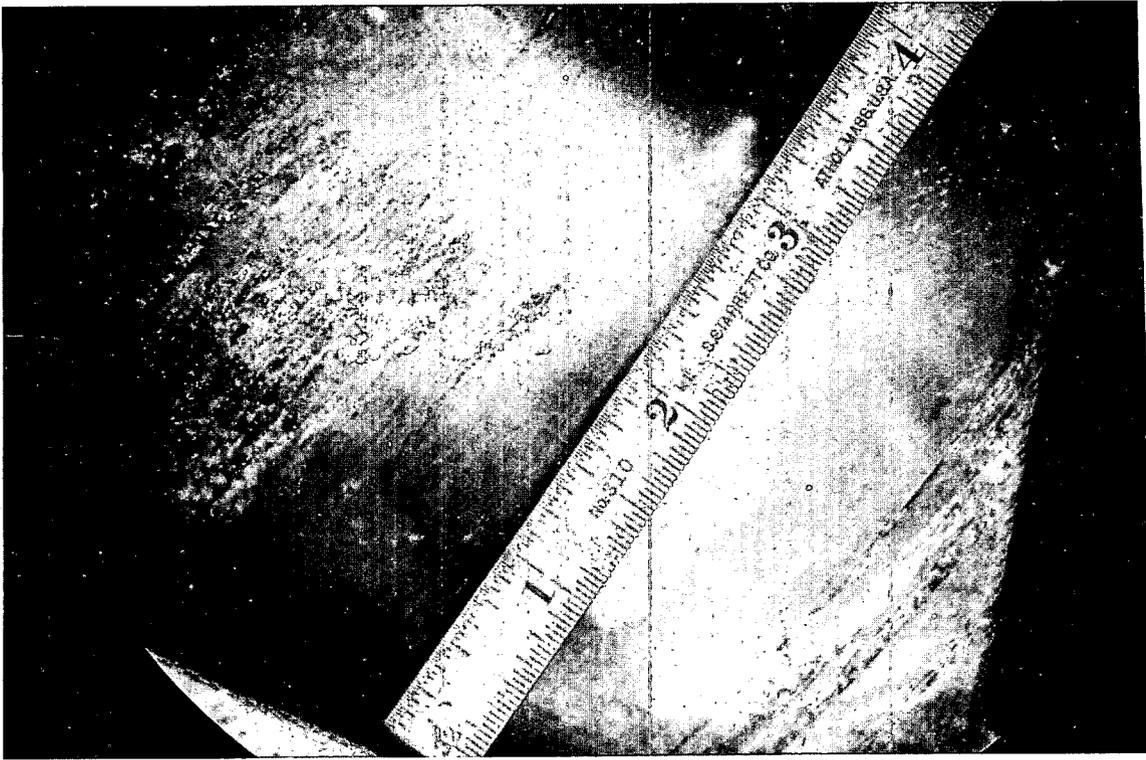
Figure III-46, Blade #1, note longitudinal marks.

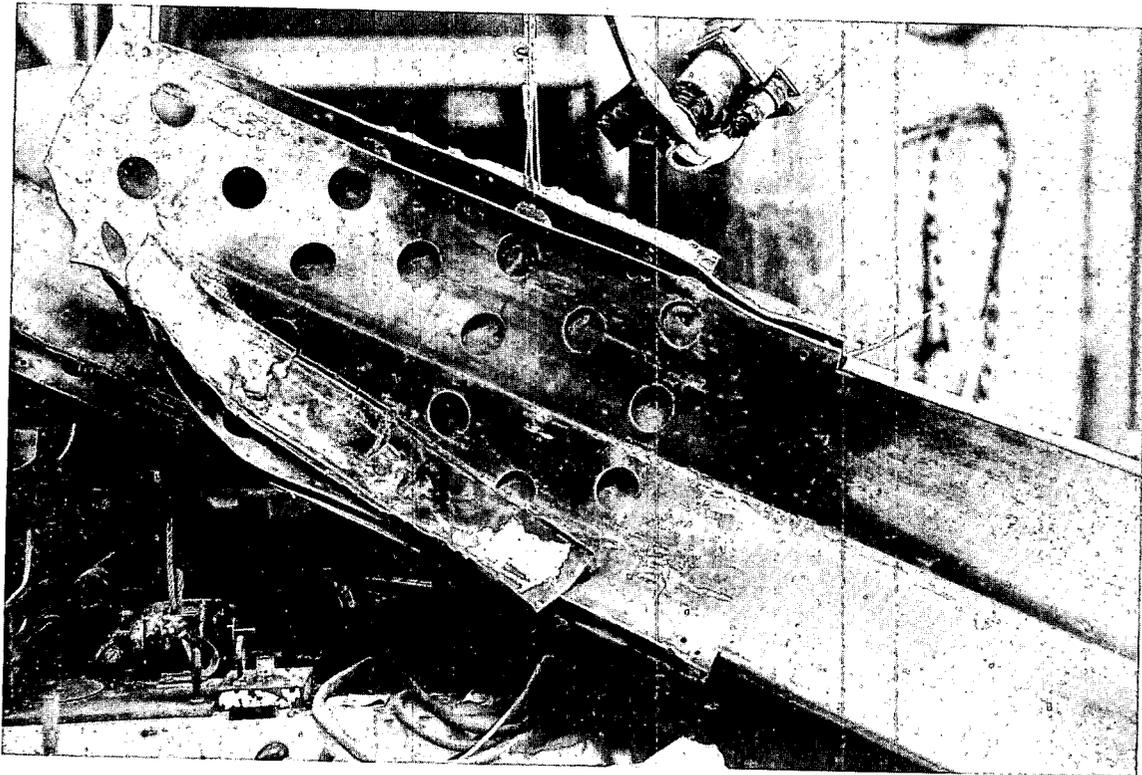
Shroud No. 5: This shroud had fuel plate E-674, element 50, very lightly attached to the face of the shroud by its being pressed into the relief holes (Figure III-50). The control blade extended 4-3/4 inches below the bottom of the shroud, but impact marks by relief holes indicate that the blade had moved downward 1-1/4 inches after impact. Rub marks are very pronounced along a major portion of the control blade and are of pre-incident origin (Figure III-51). Figure III-52 shows marks from the source cartridge and element 9 attached to shroud. The bottom section of the blade below the shroud also shows a considerable amount of sliding and abrasion marks. The shroud was collapsed radially outward and all rivets sheared. Seam welds were also partially fractured.

Figure III-50, Shroud Assembly #5.

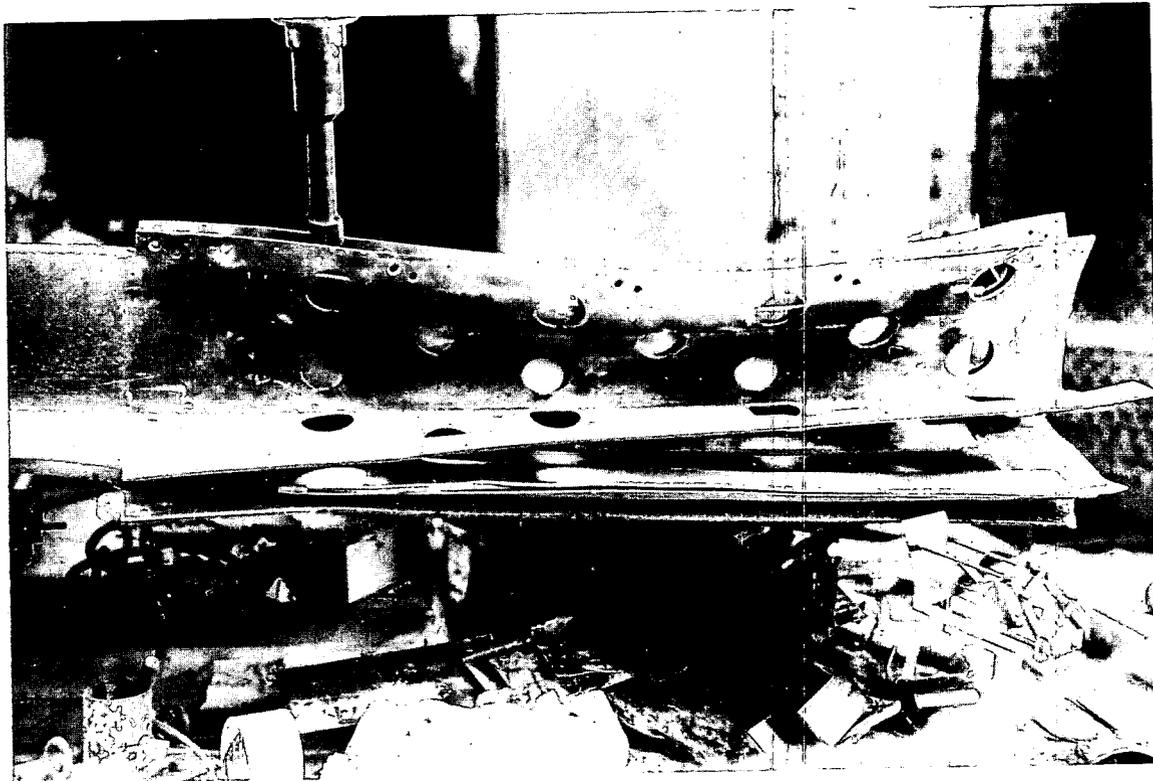
Figure III-53, Shroud Assembly #6.

Shroud No. 6: No fuel cartridges were attached to this shroud assembly. Figures III-53 and 54 show the separation of the cadmium blade edges. The welds at the upper end of the shroud appear to be partially fractured. One cadmium blade was 2-1/2 inches up from the bottom of the shroud, and the other two blades were 5 inches above the bottom of the shroud. One of the cadmium blades had the lifting fixture blown off. The tee-shroud was not collapsed but was deformed and all the rivets were sheared.

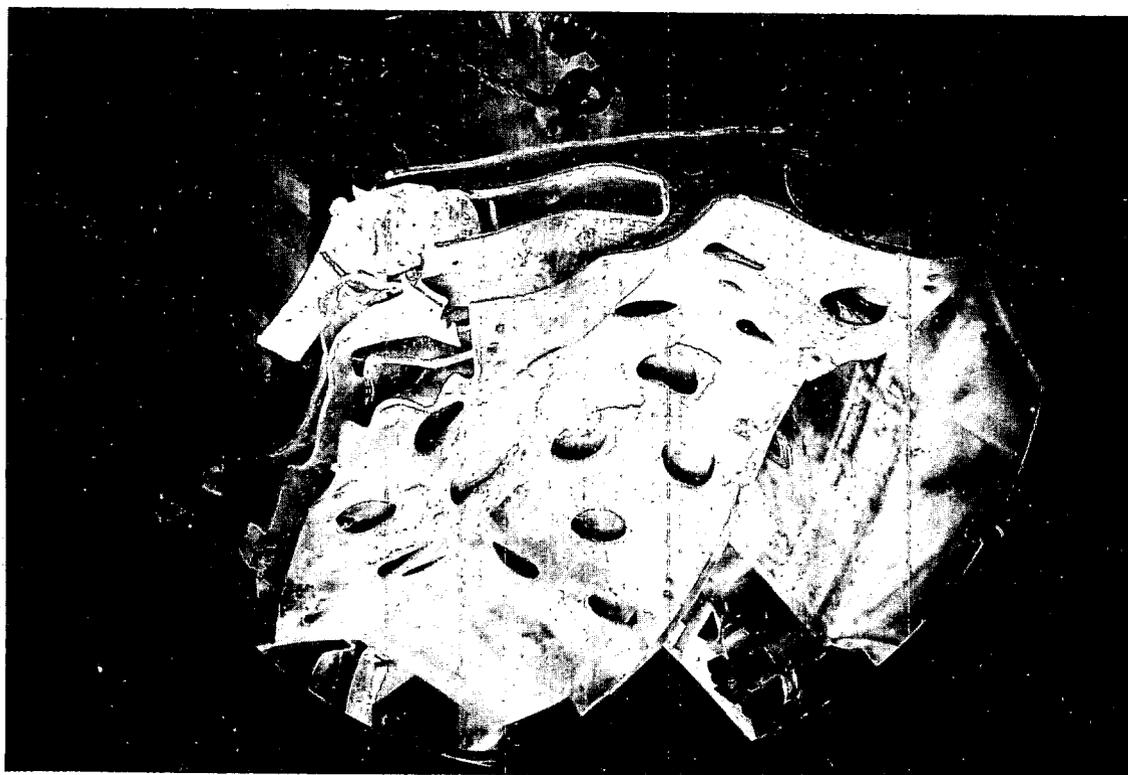
Figure III-60, Shroud and control blade #9.

Many scouring marks have been detected on the control blade. These marks appear to be of pre-incident origin since many of them are covered with splattered metal.

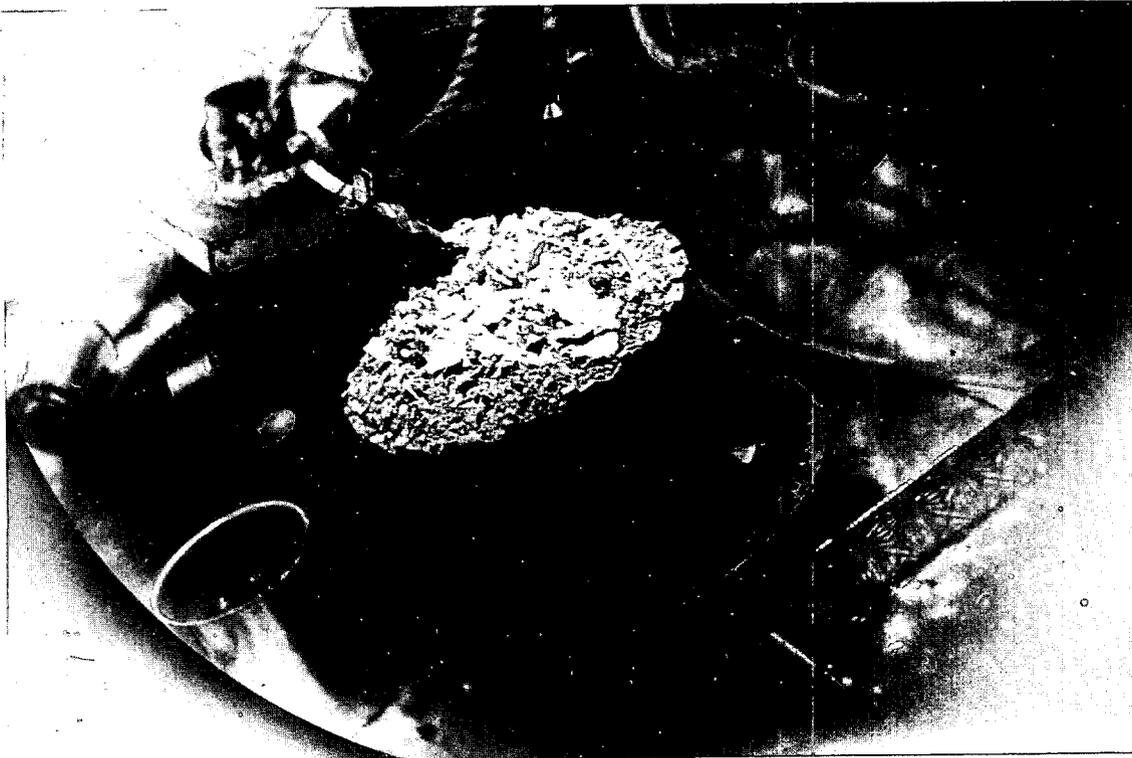
A considerable number of fragmented boron strips were recovered with the debris from the reactor pressure vessel. These pieces were not included in the inventory because of their lack of identification and difficulty in separation. Figure III-68 shows pieces of boron strips atop the cutter loaded with debris from the bottom of the core. An unanswered question is what percentage of flaking of the boron strips occurred during the incident and what took place during the preceding normal operation as reported in CEND-1005.

Figure III-68 Cutter Loaded with Debris from Bottom of Pressure Vessel

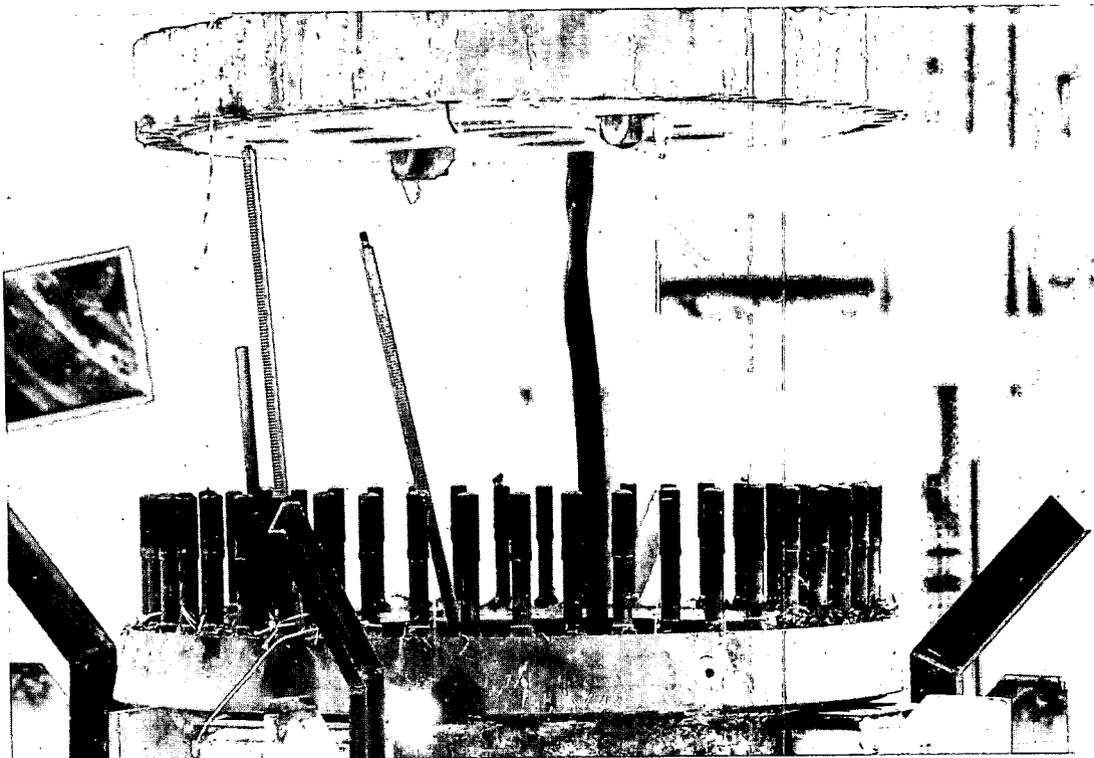
Figure III-69 Deposit Underneath Reactor Head Surface

A visual examination of the top of the pressure vessel, the inner walls and the fuel elements and shrouds produced evidence that the boric acid, leached from shielding atop the reactor, ran down these surfaces. Figure III-69 shows evidence of boric acid deposits on the top cap. This residue, deposited as boric acid, ran under the ring over the top cap and into the core through the opening between the top cap and the pressure vessel. Upon removal of the top cap it was noted that the complete under side area (approximately 23.5 square feet) was covered with the boric acid deposit. An analysis showed that 40 grams of boric acid had been deposited in this region.

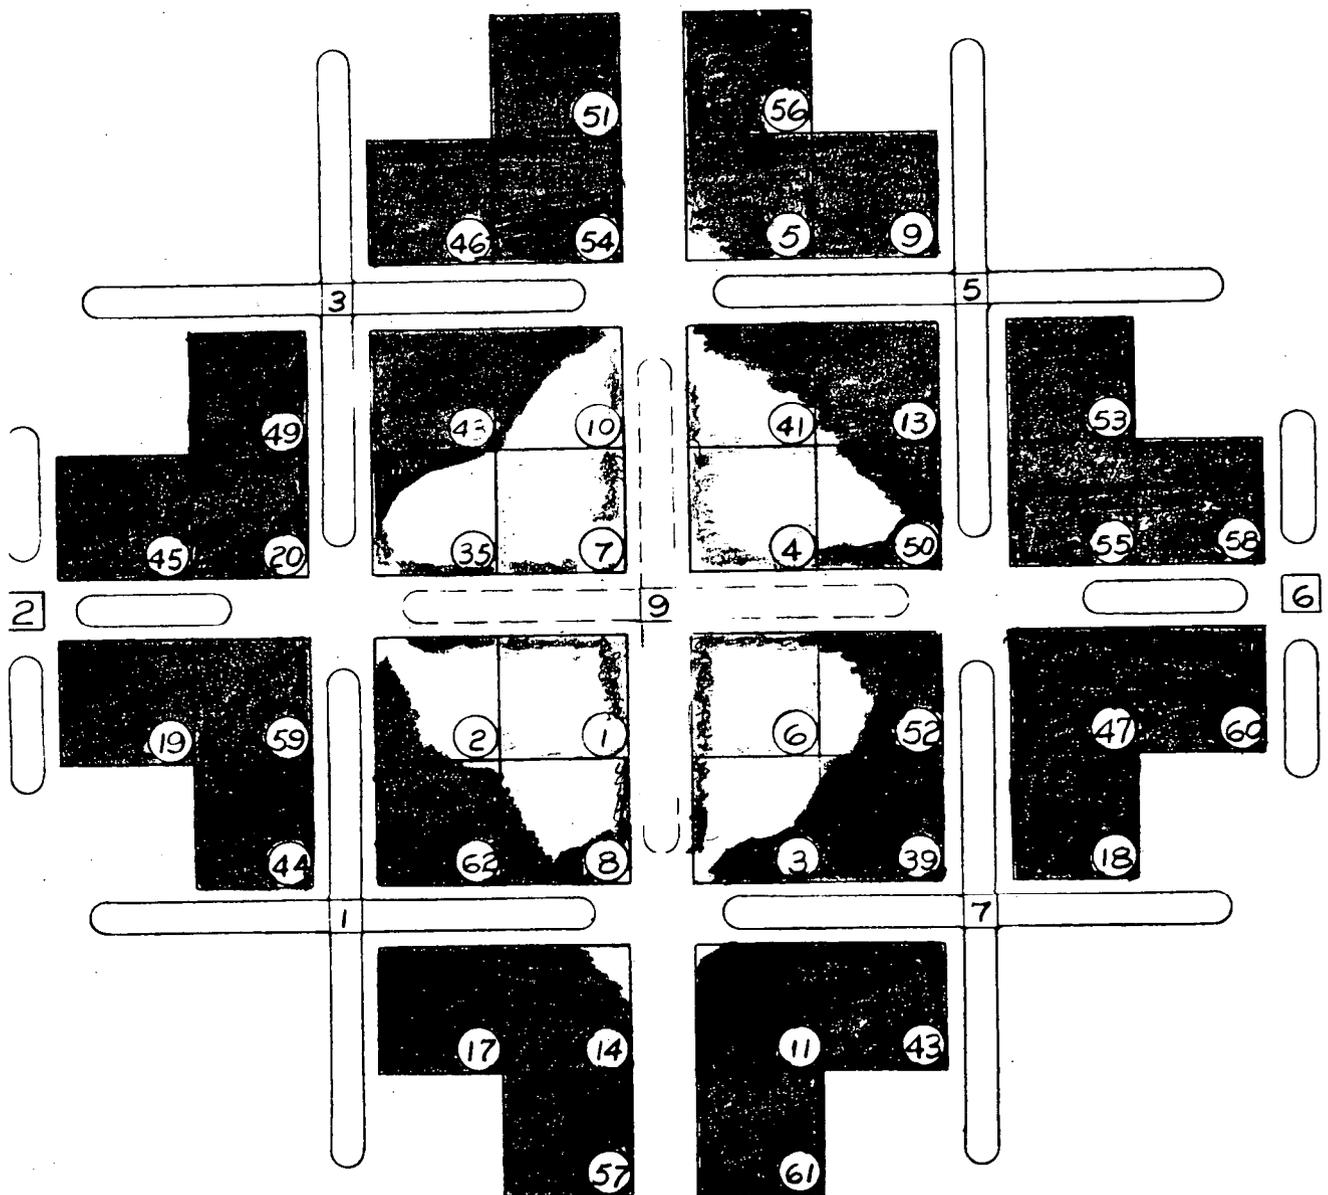
Figure III-70 is a schematic view showing approximately the damaged areas of the core (averaged throughout the vertical direction). The darkened areas represent intact or unaffected parts of fuel elements; the light areas represent the destroyed portions of the fuel assemblies. The four center-most elements were severely destroyed so that only the top 4 to 6 inches of fuel plate remained intact, with slightly less destruction adjacent to the central control blade.

Figure III-70 Schematic View of Core, Showing Areas of Destruction

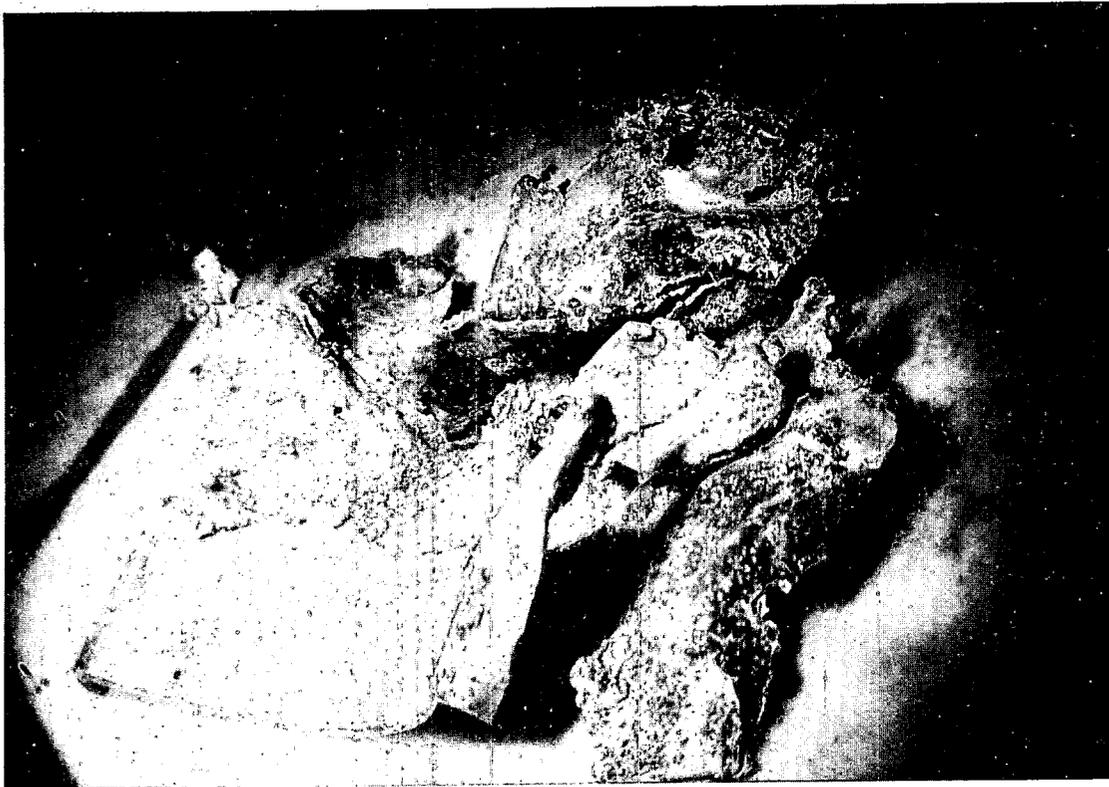
By August of 1961, the only amount of significant fuel material recovered external to the reactor was four (4) small pieces on the fan room floor. See Figure III-71. Examination of these pieces showed that most of the fuel matrix melted and virtually exploded away from its clad, leaving behind a small amount of sponge-like fuel material. Most of the clad and side dead edge was relatively unaffected. The corrosion film still was evident on the pieces but for the most part it had spalled off. The trailing dead edge of one piece shown in the figure was unaffected and the corrosion film remains intact.

Figure III-71 Sections of Fuel Plate Recovered from Fan Room Floor

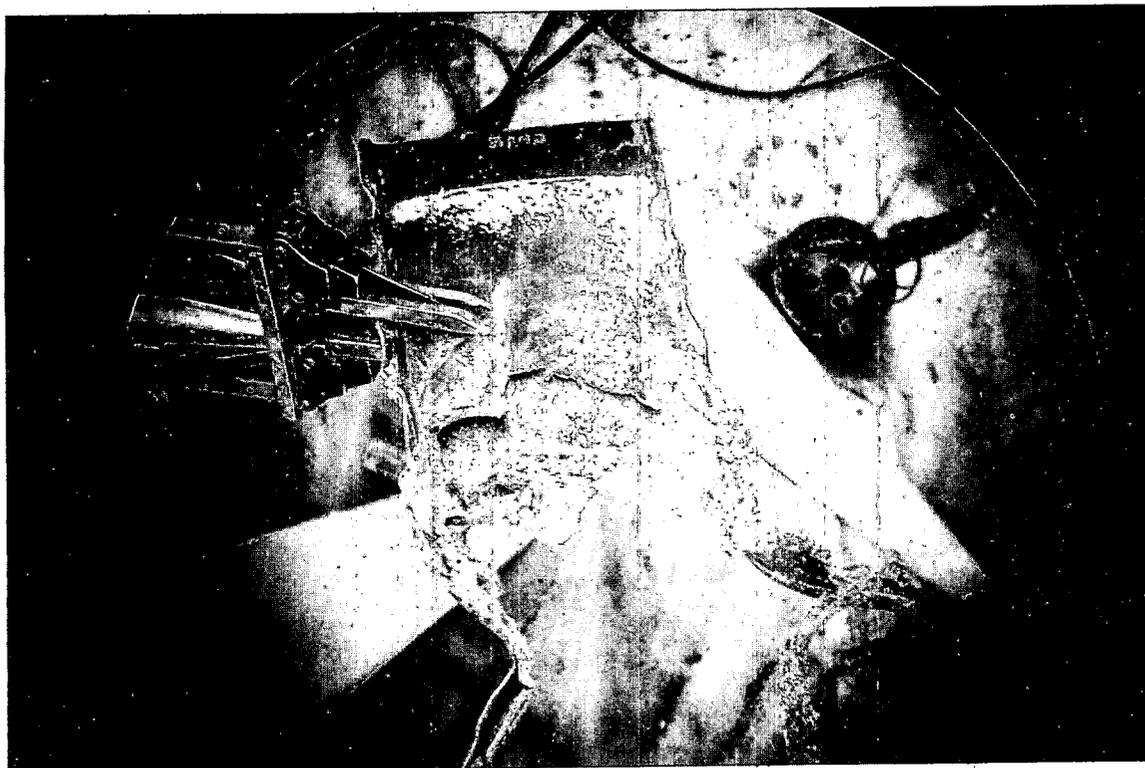
Figure III-72, Section of Fuel Plate from Element #7

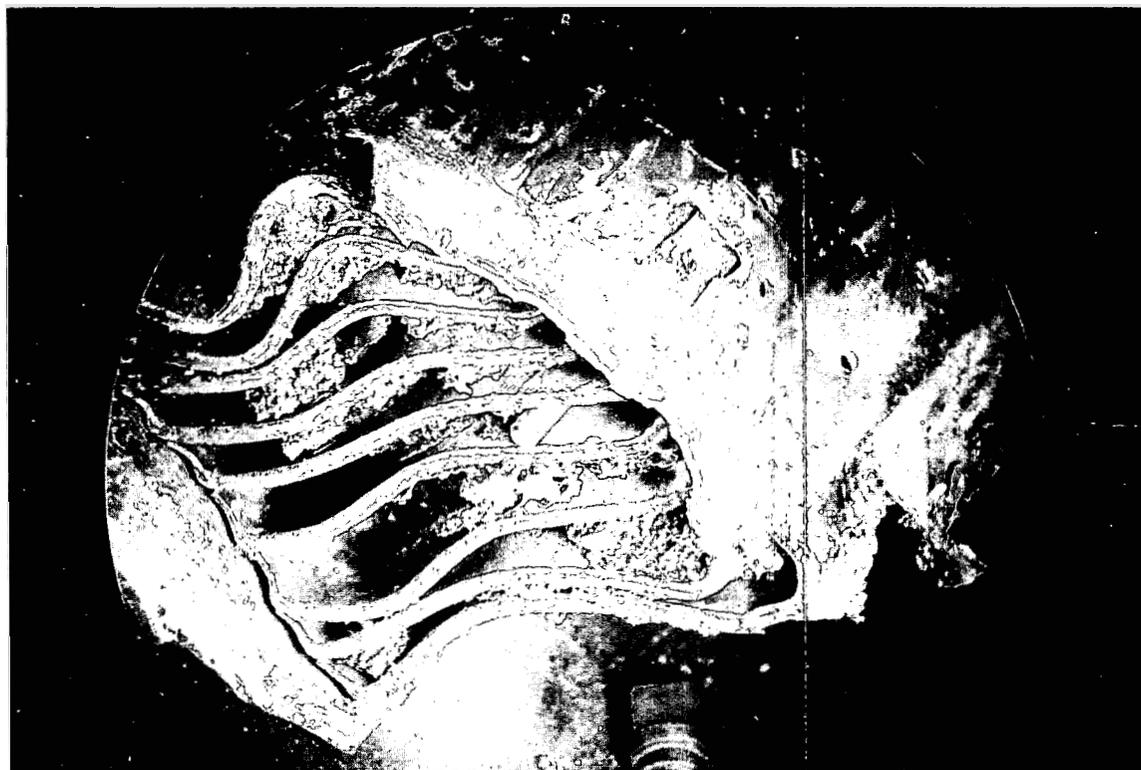
Figure III-74 Extraneous Material in Fuel Element #52

Figure III-74 shows the lower end of fuel element #52 with the spaces between plate filled with some molten material, sponge-like material and unmelted pieces.

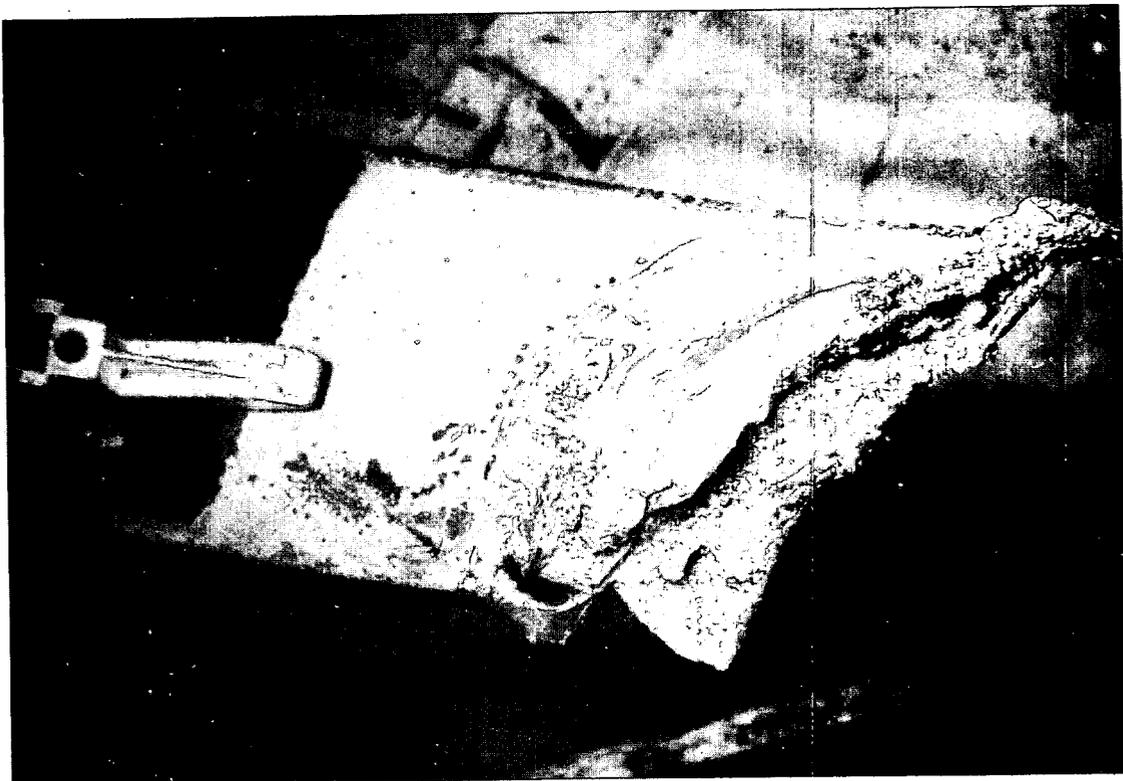
A section of fuel plate recovered from a center section fuel assembly, shown in Figure III-76, is typical of damage sustained to many individual fuel plates that were blown off their assemblies. The darkened area, Figure III-76, indicates the leading dead edge with the corrosion coating relatively unaffected. It is estimated that it experienced only a moderate rise in temperature; probably in the range of 300°-450°F.

The light area, the corrosion coating having spalled off, shows undisturbed plate. This indicates a heat affected zone in the temperature range between 1000°-1150°F.

The disturbed area, characterized by the folds in the clad, probably reached a temperature between 1250°-1320°F. The fuel matrix in this region was above molten temperature, 1350°-1450°, and was ejected from the clad plate. There is no evidence of molten material having flowed out between the plates, although there is a small amount of sponge-like material along the edges of the plates.

Figure III-76, Fuel Plate from Fuel Element #4
Showing Heat Affected Zones

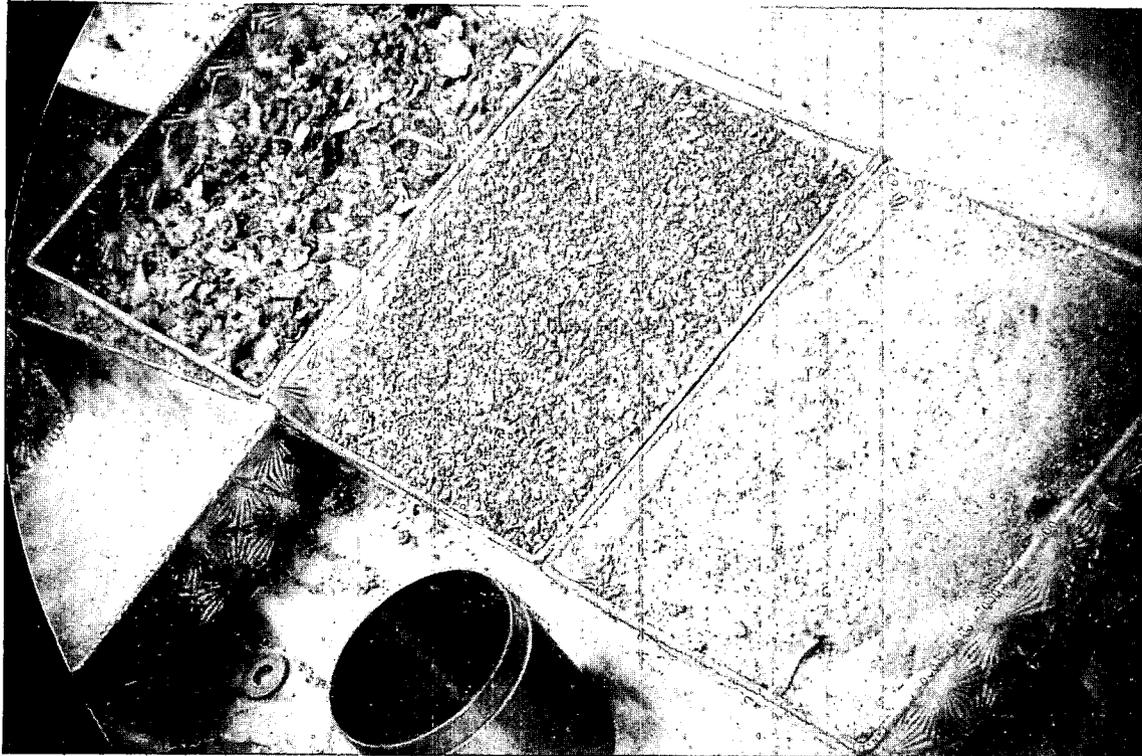
Examination showed the debris from the pressure vessel contained a large quantity of fuel material fragments. See Figure III-78. The small pieces, identifiable as fuel plate material, has a sponge-like appearance. Figure III-73 is a photograph showing fuel material which was ejected from fuel element #3, one of the center 16 elements, and has practically filled the relief hole of shroud #7.

Figure III-78 Screened Debris Recovered from the Pressure Vessel

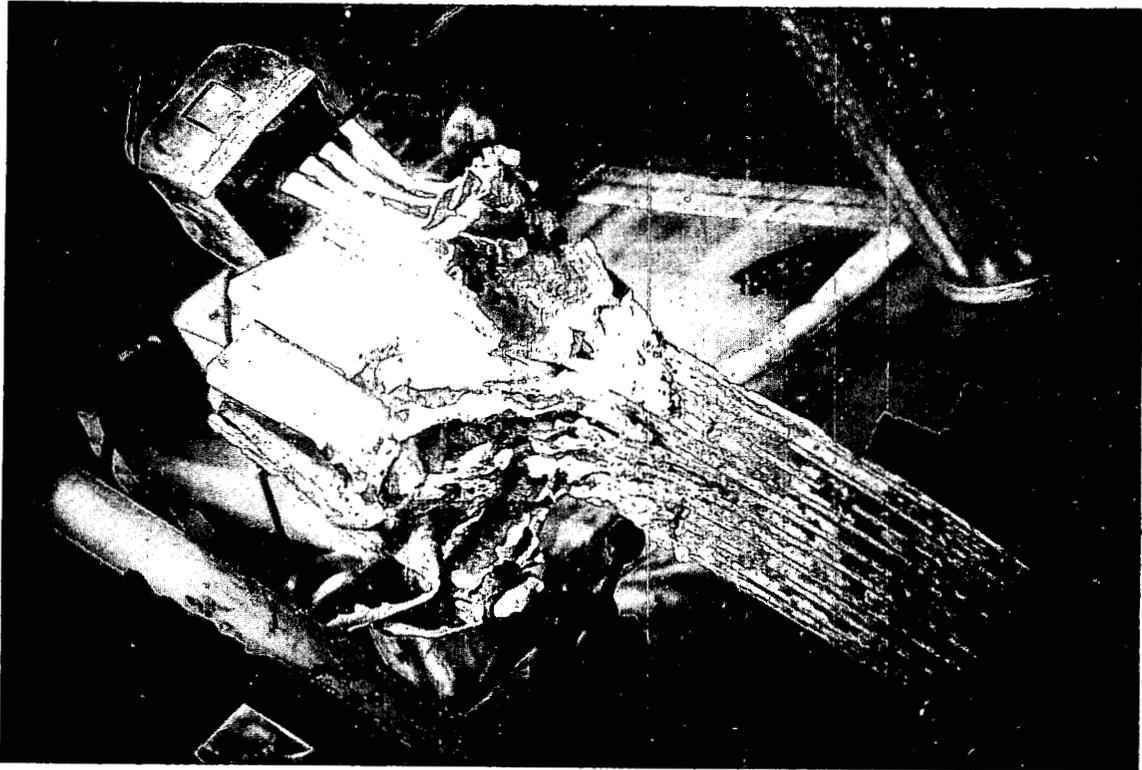
Figure III-81, Upper Section of Fuel Element #4
