FINAL REPORT
OF
SL-1 RECOVERY OPERATION

SL-1 Project
Idaho Test Station
General Electric Company
July 27, 1962

United States Atomic Energy Commission
Contract No. AT (10-1) 1095

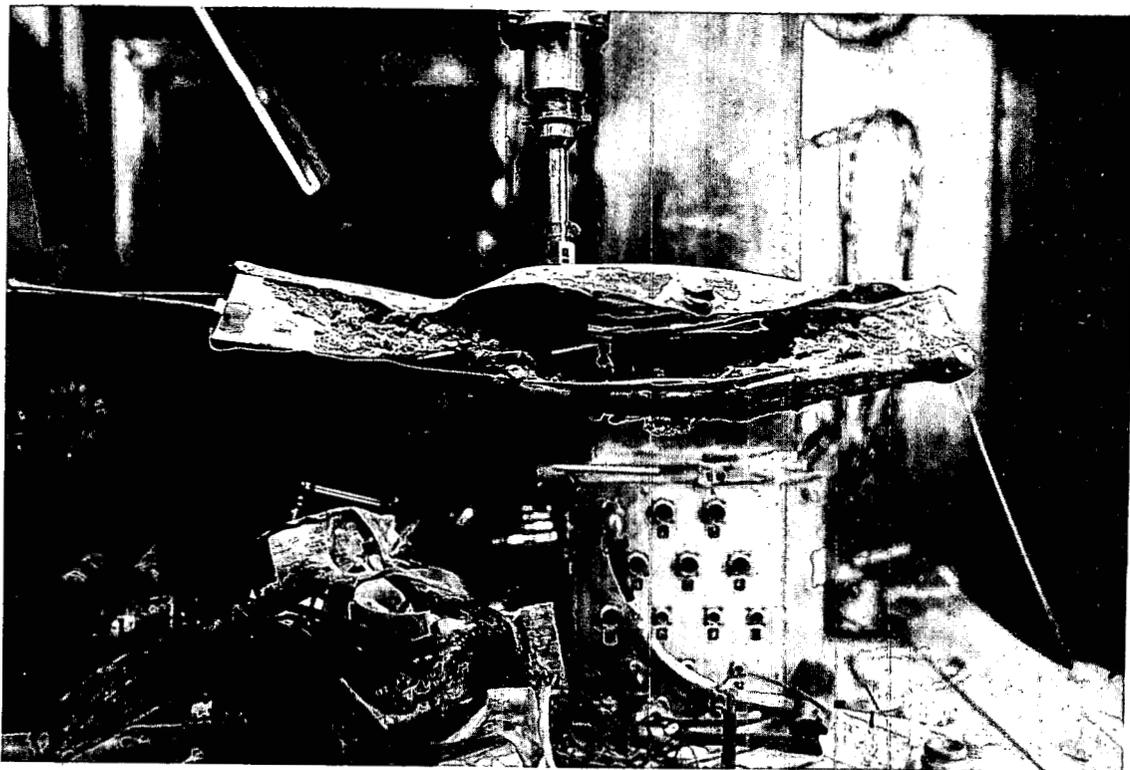
Figures III-82 and 83 show one of the center 16 fuel elements, fuel element #3, which was over 50% destroyed. The center of greatest destruction is approximately 3 to 4 inches below the midpoint of element. However, both side plates remain relatively intact, the two flux wire assemblies were unaffected, and residue of fragmented and melted material was blown both upward and downward into the spaces between the fuel plates. Figure III-83 shows that a portion of the outer fuel plate is missing. The missing portion of plate was found attached, but unbonded, to the neighboring shroud. The portion of plate was intact, distorted and partly splattered with metal.

Figure III-82, Fuel Element #3

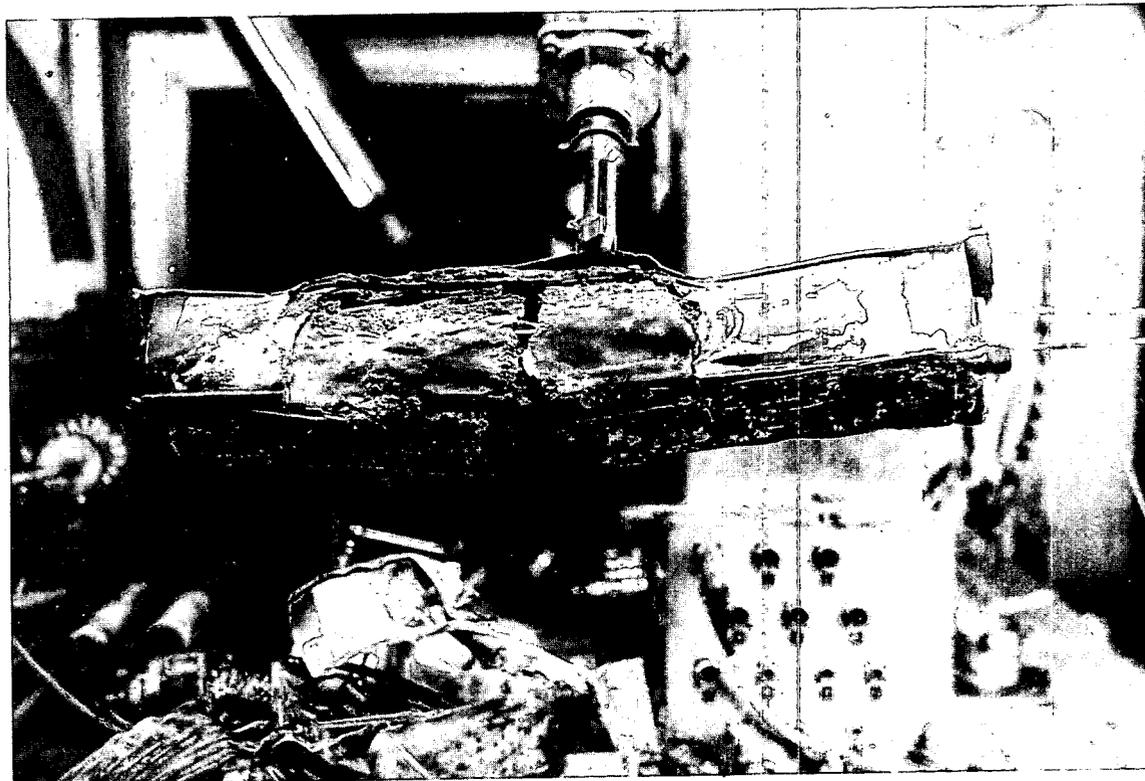
Figure III-83, Fuel Element #3

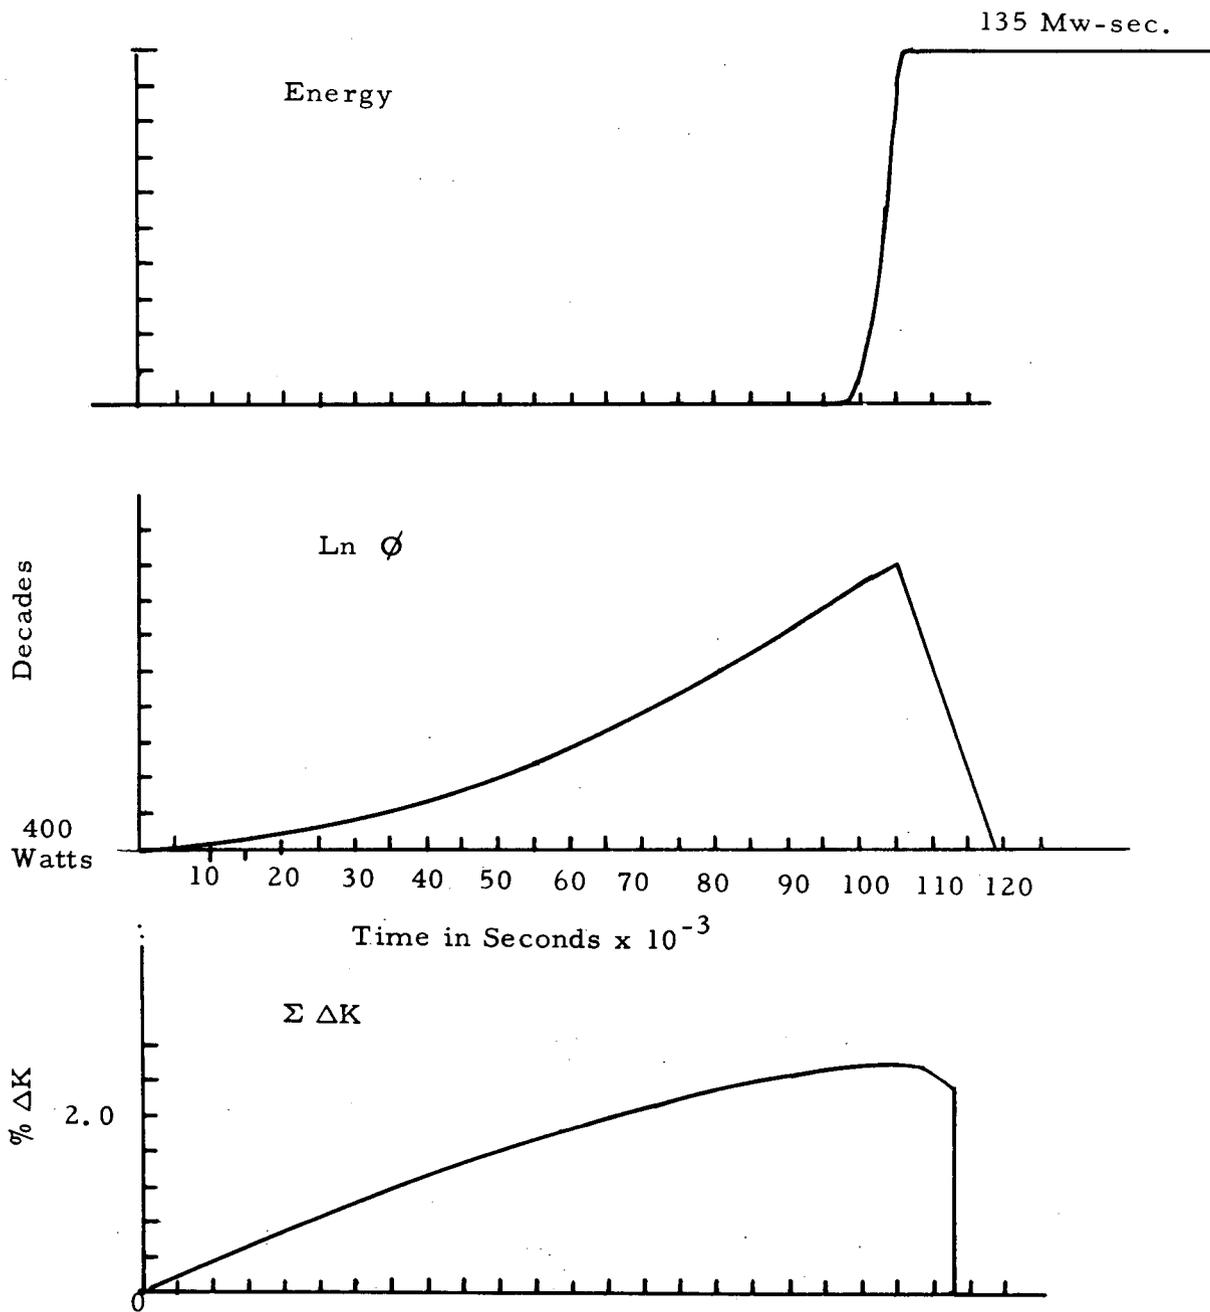
Figure F-2 Typical Transient Power Run

The major remaining portion of the shutdown must come from steam void formation. As discussed earlier, this mechanism is quite complicated, but is evidently delayed by approximately 3 milliseconds, for short period excursions, from the time the

plate surface temperature reaches 100°C until the appearance of any steam voids. The 130 Mw-sec total energy generated in the excursion was used as a constraint on the shutdown mechanism. It was found that without a delay between saturation temperature on the plate surface and the beginning of void formation, it was impossible to achieve a reasonable power trace in which the feedback was proportional to energy and the total accumulated energy was about 130 Mw-sec. For the tests of simulated rod-withdrawals, discussed in Section III-4.6, the excursion was made to approach a chopped exponential, a condition approximating the bursting of plates due to vaporization. Such an approximation will have little influence on the conclusions derived concerning the rate of reactivity insertion and the position of the central control rod at the peak of the excursion.
