General Public Utilities • Electric Power Research Institute • U.S. Nuclear Regulatory Commission • U.S. Department of Energy

Examination Results of the Three Mile Island Radiation Detector HP-R-211

October 1981

Sandia National Laboratories
Albuquerque, New Mexico 87185
and
Livermore, California 94550

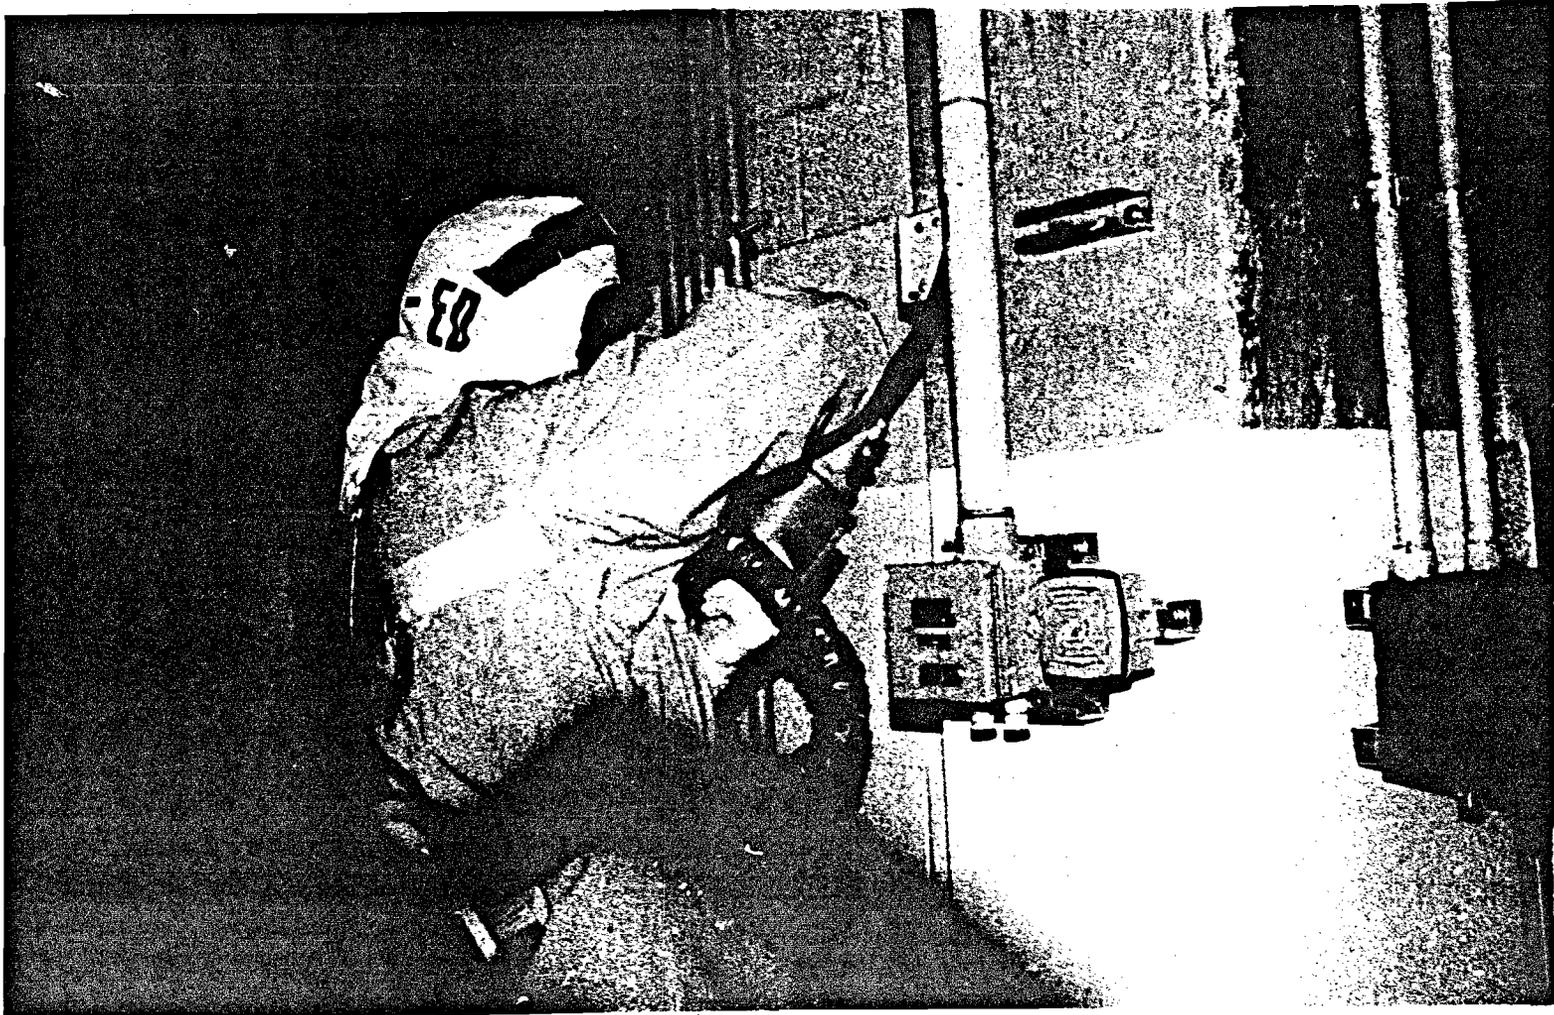
FIGURE 3. Detector Removal. The detector has been removed from the wall slide bracket and the cable is being disconnected.

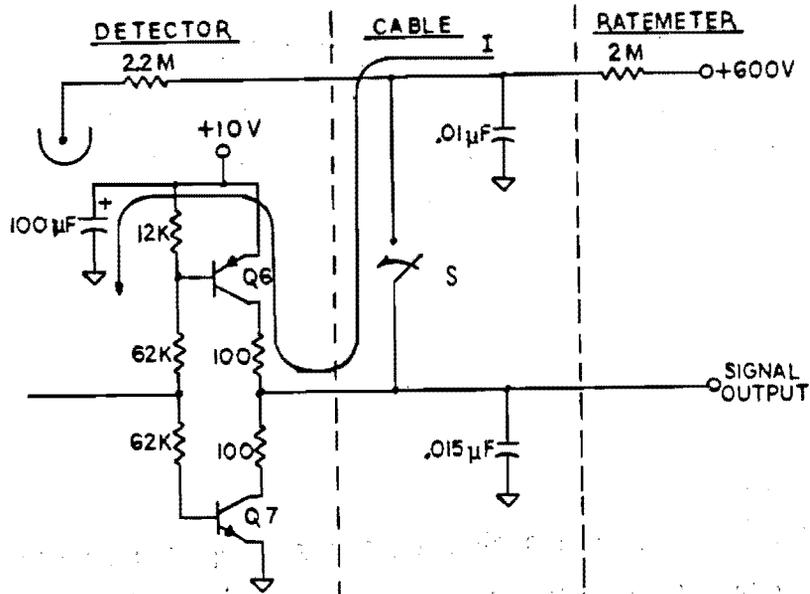
To investigate this postulated mode of failure, several laboratory simulations were conducted and will now be discussed. The presence of the 100 ohm current limiting resistors in the signal output line preclude Q6 from being destroyed by a short of the signal line to ground. In fact, DC shorts were made from each connector pin to the next, using the test channel, and a failure could not be induced. The 600 Volt line has a 2 Megohm current limiting resistor at the ratemeter; even though the transistor can break down, the steady-state current is limited to only 300 Microamperes. No discharge paths were found on the circuit board. Recall however, that some 152 M (500 ft.) of cable connects the detector to the power source. We found that the energy stored in the line capacitance was sufficient to cause punch-through. This was found by conducting the following experiment (refer to Figure 16): Capacitors of 0.015 μ F and 0.01 μ F were connected to the signal output and 600 Volt lines going to the test detector to simulate the charges stored in the 50 Ohm and 75 Ohm cable capacitances. A switch was then thrown to discharge the capacitor on the 600 Volt line into the signal output. This results in a surge current of approximately 6 amperes. The circuit diagram shows a possible current path, I.

FIGURE 16. Test Circuit Showing Energy Discharge Path

We opened and closed Switch S repeatedly while constantly monitoring the signal output line. After approximately 40 closures the "0" level voltage had increased to 6.65 Volts. After 80 closures, the transistor in slot Q6 was removed, tested and found to exhibit a 96 Ohm collector-to-emitter resistive path, similar to that in the failed detector. No other circuit defects were observed. Tests have been conducted on four other 2N 3906 transistors from a different manufacturer and on two higher current 2N 2904's. All could be made to fail with a single discharge, but only if the 100 Ohm current limiting resistor was decreased. One 2N 3906 failed when the resistor was 72 Ohms, however, all others required lower resistance. The capacitive model of the cable does not simulate exactly the cable characteristic impedance of 75 Ohms and stored charge, since the cable is a transmission line and will appear to have a 75 Ohm source impedance. Since the line is not

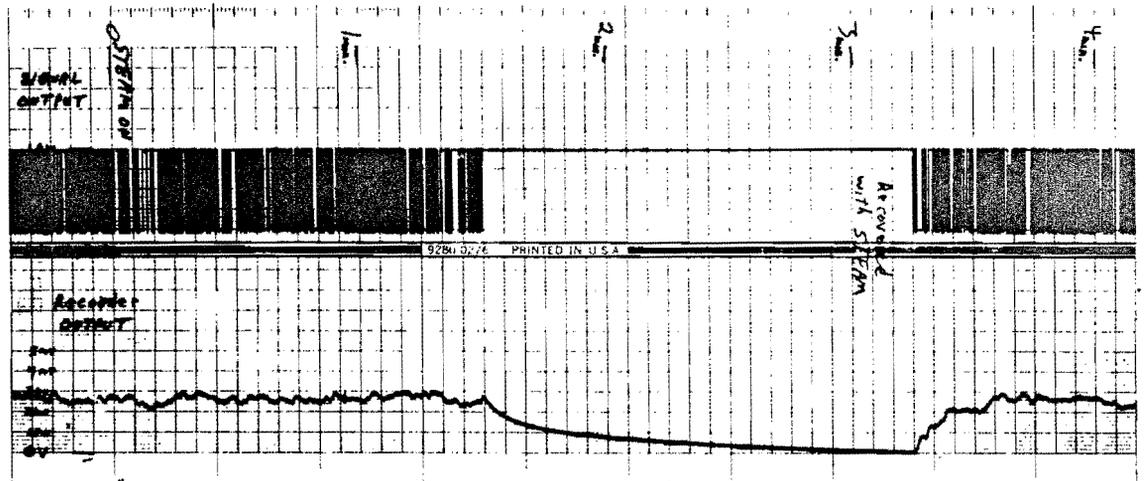
tive paths between pins can form quite abruptly and disappear as fast. Interestingly, even in the presence of steam, the path can open quickly and remain open. This is illustrated in Figure 17a. Here, using the test detector and its connector, we deposited NaOH of PH 12.7 on the surface and allowed the water to evaporate. We then directed steam onto the surface, and after 100 seconds the signal output dropped to zero indicating a reduction in the 600 Volt to somewhere below 380 Volts. A minute and a half later the detector recovered and did not fail again even in the presence of steam. What happened was that the sodium ions were attracted to a more negative terminal, the surface near the 600 Volt pin was depleted, and conduction terminated. In fact, water ceased to wet this area and even to form droplets there. Figure 17b shows the 600 Volt line in the test where a large droplet of NaOH had been introduced between pins. The 600 Volts decreased abruptly then rapidly increased time-after-time (the 0.01 μ F capacitor was used to supply energy). Tiny arcs could be seen around the 600 Volt pin. Each one of these delivered energy to ground or to ground through another pin.

FIGURE 17a. Steam on a Contaminated Backshell. A detector connector backshell was exposed to steam after the backshell was first contaminated with NaOH. NaOH was introduced and then allowed to dry before steam was applied. The top trace is the signal output, and the lower trace is the ratemeter output. The detector failed after about 1.5 minutes of steam, but recovered even though steam was still being applied.

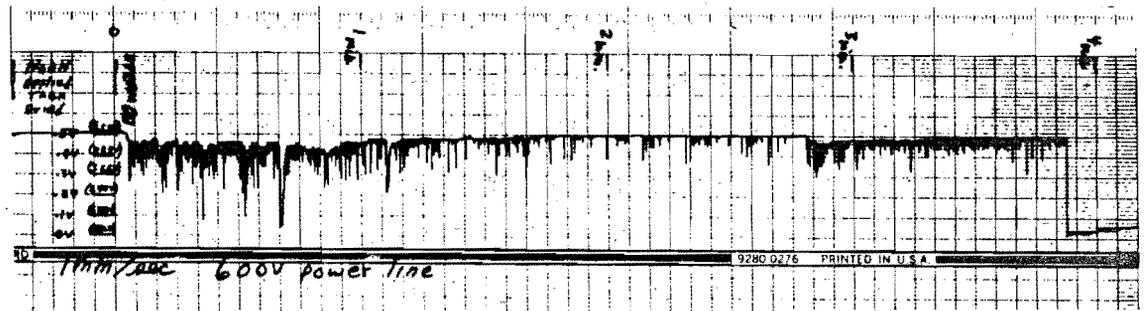
We conclude from these tests that a large droplet of water or spray was not in the connector shell due to the absence in the strip-chart recording of any long duration short or repeated signal irregularities. A highly contaminated connector, introduced abruptly to only a small puff of steam, is sufficient to produce the single drop-out noted. The presence of sodium is indicated, and it is possible that even though a single discontinuity was observed other short duration discontinuities could have occurred without being registered on the stripchart recording.

FIGURE 17b. Large Droplet Formation. A similar experiment to that shown in Figure 17a was conducted, except that here all of the detector pins are covered with a water droplet. The 600 Volt power line is plotted versus time. Repeated surges are delivered to a load during each breakdown.

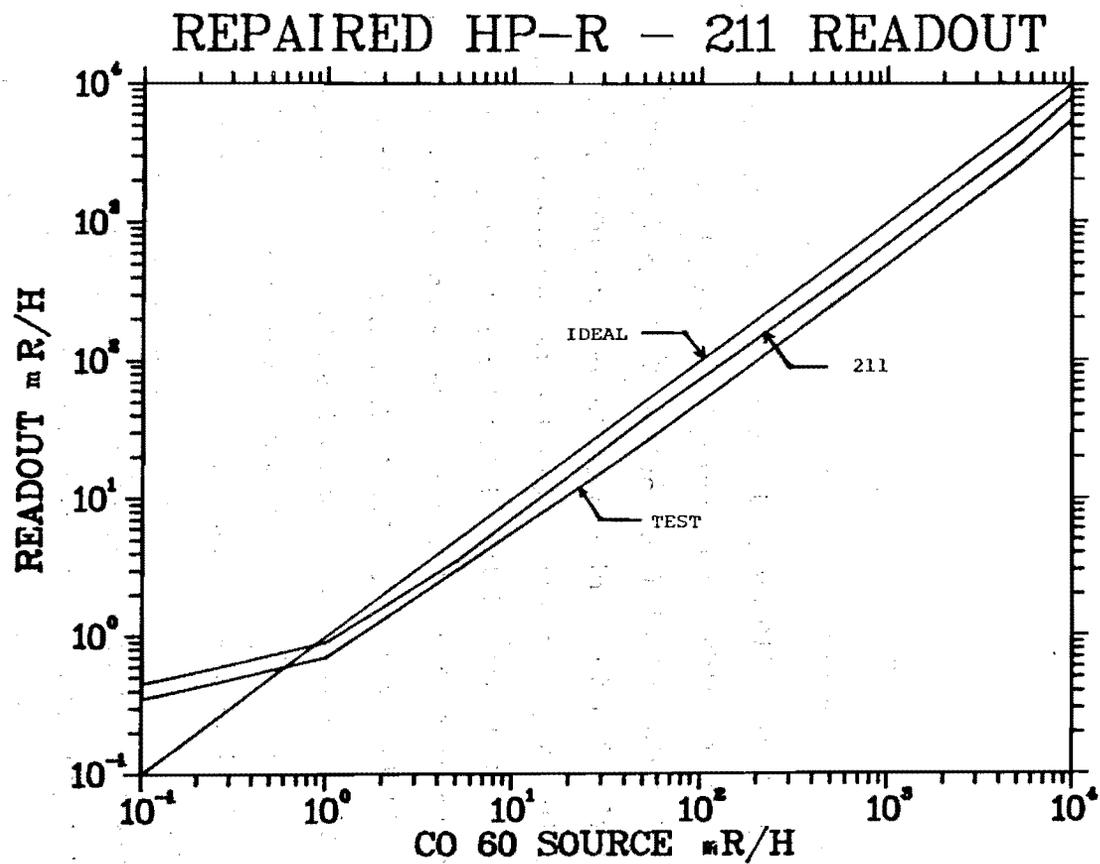
FIGURE 19. Repaired Detector Characteristics. The curve labeled 211 is a plot of the HP-R-211 readout versus Co-60 source level using the test channel ratemeter. The ideal input vs output is shown. The two curves differ by a calibration factor associated with each GM tube. So that there be no mistake that HP-R-211 is operating properly, the test detector is included for comparison. This curve also shows the need for ratemeter calibration. The changes in slope at low radiation levels are due to normal background radiation.

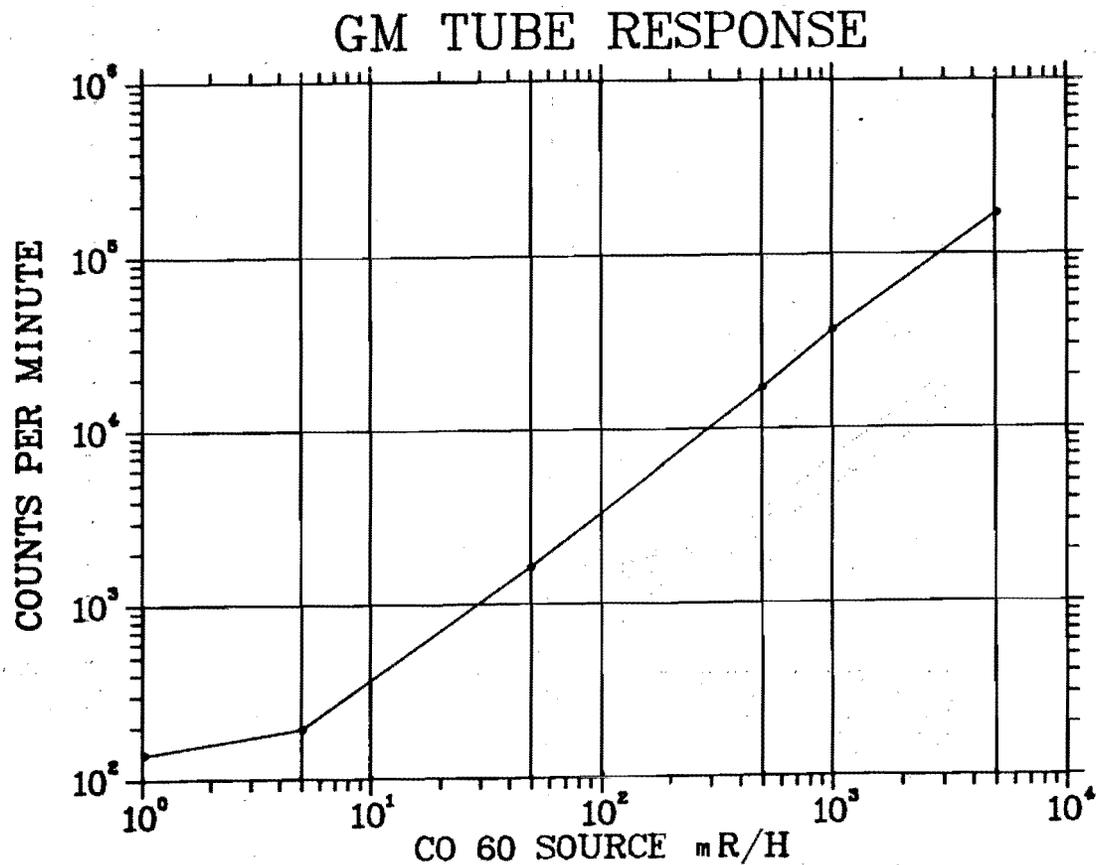
FIGURE 20. GM Tube Characteristics. The detector counts-per-minute are plotted vs gamma source level as measured with a frequency counter. Since the detector was contaminated, the lower end of the curve has a slope change.

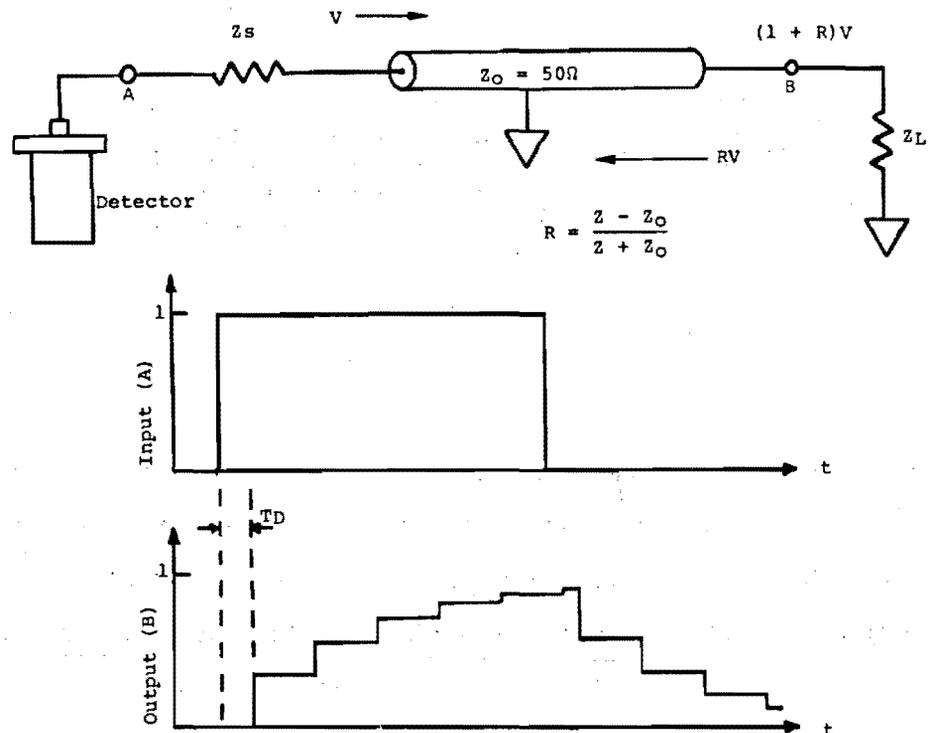
The dip has, in fact, been determined to be due to two items: impedance mismatches between the coaxial cable and both the detector and ratemeter circuits, and GM tube circuit interactions above the antijam point. First, and probably most importantly, the detector output circuit is not designed to properly match in impedance the 50 ohm cable attached to it. The normal output impedance of the detector is approximately 100 ohms rather than 50 ohms. Further, the ratemeter input appears as an open circuit for the steady-state signal. This open circuit combined with the mismatched driver sets up reflections in the cable which have the same effect as filtering the signal. Since the ratemeter circuit is a linear log pump, both the amplitude and the frequency of the signal affect readout accuracy. Figure 22 illustrates the effects on the waveform of the mismatch. For a voltage V propagating down a coaxial cable of characteristic impedance Z_0 , the voltage across the load impedance Z_L is equal to $(1 + R)V$, where R is the reflection constant. If Z is the termination impedance, R is given by:

FIGURE 22. Input and Output Waveforms for a Mismatched Transmission Line ($Z_S = 250\Omega$, $Z_L = \infty$)

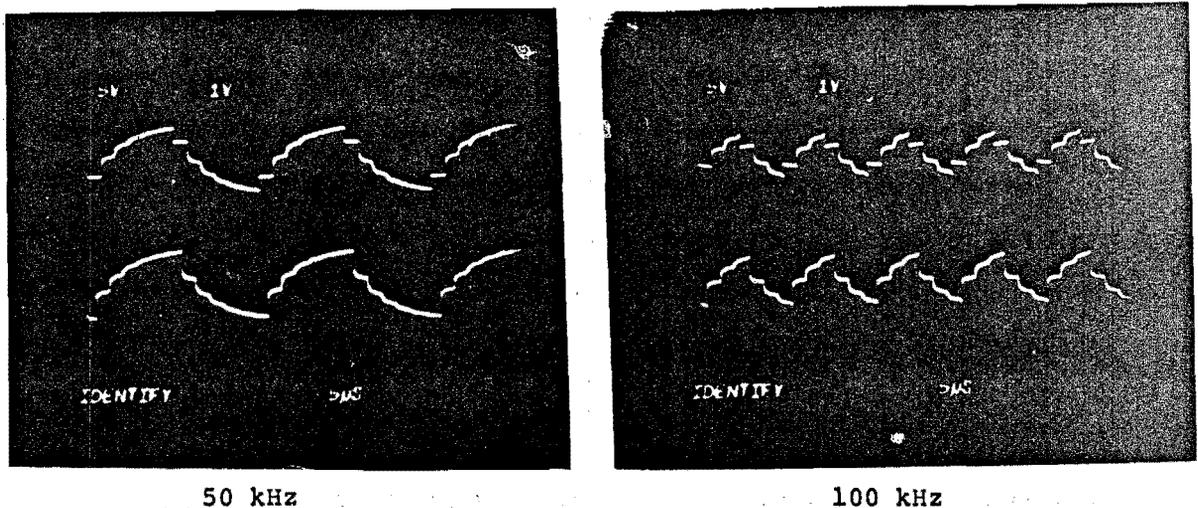
FIGURE 23. Mismatch Filtering. For both photographs $Z_S = 250$ ohms and $Z_L = \infty$. The top trace is the transmission line input voltage and the bottom trace is the output voltage. The input frequencies for left and right photographs were 50 kHz and 100 kHz respectively.
