CHARACTERIZATION OF EPICOR II PREFILTER LINER 3

Nancy L. Wynhoff V. Pasupathi

Published April 1983

Battelle Columbus Laboratories 505 King Avenue Columbus, Ohio 43201

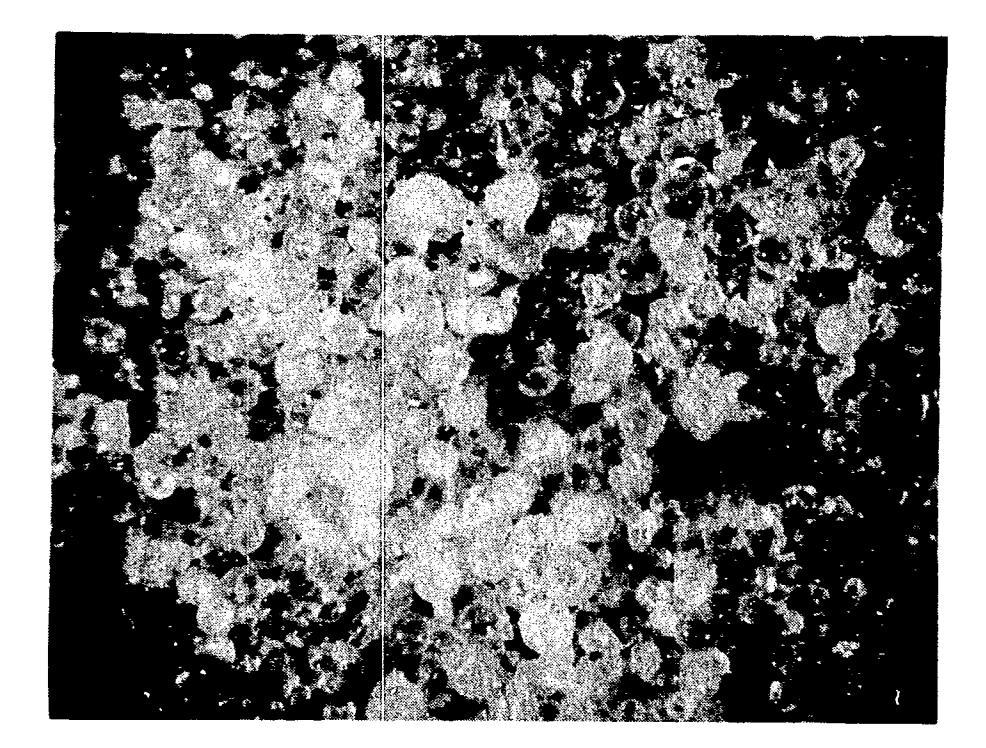
Using the hot cell stereomicroscope at $\sim 30X$ magnification, a preliminary visual examination of core sample #2 was made with ion-exchange media exposed by removing the shutter from the core sampler. A schematic of the core sample is given in Figure 16. Two distinct regions were observed. The bottom region, approximately 16 inches in length, consisted of regular-shaped, lightcolored, spherical particles that appeared translucent. These particles were yellow or orange in color. Figure 17 is a photomicrograph of this region. The top 8 inches of the core sample appeared darker than the bottom region. This region consisted of translucent, spherical particles in varying shades of dark and light and irregular shaped particles which were dark brown or black and looked like charcoal. Because the identity of the material used in liner PF-3 is considered proprietary and is not available for use in this project, it is not possible to determine the reason why some of the spherical particles are darker in color than others. A photomicrograph of this region is shown in Figure 18. Figure 19 is a micrograph of the light, powdery material at the top of the media bed.

Figure 17. Micrograph of Core Sample, Bottom Region, 5 inches from bottom of core sample.

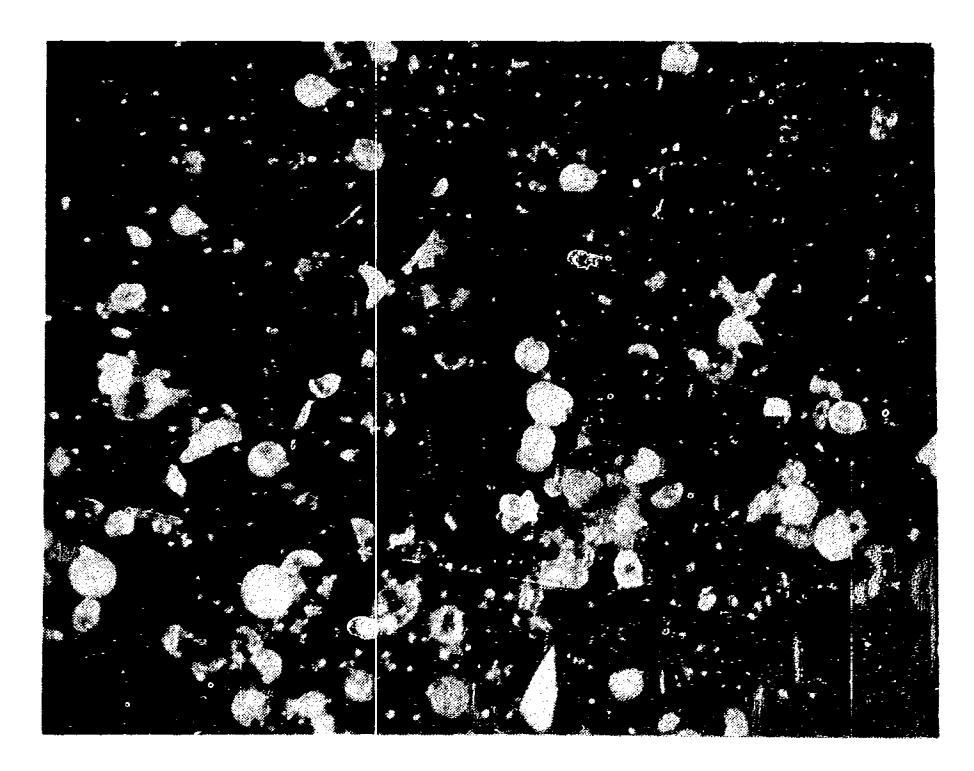
Figure 18. Micrograph of Core Sample, Top Region, 22 inches from bottom of core sample.

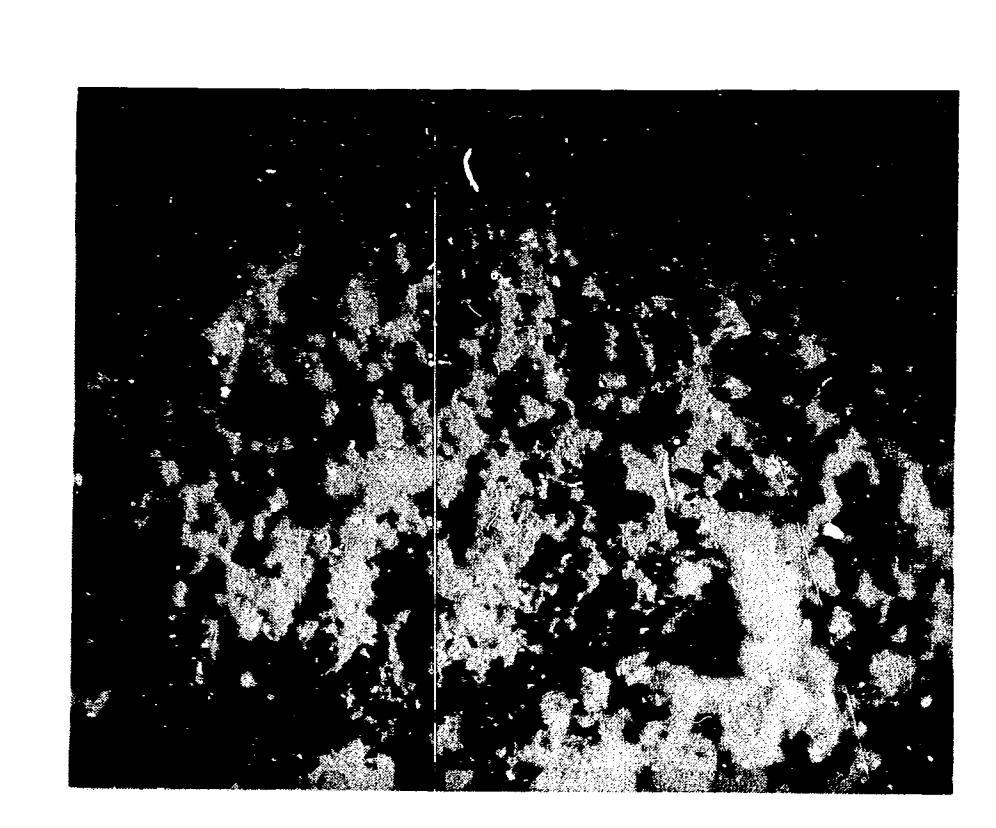
Figure 19. Micrograph of Light, Powdery Material at Top of Core Sample.

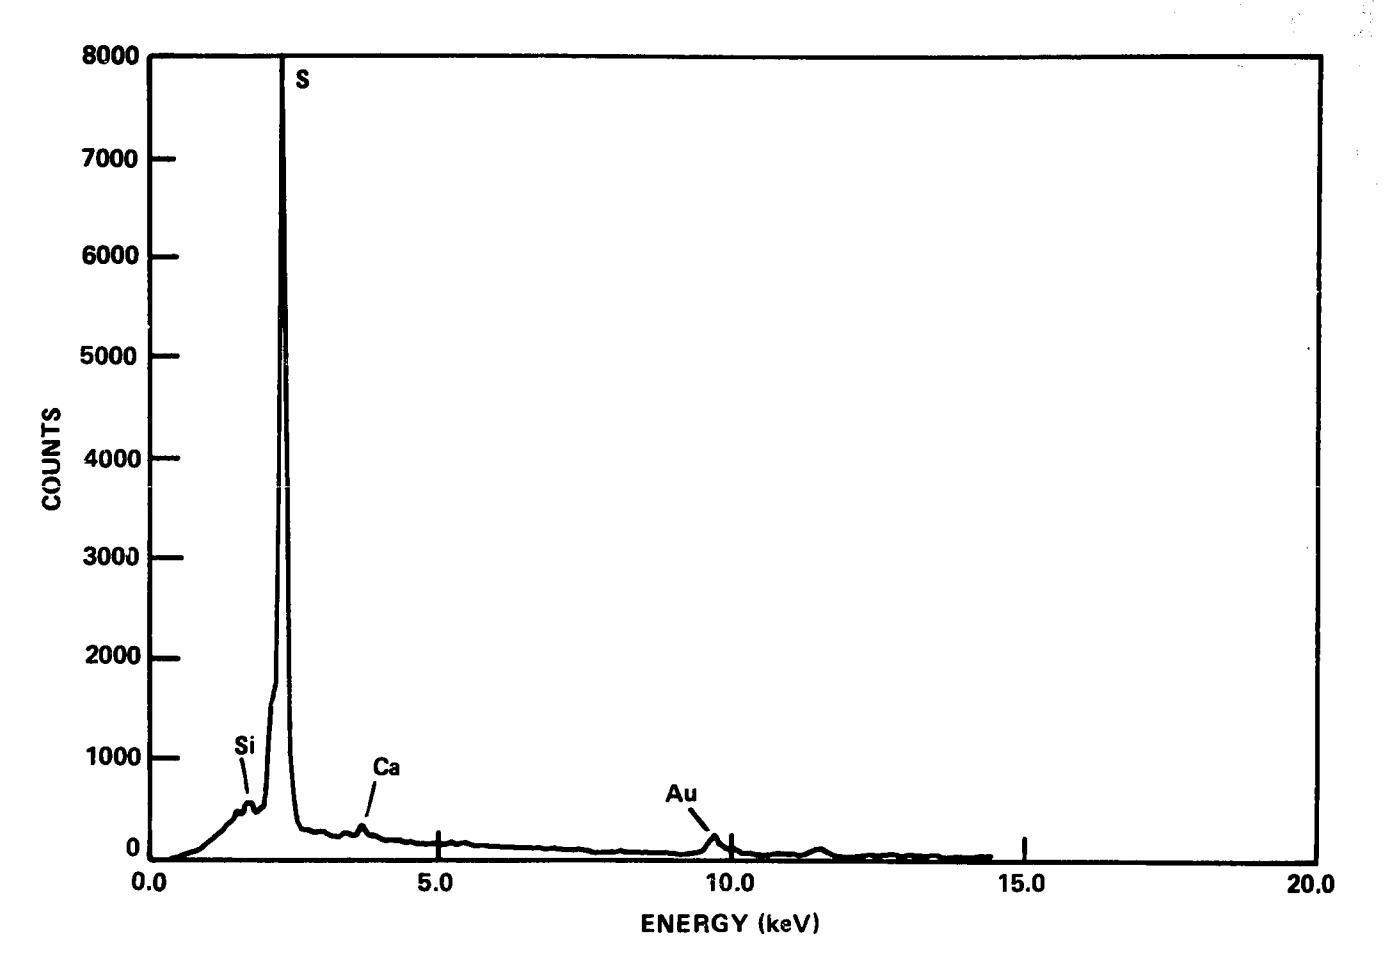
in this region. Two typical spectra are shown in Figures 25 and 26 and indicate sulfur (the predominant constituent), sodium, silicon, and calcium as the only detectable elements (elements of atomic numbers below sodium (11), including carbon and hydrogen, are not detectable with the EDAX system).

FIGURE 25. EDAX SCAN OF A MEDIA PARTICLE FROM BOTTOM REGION, 4-8" SEGMENT (Au IS COATING MATERIAL).

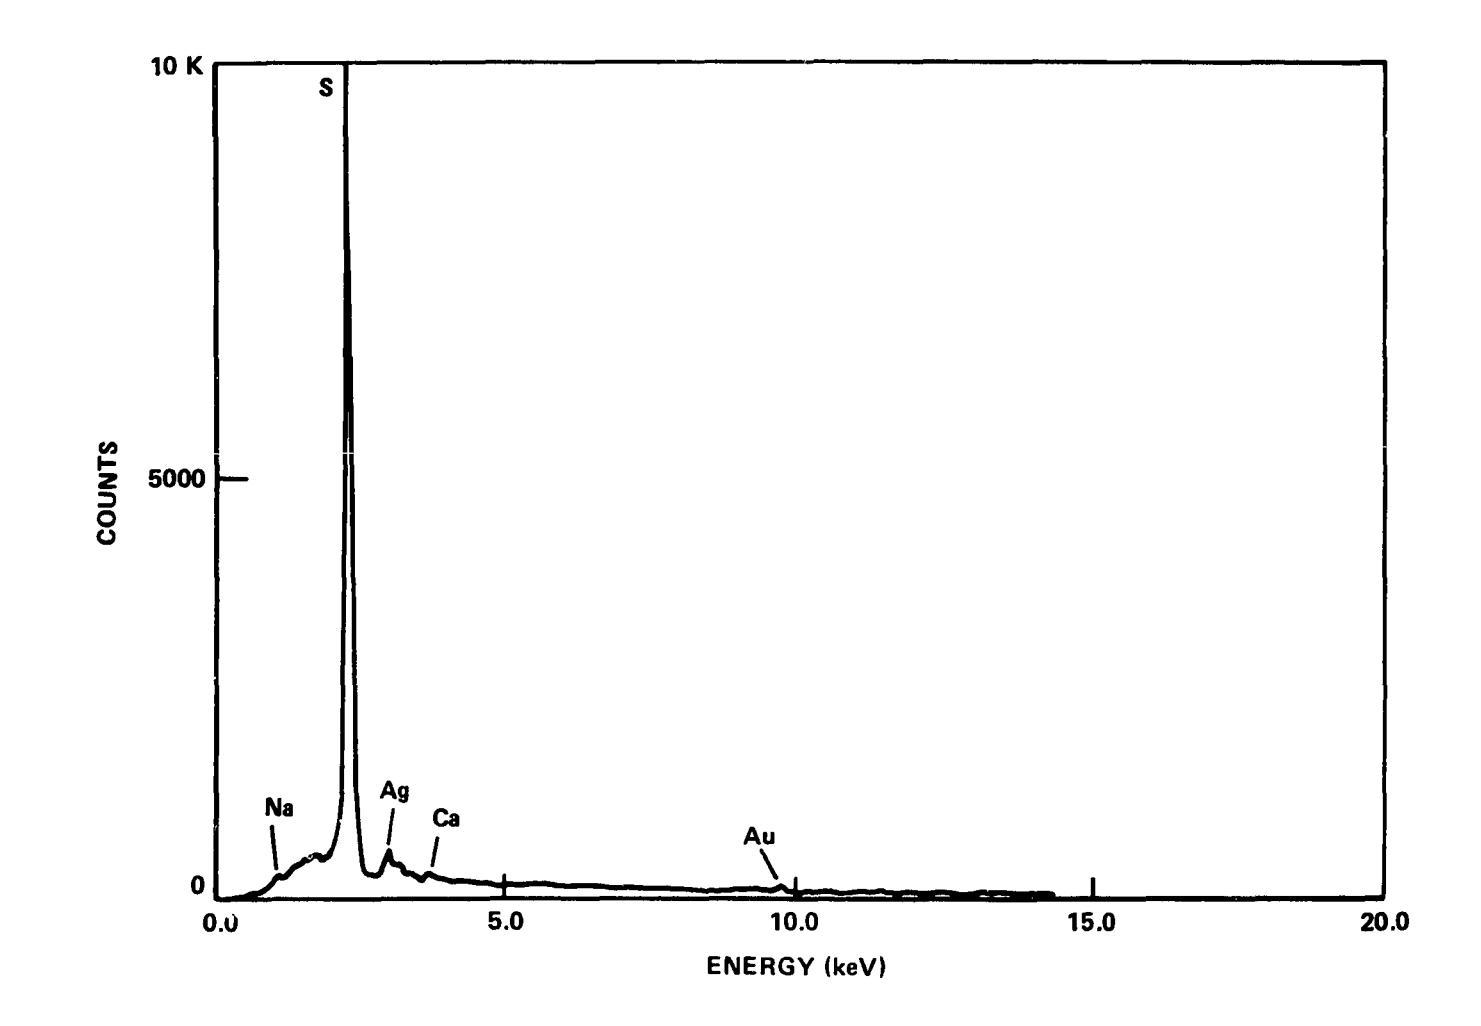
FIGURE 26. EDAX SCAN OF A MEDIA PARTICLE FROM BOTTOM REGION, 8-16" SEGMENT (Ag AND Au ARE MOUNTING AND COATING MATERIALS).

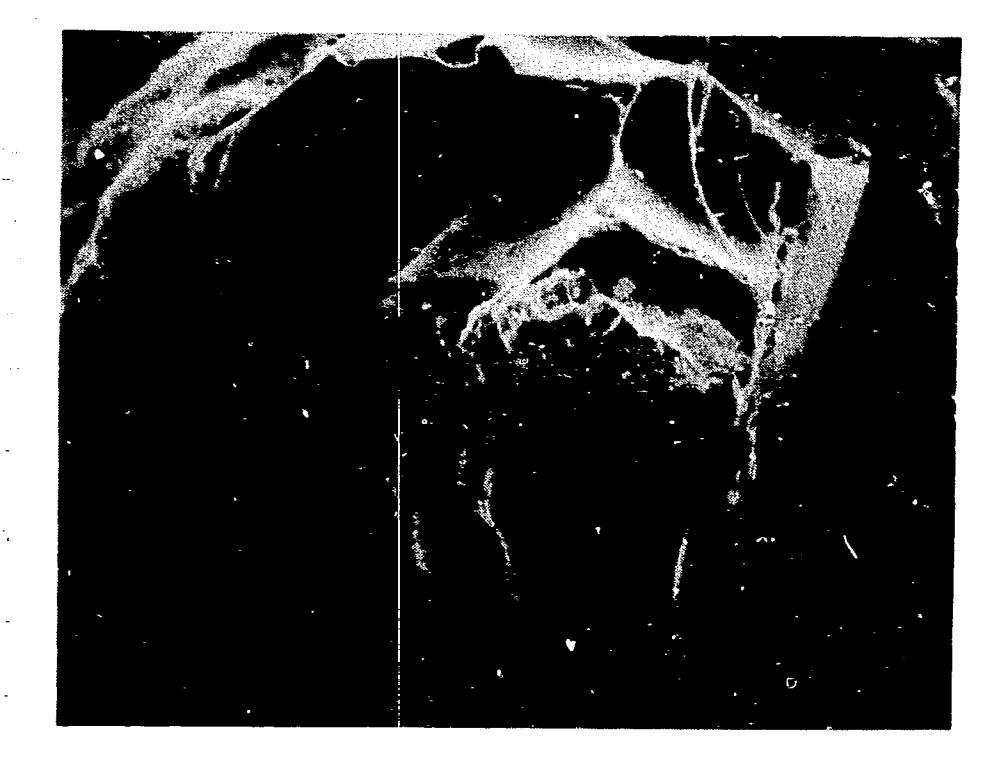
Figure 27. SEM photomicrograph of a typical granular particle, Top Region, 16-18" segment, 150X.

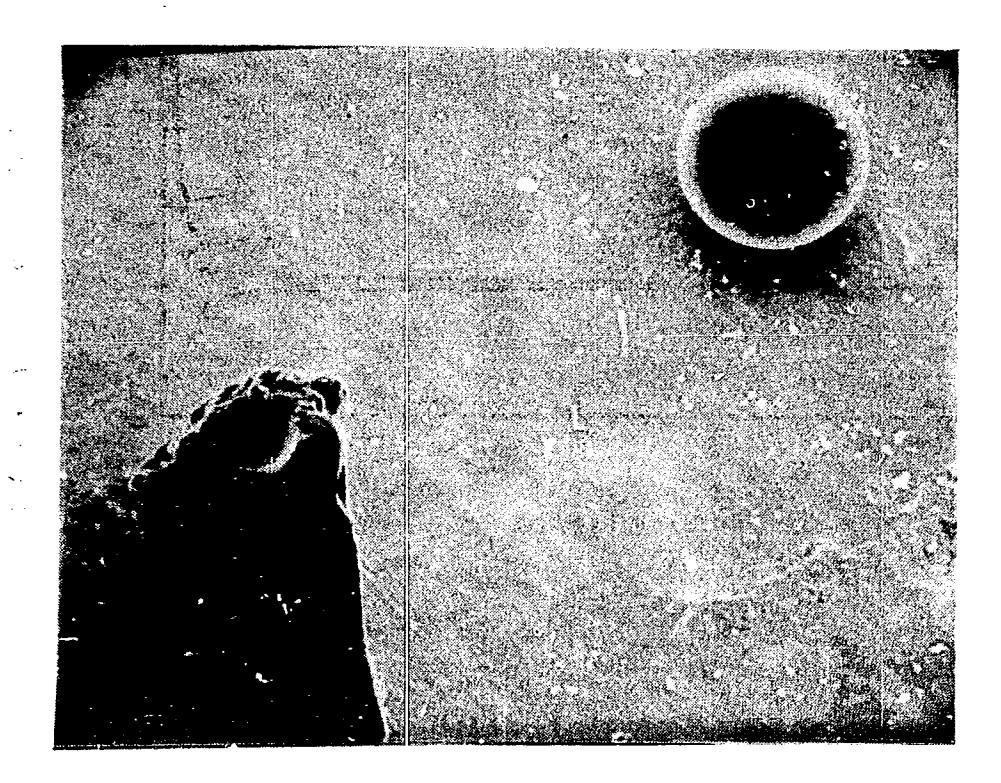
Figure 28. SEM photomicrograph of typical particles in the lower layer of the Top Region, 18-20" segment, 30X.

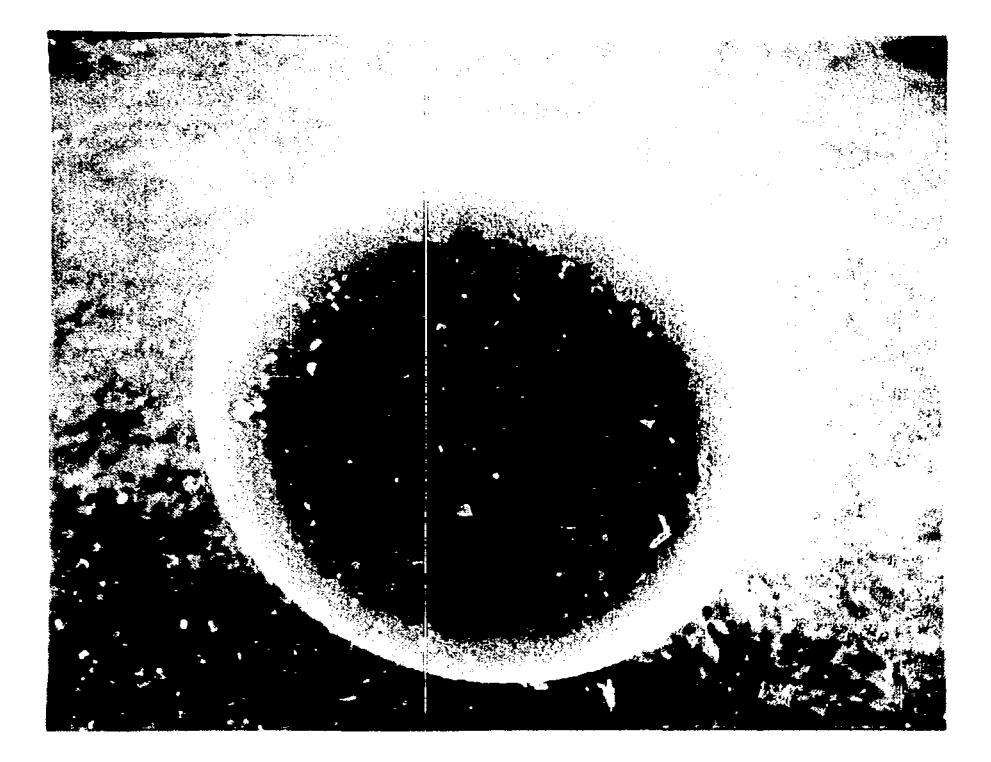
Figure 29. SEM photomicrograph of a typical spherical particle in the lower layer of the Top Region, 18-20" segment, 150X.

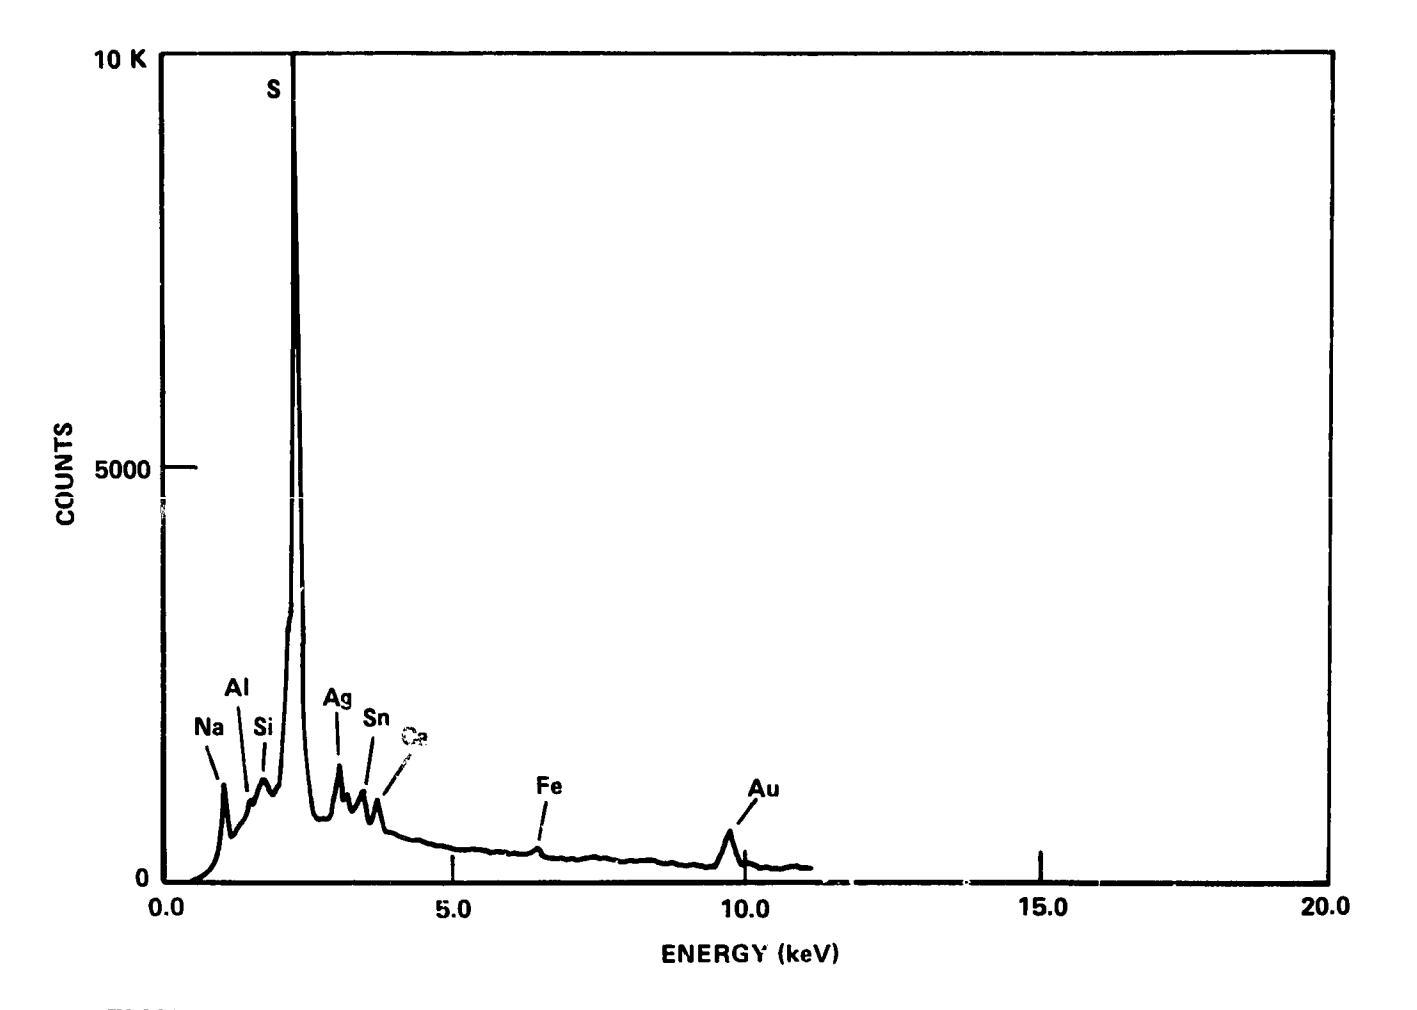
An EDAX spectrum from a typical particle is shown in Figure 30. Sulfur is again the predominant constituent with smaller amounts of sodium, aluminum, silicon, tin, calcium and iron detected.

FIGURE 30. EDAX SCAN OF A MEDIA PARTICLE FROM TOP REGION, 16-20" SEGMENT (Ag AND Au ARE MOUNTING AND COATING MATERIALS).

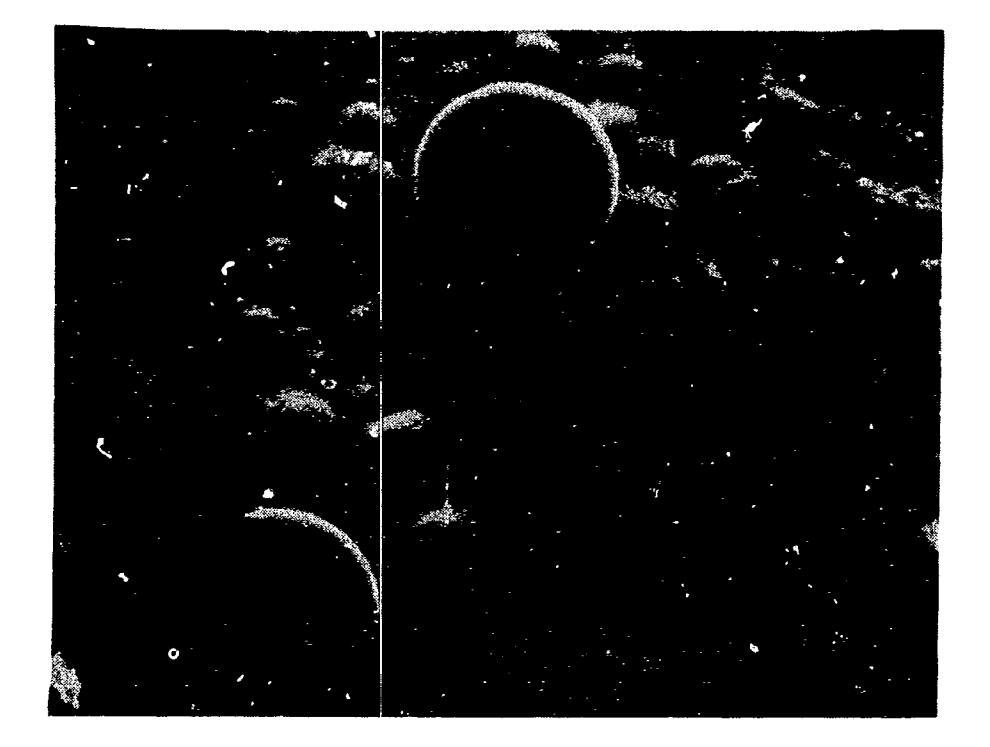
In the top four inches of this region (20-24" from the bottom of the core sample), only spherical particles, showing little or no evidence of surface defects were found. Two particle fragments were found and are shown in Figures 31 and 32. These fragments appear to be from cleanly split particles. Neither fragment showed any evidence of cracking or spalling on its outer face. Figure 33 shows a typical particle from this top layer of the core sample. An EDAX spectrum from a typical particle is shown in Figure 34. Sulfur is again the predominent constituent with smaller amounts of sodium, silicon, and calcium.

Figure 31. SEM photomicrograph of media particles, Top Region, 20-22", 30X.

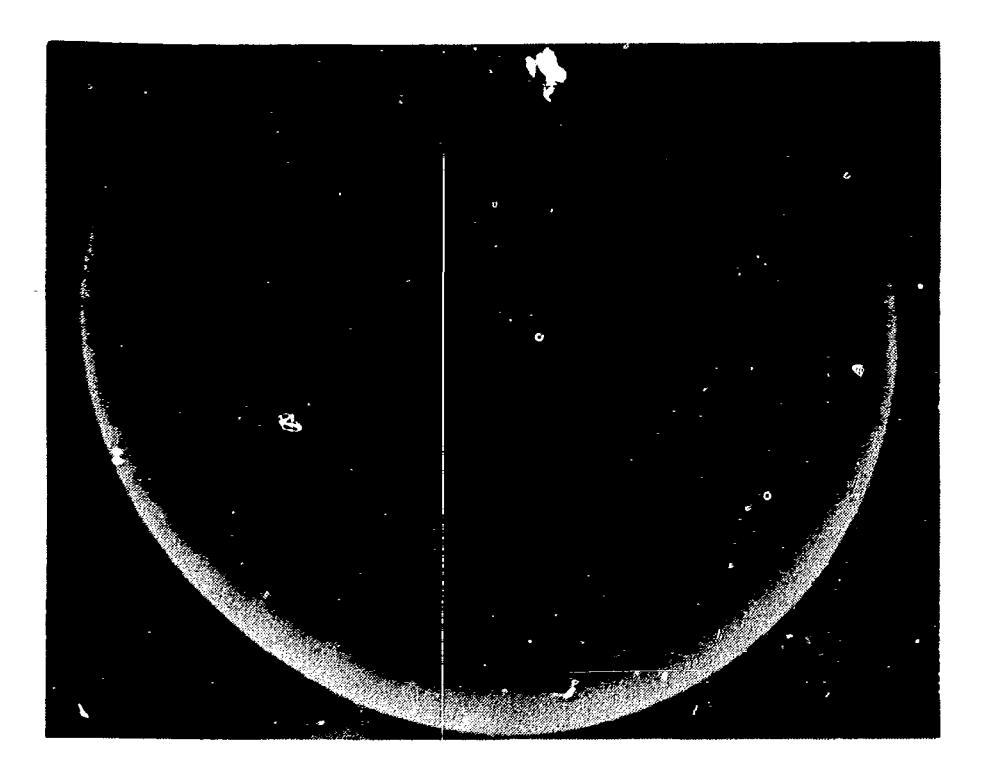
Figure 33. SEM photomicrograph of a typical particle in the upper layer of the Top Region, 22-24" segment, 150%.

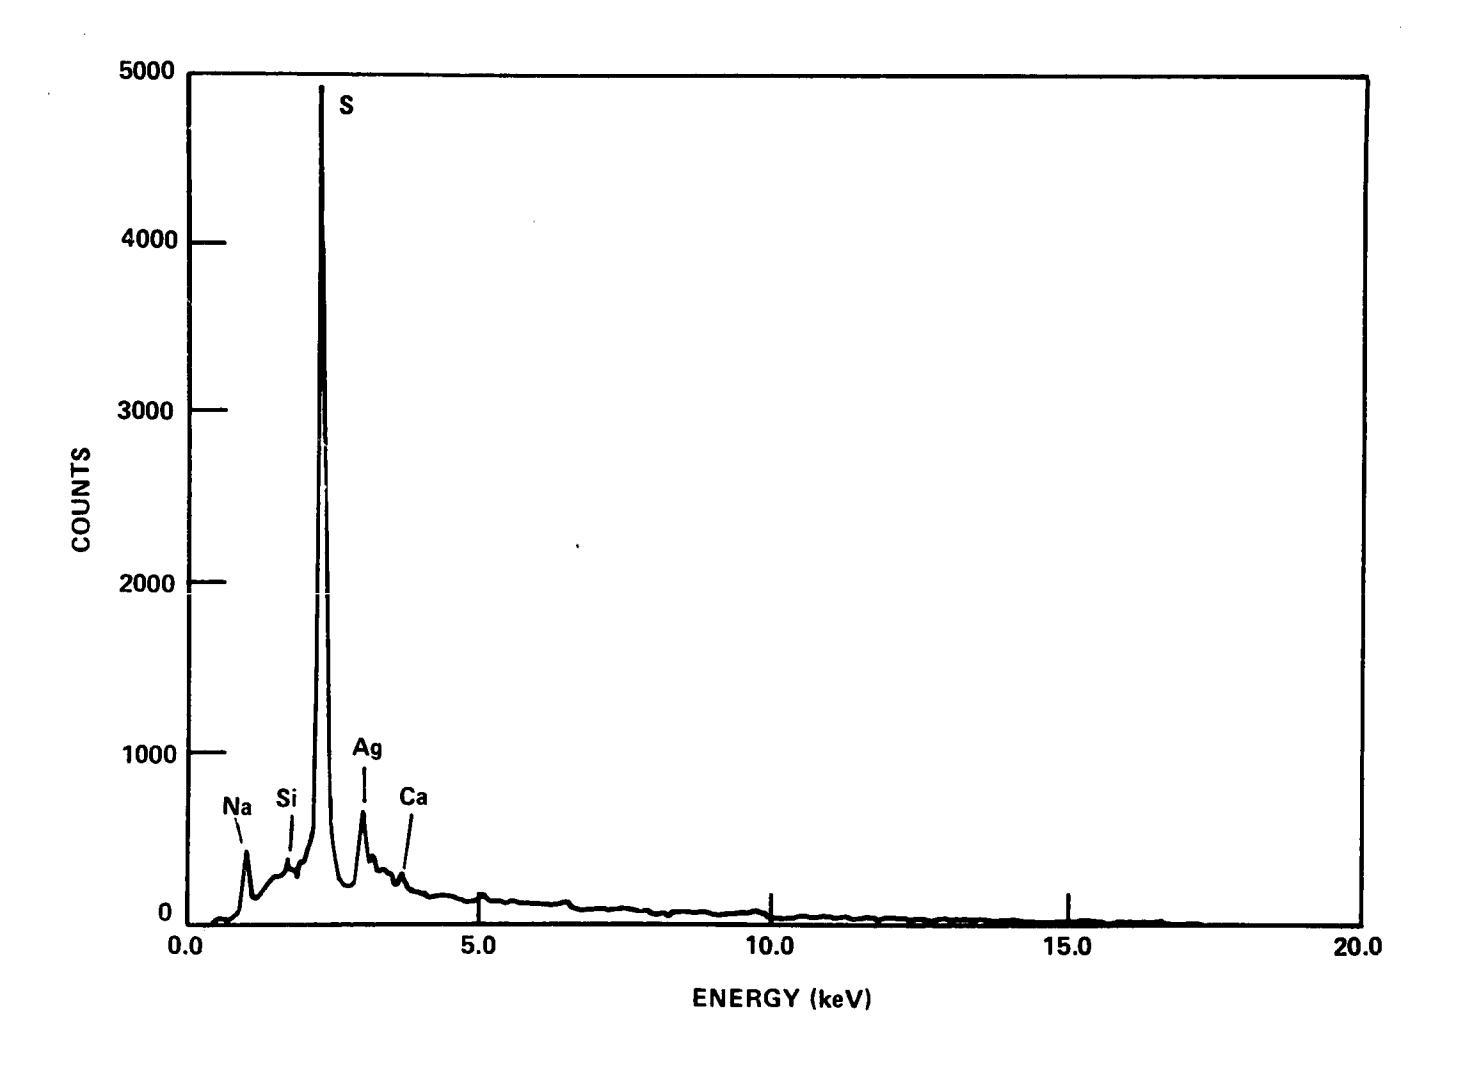
FIGURE 34. EDAX SCAN OF A MEDIA PARTICLE FROM TOP REGION, 20-24" SEGMENT (Ag IS MOUNTING MATERIAL).
