# METALLURGICAL EXAMINATION OF, AND RESIN TRANSFER FROM, THREE MILE ISLAND PREFILTER LINERS

John W. McConnell, Jr.  
Howard W. Spaletta

Published August 1984

EG&G Idaho, Inc.  
Idaho Falls, Idaho 83415

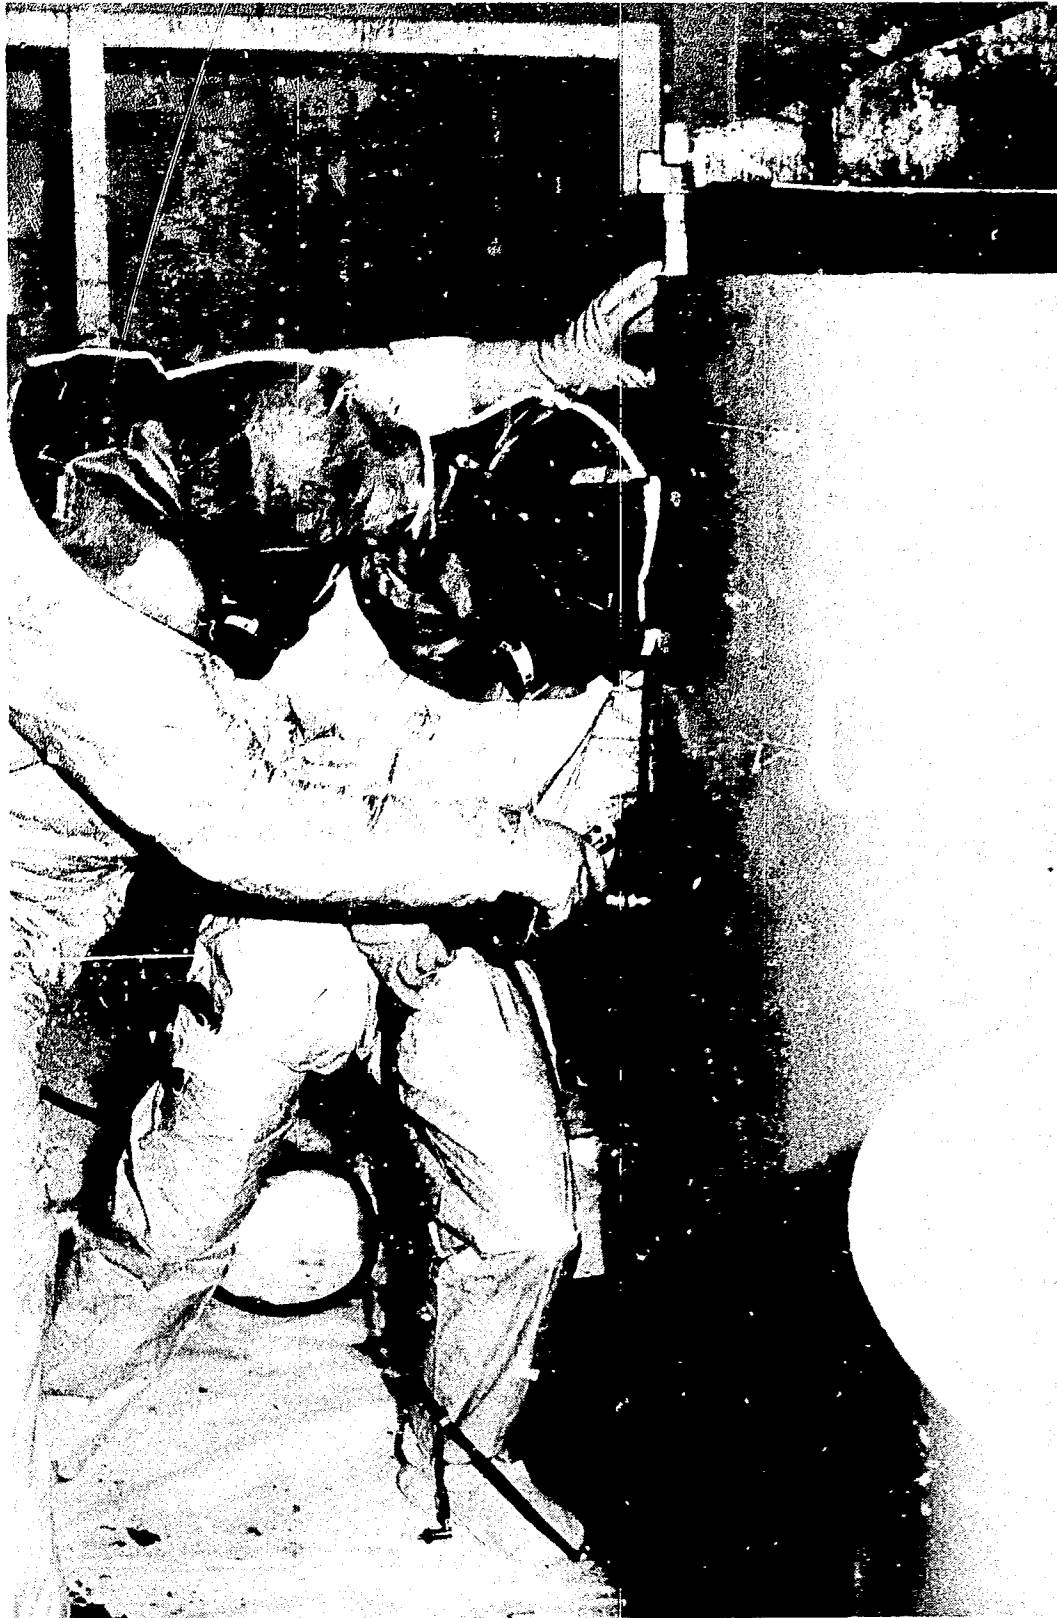
INEL 4 4325

Figure 4. Removal of a study section from the cylindrical wall of liner PF-3 using a hole saw.

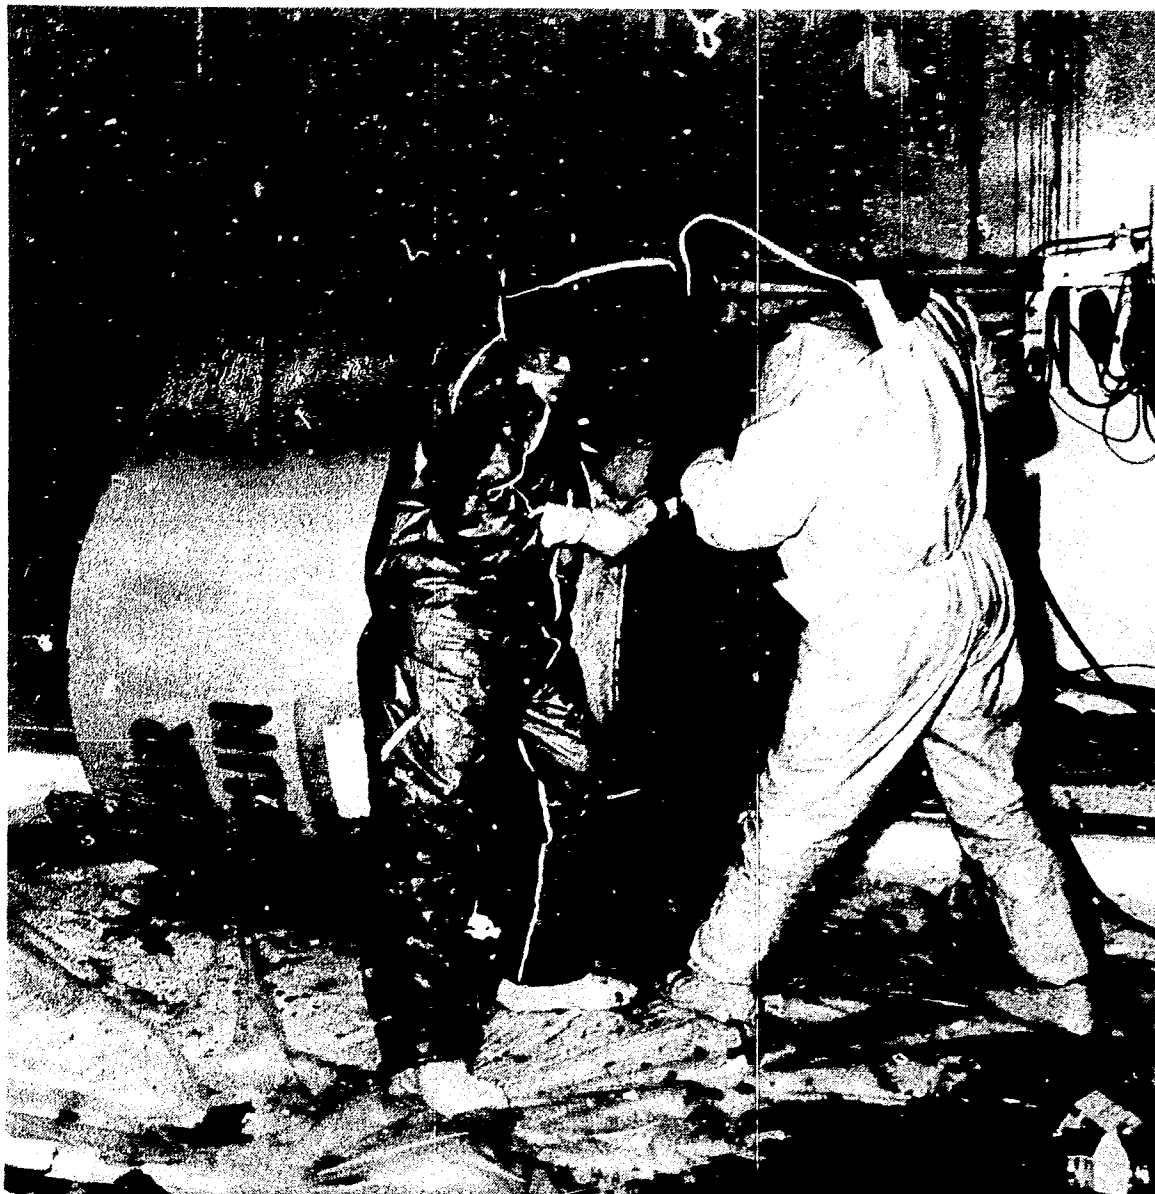
INEL 4 4327

Figure 5. Removal of a study section from liner PF-16 using a portable reciprocating saw.

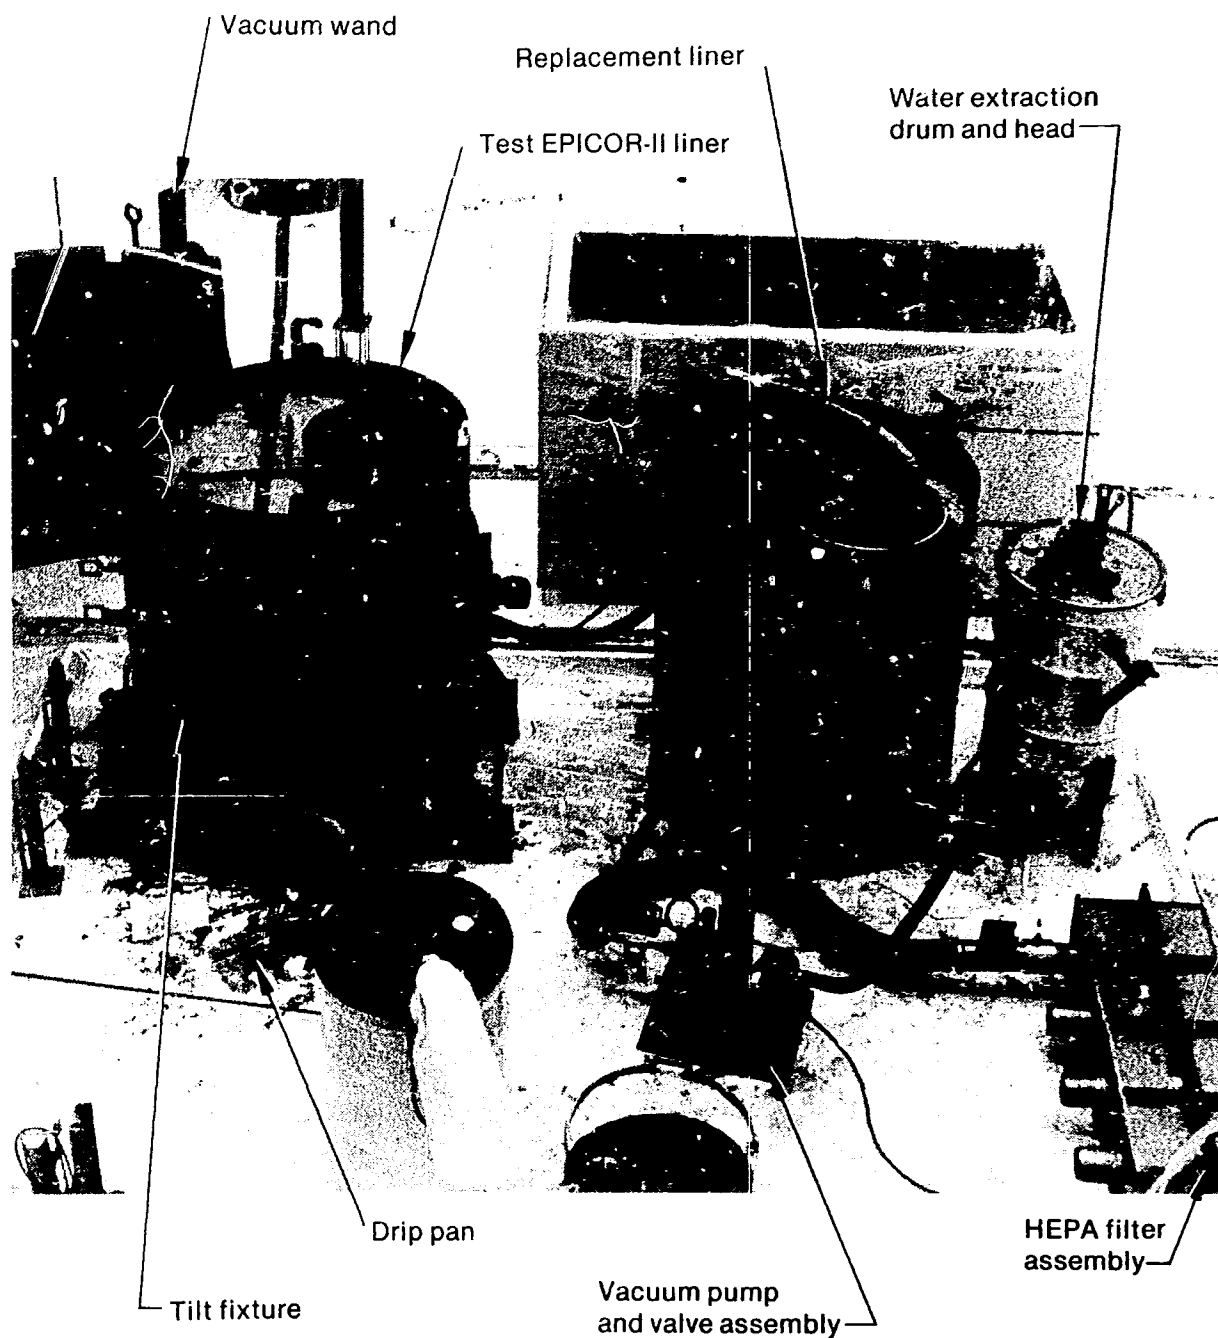
INEL 4 4323

Figure 6. Resin transfer system in the TAN-607 Hot Shop used to transfer resins from one EPICOR-II liner to a replacement liner.

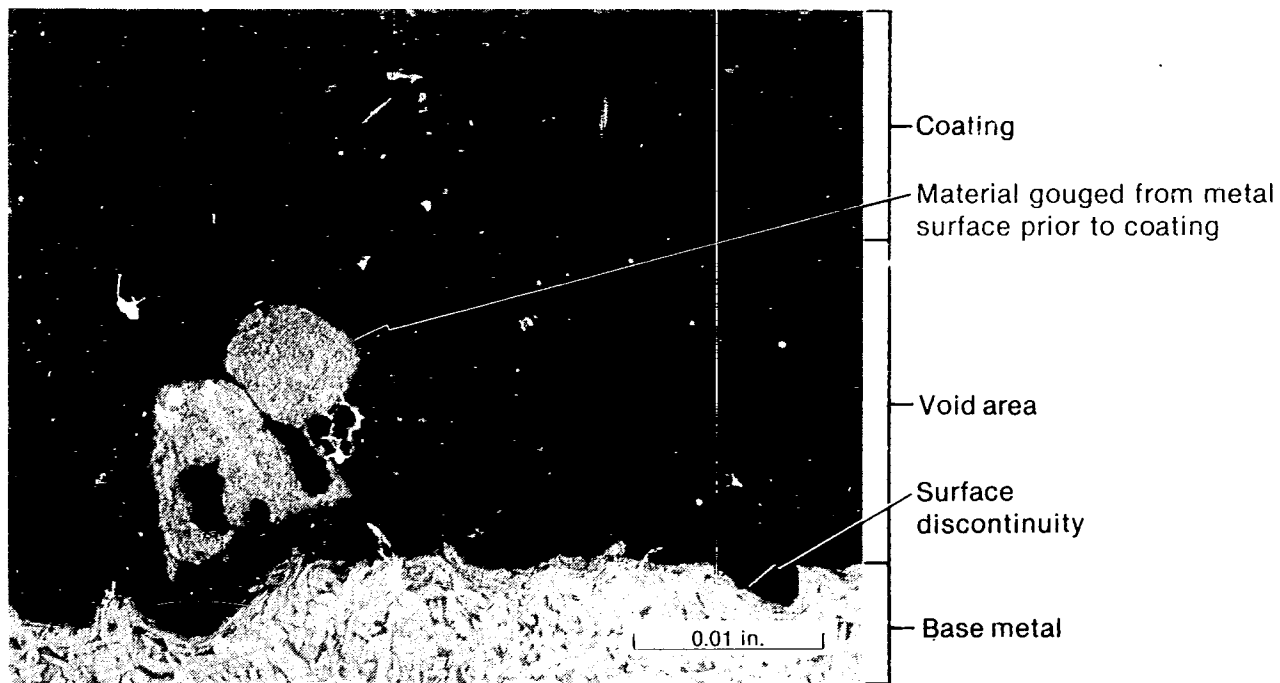
INEL 4 4349

Section 4, Specimen 6--Surface discontinuities and large void areas were observed under the blister on Specimen 6, which was prepared from the inside of the bottom plate (Figure 37). The surface discontinuities indicate that the base metal had been gouged during fabrication.

Figure 37. Photomicrograph of Section 4, Specimen 6 from liner PF-16 (made normal to the interior surface of the bottom plate) showing surface discontinuities and large void areas under the blister between the coating and the base metal.
