EXAMINATION OF SOLENOID VALVES AH-EP-5037 AND AH-EP-5039 AND LIMIT SWITCHES AH-KS-5037 AND AH-KS-5039

GEND-INF-018

Published December 1984

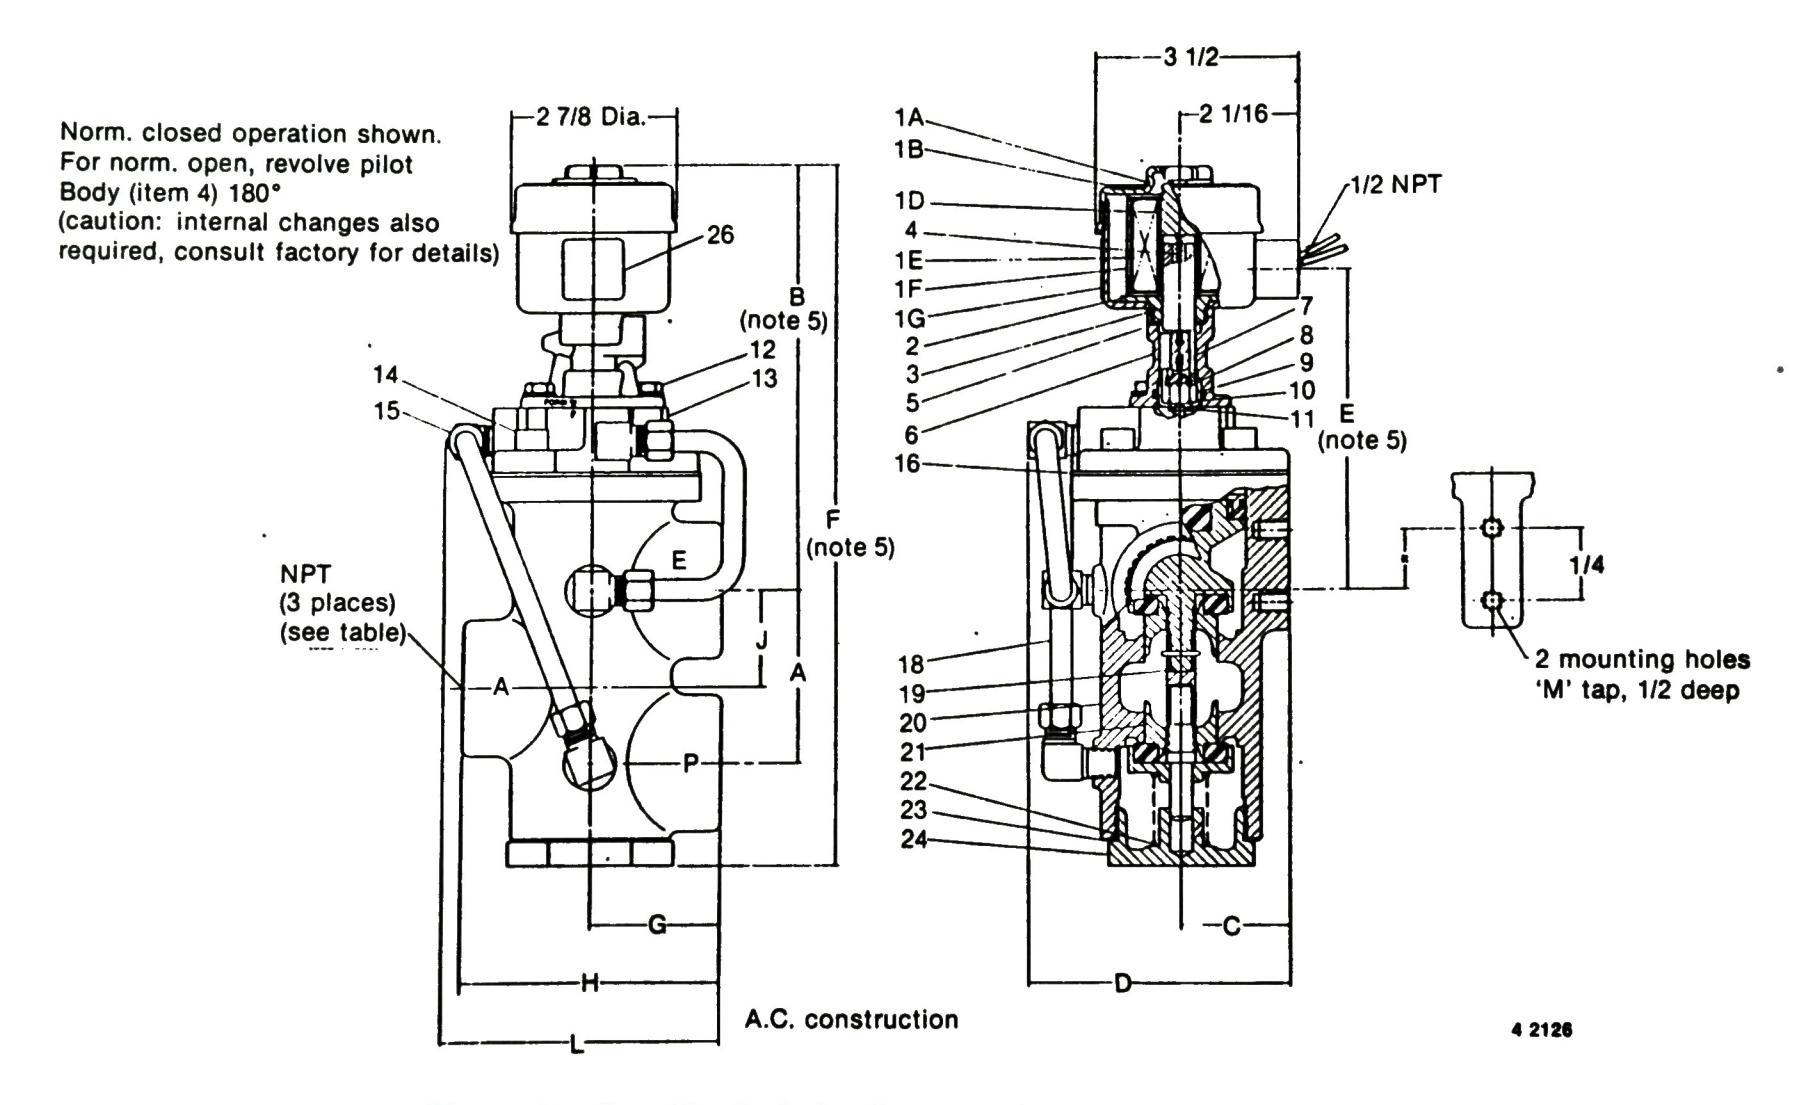
Figure 1. Detail of ASCO solenoid valve model HT8331A45.

The pilot solenoid values are normally-closed three-way 1-1/4 in. pilot controlled piston operated ASCO model HT8331A45 (Figure 1). Each unit has a 120 V ac solenoid coil, with class HT insulation, housed in a NEMA 4 enclosure. The value, shown in an exploded view in Figure 2, contains parts that are made of low radiation-tolerant materials. The bottom plug and disk holder of the pilot values are made of acetal plastic. The gaskets, O-rings, and main value disks are made of Buna-N elastomers, reported to have a damage threshold of 7 x 10^6 rads. A typical value is shown in its installed position in Figure 3.

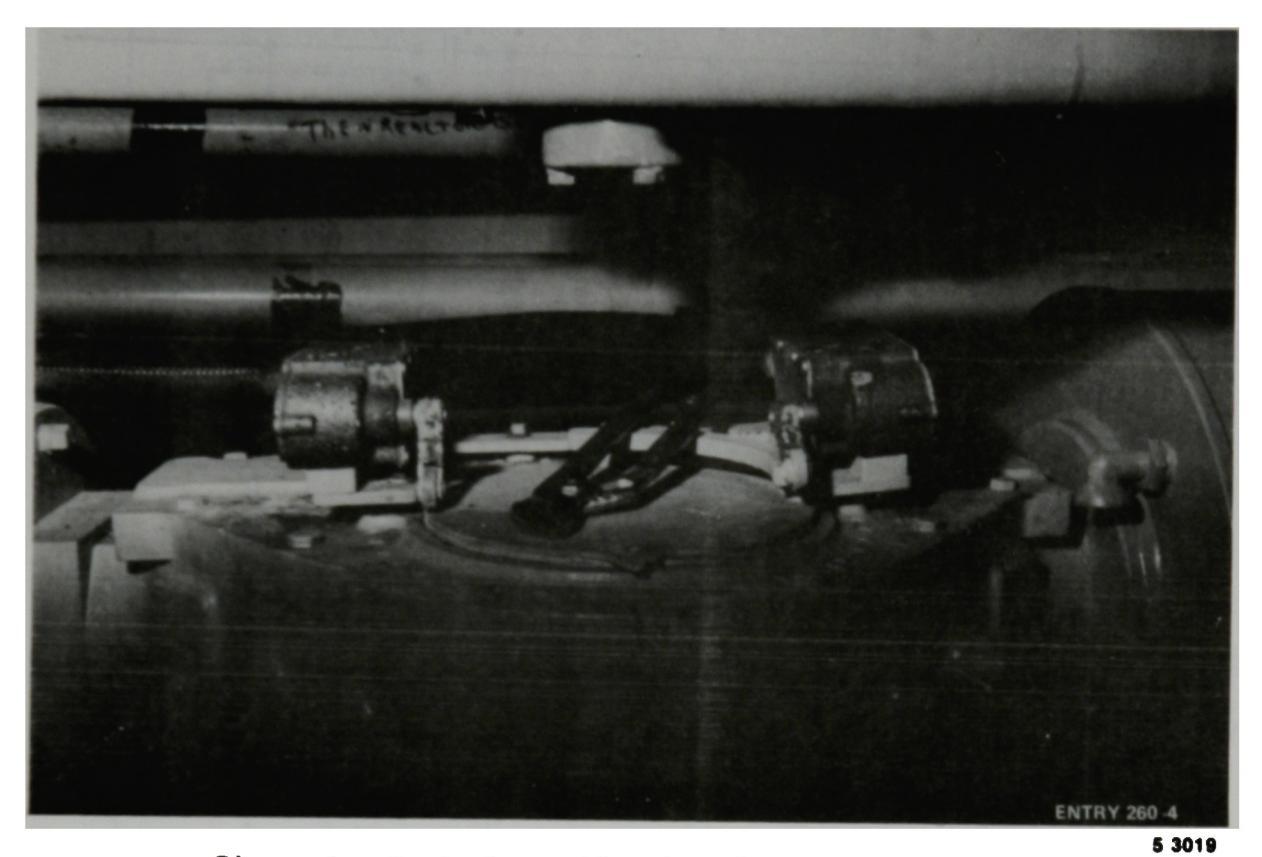
Figure 4. Typical mounting detail of limit switches.

The limit switches are NAMCO model EA740-20000 with snap-action switching. This model is loss-of-coolant accident (LOCA)-qualified; however, the TMI-2 units are not since they were manufactured before the qualification standard was put into effect. The vintage units and current models are identical in design; however, the vintage units contain parts made of materials that are not radiation tolerant. The switches are mounted on their respective value and are actuated by a cam that is attached to the purge value position indicator plate as shown in Figure 4.

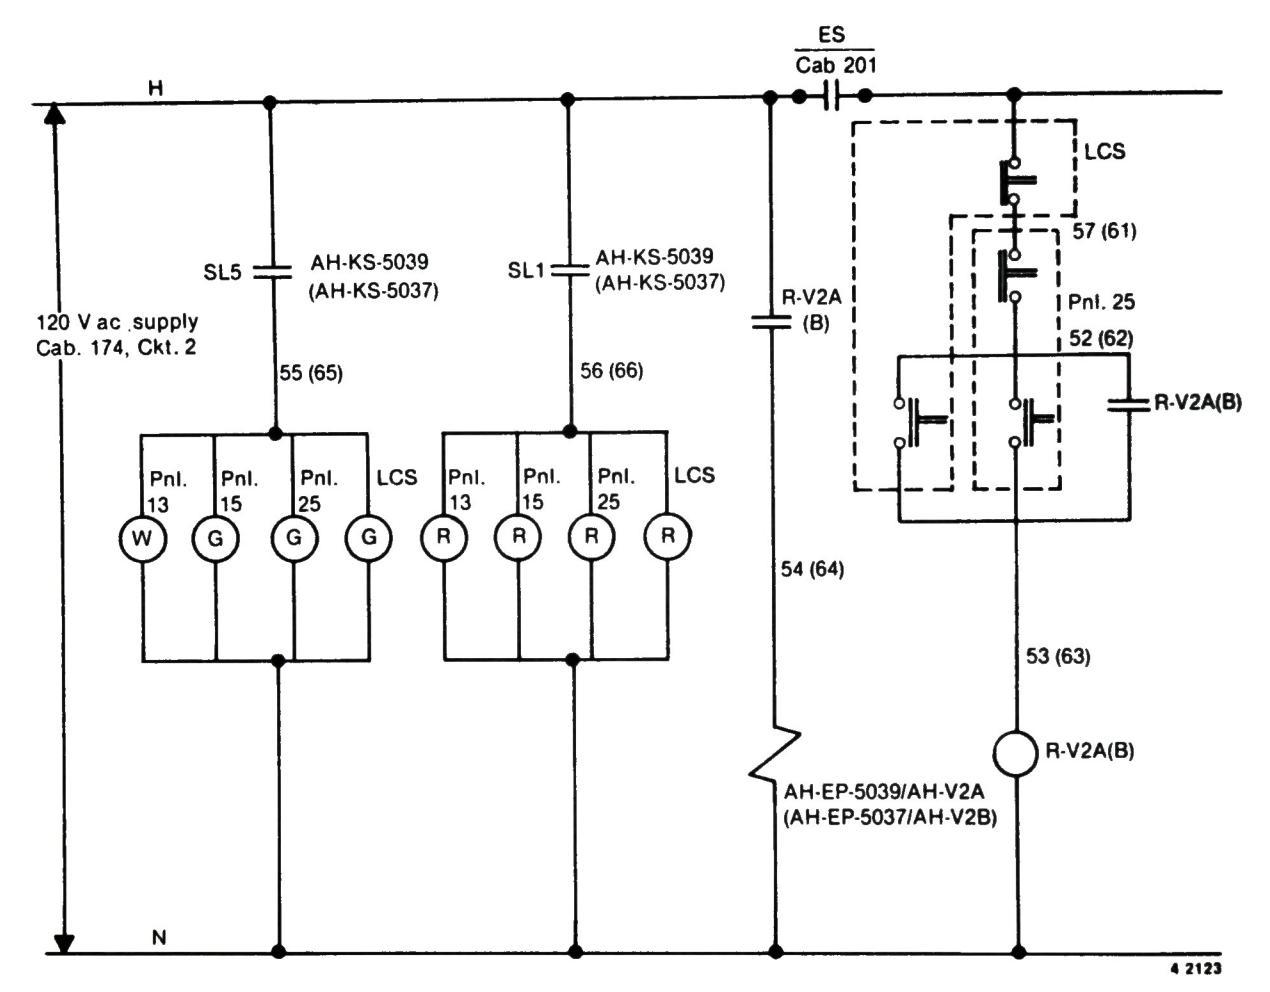
Figure 5. AH-V2A/AH-V2B control schematic.

AH-V2A and AH-V2B have the same control scheme, as shown in Figure 5, and share the same cabling, as shown in Figure 6.
