GEND-INF--023 Vol. 1

INVESTIGATION OF HYDROGEN-BURN DAMAGE IN THE THREE MILE ISLAND UNIT 2 REACTOR BUILDING

N. J. Alvares and D. G. Beason Lawrence Livermore National Laboratory and G. R. Eidam EG&G Idaho, Inc.

Published June 1982

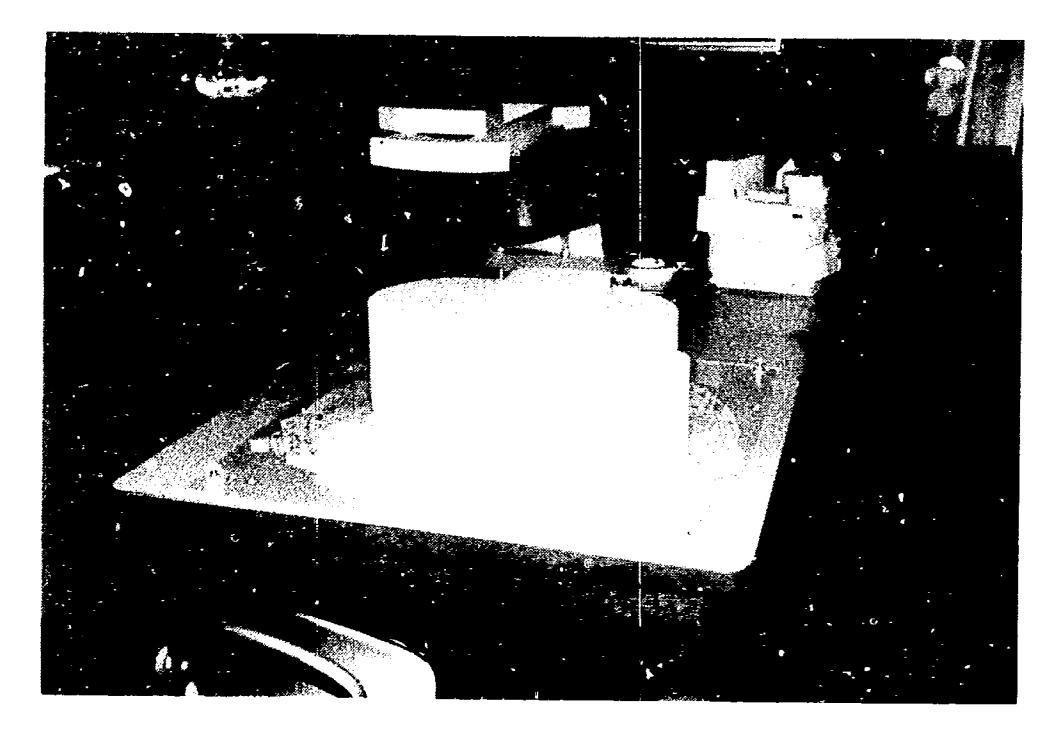
Figure 31. Euilaing model south view--305 level.

Figures 31 through 33 are photographs of the styrofoam model on which damage patterns were plotted according to photographs from the first 15 reactor building entries. This model currently resides at the EG&G Idaho site office at TML. New information about thermal and overpressure damage recorded during subsequent reactor building entries is being added to the model to increase the accuracy of the damage pattern.
