ASSESSMENT OF EXTENT AND DEGREE OF THERMAL DAMAGE TO POLYMERIC MATERIALS IN THE THREE MILE ISLAND UNIT 2 REACTOR BUILDING

N. J. Alvares

Published February 1984

Lawrence Livermore National Laboratory Livermore, California

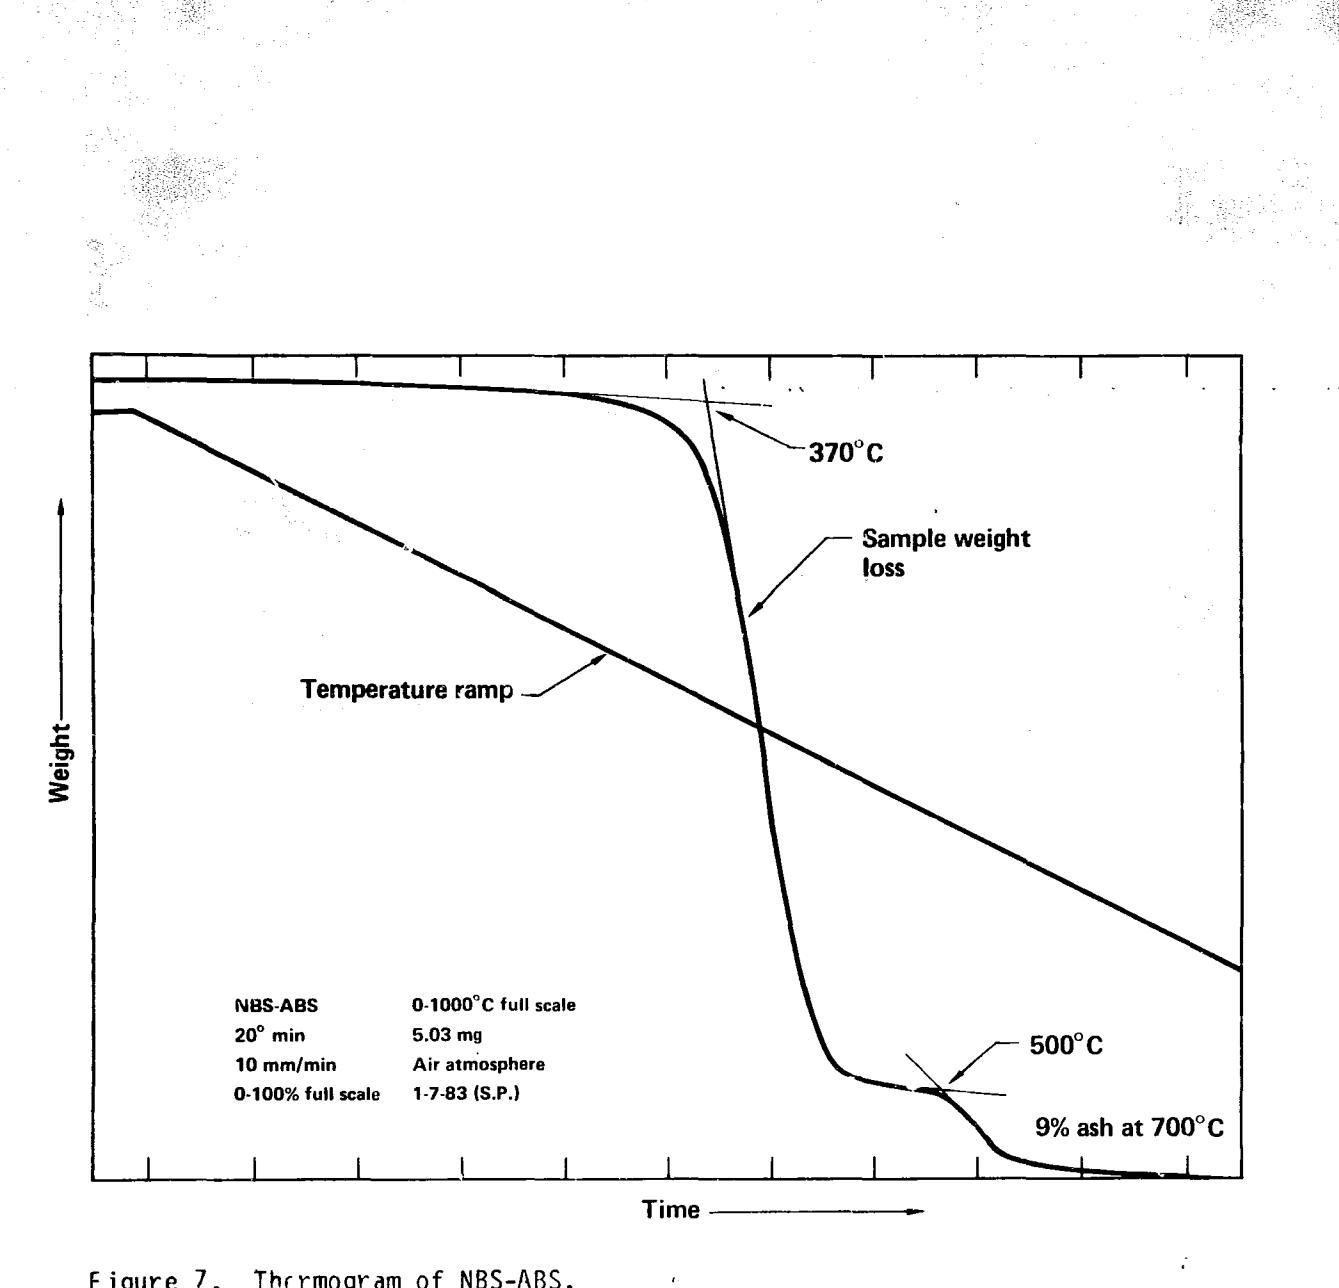
These figures are included to illustrate how different TGA records can be used to analyze performance of exposure materials. Figure 7 shows that NBS-ABS commences major weight loss at 370°C and terminates at 500°C. Most flammable pyrolyzates are emitted in this range, leaving about 20% inert material as residue. This material is flammable and, with an external ignition source, it will ignite within this range. Figure 8 shows two major weight-loss periods, the first occurring at 265°C and the second at 365°C. This ABS formulation included bromine- and antimony-containing fire retardants that release upon pyrolysis to inhibit flaming combustion.

Figure 7. Thermogram of NBS-ABS.

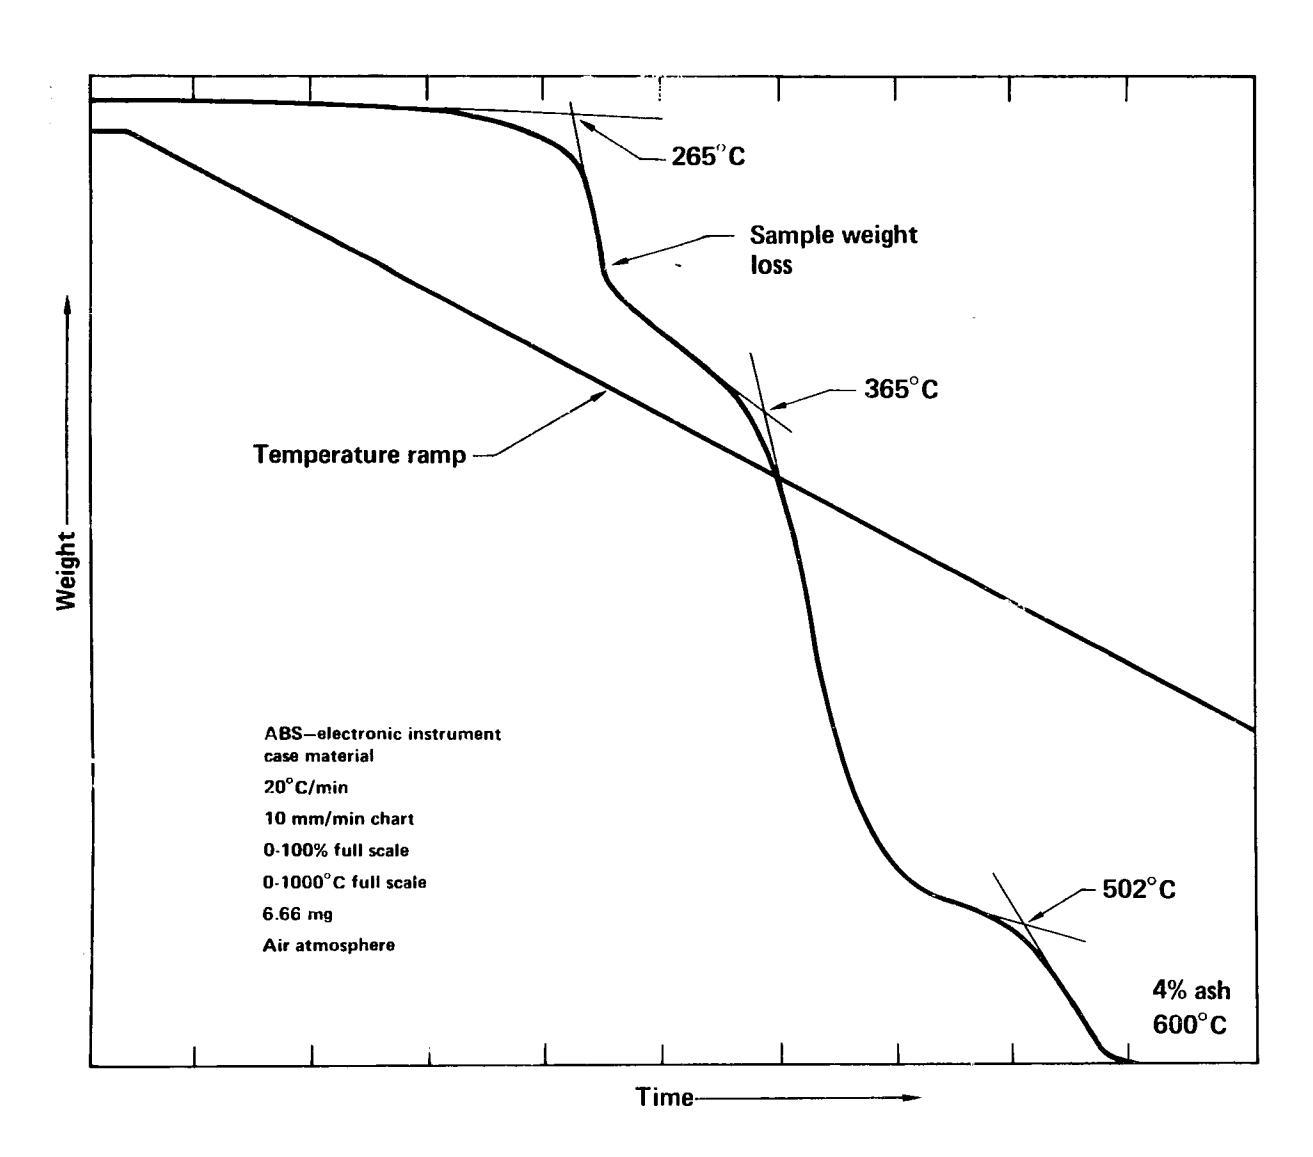
Figure 8. Thermogram of instrument-case ABS.

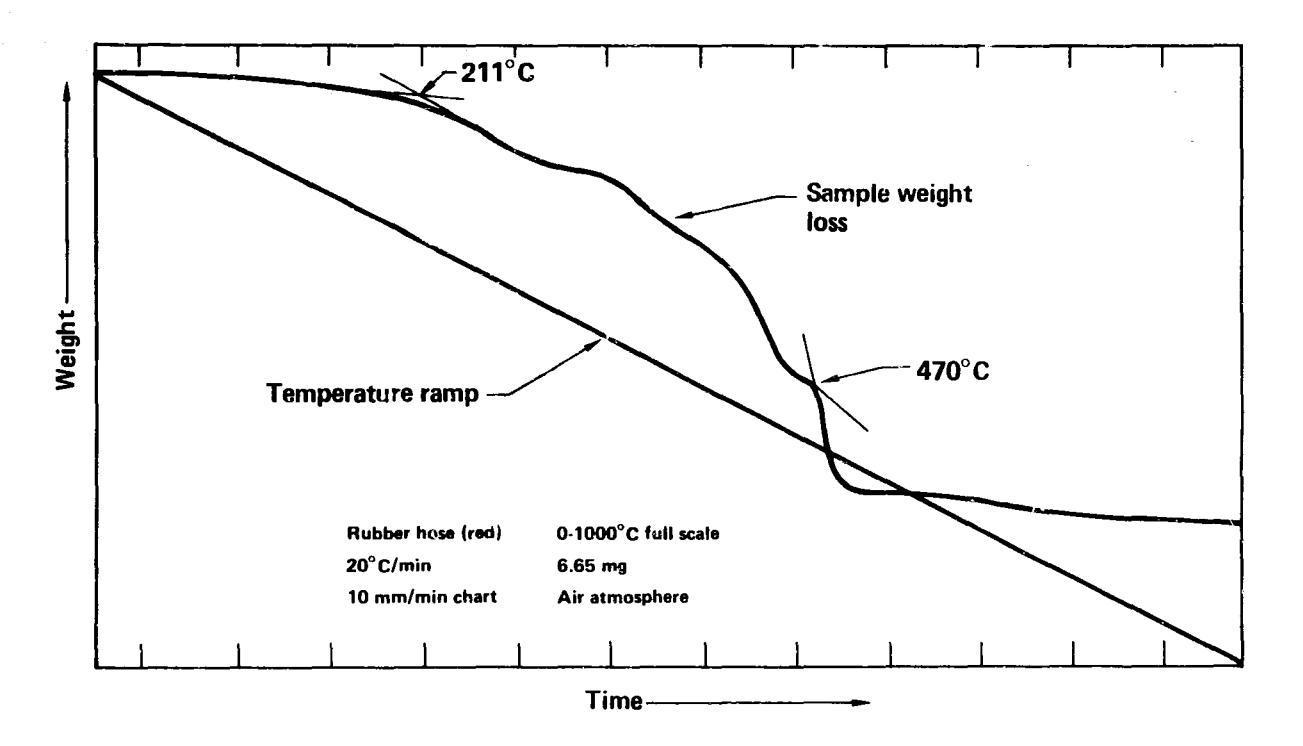
Figure 9 illustrates the thermal degradation pattern for red rubber fire hose. This material begins slow degradation at 211° C, ultimately forming an inert char at 470° C. We would expect that this material would be difficult to ignice because of low pyrolyzate production.

Figure 9. Thermogram of red rubber fire hose.
