TMI-2 PRESSURE TRANSMITTER EXAMINATION PROGRAM
YEAR-END REPORT: EXAMINATION AND EVALUATION OF PRESSURE
TRANSMITTERS CF-1-PT3 AND CF-2-LT3

Rolf C. Strahm
Merlin E. Yancey

February 1983

Published on Behalf of the GEND Group
by
EG&G Idaho, Inc.
Idaho Falls, Idaho 83415

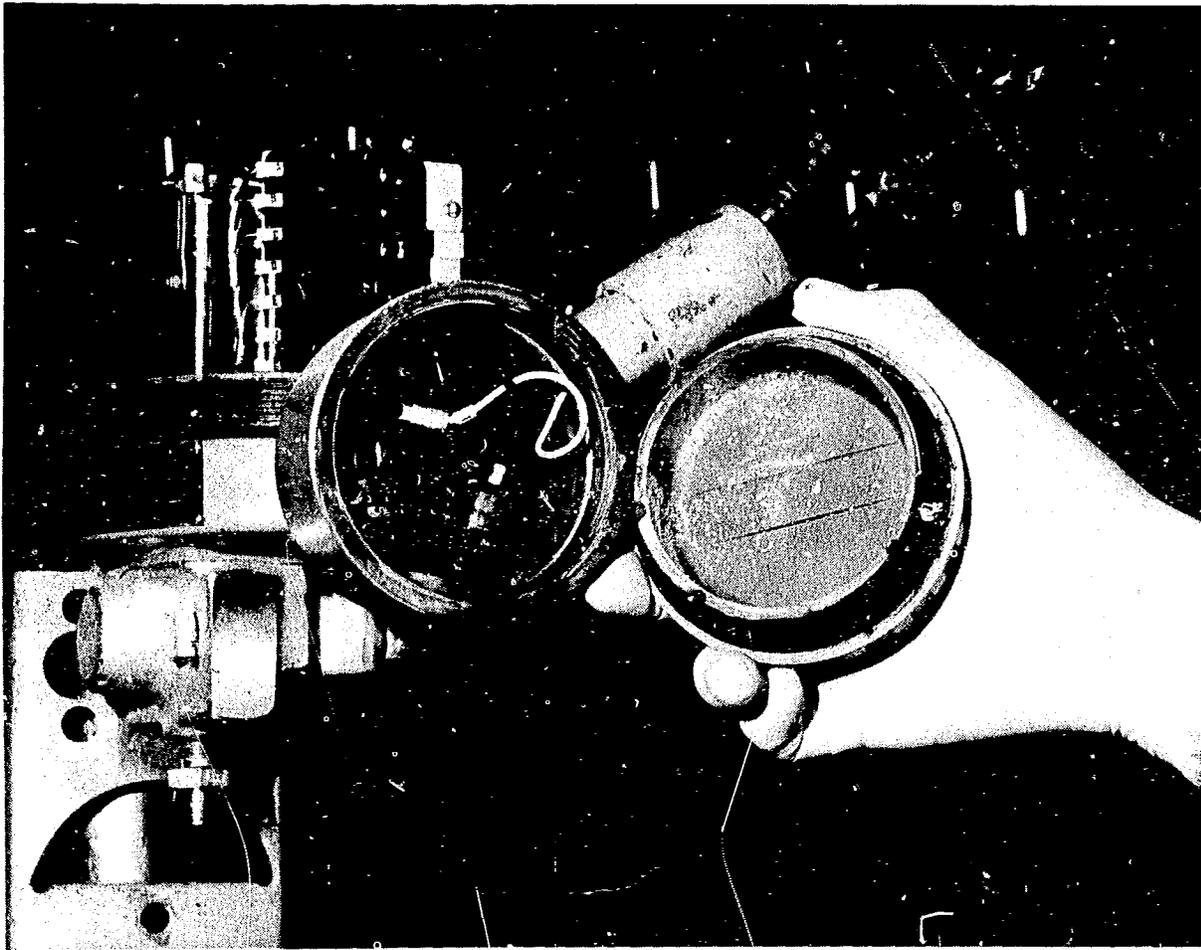
Figure 3. Photograph, Foxboro pressure transmitter.

- o The interior of the sensor/electronic module assembly was clean and free of radioactive and other contaminants.
- o The interior of the circular junction box was radioactively contaminated and appeared to have had water in it, as evidenced by corrosion depositions (see Figure 3). Since the junction box gasket appeared to be in good condition, it is likely that water entered the junction box through the conduit or its associated fittings. A cable seal located between the transmitter and the circular junction box probably prevented moisture from entering the transmitter itself.

the point of leakage could not be determined. In future removals this evidence will be preserved, and more information on potential sources of leakage obtained. The Foxboro assembly appeared to have leaked in a similar manner, judging from the residue in its junction box. However, the cable seal apparently saved it from the same fate as the Bailey.

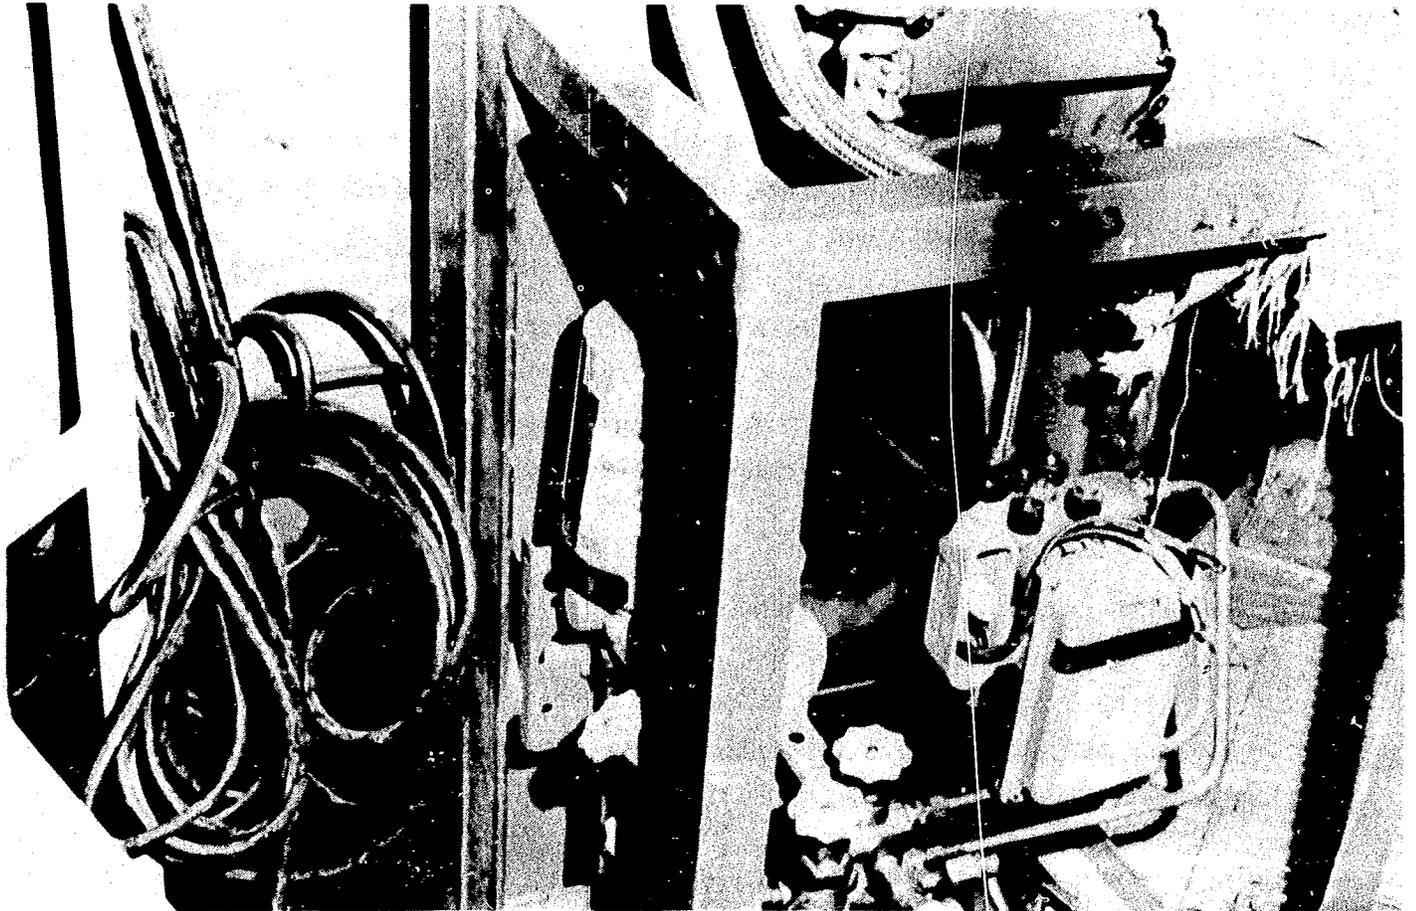
Figure 11. Photograph, typical pressure transmitter installations.

It appears that the cause of failure of the Bailey unit was due to water entering the unit and shorting the electronics. The question remains, how and where did the water enter the assembly: It is known that during and following the accident, there was steam and high humidity in the building from the reactor system with a resulting rain-like atmosphere, so all components in the building were subjected to water. Since the transmitter case cover gasket and the conduit junction box gasket were inspected and found to be in good condition, and since the water was highly contaminated, it is believed that reactor water entered the transmitter through the electrical conduit or its fittings. When the water entered the conduit is not clear. Figure 11 shows what is believed to be a typical transmitter installation. Potential sources of leakage are the flexible conduit itself, the flexible conduit fittings, and the termination point of the flexible conduit (not shown) or the junction box into which the conduit terminates. As can be seen in Figure 11, there is no drip loop in the conduit. If the fitting at the conduit junction was not sealed, any water running down the outside of the conduit could enter at this point. Unfortunately, the conduit junction was disassembled during removal of the assembly, so that whether this was
