GEND-INF--041

## EVALUATION OF TMI-2 PRESSURE SWITCHES NM-PS-1454 AND NM-PS-4174

EG&G Idaho, Inc.  
Idaho Falls, Idaho 83415

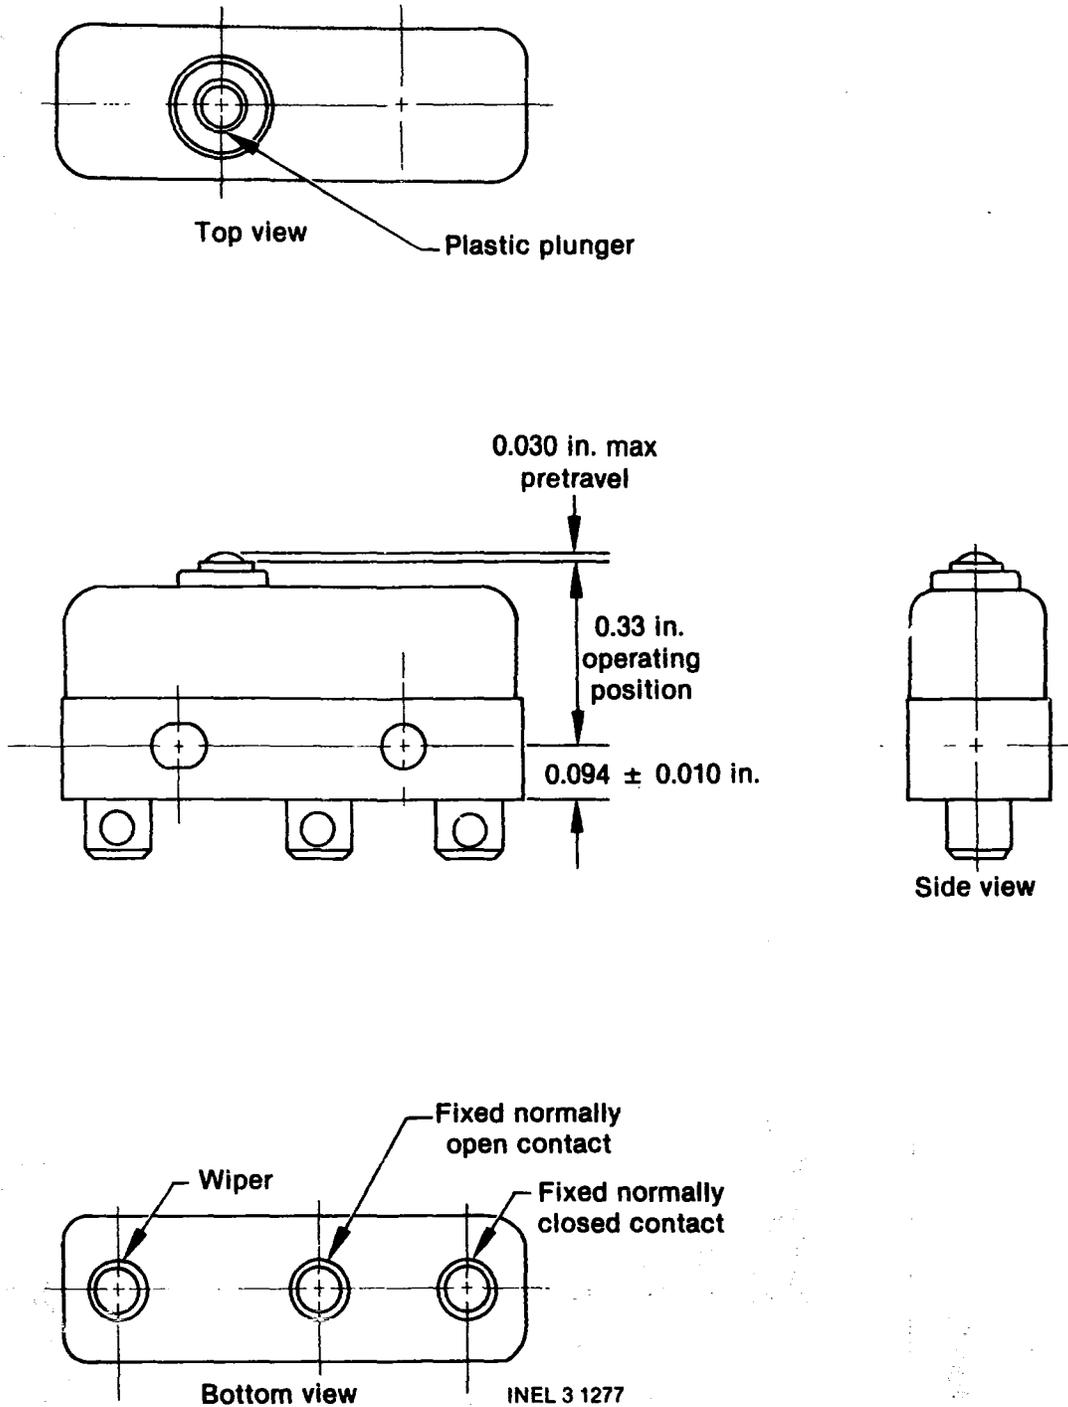
Figure 8. Switch mechanical characteristics showing distance of movement upon activation.

Switch Operating Forces--The switch operating forces were reasonably close to vendor's tolerance. Results are shown in Table 7. (Also see Figure 8 for the mechanical characteristics of the switch.)

Function	Manufacturer's Specification	NM-PS-4174		NM-PS-1454	
		Left Switch	Right Switch	Left Switch	Right Switch
Operate	3 to 5 oz	3.8 oz	2.8 oz	3.8 oz	3.8 oz
Release	1 oz min	2.8 oz	1.95 oz	2.75 oz	2.75 oz
Differential Travel	0.004 in. max	0.003 in.	0.001 in.	0.0015 in.	0.002 in.
Over Travel	0.005 in. min	0.016 in.	0.015 in.	0.0165 in.	0.018 in.

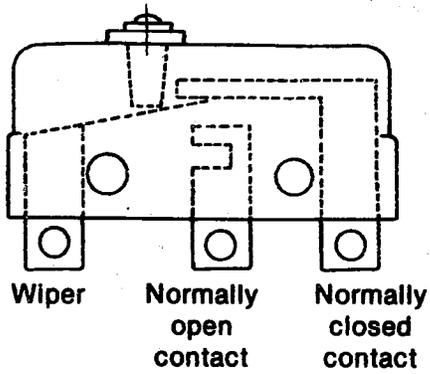
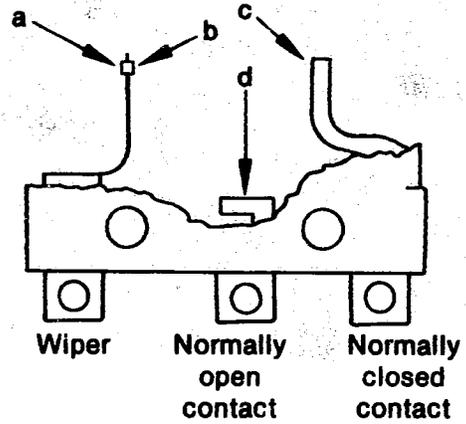
Figure 10. Approximate direction of scanning electron microscope photographs, as indicated by arrows above. (Footnotes correspond with views in Figures 11, 12, and 13.)

AC/DC Overload. Scanning electron microscope photographs of the right switch (ac overload) of NM-PS-4174 showed evidence of marked contact pitting (see Figures 10 and 11). Consequently, this right switch is considered unacceptable for further use. The left switch (dc overload) of both NM-PS-4174 and NM-PS-1454 showed evidence of contact arcing, but pitting appeared to be minimal (see Figures 10, 12, and 13).
