Electrochemical Corrosion Testing of Neutron Absorber Materials

May 2007

INL/EXT-06-11772, Rev. 1

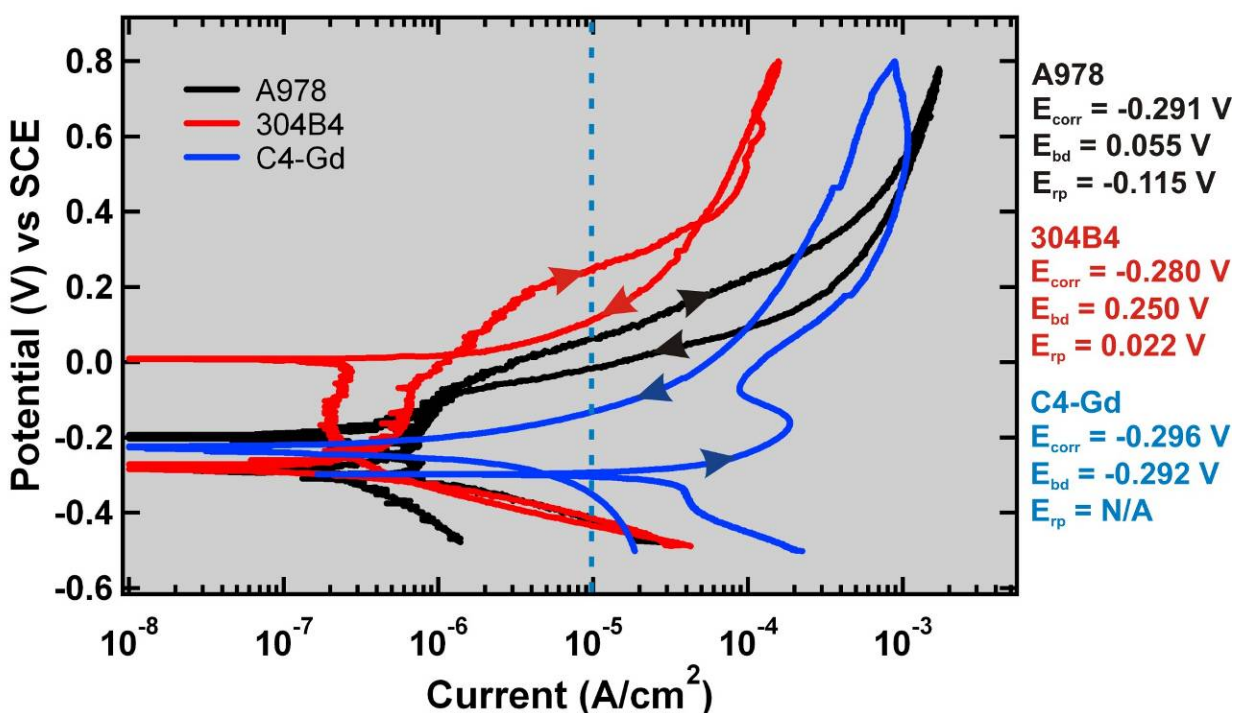
PD curves of the three specimens are shown in Figure 4, with the E_{corr} breakdown potentials (E_{bd}) and repassivation (E_{rp}) values provided. The A978 specimen had a breakdown value (using a $10 \mu\text{A}/\text{cm}^2$ criteria; see the dashed blue line on the plot in Figure 4) approximately 0.2 V negative of the 304B4 specimen, indicating a greater tendency to pitting. The E_{bd} value for Ni-Cr-Mo-Gd is very close to the E_{corr} value indicating a very reactive surface due to the initial gadolinide dissolution. The E_{rp} value (using the crossover criteria) for A978 is about 0.14 V more negative than 304B4, indicating a reduced tendency to repassivate, as compared to the 304B4 specimen under these conditions. The total current passed during breakdown is also much greater for the A978. The Ni-Cr-Mo-Gd has a much higher current in the forward sweep but a reduction in current during the reverse sweep. Thus, no E_{rp} value applies. The measurements are consistent with the observations of the specimen as discussed in the next paragraph.

Figure 4. Potentiodynamic (PD) curves for the three alloys in solution B1 at 60°C

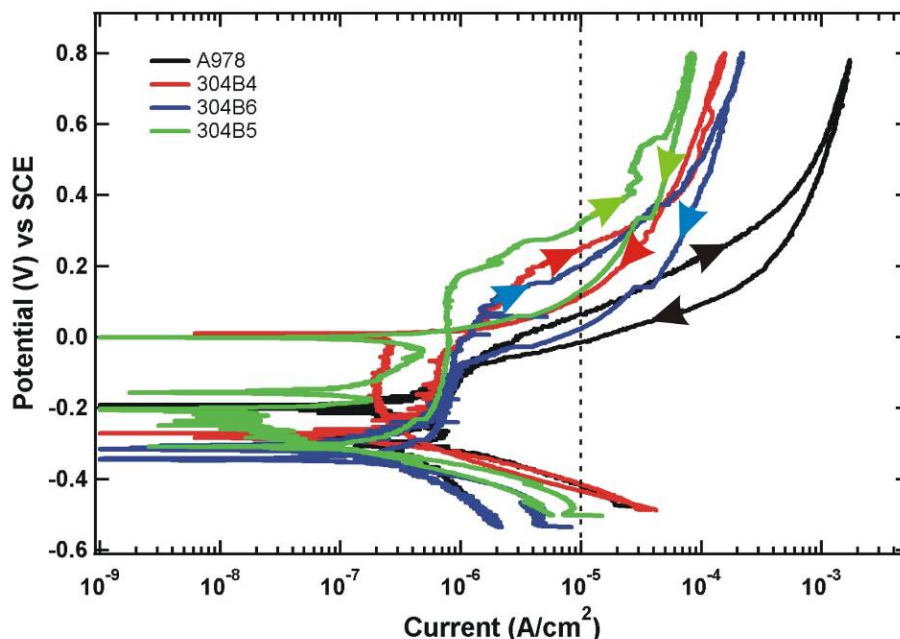
Figure 7 shows cyclic PD polarization scans for the four borated stainless steel specimens in B1 solution (see Tables 1 and 3). The solution was purged with N_2 during the entire test period. A 50-min E_{corr} measurement was performed before initiating the test sequence. The dotted line in Figure 7 indicates the breakdown threshold using a $10 \mu A/cm^2$ criterion. Table 5 contains parameters obtained from the corrosion potential (E_{corr}) and PD curves. Note that the 304B5 has the most positive breakdown potential (E_{bd}), and the repassivation potential (E_{rp}) value is very similar to 304B4 (best performing). This observation is consistent with the low number of negative spikes in the aerated E_{corr} measurements for 304B5. The A978 specimen has the most negative values for E_{bd} and E_{rp} (worst performing). The 304B6 has a similar E_{bd} to 304B4 but has a much more negative E_{rp} that is similar to the A978. Because the 304B6 has significantly more B content than A978, the similar E_{rp} value indicates a microstructural effect. Thus, these tests show that the amount of boron and the alloy grade (microstructure) influence the localized-corrosion characteristics. In all cases, significant pitting was observed under the crevice formers. In some cases, pitting was observed on boldly exposed surfaces as well.

Figure 7. PD curves for borated SS alloys in solution B1 at 60°C.

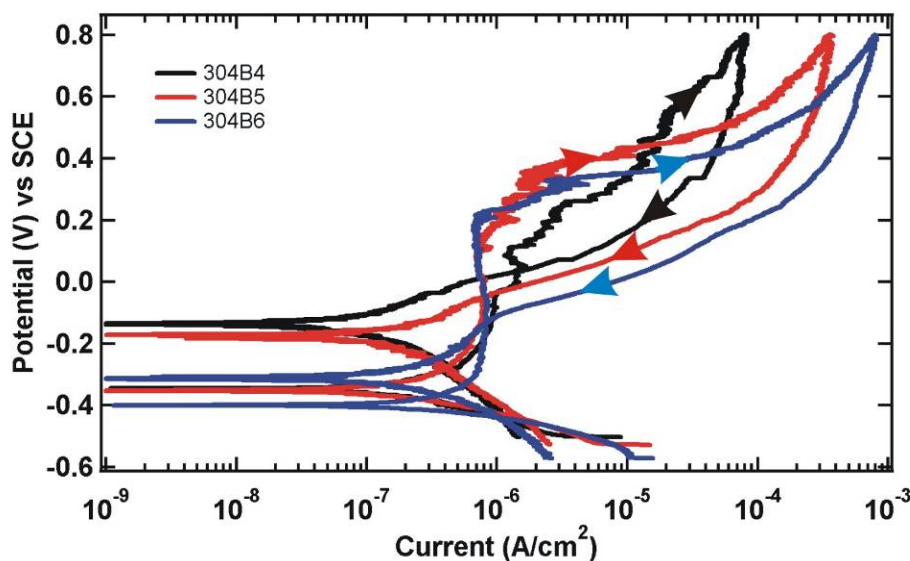
Additional PD tests were performed for the three Neutrosorb Plus alloys in solution B3 using Teflon MCA crevice formers. The curves from these tests are shown in Figure 8, with the data tabulated in Table 6. The E_{corr} values follow the trend of decreasing with increasing boron level. The E_{bd} potentials do not follow the trend of boron content because 304B5 has a higher E_{bd} value than 304B4. The E_{rp} values decrease with increasing boron level, as expected. A comparison of the alloys in the two solution types shows only a slight depression of the E_{corr} and E_{rp} values in B3, which is a significantly lower $\text{NO}_3/(\text{Cl}+\text{F})$ value. The E_{bd} values are actually higher in the B1 solution, which is counter to the effect of halides. It is thought that at these low ionic contents the concentration of halides, which contribute to enhanced corrosion, must be less of an influence in localized corrosion processes. More testing would be required to make any significant statements about these results because they are based on single observations.

Figure 8. PD curves in solution B3 using Teflon multiple crevice assembly (MCA) crevice formers.

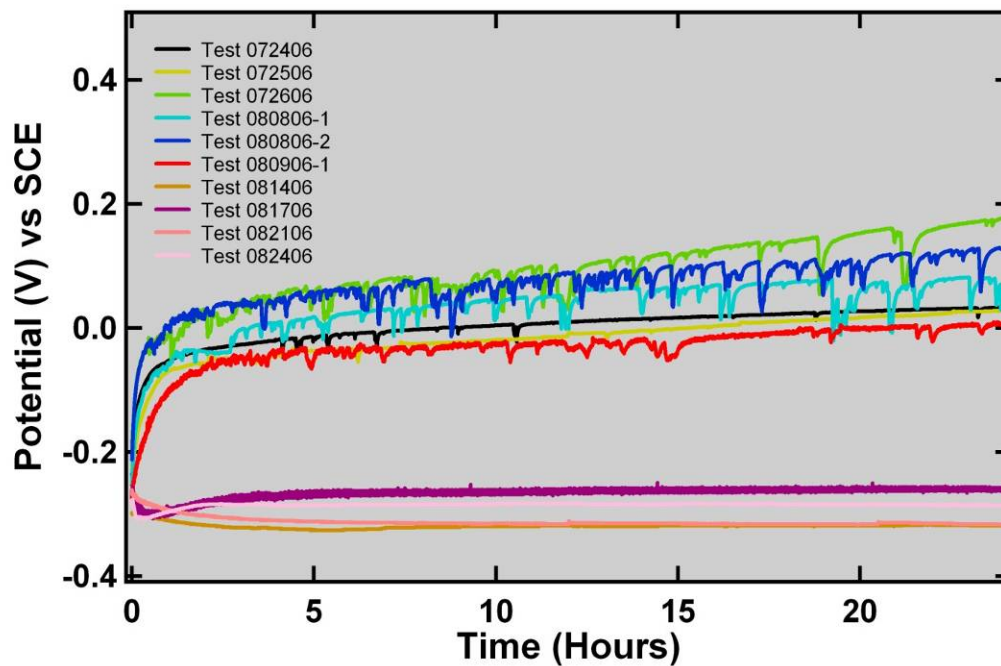
The E_{corr} values measured under aeration demonstrated vastly different results for the borated stainless steels and the Ni-Cr-Mo-Gd alloy. The E_{corr} values were observed to shift positive of -0.1 V for the 304B4 alloy and as far positive as 0.178 V (Test 072606). Most tests showed E_{corr} values for 304B4 under aerated conditions between 0 and 0.2 V. These values should not be considered equilibrated because the potentials were trending positive at the end of the test. The values decreased to between -0.4 V and -0.25 V after the N₂ gas purge. The E_{corr} for the Ni-Cr-Mo-Gd was unaffected by the aeration, with observed values near -0.3 V. Examples of E_{corr} versus time are shown for conditions of aeration (see Figure 9) and N₂ gas purge (see Figure 10). The E_{corr} for the 304B4 alloy shows numerous negative excursions while being aerated. These are due to metastable (short-lived) pitting events. The E_{corr} for the Ni-Cr-Mo-Gd alloy does not show this type of activity, likely due to the corrosion potential being pinned to more negative potentials, which is due to the dissolution of the gadolinide phase.

Figure 9. E_{corr} versus time for aerated cell. Tests 072406, 072506, 072606 080806-1, 080806-2, and 080906-1 are 304B4 specimens and test 081406, 081706, 082106, and 082406 are Ni-Cr-Mo-Gd specimens.

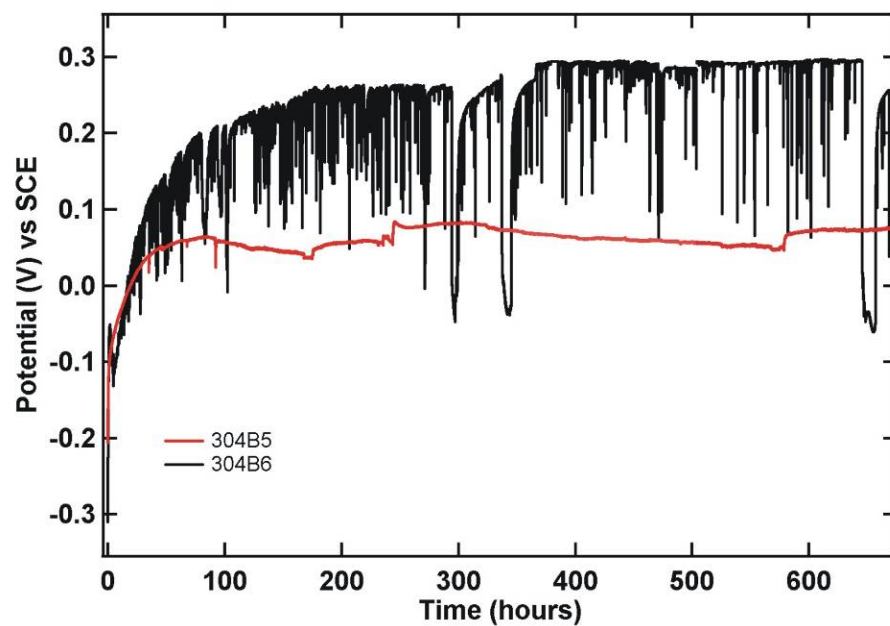
Figure 11 shows a plot of the data for specimens 304B5 and 304B6. The potential of both specimens rose in the initial hours to over 0 V, with 304B6 attaining the more positive value. The 304B6 specimen also had a significant number of negative spikes due to localized corrosion. After 2 weeks, some of the negative spikes are up to 0.3 V in magnitude and last for many hours. The 304B5 specimen showed few negative excursions comparatively. After 1 week, two LPR scans were performed on the 304B6 specimen while under aeration. The corrosion rate was 80 ± 3 nm/yr, indicating very low general corrosion rate in the passive region compared to those measured under N_2 purge in the PS tests, where the E_{corr} values were much more negative. The lower corrosion rate is due to the specimen residing in the passive region when aerated. After the tests, the specimen was examined with LOM, as shown in Figure 12. The most significant damage was observed at the Teflon compression gasket, where pitting around the circumference of the gasket was observed. Other less extensive pitting damage was observed under the MCA crevice formers. No significant damage to the 304B5 specimen with a ceramic MCA was observed.

Figure 11. E_{corr} versus time for 304B5 and 304B6 specimens in solution B3 at 60°C.

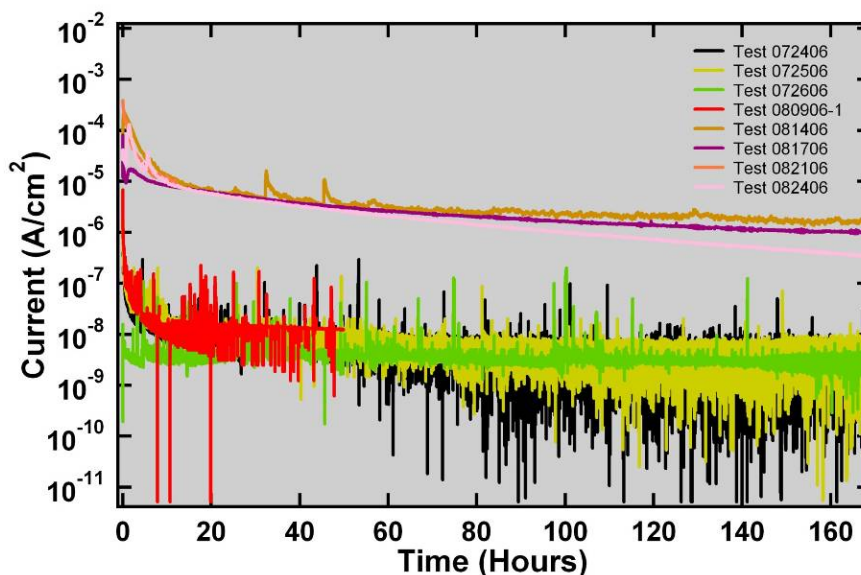
The PS measurements were performed primarily at 0.1 V, with 0.2 V used to determine the effect of higher potential in some tests. These values were derived from the E_{corr} measurements under aeration as described in Section 3.2.4. Figure 13 shows a plot of curves for the 304B4 and Ni-Cr-Mo-Gd alloys. In the case of 304B4, the current dropped to very low values at both potentials. The current translated into corrosion rates of less than 100 nm/year, which indicate very passive behavior. Spikes up to several hundred nA/cm² were observed during the tests, indicating metastable pitting activity, but no long-lived current excursions were observed. The total charge values were also very low, which is another indication that very little corrosion had occurred. Test 080806-2 was run at a higher potential of 0.2 V with similar behavior; however, a power outage resulted in the test ending early, and the data was lost. The data for the Ni-Cr-Mo-Gd alloy indicated lower general corrosion performance. This is likely due to the slow dissolution of the gadolinide phase. Steady decreases in current were observed for all Ni-Cr-Mo-Gd alloy tests. Longer test times or secondary-phase removal prior to testing should be considered to evaluate the true performance of the Ni-Cr-Mo-Gd alloy.

Figure 13. Current versus time plots for potentiostatic (PS) tests. Test 072406, 072506, 072606, and 080906-1 are for 304B4 specimens, and Tests 081406, 081706, 082106, and 082406 are Ni-Cr-Mo-Gd specimens. Note that Tests 080906-1 and 082106 are not complete 7-day data sets.

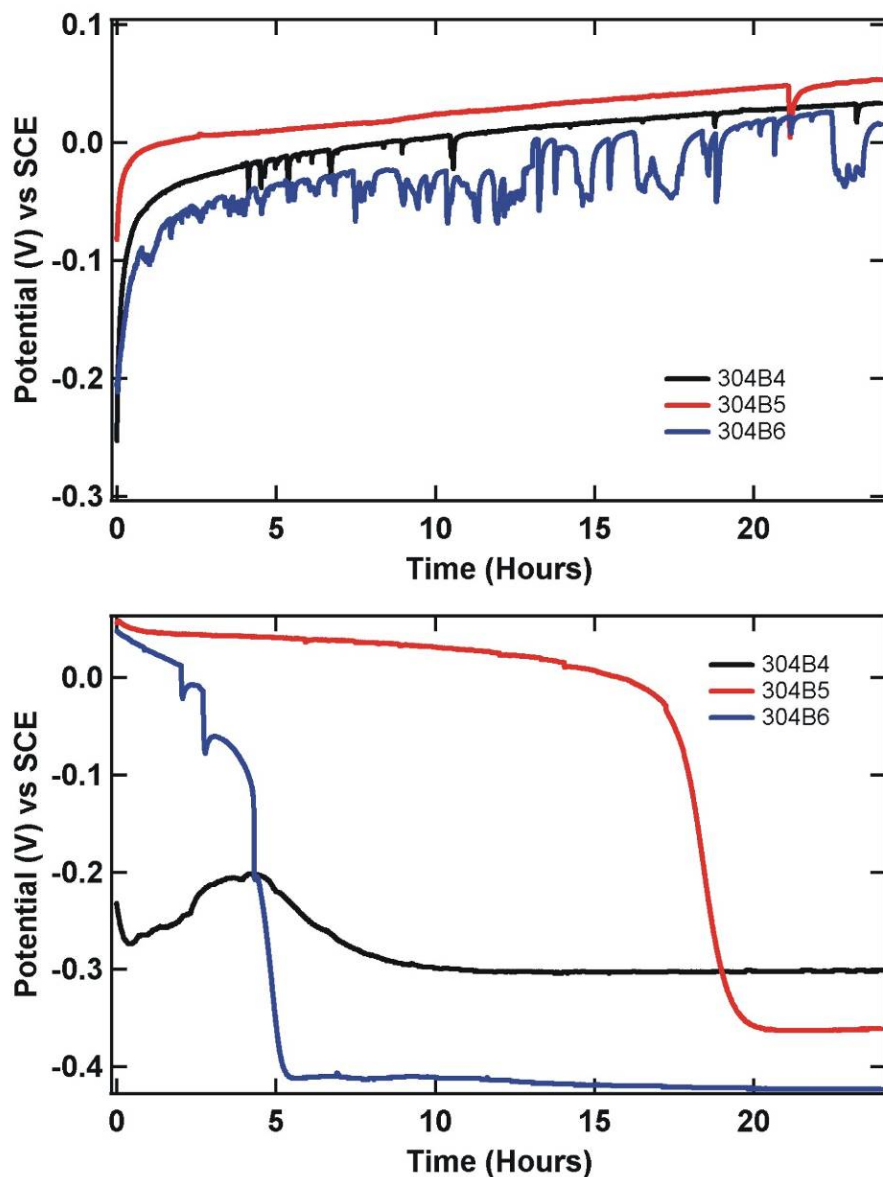
Figure 14 shows the E_{corr} data for 304B4, 304B5, and 304B6 under aeration and N_2 purge. The E_{corr} increases with time under aeration into the passive region. The negative excursions are localized corrosion initiations. The 304B6 specimen showed much more activity than the lower boron-containing alloys. Purging with N_2 resulted in the potential dropping to below -0.3 V versus SCE.

Figure 14. E_{corr} for 304B4, 304B5, and 304B6 in solution B3 at 60°C with air (top) and N_2 (bottom) purge.

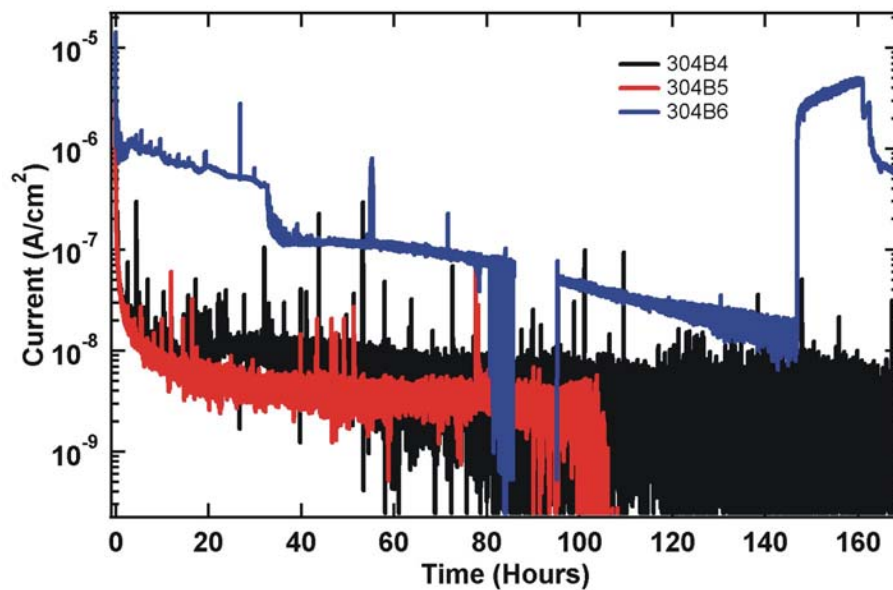
The PS curves for the three Neutrosorb Plus alloys are shown in Figure 15. The alloys with lower boron content (304B4, 304B5) show passivation during the test while the 304B6 shows much higher current, particularly at the end of the test where crevice corrosion was observed. This specimen was coated with a thick iron-oxide film. While small pits were observed under the MCA crevice formers, the most significant corrosion was observed at the Teflon compression fitting used to isolate the specimen electrical contact. One PS experiment was performed for 304B5 with Teflon MCA washers at 0.1 V versus SCE. Figure 16 shows significant current increase initiated during the test that was consistent with crevice corrosion under the MCA in post-test inspection.

Figure 15. PS curves for 304B4, 304B5, and 304B6 in solution B3 with ceramic MCA.

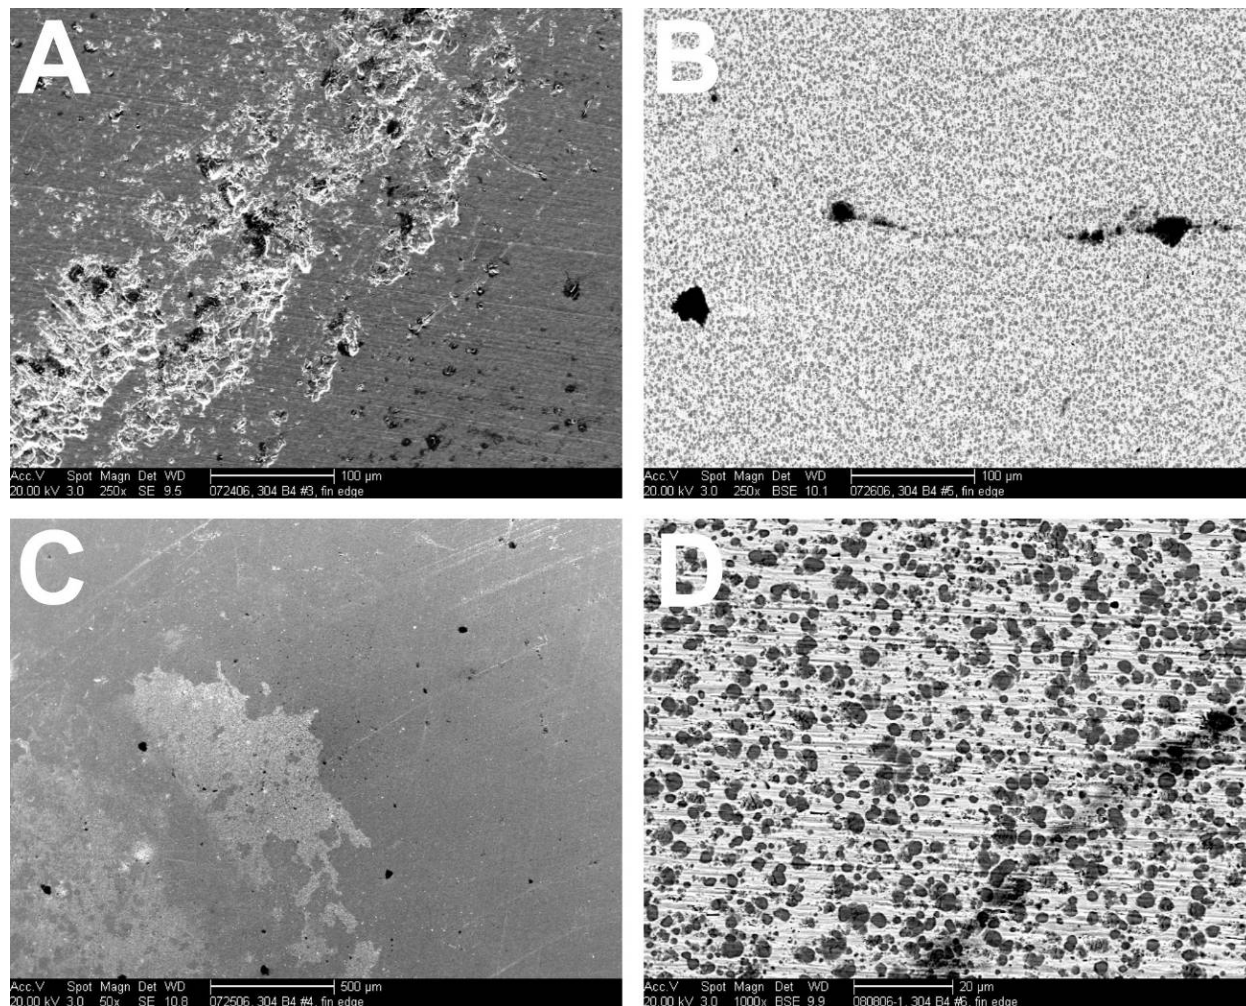
The specimen surfaces were also observed with SEM in both secondary electron (SE) and backscatter electron (BSE) modes. Images of 304B4 are shown in Figure 20. Figure 20A shows a large shallow area of damage while the other images are of smaller pits, less than 100 μm in size. The BSE images show the numerous Cr_2B phases (darker grey) in the material. The darker areas are corrosion sites or accumulated

Figure 20. Scanning electron microscopy (SEM) images of 304B4 alloy corrosion specimens following testing. The images were obtained in SE (A and C) and backscatter electron (BSE) (B and D) modes.

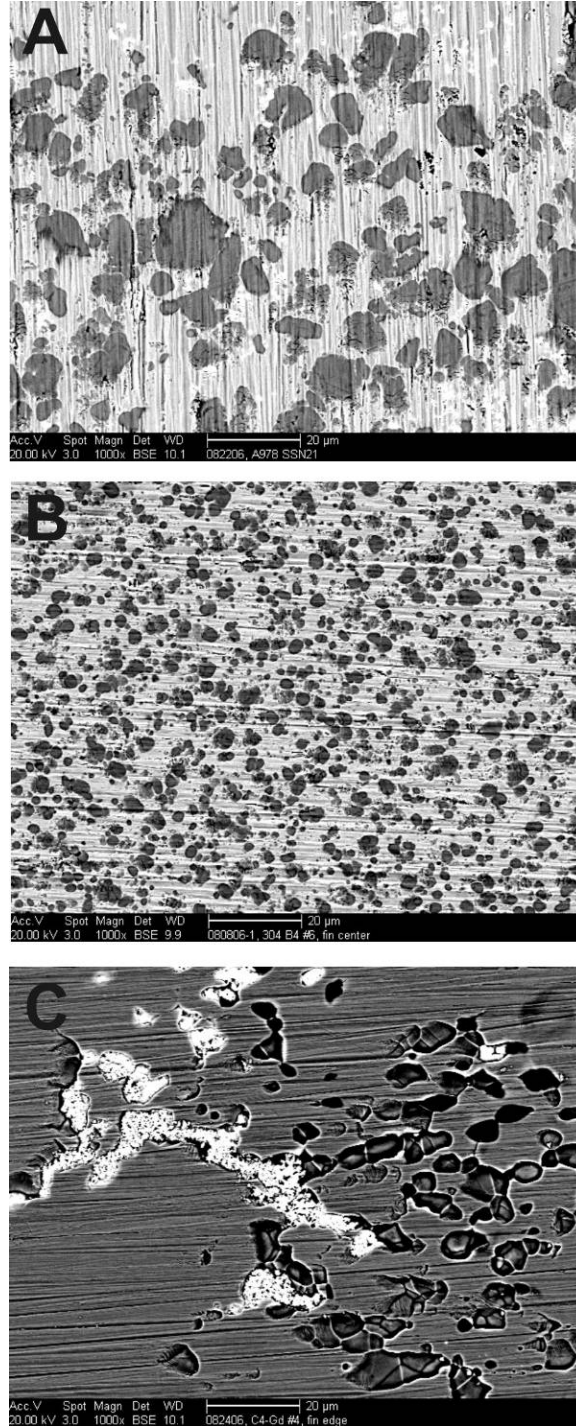
Additional SEM work was performed to show the microstructure of the secondary phases after testing. The SEM images were obtained in BSE mode to enhance the contrast of the secondary phase. Figure 22A and B shows the microstructure of the A978 alloy (Test 080206), with large secondary-phase particles compared with the 304B4 specimen (Test 080806-1), having smaller, more evenly distributed secondary-phase particles. The SEM image of the Ni-Cr-Mo-Gd specimen from Test 082406 shows the partial removal of the gadolinide phase. Small cavities remain from particles that were dissolved. No evidence of localized corrosion damage extending beyond these cavities was found.

Figure 22. SEM images obtained in BSE mode showing the secondary phase particles for (A) A978, (B) 304B4, and (C) Ni-Cr-Mo-Gd alloys.

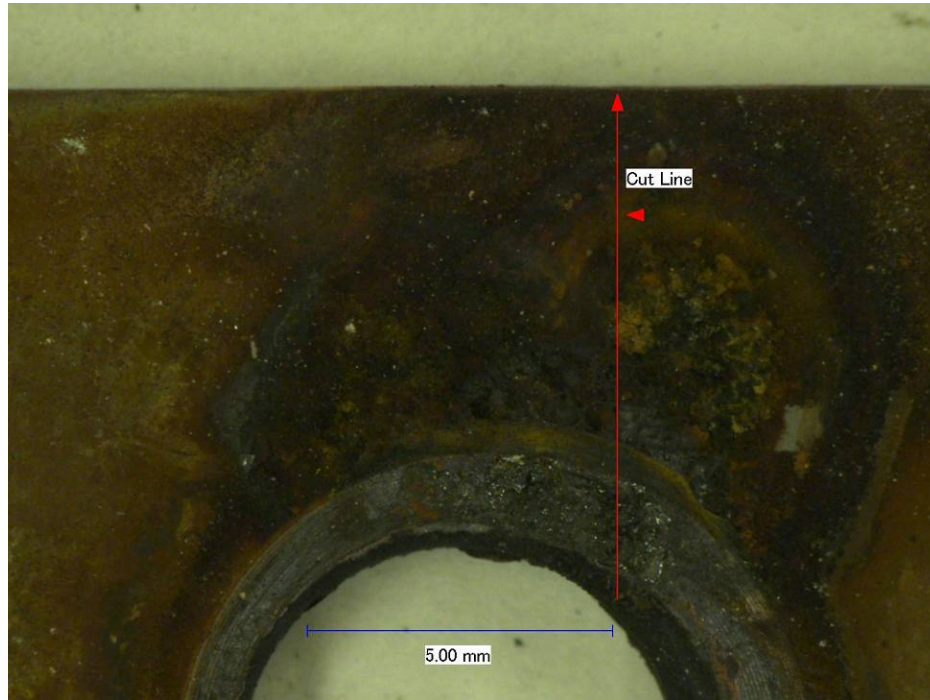
Figure 30. Specimen SSE 30 cut line.

For preparation of the sample for analysis, an area with a large corrosion product cap on the surface was chosen, and the cut was made through this area, which is marked by the red line in Figure 30. This surface corrosion product was located under and adjacent to a Teflon washer as described in the experimental procedure section of the LLNL corrosion paper. Figure 30 shows the area of the test specimen that was prepared for analysis.

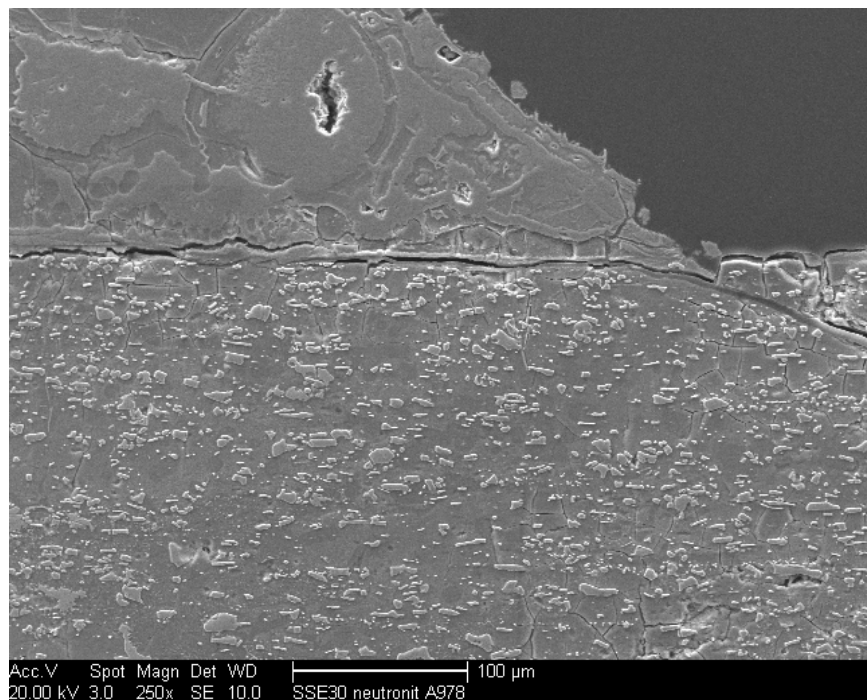
Figure 33. Specimen SSE 30 SE image.

Figure 33 shows a SEM SE image of the sampling areas for the corrosion products that lie above and below the original sample surface.

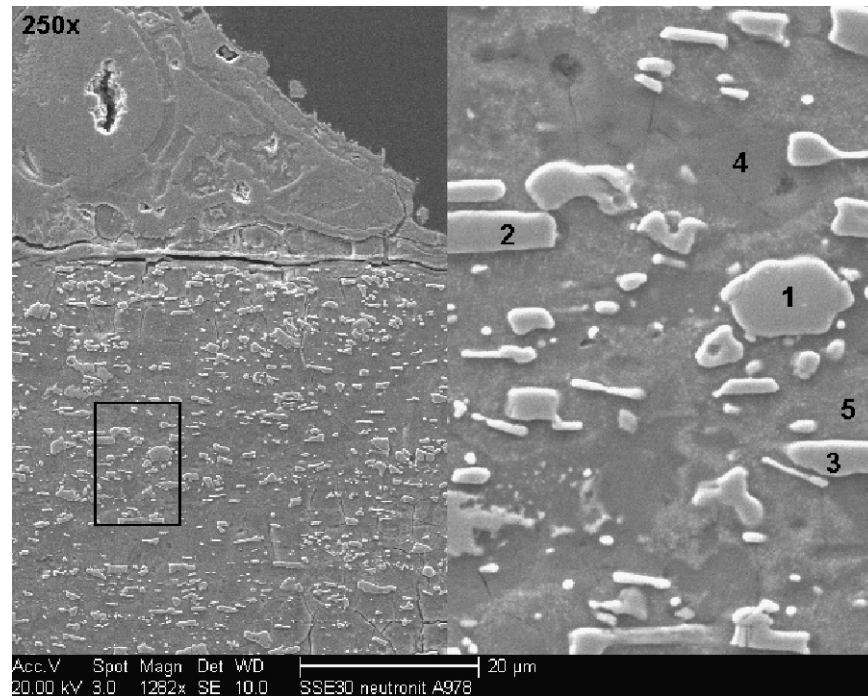
Figure 34. Specimen SSE 30 SE image, corrosion product analysis. (The 20 μm bar corresponds to the image on the right.)

As shown in Figure 34, an area was chosen (box with black border) for sampling in the corrosion product found under the apparent original sample surface. The analytical results are in Table 11. The particles, marked as spots 1 and 2, appear to be borides. Spot 3 has the physical appearance of a boride, but no boron was detected. Spots 4 and 5 are corrosion products where some boron was detected in spot 4 and no boron was detected in spot 5.

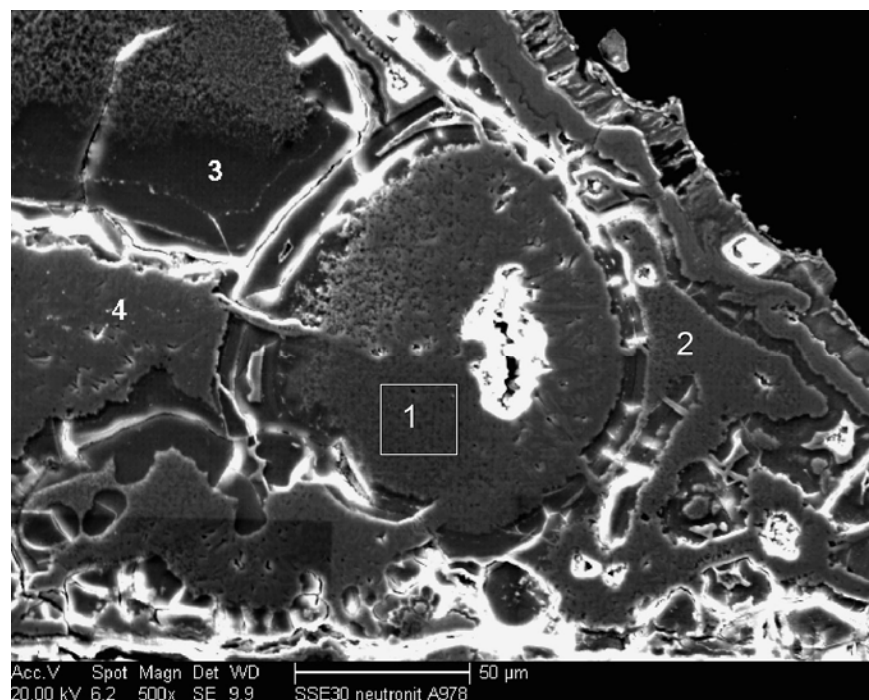
Figure 35. Specimen SSE 30 SE image, corrosion product analysis.

The sample area shown in Figure 35 is the corrosion product deposited above the apparent original-sample surface. The analysis results of the sampled areas are shown in Table 12. The sample areas are iron and chromium-corrosion-product oxides in which boron was detected. Boron was found in the four sampled areas of the corrosion product found on the sample surface.

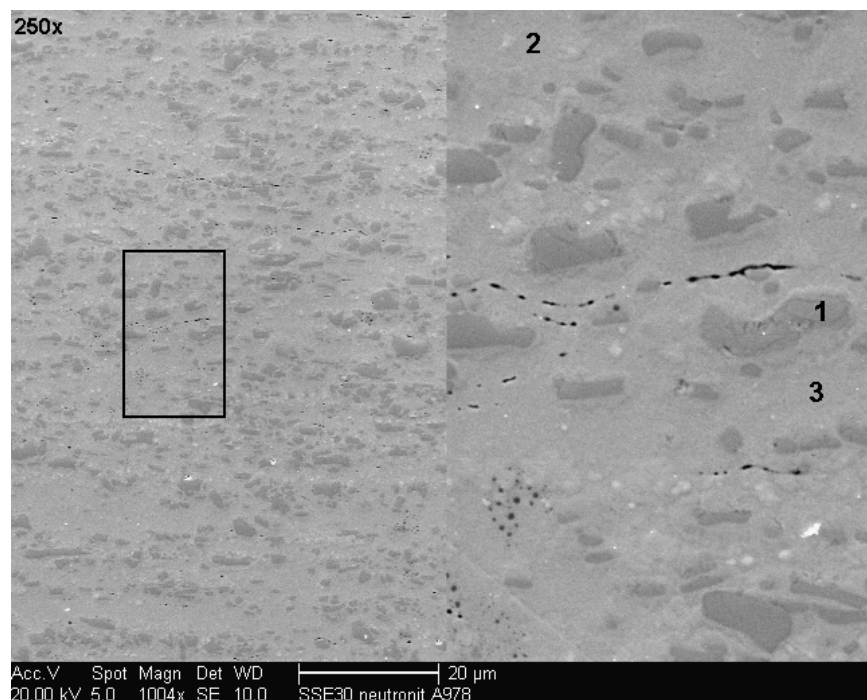
Figure 36. Specimen SSE 30 SE image, bulk metal boride analysis. (The 20 μm bar corresponds to the image on the right.)

An area of the bulk metal (unetched) below the corroded surface is shown in Figure 36. The analysis results for the sampled areas are shown in Table 13. The secondary-phase particle sampled at spot 1 is a boride, and spots 2 and 3 correspond to the chemistry of the base austenitic structure of this alloy. Spot 3 does identify boron, but this value may be from borides adjacent or underneath the sampled area being measured by the beam.

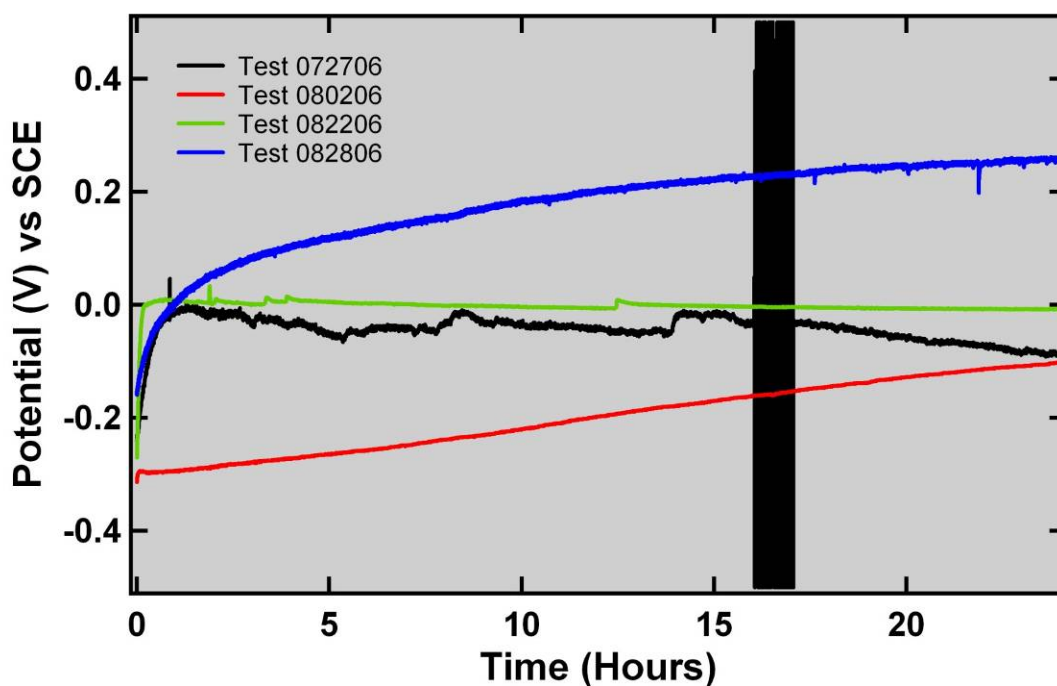
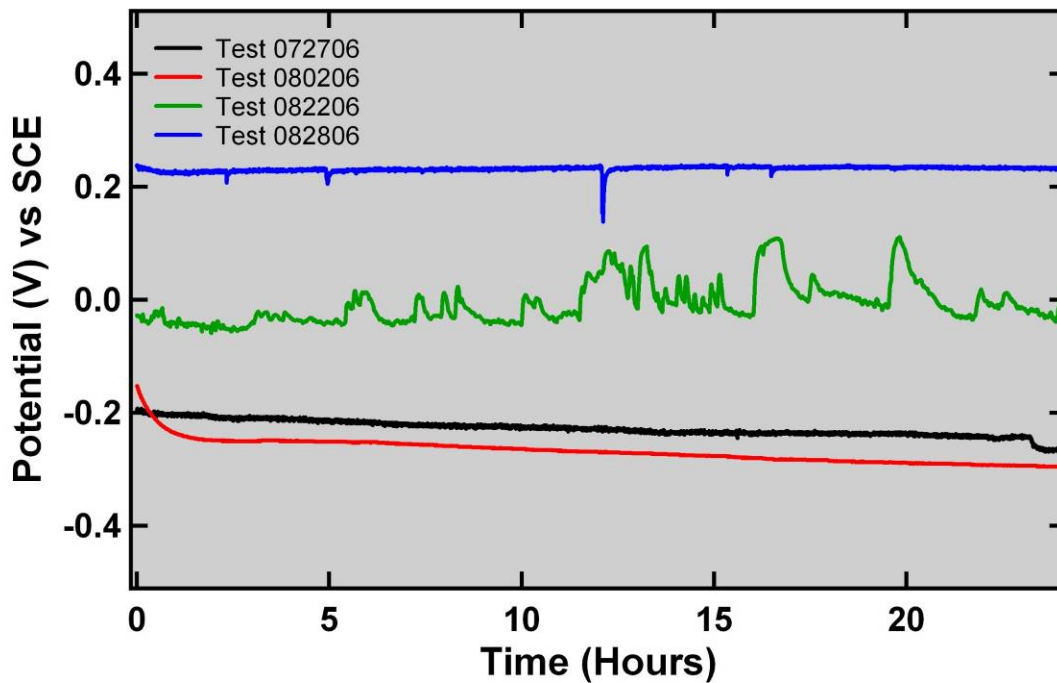
Figures A1 and A2 show the E_{corr} measurement for the A978 tests under aerated and N_2 purge. There does not appear to be a consistent common behavior in the E_{corr} data except of the two epoxy coated specimens under N_2 purge.

Figure A1. Plots of E_{corr} versus time for A978 specimens with aeration.

Figure A2. Plots of E_{corr} versus time for A978 specimens during N_2 purge.

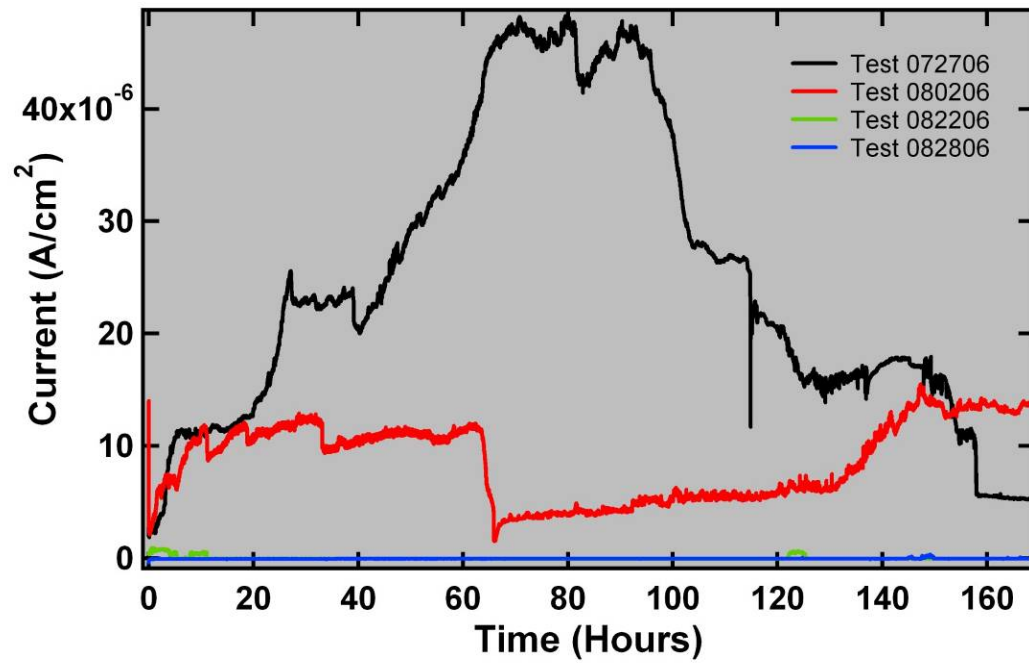
Figure A3. Plots of current versus time for PS tests of A978 specimens.

Figure A3 shows the PS data obtained from the four A978 specimens. The two specimens using an epoxy coating have much higher current. After examination of the specimens after the test (see Figure A4), it was noticeable that the contact to the specimens was corroded. The specimens using only a bare, platinum-wire contact showed low negative currents with a short positive current excursion due to localized corrosion. This negative current is evidently due to the exposed platinum wire and is likely an electrochemical reaction with dissolved species. Thus, in all cases a corrosion rate cannot be ascertained because the current is dominated by other reactions at the contact wires. Because the net current was negative, this suggests that the anodic corrosion current for the A978 was low.
