# **Fiscal Year 2010 Revegetation Assessment**

November 2010

**INL/EXT-10-20331**

**Idaho National Laboratory  
Idaho Falls, Idaho 83415**

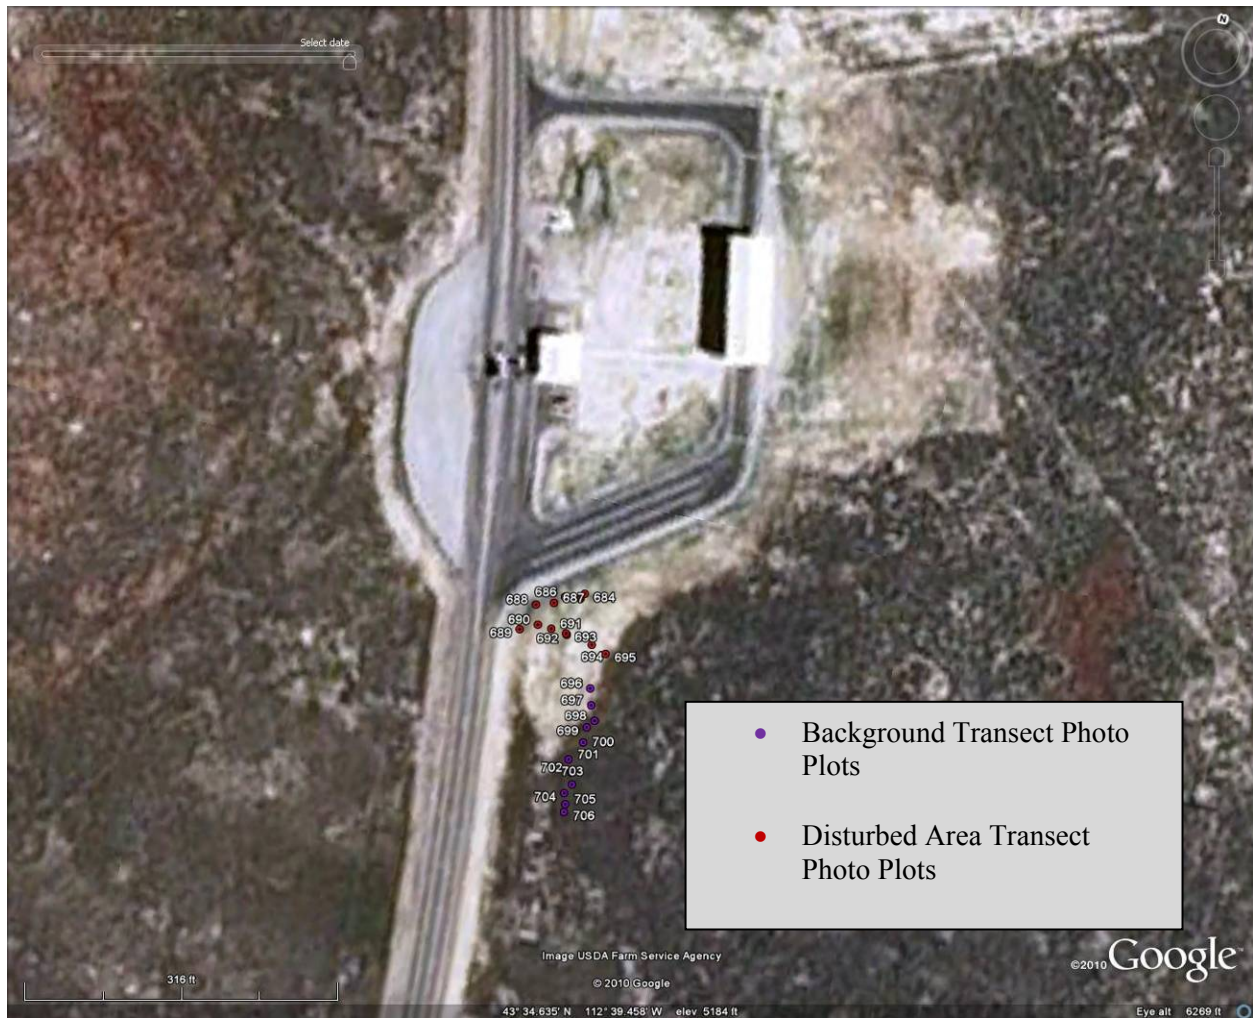
Figure 4. Transect locations for the MFC Septic Tank Drain Field.

The septic tank drain field is approximately 58 ft x 105 ft. Perennial vegetation has reached 79.2% of background (Table A-3, Figure B-12) and consists almost entirely of crested wheatgrass. There is not a statistical difference between mean cover percentages for background and disturbed area transects ( $p = 0.093$ ). The mean percentage of grass in the background is significantly higher than that of the disturbed area ( $p = 0.044$ ). Annuals including kochia, pinnate tansymustard, halogeton, cheatgrass, and clasping peppergrass were also observed, but mean cover percentage of annual species is not significantly different between the background and disturbed areas ( $p = 0.305$ ). There is still a small strip of bare ground running down the middle of the disturbed area. Transects were located as shown in Figure 4.

Because the area surrounding the project is dominated by crested wheatgrass, it is expected that crested wheatgrass will eventually become the dominant species on the disturbed sites. The Septic Tank Drain Field and fenced area east of MFC-736 have achieved final stabilization and will not be evaluated in future assessments. The Power Cable Corridor and fenced area between MFC-735 and MFC-736 will be evaluated again in 2011 to determine whether or not final stabilization has been achieved.

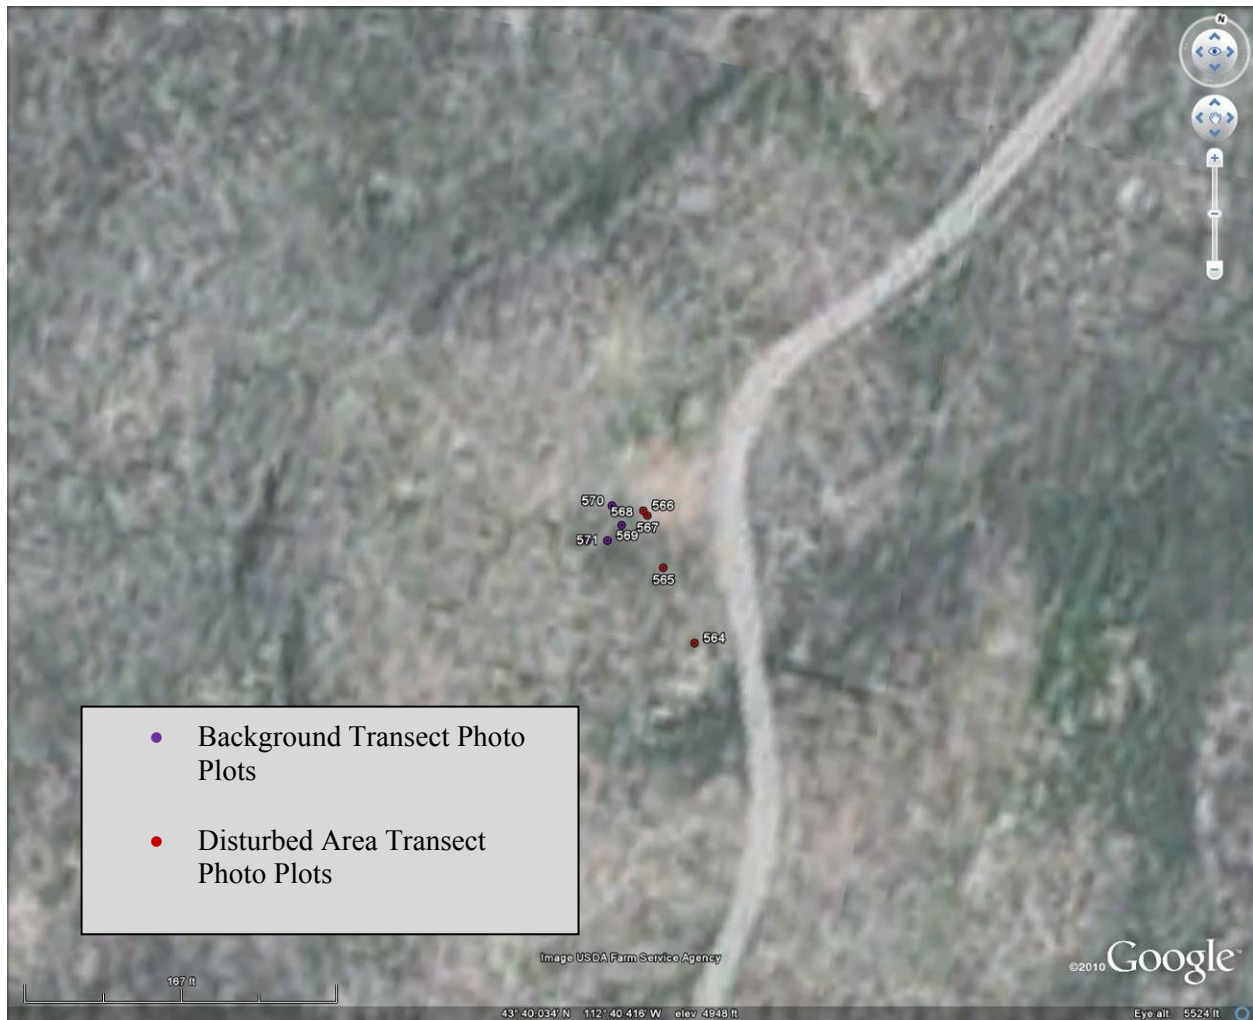
Figure 6. Location of transects at Power Pole 170.

This site is located on a slope approximately 100 ft north of power pole 170 on the west side of the T-25 Road. The disturbed area is approximately 30 ft x 40 ft. Soils are fine textured with scattered small rocks and some gravel. Some of the wood chips that were applied after the area was seeded have piled up, yet this does not appear to have impacted plant growth. The disturbed transect was located along the long axis of the disturbed area. The background transect was located outside of the disturbed area as shown in Figure 6.

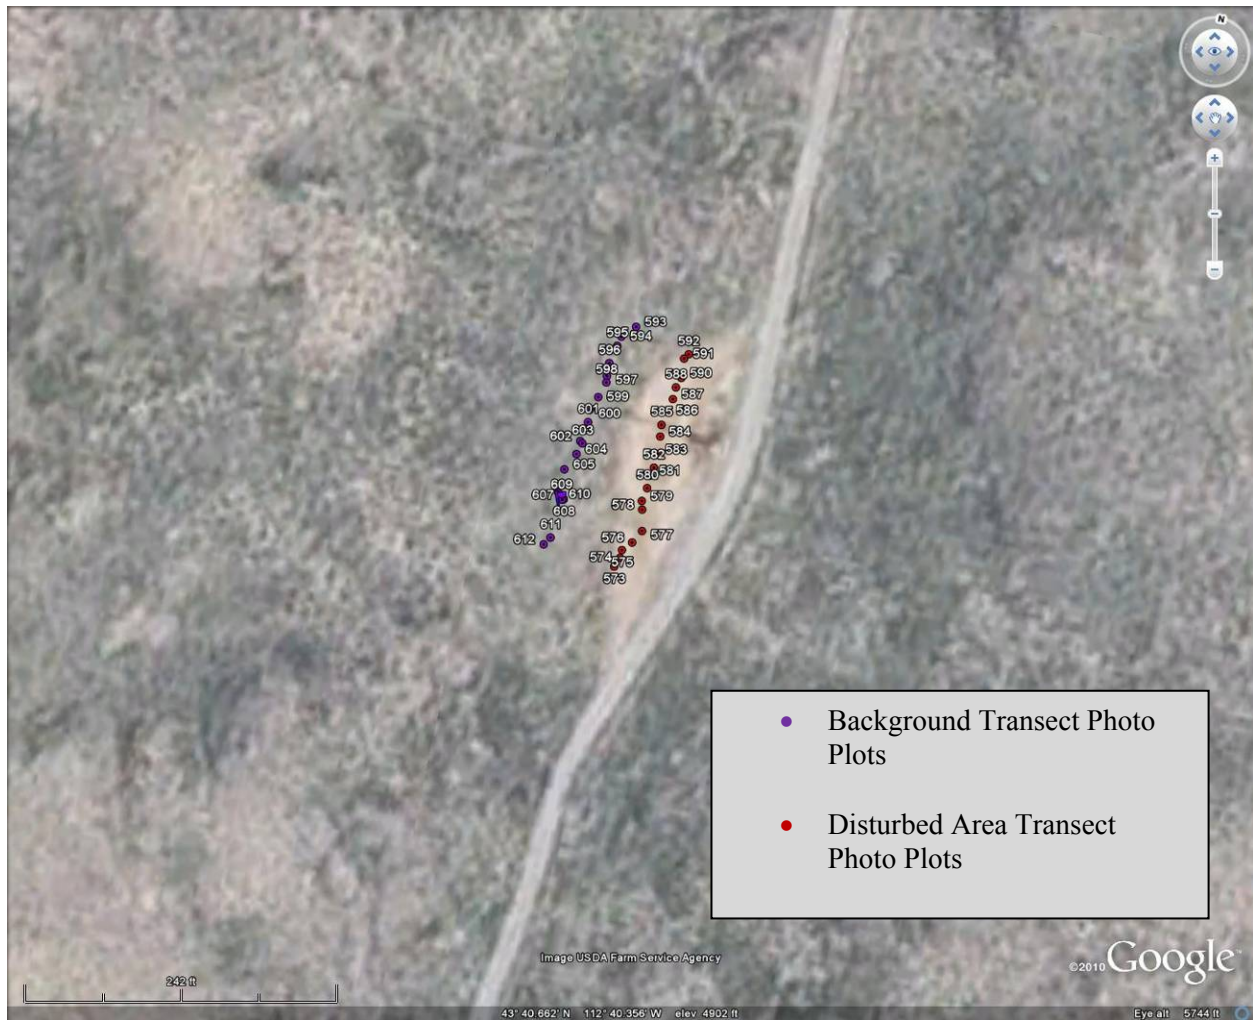
Figure 7. Transect locations for Power Pole 176.

This site was used as a turnaround for large trucks. Entry was from the T-25 Road on both the north and south sides of power pole 176. The turnaround curves around the west side of power pole 176. The project did not disturb the area located between the power poles; therefore that area was not included in the assessment. Soils are fine to sandy textured with scattered small rocks and some gravel. Wood chips were applied after the area was seeded. Transects were located as shown in Figure 7.

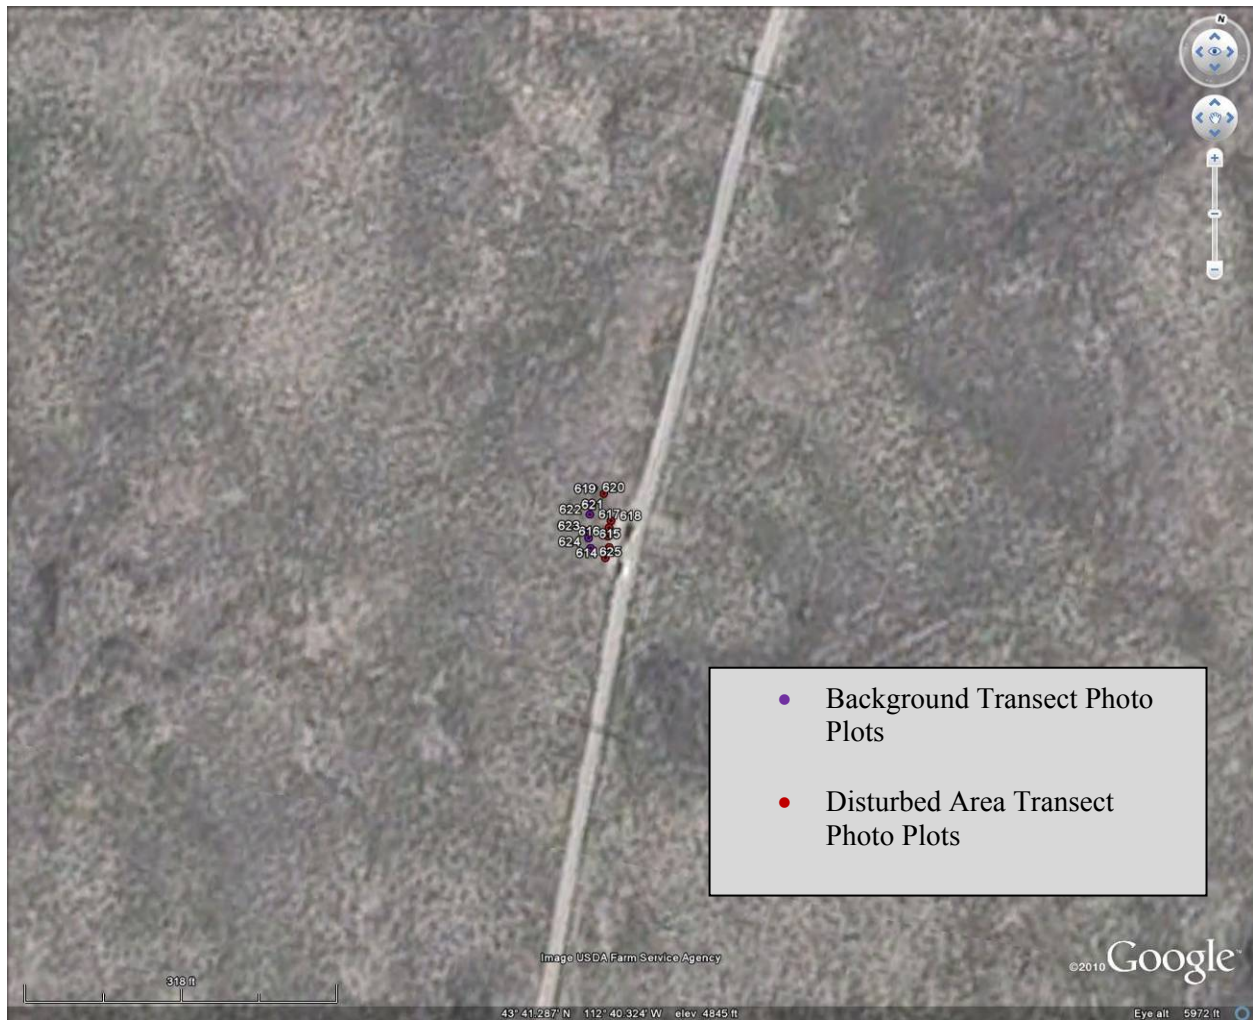
Figure 8. Transect locations at Power Pole 181.

This site is located approximately 150 ft north of power pole 181 on the west side of the T-25 road. The disturbed area runs parallel with the T-25 road and is approximately 12 ft x 65 ft. Soils are sandy with scattered small rocks. Wood chips were applied after the area was seeded. Transects at this location are shown in figure 8.

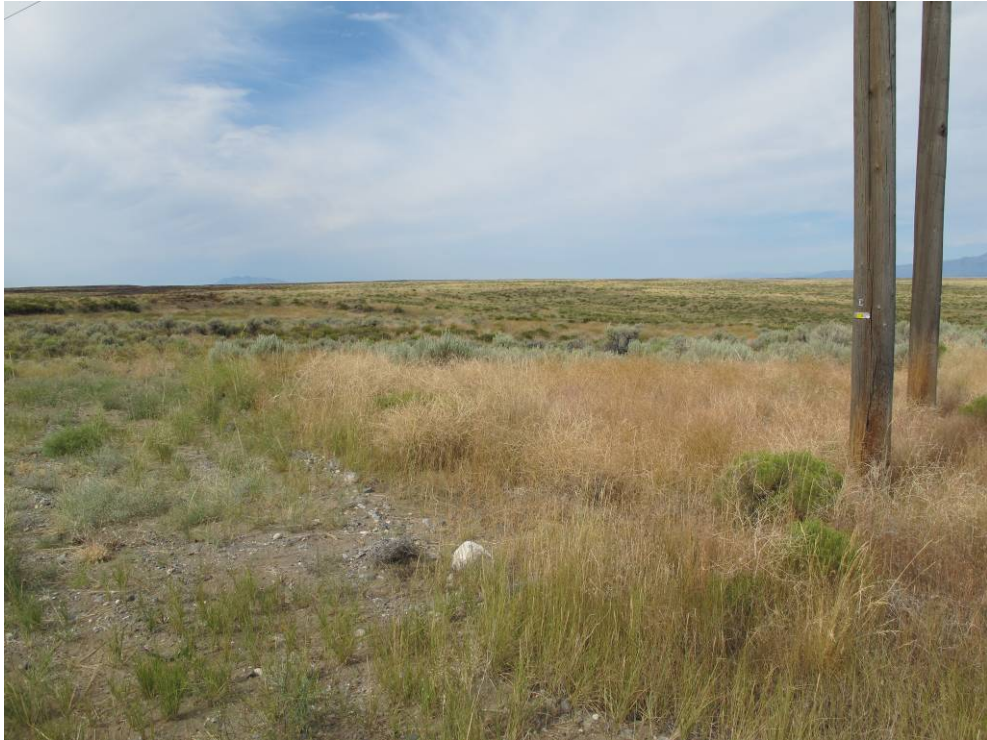
Figure B-15. Disturbed vegetation near power pole 179.

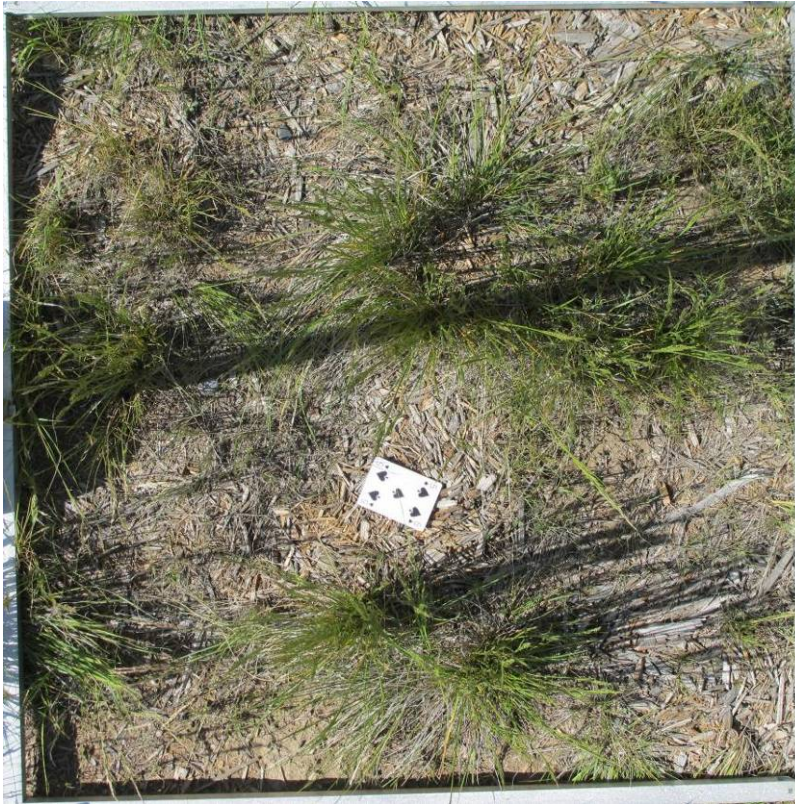
Figure B-17. Disturbed vegetation plot at Power Pole 170.

The site assessment was conducted on June 10, 2010 and globemallow was the most abundant forb. Cheat grass, Indian ricegrass, bottlebrush squirreltail, thickspiked wheatgrass, and needle and thread grass were found within the disturbed area. There was a good mixture of desirable perennial grasses with thickspiked wheatgrass being the most common (Figure B-17). Several young green rabbitbrush plants had also established within the disturbed site. Perennial cover was 116.2% of background (Table A-4), and there was not a significant difference between mean perennial cover in the background and disturbed area ( $p = 0.544$ ).

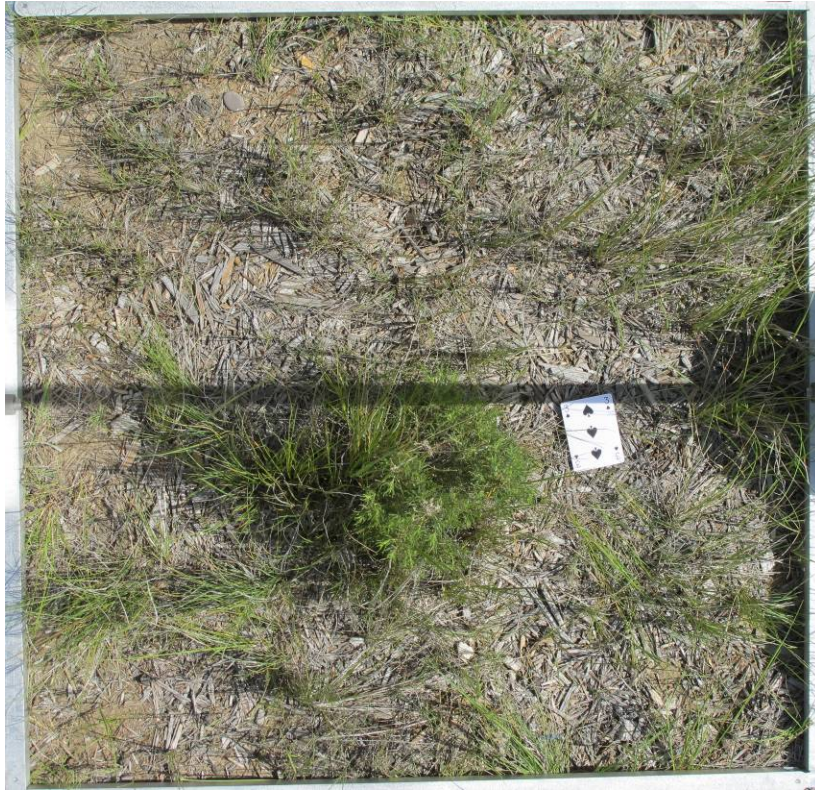
Figure B-19. Disturbed vegetation plot at Power Pole 176.

As of June 10<sup>th</sup>, 2010 perennial cover at this location had reached 98.8% of background (Table A-5) and was composed mostly of grasses including Indian ricegrass, bottlebrush squirreltail, thickspiked wheatgrass, and needle and thread grass (Figure B-19). Green rabbitbrush seedlings were reestablishing within the disturbed site. There was not a significant difference between the mean percentage of cover between the background and disturbed areas ( $p = 0.948$ ). Additionally, the mean percentages for rock and soil cover were significantly higher in the background area than in the disturbed area ( $p = < 0.001$  for both). Part of the disturbed area and the background area was burned by the Jefferson Fire in mid July (Figure B-20).

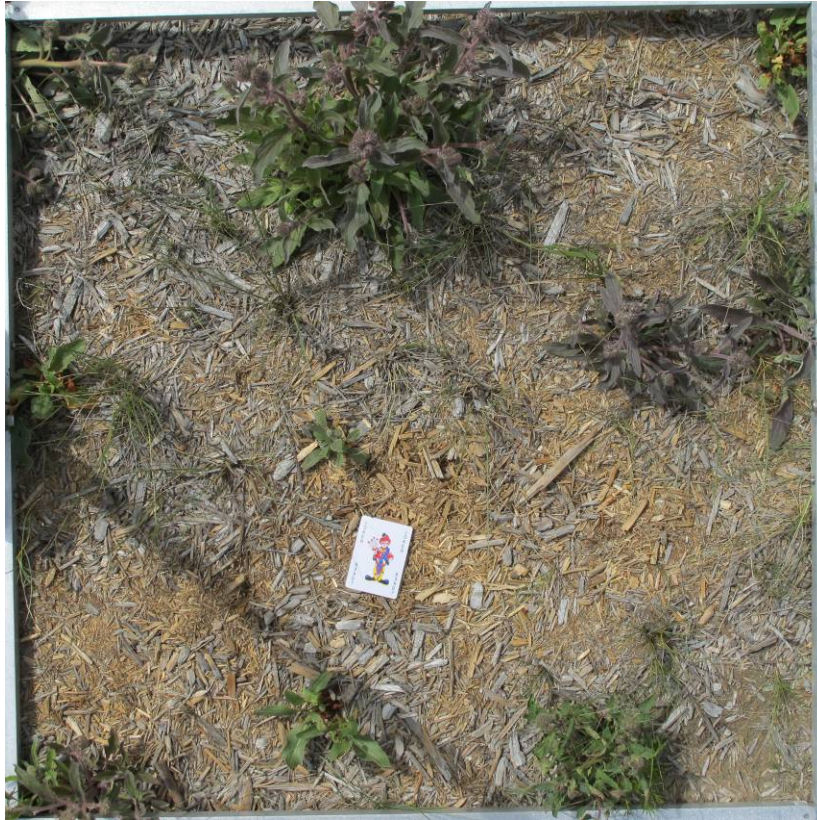
Figure B-21. Disturbed vegetation plot at Power Pole 181.

Forbs observed include largeflower skeletonweed (*Lygodesmia grandiflora*) and silverleaf phacelia (*Phacelia hastate*). Indian rice grass is the dominant grass at this location, but scattered cheatgrass and needle and thread grass have also established in the disturbed area (Figure B-21). Green rabbitbrush was absent within the disturbed area even though it is present in nearby undisturbed areas. This site has achieved final stabilization with cover at 87.6% of background (Table A-6). There is not a significant difference between mean annual cover percentage between the background and disturbed areas ( $p = 0.525$ ).

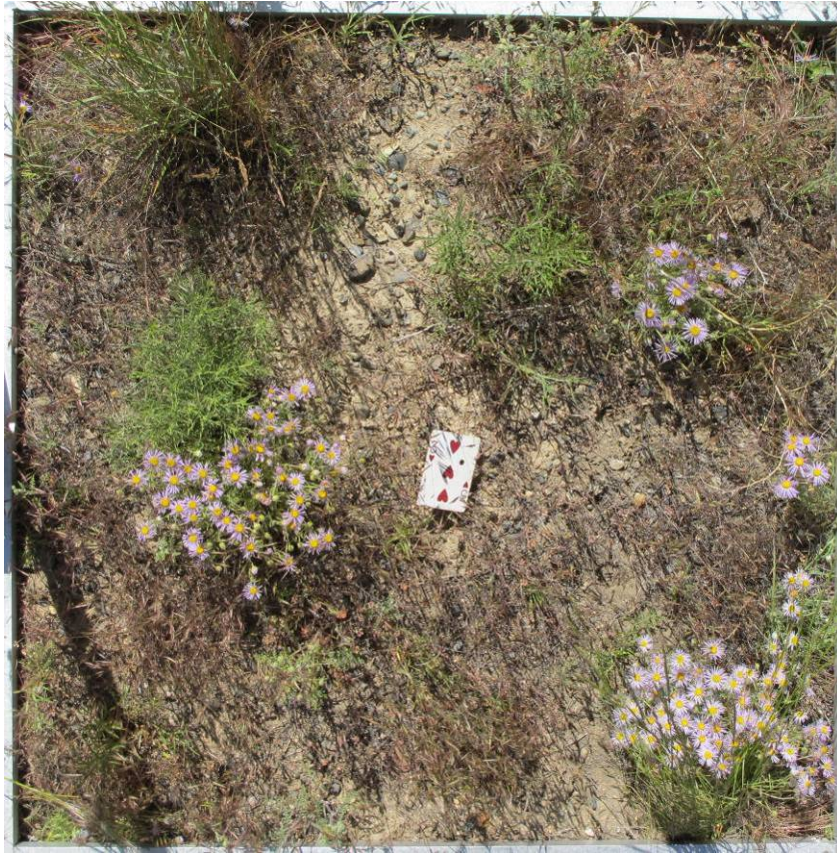
Figure B-27. Background vegetation plot at the VZRP.

The VZRP is located within a large area previously burned by wildfire. Background vegetation was assumed to be represented by the reestablished burn area. Background vegetation is represented by Figure B-27.

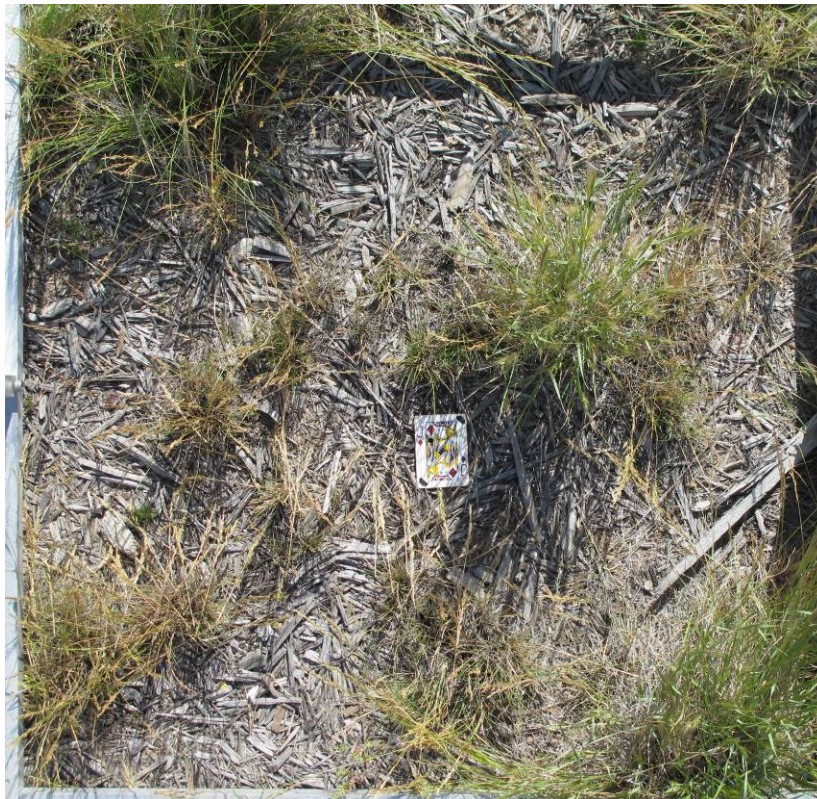
Figure B-28. Disturbed vegetation plot at Wells 164A and 164B.

Two transects were placed parallel to each other through the disturbed area (Figure 10). Perennial cover has reached 68.1% of background (Table A-7, Figure B-28), and there is not a significant difference between mean percent perennial cover for the background and disturbed areas ( $p = 0.152$ ). However, the mean percentage of grass within the disturbed area is significantly higher than in the background ( $p = 0.029$ ), while the mean percentages for forbs and shrubs were significantly lower ( $p = 0.035$  and  $p < 0.001$ ). The disturbed area at this location has not yet achieved final stabilization. Bottlebrush squirreltail, shaggy fleabane, and thickspiked wheatgrass are the most common native species in the disturbed area. Green rabbitbrush is also establishing well.

The recommendations in the 2009 report for wells 164A and 164B included signs prohibiting the use of the area as a vehicle turn-around, accompanied by better vehicle barriers, e.g. fencing, are needed. Russian thistle should be controlled adjacent to the road. Additionally, the 2009 report stated wood chips in some locations in the disturbed area appear to be thick and impeding re-establishment of vegetation. Chips should be re-scattered and thinned if this can be completed without disturbing the re-establishing perennial vegetation.

During the 2010 review of wells 164A and 164B, it was noted that there is a sign designating the area as a revegetation site near the well heads. In addition, there was little indication of vehicle disturbance around most of the wells this year. Similar to other revegetation sites, Russian thistle abundance is significantly lower along the entire VZRP road than it was in 2009. Only one small Russian thistle plant was actually observed. Thick accumulations of wood chips could not be located. As discussed in Section 8.1.1.1, the disturbed area was 68.1% of background. Therefore, the digital camera sampling and analysis method will be performed on these well sites in 2011.

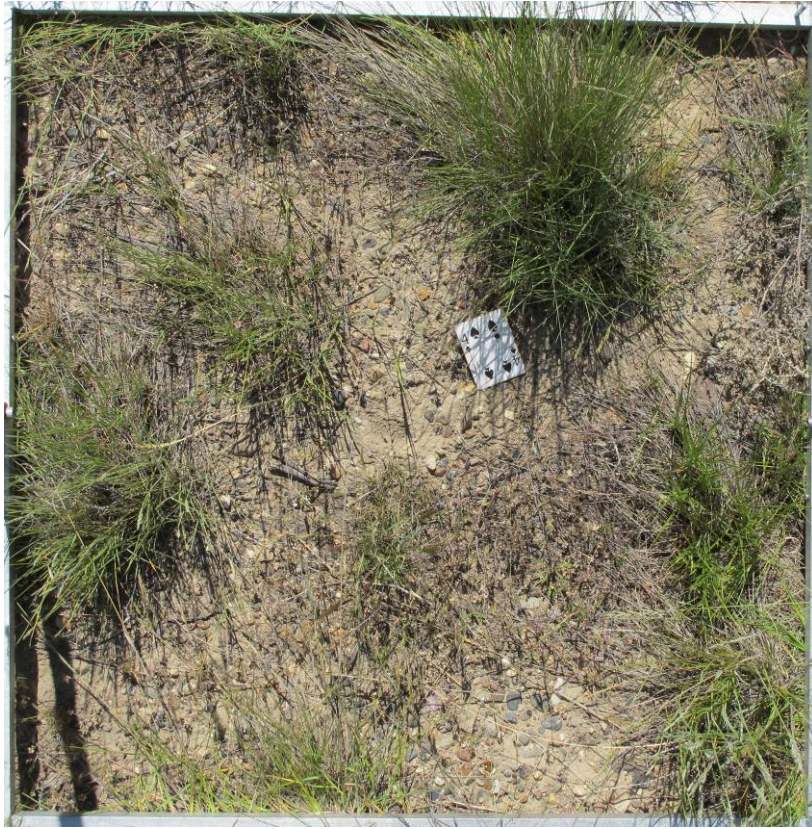
Figure B-29. Disturbed vegetation plot at Wells 199, 200, and 205.

Figure 11 shows transects at Wells 199, 200, and 205. The disturbed area at this location has achieved final stabilization. Cover in the disturbed area is 97.8% of background (Table A-8), and there is not a significant difference between mean percent perennial cover in the background and disturbed areas ( $p = 0.882$ ). Mean percent forb cover is significantly higher in the background than in the disturbed area ( $p = 0.006$ ). Thickspiked wheatgrass, green rabbitbrush, sagebrush, and fleabane have colonized the site. Western tansymustard and cheatgrass are also present. Figure B-29 shows vegetation typical of the location.
