# Instrumentation Performance During the TMI-2 Accident

**ANIMMA 2013**

Joy L. Rempe  
Darrell L. Knudson

June 2013

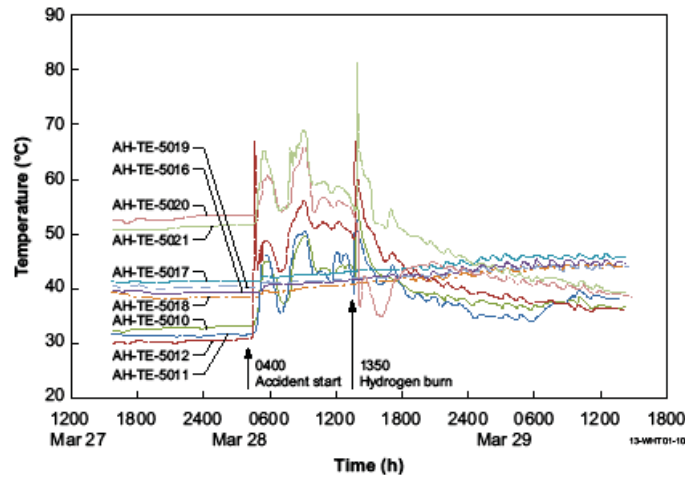
- Peak values for containment building temperature would not have been obtained without considering data from other sensors such as the containment building pressure transmitters. Calculations assuming peak containment pressures (see Fig. 8) yielded peak containment temperatures of 650 °C, which are much higher than the measured 93 °C peak temperature data (Fig. 9). Recognizing that the TMI-2 containment temperature data had a limited sampling rate, experts qualified the containment pressure and a modified set of containment temperature data.

Fig. 9. Reactor building temperatures at selected locations.
