TMI-2 – A Case Study for PWR Instrumentation Performance During a Severe Accident

Joy L. Rempe
Darrell L. Knudson

May 2014

Prepared for the
U.S. Department of Energy
Office of Nuclear Energy
Under DOE Idaho Operations Office
Contract DE-AC07-05ID14517

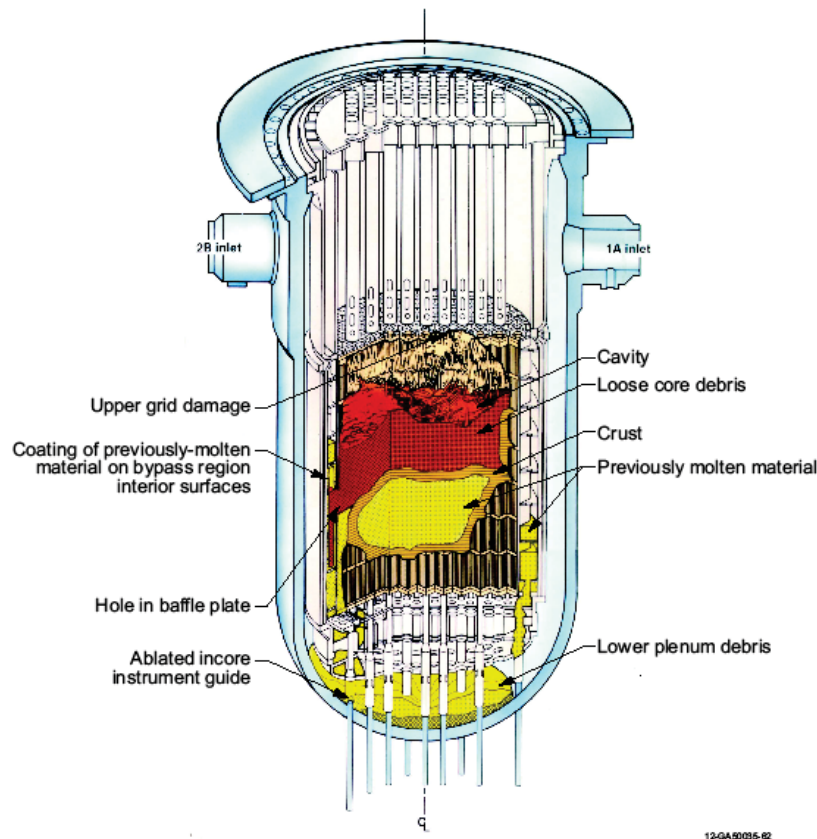
- Based on the end-state core and CSA configuration and on supporting analyses of core heatup, it is believed that the crust (or resolidified molten material) surrounding the relocated core material failed near the top of the molten core region in the southeast quadrant of the reactor vessel. Limited damage to the CSA occurred as the core material flowed to the lower plenum. Figure ES-4 illustrates the final state of materials within the TMI-2 vessel.

Figure ES-4. Postulated final state of materials within the TMI-2 vessel.

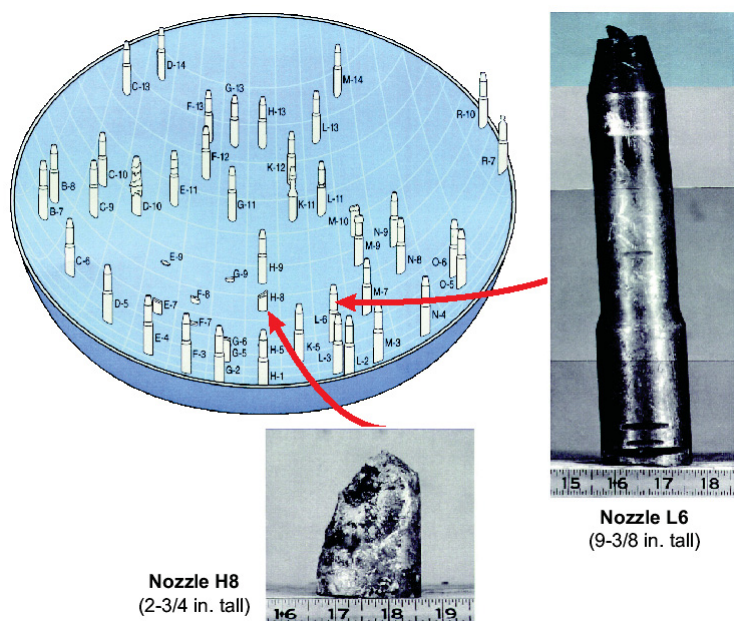
Figure ES-5. Location of TMI-2 lower head vessel boat samples and 'hot spot.'

- Metallurgical examinations of the vessel lower head steel samples in conjunction with visual observations suggest that an elliptical region of the vessel, approximately 0.8 m by 1.0 m, reached peak temperatures of 1100 °C during the accident (see Figure ES-5). At locations away from the hot spot, there is no evidence to indicate that vessel steel temperatures exceeded 727 °C.

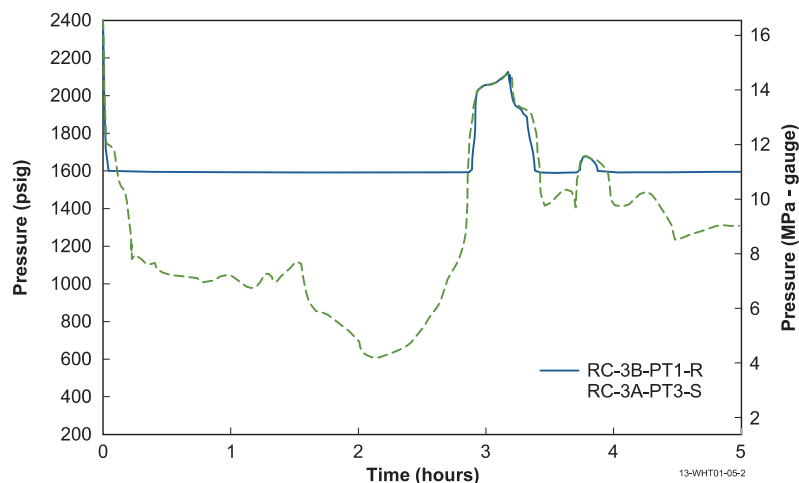
- Data unavailability was often due to computational limits, such as storage memory, inadequate paper or ink, insufficient sampling rates, and ‘preset’ limits associated with anticipated operating ranges (rather than sensor operating limits as illustrated by the pressure data shown in Figure ES-10). A wider range of limits and enhanced computational capabilities, with easy-to-read graphical displays, could alleviate such issues, as occurred with TMI-2 building resistance temperature detector (RTD) temperature and steam generator reference pressure transmitter sampling.

Figure ES-10. Comparison of A-loop wide range pressure recorded on the strip chart and B-loop narrow range pressure on the reactimeter (Note: narrow range pressure data limited to values above 1600 psig).

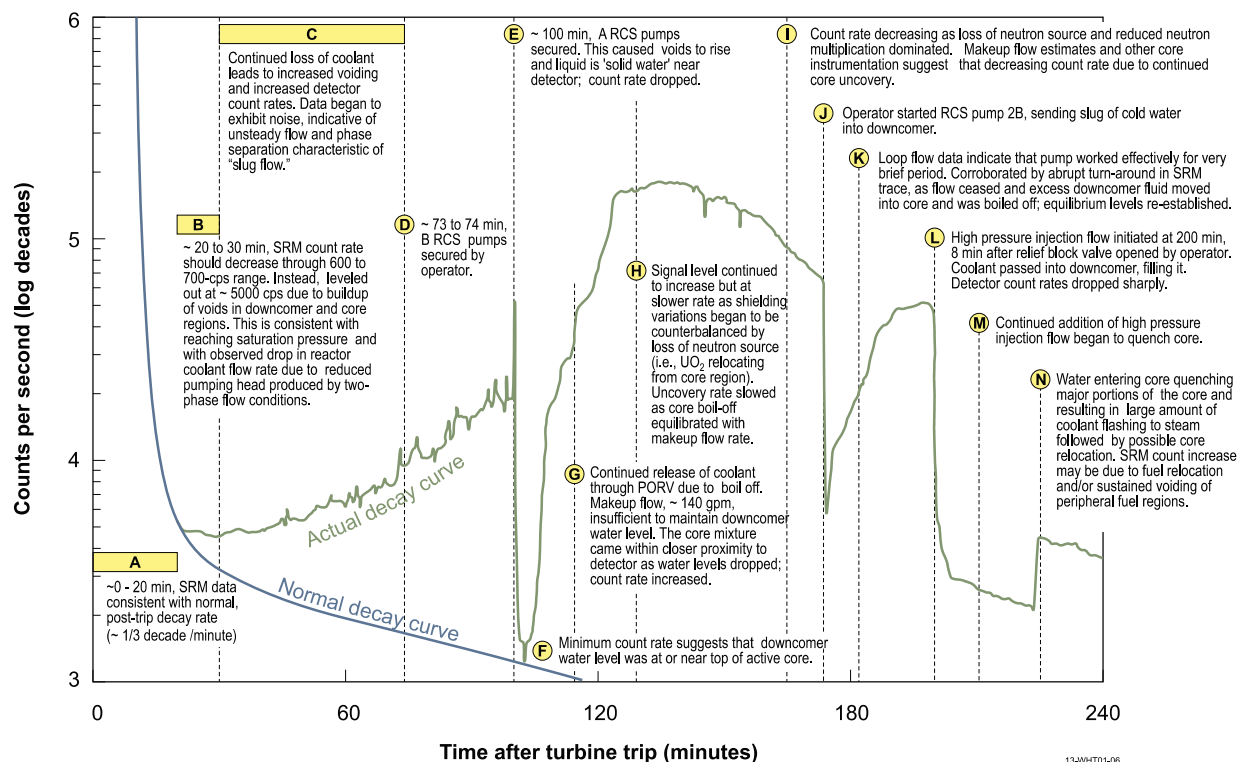
- Qualitative insights can be obtained by considering sensor response for alternate applications, e.g., ex-core source-range detector signals provide insights about real-time RCS water levels, in-core SPNDs provide insights about RCS temperature and water levels. However, such interpretations often require detailed analyses and assumptions related to the status of the core, the RCS and containment (as evidenced from efforts to interpret SRM data in Figure ES-11).

Figure ES-11. TMI-2 SRM response during the first 4 hours of the accident.

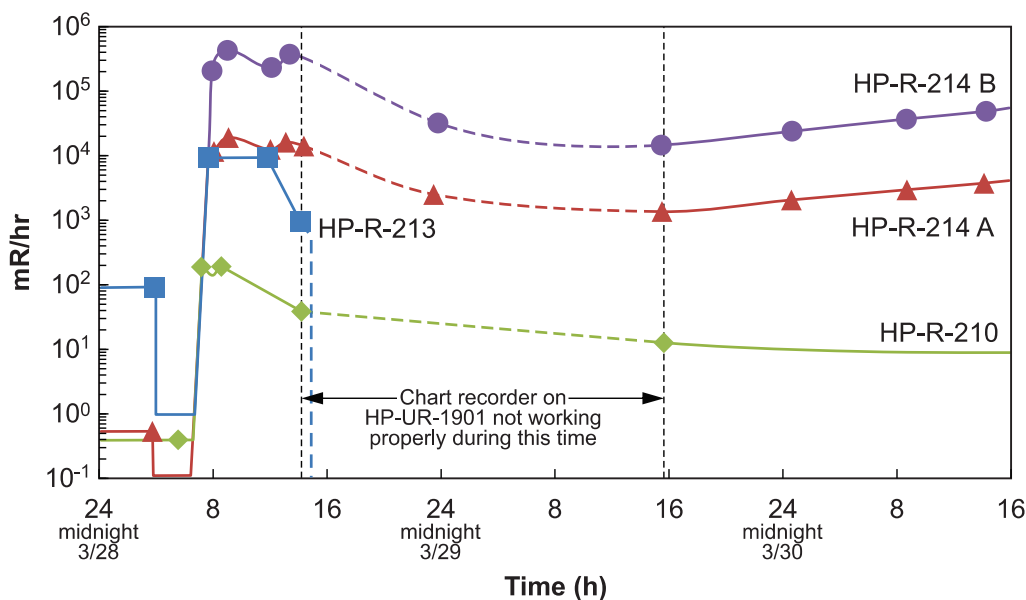
- Post-accident evaluations emphasized the need for more accurate containment radiation measurements. Identified Dome Monitor failures and data uncertainties (see Figure ES-12) led to several recommendations for design improvements, such as better seals that are periodically leak tested, the use of moisture and radiation resistant components and cabling, and relocating electronics outside the containment so that the lead shield could be removed.

Figure ES-12. Containment radiation monitor response (Two curves are provided for HP-R-214 to reflect upper and lower bounds associated with uncertainties in recording scale).

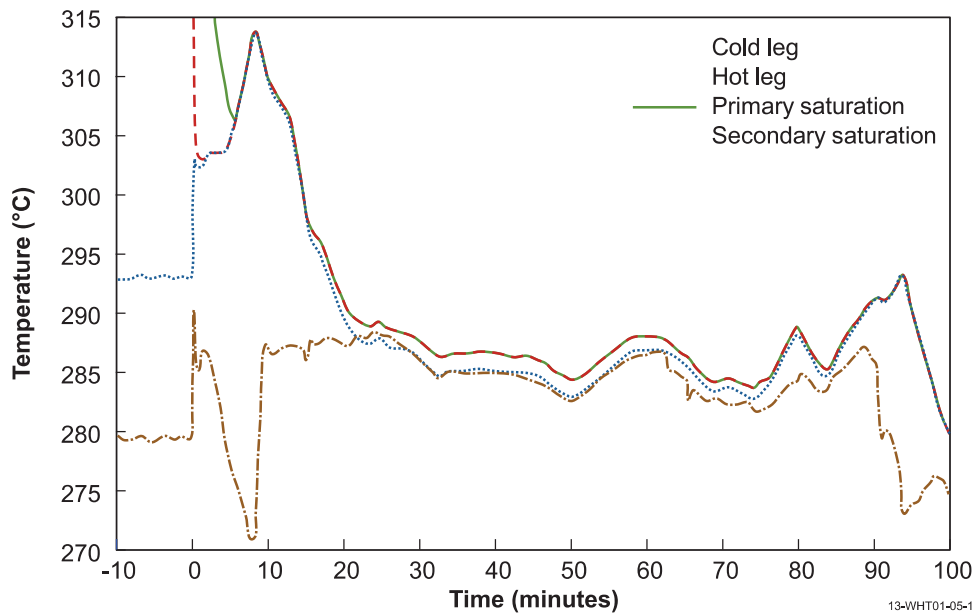
Figure 4-3 compares A-loop hot and cold leg temperatures with A-loop saturation temperatures in the primary and secondary system.⁵ Between 20 and 80 minutes, the fluid temperatures remained relatively constant, ranging from approximately 280 to 290 °C. Between 20 and 80 minutes, A-loop primary temperatures closely followed the secondary saturation temperature. During this time period, a two-phase condition existed throughout the primary system. As mass continued to be lost from the RCS through the PORV, the void fraction of the two phase flow increased. At about 85 minutes, feedwater injection into the A-loop steam generator apparently terminated. By 92 minutes, the A-loop steam generator secondary had boiled dry, which resulted in a significant decrease in primary-to-secondary heat transfer. As shown in Figure 4-3, the primary temperatures were significantly above the secondary saturation temperature. At 95 minutes, the auxiliary feedwater flow was increased to the A-steam generator, increasing primary-to-secondary heat transfer and enhancing cooling of the RCS.

Figure 4-3. TMI-2 A-loop temperatures (-10 to 100 minutes).⁵

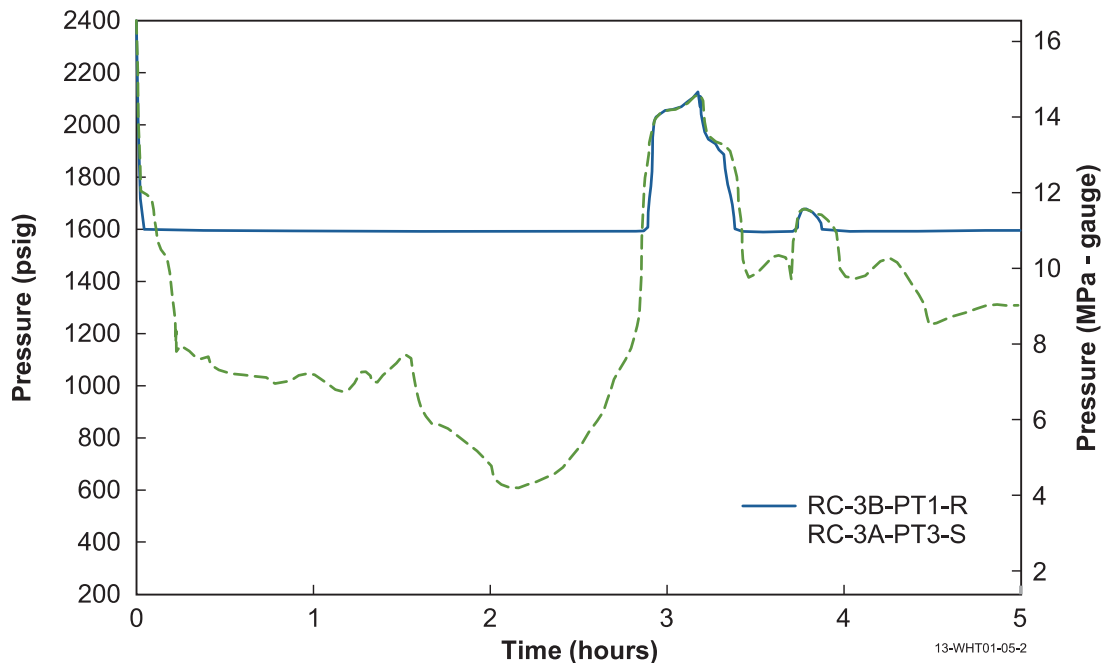
The system pressure prior to the accident initiation (initial condition) was 14.8 MPa-gauge. Output from one of the narrow range pressure transmitters in the B-loop (RC-3B-PT1-R)[†] was recorded on the reactimeter at a sample rate of one sample every 3 seconds. These data (see Figure 4-4) were considered to be the best available TMI-2 RCS pressure data.⁵⁰ Following the reactor trip, the primary system pressure quickly dropped below the minimum range for this measurement (by 2.2 minutes). With the exception of certain periods in which the system pressure increased to within the range of this transmitter (approximately 2.8 hours), other data sources were required for obtaining the primary system pressure.

* Although the narrow range measurement was set-up for a range of 11.7 to 17.2 MPa-gauge, the measurement continued to produce readings slightly below 11.0 MPa-gauge. Therefore, the reactimeter data down to 11.0 MPa-gauge was used in the composite pressure.

Figure 4-4. Comparison of A-loop wide range pressure recorded on the strip chart and the B-loop narrow range pressure on the reactimeter.

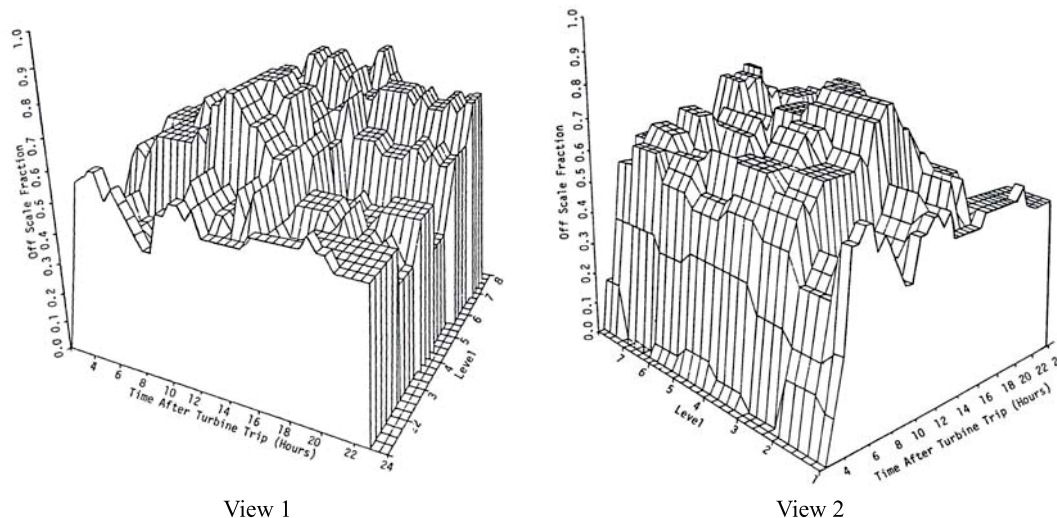
At 226 minutes into the accident, the Nuclear Science Advisory Committee (NSAC) report indicated that 51 SPNDs went offscale (see Figure 4-6). At this time, all or nearly all of the seven levels of SPNDs in locations G9, F7, F8, E7, G6, G5, H5, and M9 went off scale. This behavior suggests that something was happening along the full length of the fuel element. Since the SPNDs were individually sheathed and sealed, it is unlikely that a fault would propagate from one to another. Thus, the effect must have been external to the instrument tube. Subsequent furnace evaluations suggest that such behavior is consistent with a rapid temperature increase.

Figure 4-6. SPND Activity - Core Center.

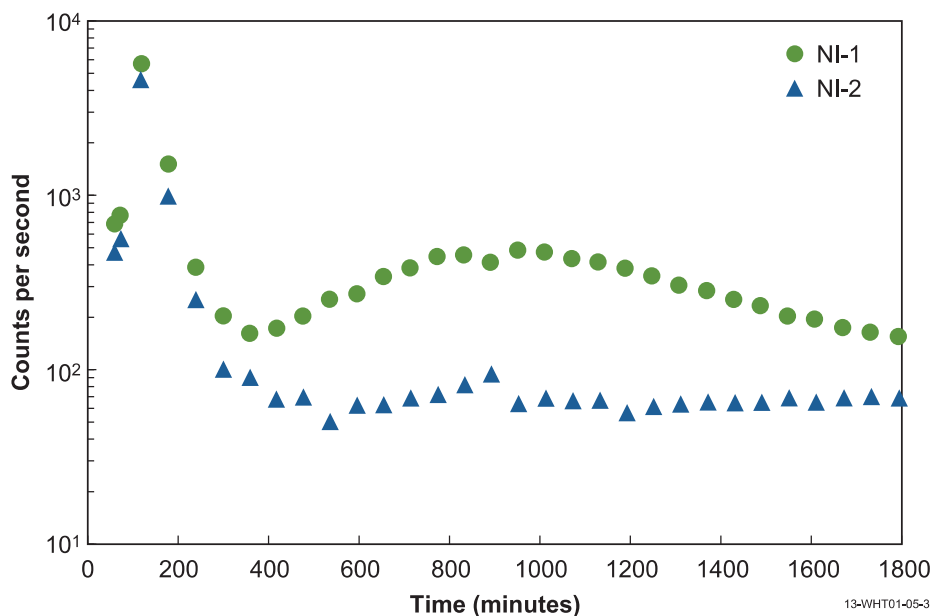
Both SRM NI-1 and IRM NI-4 data were on the stripchart recorder, so data were digitized for inclusion in the TMI-2 database.⁶⁸ In addition, data from the two SRMs were scanned and stored at hourly intervals on the plant computer. Figure 4-9 compares the NI-1 data stored on the computer, which was the only known source of data for NI-2, with data scanned from the stripchart for NI-1. The ordinate is the log of the counts per second. The amplitude as recorded on the plant computer appeared to be the most accurate, therefore, the amplitudes of the digitized data were adjusted to the computer values. Times for the digitized and computer printout data were adjusted to a zero time that corresponded to the time of turbine trip. Figure 4-10 compares plots of the IRM data from NI-4 and NI-3 during the first 1500 minutes after reactor trip. The ordinate is the log of the detector current in amperes. For most of the time duration plotted, the measured power levels are at the lower end of the IRM operating range.

Figure 4-9. SRM data.

Results⁶⁸ from an analysis of the data indicate that the peak uncertainty in the SRM data was about 7% when read from the computer and 9.3% from the stripchart. Analysis of the IRM measurement channel data indicate that the uncertainties were large when these detectors were operating at the lower end of their operating range. Hence, Reference 68 recommends that IRM data be classified as “Trend” data (see Section 3.4) and only be used to infer insights about the general shape of the neutron flux curve and the timing of plant events.

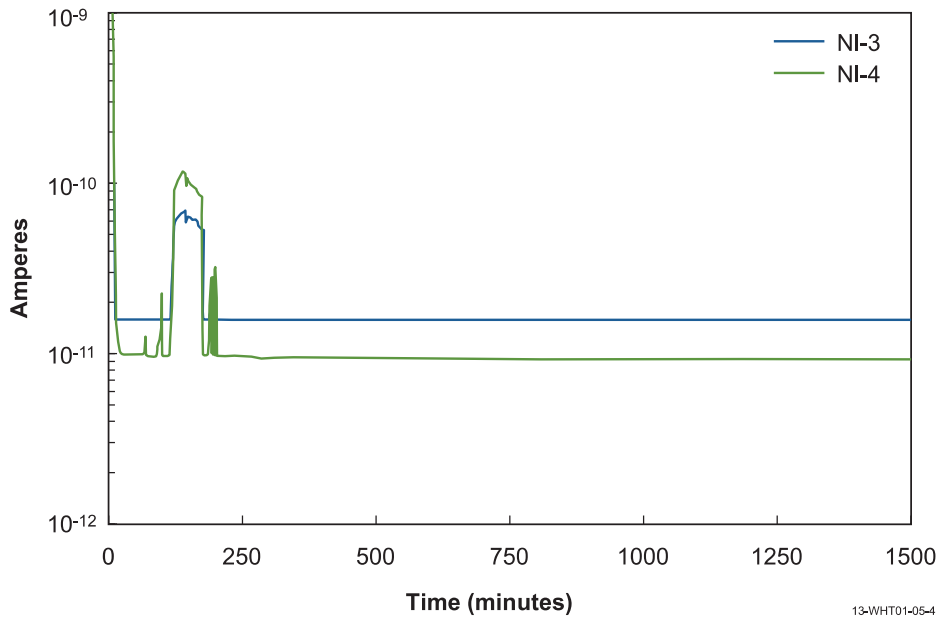
Figure 4-10. IRM data.

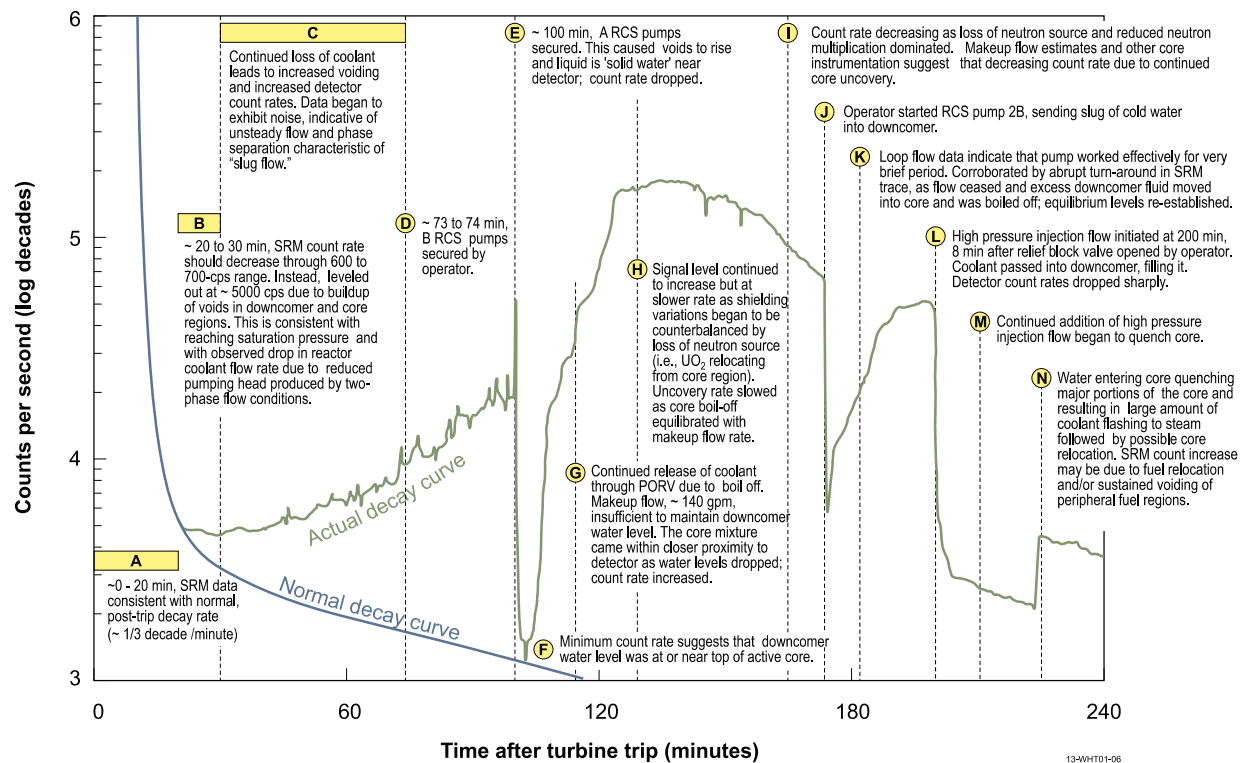
Events attributed to changes in the SRM response are shown in the annotated plot in Figure 4-14. For the first 20 minutes (A), SRM behavior was consistent with a normal post-trip decay rate of about one-third decade per minute. Between 20 to 30 minutes (B), the SRM count should be decreasing through the 600 to 700 cps range. However, the curve leveled out at around 5000 cps due to voiding (steam bubbles) in the downcomer and core regions. This hypothesis was consistent with the fact that the pressure had reached saturation and there continued to be outflow through the open PORV. Void formation is also con-

sistent with the observed drop in reactor coolant flow rate. Continued loss of coolant from the primary system (C) led to increased voiding and detector count rates. At approximately 73-74 minutes (D), the B reactor pumps were secured by the operators. At 100 minutes (E), the A pumps were secured. This caused a flow transient and voids separating to the upper regions of the RCS. The coolant filled lower regions of the RCS and caused an abrupt drop in the detector count rate (F). Continued release of fluid out of the PORV was not offset by available makeup flow, leading to an increase in count rate (G). Competing effects (H) caused the count rate to increase at a slower rate until the count rate started to decrease (I). Startup of RCS 2B pump (J) filled the downcomer. At 200 minutes, high pressure injection flow initiated (L) filling the downcomer and causing the detector count rate to drop. Relocation of core materials (N) may have led to an increase in count rate.

Figure 4-14. TMI-2 SRM response during the first 4 hours of the accident.

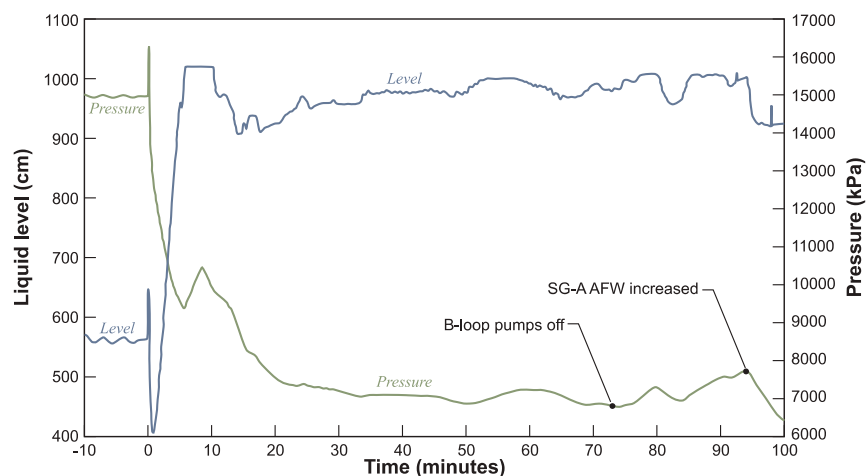
Figure 4-17. TMI-2 pressurizer liquid level and primary system pressure (0 to 100 minutes).

The pressurizer level, which was off-scale high (1016 cm) at 6 minutes, came back on scale by 11 minutes and remained on scale, though very high, through the rest of the time period shown in Figures 4-16 and 4-17. As the primary-to-secondary heat transfer degraded (in response to the termination of feedwater and the resulting decreasing secondary liquid level), more energy was released from the core than was removed from the RCS. The RCS coolant expanded, increasing RCS pressure. The pressurizer liquid level and RCS pressure continued to increase until the PORV opened at an RCS pressure of 15.7 MPa (at 3 s), and the reactor scrambled on a high-pressure trip at 16.3 MPa (at 8 s). After reactor scram, more energy

After approximately the first 20 minutes, the RCS pressure remained nearly constant at 7 MPa (see Figure 4-17). The operators, responding to the high pressurizer liquid level, decreased makeup flow and increased letdown flow. This resulted in an increasing RCS void fraction but did little to affect the pressurizer liquid level which was responding to the pressure differential caused by continued flow through the still-open PORV.

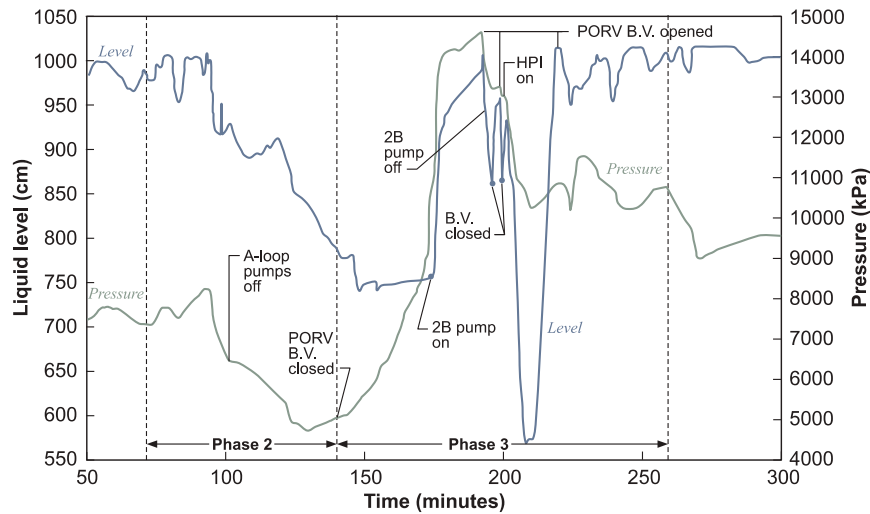
Figure 4-18. TMI-2 pressurizer liquid level and primary system pressure (50 to 300 minutes).

At 139 minutes, the operators closed the PORV block valve (see Figure 4-18). Between the time that core uncovering began (at about 125 minutes) until the PORV block valve was closed at 139 min, the pressurizer water level decreased at a rate of 4.6 cm/min (1.8 in./min). Heater operation at a power of 1386 kW would account for a rate of 2.0 cm/min (0.8 in./min). The remainder of the steam flow out the PORV would have been from steam generated in the core and entering the pressurizer through the surge line. Since part of the steam flowing out the PORV was generated in the pressurizer, the reduced steam velocities in the surge line probably allowed some liquid to drain out of the pressurizer.

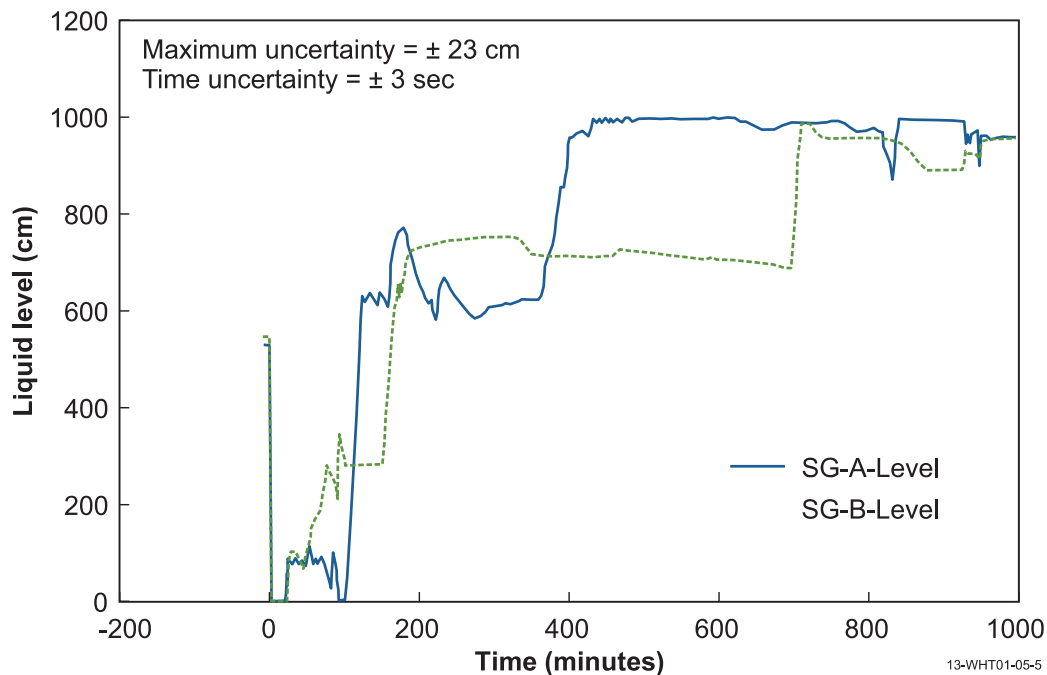
In order to obtain an accurate time history of the secondary liquid levels, all three measurements had to be converted to a common basis. However, Reference 77 omitted the full range transmitter from this process because it was observed that an installation issue had led to the full range transmitter giving erroneously low readings whenever the steam generator was steaming. Two problems must be addressed in combining readings from the startup and operating transmitters. First, the pressure drop across the orifice is unknown during the time of feedwater flow. However, once the feedwater pump tripped, the two levels should have equalized within a short time period, at least by the time that the secondary level increased to the bottom tap of the operating level at 259 cm. The second problem with direct comparison of the levels is the need to consider temperature compensation of the operating level to compensate for changing liquid density as secondary pressures and temperatures change.

The best estimate composite water level obtained by converting the recorded operating level and start-up level for the A-loop and B-loop OTSG are shown in Figure 4-20 for the first 1000 minutes of the accident. Data chosen prior to the feedwater pump trip was from the start-up level transmitter. Then, the composite level was obtained by using the start-up level for levels less than 550 cm and the operating level for levels greater than 550 cm. No adjustment was made in the A-loop level during the period when the operating level was saturated.

Figure 4-20. Water level in each TMI-2 steam generator.

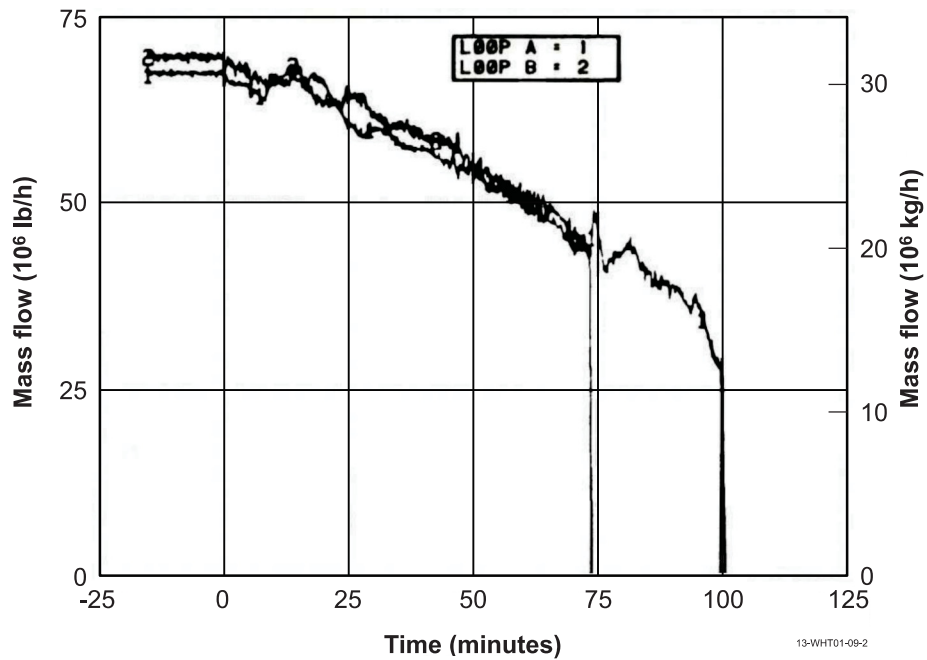
The mass flowrate and temperature in the primary coolant system were recorded on the reactimeter prior to and during the accident, which was set to sample each channel on a 3 second interval. As shown in Figure 4-21, the mass flowrate data are somewhat noisy.

The flowmeter was designed to operate near the normal reactor full power conditions. During the accident, the flowmeter continued to indicate mass flowrate but was using an erroneous coolant density when the RCS depressurized and the coolant voided. Hence, the mass flowrate data from each hot leg had to be corrected for the error caused by calculating the liquid density using the flowmeter electronic circuits. Although it was known that the reduction in liquid density was due to the increased void fraction in the liquid, there was no way of knowing the time-dependent void fraction. A method was devised to estimate the maximum and minimum possible void fractions in the hot leg liquid. From these values, lower and upper densities were calculated. The recorded mass flowrate data were then corrected using the upper and lower density limits to yield a maximum and minimum probable mass flowrate. The mean value between the upper and lower limits was used as a substitute for the expected value. The actual expected value was thought to be between the mean value and the upper flowrate bound. Figure 4-22 shows the qualified mass flowrate data but with error bands. The error bands show calculated uncertainties, and qualified mean val-

Figure 4-21. Recorded hot leg mass flow rate.

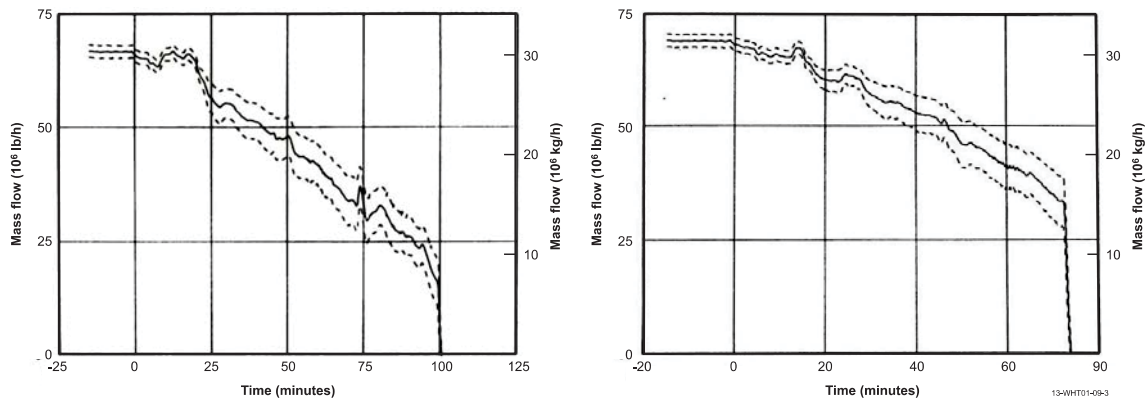
Figure 4-22. Qualified hot leg mass flow rates and uncertainties.

ues have been corrected for all known errors. As documented in Reference 82, the mass flowrate data were classified as “Qualified.”

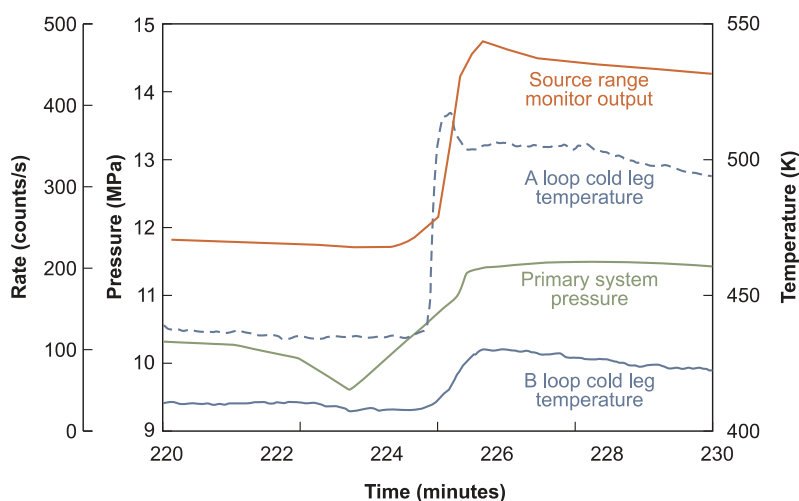
Initially, RCS sensors were interrogated in-pile and data were compared with data from other sensors to evaluate if responses were consistent (e.g., higher temperatures at times when flux levels implied lower water levels, etc.). In addition, a comprehensive review provides confidence about the timing of accident phenomena such as a major relocation of materials from the reactor core to the lower head. For example, the consistent increase from various sensors shown in Figure 4-23 suggests when relocation of core debris to the lower head occurred. The SRM count rate increased approximately 100% in less than 2 minutes (between 224 and 226 minutes) and then indicates a normal decay profile. Measured cold leg temperatures and RCS pressure shown in Figure 4-23 also increase rapidly at a time nearly coincident with the time when the abrupt increase in SRM response occurred.

Figure 4-23. Overlay of SRM count rate, RCS pressure measurements, and cold leg temperatures.

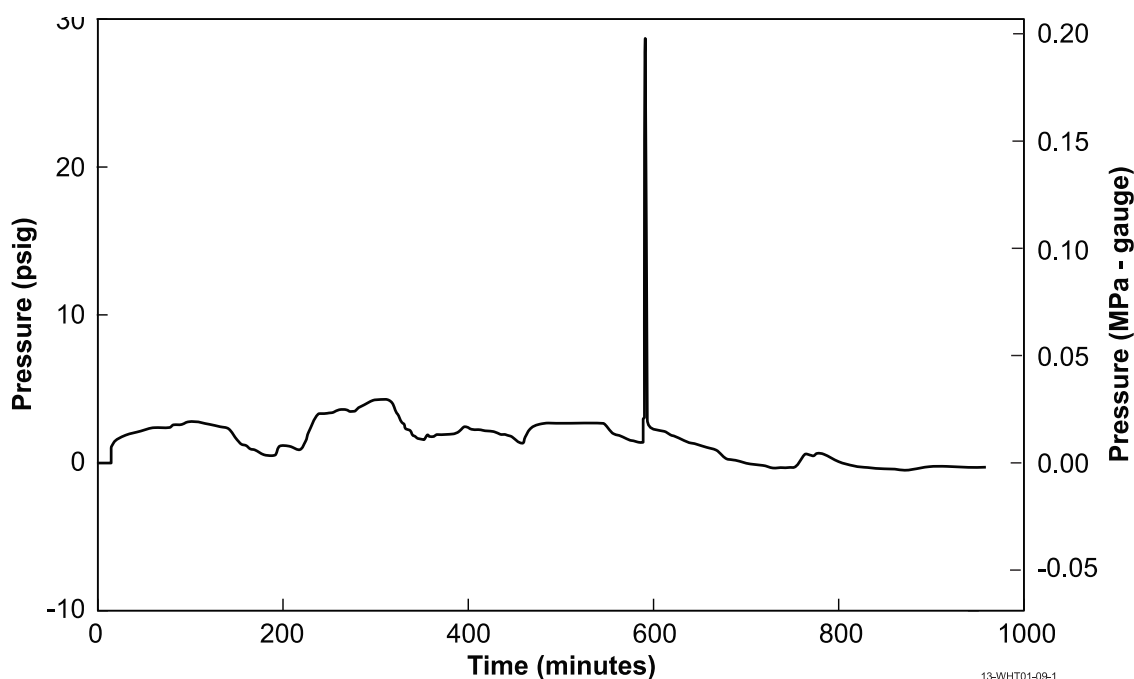
Reactor building pressure was estimated by combining the narrow range data and the single data point for the pressure spike from the wide range channel. This combined measurement was designated as BS-PT-4388-S. The recommended composite reactor building pressure data are shown in Figure 5-1.

Figure 5-1. Containment building pressure.

Data uncertainty estimates are +2 kPa-gauge for the narrow range measurement and +14.8 kPa-gauge for the wide range estimate. The magnitude of the pressure spike, which occurred at the hydrogen burn was 0.20 MPa-gauge from the wide range pressure measurement, BS-PT-4388-W-S. This compares well with other recorded pressure data, considering uncertainty associated with data digitization. The recommended composite reactor building pressure data were deemed “Qualified” in the TMI-2 Database.

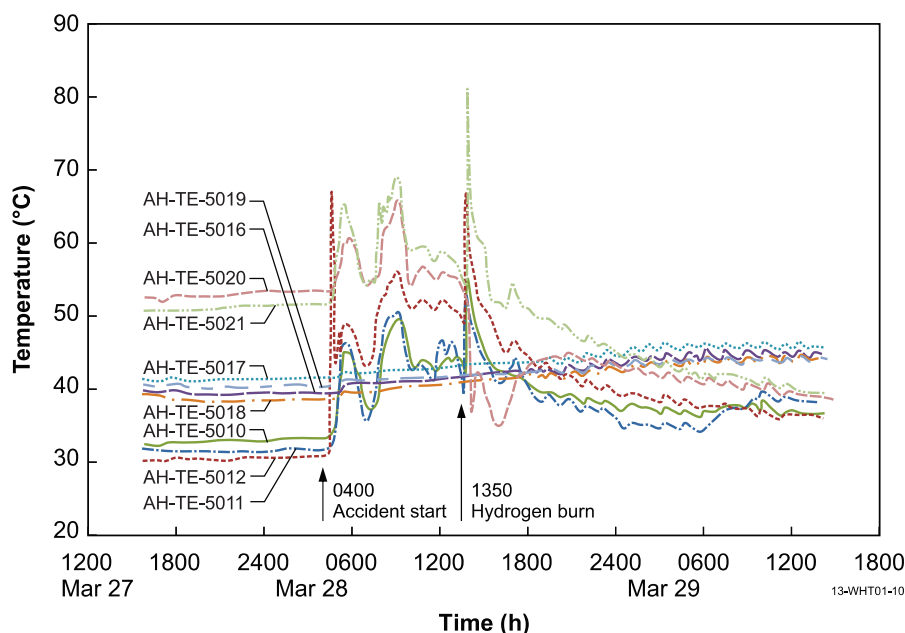
Figure 5-2 shows selected RTD data. Certain locations, such as the reactor coolant drain tank room (RTD 5012), experienced many temperature changes. Other locations showed no temperature change, such as the primary shield (RTDs 5016 through 5019). None of the 16 RTDs indicated a peak temperature greater than 90 °C. However, during the hydrogen burn, the top ceiling RTD 5020 behaved unexpectedly

and recorded a negative trending trace, probably because of spray activity. Most other locations, including the other top ceiling RTD recorded a positive-trending trace during this time.

Figure 5-2. Reactor building temperatures at selected locations.

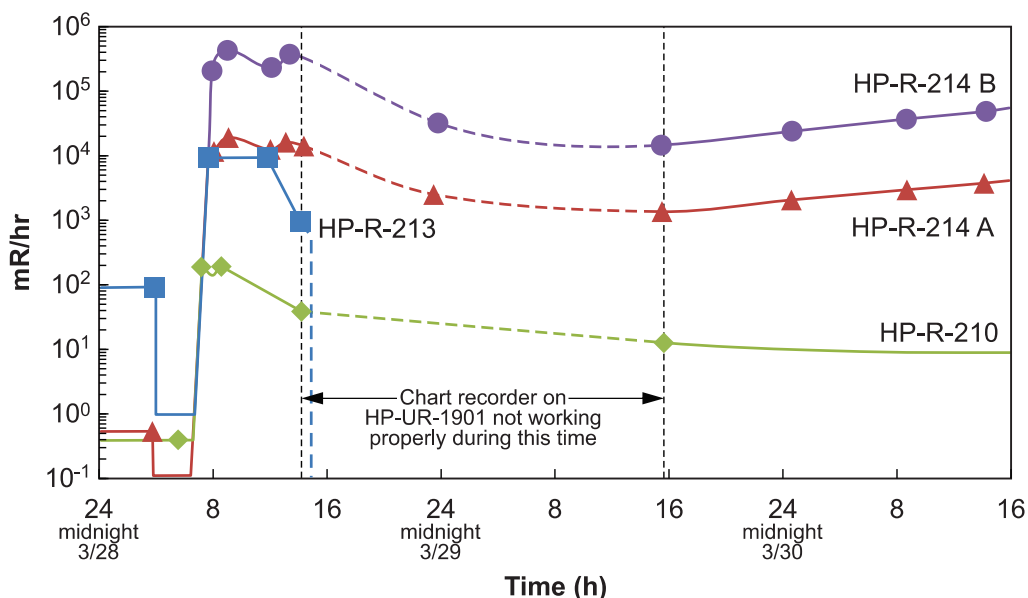
Figure 5-6 compares data from HP-R-210, HP-R-213, and HP-R-214. Two curves, HP-R-214A and HP-R-214B, are given for the dome monitor. These two curves are due to uncertainties in the scale on the recorders. Curve A was prepared on the assumption that the span of HP-R-214 covered the full ten inches of recorder HP-U-1901 chart paper. A calibration performed after the accident suggested that the span of the instrument only covered eight inches, i.e., full range of 10^7 mR/hr occurred at 3.9 decades on the HP-UR-1901 chart. Since such a shift in calibration could have occurred immediately after the accident, there is no way to determine which calibration applied at the time of the accident. Therefore, these curves may be considered as upper and lower bounds. Furthermore, it should be noted that there are additional uncertainties associated with HP-R-214 data because the dome monitor was positioned inside a lead-lined stainless steel shield.

Figure 5-6. Containment radiation monitor response (Two curves are provided for HP-R-214 to reflect upper and lower bounds associated with uncertainties in recording scale).

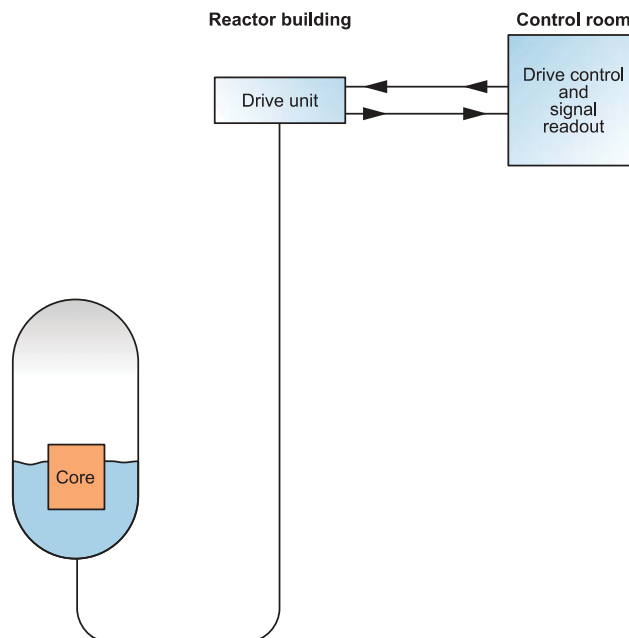
The normal parking position for the detector was approximately 3 m below the active section of the core. It could normally be inserted to a point a few centimeters above the active length of the core. During the early hours of the accident, an attempt was made to make a traverse of the core with the MIDS. The detector could not be moved from the parking location. A second attempt to move the detector was also unsuccessful. However, on the third attempt on April 11, the detector moved away from the parking posi-

Figure A-5. Moveable in-core detection system.

tion toward the core. After the detector moved only a foot or two into the core, it encountered resistance. Finally, when the unit was inserted approximately three feet into the core, it became stuck and could no longer be either inserted or withdrawn. From these observations, one may conclude that debris had been driven through the tube and deposited around the detector, and that this debris was dislodged after several attempts to insert the detector. After finally getting the detector underway, it encountered an obstruction at the three-foot level. This suggests that the guide tube was damaged and had admitted debris, and that the damage was enough to distort the tube down to the three foot level.

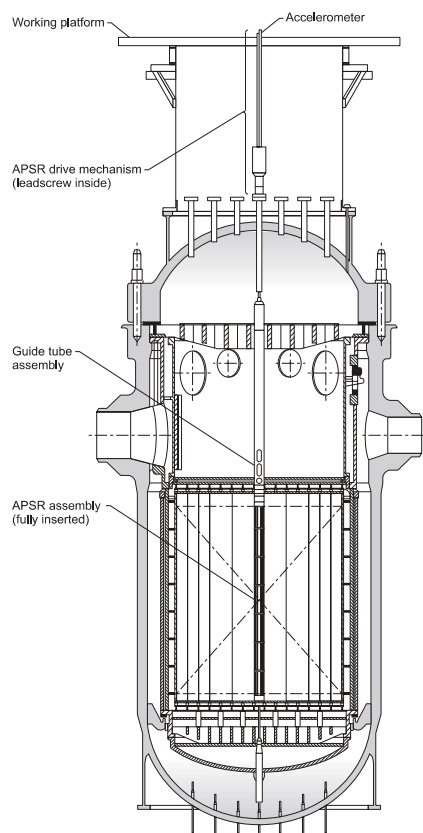
As noted in Reference 106, the position indicators for the APRs survived the accident. However, as noted in References 106 and 107, initial attempts (June 23 to 25, 1982) to insert the APSRs encountered blockages in certain core positions. Although nearly half of the APSRs could be entirely (or almost entirely) inserted into the core [at locations 62(F-4), 65(N-10), 66(L-12), and 67(F-12)], APSRs encountered blockages that precluded much (or any) additional movement at other locations [e.g., 63(L-4), 64(N-6), 68(D-10), and 69(D-6)]. Reference 107 noted that the locations where APSRs could be fully inserted correlated with locations where severe damage was observed in the initial “Quick Look” video inspections of the TMI-2 core. It was speculated that nearly complete insertion was possible because there was nearly total breakup of fuel assemblies and APSR assemblies at these locations. In addition, Reference 107 hypothesized that limited or no APSR movement at other locations was due to interference from core debris or distorted upper plenum support plates. Although qualitative insights were possible, no definitive information related to the physical condition of the TMI-2 core was obtained from the APSR evaluations.

Figure A-7. Cross section of TMI-2 reactor vessel, showing typical axial power shaping rod assembly.
