Causal Analysis of the Inadvertent Contact with an Uncontrolled Electrical Hazardous Energy Source (120 Volts AC)

**Level 1 Cause Analysis
ORPS Number: NE-ID—BEA-HFEF-2013-0003
ICAMS Number: IO-029749
Event Occurred: September 25, 2013**

**Idaho National Laboratory
Idaho Falls, Idaho 83415**

INL/EXT-13-30442

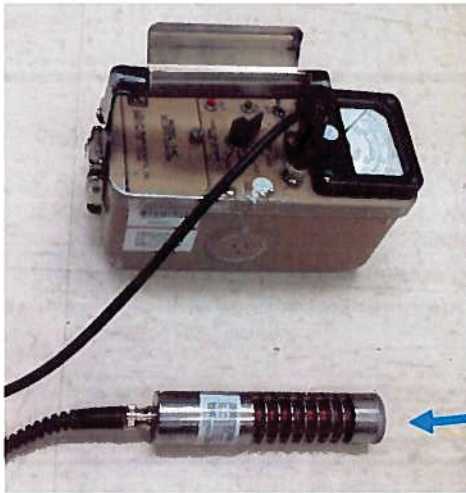
Figure 2. Type 14-C β/γ meter and probe

This activity involves an HPT setting up and climbing a portable ladder to remove the 14-C meter probe from above ball valve HBV-7. The HPT source checks the meter and probe and then replaces the probe above HBV-7, which is located above *Hood ID# 130 HP* (see Figure 2 & 3).

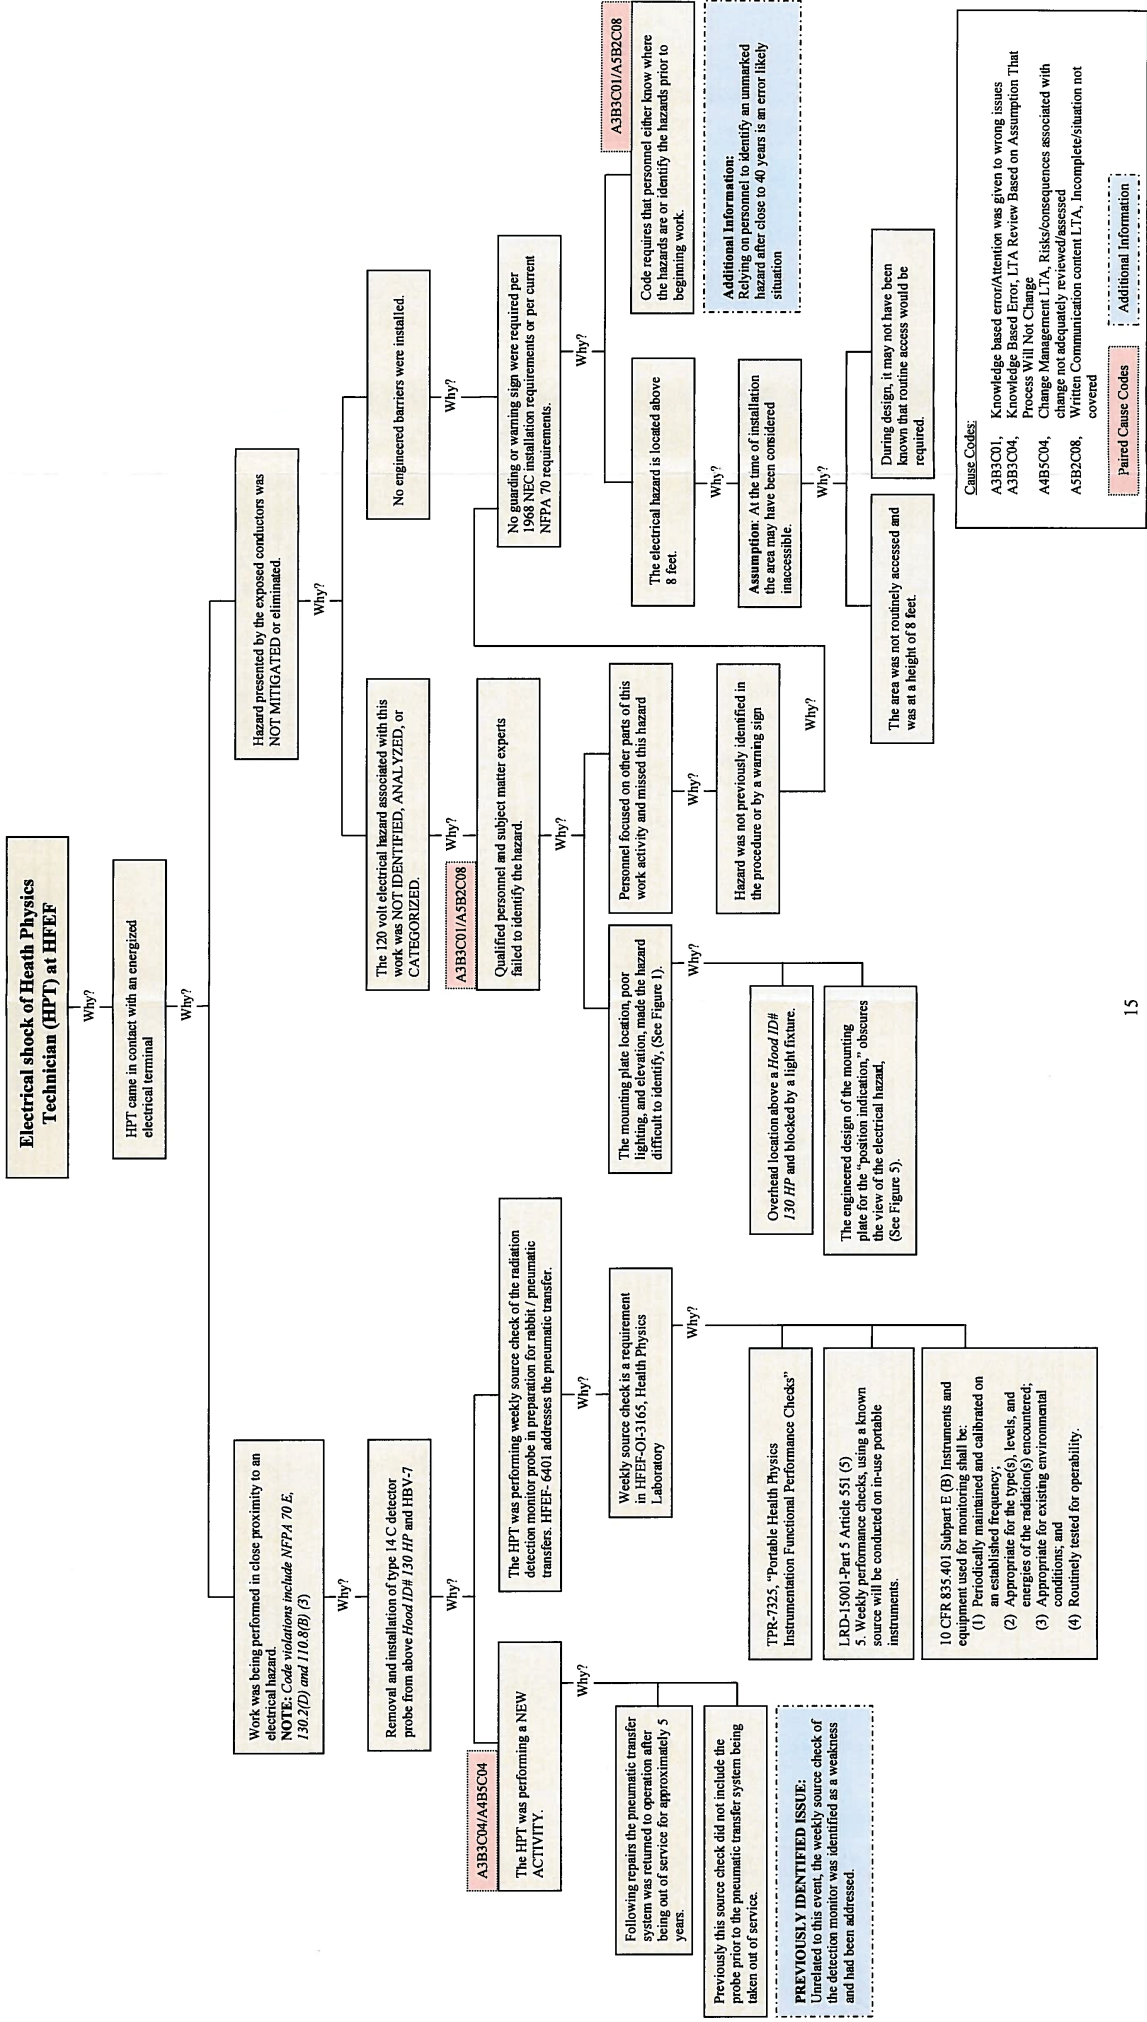
Appendix A Why Tree

The Causal Factor (root cause) was attention being given to the wrong issues during the creation, reviews, verifications, and actual performance of HFEF OI-3165, which covers the need to perform the weekly source check and ensure placement of the probe prior to performing a "rabbit" transfer. This resulted in the hazard not being identified and mitigated in the procedure. Work activities with in HFEF-OI-3165 placed the HPT in proximity of an unmitigated hazard directly resulting in this event.
